Construction noise and vibration Monthly Report – July 2024

London Borough of Hillingdon

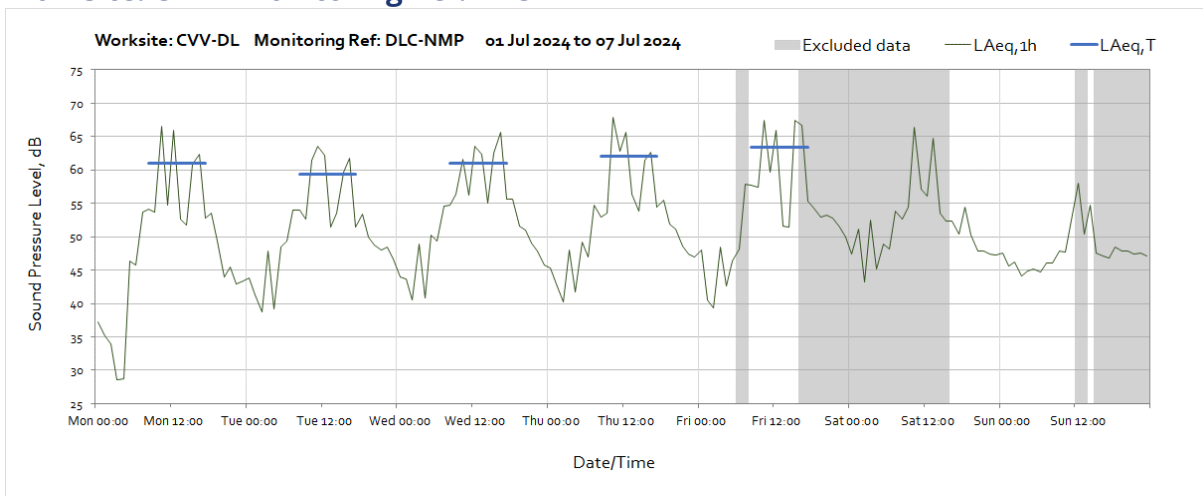
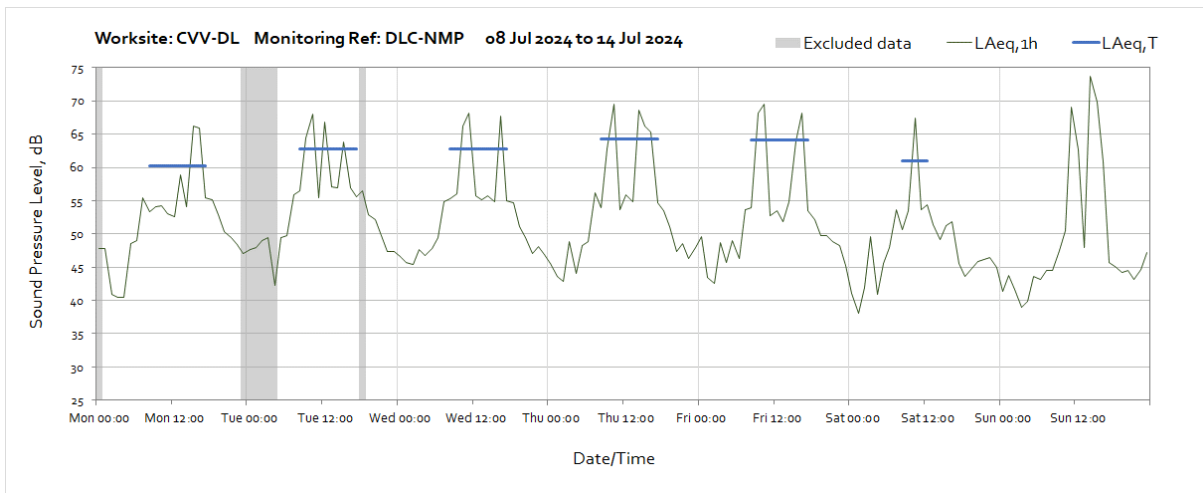
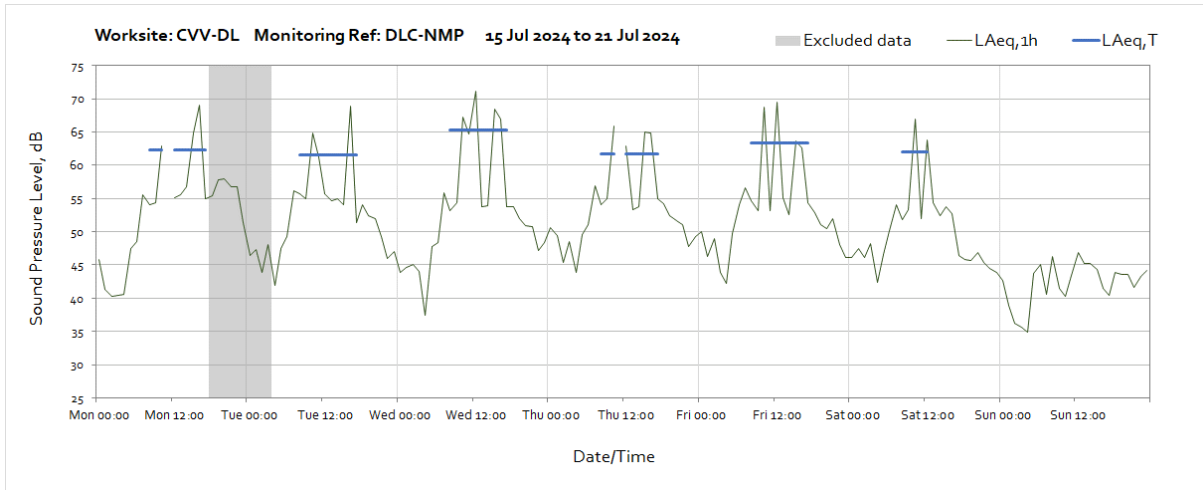
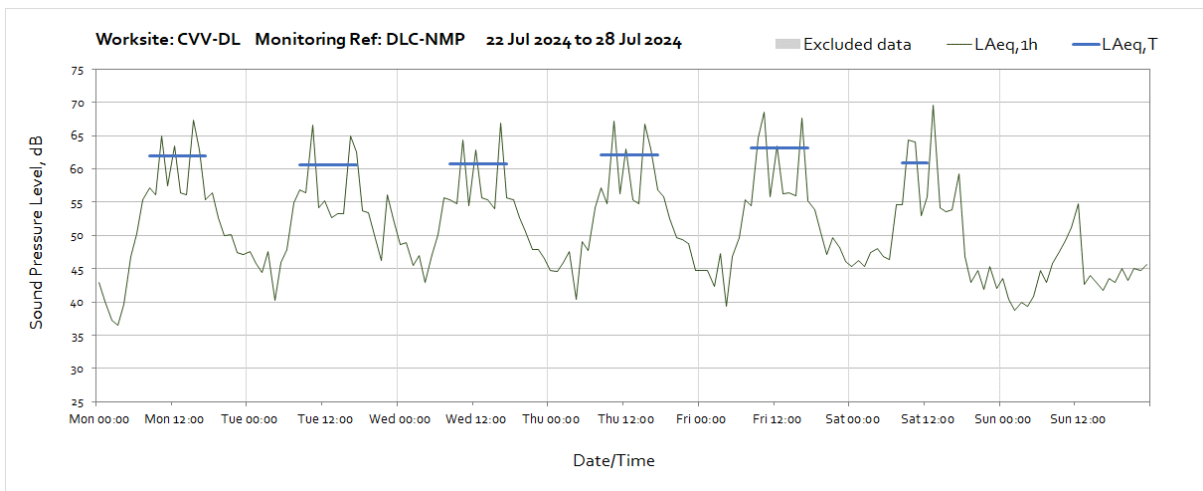
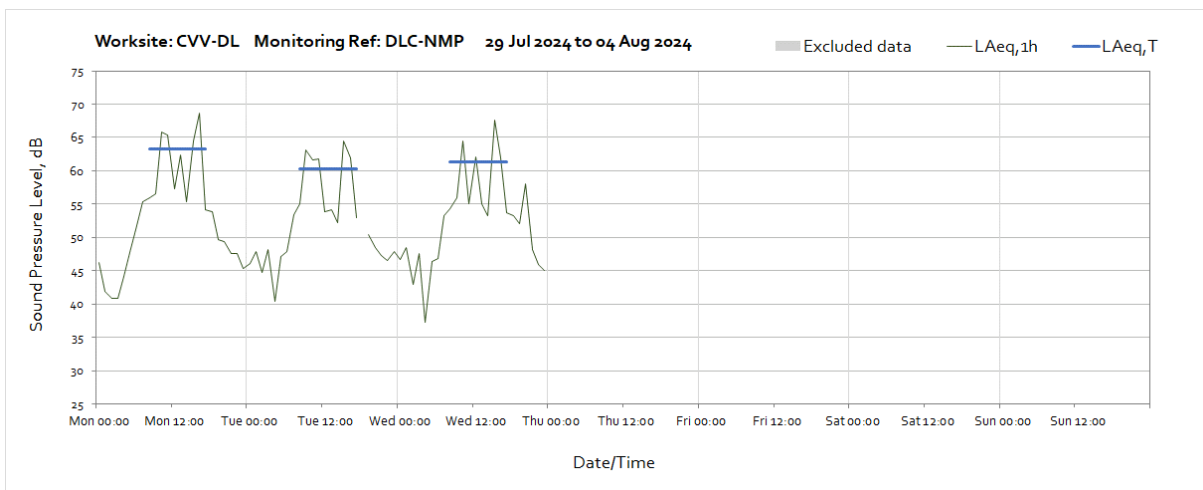
Worksite: CVV - Monitoring Ref: DLC-NMP

The following graphs show the hourly measured ambient noise level $L_{Aeq,1h}$ and, where relevant, the averaged noise level $L_{Aeq,T}$ values, where the time period T is as specified in Table 1 of HS2 Information Paper E23. Periods where noise levels are adversely affected by weather or only measured for part of the period, which are not representative of HS2 construction works, have been greyed out and excluded from the calculation of the $L_{Aeq,T}$ values in Table 3 of the main report.

Note: Missing data between 10:00 and 12:00 on Monday 15th July was due to a communication error between the monitoring station and server. Missing data between 10:00 and 12:00 on Thursday 18th July was due to monitoring station field calibration.

Note: Missing data between 17:00 and 19:00 on Tuesday 30th July was due to a communication error between the monitoring station and server.

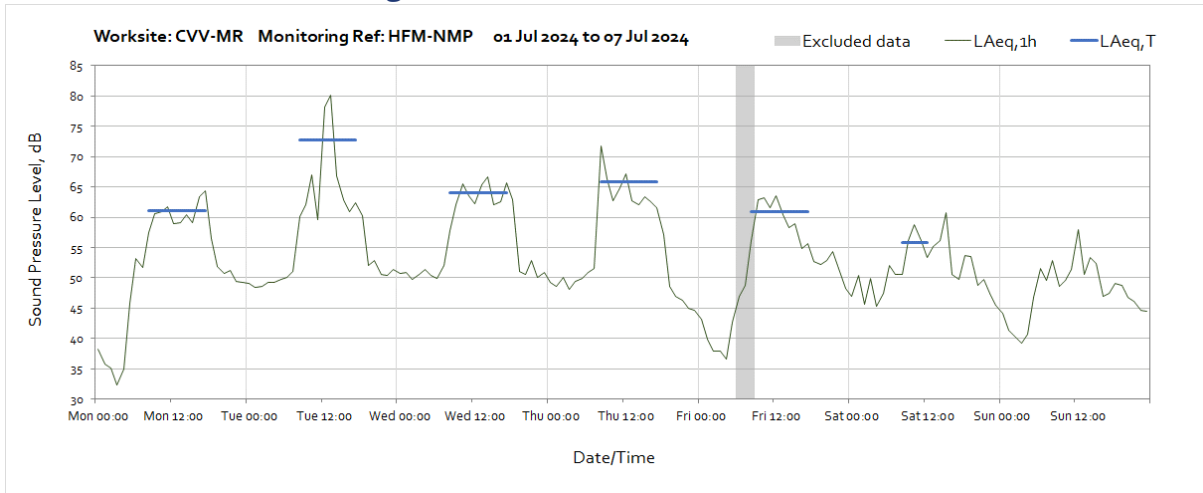
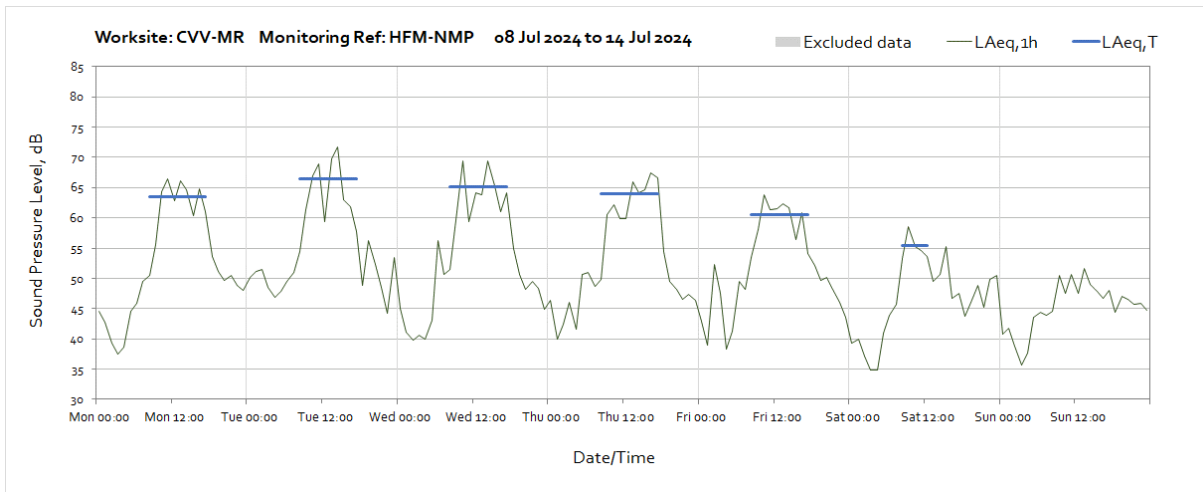
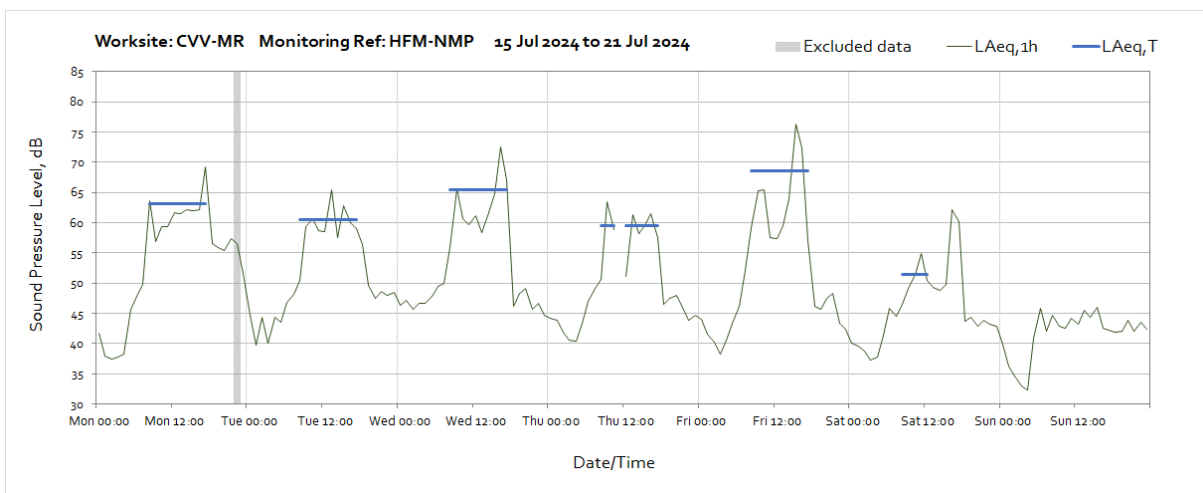
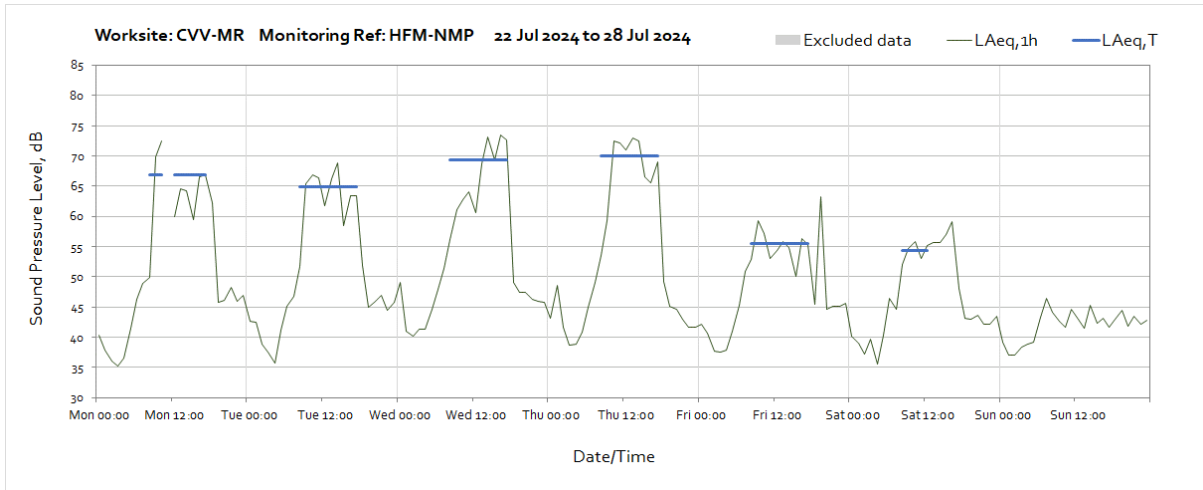
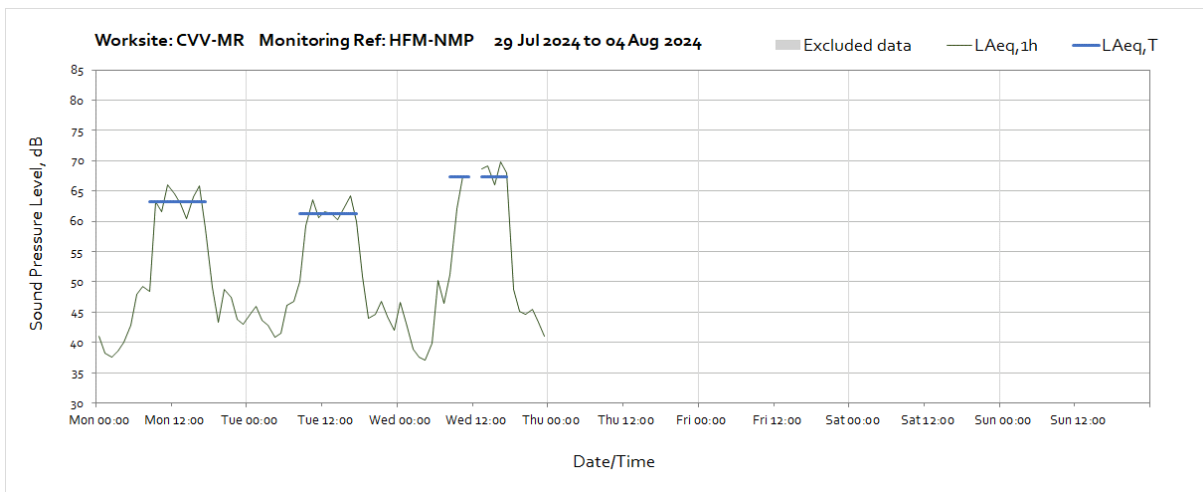
Worksite: CVV – Monitoring Ref: HFM-NMP

Note: Missing data between 10:00 and 12:00 on Monday 22nd July was due to monitoring station field calibration.

Note: Missing data between 11:00 and 13:00 on Wednesday 31st July was due to a communication error between the monitoring station and server.

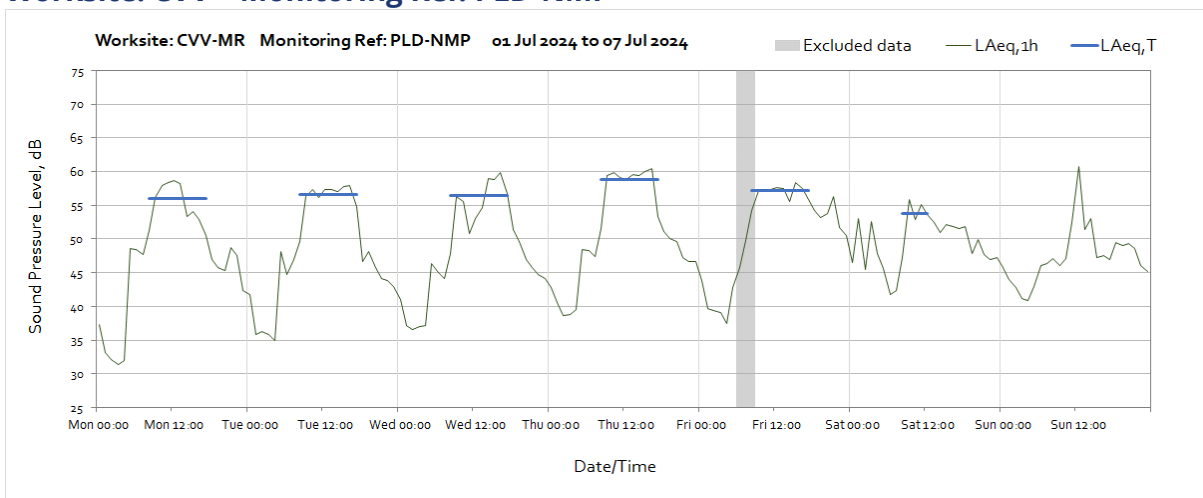
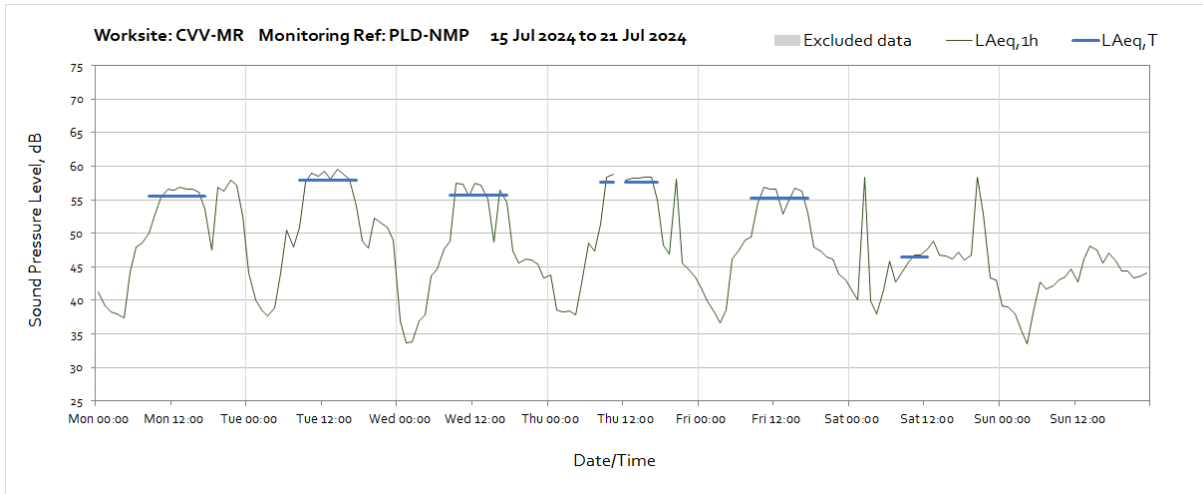
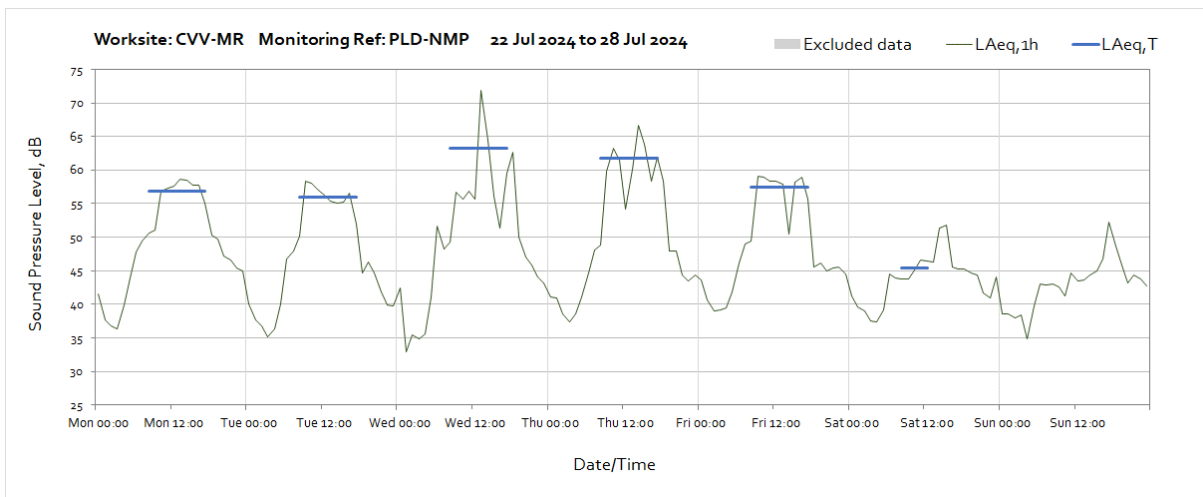
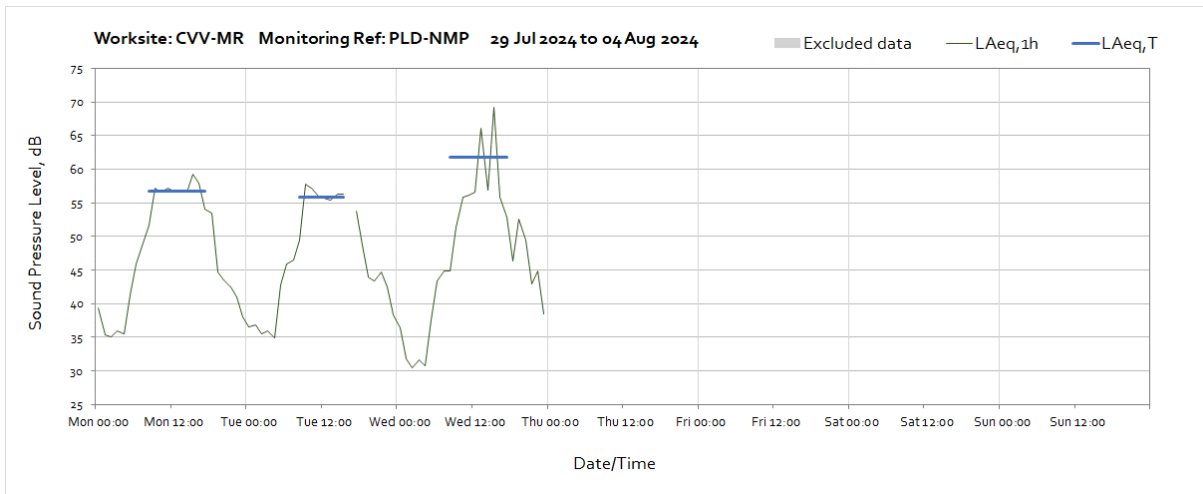
Worksite: CVV - Monitoring Ref: PLD-NMP

Note: Missing data between 10:00 and 13:00 on Thursday 18th July was due to monitoring station field calibration.

Note: Missing data between 15:00 and 17:00 on Tuesday 30th July was due to a communication error between the monitoring station and server.

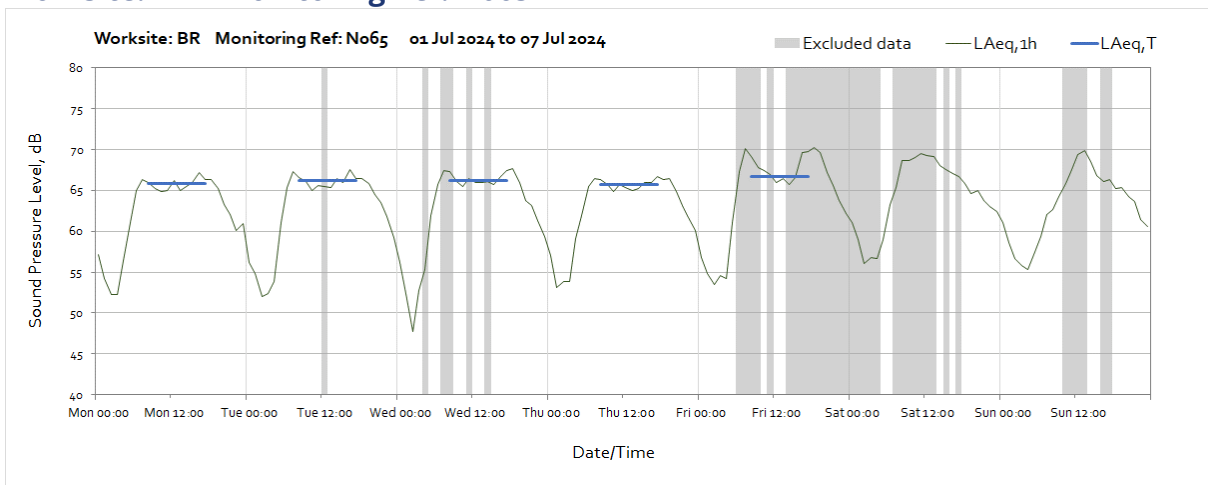
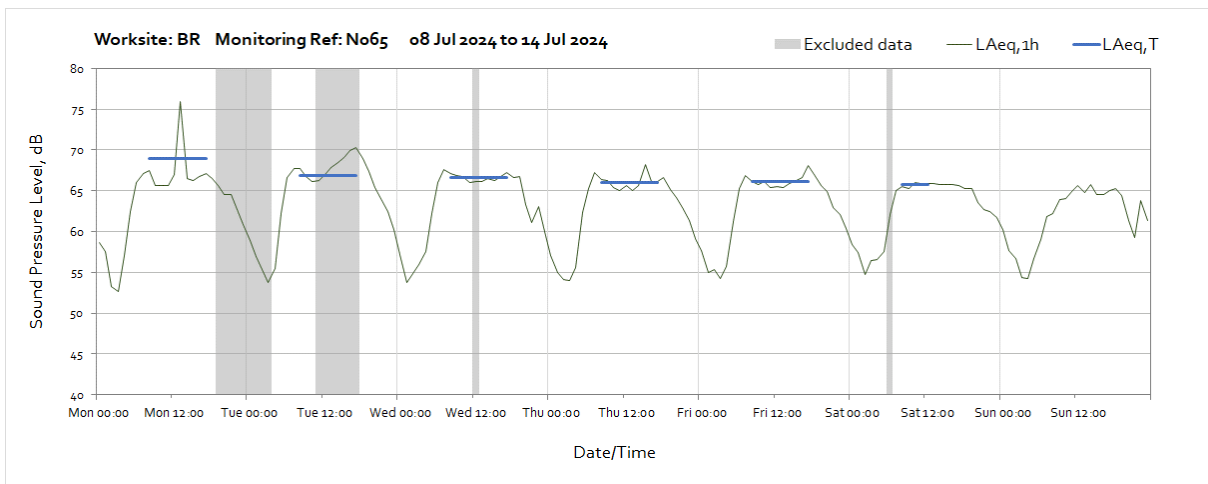
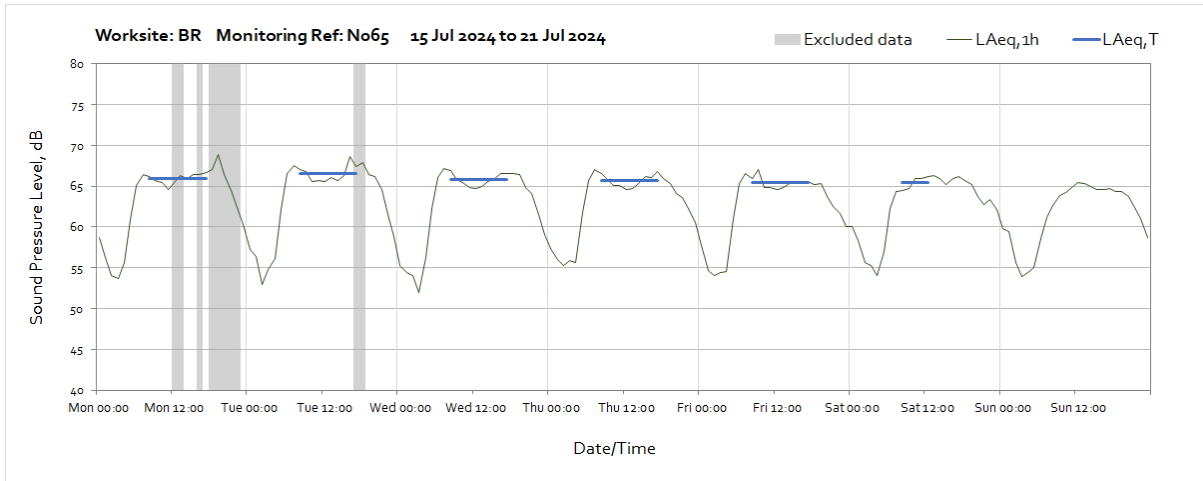
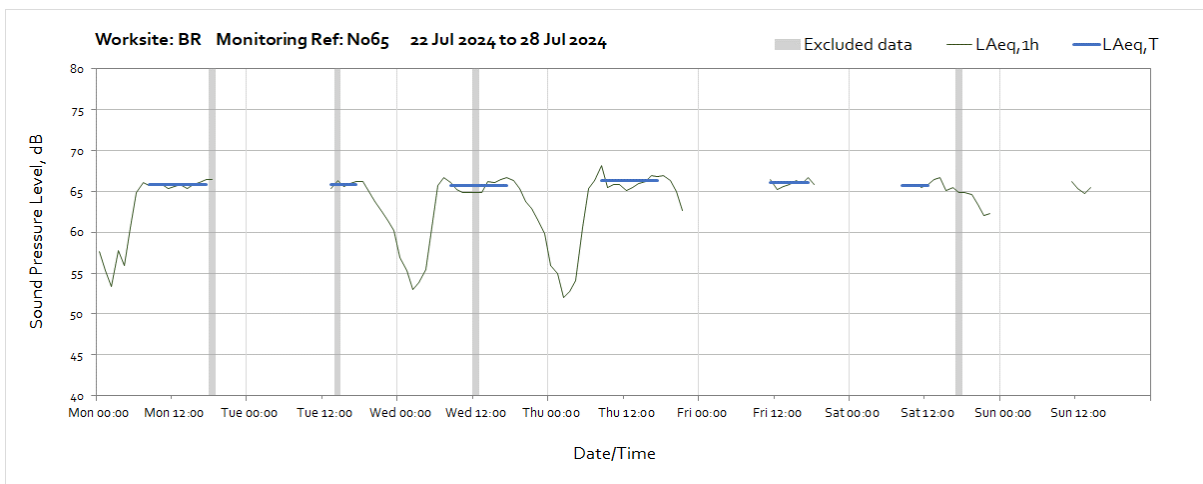
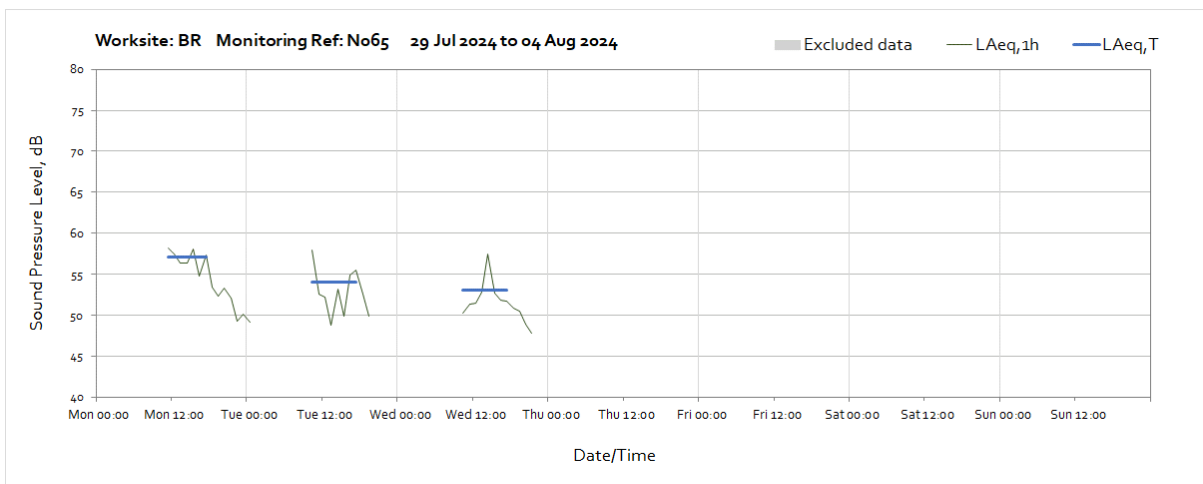
Worksite: BR - Monitoring Ref: N065

Note: Missing data throughout the week was due to a loss of power to the monitoring station caused by poor weather conditions preventing sufficient light reaching the solar panel.

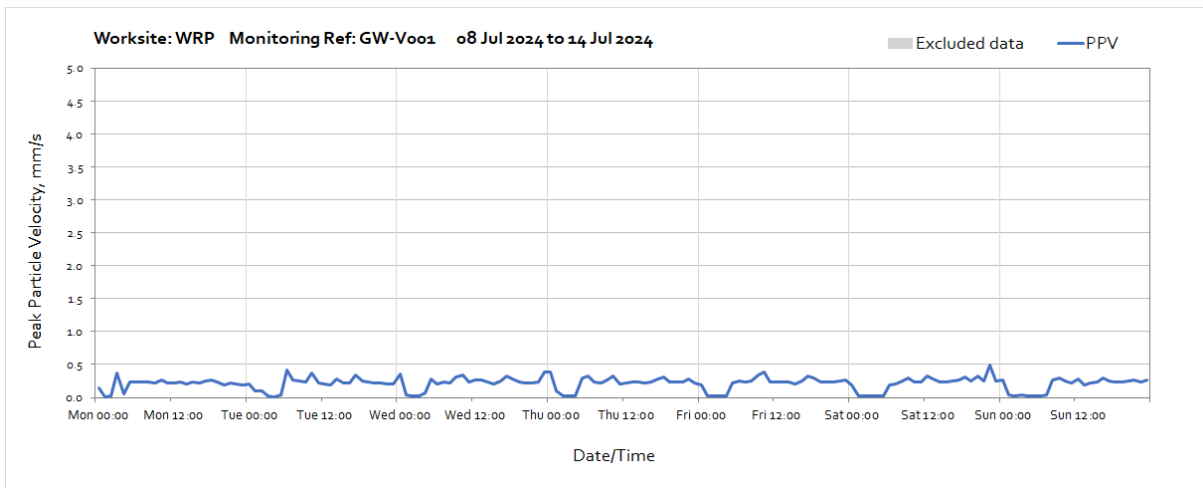
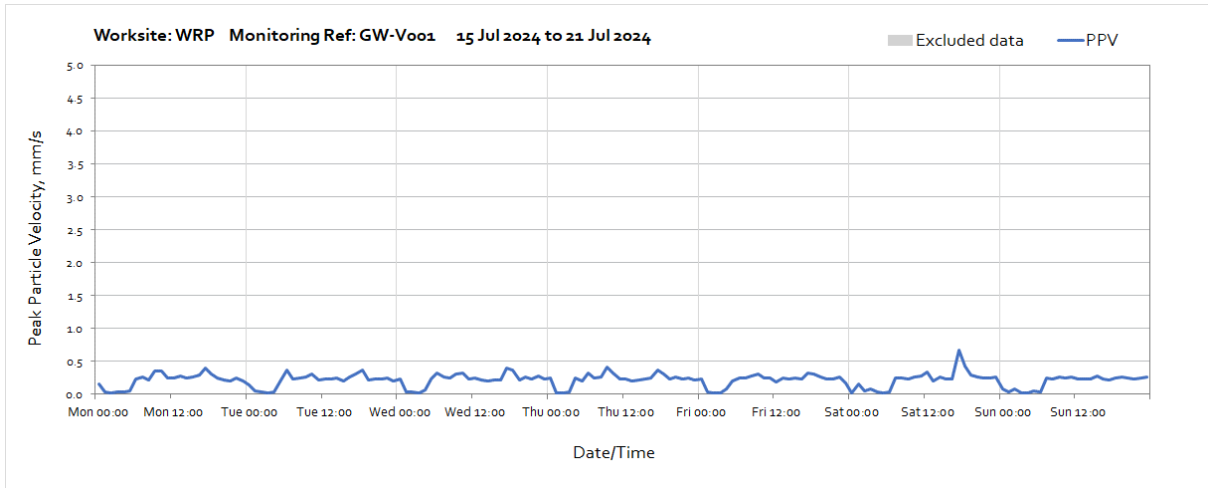
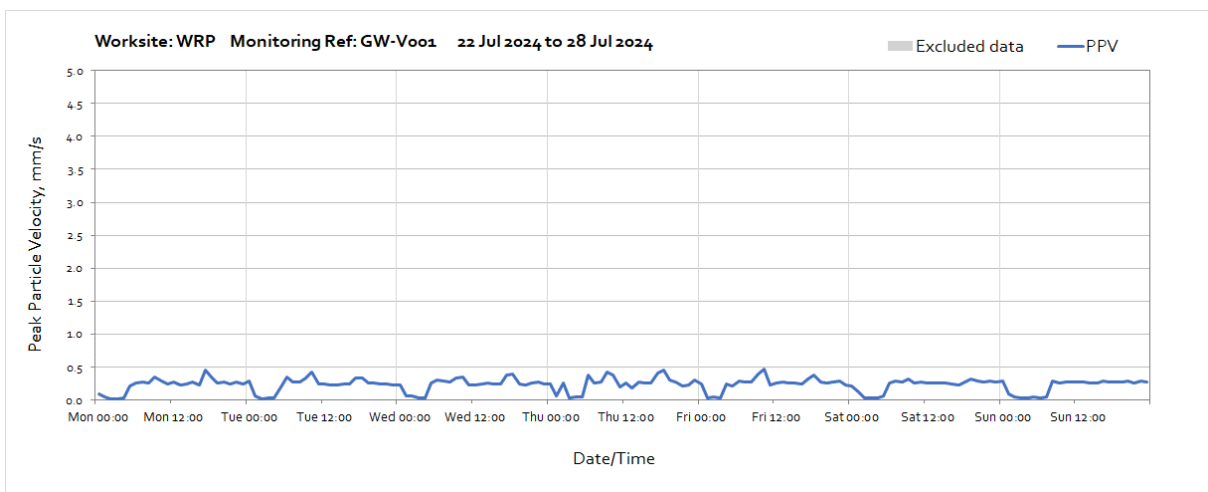
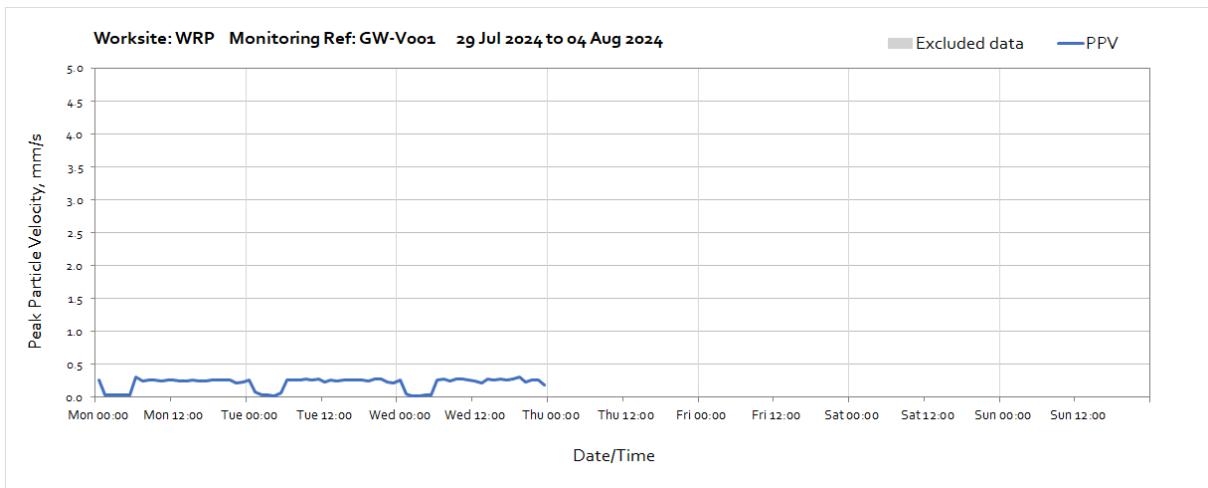
Worksite: WRP – Monitoring Ref: GW-V001

The following graphs show the hourly measured peak particle velocity PPV recorded during the monitoring period. The graphs show the highest PPV of the three orthogonal axis x, y, and z. Periods where PPV values have been affected by local interference with the vibration monitor or only measured for part of the period, which are not representative of HS2 construction works, have been greyed out and excluded when calculating values in Table 4 of the main report.
