## **Construction Noise and Vibration Monthly Report – July 2024**

**Lichfield District Council**

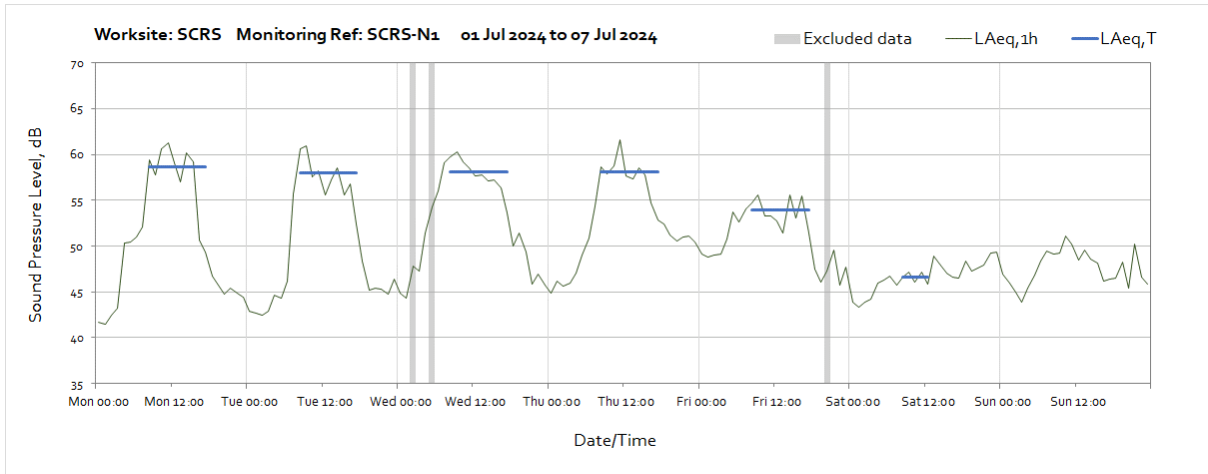
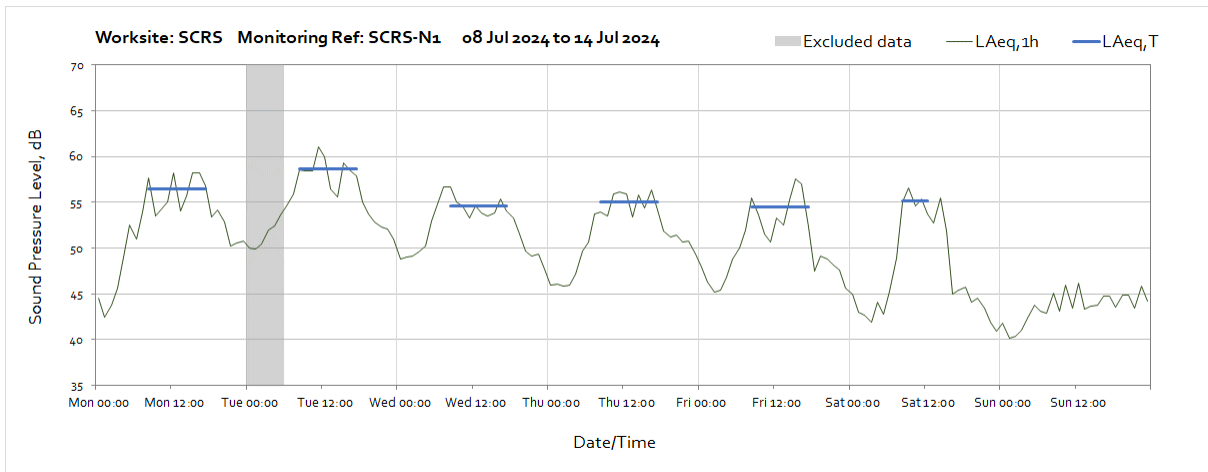
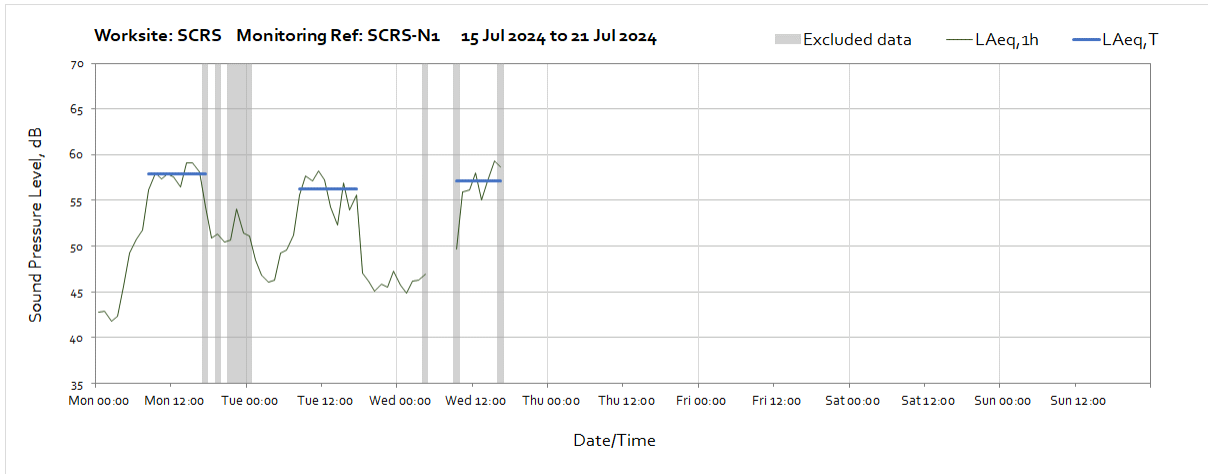
**Worksite:SCRS – Monitoring Ref: SCRS-N1**

Note: Missing data between 05:00 and 08:00 on Wednesday 17<sup>th</sup> July and between 17:00 on Wednesday 17<sup>th</sup> July and the end of the month was due to a loss of power to the monitoring station caused by poor weather conditions preventing sufficient light reach the solar panel.

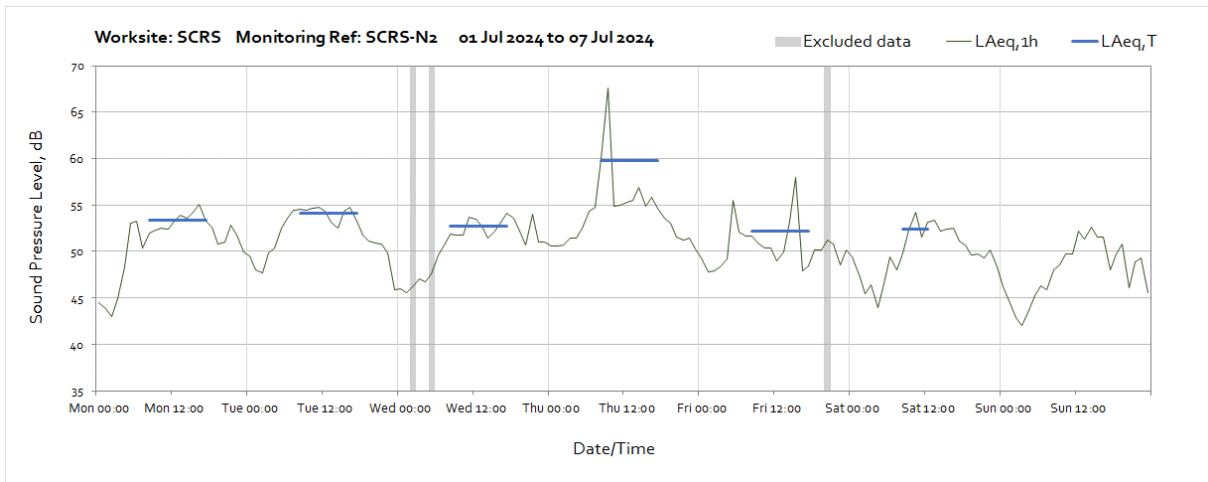
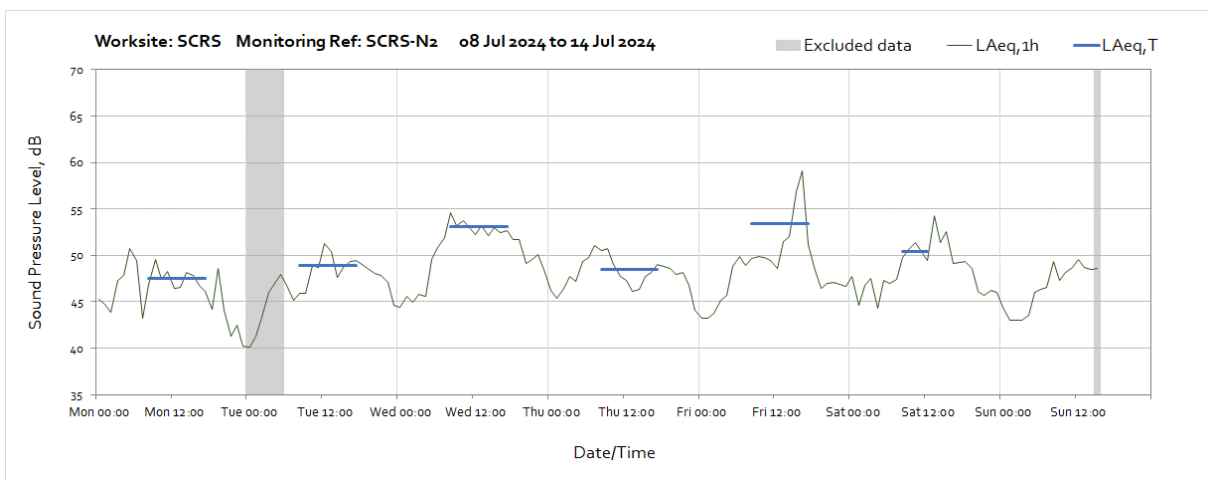
### Worksite:SCRS – Monitoring Ref: SCRS-N2

Note: Missing data between 16:00 on Sunday 14<sup>th</sup> July and 08:00 on Monday 15<sup>th</sup> July was due to a communication error between the monitoring station and server.

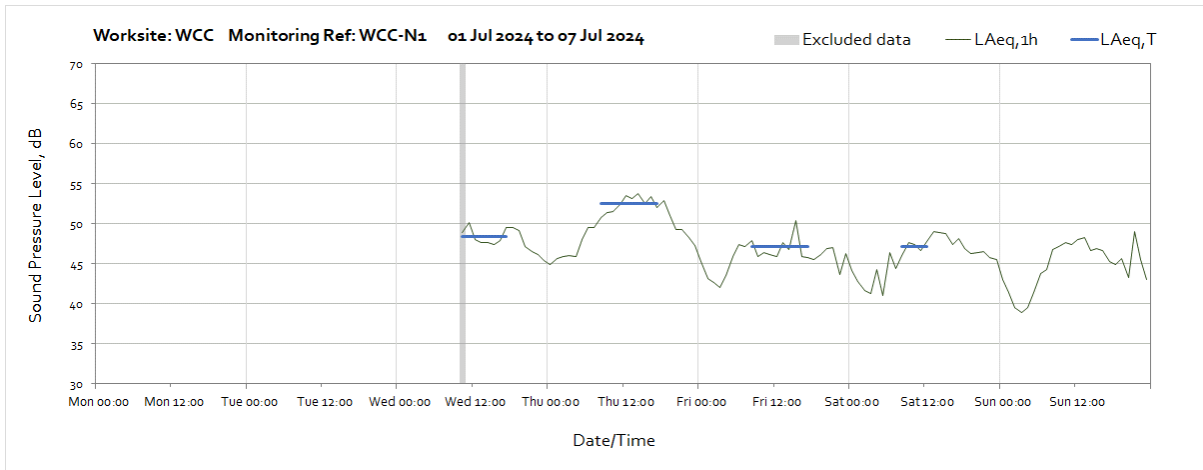
## Worksite:WCC – Monitoring Ref: WCC-N1

Note: Missing data between the start of the month and 10:00 on Wednesday 03<sup>rd</sup> of July was due to a communication error between the monitoring station and the server.

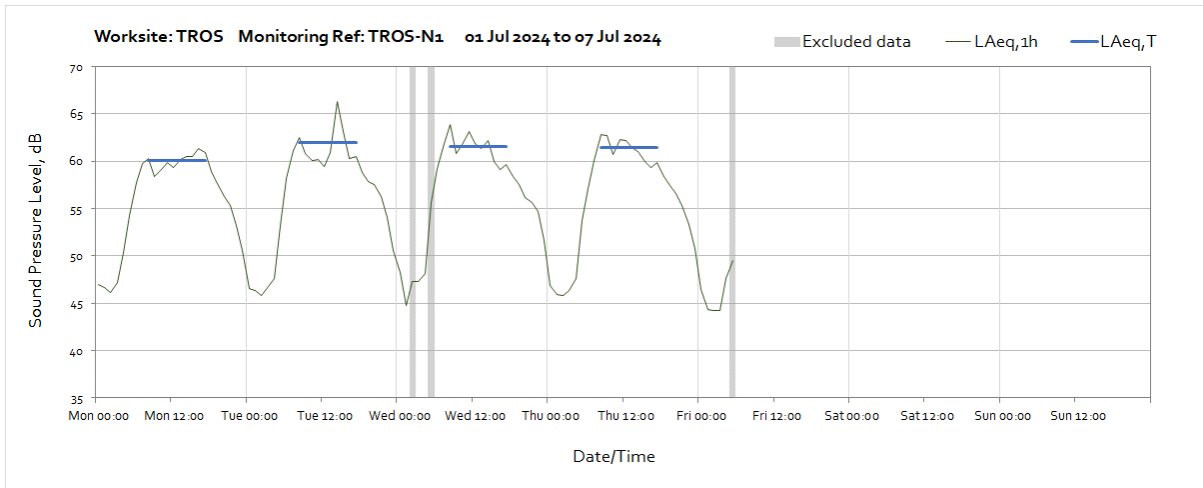
## Worksite:TROS – Monitoring Ref: TROS-N1

Note: Missing data between 06:00 on Friday 05<sup>th</sup> July and 09:00 on Thursday 18<sup>th</sup> July was due to a monitoring station system error.

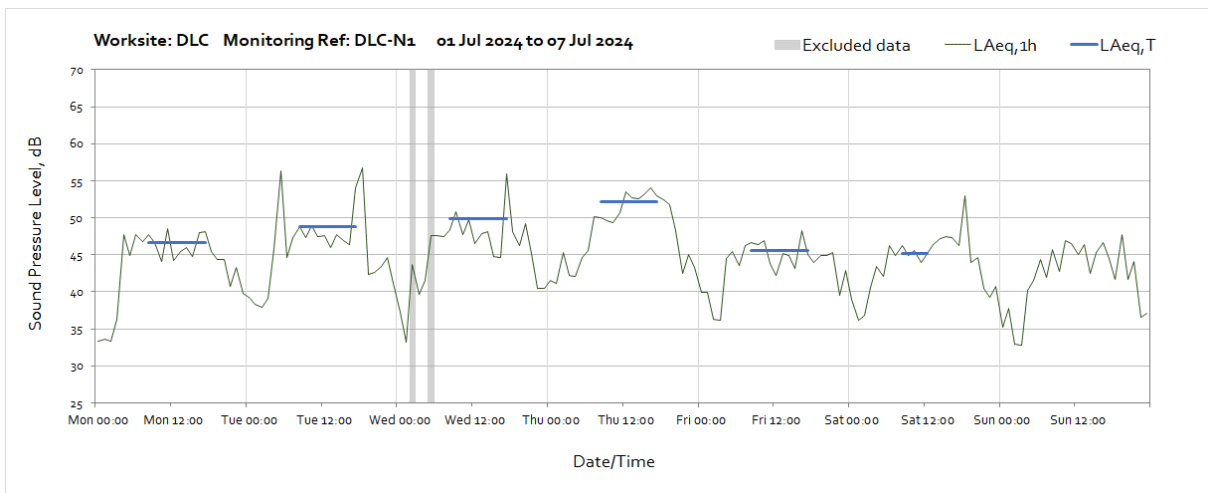
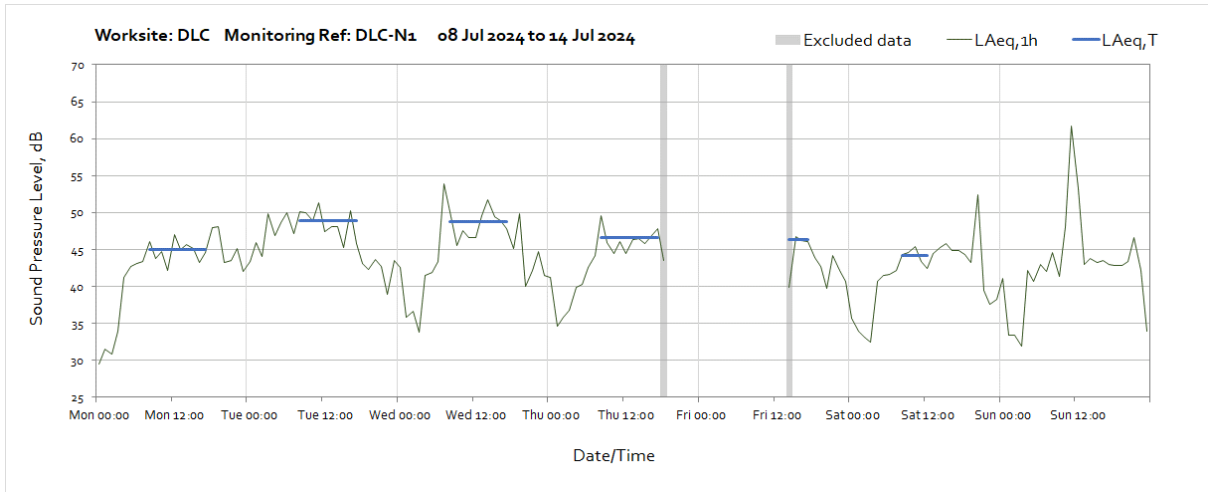
**Worksite: DLC – Monitoring Ref: DLC-N1**

Note: Missing data between 19:00 on Thursday 11<sup>th</sup> July and 13:00 on Friday 12<sup>th</sup> July was due to a monitoring station synchronization error.

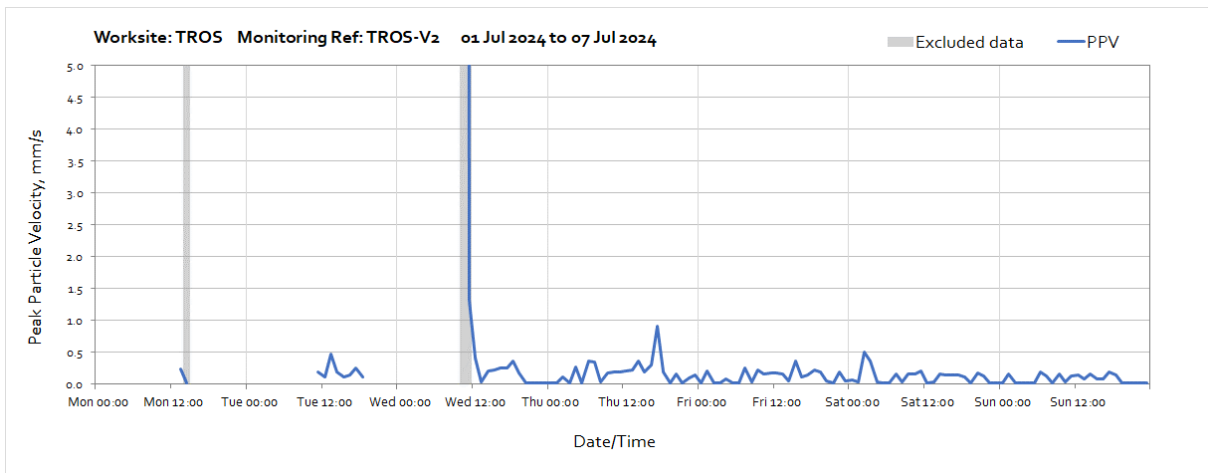
### Worksite: TROS – Monitoring Ref: TROS-V2

Note: Missing data throughout the week was due to a loss of power to the monitoring station caused by vegetation preventing sufficient light reach the solar panel.
