# HS2

September 2024

## **Construction Noise and Vibration Monthly Report – July 2024**

**North Warwickshire Borough Council**

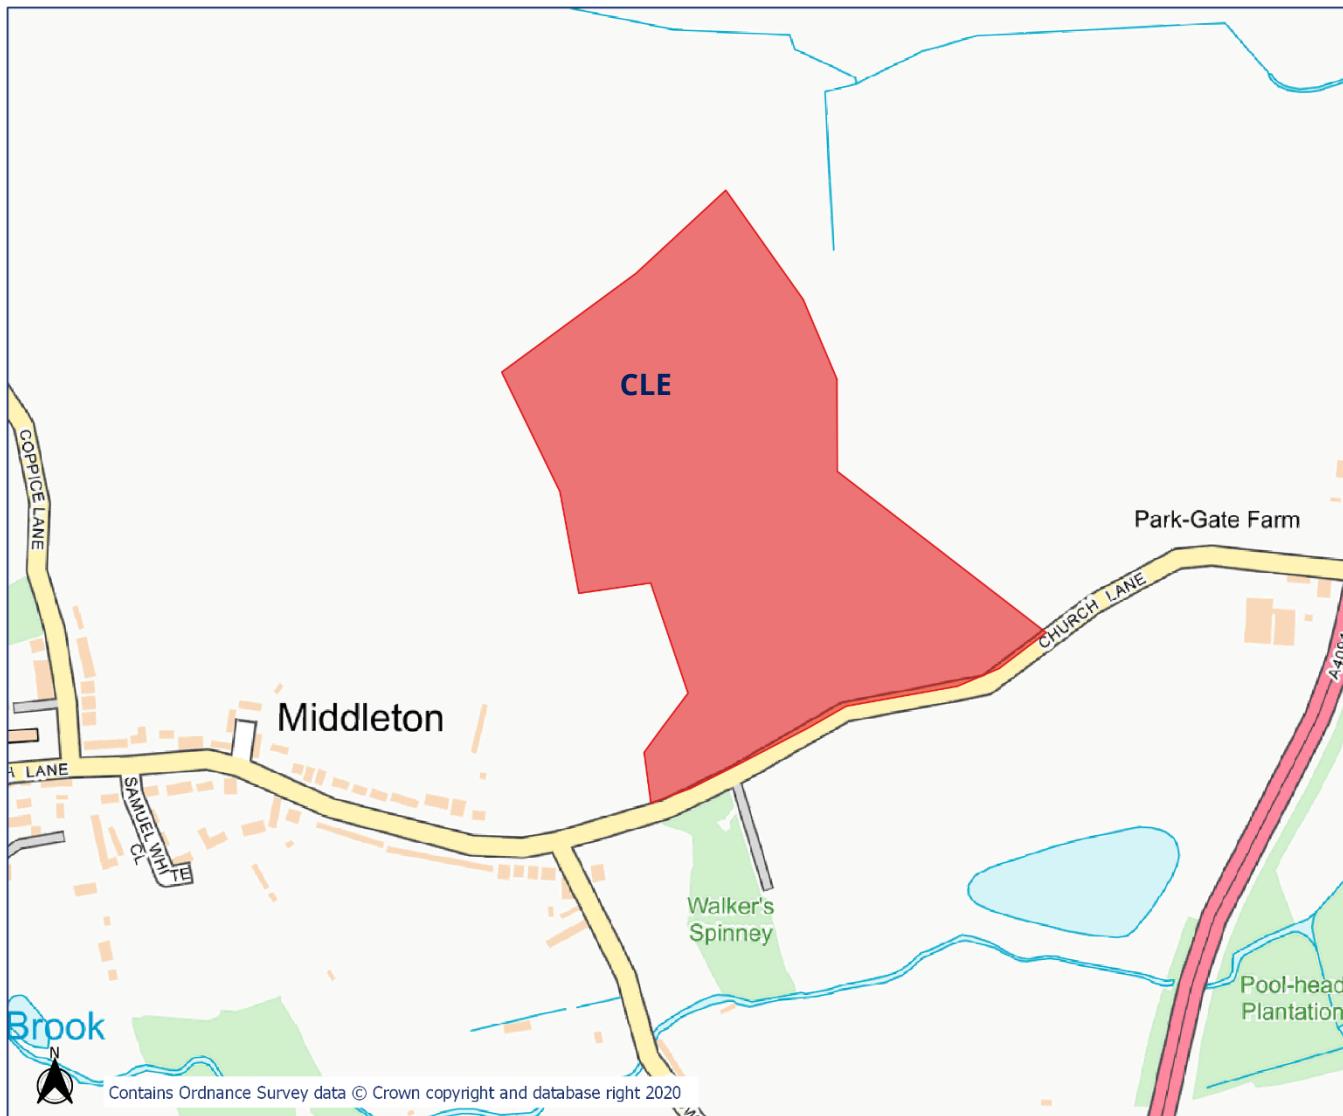
## Worksite Identification Plan - 1

- 1.1.3 Construction sites in the local authority area where monitoring was undertaken during this period include:
- Church Lane Embankment worksite, ref.: CLE (see Plan 1 in Appendix A), where works activities included:

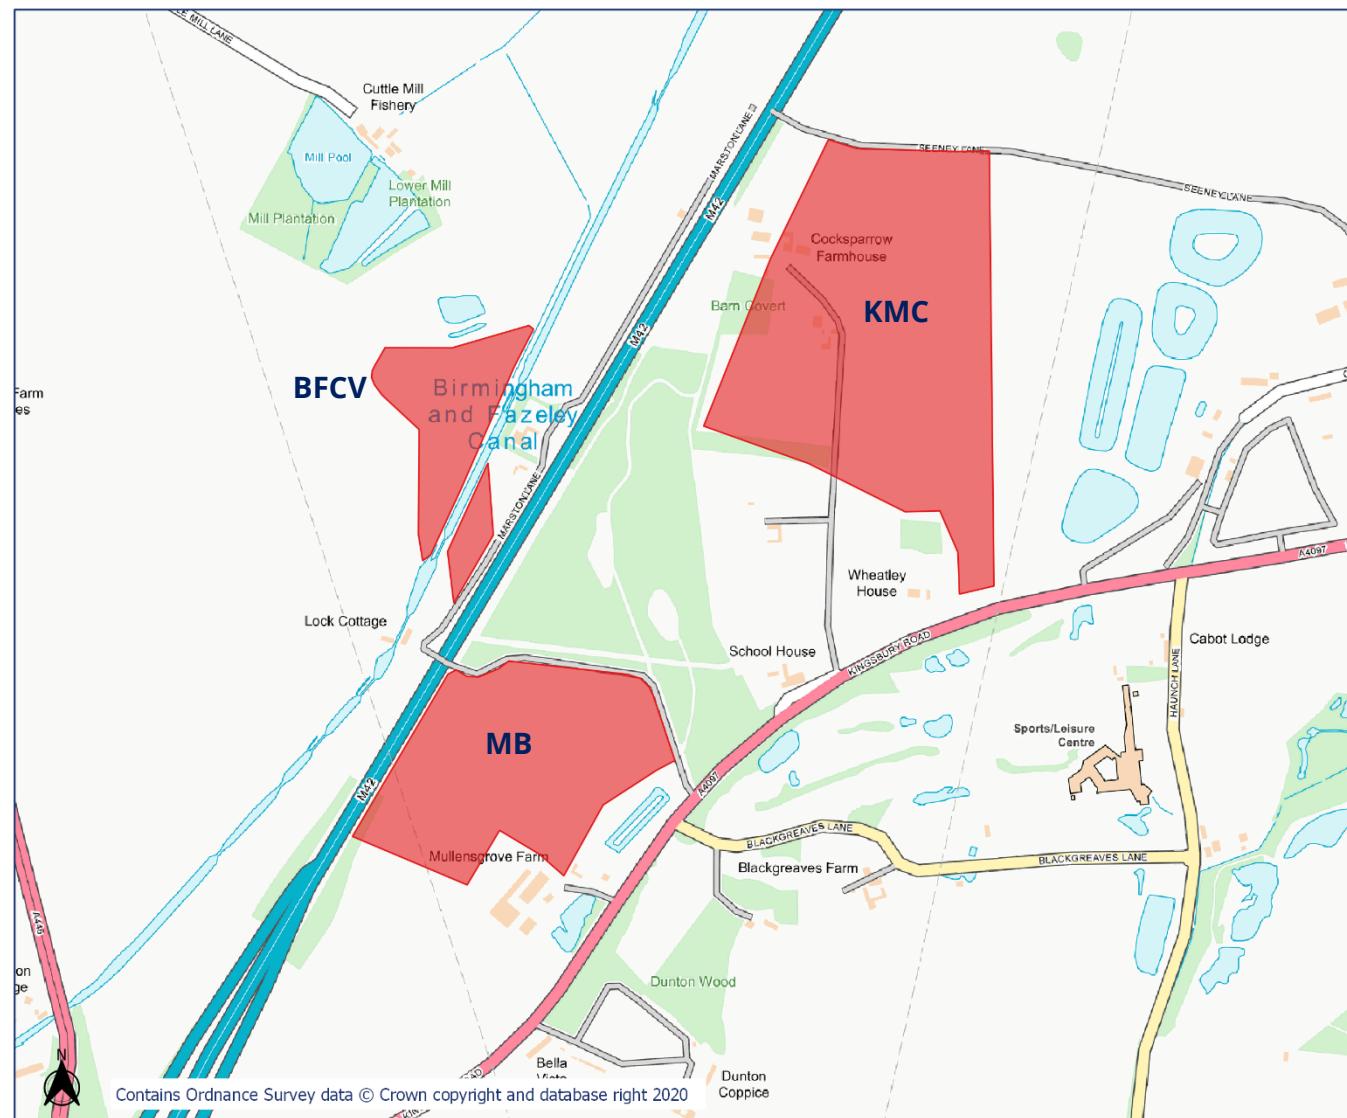
## Worksite Identification Plan - 2

- Ground investigation.
  - Kingsbury Main Compound worksite, ref.: KMC (see Plan 2 in Appendix A), where no works were underway.
  - Birmingham & Fazeley Canal Viaduct worksite, ref.: BFCV (see Plan 2 in Appendix A), where work activities included:

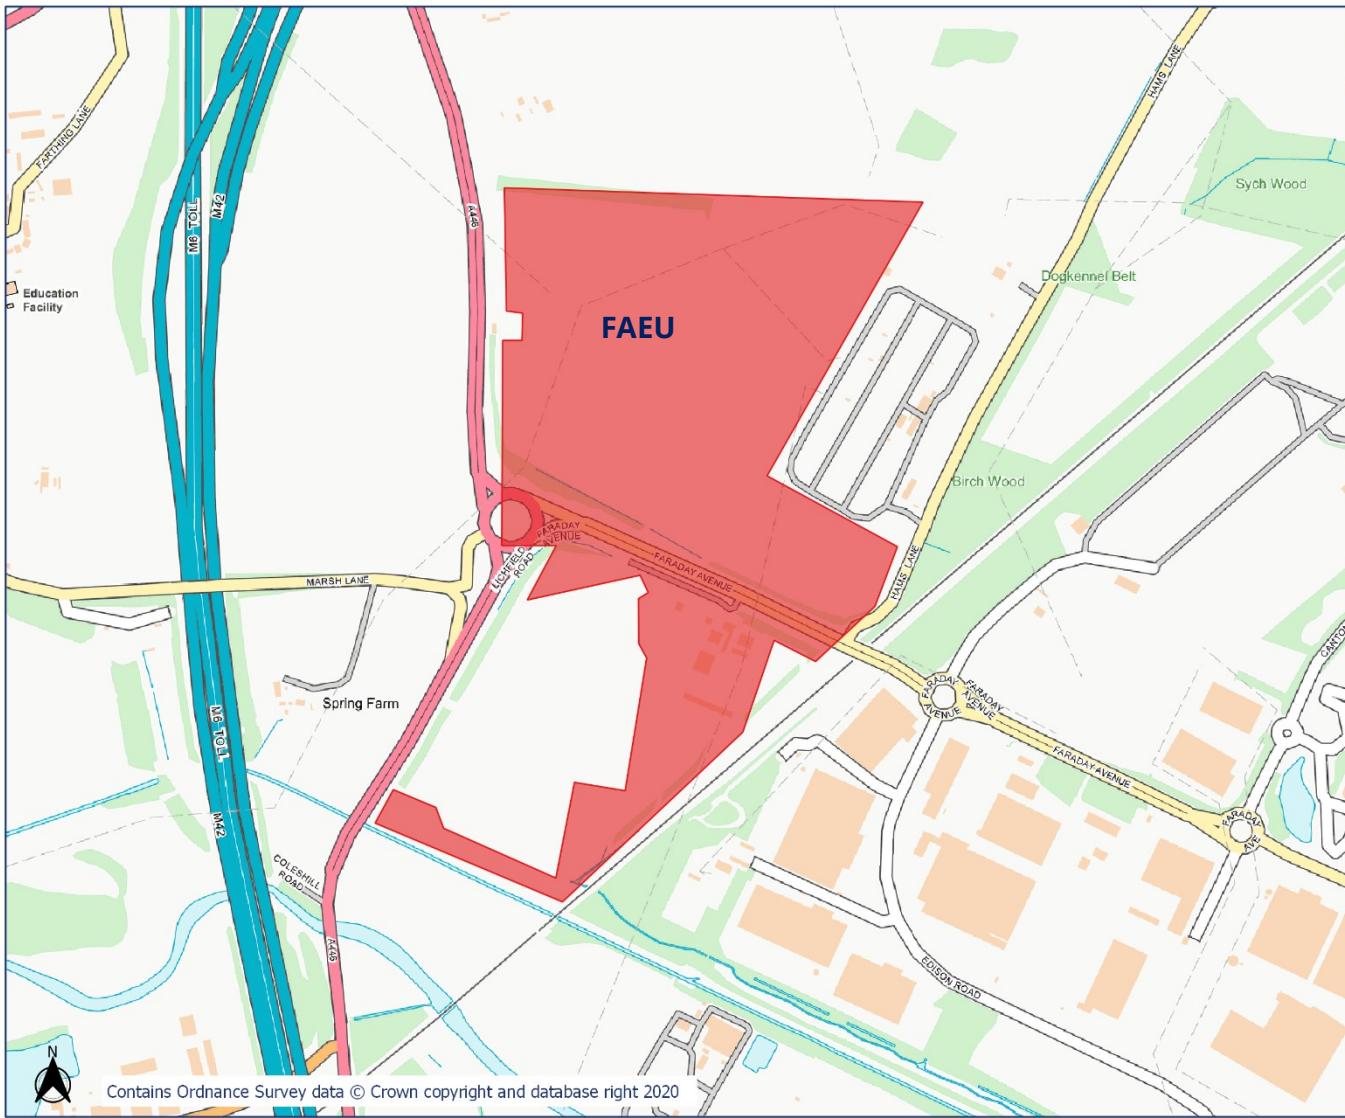
## Worksite Identification Plan - 3

- Shutter installation.
  - Formwork.
  - Excavation.
- Faraday Avenue Embankment and Underbridge worksite, ref.: FAEU (see Plan 3 in Appendix A), where work activities included:

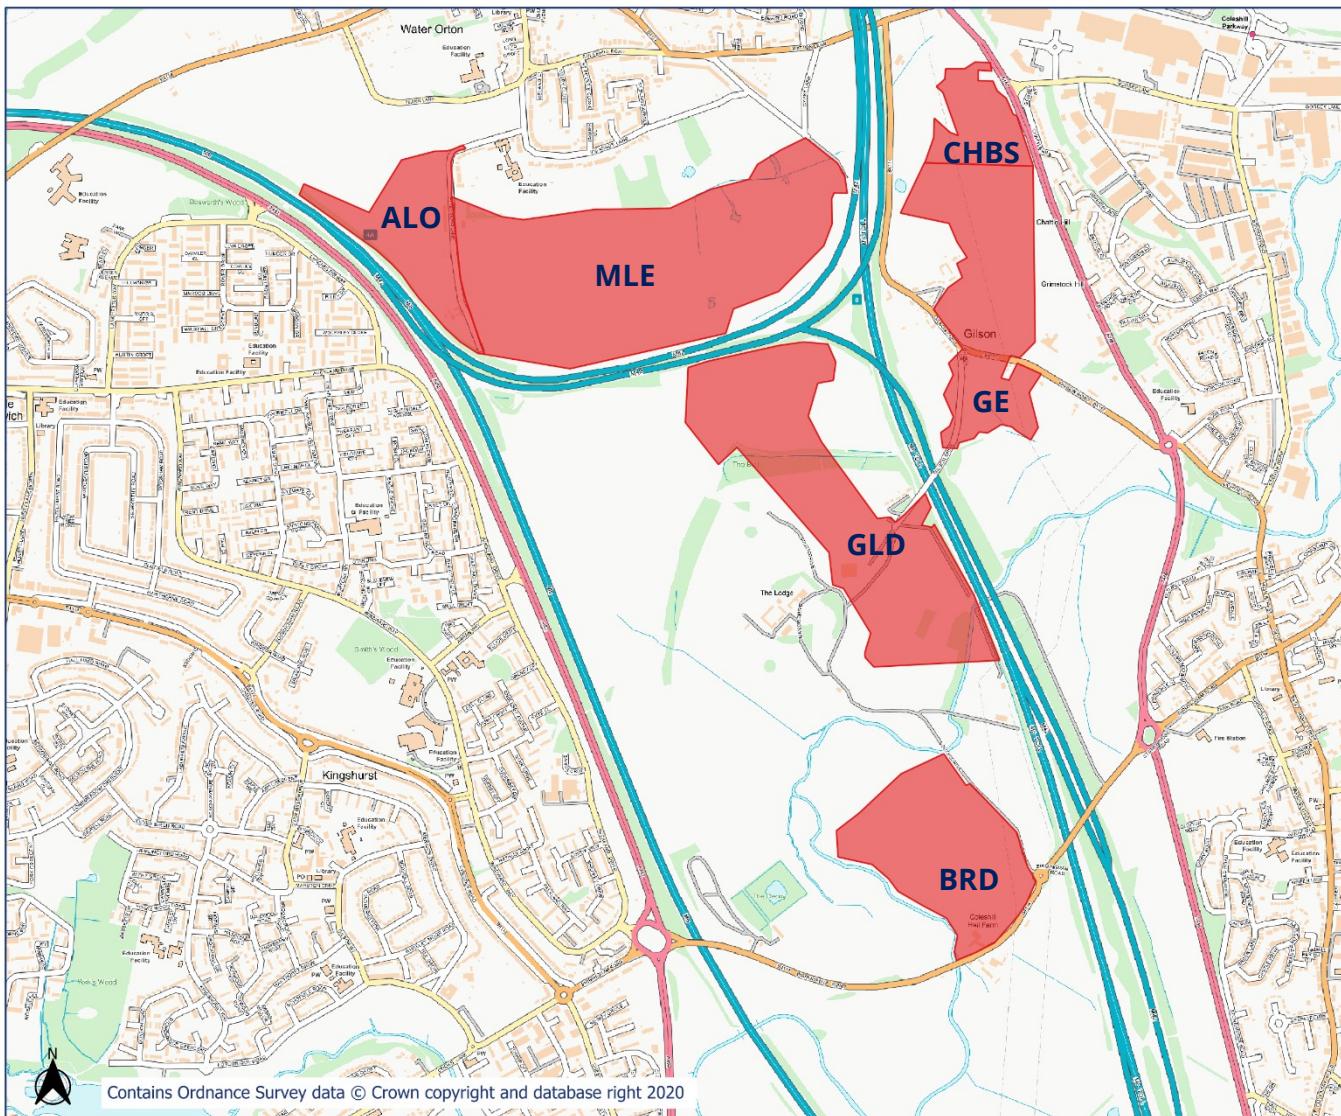
## Worksite Identification Plan - 4

- Chatte Hill Box Structure worksite, ref.: CHBS (see Plan 4 in Appendix A), where work activities included:
  - Formwork and reinforced concrete installation.

- Attleboro Lane Overbridge worksite, ref.: ALO (see Plan 4 in Appendix A), where work activities included:
  - Excavation.
  - Construction of walls and bases.

- Filling.
  - Drainage.
- Marsh Lane Embankment worksite, ref: MLE (See Plan 4 in Appendix A), where no works activities included:
  - Dig and replace.

- Gilson Embankment worksite, ref.: GE (see Plan 4 in Appendix A)
  - Pile installation.
  - Realignment works.
  - Retaining wall platform works.

- Temporary road installation.
- Gilson Drive worksite, ref.: GLD (see Plan 4 in Appendix A), works activities included:
  - Realignment works.
  - Temporary road works.
  - Stockpile management.
  - Material deliveries.
- Birmingham Road worksite, ref.: BRD (see Plan 4 in Appendix A), work activities included:
  - Embankment works.
  - Road construction.

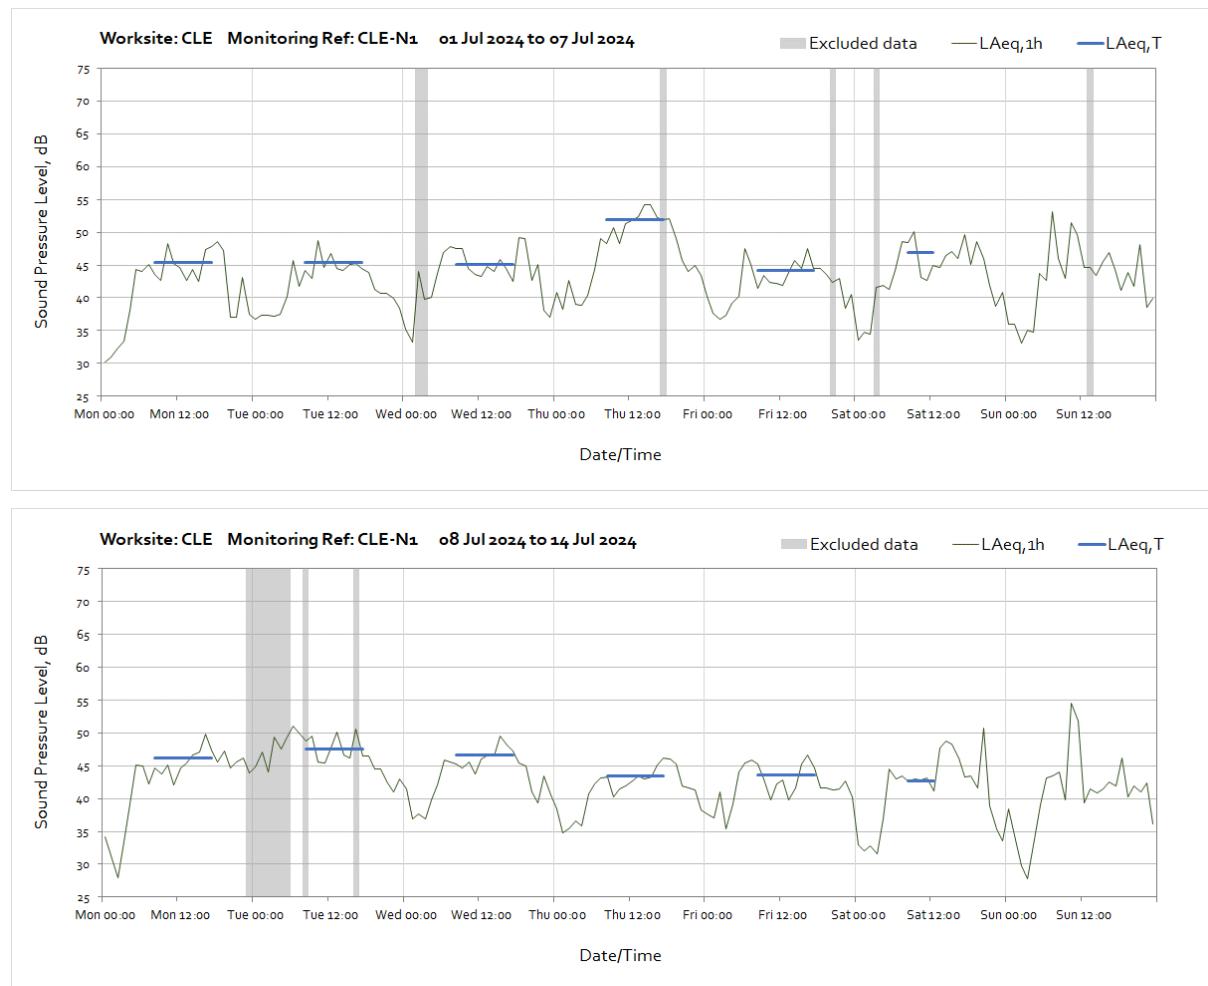
### Worksite: CLE – Monitoring Ref: CLE-N1

| Worksite Reference | Measurement Reference | Site Address | Free-Field or Façade Measurement | Weekday Average L <sub>Aeq,T</sub><br>(Highest Day L <sub>Aeq,T</sub> ) | | | | | Saturday Average L <sub>Aeq,T</sub><br>(Highest Day L <sub>Aeq,T</sub> ) | | | | | Sunday / Public Holiday Average L <sub>Aeq,T</sub><br>(Highest Day L <sub>Aeq,T</sub> ) | |
|---|---|---|---|---|---|---|---|---|--|---|---|---|---|---|---|
| CLE | CLE-N1 | Highfields Cottage, Middleton | Free-field | 45.6<br>(51.1) | 46.7<br>(63.7) | 46.3<br>(66.1) | 43.7<br>(50.1) | 41.5<br>(51.0) | 44.7<br>(48.5) | 44.4<br>(46.9) | 46.1<br>(47.7) | 45.3<br>(50.8) | 38.7<br>(45.4) | 45.5<br>(54.5) | 41.5<br>(48.1) |

The following graphs show the hourly measured ambient noise level  $L_{Aeq,1h}$  and, where relevant, the averaged noise level  $L_{Aeq,T}$  values, where the time period T is as specified in Table 1 of HS2 Information Paper E23. Periods with adversely weather affected noise levels are greyed out and have been excluded from the calculation of the  $L_{Aeq,T}$  values in Table 3 of the main report.:.

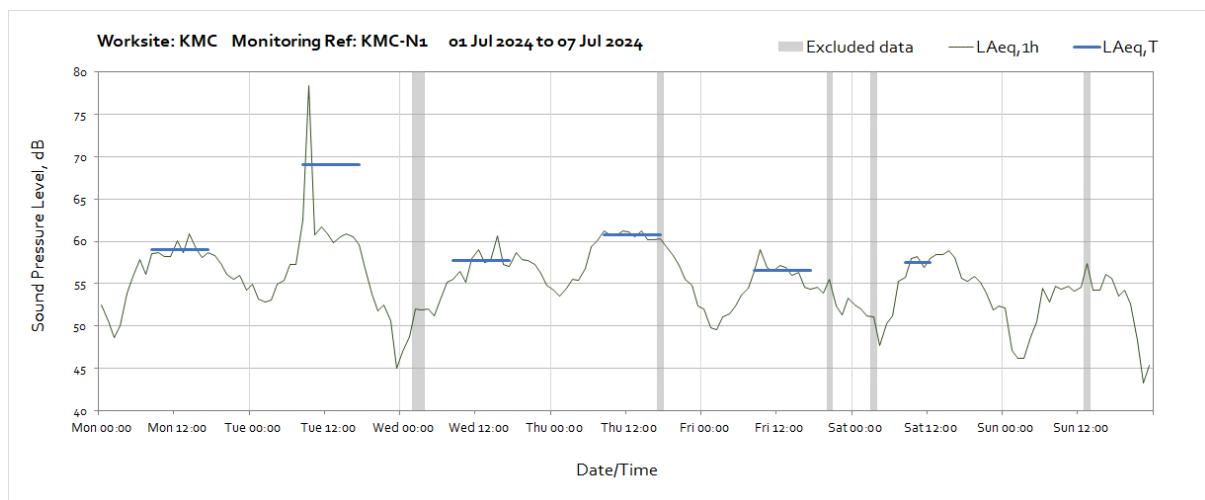
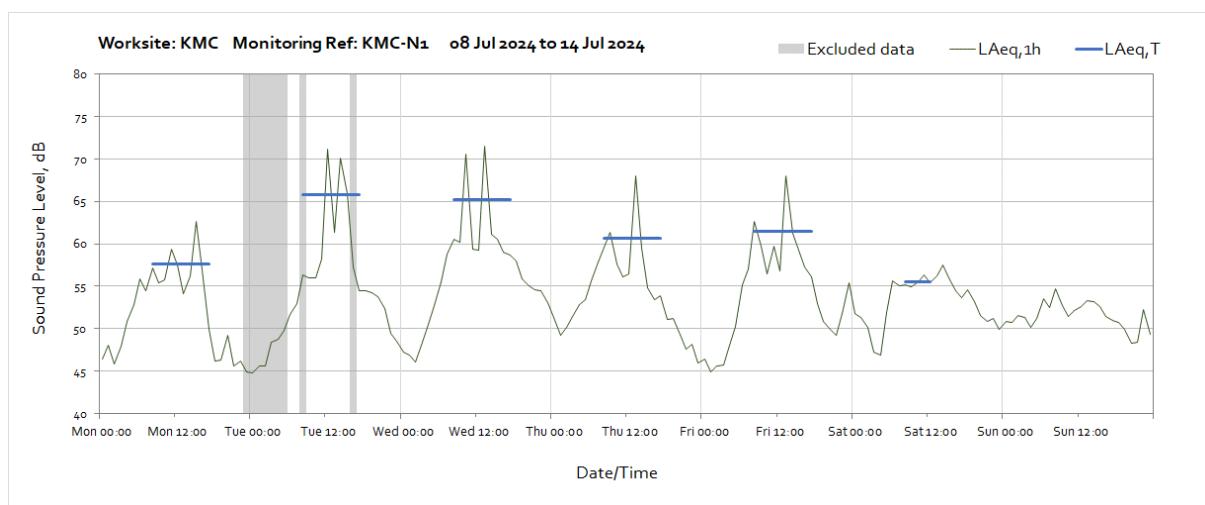
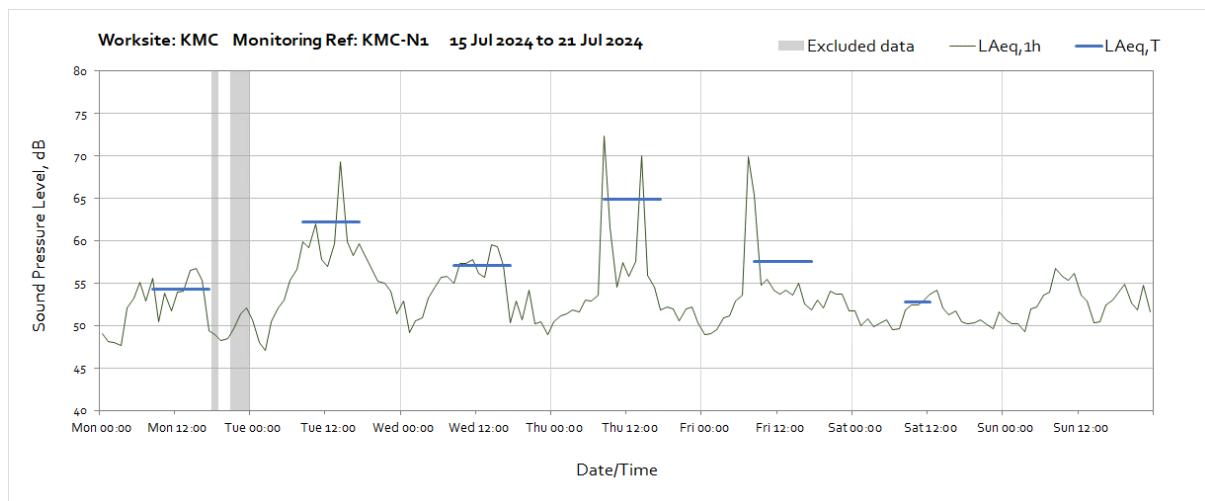
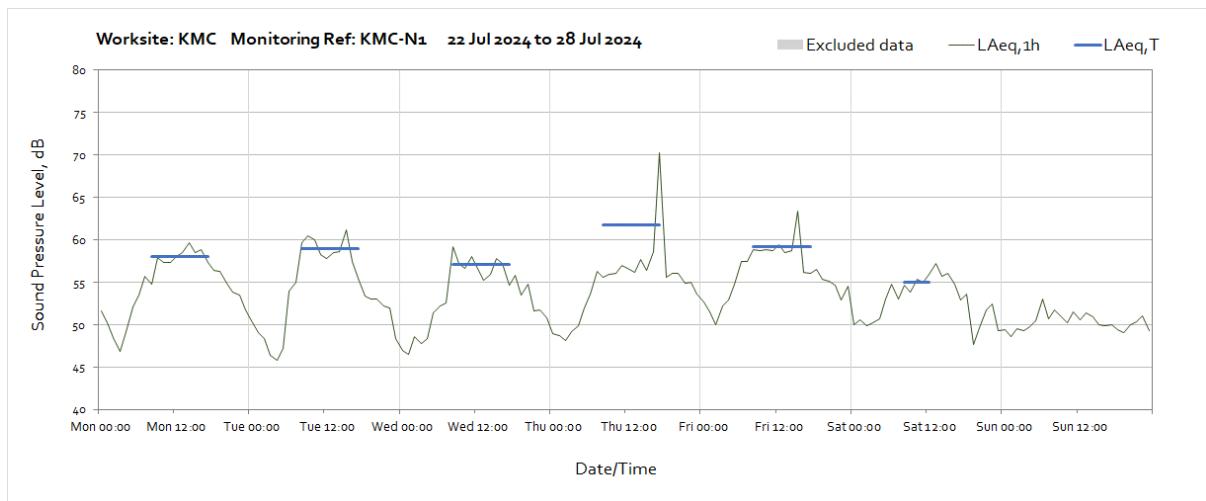
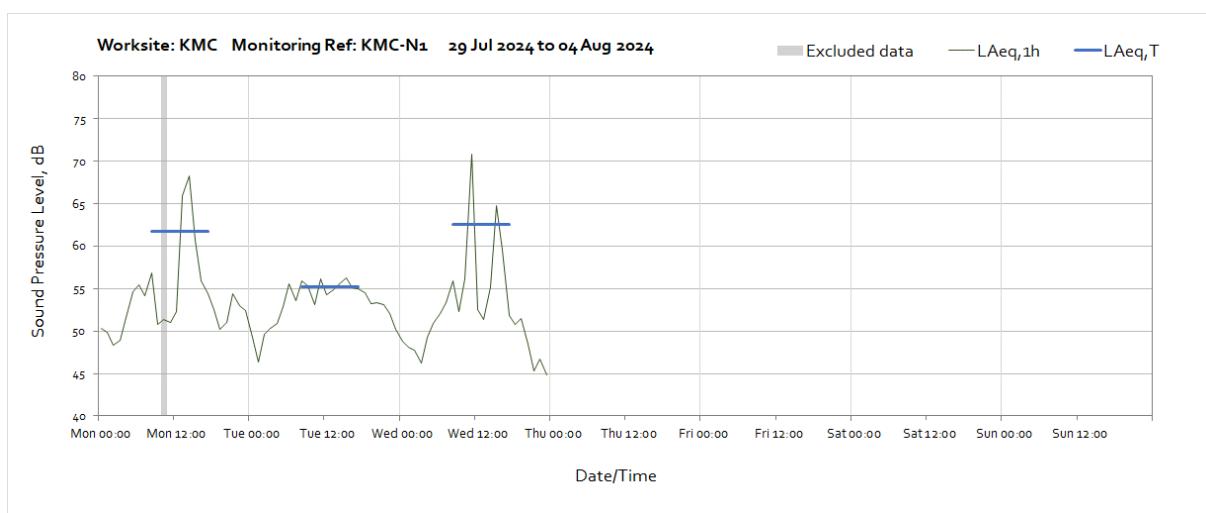
## Worksite: KMC – Monitoring Ref: KMC-N1

| Worksite Reference | Measurement Reference | Site Address | Free-Field or Façade Measurement | Weekday Average L <sub>Aeq,T</sub><br>(Highest Day L <sub>Aeq,T</sub> ) | | | | | Saturday Average L <sub>Aeq,T</sub><br>(Highest Day L <sub>Aeq,T</sub> ) | | | | | Sunday / Public Holiday Average L <sub>Aeq,T</sub><br>(Highest Day L <sub>Aeq,T</sub> ) | |
|---|---|---|---|---|---|---|---|---|--|---|---|---|---|---|---|
| KMC | KMC-N1 | Kingsbury Road, Curdworth CP, Marston | Free-field | 56.1<br>(69.9) | 60.2<br>(69.1) | 54.6<br>(59.4) | 53.1<br>(58.4) | 51.4<br>(59.4) | 53.3<br>(55.3) | 55.2<br>(57.5) | 56.5<br>(58.4) | 53.9<br>(58.9) | 51.0<br>(54.5) | 52.7<br>(56.8) | 51.2<br>(57.9) |

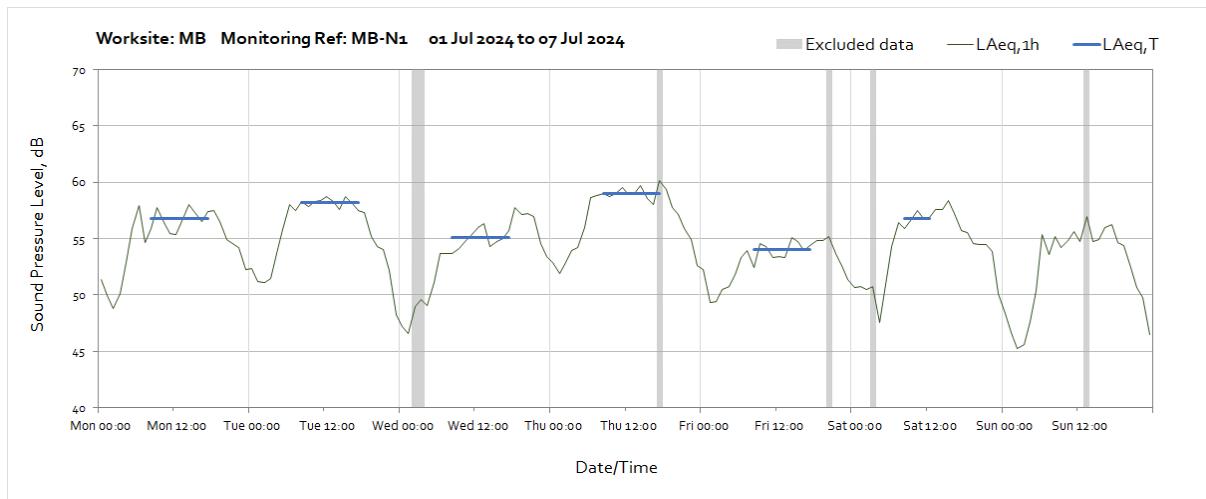
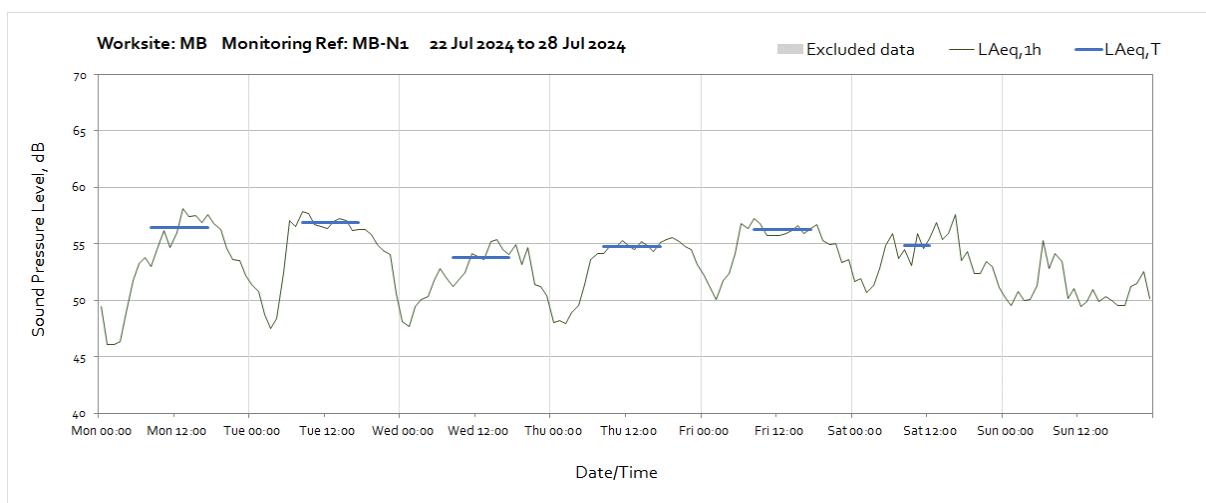
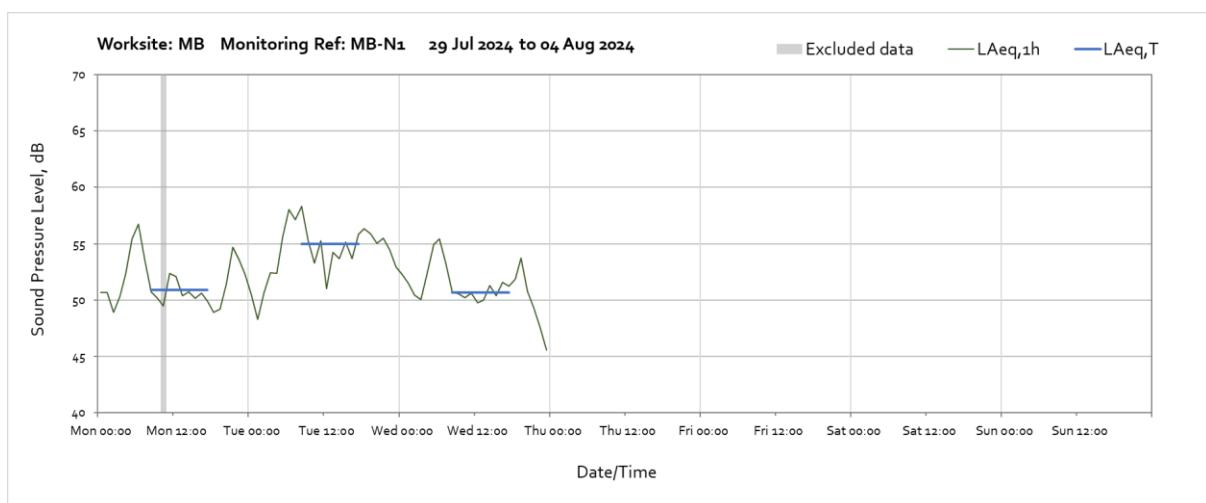
## Worksite: MB – Monitoring Ref: MB-N1

| Worksite Reference | Measurement Reference | Site Address | Free-Field or Façade Measurement | Weekday Average L <sub>Aeq,T</sub><br>(Highest Day L <sub>Aeq,T</sub> ) | | | | | Saturday Average L <sub>Aeq,T</sub><br>(Highest Day L <sub>Aeq,T</sub> ) | | | | | Sunday / Public Holiday Average L <sub>Aeq,T</sub><br>(Highest Day L <sub>Aeq,T</sub> ) | |
|---|---|---|---|---|---|---|---|---|--|---|---|---|---|---|---|
| MB | MB-N1 | Elford House, Kingsbury Road, Curdworth, Sutton Coldfield | Free-field | 54.8<br>(58.8) | 54.8<br>(59.0) | 55.4<br>(59.4) | 54.2<br>(57.8) | 51.9<br>(58.7) | 53.7<br>(56.4) | 54.7<br>(56.7) | 55.5<br>(57.6) | 54.5<br>(58.4) | 51.2<br>(55.4) | 53.7<br>(56.6) | 51.7<br>(57.9) |

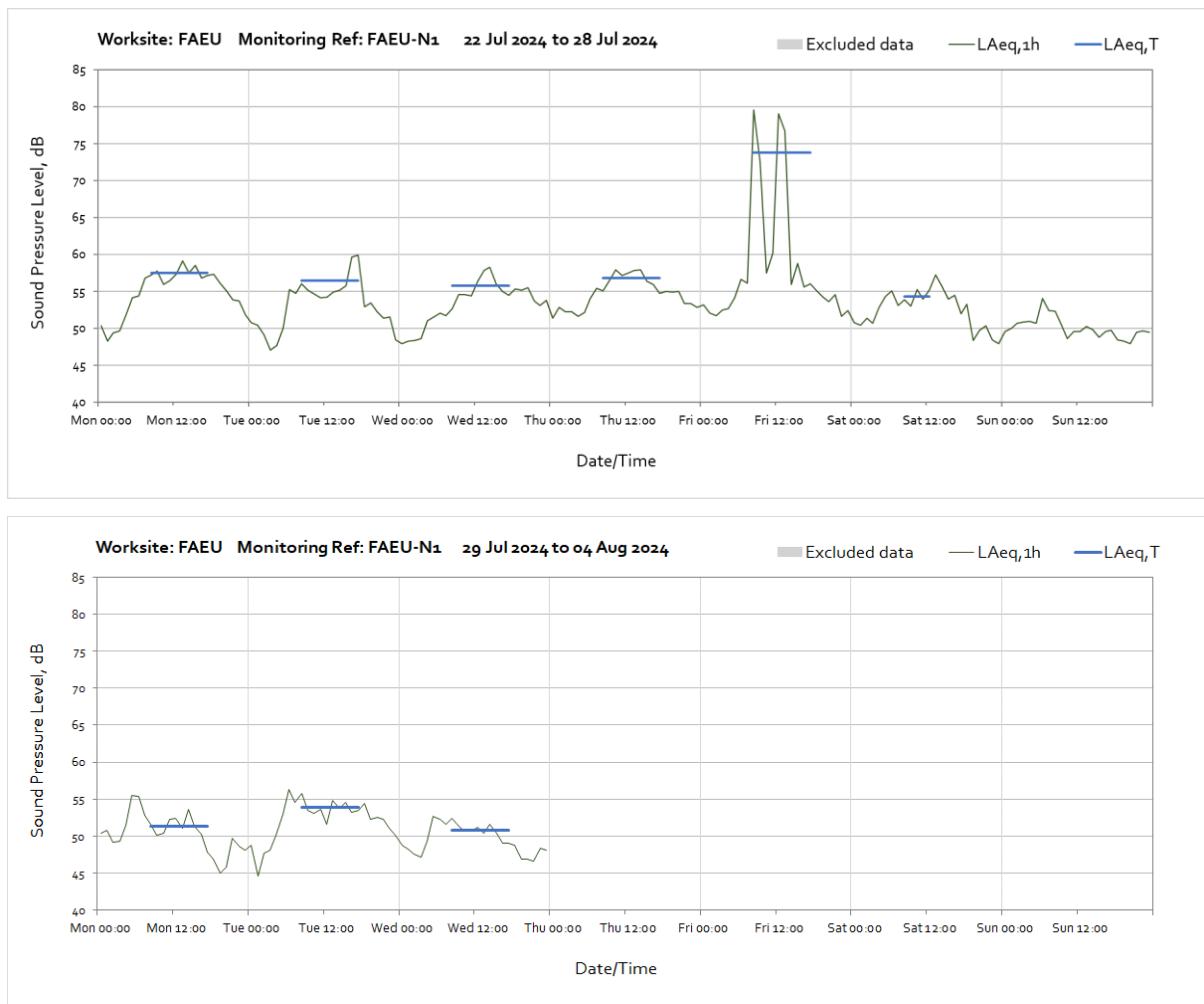
## Worksite: FAEU – Monitoring Ref: FAEU-N1

| Worksite Reference | Measurement Reference | Site Address | Free-Field or Façade Measurement | Weekday Average L <sub>Aeq,T</sub><br>(Highest Day L <sub>Aeq,T</sub> ) | | | | | Saturday Average L <sub>Aeq,T</sub><br>(Highest Day L <sub>Aeq,T</sub> ) | | | | | Sunday / Public Holiday Average L <sub>Aeq,T</sub><br>(Highest Day L <sub>Aeq,T</sub> ) | |
|---|---|---|---|---|---|---|---|---|--|---|---|---|---|---|---|
| FAEU | FAEU-N1 | South of Orchard Cottage, Newlands Lane, Curdworth | Free-field | 54.7<br>(59.9) | 56.7<br>(73.8) | 54.3<br>(59.4) | 53.1<br>(59.8) | 52.0<br>(58.6) | 53.6<br>(56.4) | 54.2<br>(56.4) | 55.5<br>(57.3) | 54.0<br>(58.2) | 51.0<br>(56.0) | 52.5<br>(57.2) | 51.3<br>(57.8) |

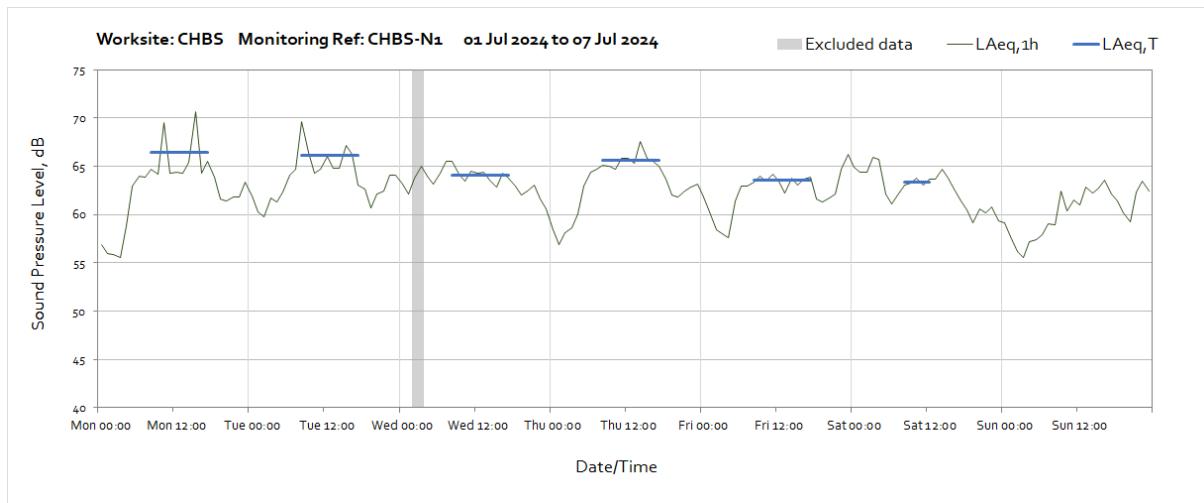
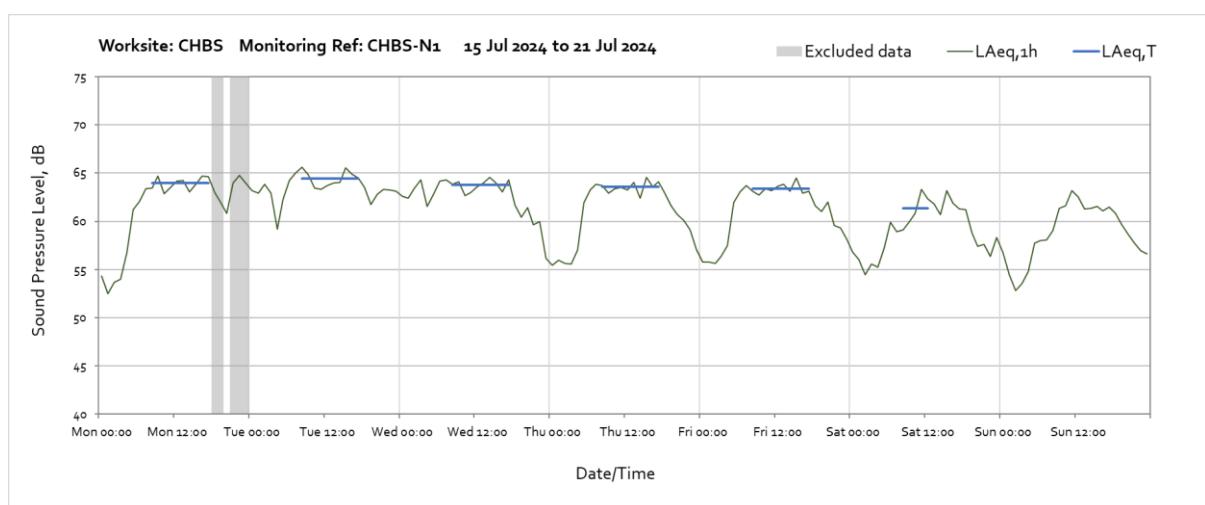
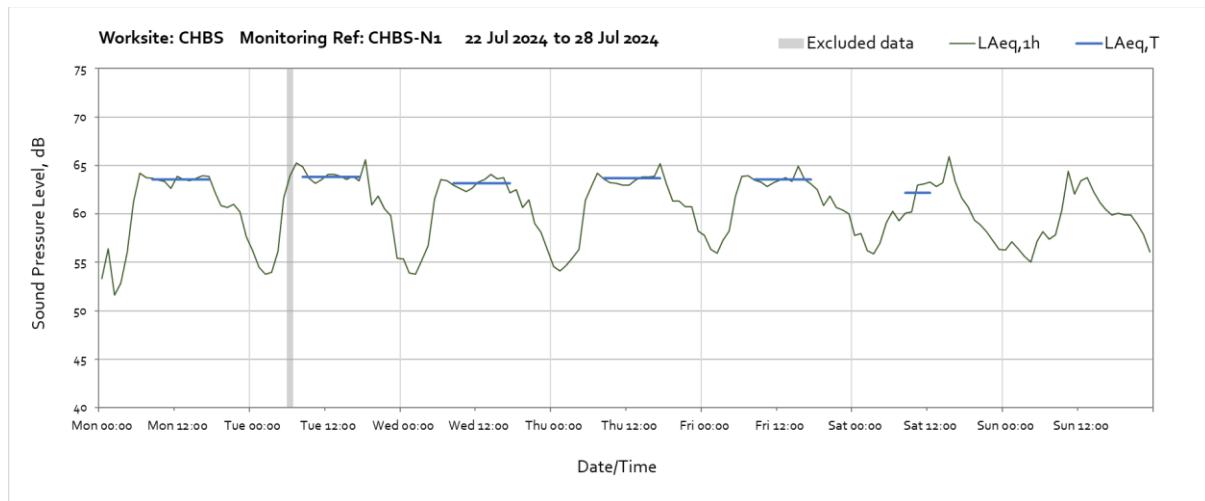
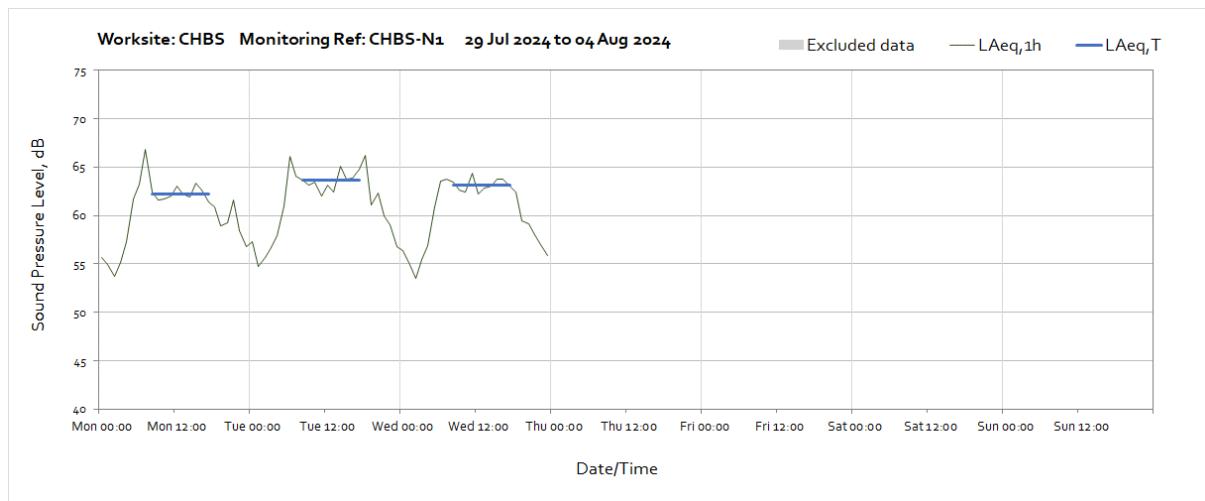
## Worksite: CHBS – Monitoring Ref: CHBS-N1

| Worksite Reference | Measurement Reference | Site Address | Free-Field or Façade Measurement | Weekday Average L <sub>Aeq,T</sub><br>(Highest Day L <sub>Aeq,T</sub> ) | | | | | Saturday Average L <sub>Aeq,T</sub><br>(Highest Day L <sub>Aeq,T</sub> ) | | | | | Sunday / Public Holiday Average L <sub>Aeq,T</sub><br>(Highest Day L <sub>Aeq,T</sub> ) | |
|---|---|---|---|---|---|---|---|---|--|---|---|---|---|---|---|
| CHBS | CHBS-N1 | 6 Gorse Way, Coleshill | Free-field | 64.4<br>(66.8) | 64.2<br>(66.4) | 62.9<br>(66.2) | 61.2<br>(63.3) | 60.5<br>(66.3) | 60.3<br>(62.0) | 62.5<br>(63.4) | 62.6<br>(63.7) | 61.5<br>(65.9) | 57.2<br>(60.8) | 61.3<br>(64.4) | 59.2<br>(64.2) |

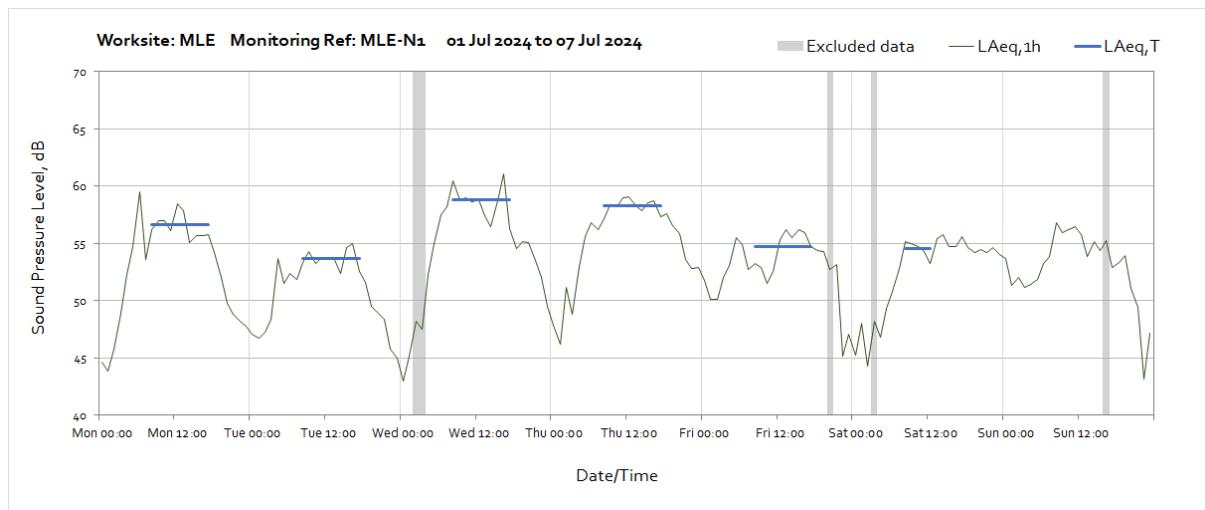
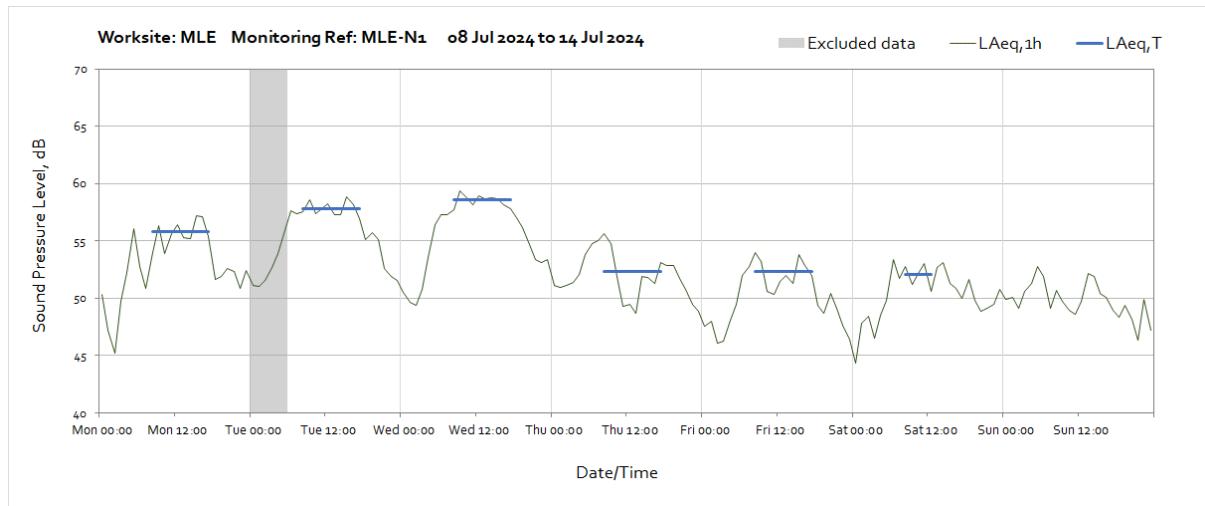
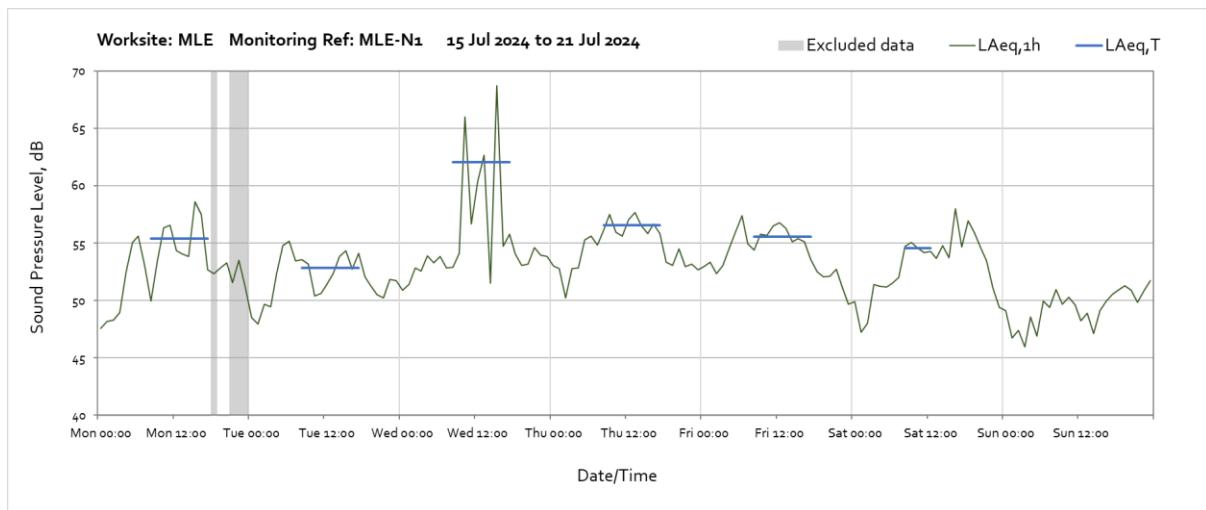
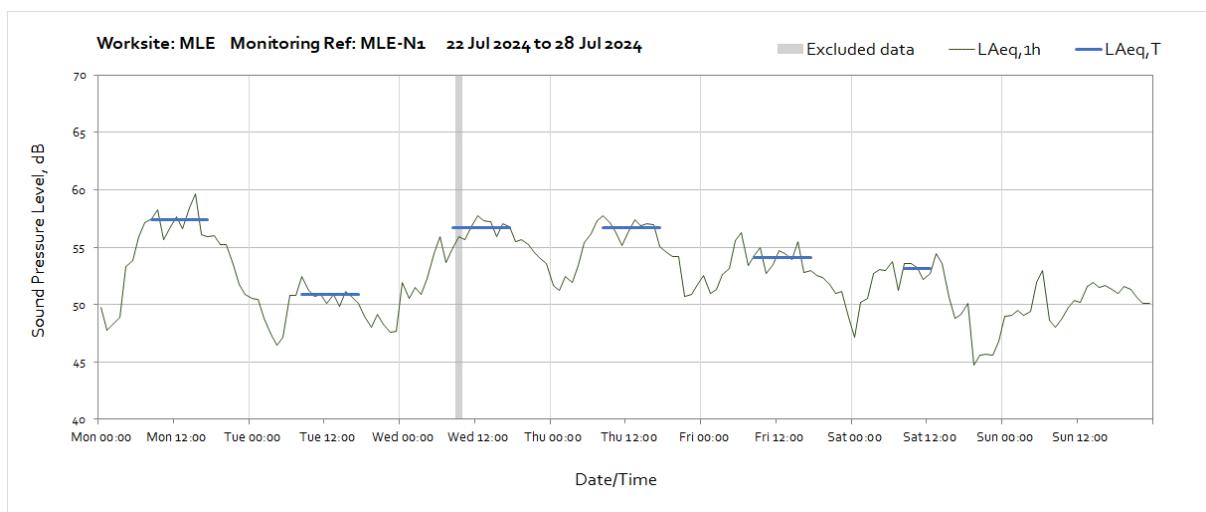
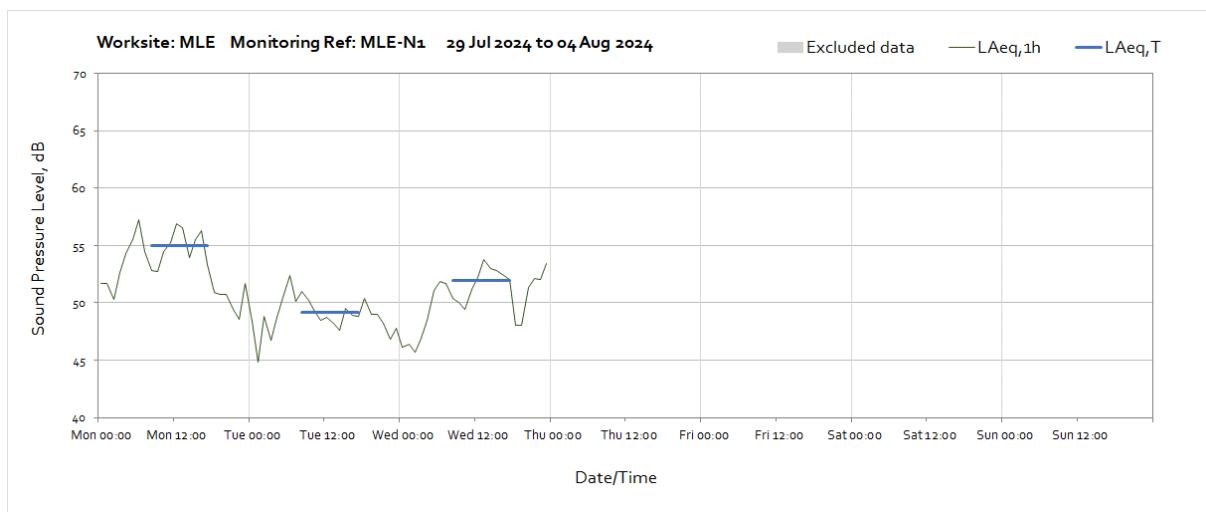
## Worksite: MLE – Monitoring Ref: MLE-N1

| Worksite Reference | Measurement Reference | Site Address | Free-Field or Façade Measurement | Weekday Average L <sub>Aeq,T</sub><br>(Highest Day L <sub>Aeq,T</sub> ) | | | | | Saturday Average L <sub>Aeq,T</sub><br>(Highest Day L <sub>Aeq,T</sub> ) | | | | | Sunday / Public Holiday Average L <sub>Aeq,T</sub><br>(Highest Day L <sub>Aeq,T</sub> ) | |
|---|---|---|---|---|---|---|---|---|--|---|---|---|---|---|---|
| MLE | MLE-N1 | Rostrevor, Vicarage Lane, Water Orton CP | Free field | 54.1<br>(58.2) | 55.4<br>(62.1) | 53.0<br>(57.6) | 52.3<br>(56.6) | 51.6<br>(57.6) | 51.9<br>(52.8) | 53.6<br>(54.6) | 54.1<br>(55.5) | 52.7<br>(58.0) | 50.5<br>(54.7) | 51.2<br>(56.8) | 52.0<br>(59.5) |

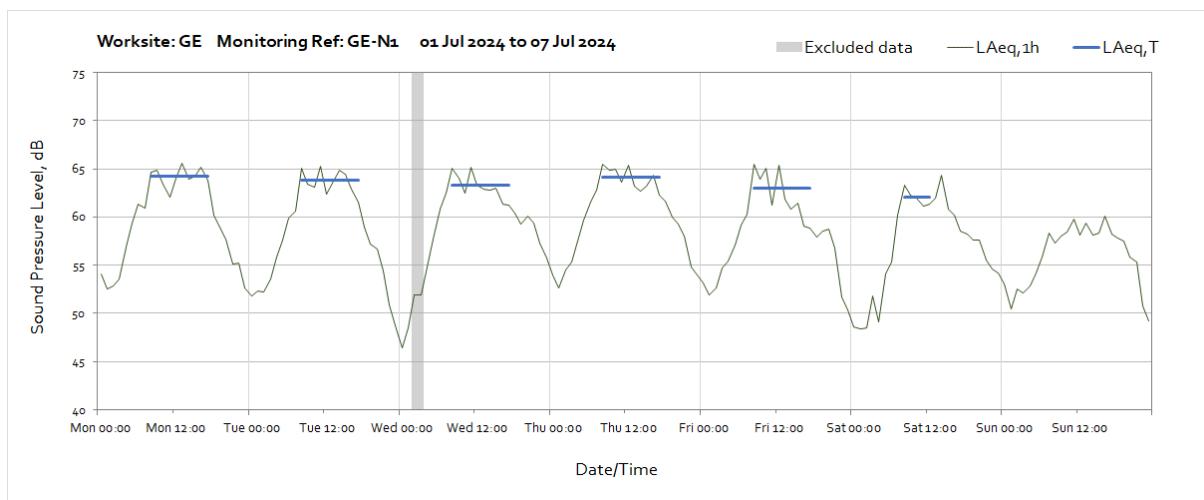
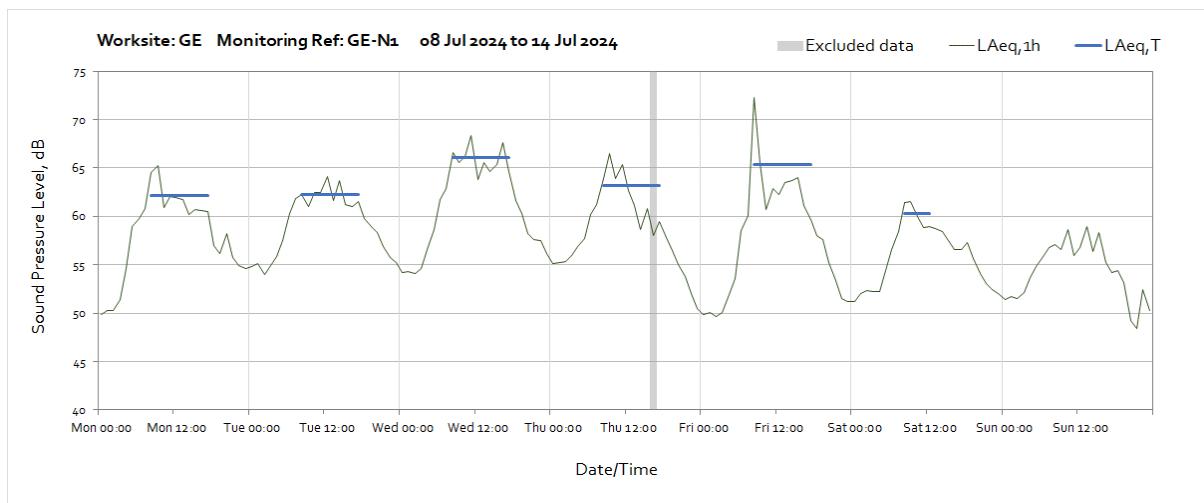
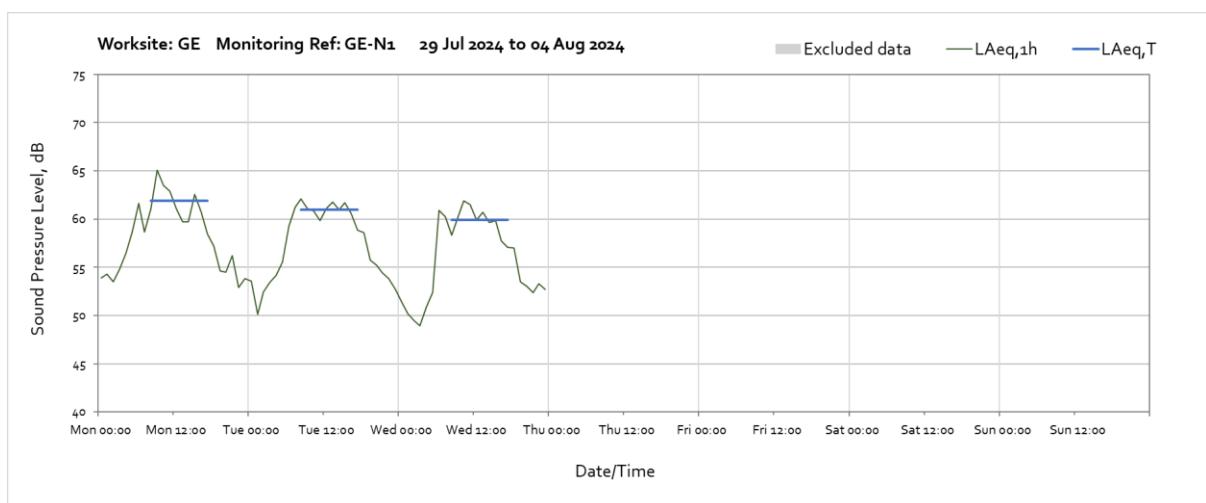
## Worksite: GE - Monitoring Ref: GE-N1

| Worksite Reference | Measurement Reference | Site Address | Free-Field or Façade Measurement | Weekday Average L <sub>Aeq,T</sub><br>(Highest Day L <sub>Aeq,T</sub> ) | | | | | Saturday Average L <sub>Aeq,T</sub><br>(Highest Day L <sub>Aeq,T</sub> ) | | | | | Sunday / Public Holiday Average L <sub>Aeq,T</sub><br>(Highest Day L <sub>Aeq,T</sub> ) | |
|---|---|---|---|---|---|---|---|---|--|---|---|---|---|---|---|
| GE | GE-N1 | The Cottage, Gilson Road, Coleshill | Free-field | 61.0<br>(62.9) | 63.1<br>(66.0) | 58.7<br>(61.7) | 56.7<br>(60.3) | 55.1<br>(61.7) | 59.8<br>(61.7) | 60.4<br>(62.1) | 59.5<br>(61.9) | 57.1<br>(64.3) | 53.7<br>(57.4) | 56.3<br>(60.1) | 54.9<br>(61.6) |
