# HS2

September 2024

## **Construction Noise and Vibration Monthly Report – July 2024**

**North Warwickshire Borough Council**

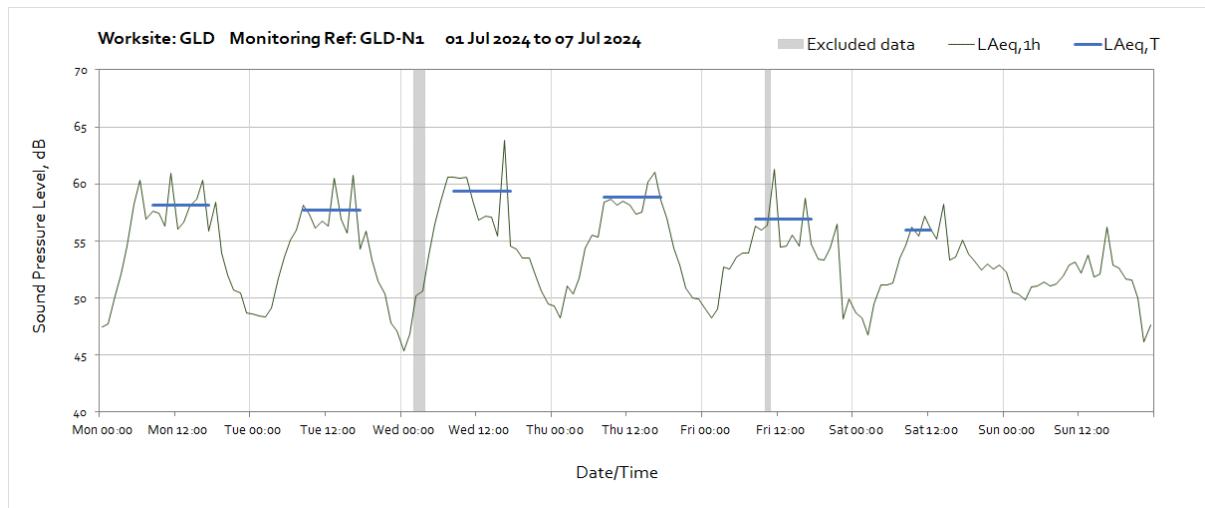
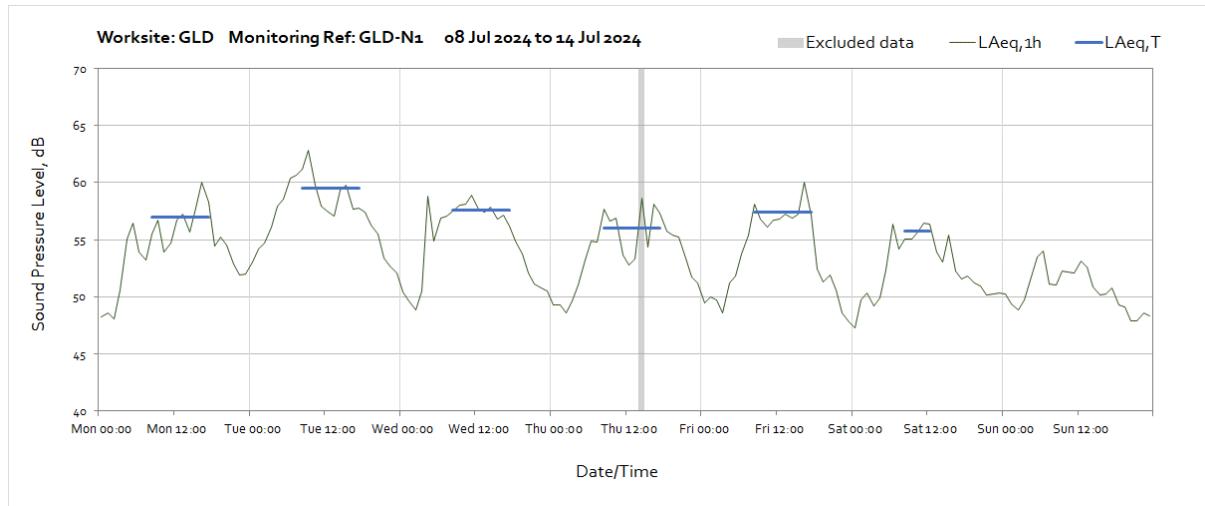
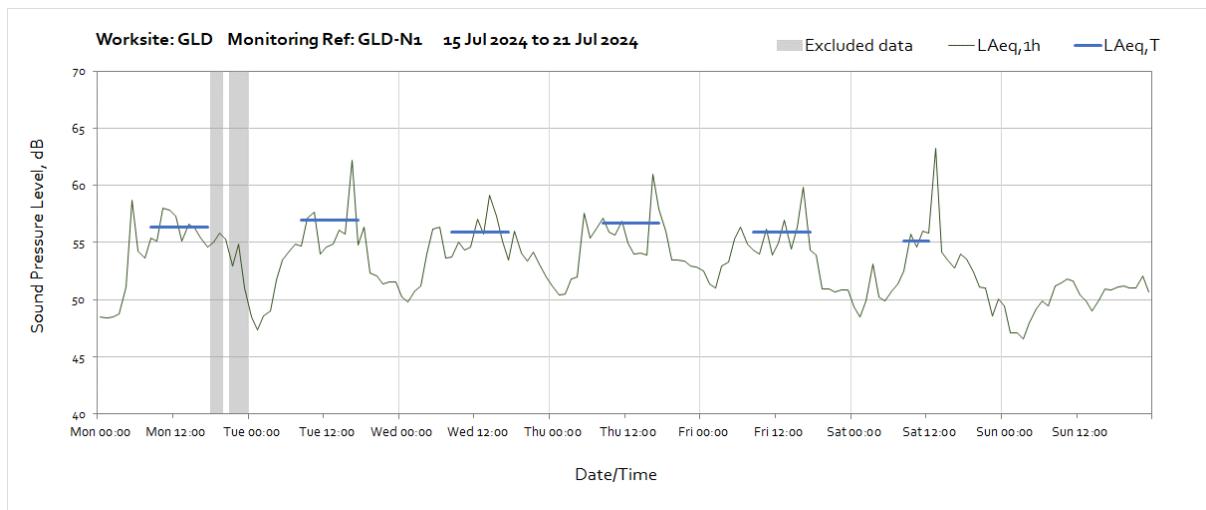
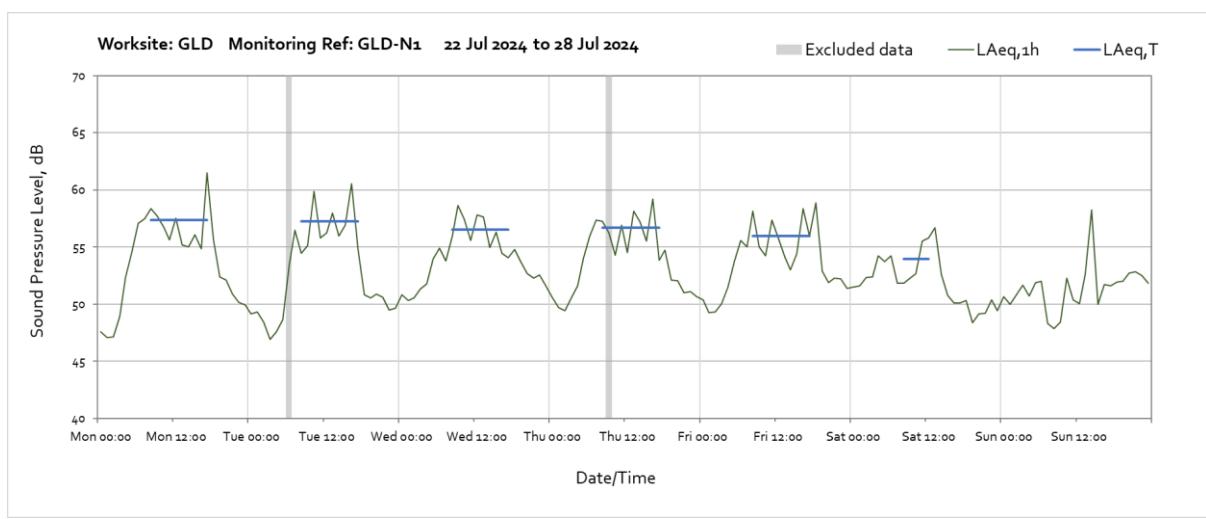
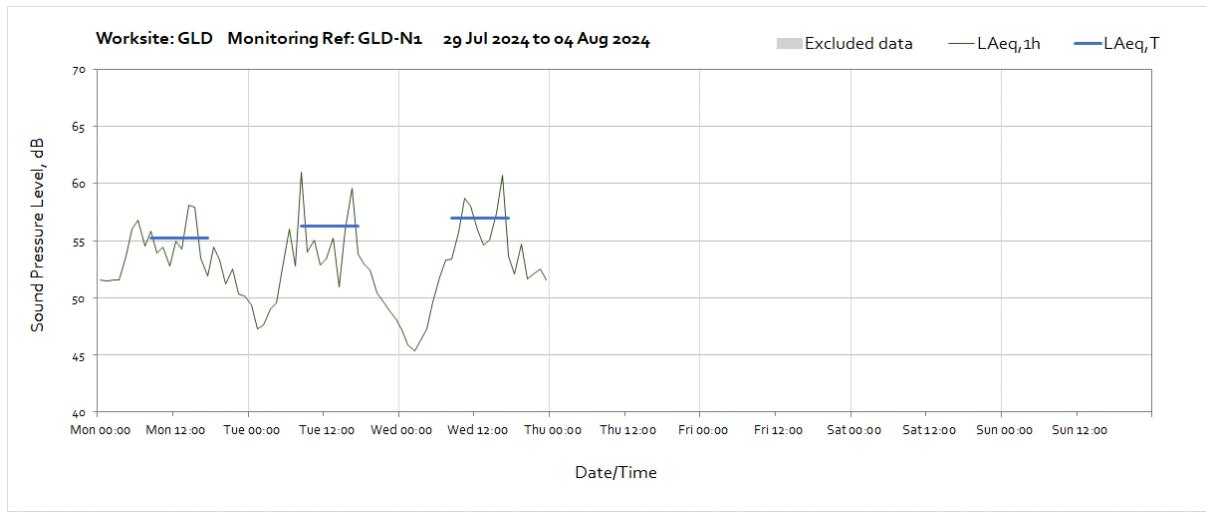
### Worksite: GLD - Monitoring Ref: GLD-N1

| Worksite Reference | Measurement Reference | Site Address | Free-Field or Façade Measurement | Weekday Average L <sub>Aeq,T</sub><br>(Highest Day L <sub>Aeq,T</sub> ) | | | | | Saturday Average L <sub>Aeq,T</sub><br>(Highest Day L <sub>Aeq,T</sub> ) | | | | | Sunday / Public Holiday Average L <sub>Aeq,T</sub><br>(Highest Day L <sub>Aeq,T</sub> ) | |
|---|---|--|---|---|---|---|---|---|--|---|---|---|---|---|---|
| GLD | GLD-N1 | 10 Gilson Dr, Coleshill | Free-field | 55.5<br>(60.6) | 57.1<br>(59.5) | 55.0<br>(58.9) | 52.8<br>(56.5) | 51.8<br>(60.4) | 52.7<br>(54.2) | 55.2<br>(56.0) | 57.3<br>(63.3) | 52.5<br>(58.2) | 50.5<br>(54.0) | 51.7<br>(58.3) | 52.5<br>(60.4) |

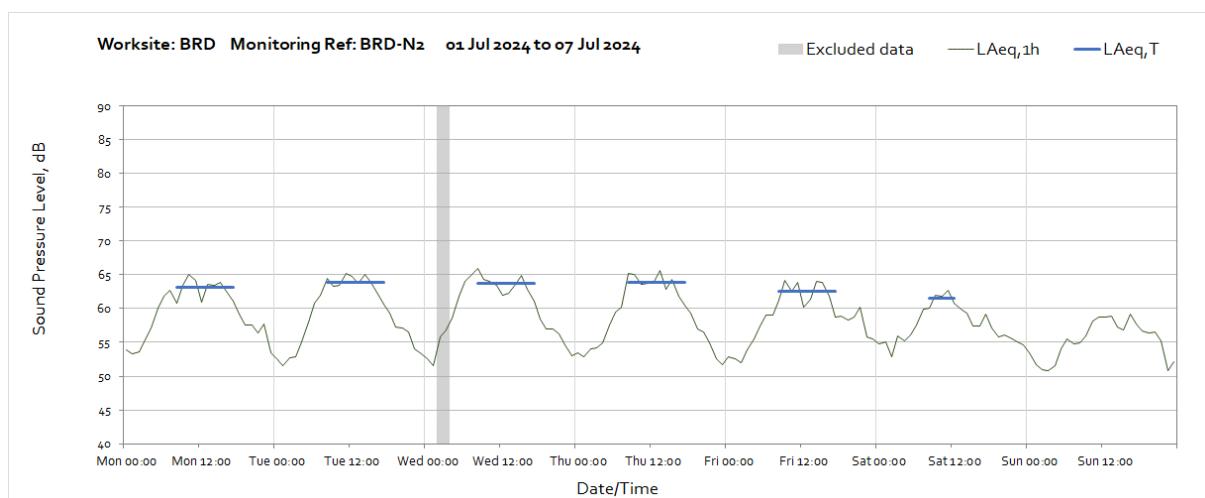
## Worksite: BRD - Monitoring Ref: BRD-N2

- 2.1.3 Appendix C presents graphs of the noise and vibration monitoring data over the month for each of the measurement locations. Noise data presented consists of the hourly  $L_{Aeq}$  values and, where relevant, the  $L_{Aeq,T}$  values (where the time period T has been taken to be the averaging period as specified in Table 1 of HS2 Information Paper E23). Vibration data presented consist of hourly PPV values. The full data set for the monitoring equipment can be found at the following location:  
<https://data.gov.uk/dataset/24542ae7-dd44-444f-b259-871c4cc43b5e/environmental-monitoring-data>.

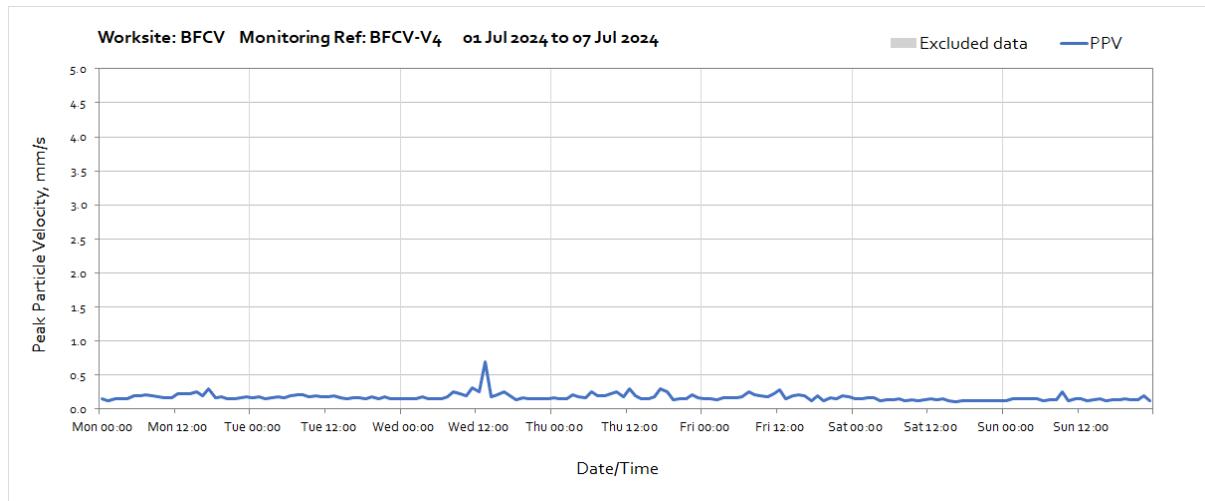
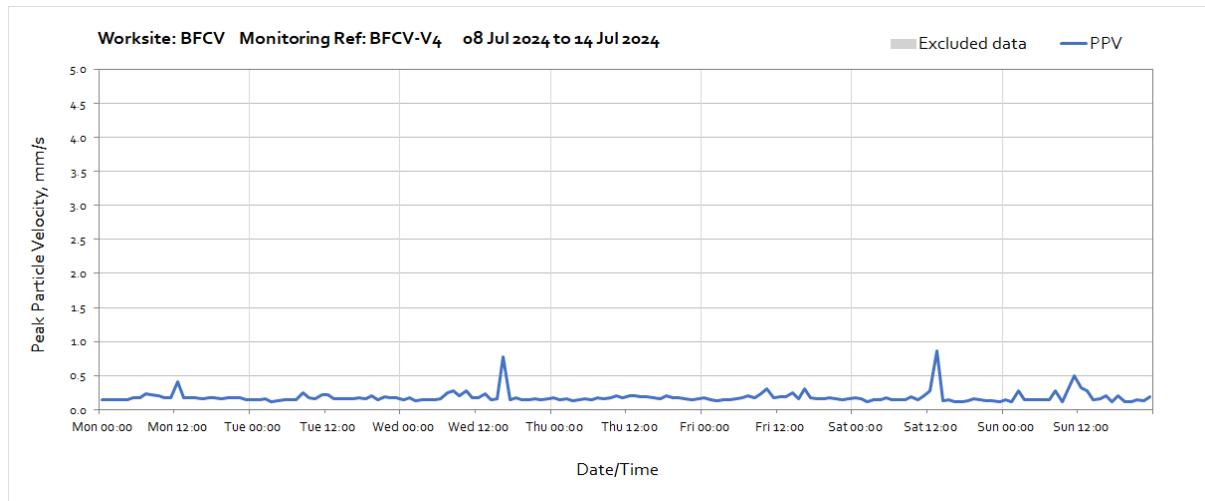
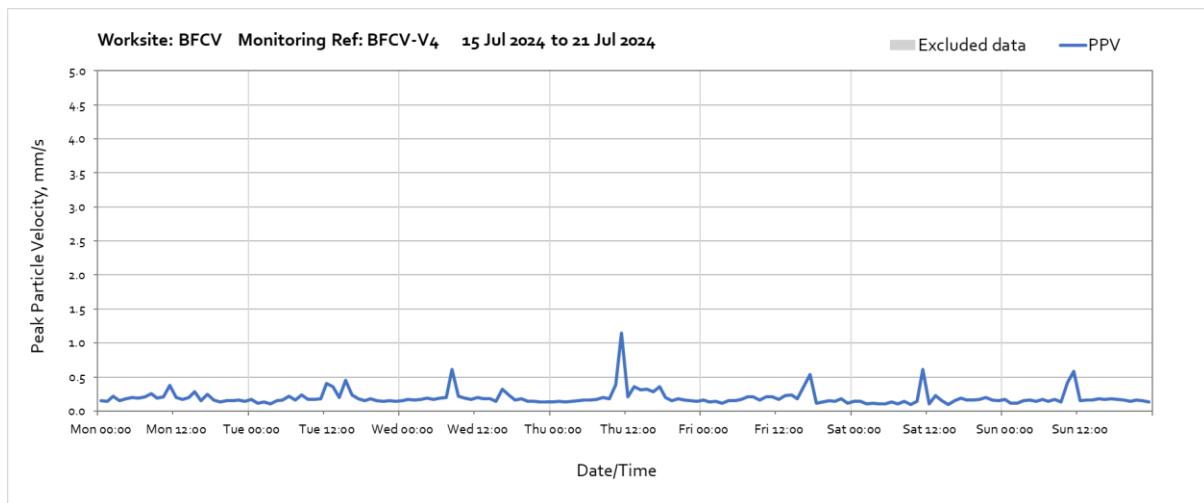
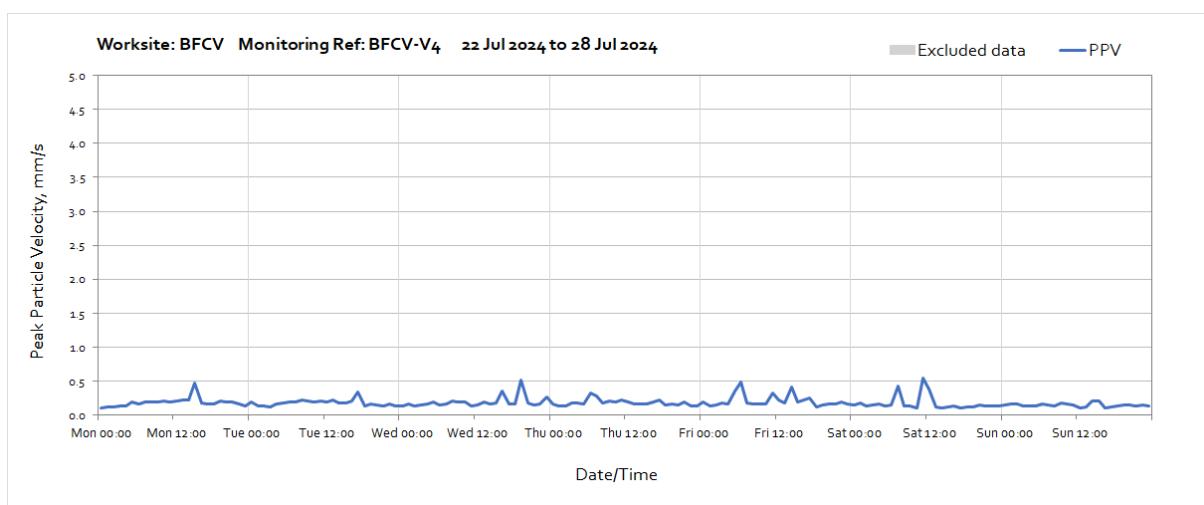
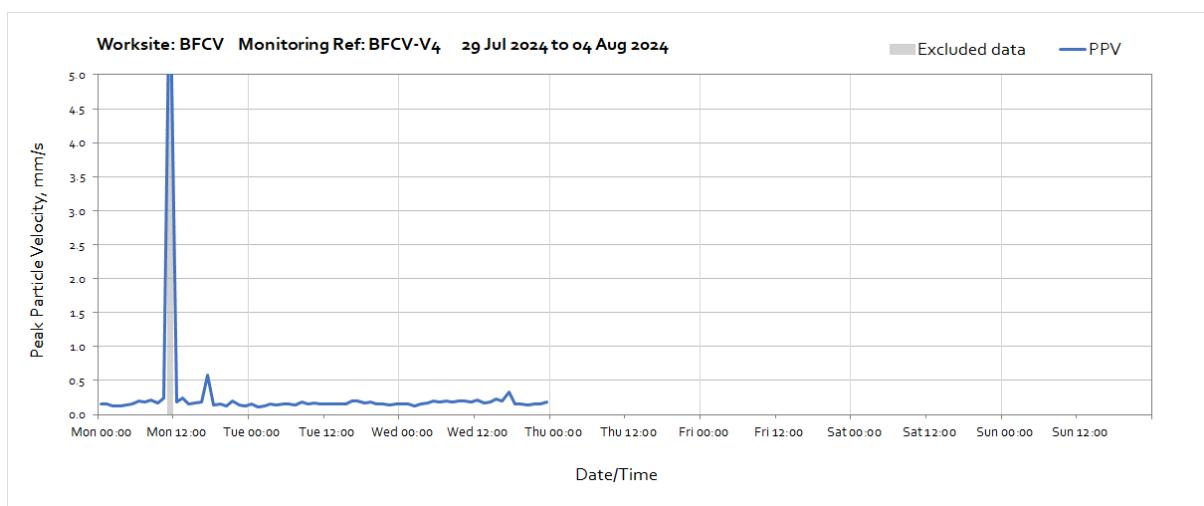
### Worksite: BFCV – Monitoring Ref: BFCV-V4

The following graphs show the hourly measured peak particle velocity PPV recorded during the monitoring period. The graphs show the highest PPV of the three orthogonal axes x, y and z. Where high values of PPV were caused by local interference with the vibration monitor, which are not representative of HS2 construction works, these values have been greyed out in the following charts and have been excluded to calculate values in Table 4 of the main report.

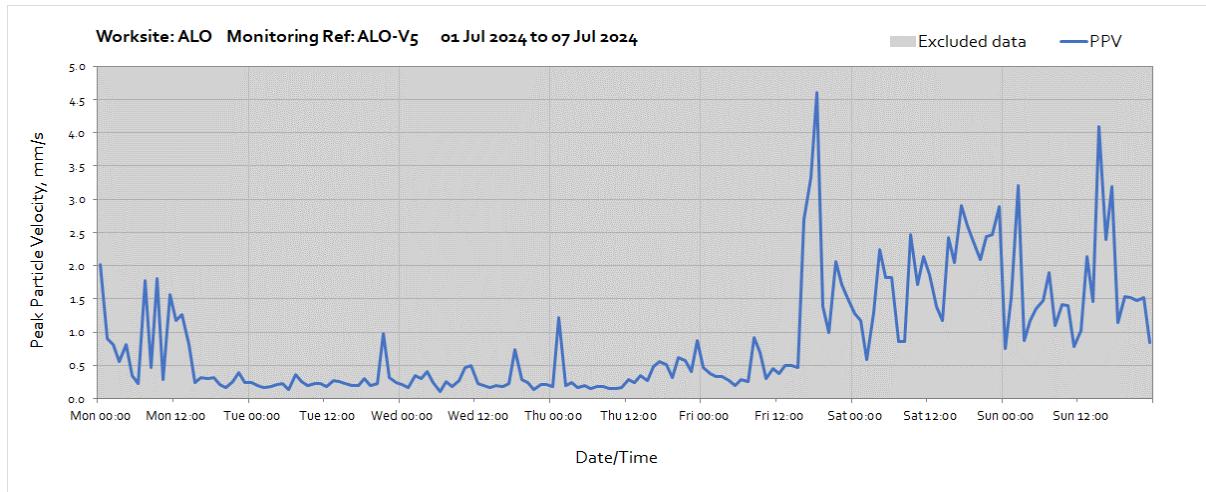
### Worksite: ALO – Monitoring Ref: ALO-V5

Note: Excluded data throughout the week was due to a monitor fault, the monitor was swapped out at 15:00 on Thursday 11<sup>th</sup> July.

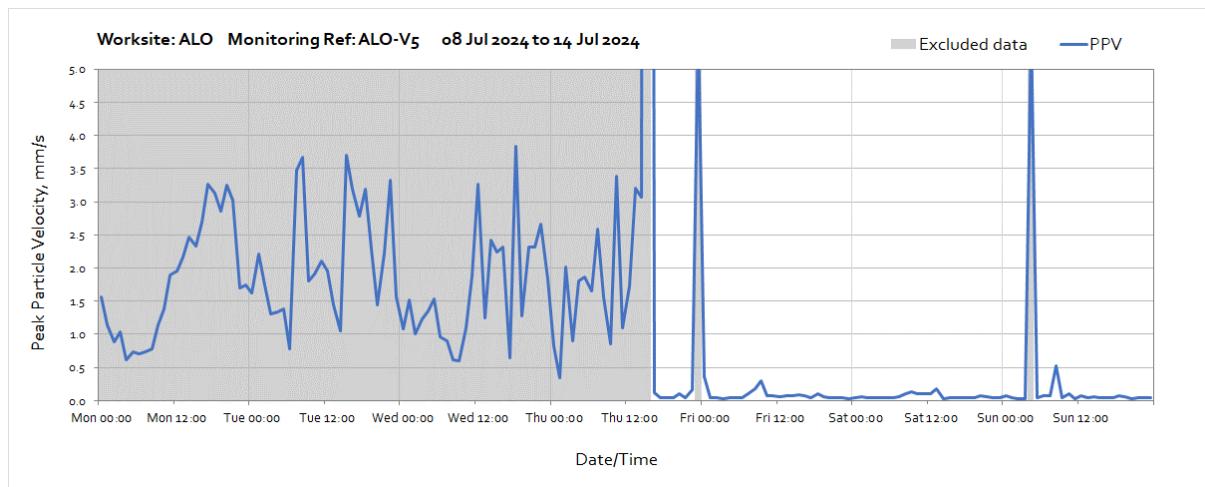
Note: Excluded data throughout the week was due to a monitor fault, the monitor was swapped out at 15:00 on Thursday 11<sup>th</sup> July.
