HS2

September 2024

Construction Noise and Vibration Monthly Report – July 2024

Solihull Metropolitan Borough Council

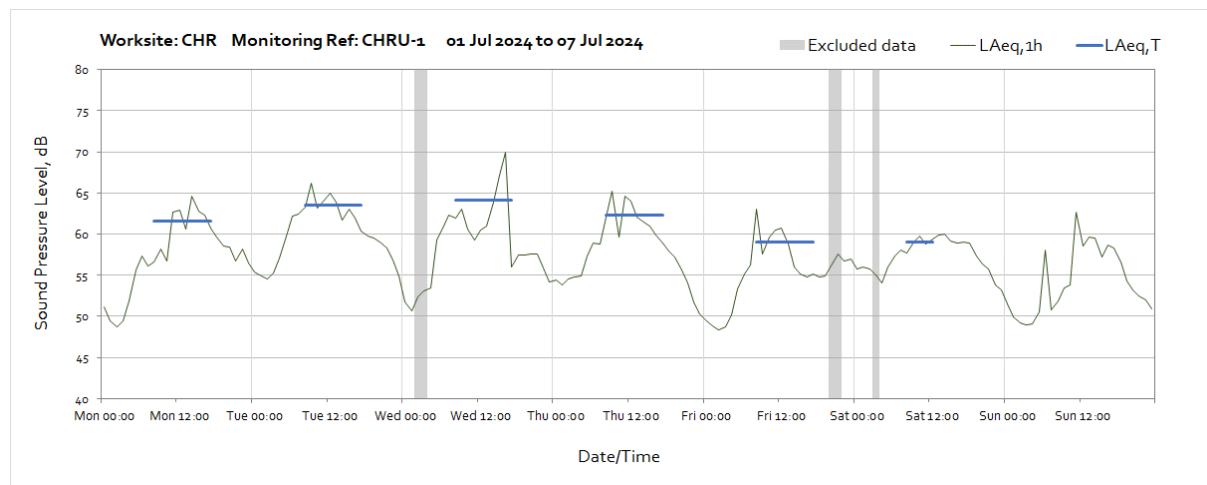
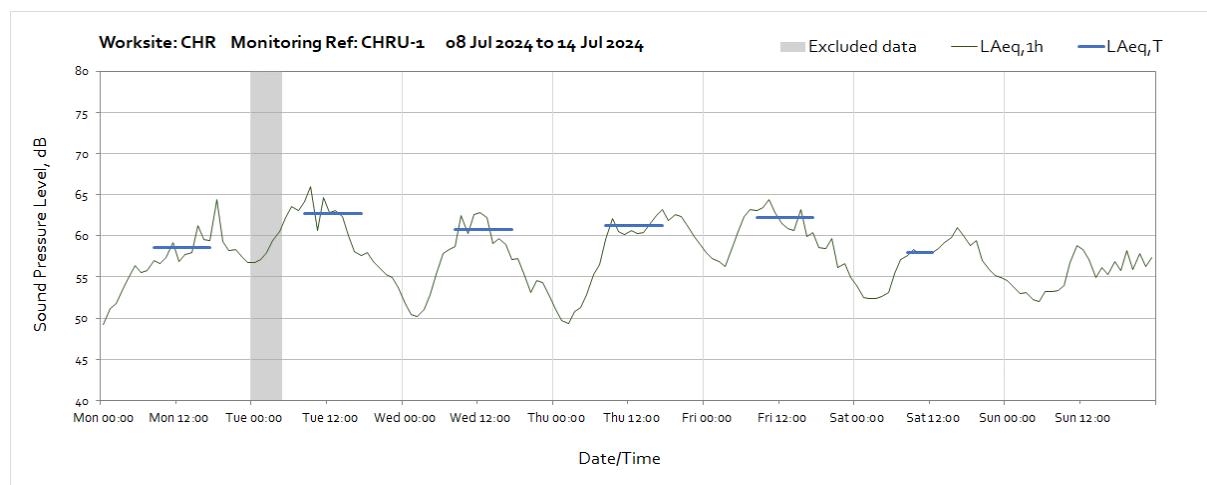
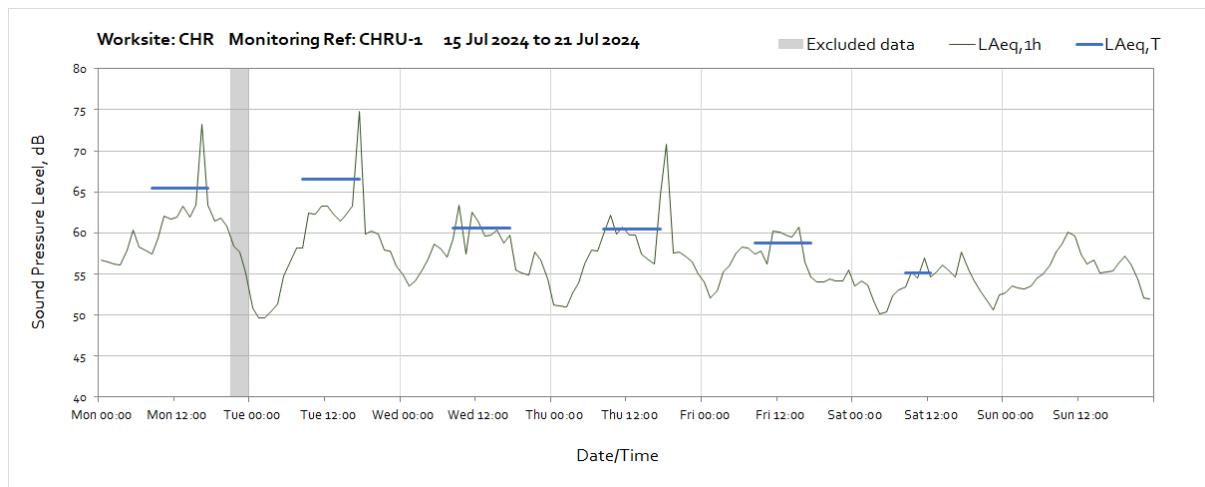
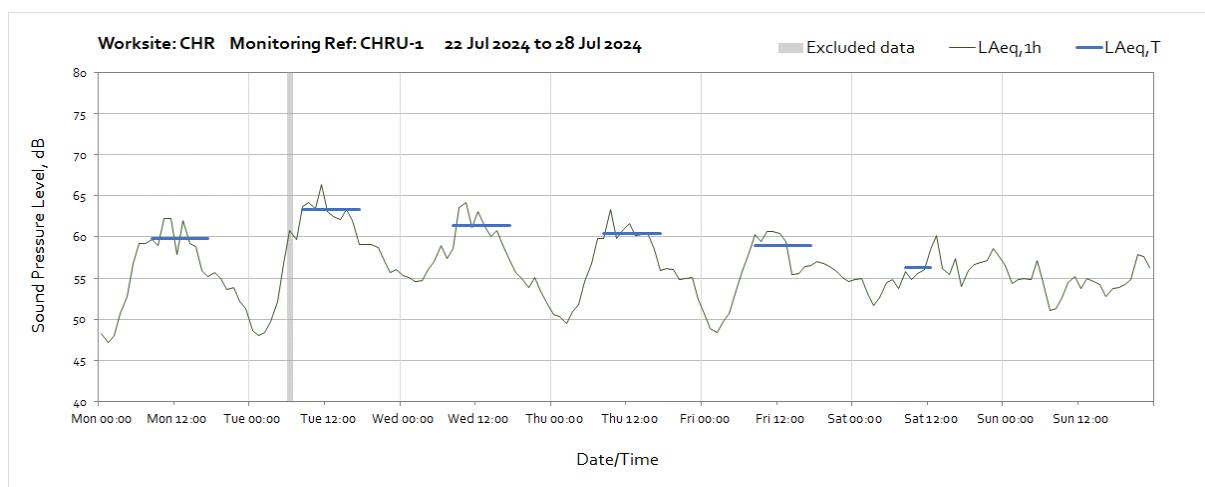
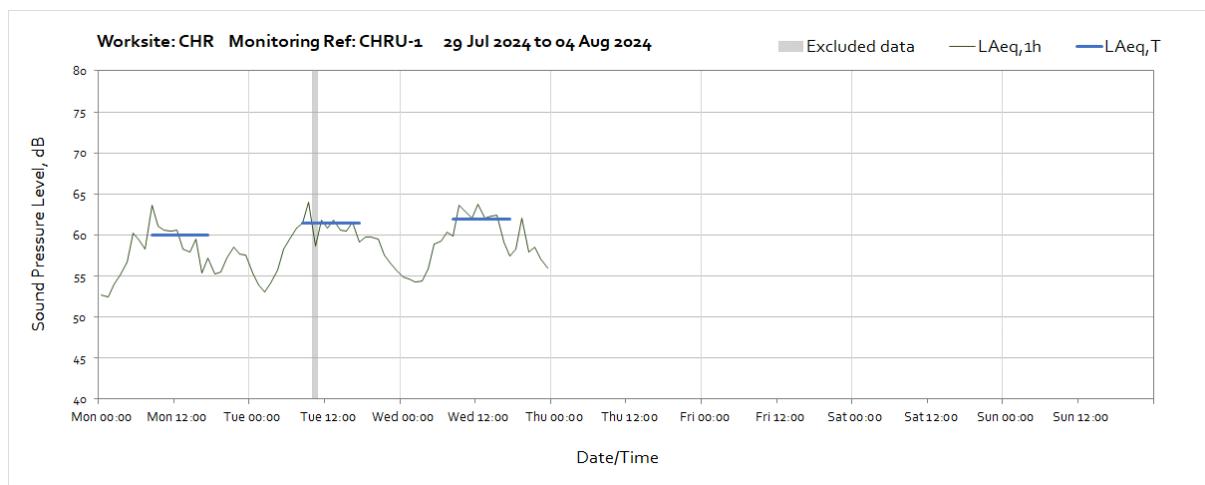
Worksite: CHR - Monitoring Ref: CHRU-1

The following graphs show the hourly measured ambient noise level $L_{Aeq,1h}$ and, where relevant, the averaged noise level $L_{Aeq,T}$ values, where the time period T is as specified in Table 1 of HS2 Information Paper E23. Periods where noise levels are adversely affected by weather or only measured for part of the period, which are not representative of HS2 construction works, have been greyed out and excluded from the calculation of the $L_{Aeq,T}$ values in of the main report.

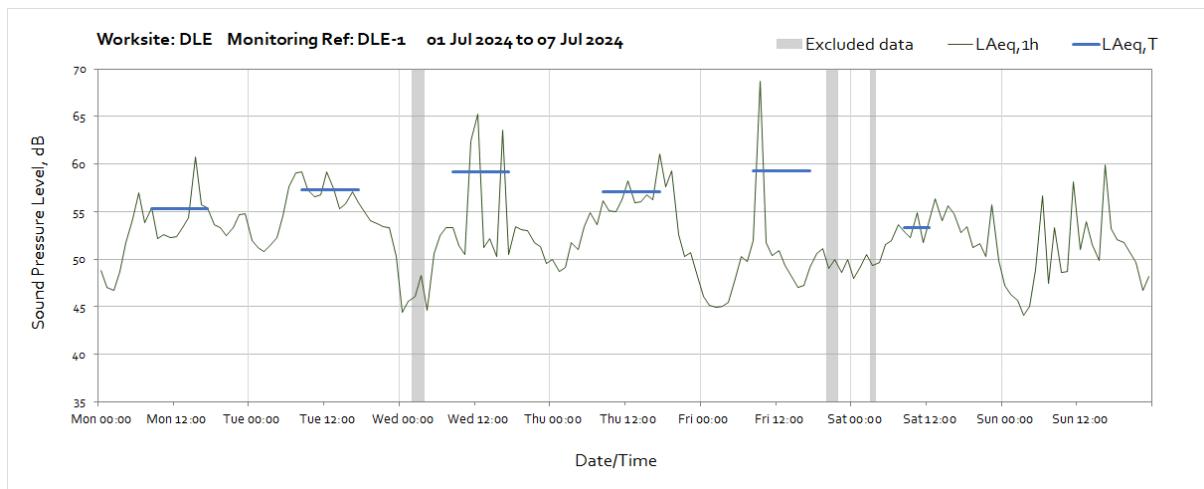
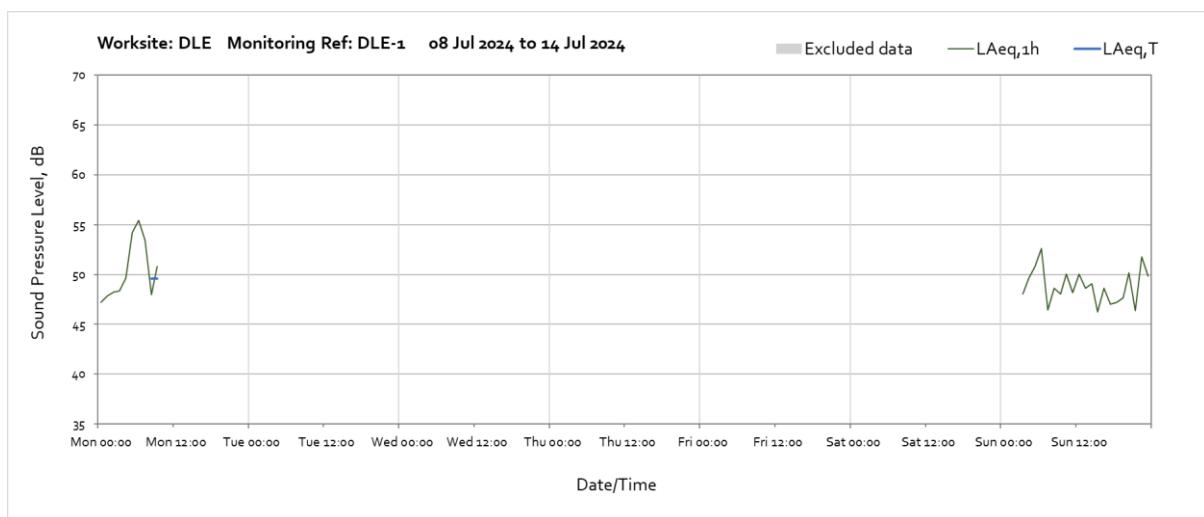
Worksite: DLE - Monitoring Ref: DLE-1

Note: Missing data between 10:00 Monday 8th and 03:00 on Sunday 14th July was due to a meter error causing loss of data.

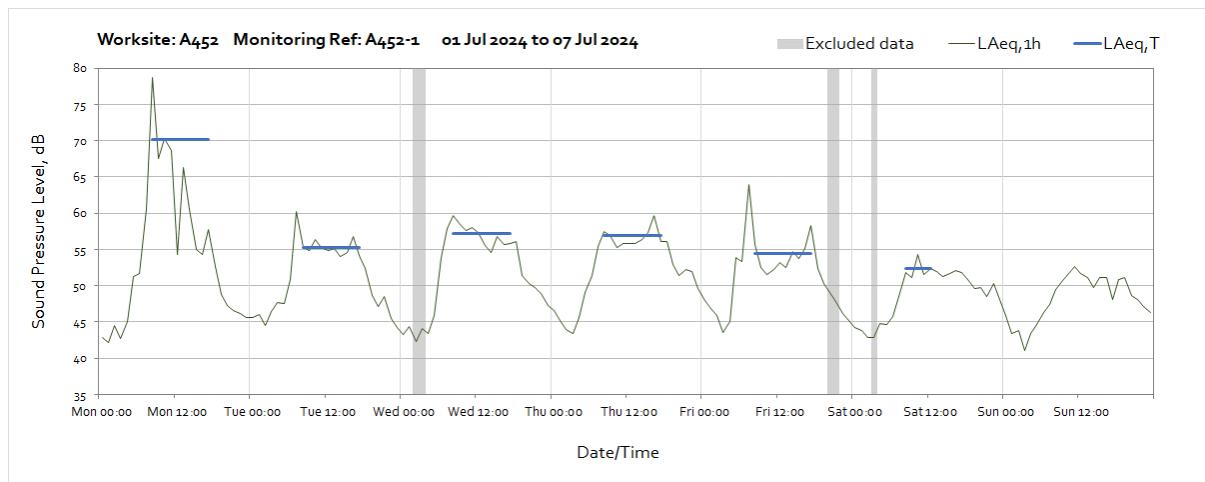
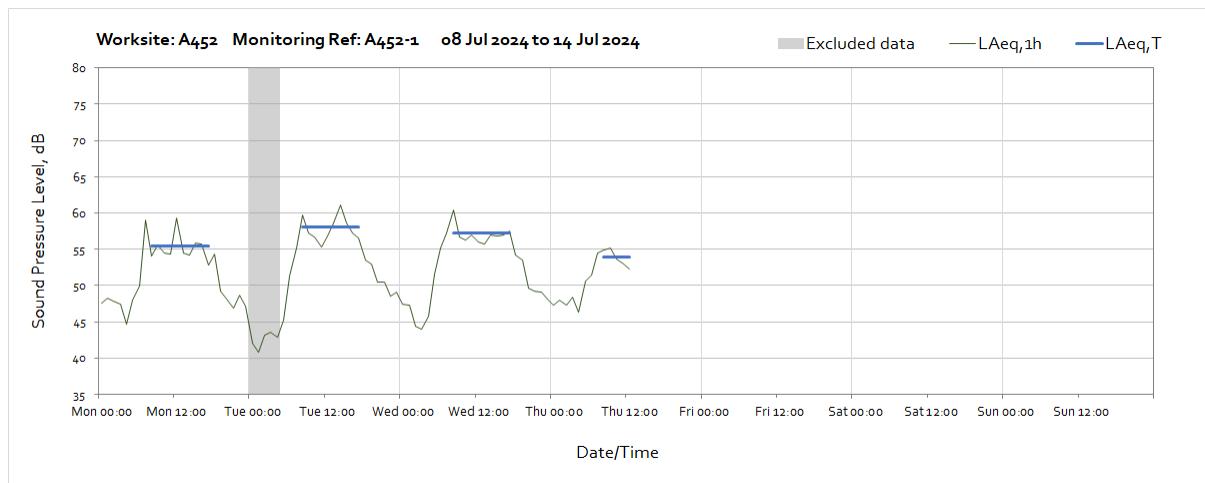
Worksite: A452 – Monitoring Ref: A452-1

Note: Missing data from 13:00 on Thursday 11th July until the end of the month was due to a loss of power to the monitoring station caused by vegetation overgrowth preventing sufficient light reach the solar panel.

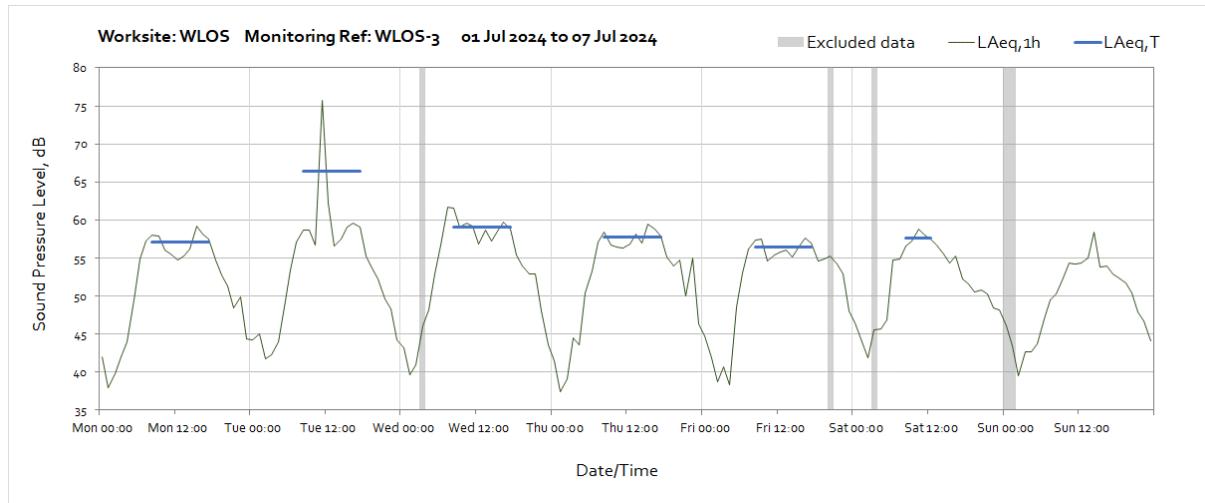
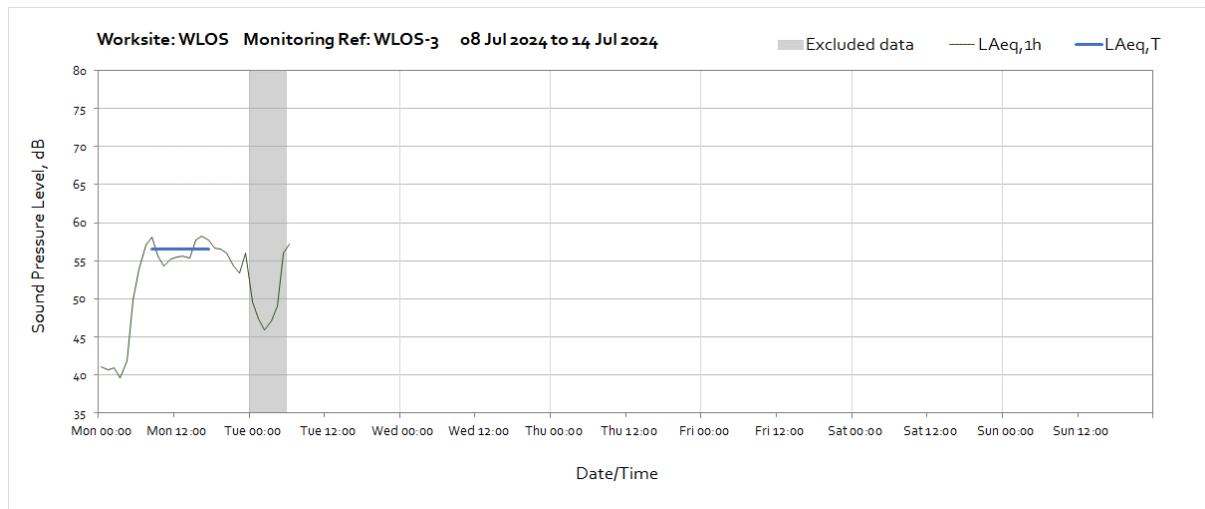
Worksite: WLOS – Monitoring Ref: WLOS-3

Note: Missing data from 07:00 on Tuesday 9th July until the end of the month was due to a loss of power to the monitoring station caused by vegetation overgrowth preventing sufficient light reach the solar panel.

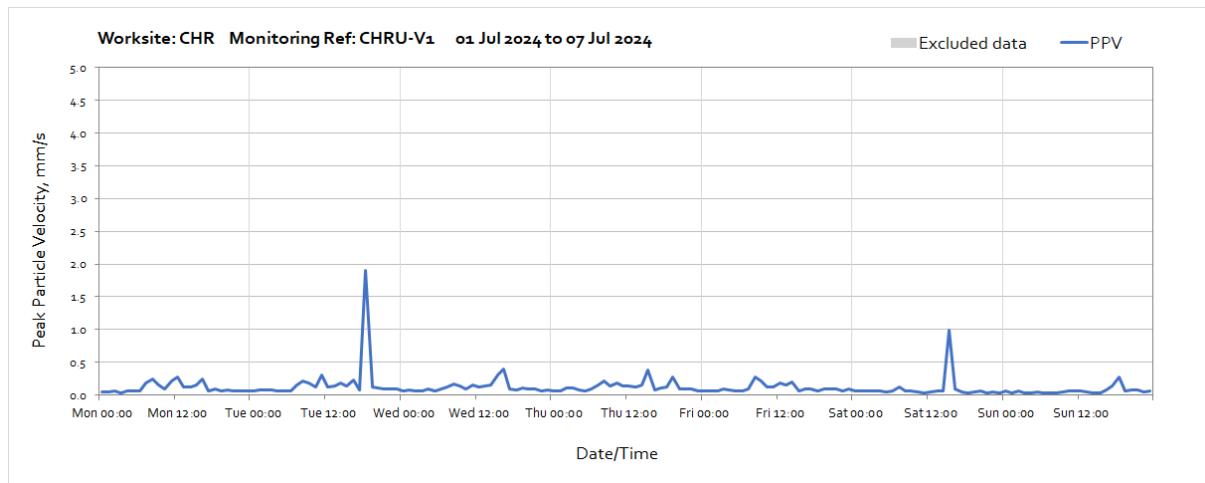
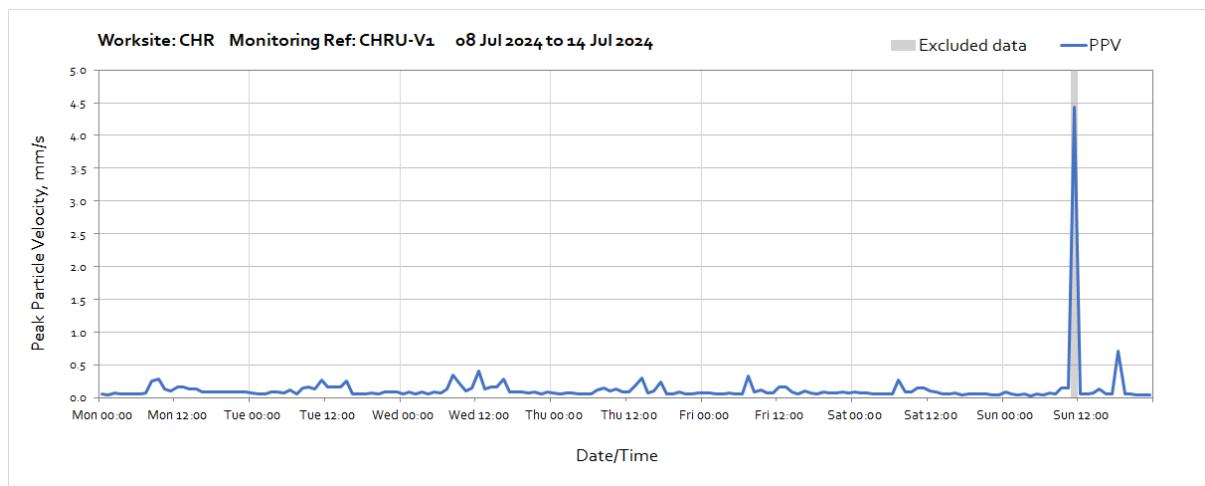
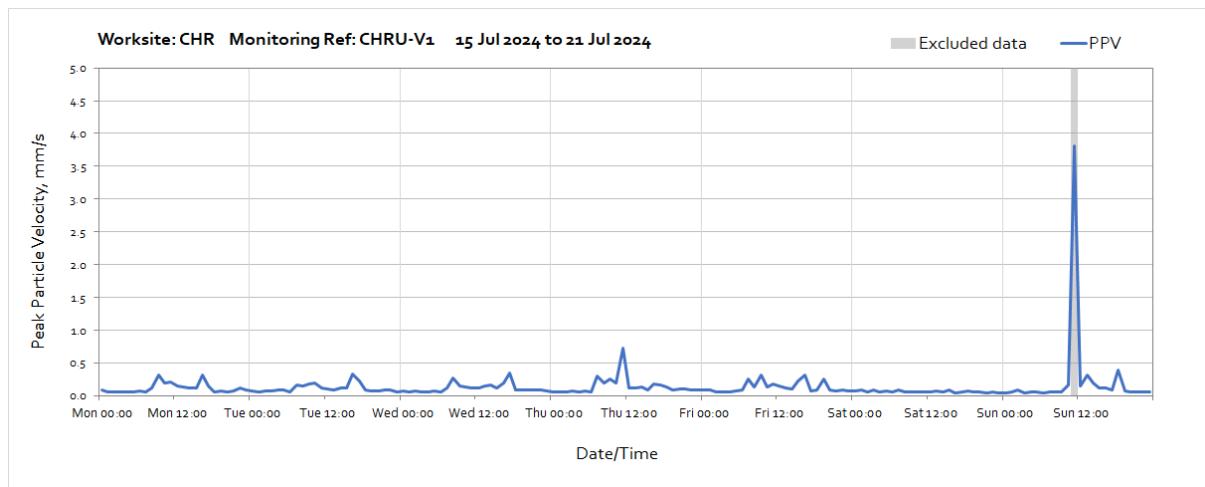
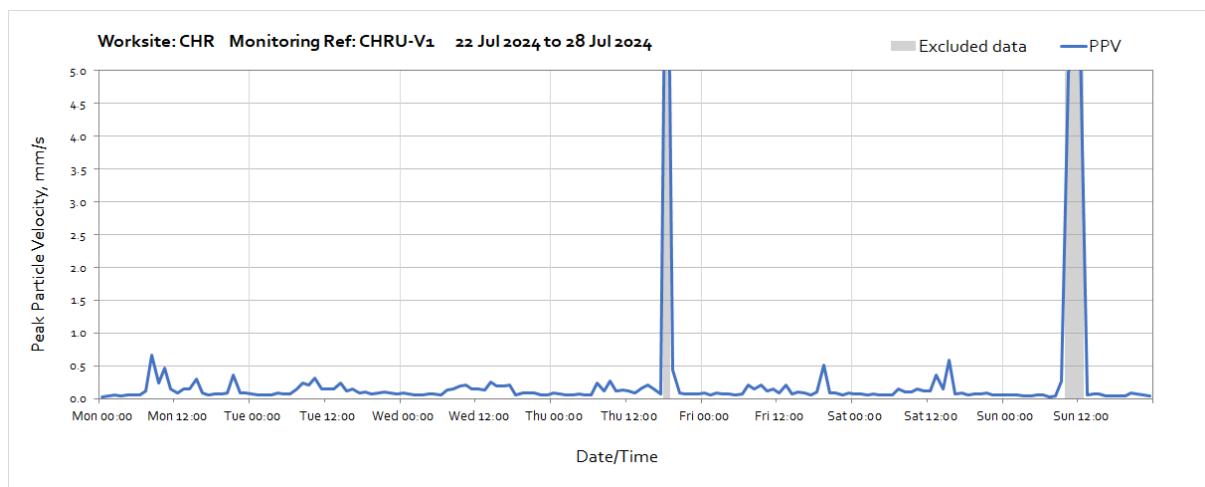
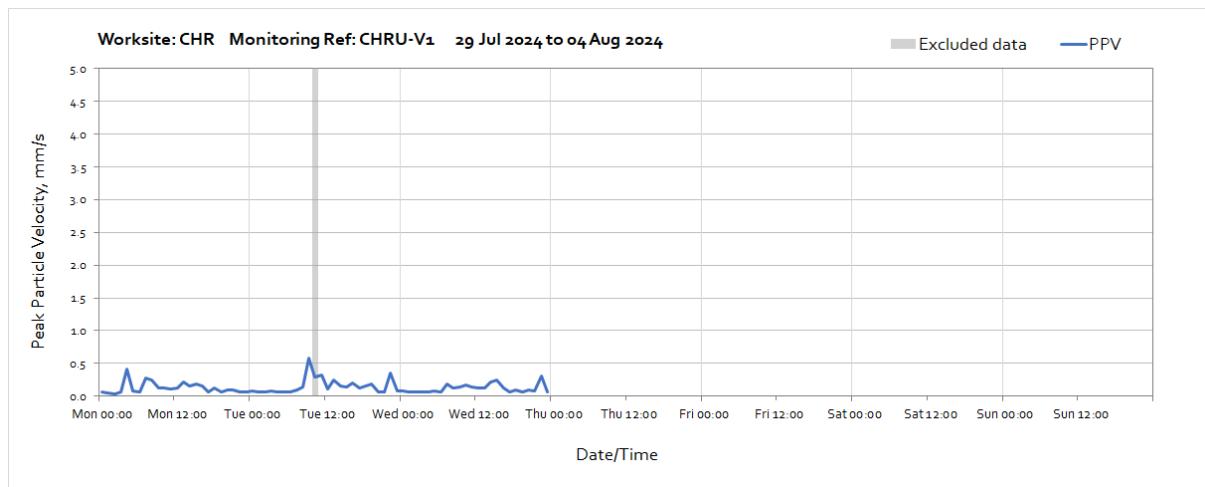
Worksite: CHR – Monitoring Ref: CHRU-V1

The following graphs show the hourly measured peak particle velocity PPV recorded during the monitoring period. The graphs show the highest PPV of the three orthogonal axes x, y and z. Periods where PPV values have been affected by local interference with the vibration monitor or only measured for part of the period, which are not representative of HS2 construction works, have been greyed out and excluded when calculating values in of the main report.
