HS2

September 2024

Construction Noise and Vibration Monthly Report – July 2024

Warwick District Council

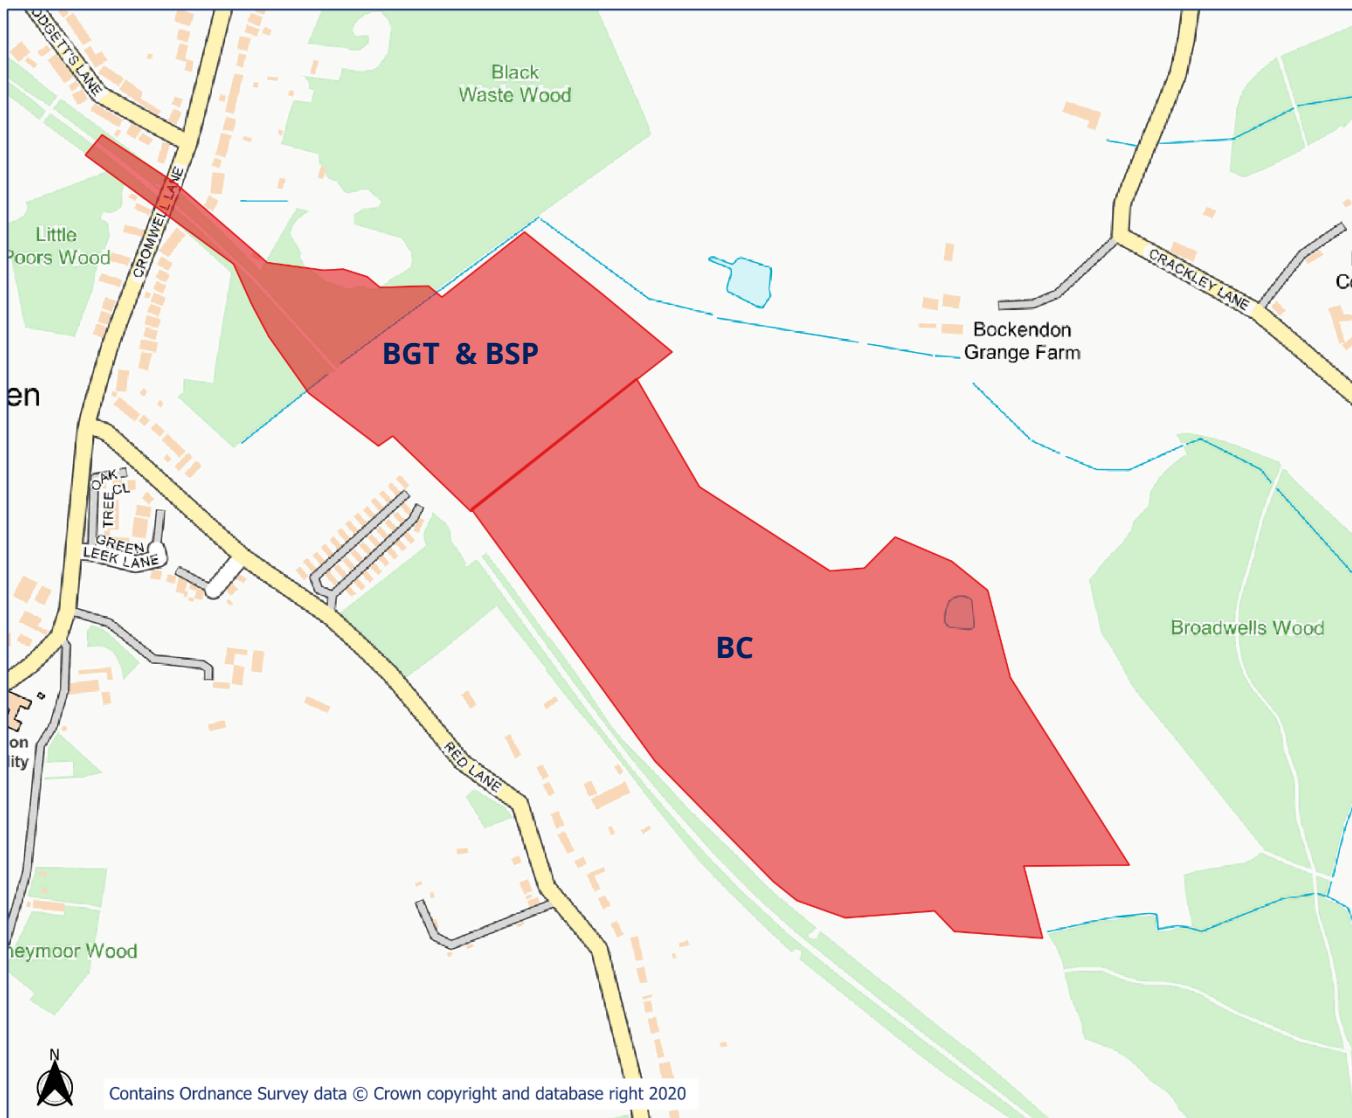
Worksite Identification Plan - 1

- 1.1.3 Construction sites in the local authority area where monitoring was undertaken during this period include:
- Burton Green Tunnel worksites (ref.: BGT, see plan 1 in Appendix A) where work activities included:

- Tunnel excavation.
 - Piling works.
 - Concrete pouring.
 - Burton Green Tunnel Southern Portal (ref.: BSP, see plan 1 in Appendix A) where no works were undertaken.

- Bockenden Cutting worksites (ref.: BC, see plan 1 in Appendix A), where no works were undertaken.
 - A429 Kenilworth Road Overbridge (ref.: A429, see plan 2 in Appendix A), where no works were undertaken.

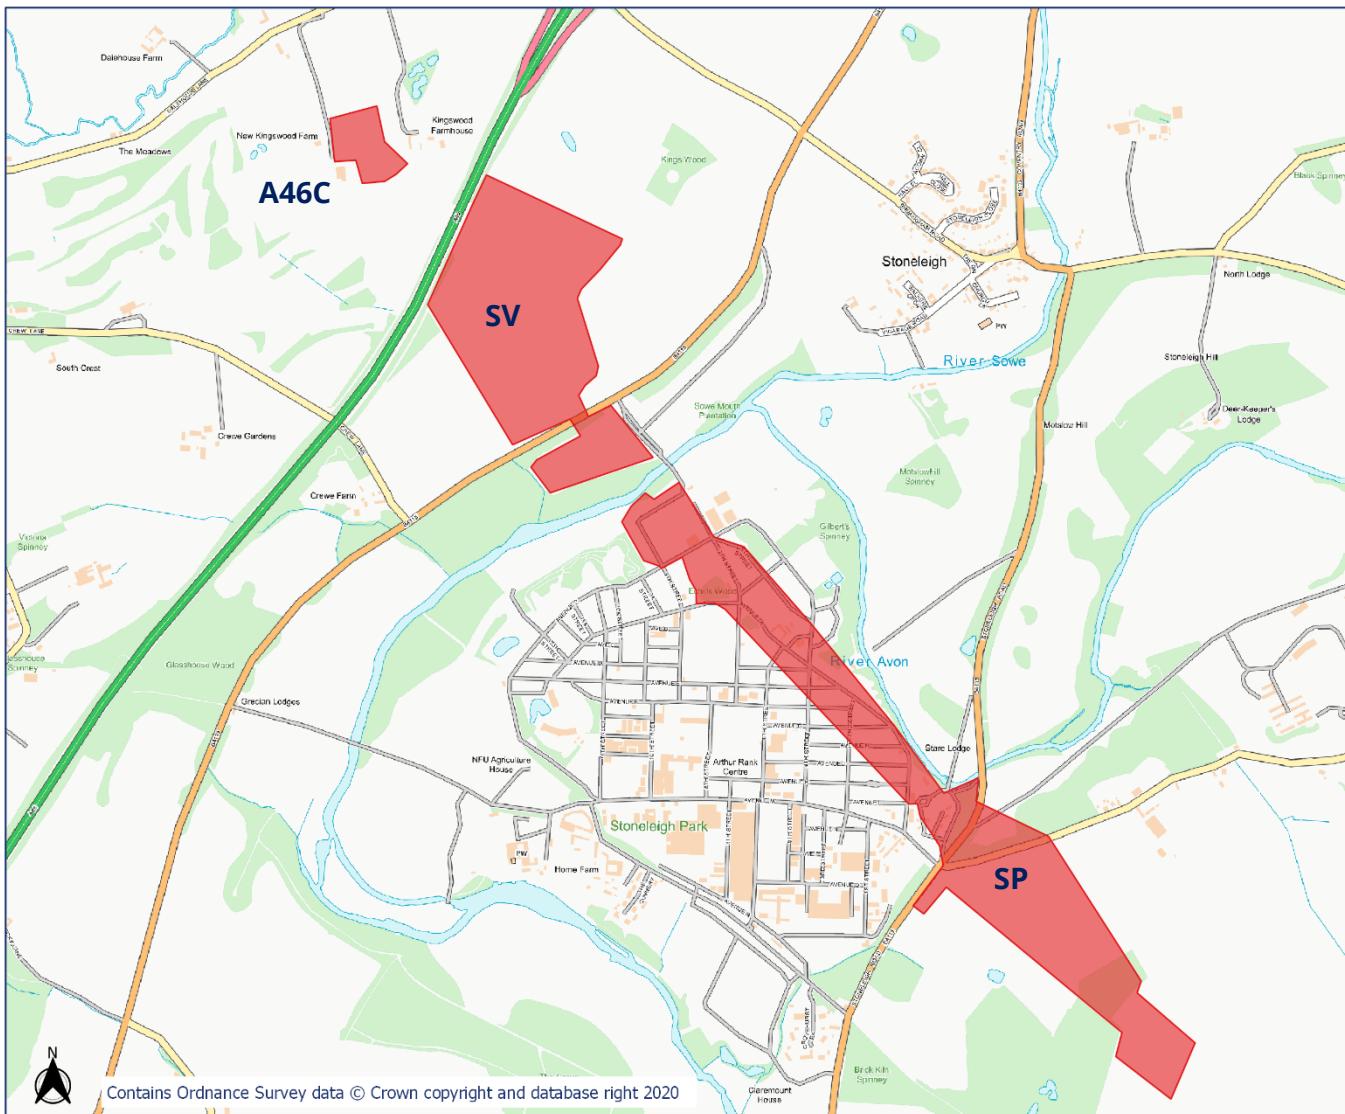
Worksite Identification Plan - 3

- A46 Compound, (ref.: A46C, see plan 3 in Appendix A), where work activities included:
 - Operation of batching plant, mechanical workshop, stockpile, site generators and compound.

- Stoneleigh Village, (ref.: SV, see plan 3 in Appendix A), where work activities included:
 - Mobilisation of satellite compounds.
 - Site access point and plant crossings installation.

- Temporary fencing and hoarding installation.
 - Earthworks.
 - Structures works.
- Stoneleigh Park, (ref.: SP, see plan 3 in Appendix A), where work activities included:

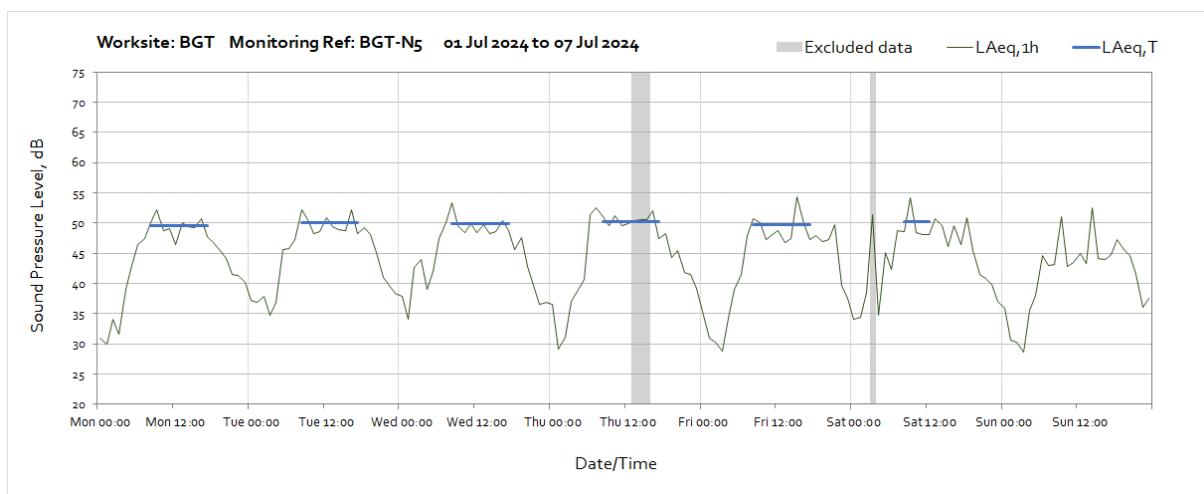
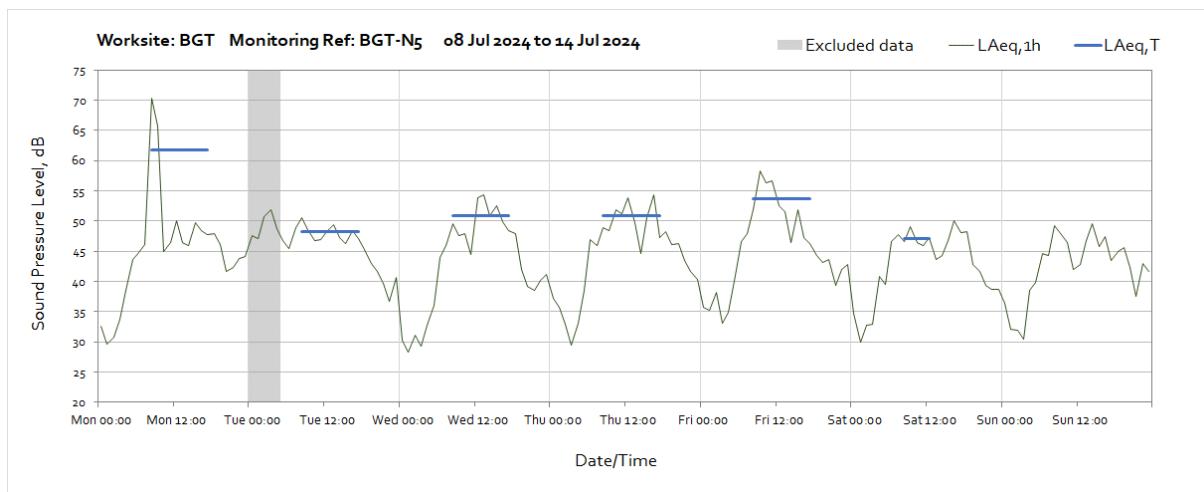
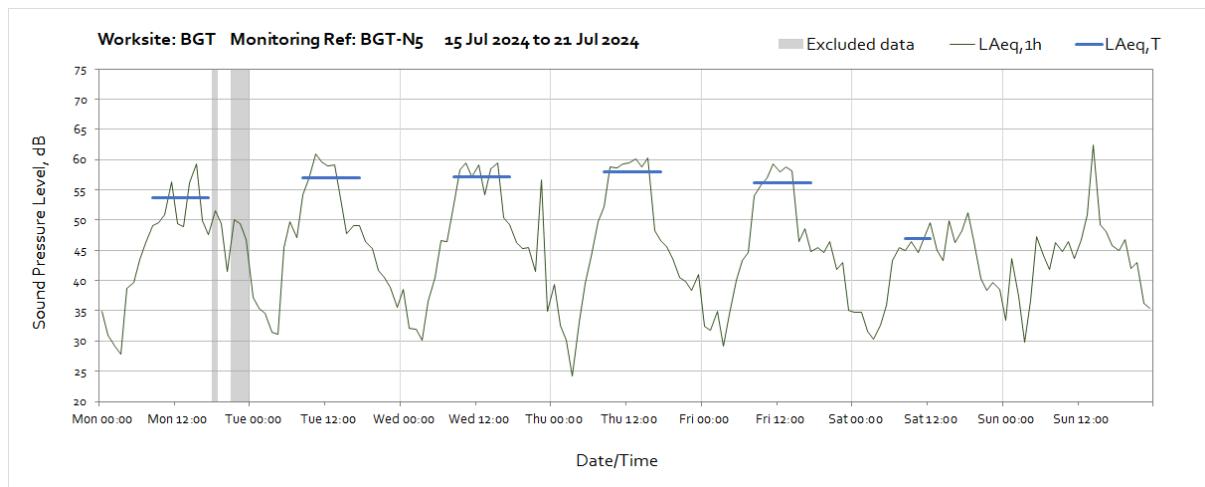
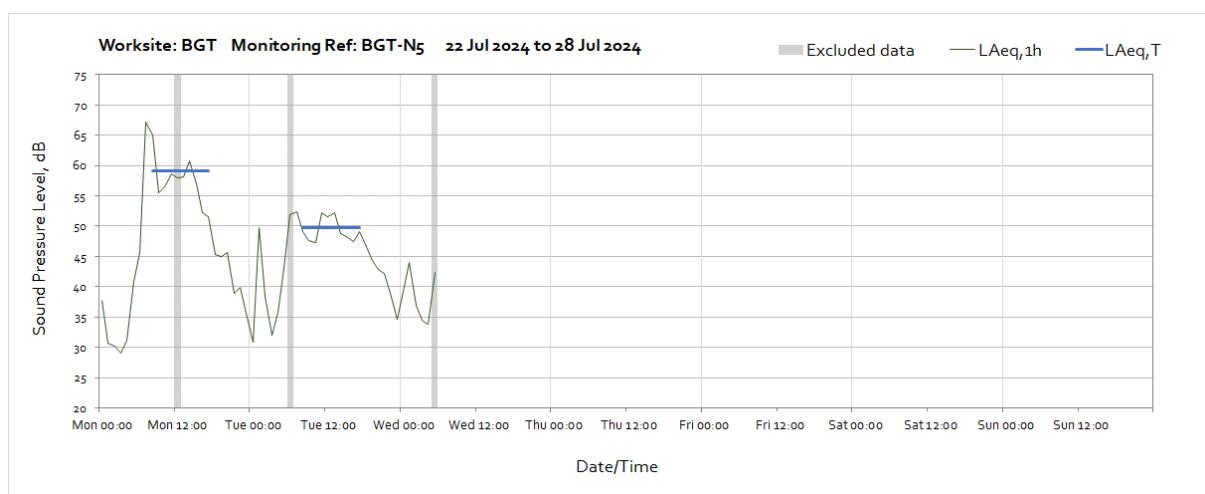
Worksite: BGT – Monitoring Ref: BGT-N5

Note: Missing data between 06:00 on Wednesday 24th of July and the end of the month was due to a power supply issue at the monitoring station.

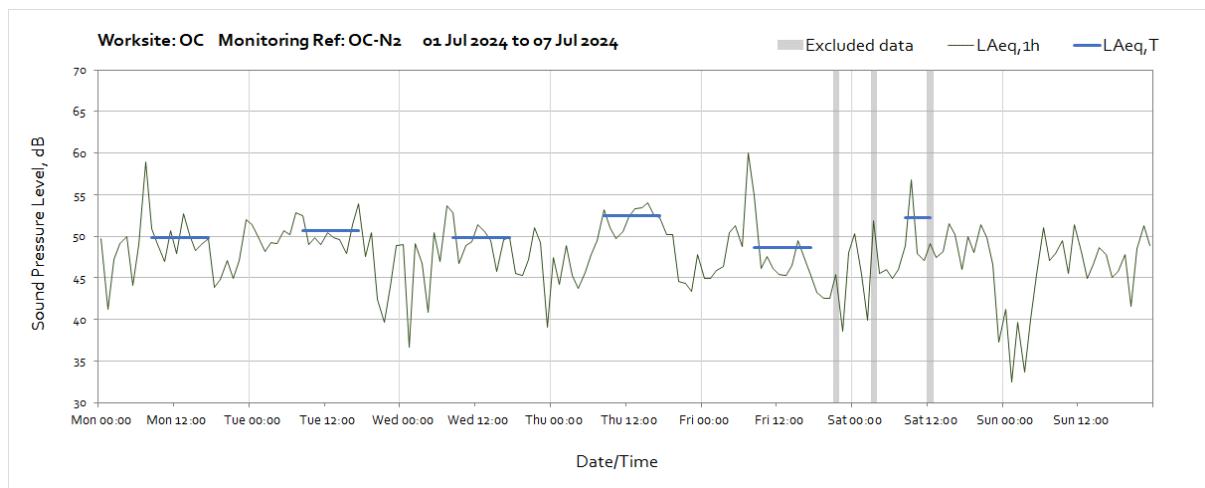
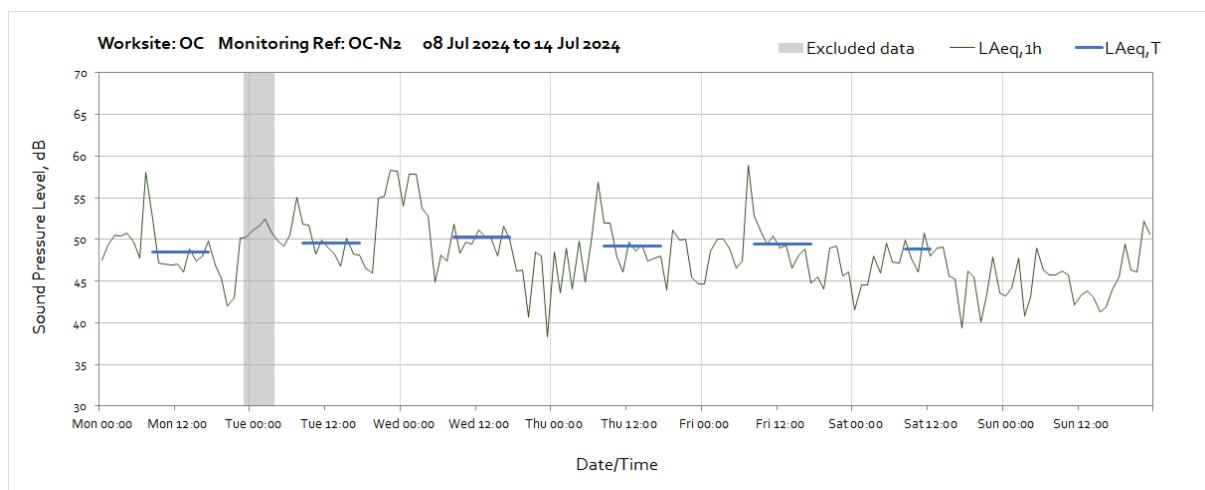
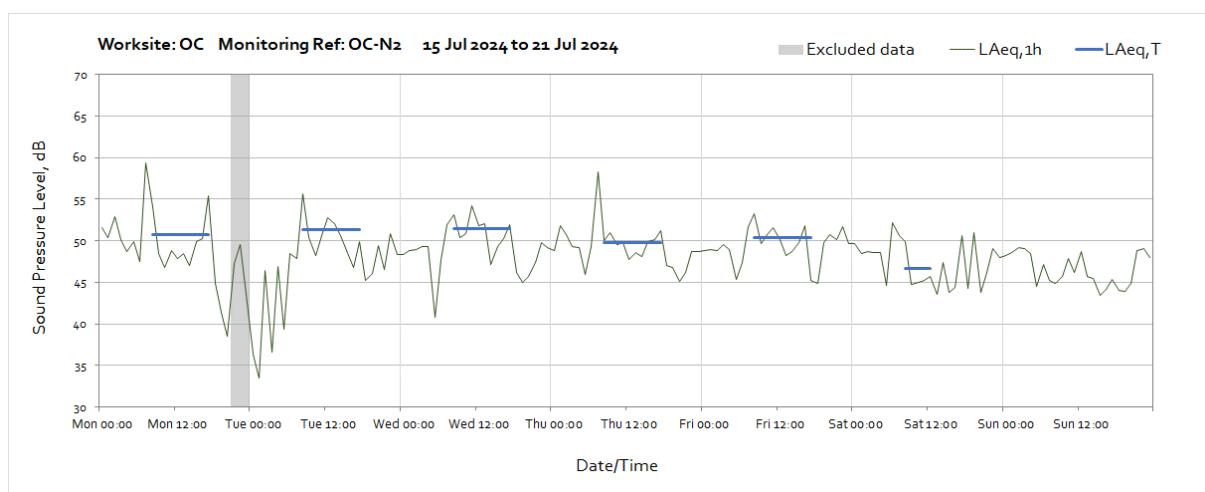
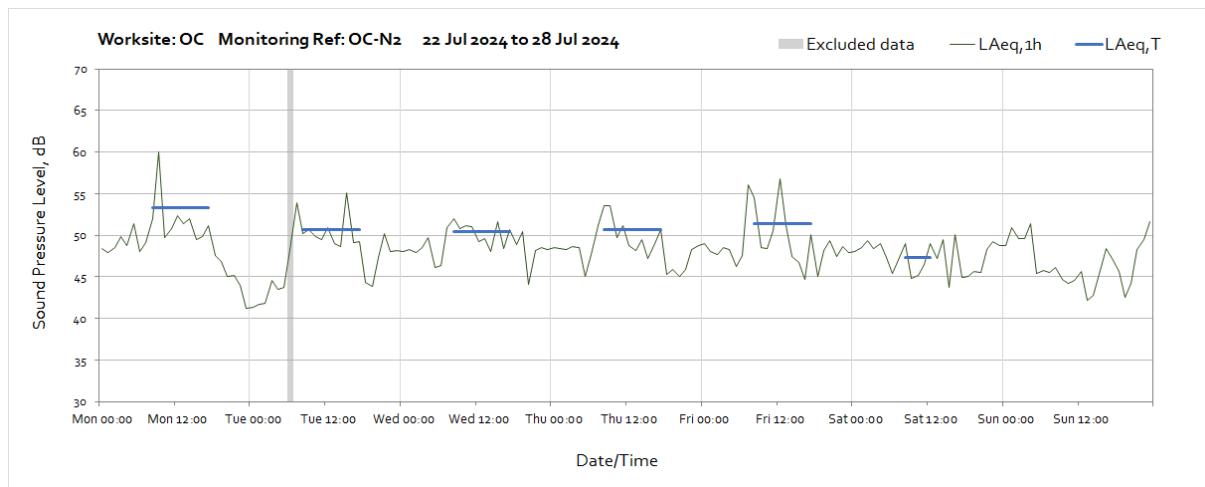
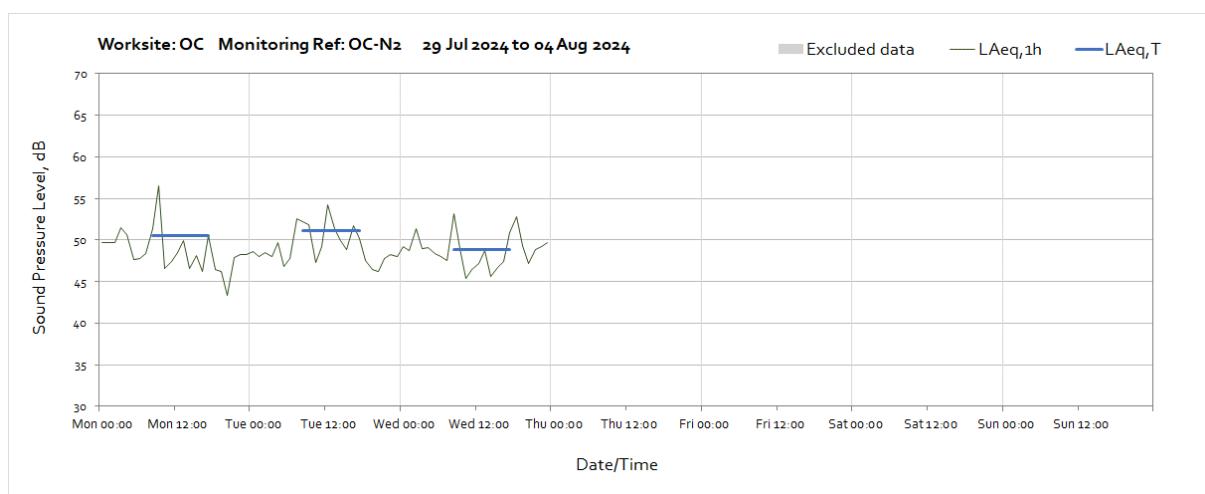
Worksite: OC – Monitoring Ref: OC-N2

- 2.1.3 Appendix C presents graphs of the noise and vibration monitoring data over the month for each of the measurement locations. Noise data presented consists of the hourly L_{Aeq} values and, where relevant, the $L_{Aeq,T}$ values (where the time period T has been taken to be the averaging period as specified in Table 1 of HS2 Information Paper E23). Vibration data presented consist of hourly PPV values. The full data set for the monitoring equipment can be found at the following location:

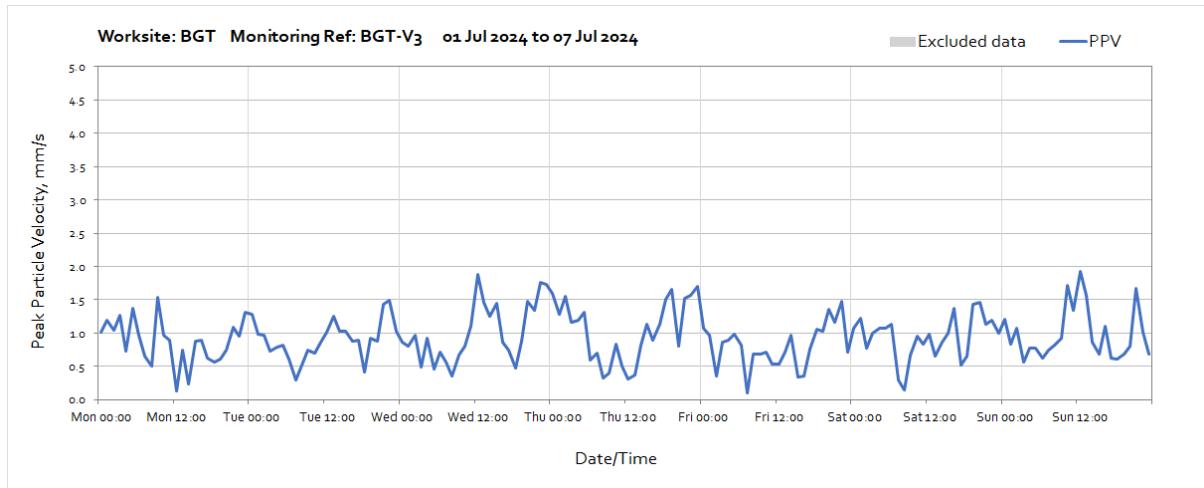
Worksite: BGT – Monitoring Ref: BGT-V3

The following graphs show the hourly measured peak particle velocity PPV recorded during the monitoring period. The graphs show the highest PPV of the three orthogonal axes x, y and z . Periods where PPV values have been affected by local interference with the vibration monitor or only measured for part of the period, which are not representative of HS2 construction works , have been greyed out and excluded when calculating values in Table 4 of the main report.

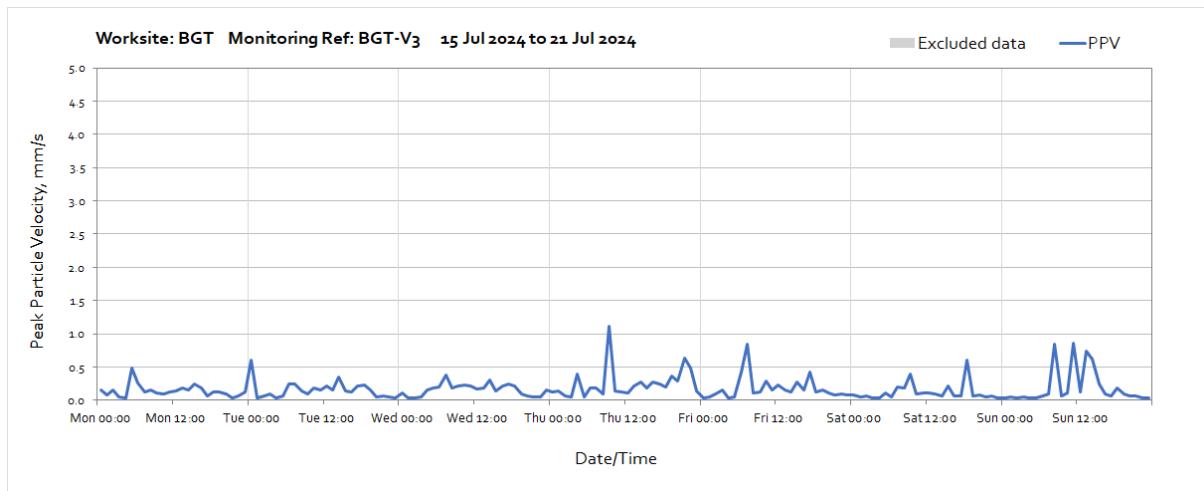
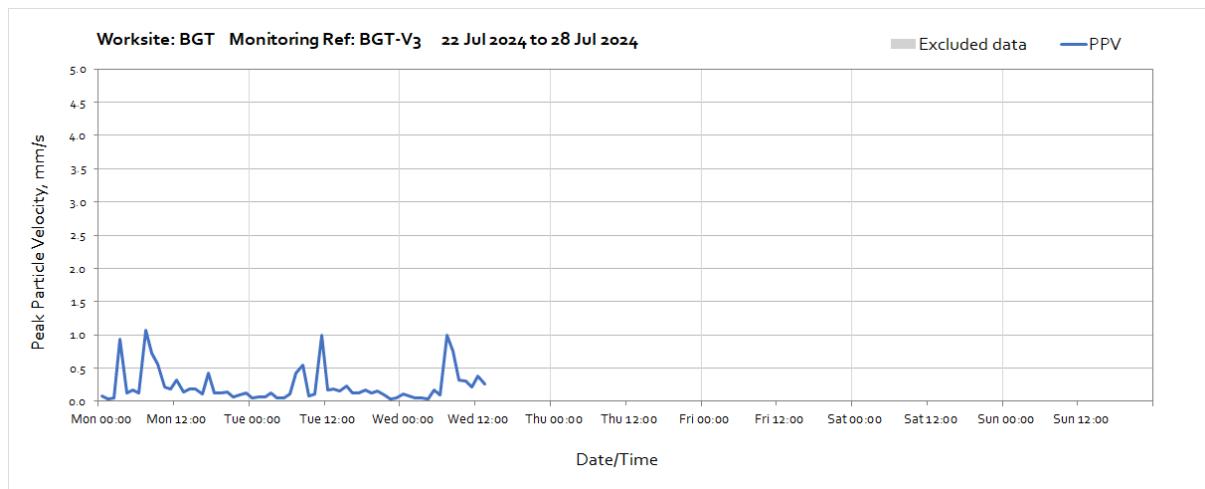
Note: Missing data between 14:00 on Wednesday 24th of July and the end of the month was due to a power supply issue at the monitoring station.

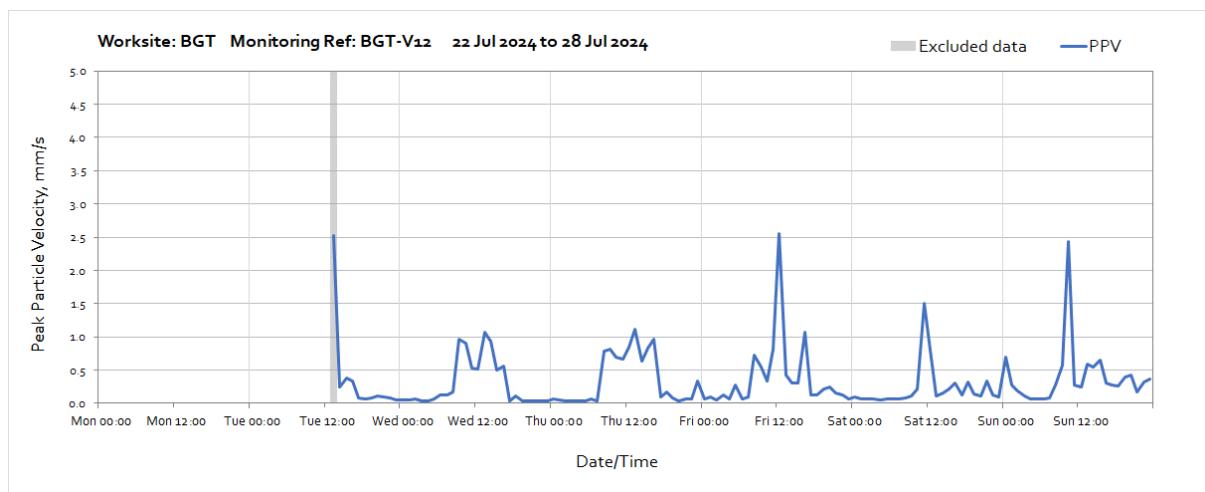
Worksite: BGT – Monitoring Ref: BGT-V12

Note: Monitoring station installed at 12:00 on Tuesday 23rd July.
