7. CHARACTER ANALYSIS

7.1 Overview & Character Areas

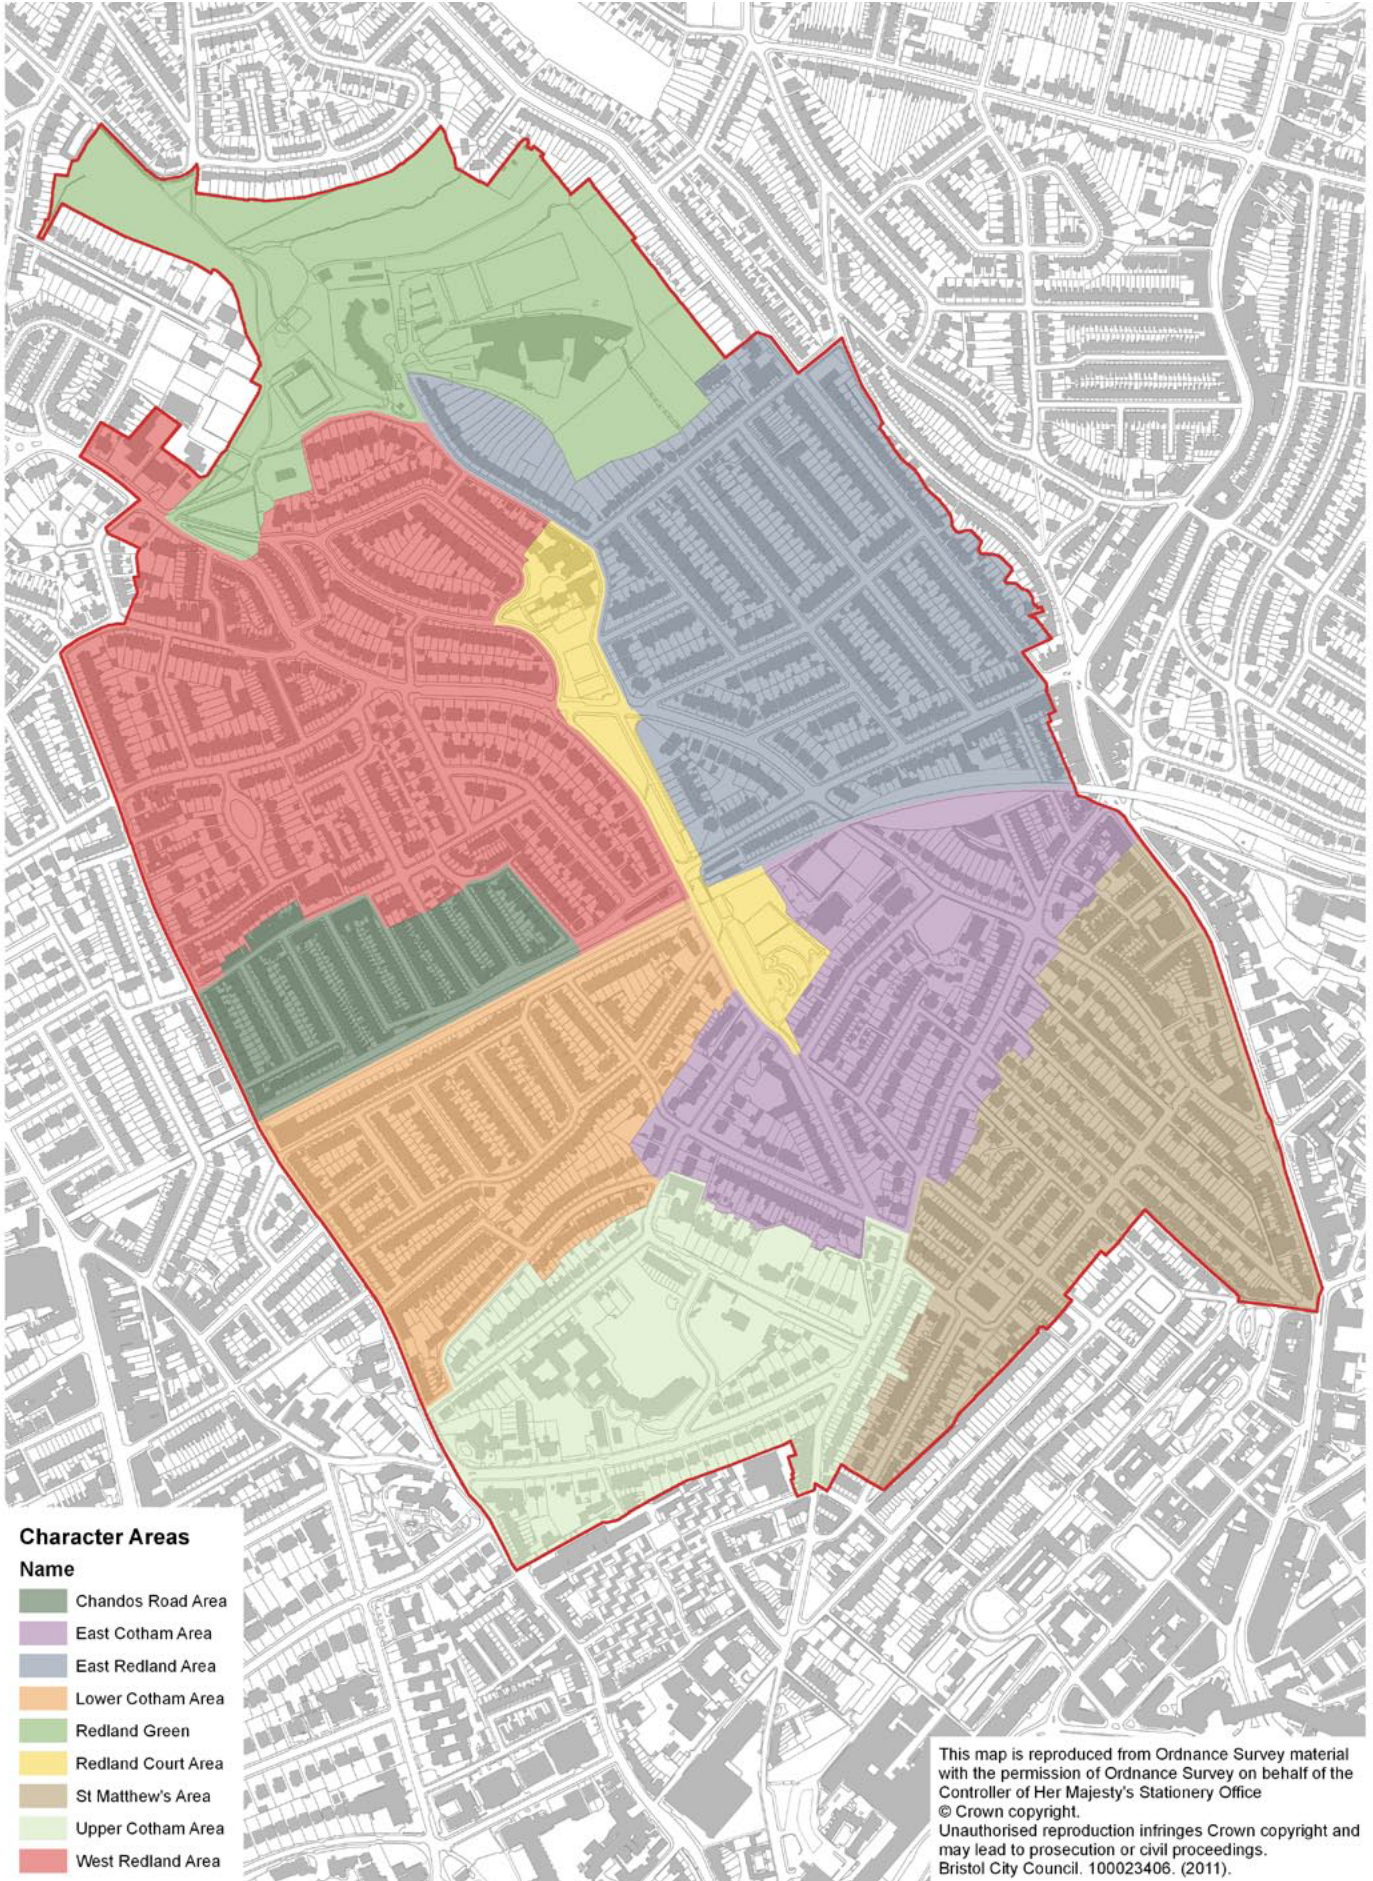
Map 5: Cotham & Redland Character Areas

7.1.6 The Conservation Area can be divided into a number of areas of distinct character, each reflecting a particular aspect that goes beyond planned layout and built form:

- **Character Area 1:** Upper Cotham
- **Character Area 2:** Lower Cotham
- **Character Area 3:** East Cotham
- **Character Area 4:** St Matthews
- **Character Area 5:** Chandos Road
- **Character Area 6:** West Redland
- **Character Area 7:** Redland Court & Redland Green
- **Character Area 8:** East Redland

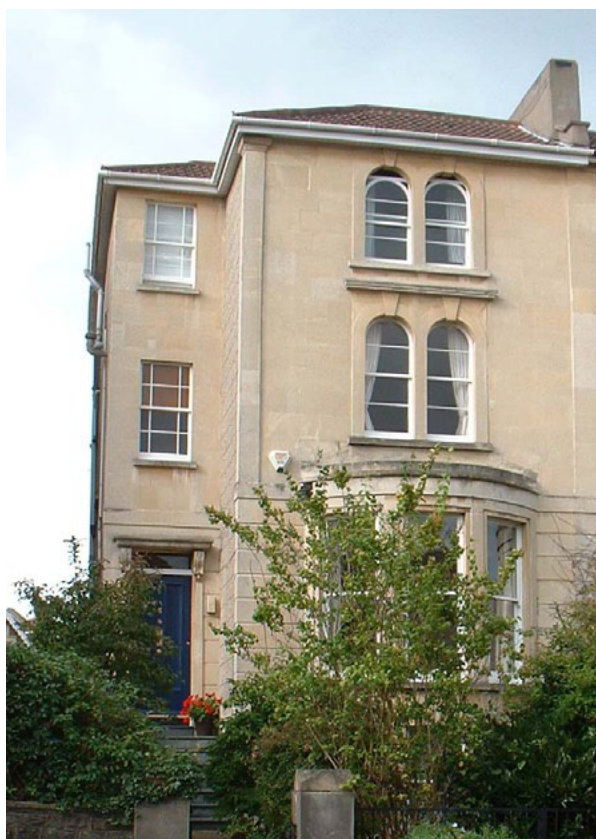
7.1.3d Semi-detached villas predominate; typically four storey with side entrances. The consistency of materials is a strong character factor: oolitic limestone ashlar or rubble faced, with limestone dressings and decorative features; low pitched (originally slate) roofs; timber double-hung sash windows, with bay windows common to the ground floor.

Figure 42: Typical semi-detached villa with side entrance and ground floor bay

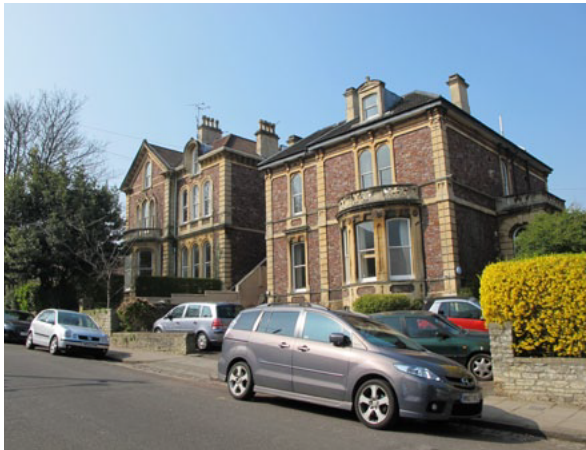
Figure 43: Red Pennant villas with limestone details, Cotham Park North

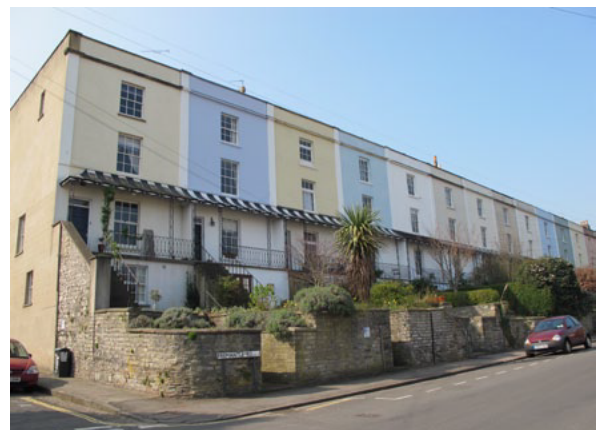
7.1.4d Of the relatively few listed buildings in the Conservation Area as a whole, a number populate this character area. (Including properties on Gibson Road, Fremantle Road, St Matthews Church). Beyond these, there is a high quality and unity of built fabric in the area, with a strong architectural character given by the consistent material palette and neo-Classical treatment.

Figure 50: Fremantle Road, Grade II listed terrace

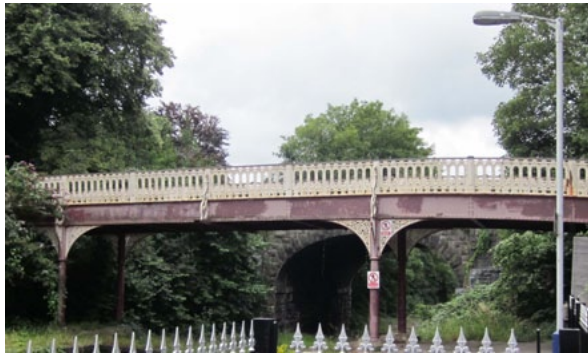
7.1.7q **Other Heritage Assets.** The cast iron footbridge (Grade II) over the railway provides an attractive element in Lovers' Walk; it is also a historic landmark.

Figure 81: Cast iron footbridge over railway line, from Redland Station

| Strengths | Opportunities |
|--|---|
| Poor condition of listed railway footbridge | Continued neglect of railway footbridge |

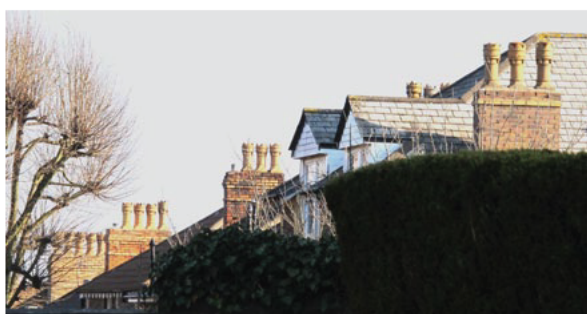
7.3.4 **Chimney stacks and pots** form striking features when seen against the skyline. Replacement or removal of chimney pots and stacks is discouraged. The pairs of houses on Woodstock Road have grouped stacks, distinctive as the road drops down the contour of the hill, most of which retain their numerous clay pots.

Figure 92: Woodstock Road roofs

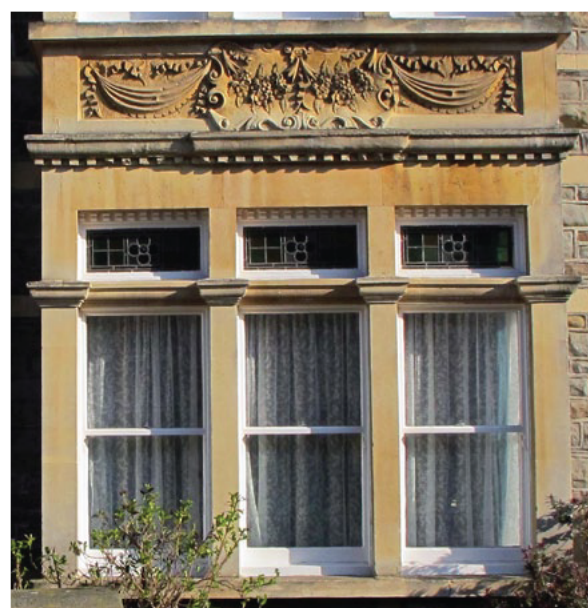
7.3.6 Typically, Victorian windows in the Conservation Area are single glazed, double hung, timber sashes, recessed within the window reveal and painted white. Sashes are usually six-over-six, though there are variations to this pattern. Victorian windows are heavier, one-over-one timber sashes with moulded window horns.

Figure 93: Late Victorian windows, Luccombe Hill

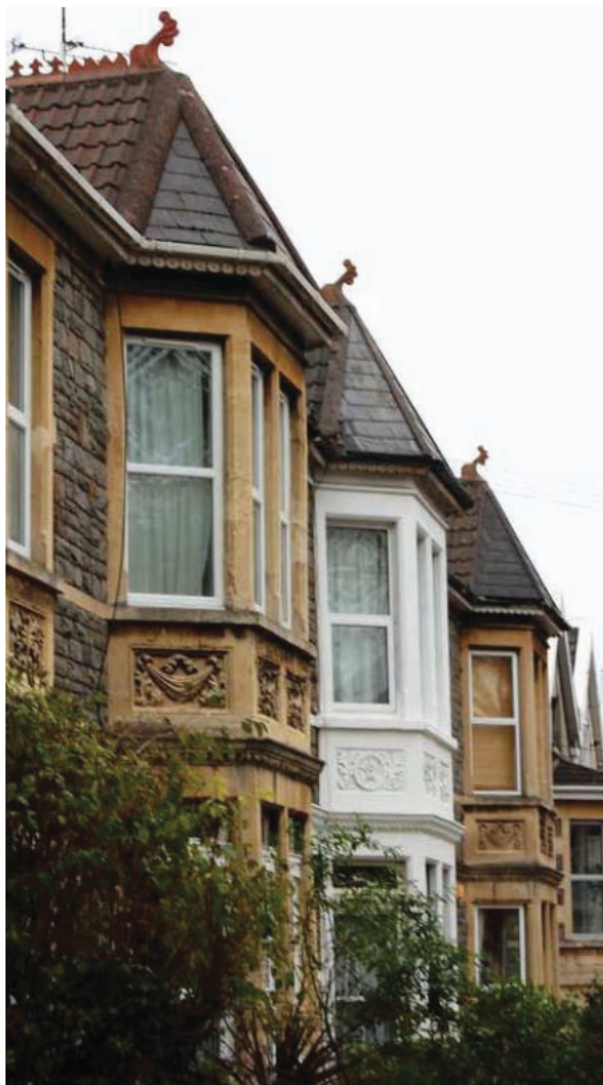
7.3.7 Throughout much of the Conservation Area, bay windows form a strong rhythmic verticality to the facades, which is balanced by the horizontal fenestration and various stone string courses. Bays vary considerably, the most common are the two-storey canted bays, with 3 or 4 double hung sashes per floor. Generally the older sash bays have stone mullions which the new casement windows don't have. A small proportion of sashes have high level stained glass panels.

Figure 94: 2-storey canted bays

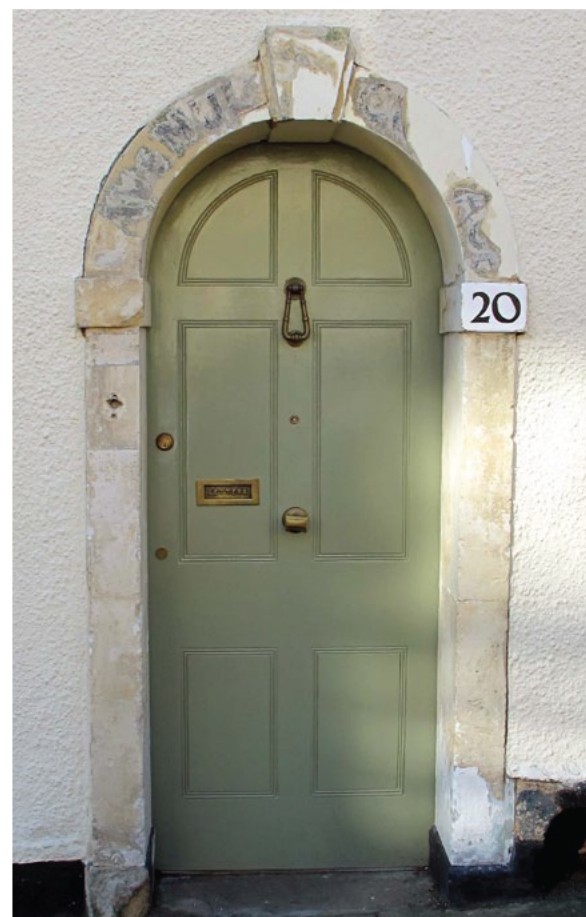
Figure 95: Flush-panel door with limestone surround, Luccombe Hill

7.3.7 **Doors and surrounds**, where the original has been retained and well maintained add greatly to the character and appearance of individual buildings and to the wider street scene. Front doors vary throughout the area, most common examples are 6-panels. Rectangular fanlights are a common feature, many later Victorian buildings have stained glass fanlights or side panels.

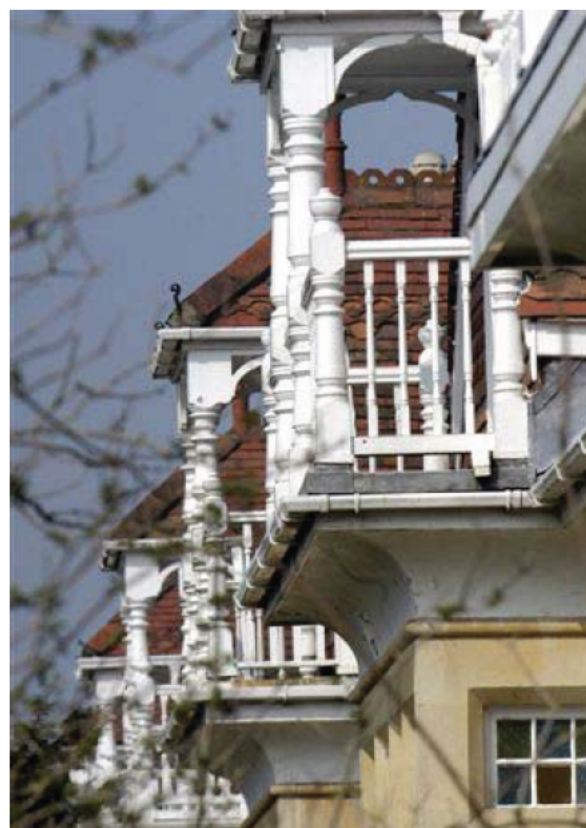
7.3.9 **Balconies** In a few instances, low level roofs over doors and windows have decorated timber brackets forming roof bearers, there are also a small number of timber balconies.

Figure 96: Timber balconies, Cotham Park

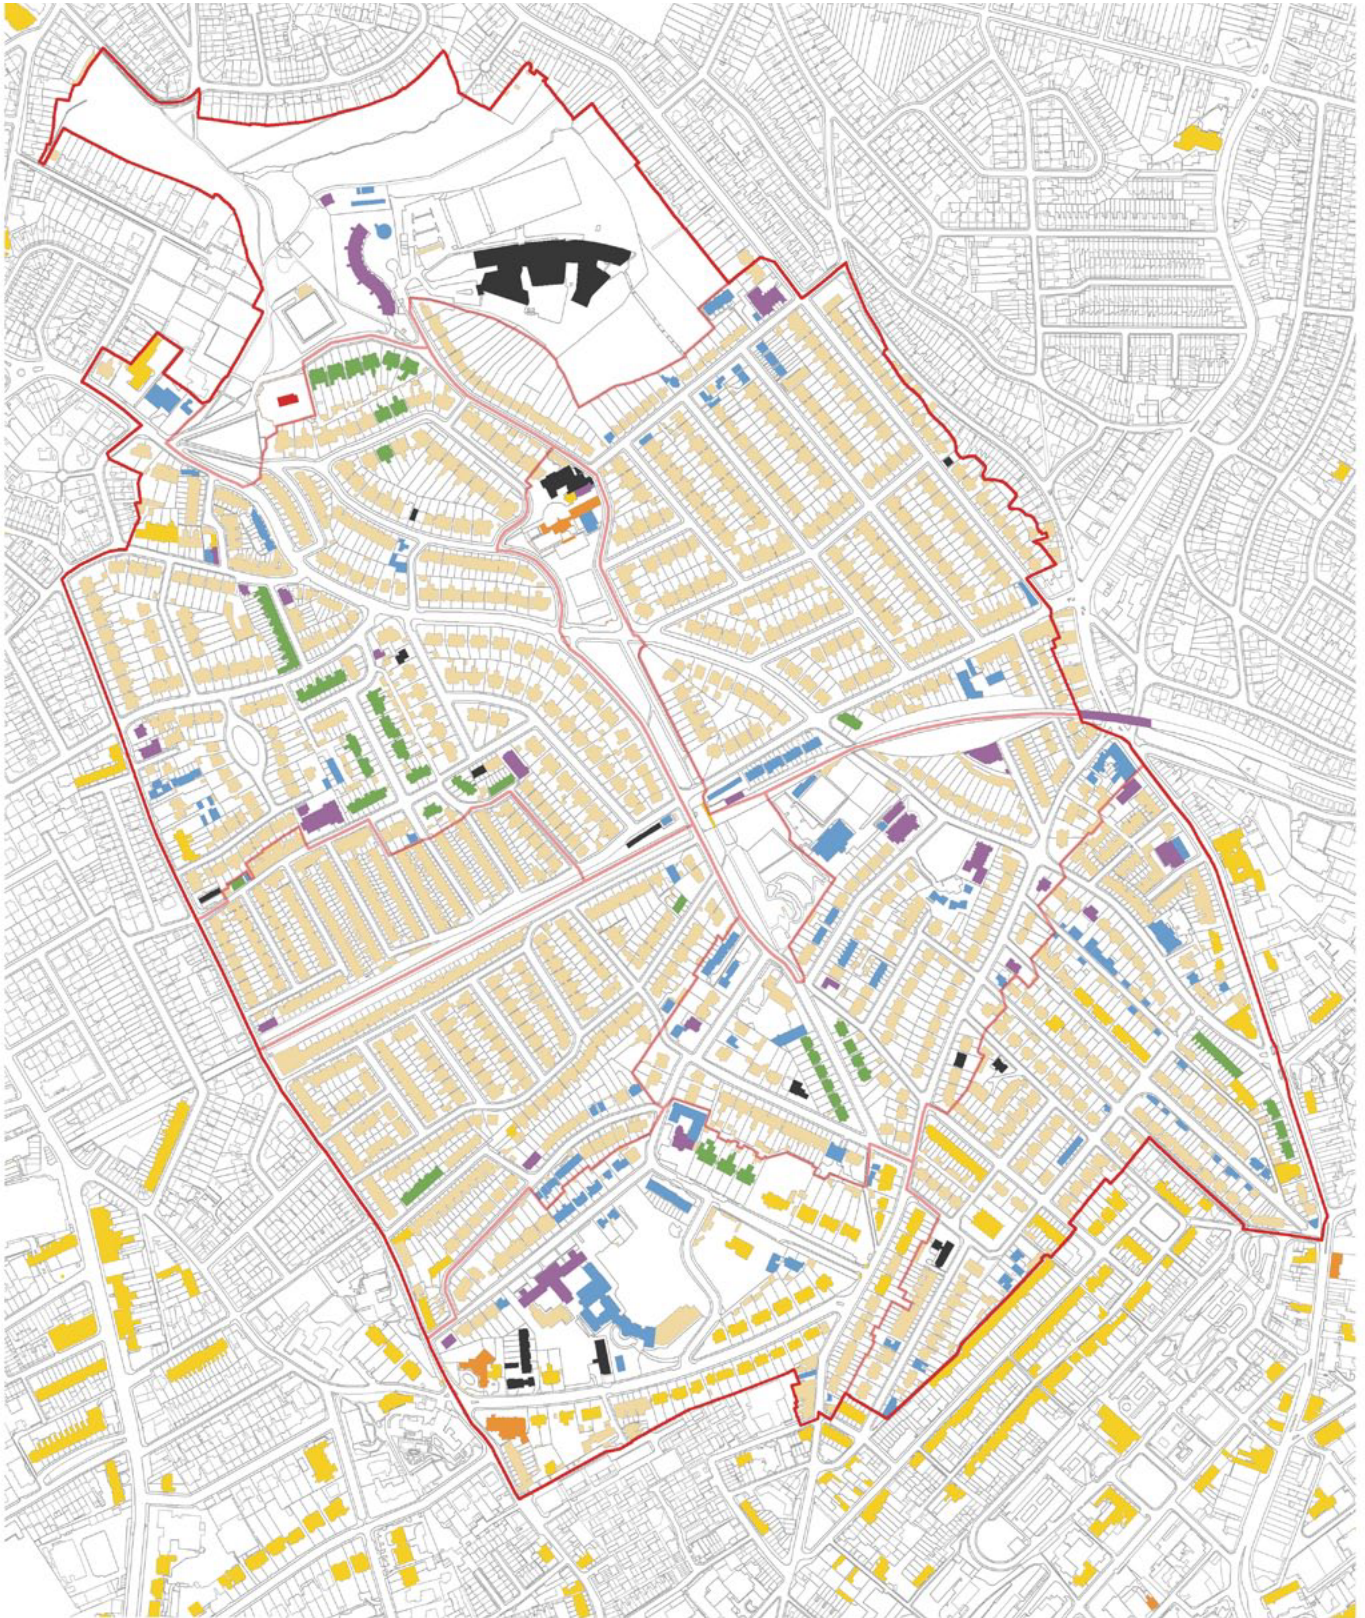
Map 6: Cotham & Redland Conservation Area Relative Merit of Unlisted Buildings

- Character Areas
- Building Types**
- Building of Merit
- Grouped Buildings of Merit
- Character Buildings
- Neutral Building
- Negative Building

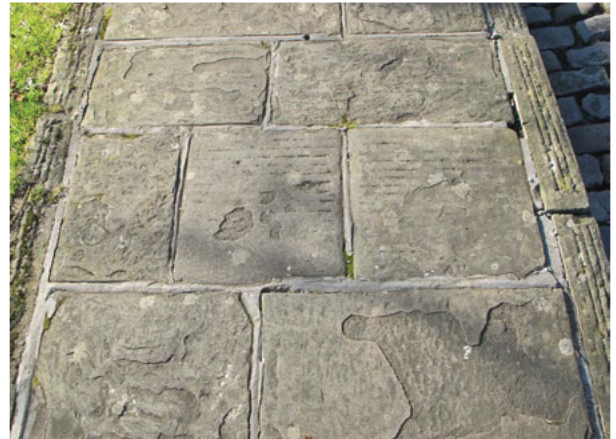
7.6.4 The protection and appropriate maintenance of traditional street surfaces would ensure the preservation of local character; schemes to appropriately restore or reinstate street surfaces could greatly enhance the Conservation Area. Stone kerbs with asphalt and removal of Pennant Stone slabs where they still exist should be avoided. Pavement build outs should be in appropriate materials and traditional cobble highway edges maintained. Any street works including line and signs must be in keeping with the area.

Figure 97: Pennant pavement and kerb, Redland Green

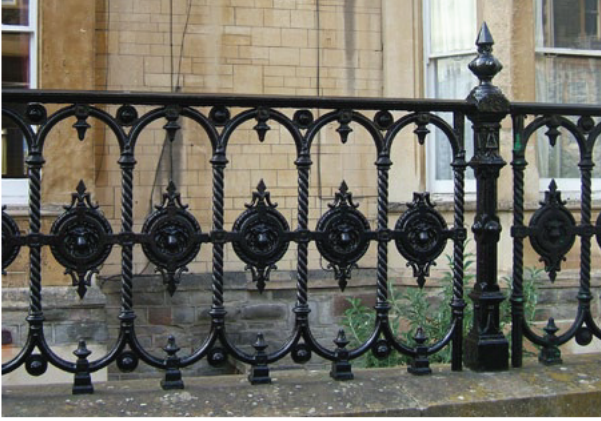
Figure 99: Cast iron railings, Cotham Vale

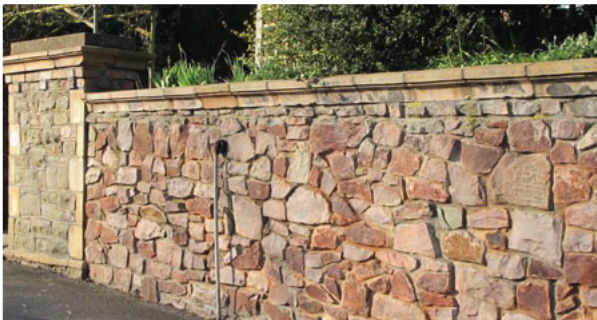
Figure 100: Brandon Hill stone retaining wall, Woodstock Road

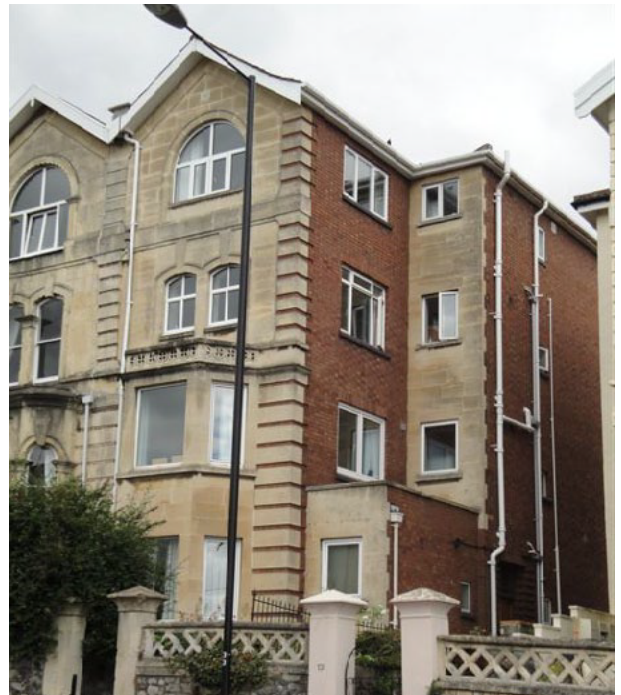
Figure 118: uPVC windows, Redland Road

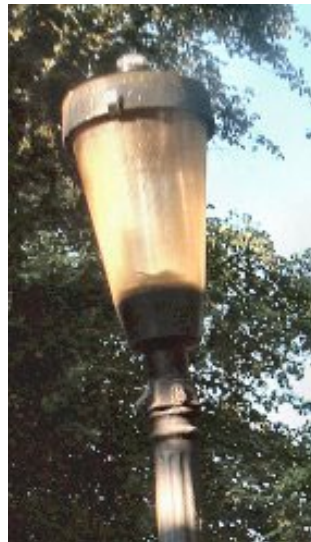
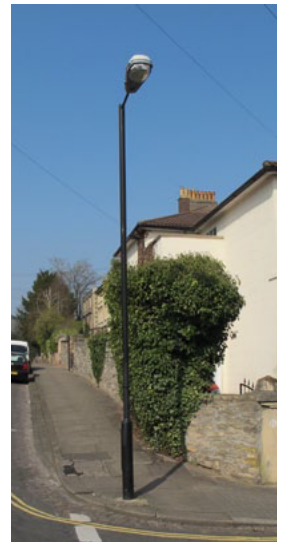
Figures 120 & 121: Unsympathetic lamp head and post
