## **Construction Noise and Vibration Monthly Report – August 2024**

**London Borough of Ealing**

# Non-Technical Summary

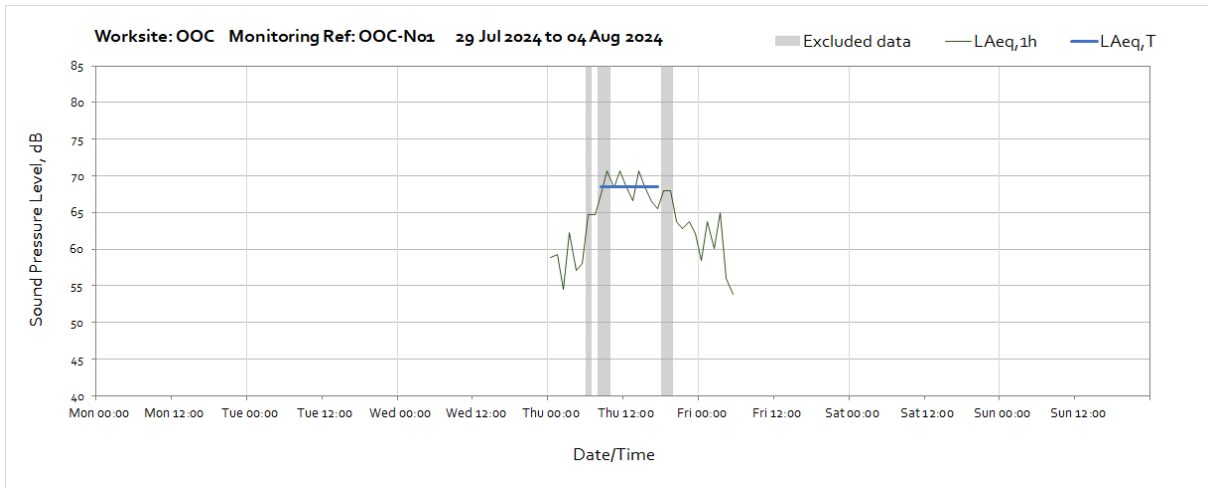
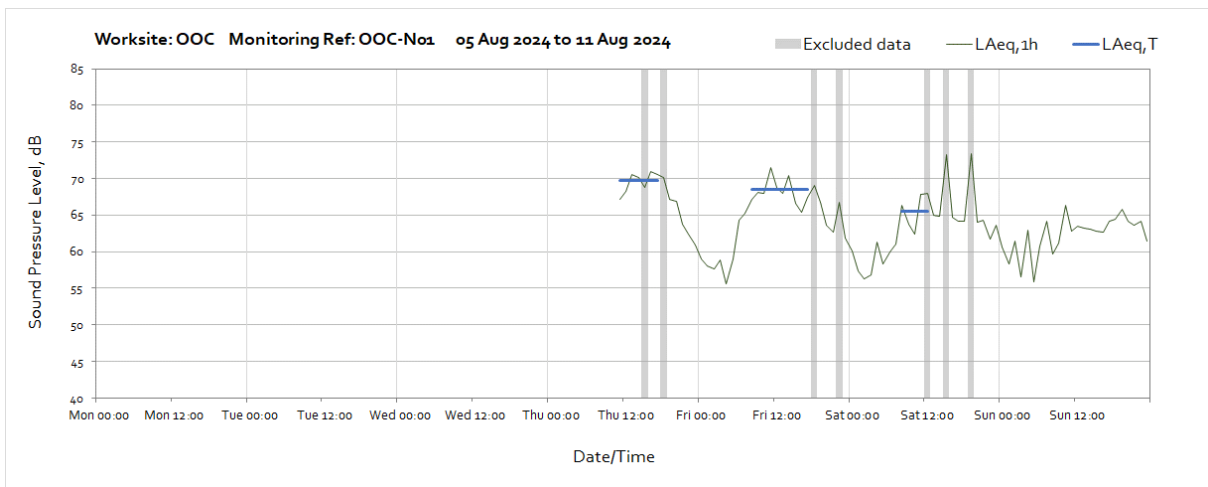
**Worksite: OOC – Monitoring Ref: OOC-N01**

Note: Missing data from 06:00 on Friday 2<sup>nd</sup> August until 11:00 on Thursday 8<sup>th</sup> August was due to loss of power to the monitoring station.

Note: Missing data from 06:00 on Friday 2<sup>nd</sup> until 11:00 on Thursday 8<sup>th</sup> August was due to loss of power to the monitoring station.

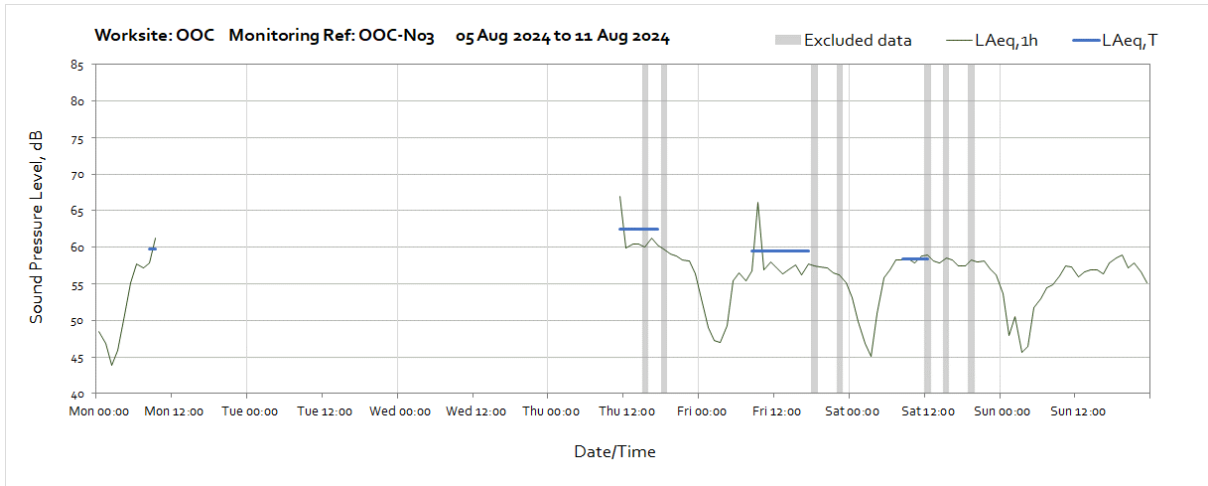
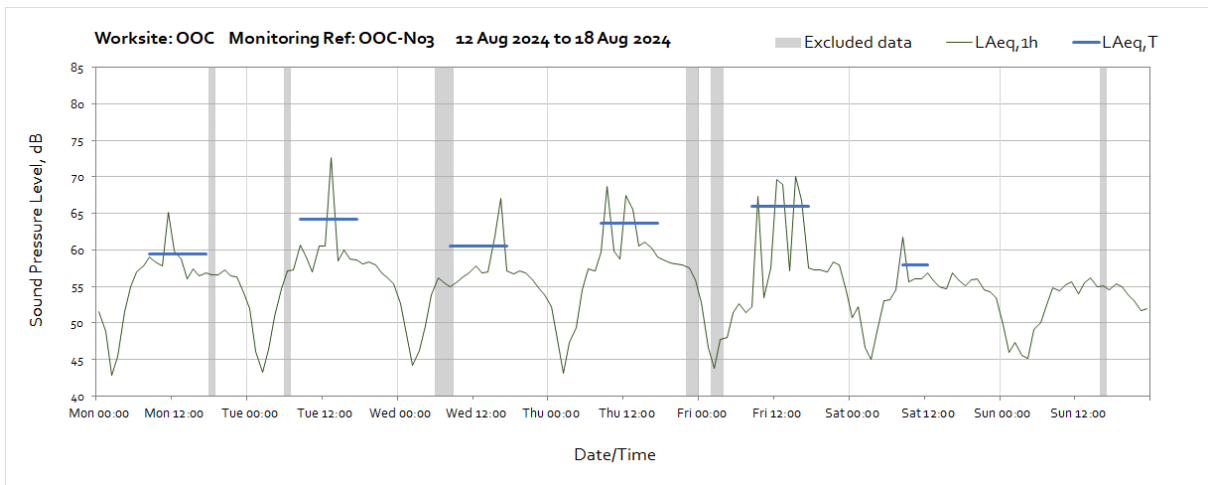
**Worksite: OOC - Monitoring Ref: OOC-N03**

Note: Missing data from 10:00 on Monday 5<sup>th</sup> until 10:00 on Thursday 8<sup>th</sup> August was due to loss of power to the monitoring station.

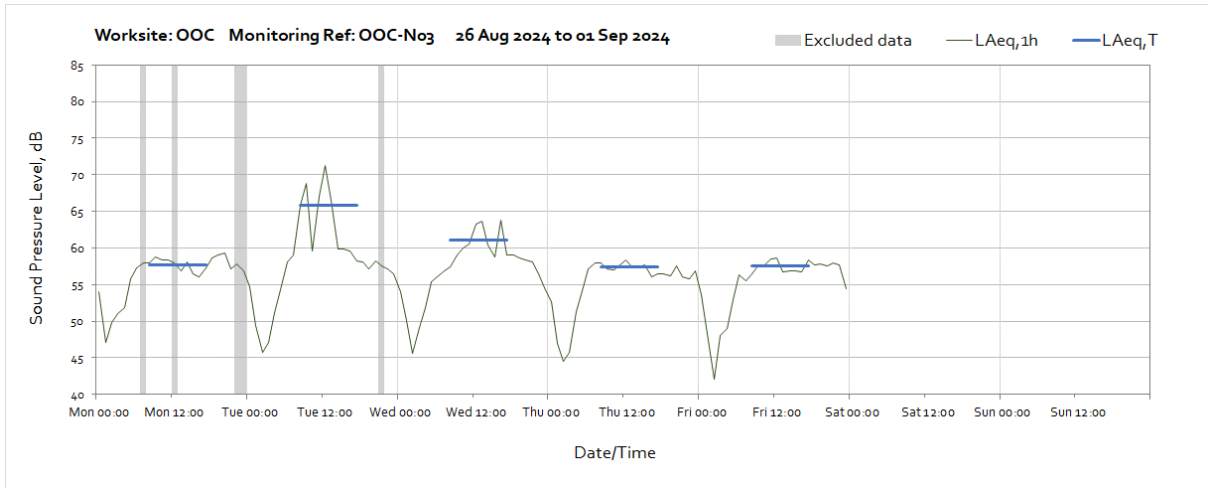
Note: Missing data from 00:00 on Saturday 31<sup>st</sup> August until the end of the month was due to a fault with the monitoring station.

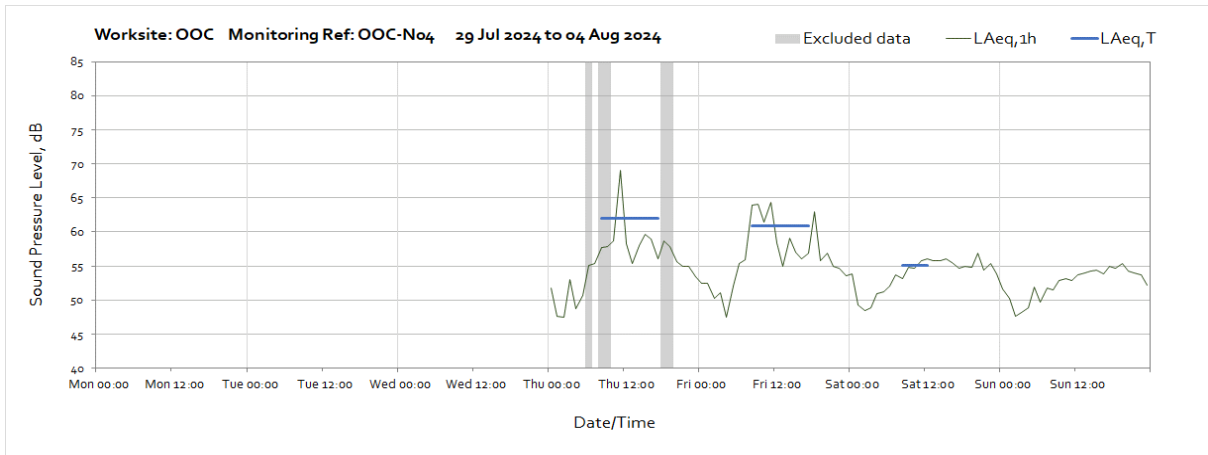
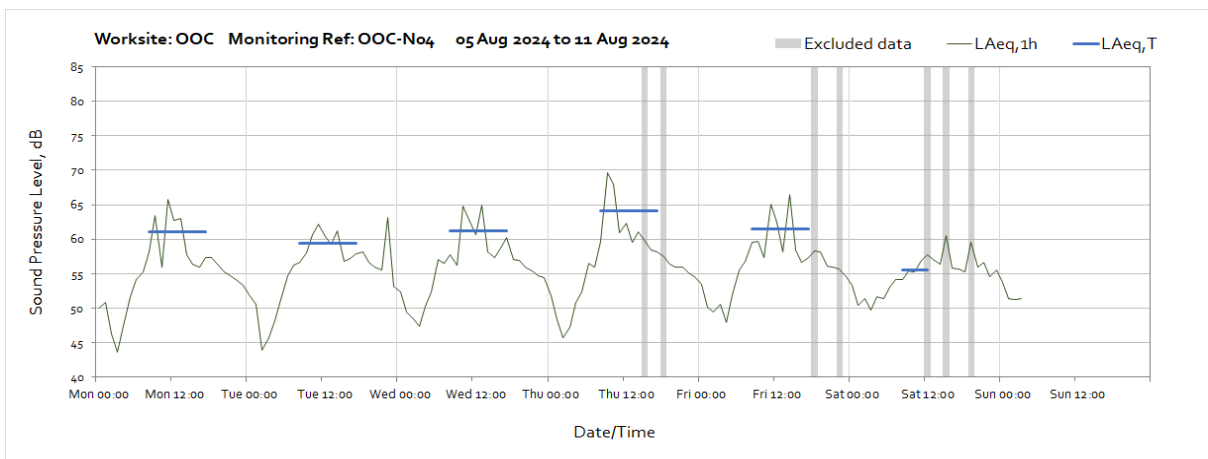
**Worksite: OOC – Monitoring Ref: OOC-N04**

Note: Missing data from 04:00 on Sunday 11<sup>th</sup> until 09:00 on Monday 12<sup>th</sup> August was due to loss of power to the monitoring station.

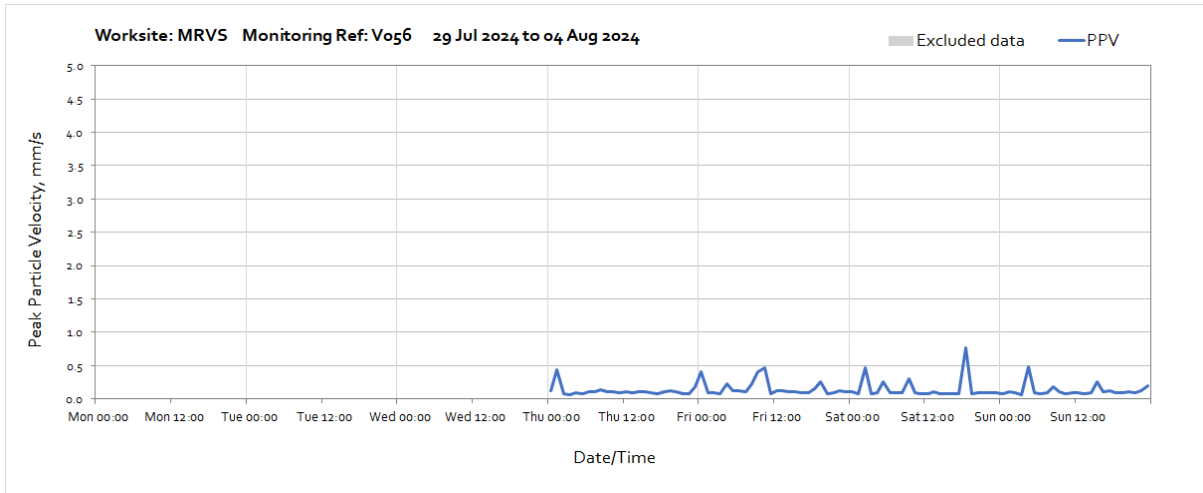
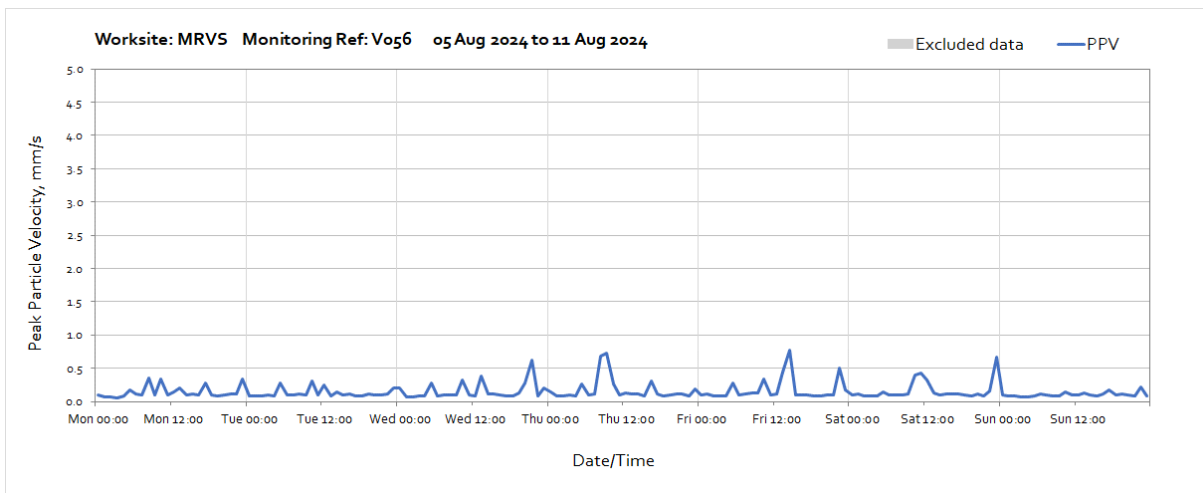
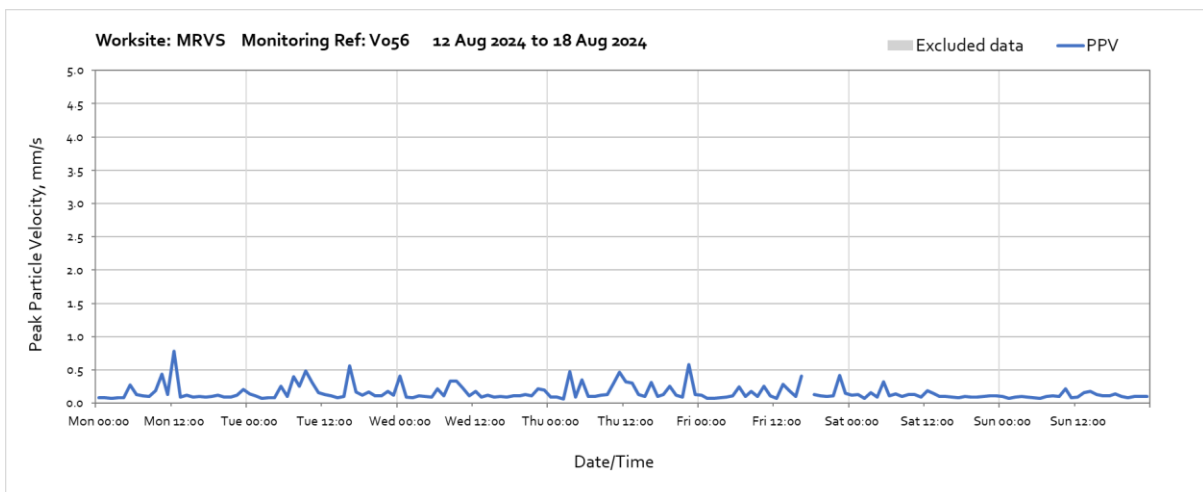
## Worksite: MRVS – Monitoring Ref: V056

Note: Missing data from 17:00 until 18:00 on Friday 16<sup>th</sup> August is currently under investigation.

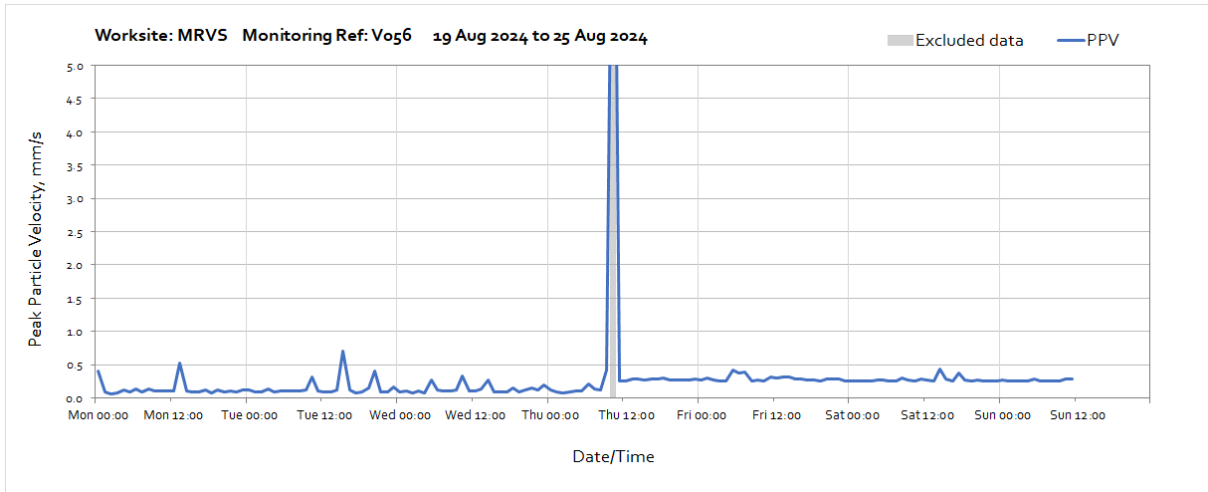
Note: Missing data from 12:00 on Sunday 25<sup>th</sup> until 16:00 on Wednesday 28<sup>th</sup> August was due to a vibration monitoring station crash.

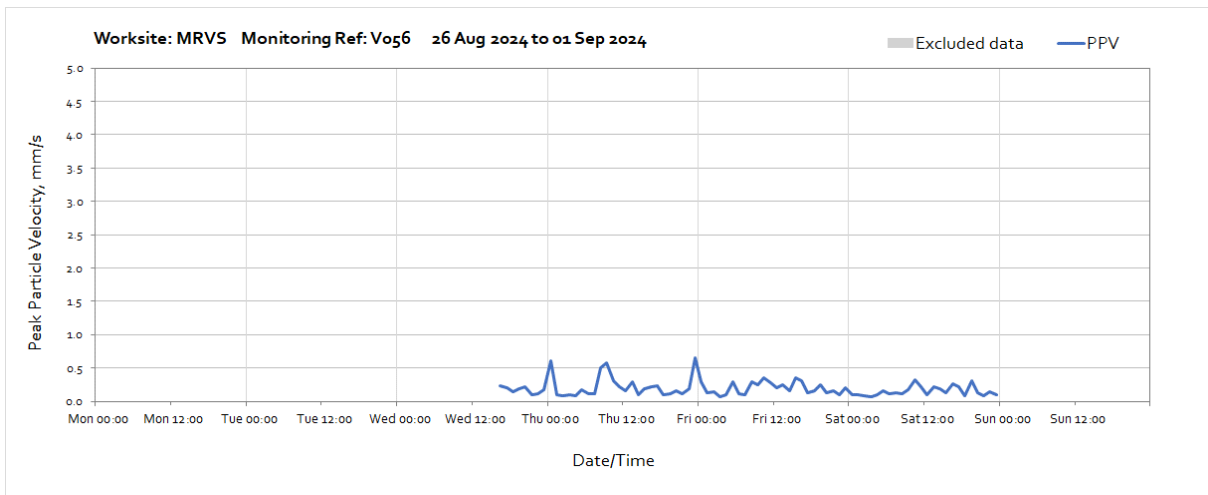
Note: Missing data from 12:00 on Sunday 25<sup>th</sup> until 16:00 on Wednesday 28<sup>th</sup> August was due to a vibration monitoring station crash.
