Construction noise and vibration Monthly Report – August 2024

London Borough of Hillingdon

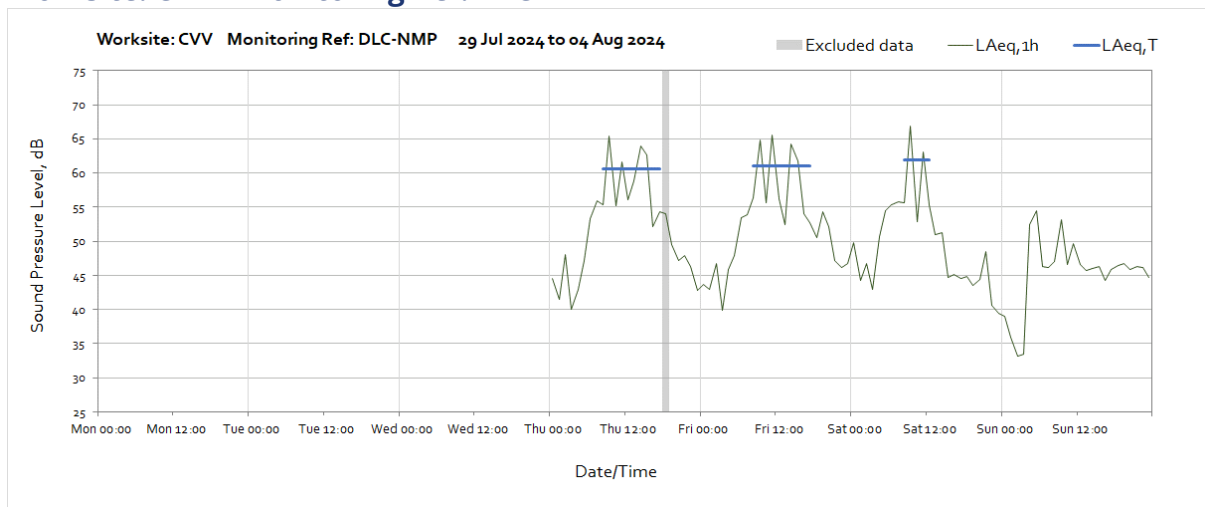
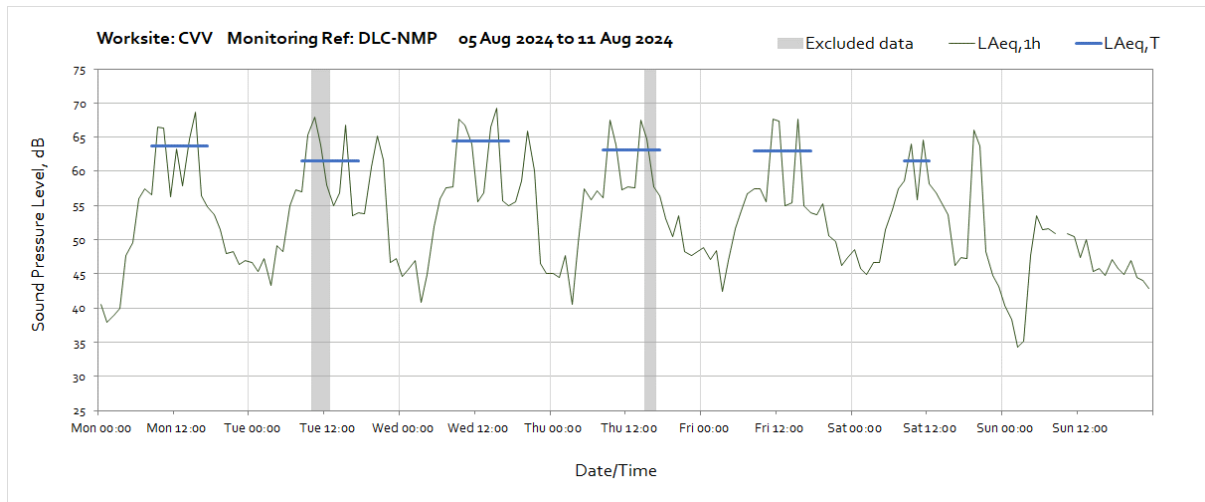
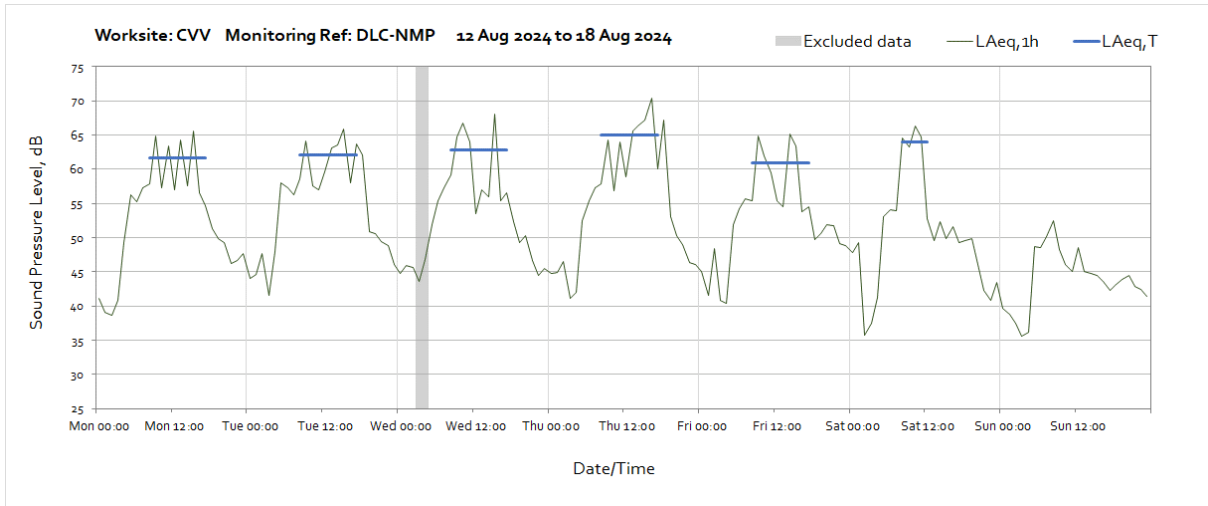
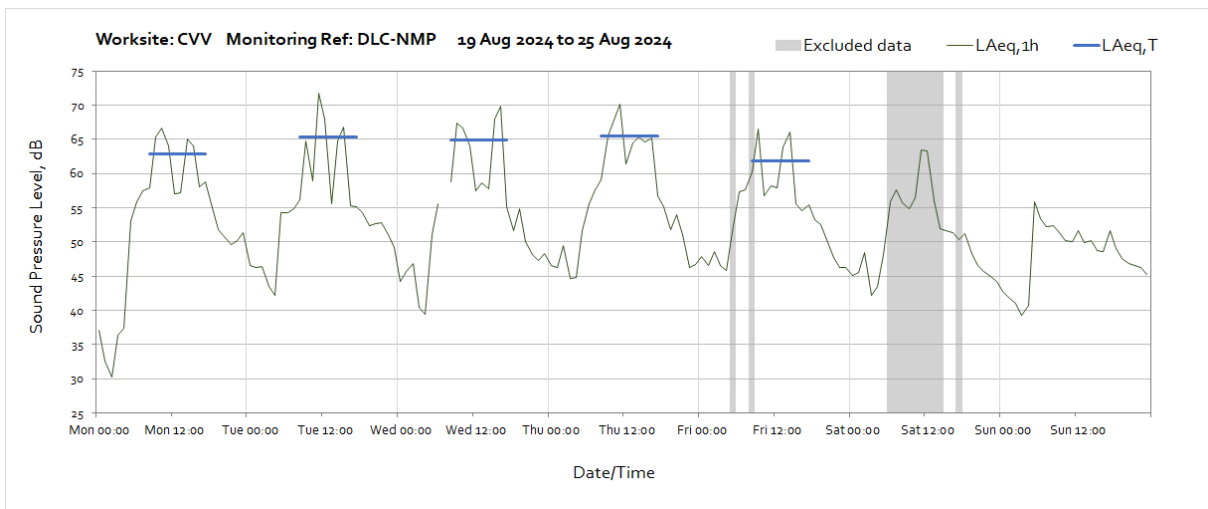
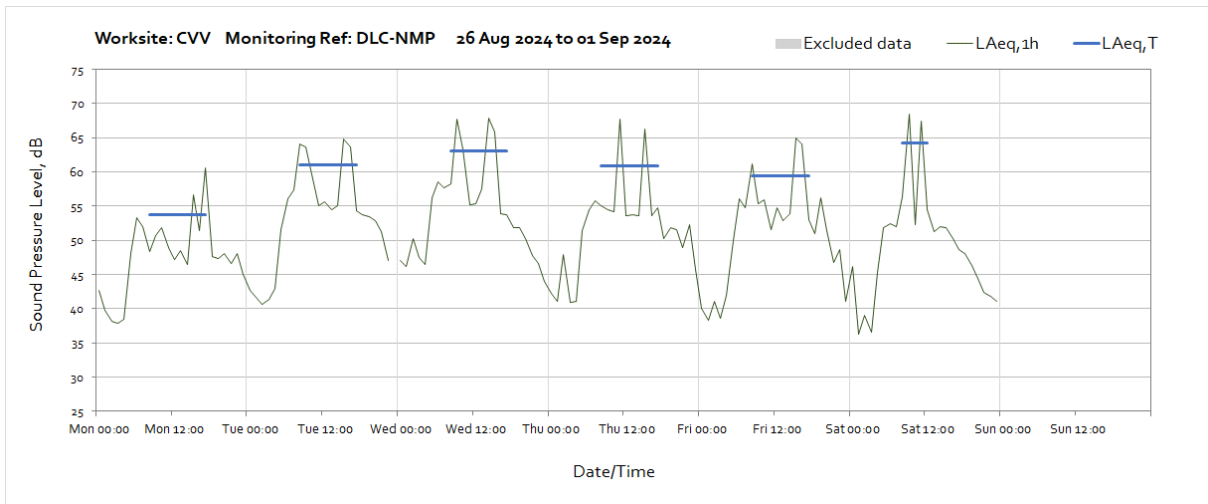
Worksite: CVV – Monitoring Ref: DLC-NMP

Note: Missing data between 09:00 and 10:00 on Sunday 11th August was due to field calibration.

Note: Missing data between 07:00 and 08:00 on Wednesday 21st August was due to a communication error between the monitoring station and the embedded system.

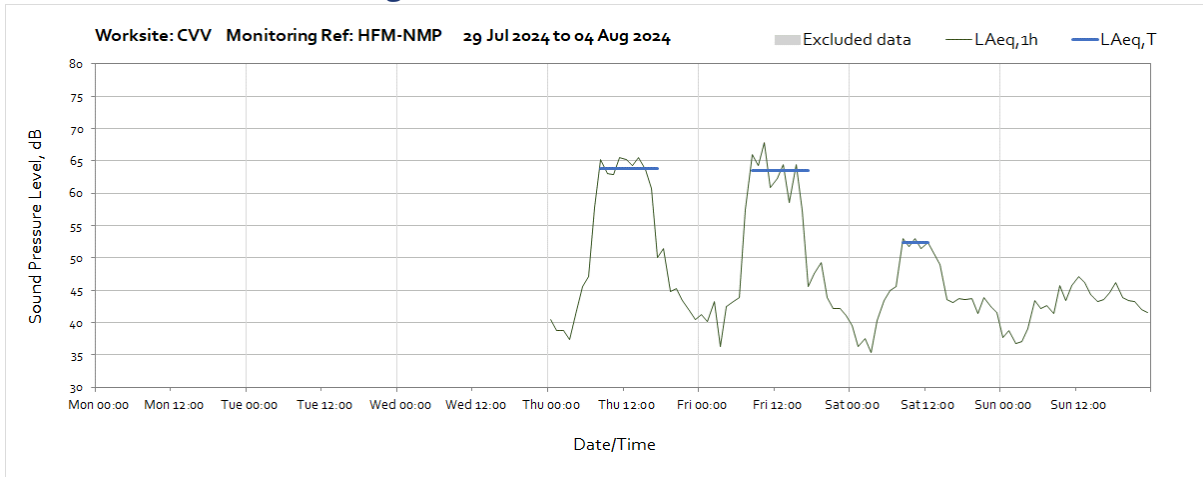
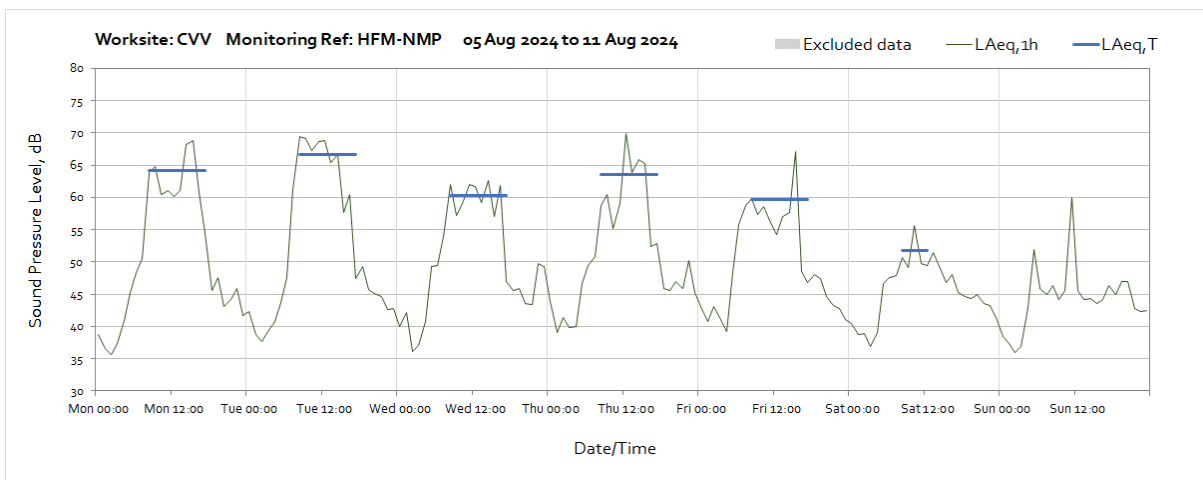
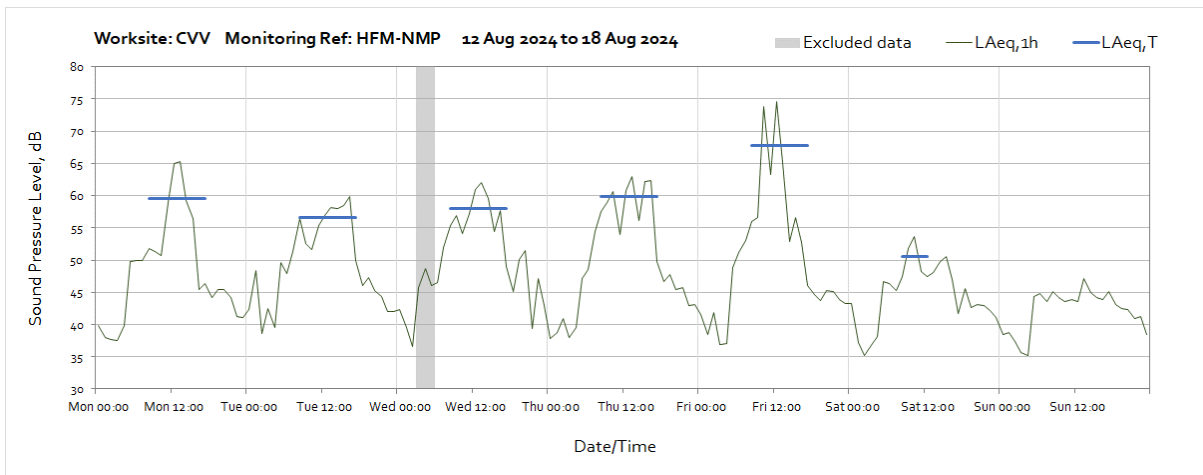
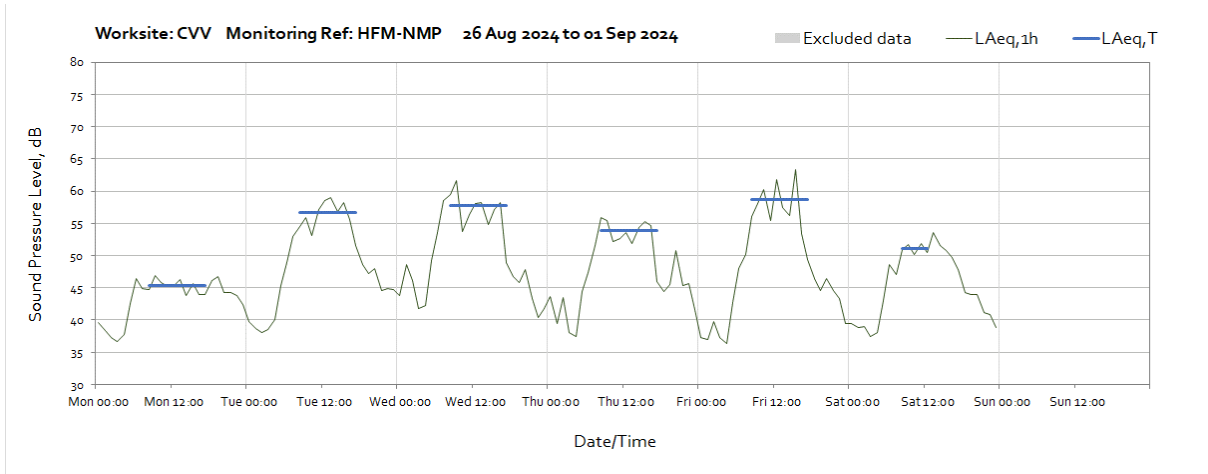
Worksite: CVV – Monitoring Ref: HFM-NMP

Note: Missing data between 20:00 and 21:00 on Friday 23rd August was due to a communication error between the monitoring station and the embedded system.

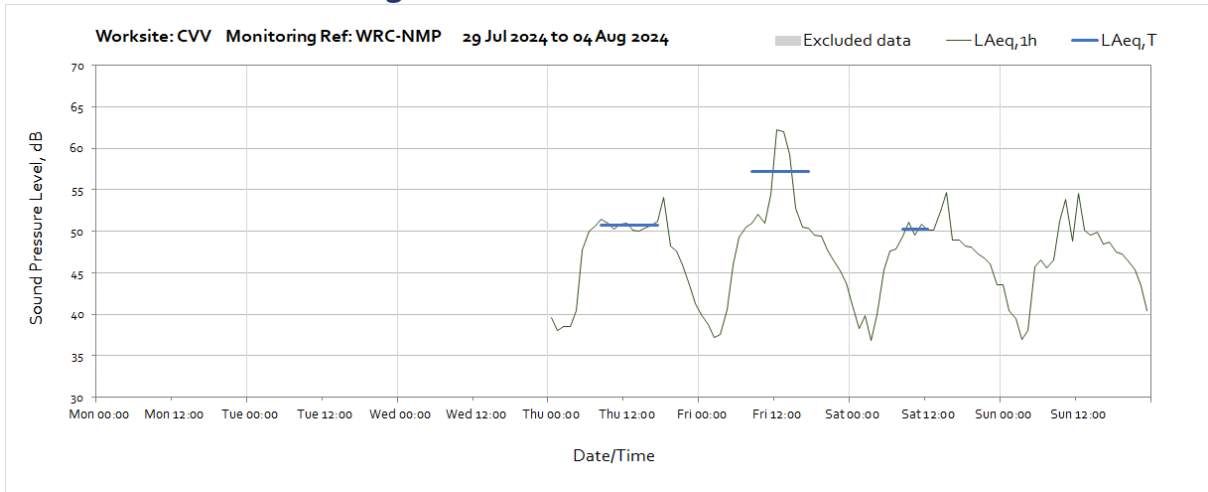
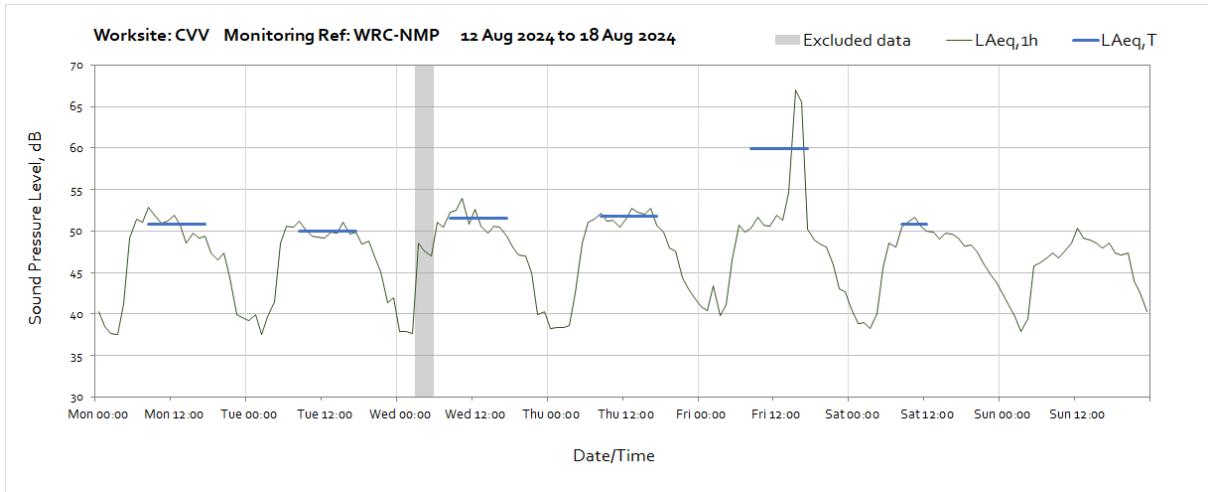
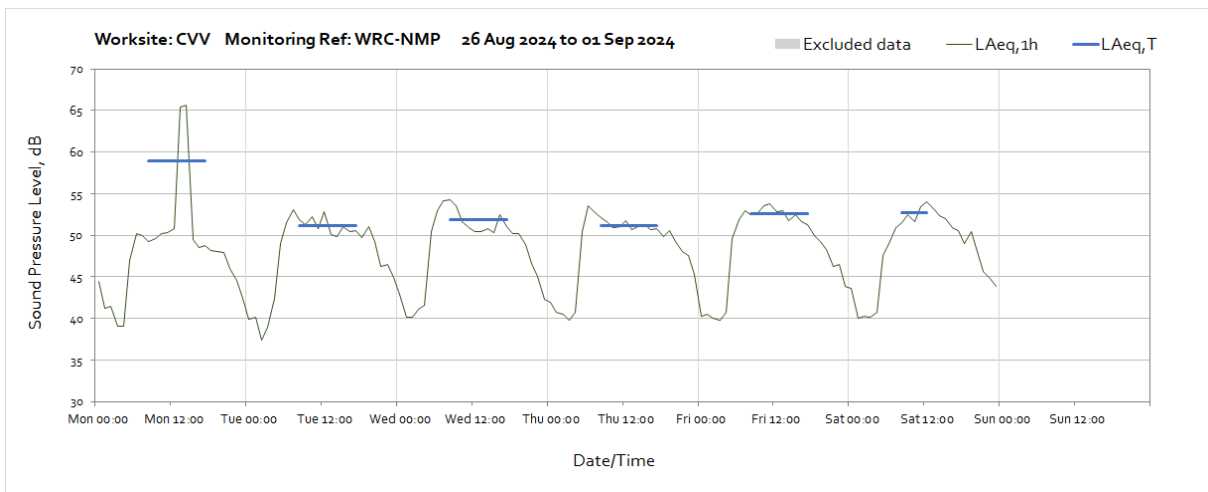
Worksite: CVV - Monitoring Ref: WRC-NMP

Note: Missing data between 13:00 and 14:00 on Thursday 22nd August was due to field calibration.
