HS2

October 2024

Construction Noise and Vibration Monthly Report – August 2024

North Warwickshire Borough Council

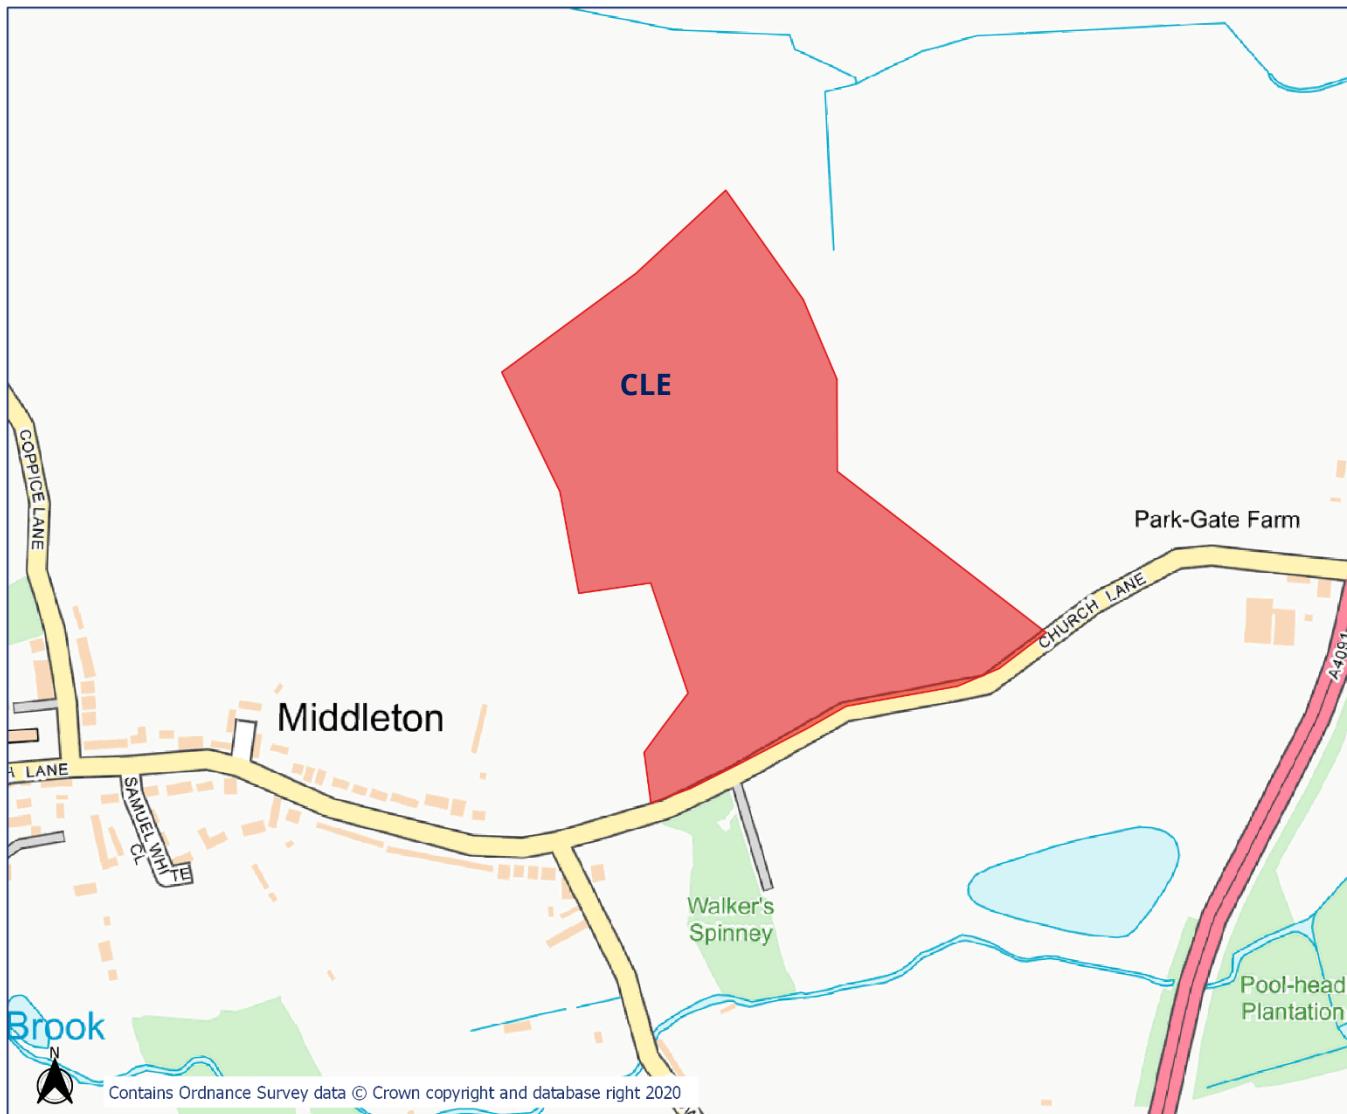
Worksite Identification Plan - 1

- 1.1.3 Construction sites in the local authority area where monitoring was undertaken during this period include:
- Church Lane Embankment worksite, ref.: CLE (see Plan 1 in Appendix A), where no works were underway.

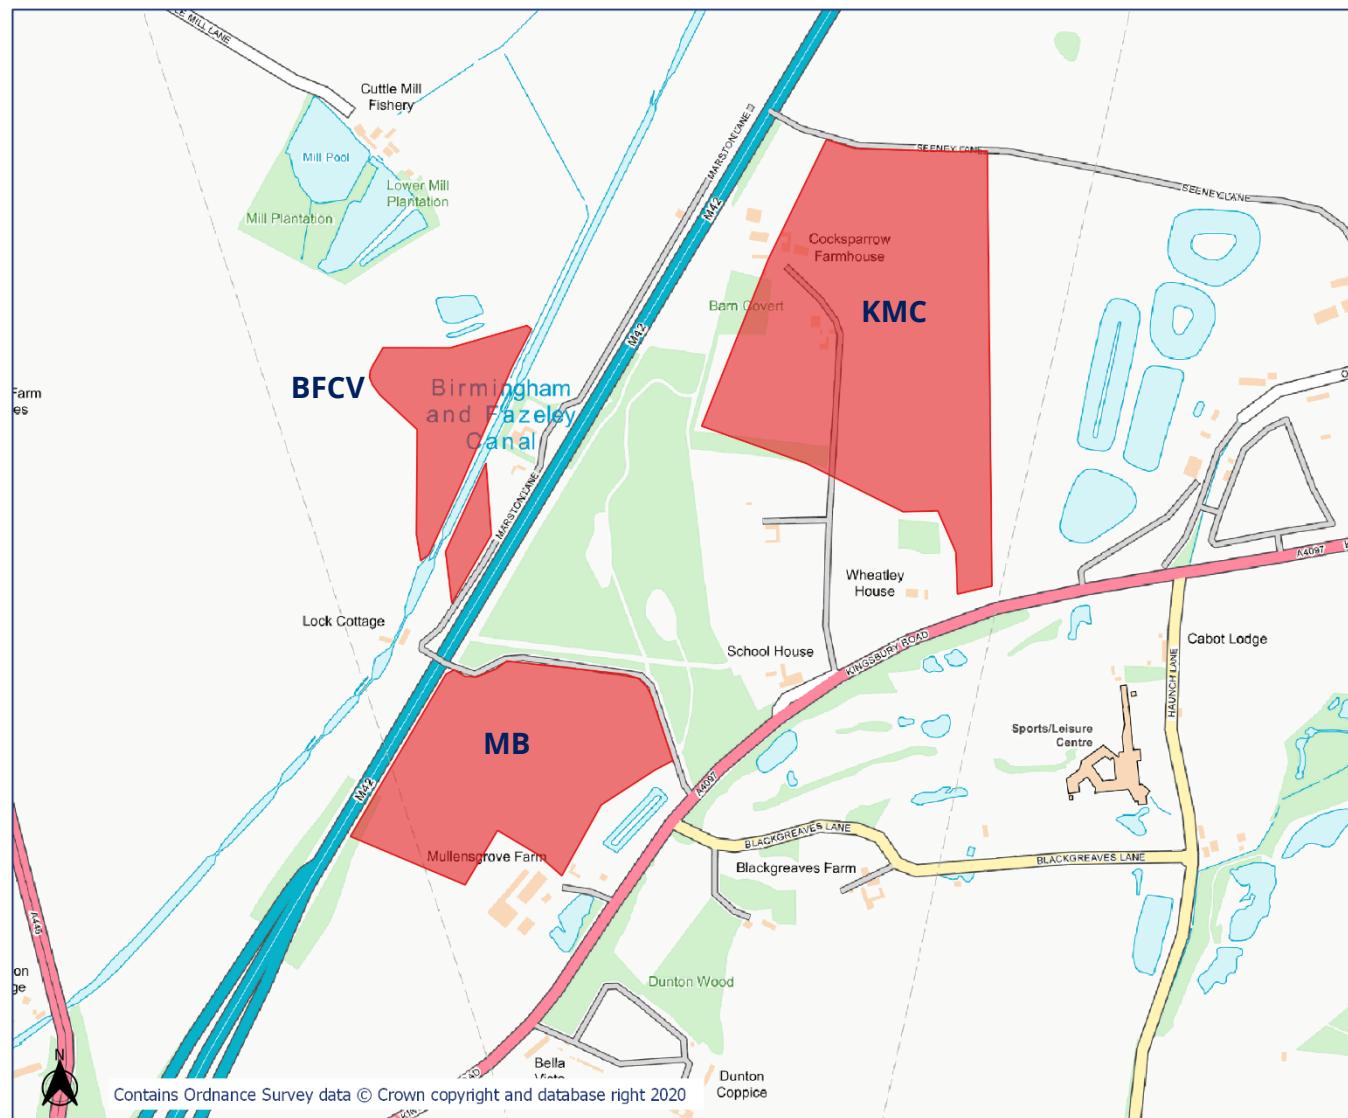
Worksite Identification Plan - 2

- Kingsbury Main Compound worksite, ref.: KMC (see Plan 2 in Appendix A), where no works were underway.
 - Birmingham & Fazeley Canal Viaduct worksite, ref.: BFCV (see Plan 2 in Appendix A), where work activities included:

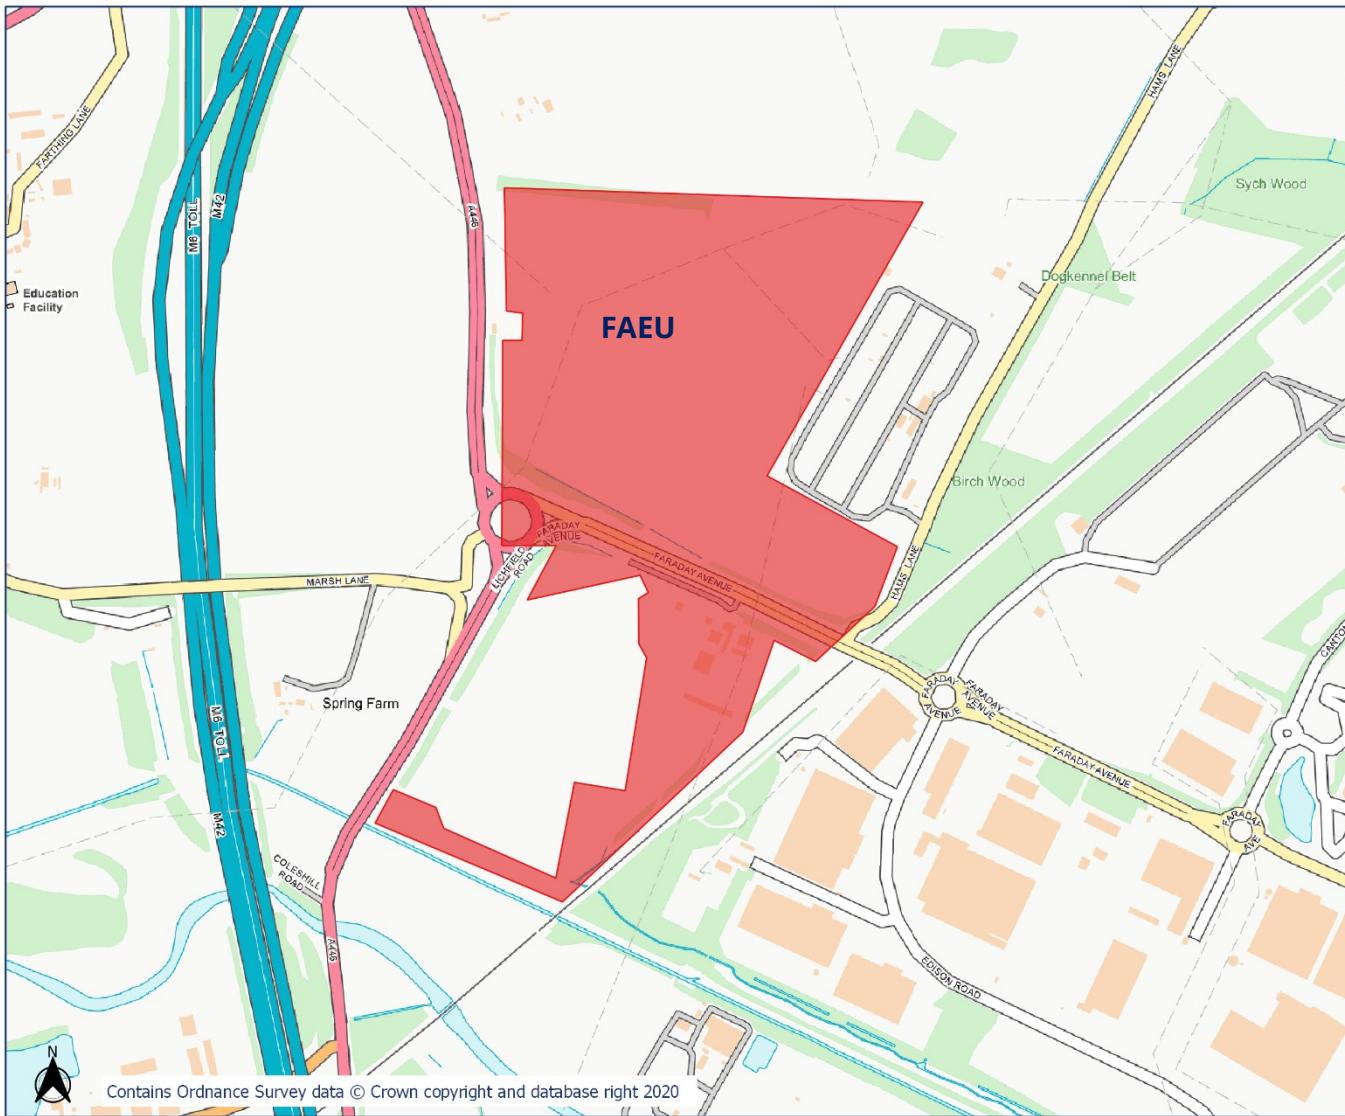
Worksite Identification Plan - 3

- Installation of prefabricated deck cages.
 - Vegetation clearance.
- Faraday Avenue Embankment and Underbridge worksite, ref.: FAEU (see Plan 3 in Appendix A), where work activities included:
