## Flooding and partial sinking of an inflatable migrant boat resulting in the loss of at least 8 lives in the Dover Strait on 14 December 2022

### SUMMARY

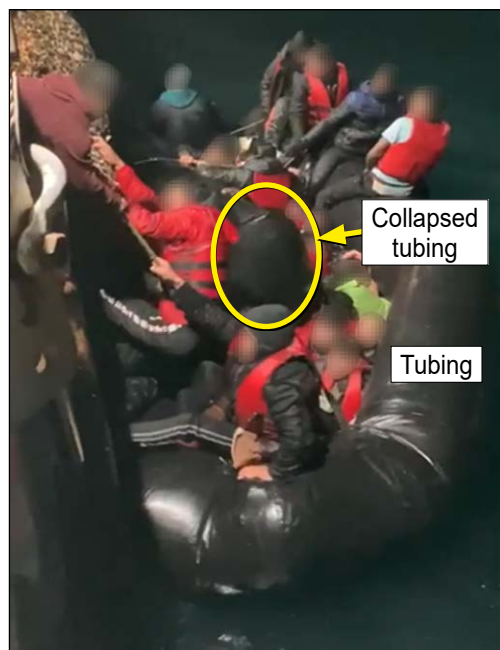
At around 0300, approximately 3.5 hours into the crossing, the occupants of the inflatable boat heard a pop or bang and the boat started to flood rapidly from under the floorboards. The fabric floor section of the boat then ripped and it is likely that the floorboards escaped through this tear, allowing the side tubing to collapse inward and almost meet in the middle. Several of the migrants entered the water, while some were able to stay on the tubing (**Figure 2**).

**Figure 2:** Inflatable migrant boat *Charlie* alongside *Arcturus*, with its flooring missing and tubing collapsed together

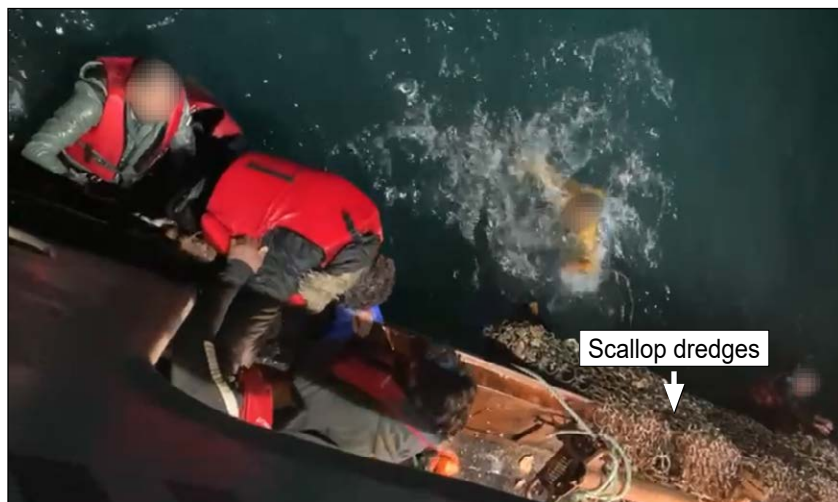
**Figure 3:** Video still, showing migrants climbing the scallop dredges and ladders of *Arcturus*

During the recovery of the migrants by *Arcturus*, the migrants were holding on to small gauge lines, climbing up the scallop dredges and swimming from point to point around the fishing vessel (see **Figure 4**), indicating they had been in the water for a short period and the effects of cold incapacitation had yet to materialise for some. All 31 migrants recovered by *Arcturus* were assessed by the paramedic from *R175* and found to be in good physical health with no injuries. The postmortems of the four deceased migrants who were recovered showed signs consistent with drowning.

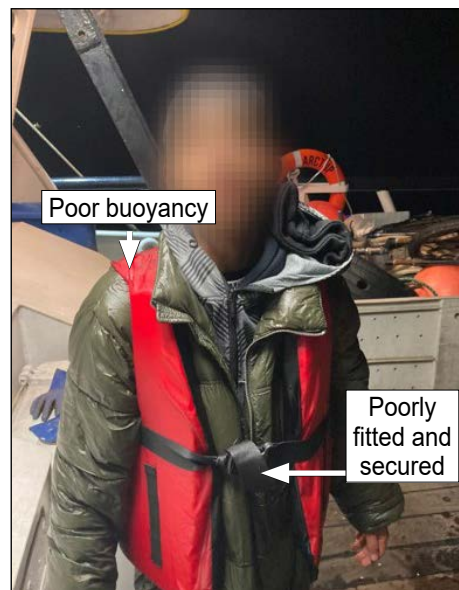
Some buoyancy aids had been placed in the boat before it was launched from the beach, but the quantity was insufficient and the quality was poor, with many of them missing buckles (**Figure 6**). The migrants had been provided with at least one additional fuel tank and a manually operated air pump, which was to be used to maintain *Charlie's* buoyancy.

**Figure 6:** A survivor on board *Arcturus*, wearing one of the buoyancy aids supplied to the migrants before the boat was launched from the beach

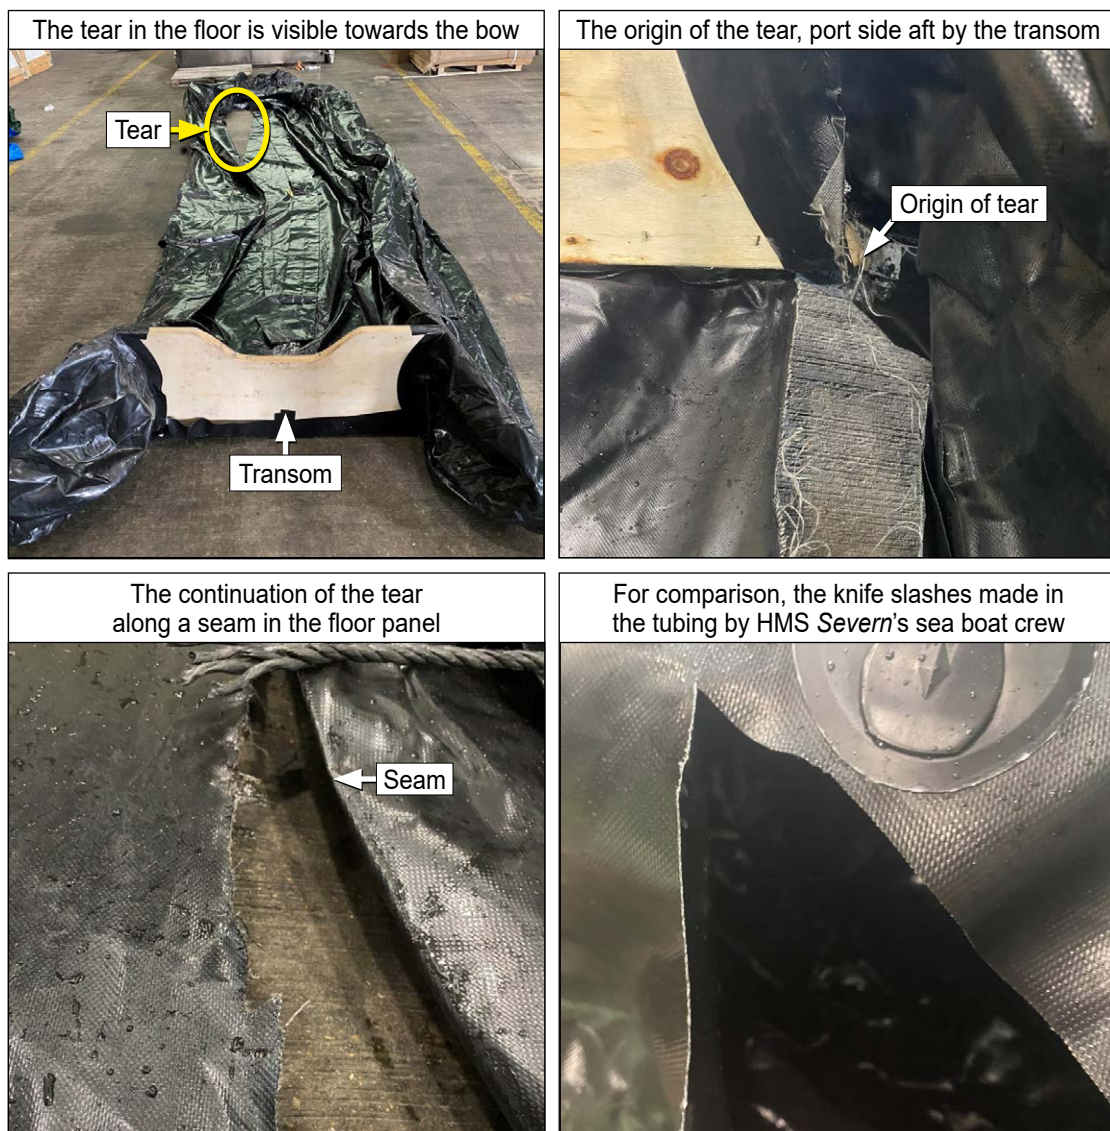
The inflatable boat was recovered by HMS *Severn* and taken to a BF warehouse for analysis. The crew of HMS *Severn*'s rescue boat had made several knife slashes in the tubing during the recovery of a body from the water and again while recovering the inflatable boat. There was also a large tear in the fabric floor panel, which originated in the port quarter and ran longitudinally almost the full length of the boat (**Figure 7**).

Further assessment of inflatable migrant boat *Charlie* by UK authorities concluded that it was poorly built compared to the many others that had been recovered and inspected in the preceding years. It was reported that there were glue marks consistent with the presence of handholds that had come away from the tubing, and the fabric floor panel, which was constructed with one side slightly textured to improve grip, was fitted upside down.

Internally, the fabric bulwark between the port aft chamber and port forward chamber tubing was found partially detached. Some occupants of the inflatable boat reported that they heard a pop or a bang coming from the boat as it was being inflated on the beach.

**Figure 7:** Inflatable migrant boat *Charlie* in the warehouse, ready for post-recovery inspection

The initial cause of the tear in the boat's fabric floor panel (**Figure 7**) is unknown; however, it was assessed that the weight of the many migrants sitting on the floor of the boat could have caused the tear to spread quickly and extend to almost the full length of the boat. The rescuing vessels did not recover or see any floorboards from the inflatable migrant boat, indicating that these almost certainly fell through the tear and either drifted away or sank. The loss of the floorboards would have removed the boat's structural integrity and allowed the still inflated tubing to collapse together. While some occupants were able to straddle the tubing, many entered the water.

- The cause of the tear in the fabric floor panel of the migrants' boat is unknown but the floorboards most likely sank or floated free as a result. This removed what structural integrity the inflatable boat had, causing the tubing to collapse together and some of the migrants to enter the water. The boat was poorly constructed, uncertified and unregulated, and was inherently dangerous.
