## Construction Noise and Vibration Monthly Report – September 2024

London Borough of Ealing

This Noise and Vibration Monitoring Report fulfils HS2 Limited's commitment detailed in the Environmental Minimum Requirements (EMRs), Annex 1, Code of Construction Practice, to present the results of noise and vibration monitoring carried out within the London Borough of Ealing (LBE) during the month of September 2024.

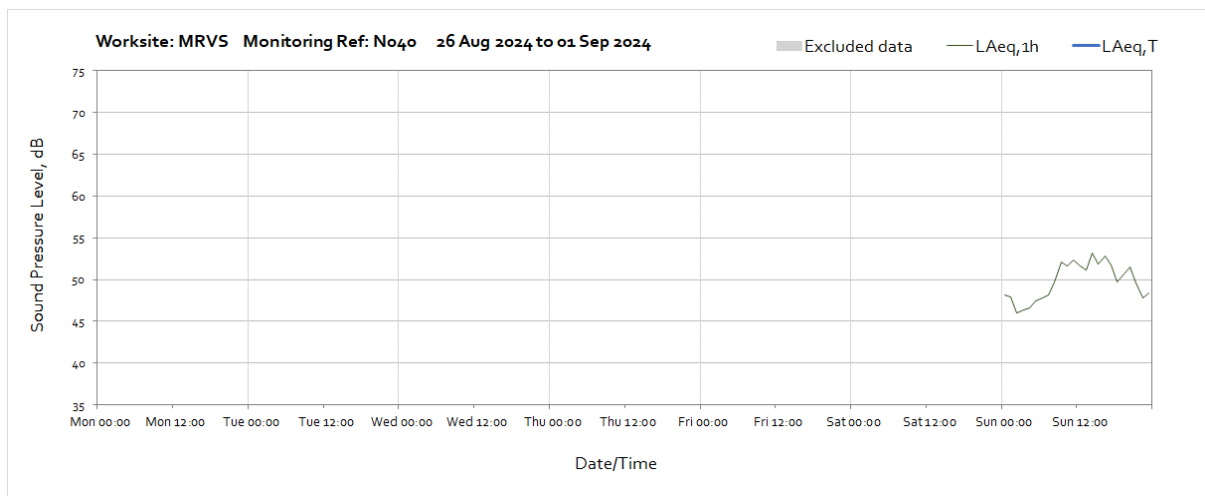
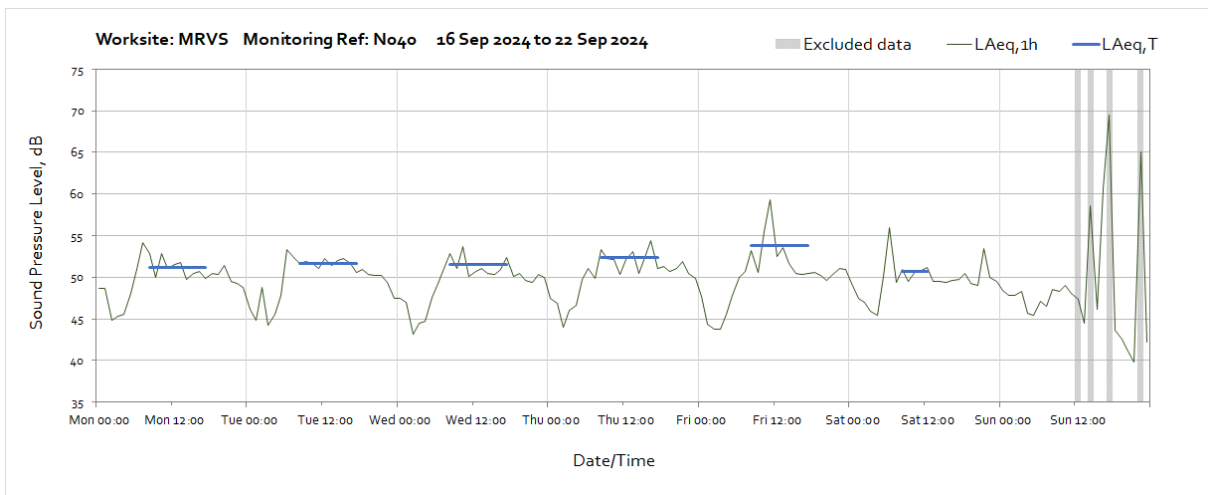
### Worksite: MRVS – Monitoring Ref: N040

The following graphs show the hourly measured ambient noise level  $L_{Aeq,1h}$  and, where relevant, the averaged noise level  $L_{Aeq,T}$  values, where the time period T is as specified in Table 1 of HS2 Information Paper E23. Periods where noise levels are adversely affected by weather or only measured for part of the period, which are not representative of HS2 construction works, have been greyed out and excluded from the calculation of the  $L_{Aeq,T}$  values in Table 3 of the main report.
