Construction Noise and Vibration Monthly Report – September 2024

Lichfield District Council

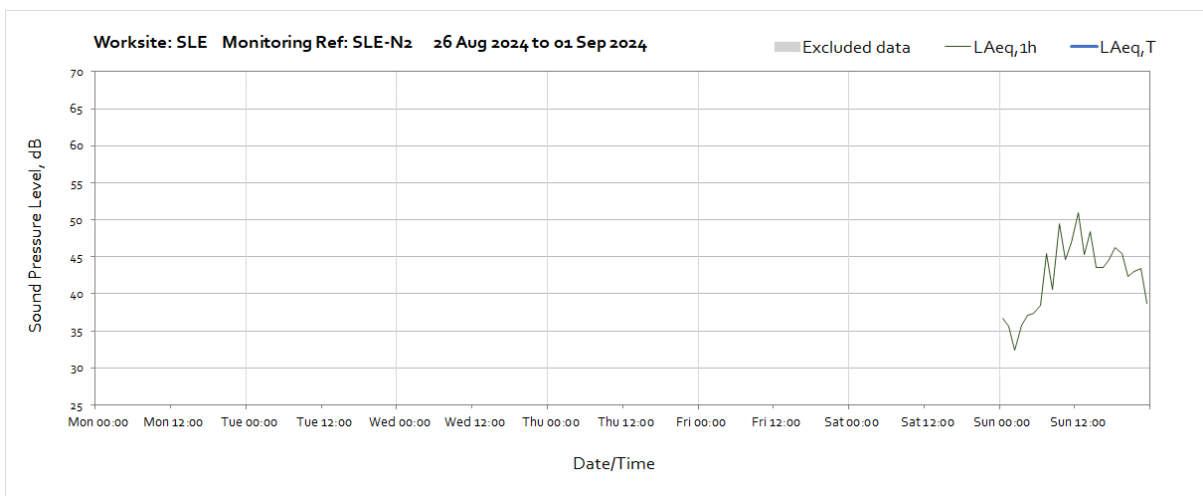
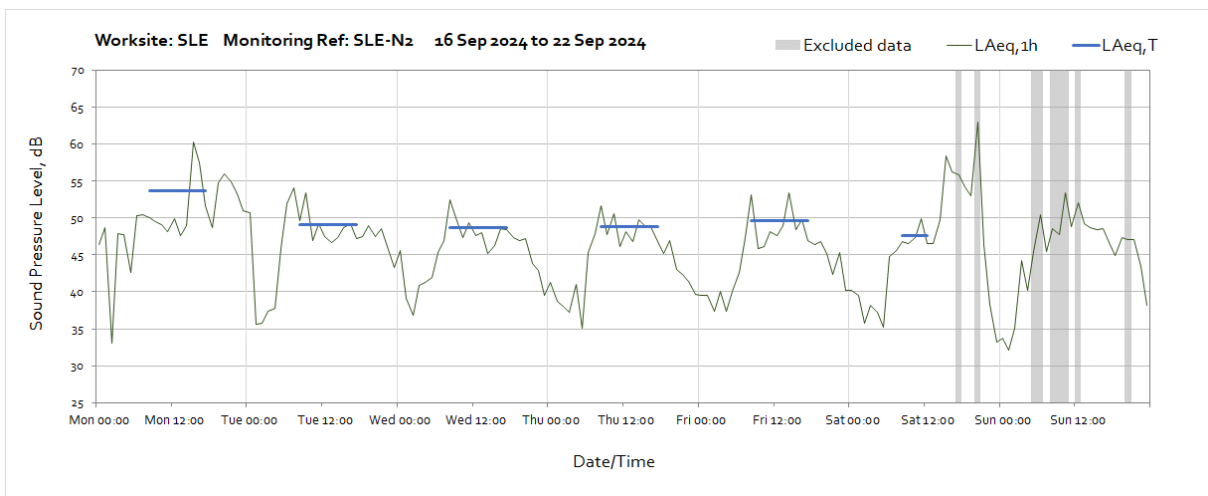
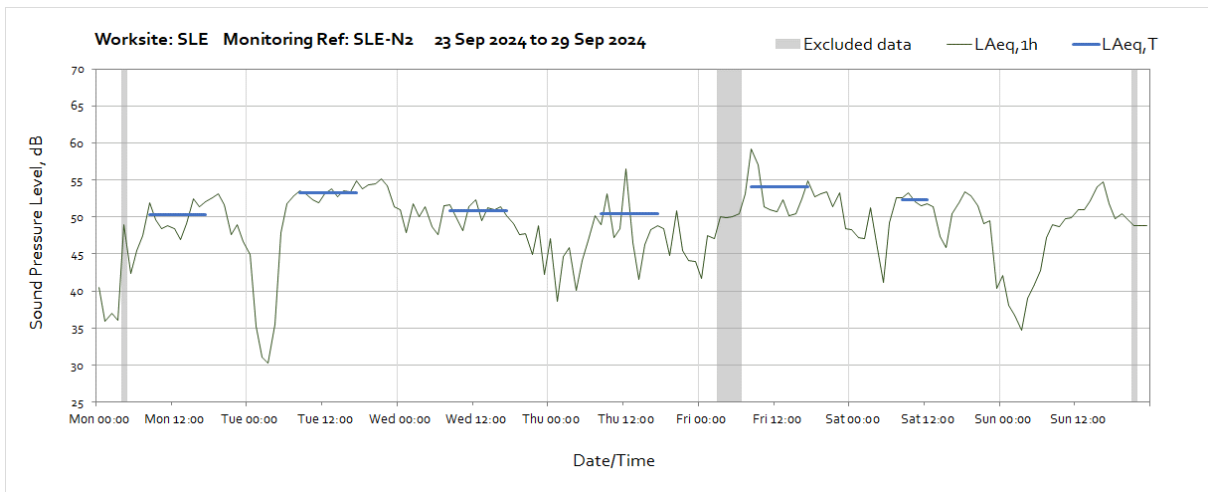
Worksite:SLE - Monitoring Ref: SLE-N2

The following graphs show the hourly measured ambient noise level LAeq,1h and, where relevant, the averaged noise level LAeq,T values, where the time period T is as specified in Table 1 of HS2 Information Paper E23. Periods where noise levels are adversely affected by weather or only measured for part of the period, which are not representative of HS2 construction works, have been greyed out and excluded from the calculation of the LAeq,T values in Table 3 of the main report.
