Construction Noise and Vibration Monthly Report – September 2024

North Warwickshire Borough Council

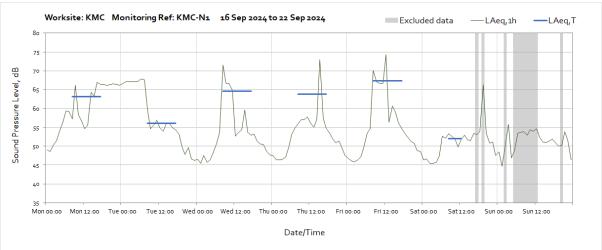
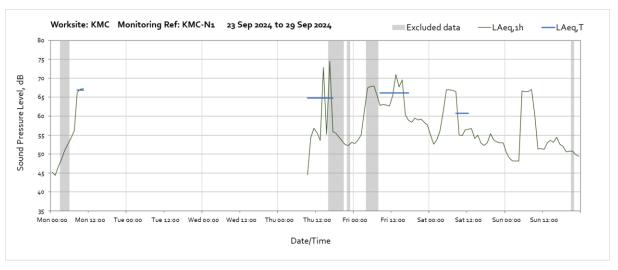
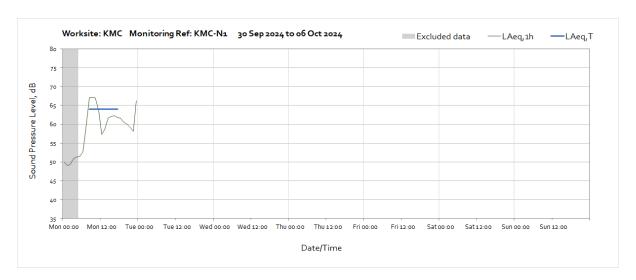
Worksite: KMC - Monitoring Ref: KMC-N1

Note: Missing data between 11:00 on Monday 23rd and 09:00 on Thursday 26th September was due to a remote reset error causing the monitor to remain offline until manually reset.

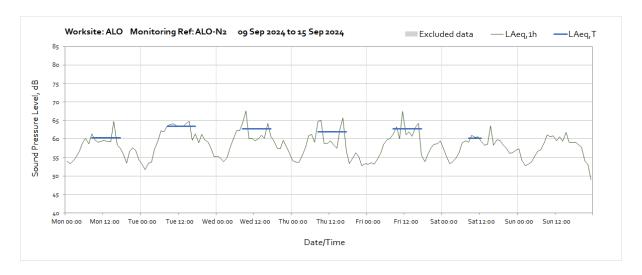
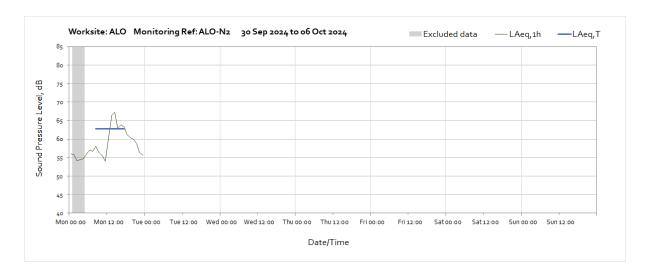
Worksite: ALO - Monitoring Ref: ALO-N2

2.2.8 One (1) SOAEL exceedance was recorded due to HS2 construction works during September 2024. The exceedance occurred at ALO-N2 during the weekday daytime period.

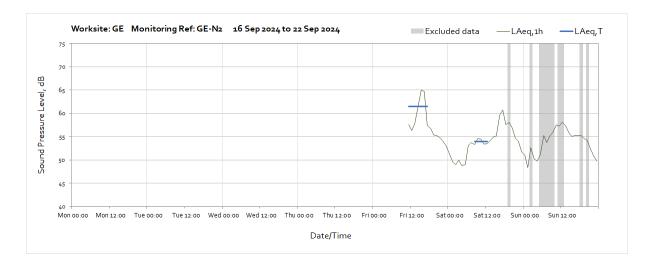
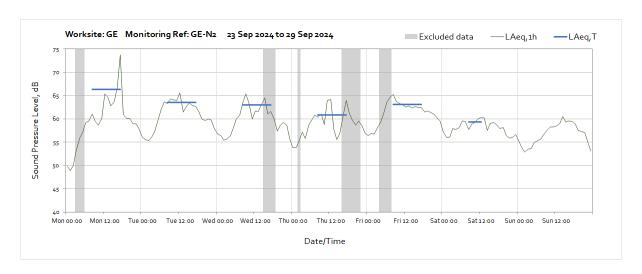
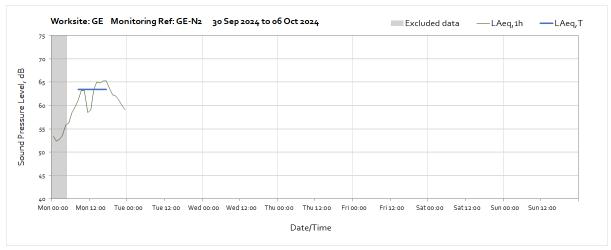
Worksite: GE - Monitoring Ref: GE-N2

Note: Missing data from the beginning of the month until 11:00 on Friday 20th September was due to the monitor being replaced.

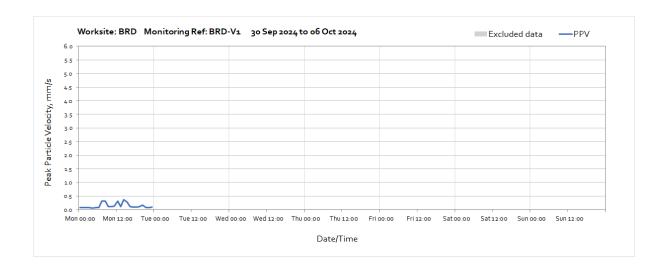
Worksite: BRD - Monitoring Ref: BRD-V1

^{*}High vibration level due to vacuum excavation taking place in close proximity to the monitoring station.
