SAFETY FLYER TO THE FISHING INDUSTRY

**Fatal man overboard from the potting vessel *Pioneer* (NN200)
south of Hastings, England, on 29 July 2021**

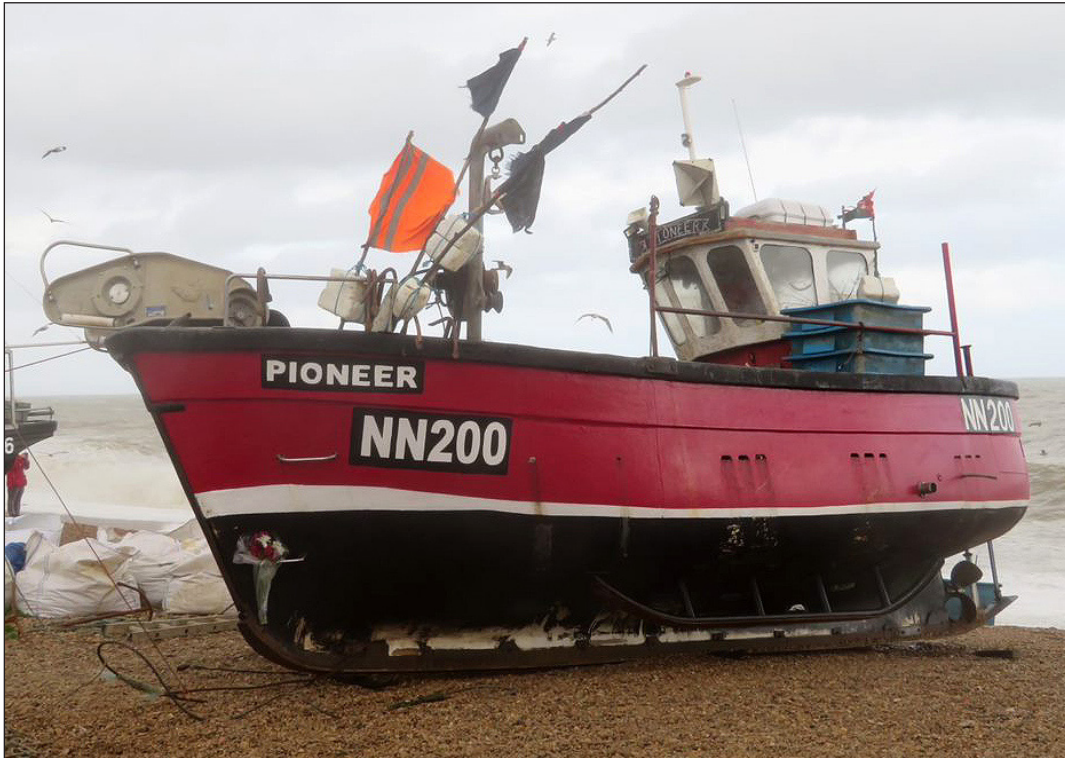
Pioneer

The investigation found that the bulwark around *Pioneer's* aft deck was low and the vessel's wheelhouse windows were semiopaque and cracked, restricting visibility from inside. Some items of mandatory safety equipment were missing, damaged or out of date, the Seafish risk assessment had not been completed, emergency drills had not been conducted and the skipper had not undertaken mandatory safety awareness training.

1. Make sure your vessel is well maintained and fit to go to sea. Check that your safety equipment is in its correct position on board and in date for service.

2. Risk assessments provide the opportunity to take stock of a fishing vessel's normal working activities, identify hazards and put in place measures to mitigate them. Had *Pioneer* had a guardrail of adequate height, or had the skipper been wearing a tethered safety harness in this case, either would have offered protection against the risk of falling overboard. Make sure you have attended the Seafish Safety Awareness course and refer to the Maritime and Coastguard Agency publication *The Fishermen's Safety Guide* for advice on how to prepare risk assessments for your vessel.
