Air Quality and Dust Monitoring Monthly Report - November 2024

Warwick District Council

A report prepared by EWCs and MWCCs on behalf of HS2 Ltd.

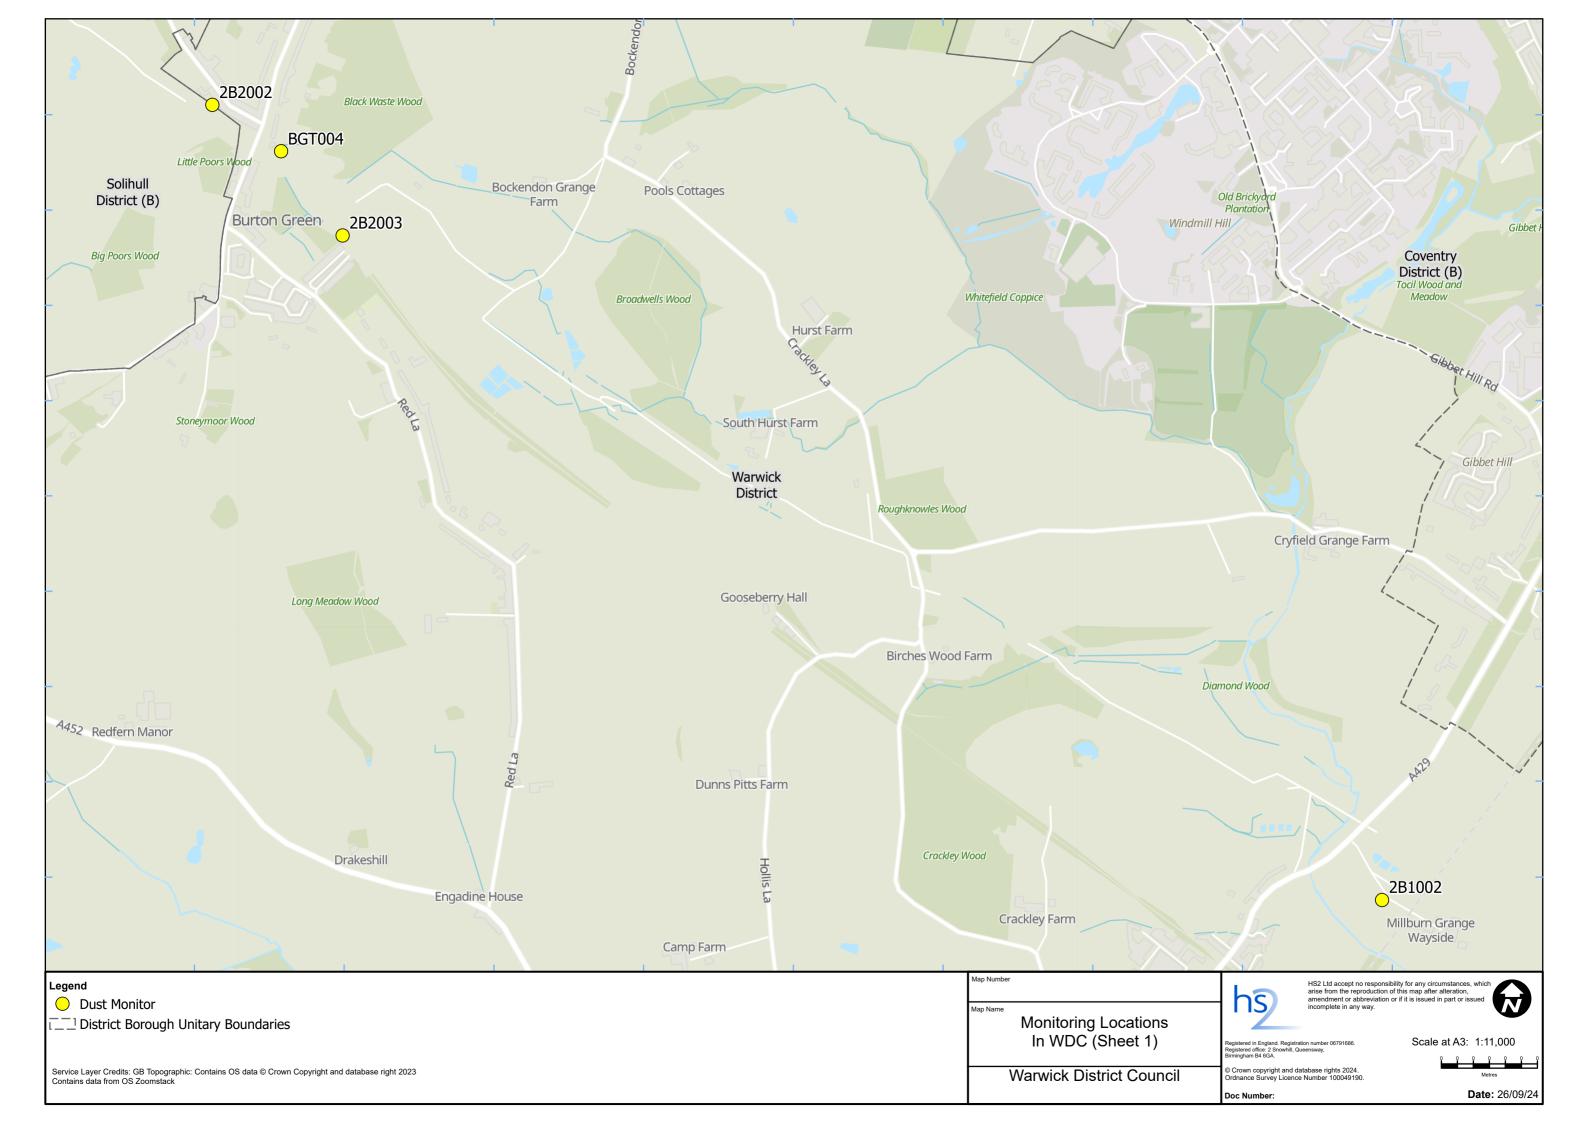
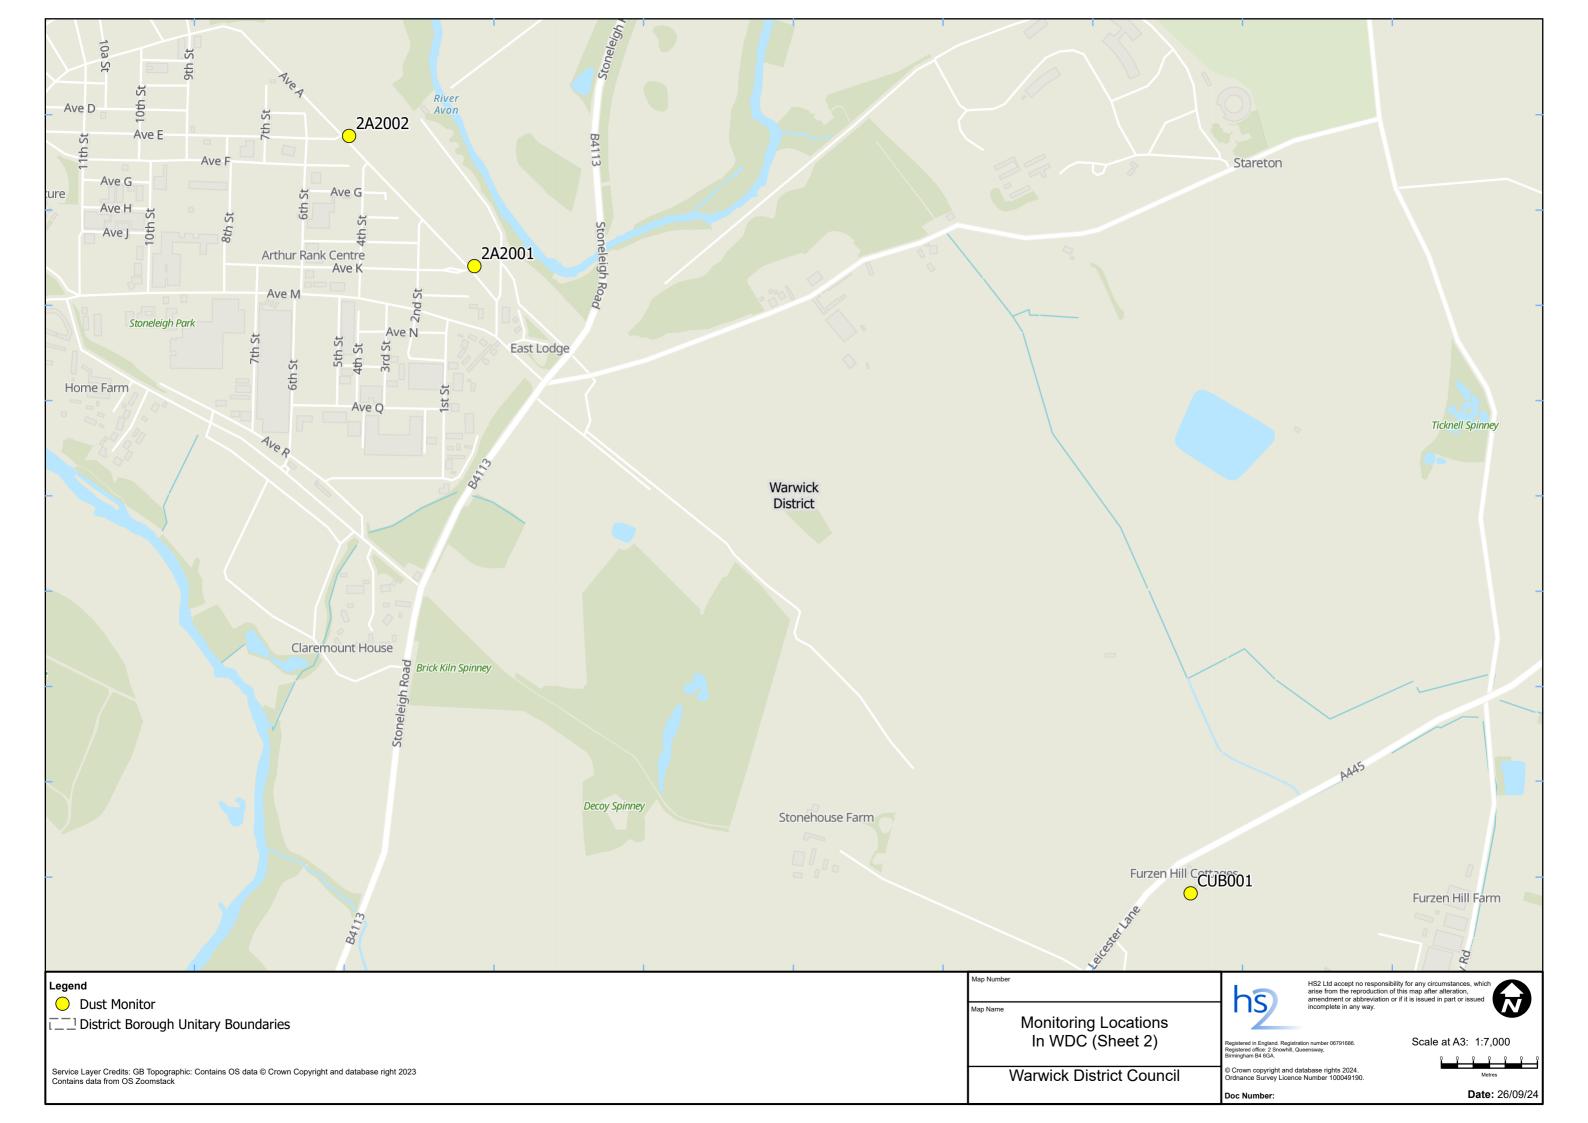
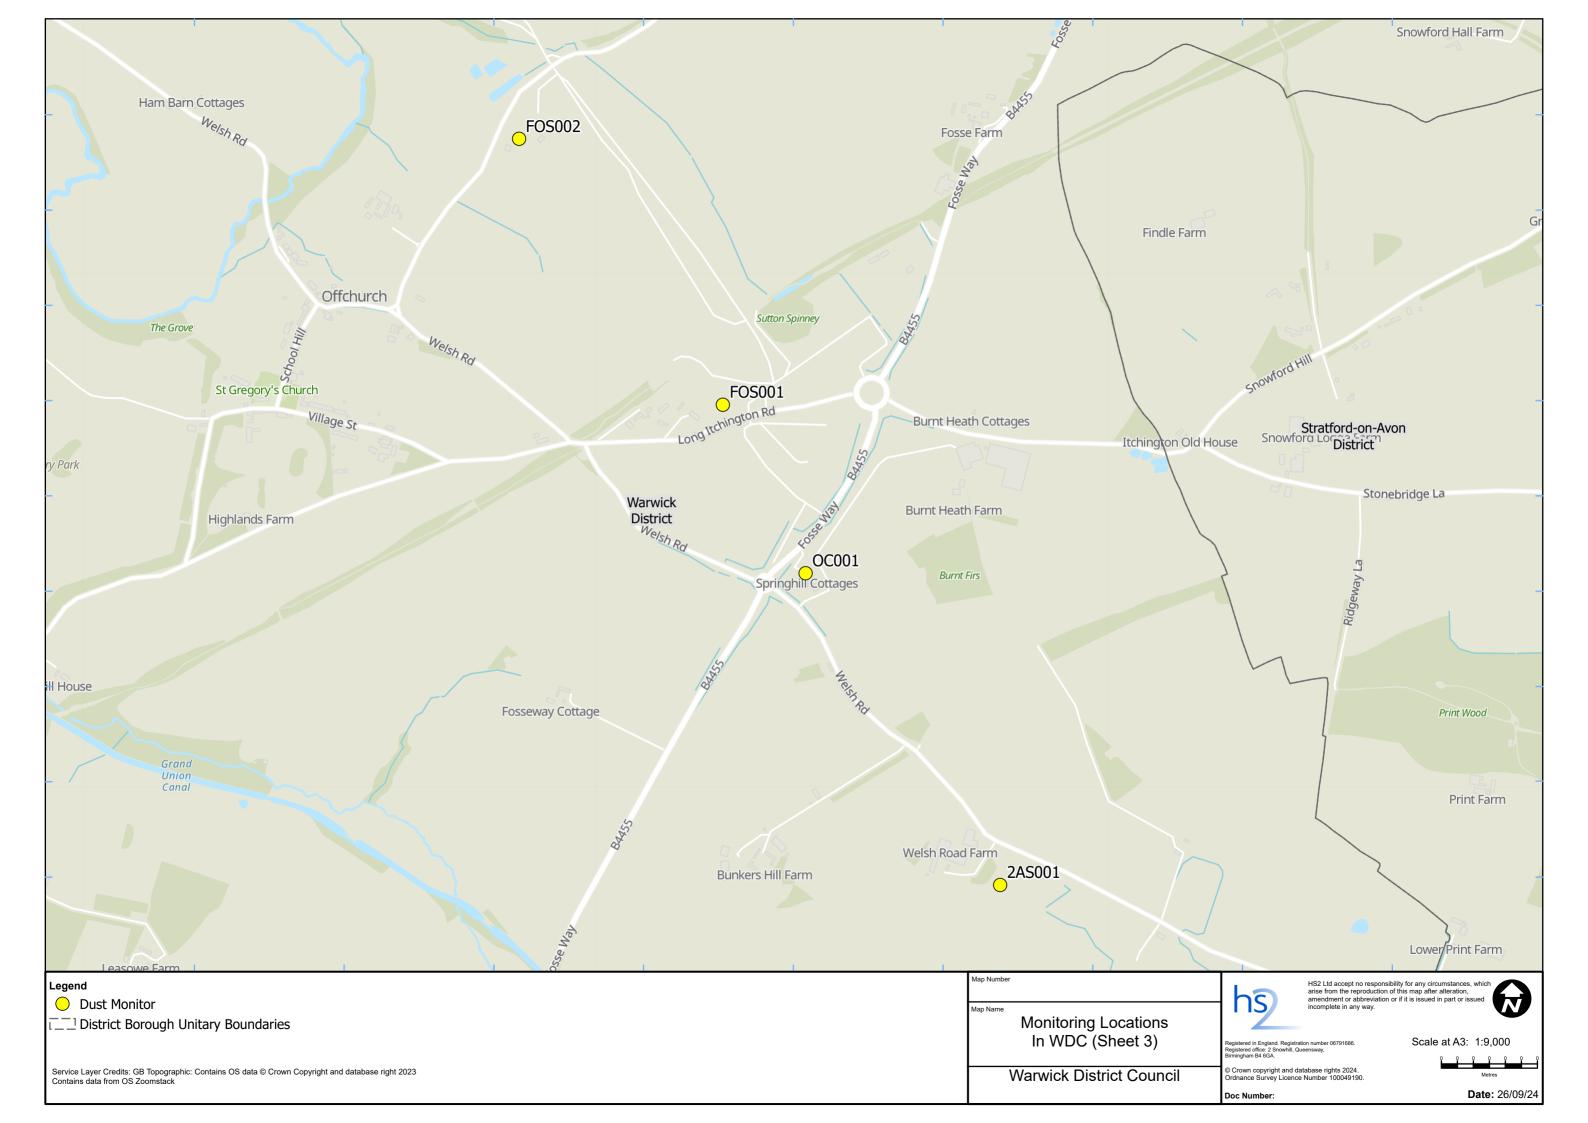
Figures 1-3: Worksites and Monitoring Locations within WDC

- 1.1.2 Figures 1 to Figure 3 in Appendix A present the current worksites together with the dust monitoring locations.
- 1.1.3 This summary should be read in conjunction with the overview monitoring report monthly available from www.gov.uk/government/collections/monitoring-the-environmental-effects-of-hs2, which highlights: the applicable standards and guidance, as well as the air quality and dust monitoring methodologies to be implemented by nominated undertakers throughout construction.

- 1.1.4 The current worksites, as presented in Appendix A, Figures 1 to 3, include:

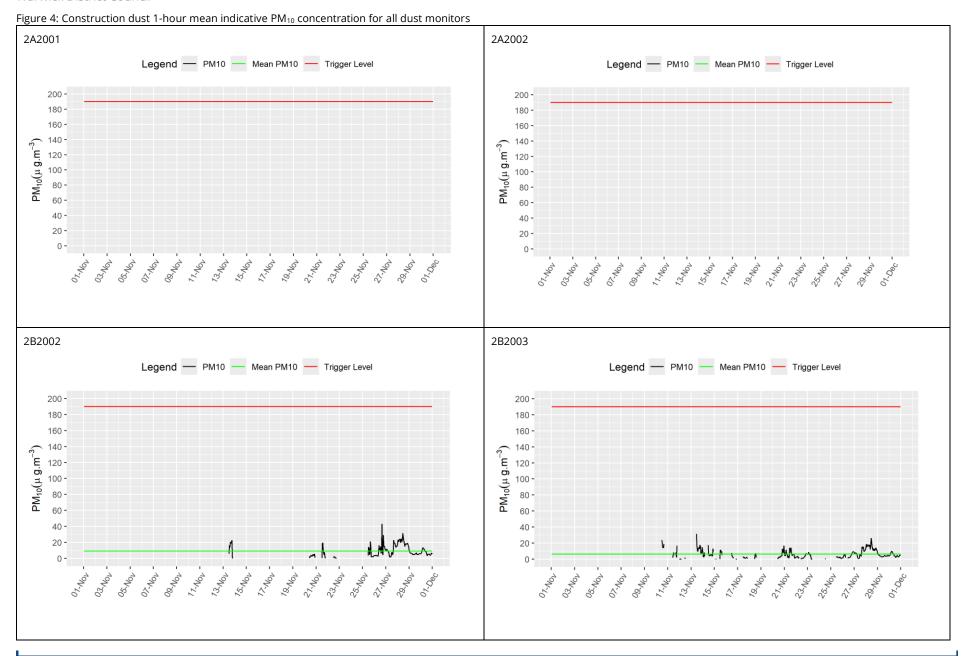
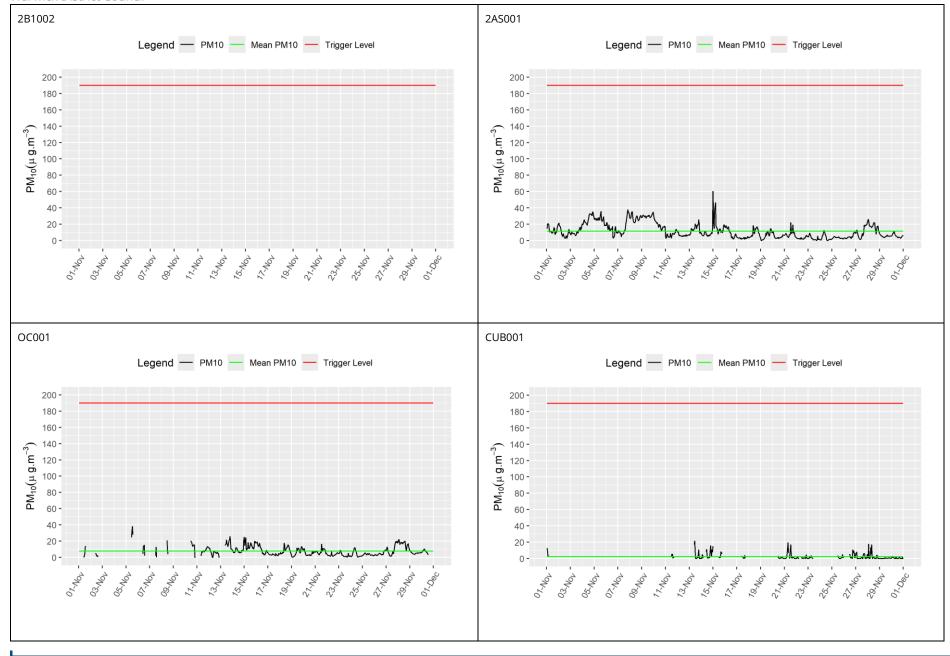
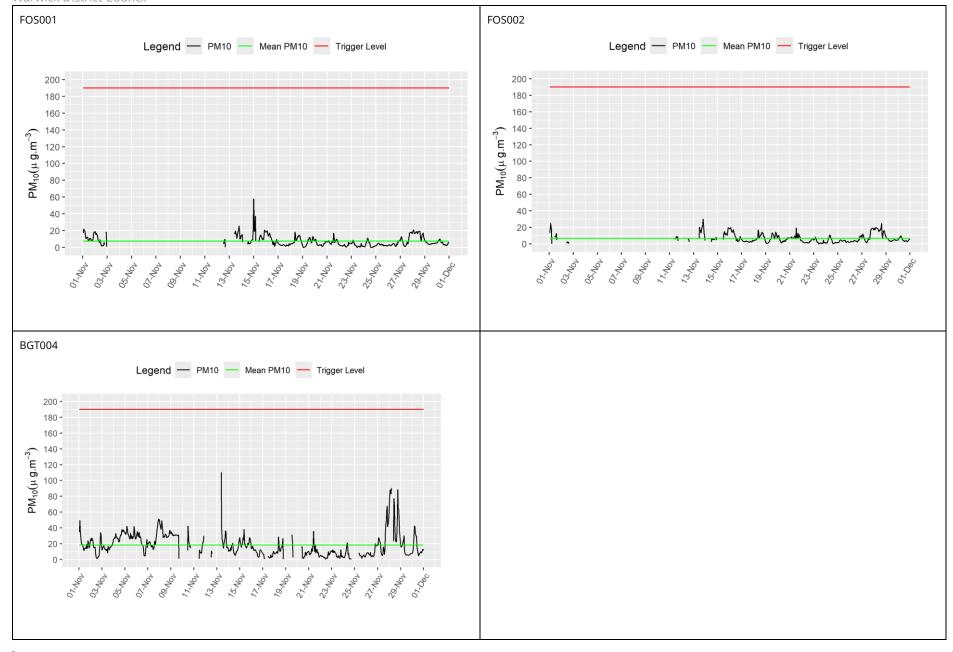
- 1.1.6 Dust monitoring locations and results are presented in Appendix B, Table 1, together with line charts of monthly data from each dust monitor, presented in Figure 4. All continuous dust monitoring is undertaken using indicative monitors. Despite being Environment Agency (MCERTS) certified, indicative monitors carry a higher level of uncertainty than reference monitors, and therefore cannot be strictly compared with Air Quality Standards for human health and the environment. The purpose of the monitoring undertaken is to ensure the effectiveness of the on-site mitigation.

- 1.1.7 The trigger level for PM_{10} concentrations of 190 μ g/m³, over a 1-hour period, in accordance with the updated guidance document 'Guidance on Monitoring in the Vicinity of Demolition and Construction Sites (October 2018)' has been applied.

- 1.1.8 No (0) dust trigger alerts were recorded during the monitoring period (November 2024).
- 1.1.9 Data capture was below 90% for multiple monitors due to:
