Construction Noise and Vibration Monthly Report – November 2024

North Warwickshire Borough Council

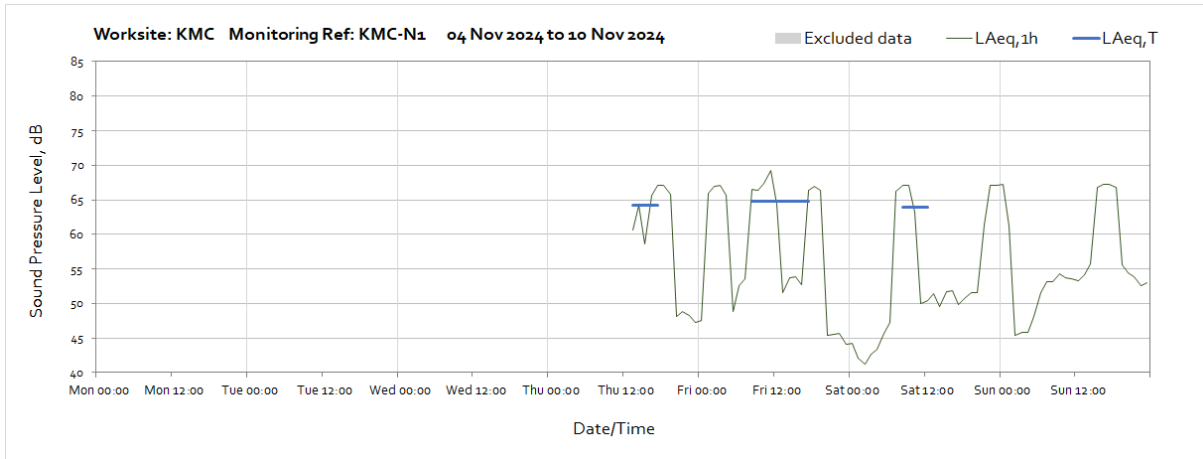
Worksite: KMC – Monitoring Ref: KMC-N1

Note: Missing data from 00:00 on Friday 1st November and 07:00 on Thursday 13th November was due to a loss of power to the monitoring station caused by vegetation preventing sufficient light to reach the solar panel.

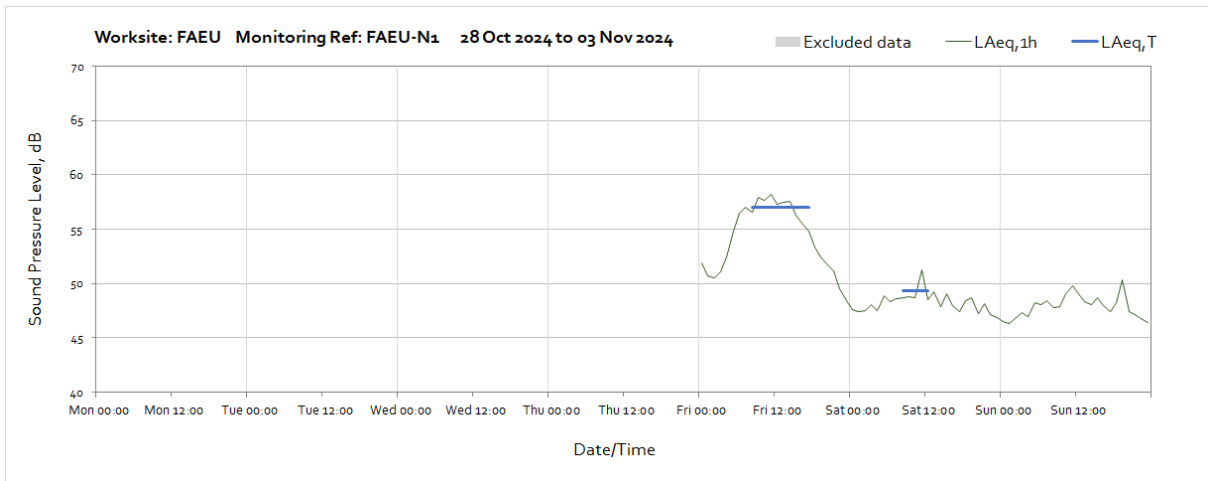
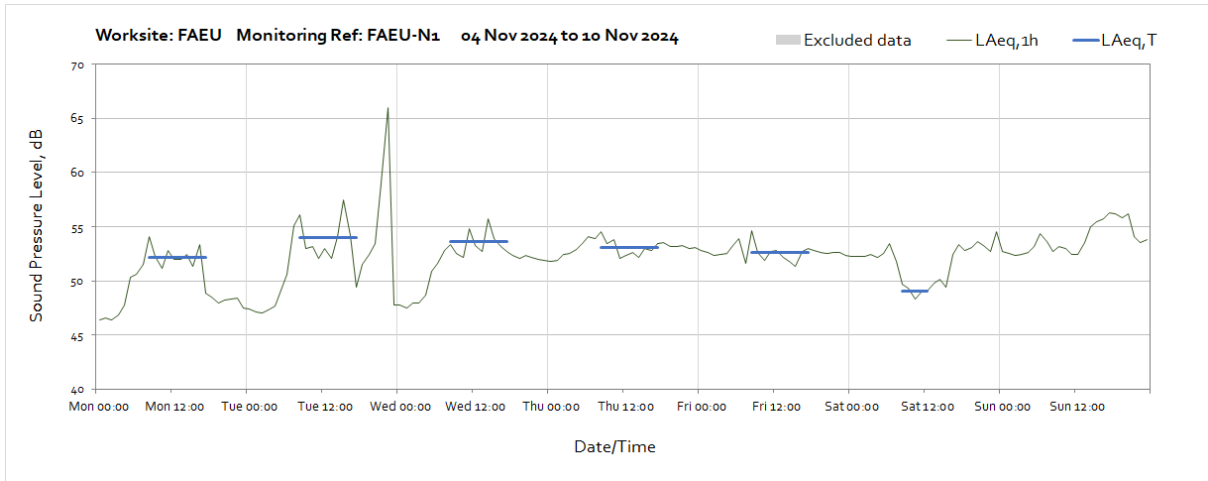
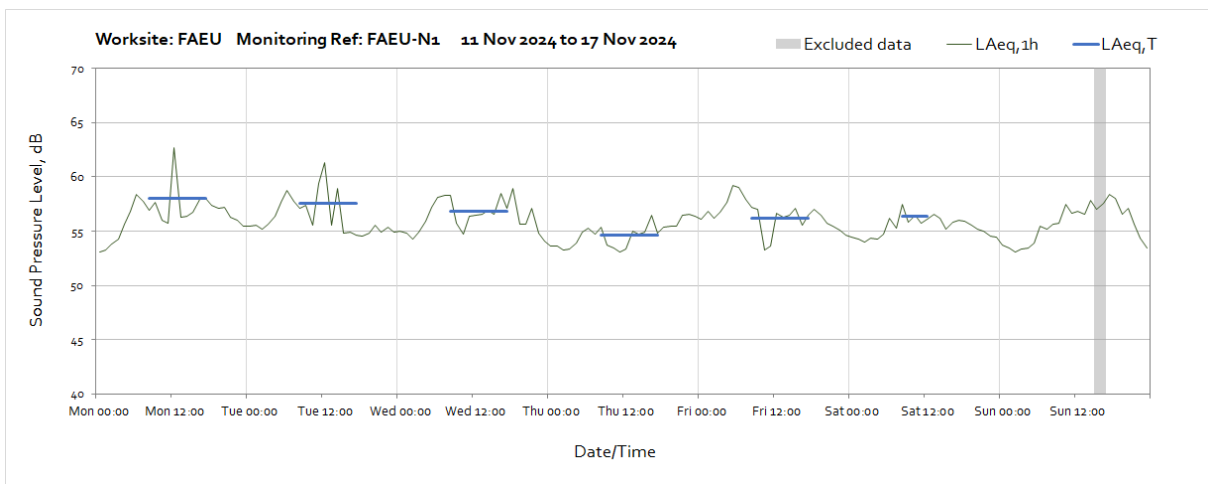
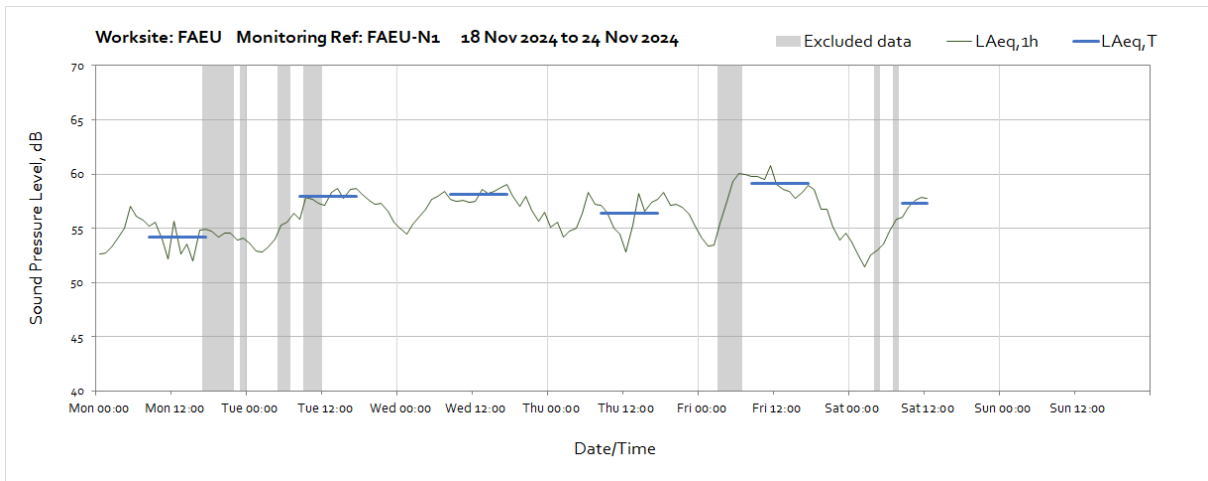
Worksite: FAEU – Monitoring Ref: FAEU-N1

Note: Missing data from 14:00 on Saturday 23rd November till the end of the month was due to a system error at the monitoring station.

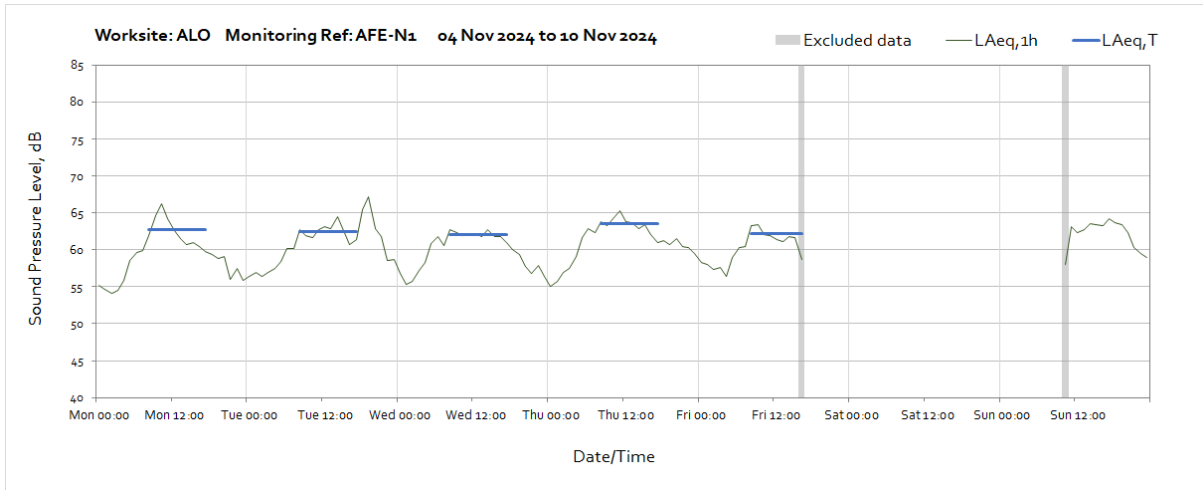
Worksite: ALO - Monitoring Ref: AFE-N1

Note: Missing data between 17:00 on Friday 8th November and 10:00 on Sunday 10th November was due to loss of power to the monitoring station caused by vegetation preventing sufficient light to reach the solar panel.

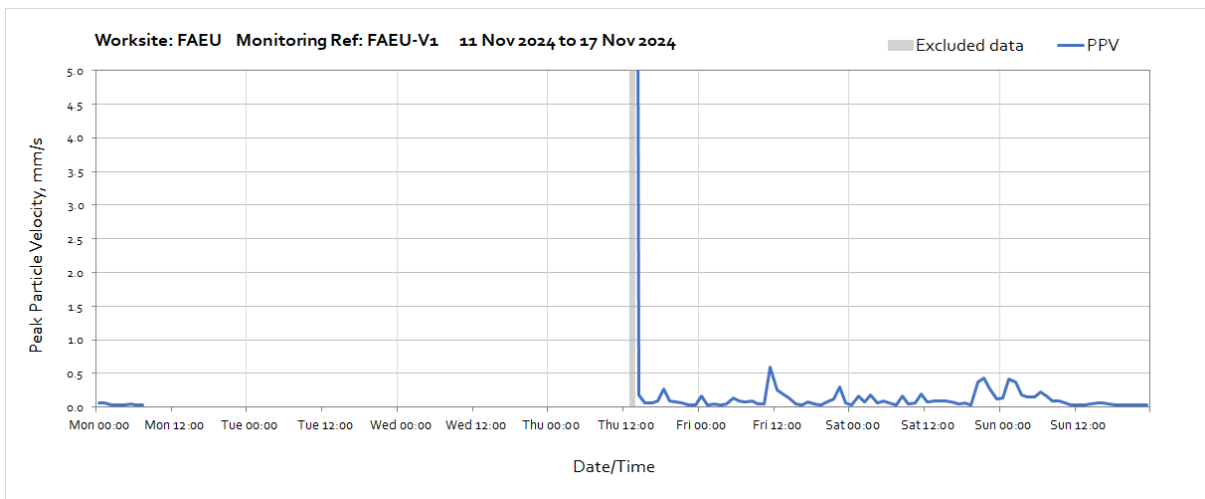
Note: Missing data between 08:00 on Monday 11th November and 13:00 on Thursday 14th November was due to loss of power to the monitoring station caused by vegetation preventing sufficient light to reach the solar panel.

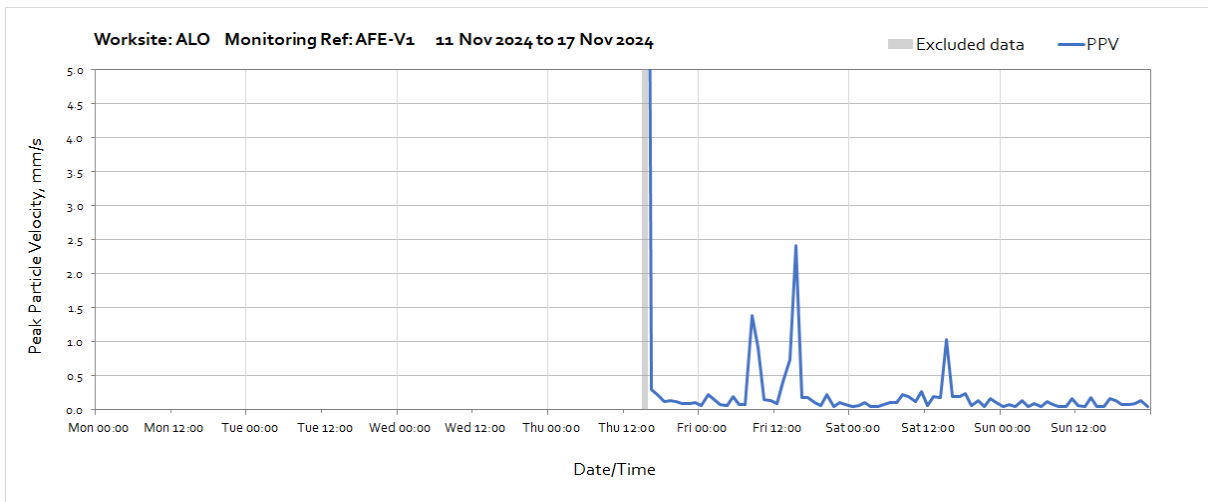
Note: Missing data between 18:00 on Sunday 3rd November and 15:00 on Thursday 14th November was due to loss of power to the monitoring station caused by vegetation preventing sufficient light to reach the solar panel.
