Construction Noise and Vibration Monthly Report – November 2024

West Northamptonshire District Council

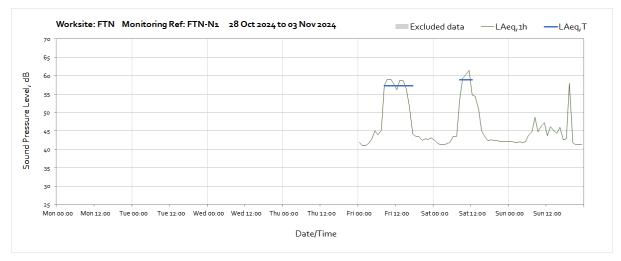
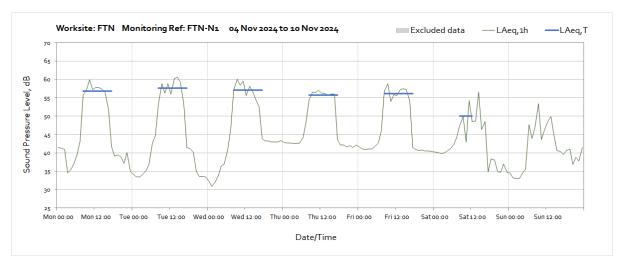
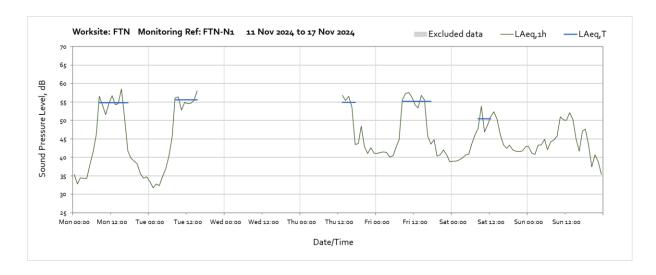
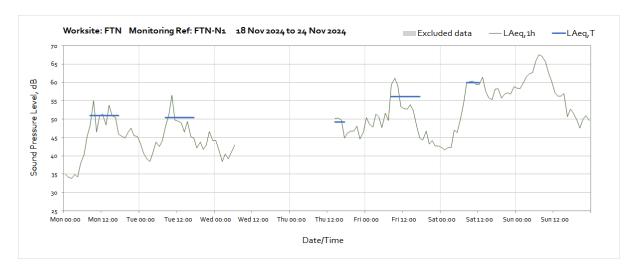
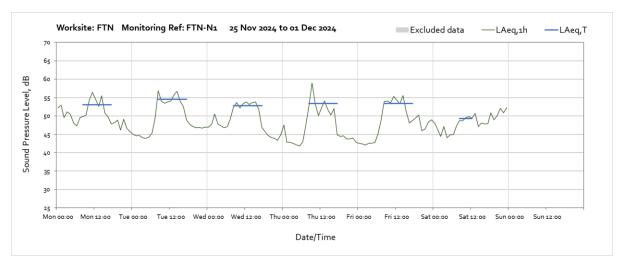
Worksite: FTN - Monitoring Ref: FTN-N1

The following graphs show the hourly measured ambient noise level $L_{Aeq,1h}$ and, where relevant, the averaged noise level $L_{Aeq,T}$ values, where the time period T is as specified in Table 1 of HS2 Information Paper E23. Periods where noise levels are adversely affected by weather or only measured for part of the period, which are not representative of HS2 construction works, have been greyed out and excluded from the calculation of the $L_{Aeq,T}$ values in Table 3 of the main report.

Note: Missing data between 16:00 on Tuesday 12^{th} and 13:00 on Thursday 14^{th} November was due to a depleted battery at the monitoring station.

Note: Missing data between 07:00 on Wednesday 20th and 14:00 on Thursday 21st November was due to a depleted battery at the monitoring station.

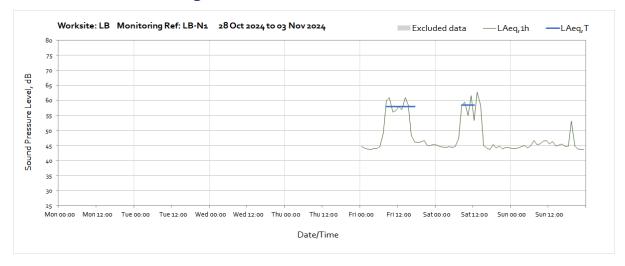
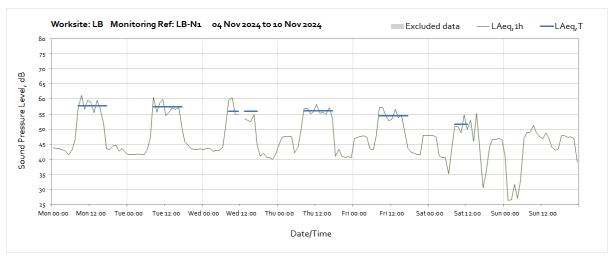
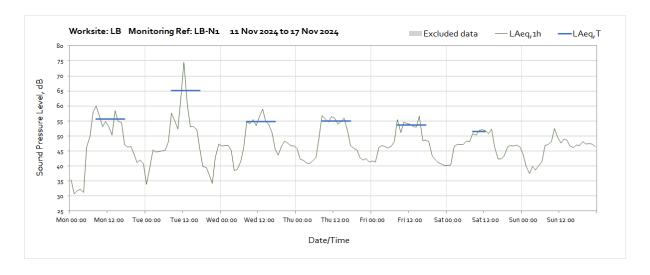
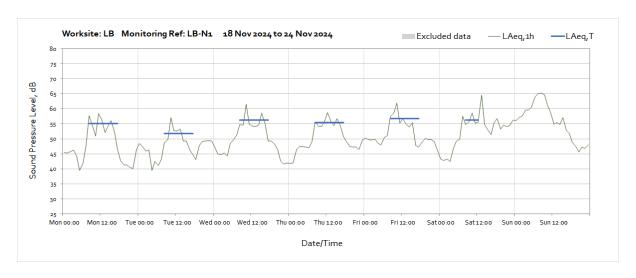
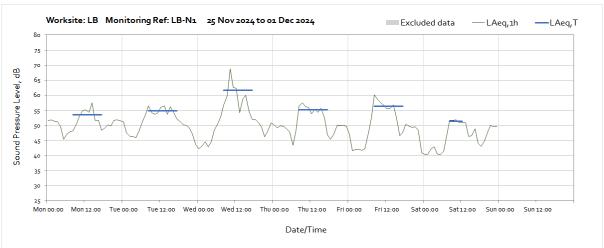
Worksite: LB - Monitoring Ref: LB-N1

Note: Missing data between 12:00 and 13:00 on Wednesday 6^{th} November was due to monitor maintenance.

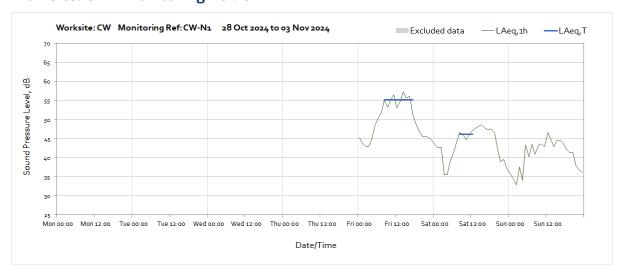
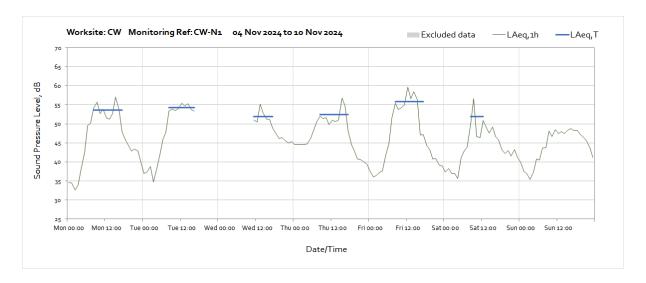
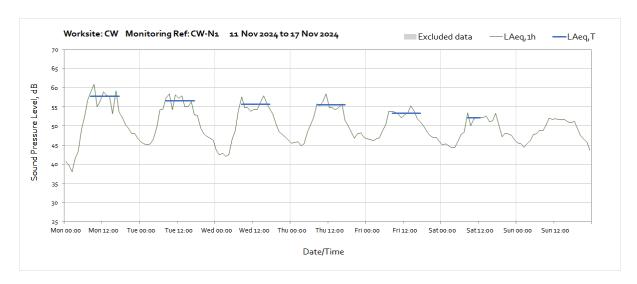
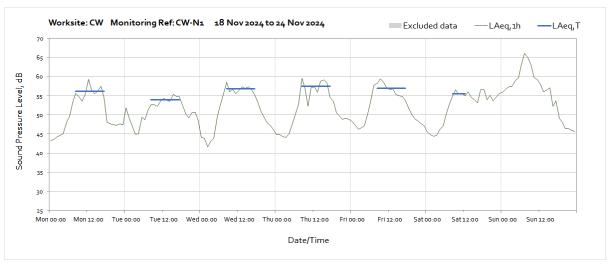
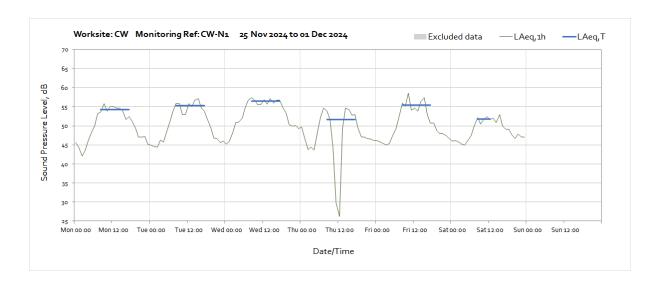
Worksite: CW - Monitoring Ref: CW-N1

Note: Missing data between 17:00 on Tuesday 5^{th} and 11:00 on Wednesday 6^{th} November was due to a depleted battery at the monitoring station.

Note: Level drop at 13:00 on Thursday 28th November was due to a monitor power issue and is currently under further investigation.

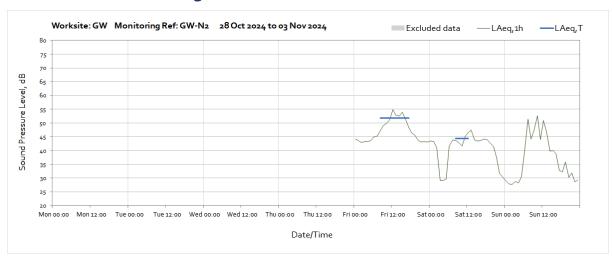
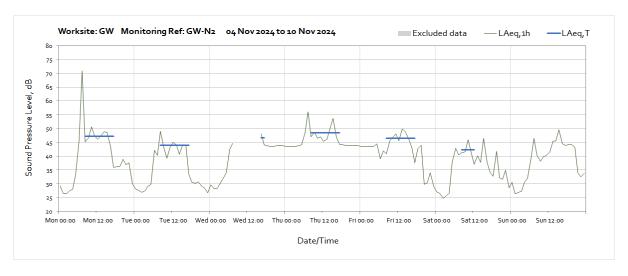
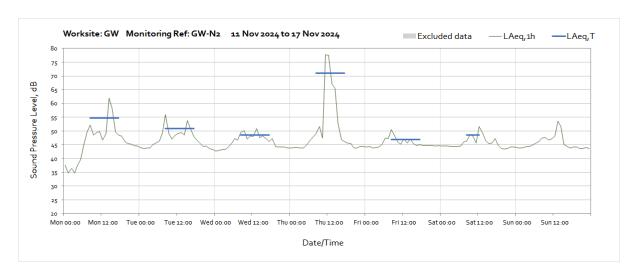
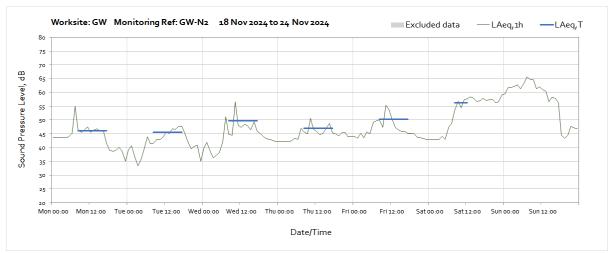
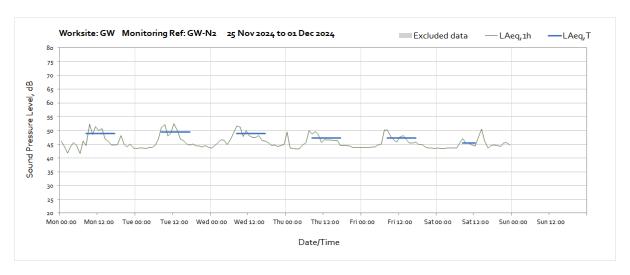
Worksite: GW - Monitoring Ref: GW-N2

Note: Missing data between 08:00 and 16:00 on Wednesday 6th November was due to a depleted battery at the monitoring station.

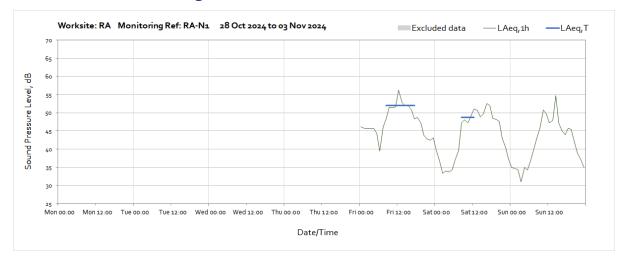
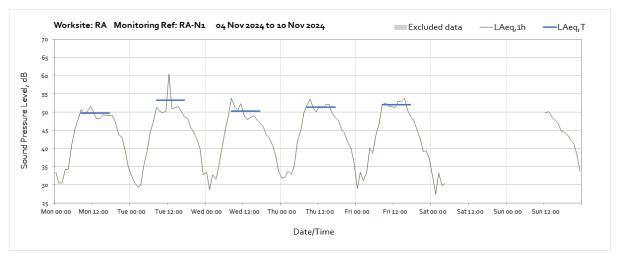
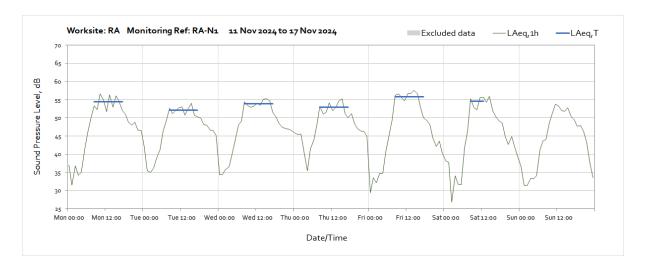
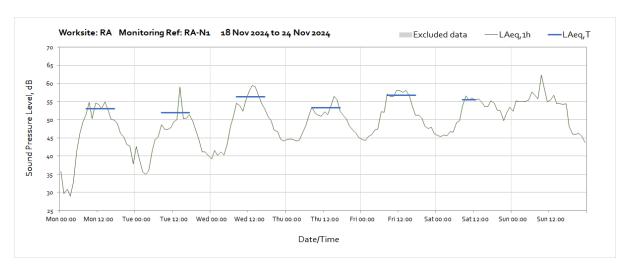
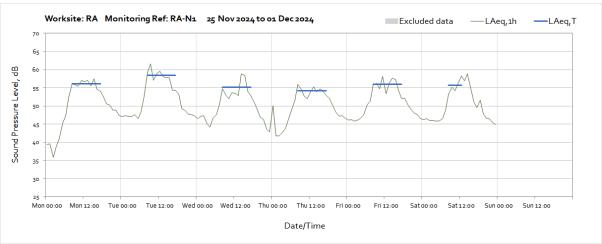
Worksite: RA - Monitoring Ref: RA-N1

Note: Missing data between 05:00 on Saturday 9^{th} and 12:00 on Sunday 10^{th} November was due to a depleted battery at the monitoring station.

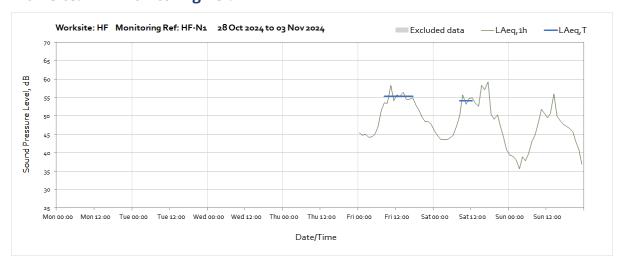
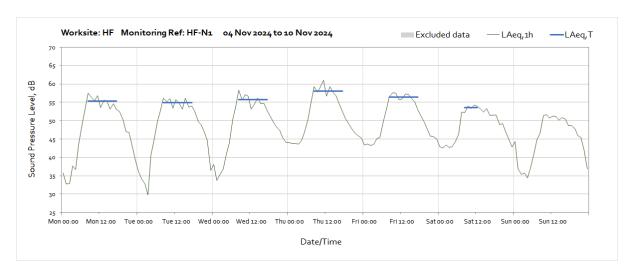
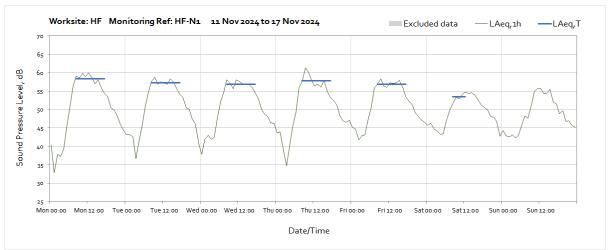
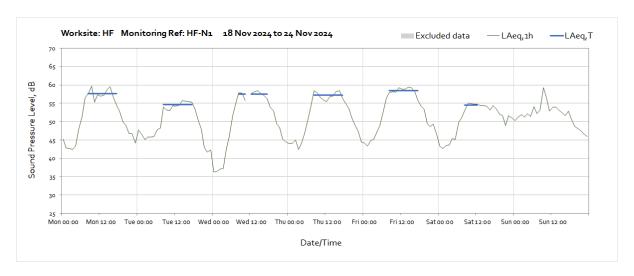
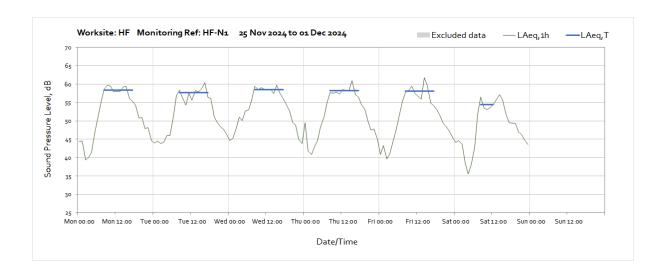
Worksite: HF - Monitoring Ref: HF-N1

Note: Missing data between 11:00 and 12:00 on Wednesday 20th November was due to monitor maintenance.
