| Power Supply (Model: TD12200) supplied with InvoSpar Massager, JC668 | |
| PSD Number | 2501-0125 |
| Product Type | Electrical Appliances and Equipment – Mains Power Supply for Neck Massager |

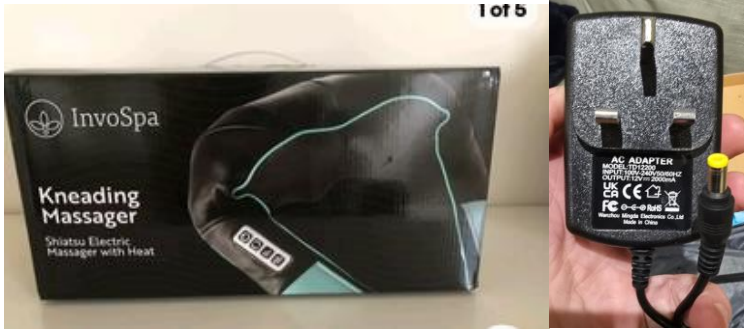
| Power Supply (Model: TD12200) supplied with InvoSpar Massager, JC668 | |
|---|---|
| Images | |

| Power Supply (Model: TD12200) supplied with InvoSpar Massager, JC668 | |
|---|---|
| Product Identifiers | Power Supply: Wenzhou Mingda Electronics Co., Ltd Power Supply Model Number: TD12200 Affected Amazon Barcodes: X000QHVFLEX; X001GD3MKD |
| Product Description | 3-pin adapter supplied with an InvoSpar Massager. Affected products were sold between 2017 and 2021. The massage unit is unaffected. |
| Risk Description | <p>The product presents a serious risk of fire as the power supply (model TD1220) supplied with the InvoSpar JC-668 neck massager was found to have poor quality connections to the input and output of the power supply, with wires soldered directly to the power circuit board with no secondary fixing. This could cause the product to short circuit, presenting a risk of fire or explosion.</p> <p>No fuse was present on the input to protect the product from overcurrent related faults, further presenting a risk of fire, explosion or electric shock.</p> <p>The product does not meet the requirements of the Electrical Equipment (Safety) Regulations 2016.</p> |

| Power Supply (Model: TD12200) supplied with InvoSpar Massager, JC668 | |
|---|---|
| Corrective Measures | The product has been recalled from end users. For further information, contact support@invospa.com with your order ID or adapter photos to arrange for a replacement power supply. |
