HS2

February 2025

Construction Noise and Vibration Monthly Report – December 2024

London Borough of Ealing

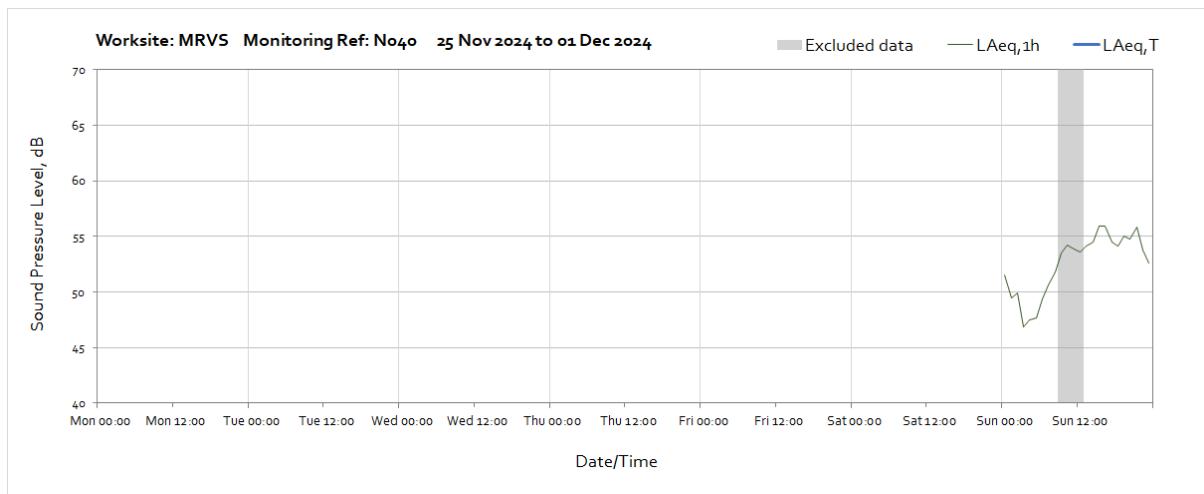
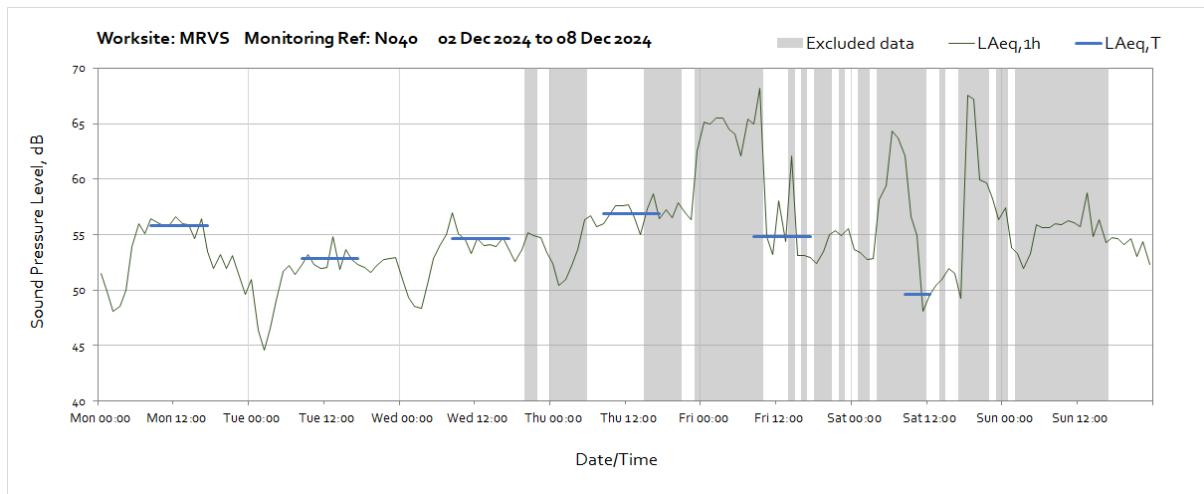
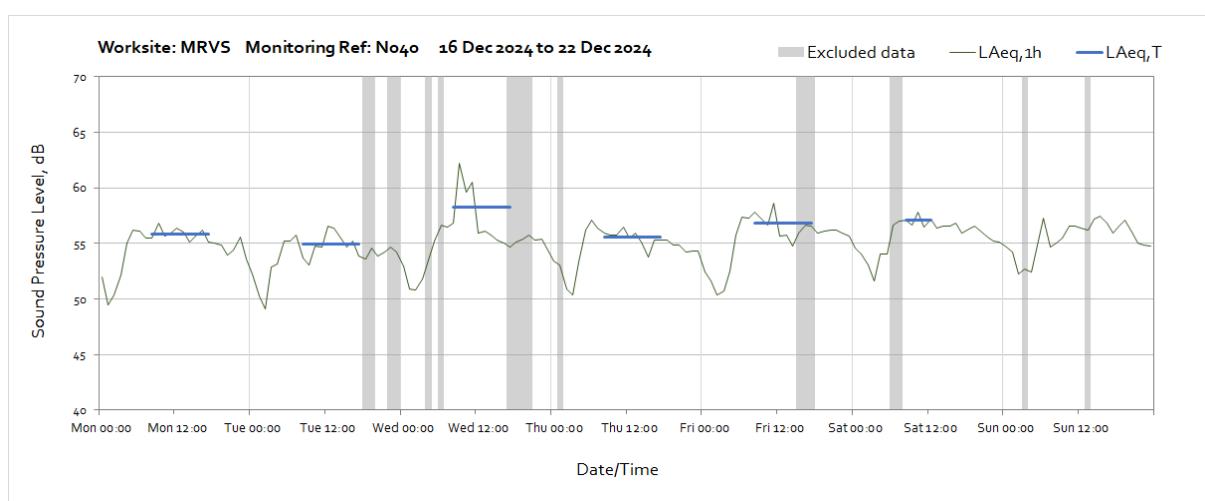
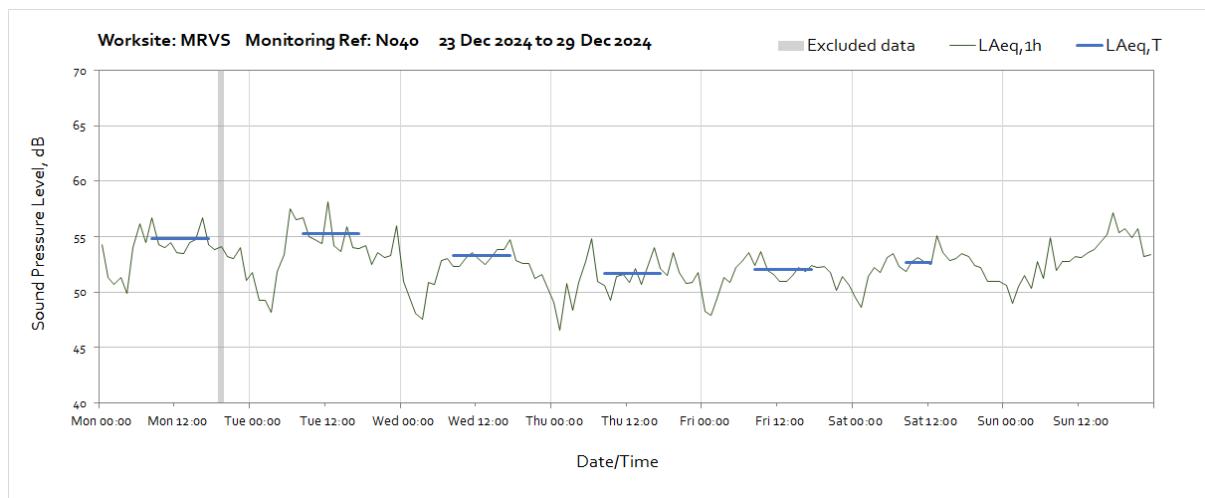
Worksite: MRVS – Monitoring Ref: N040

The following graphs show the hourly measured ambient noise level $L_{Aeq,1h}$ and, where relevant, the averaged noise level $L_{Aeq,T}$ values, where the time period T is as specified in Table 1 of HS2 Information Paper E23. Periods where noise levels are adversely affected by weather or only measured for part of the period, which are not representative of HS2 construction works, have been greyed out and excluded from the calculation of the $L_{Aeq,T}$ values in Table 3 of the main report.

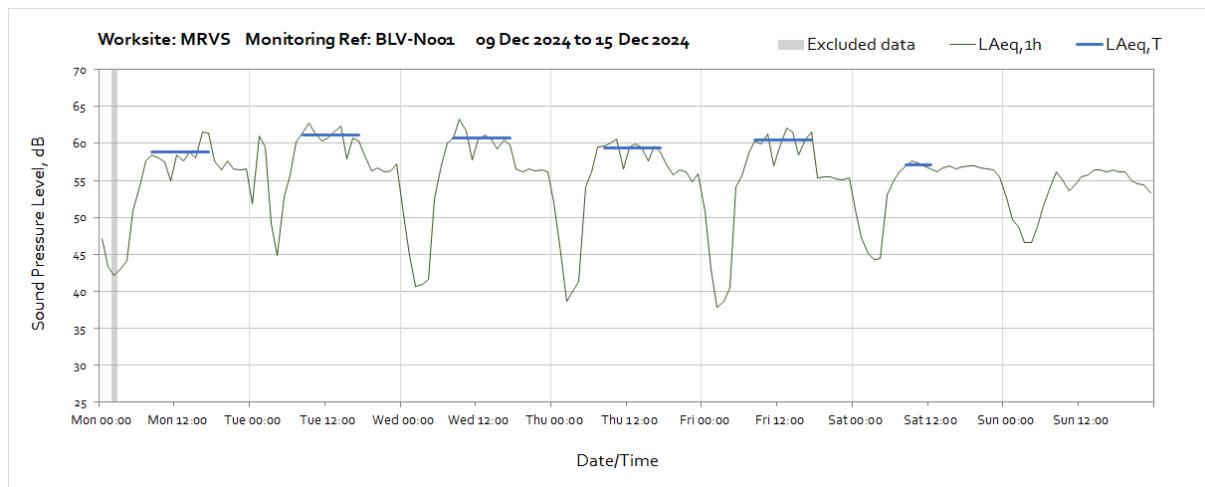
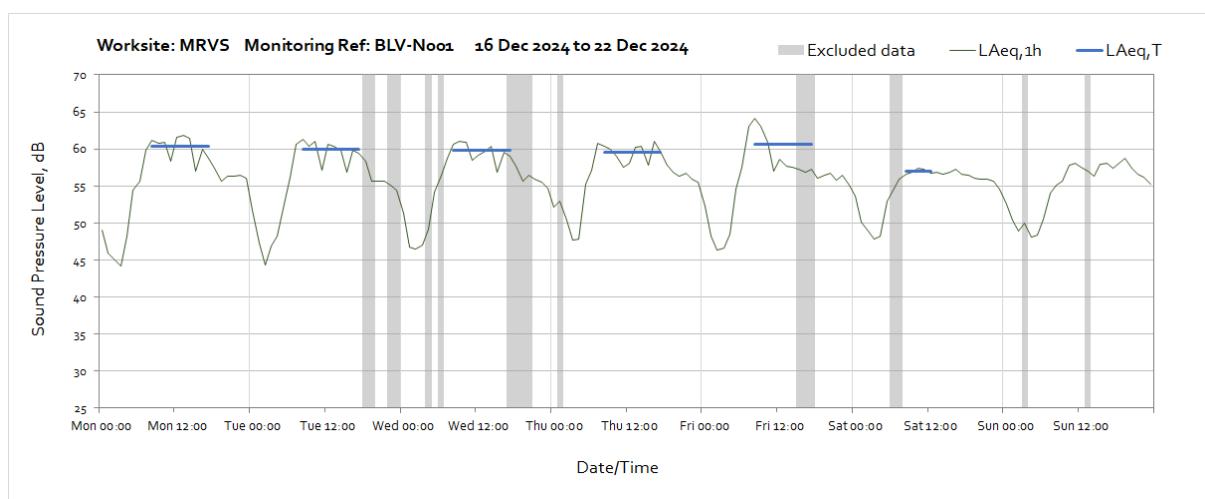
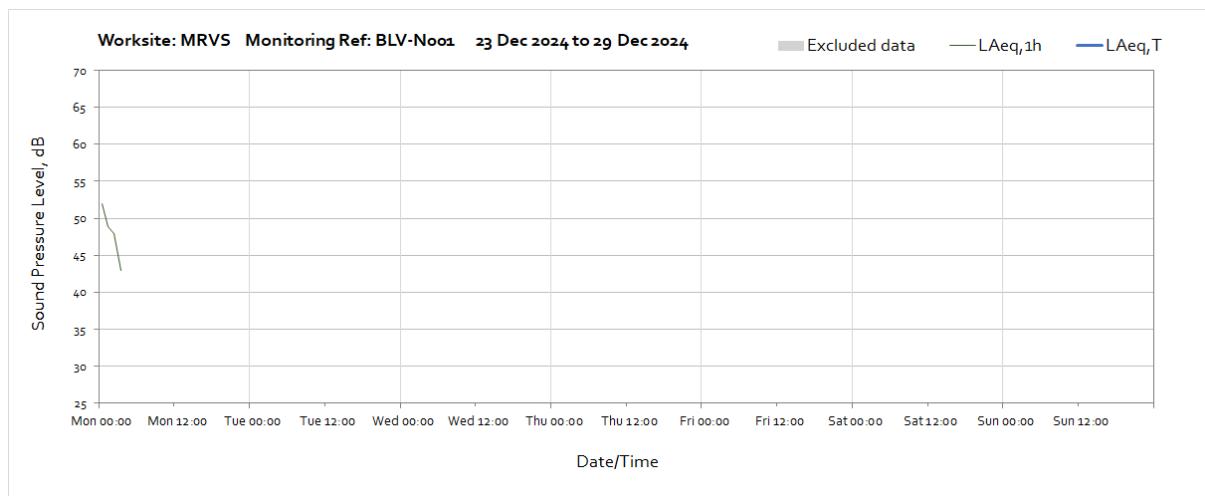
Worksite: MRVS – Monitoring Ref: BLV-N001

Note: Missing data between 04:00 on Monday 23rd December and the end of the month was due to depleted battery at the monitoring station.

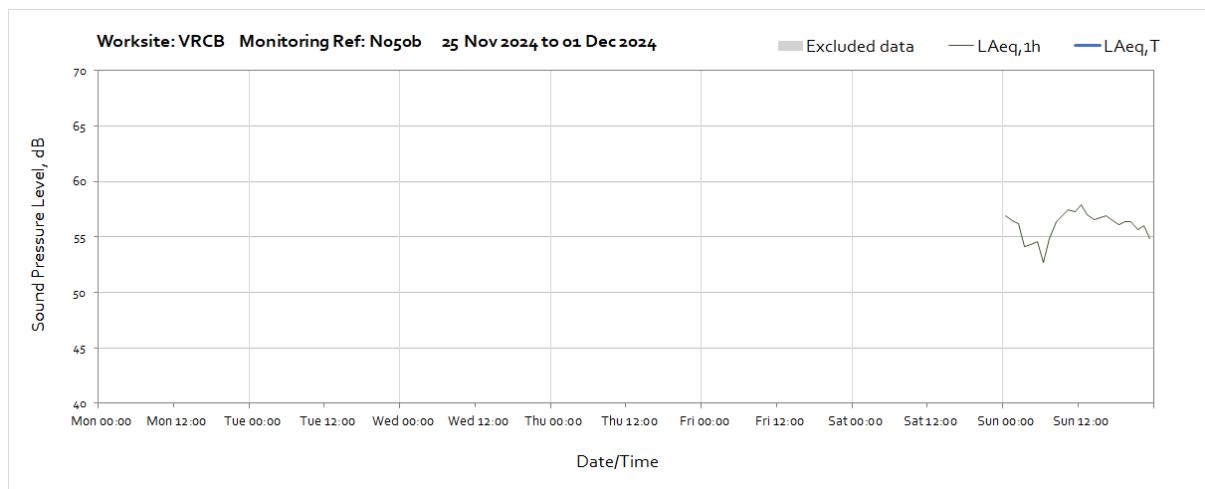
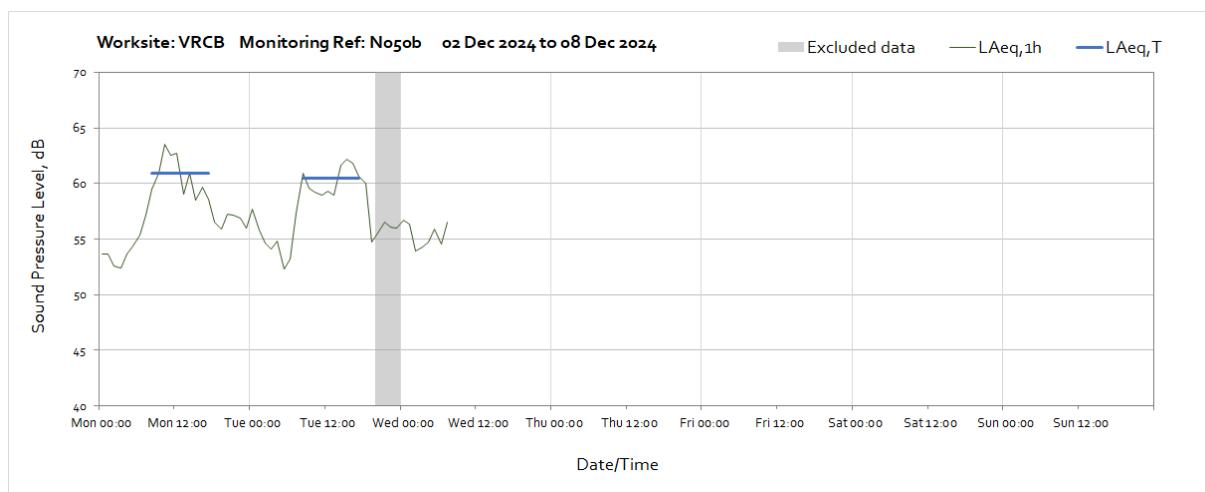
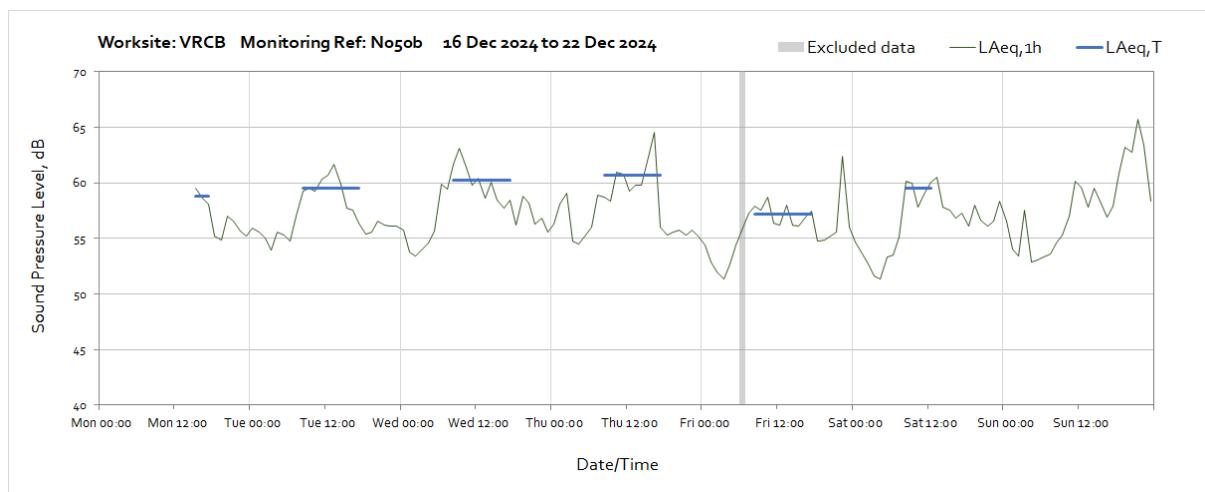
Worksite: VRCB – Monitoring Ref: N050b

Note: Missing data between 08:00 on Wednesday 4th December and 15:00 on Monday 16th December was due to loss of continuous site power.

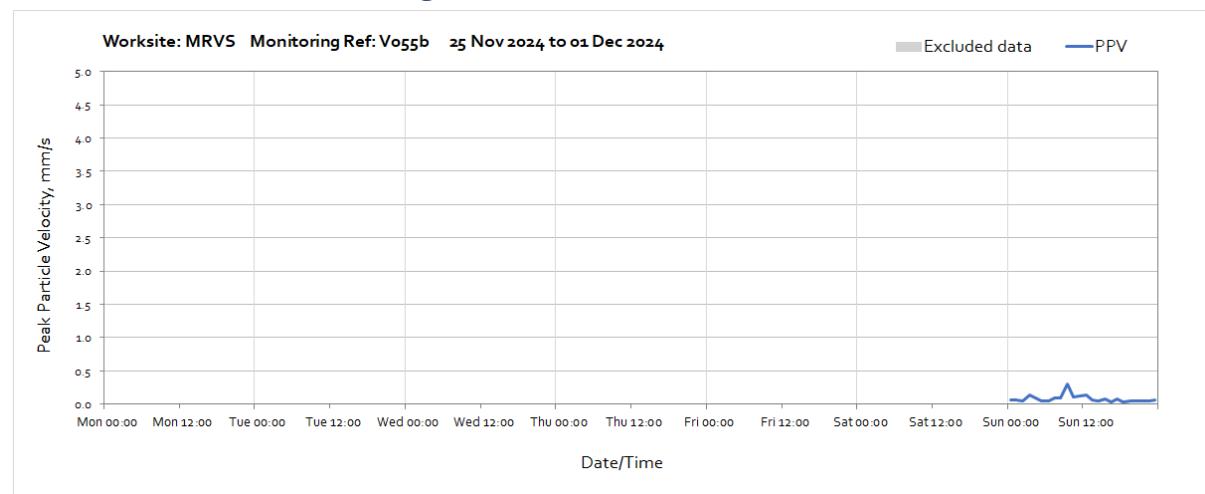
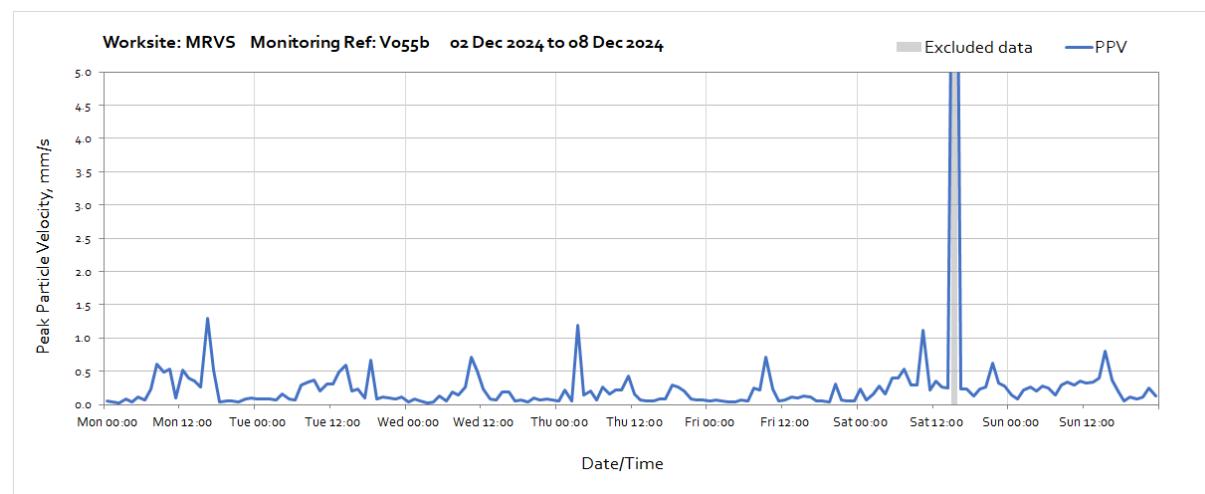
Worksite: MRVS – Monitoring Ref: V055b

The following graphs show the hourly measured peak particle velocity PPV recorded during the monitoring period. The graphs show the highest PPV of the three orthogonal axis x, y and z. Periods where PPV values have been affected by local interference with the vibration monitor or only measured for part of the period, which are not representative of HS2 construction works, have been greyed out and excluded when calculating values in Table 4 of the main report.
