HS2

February 2025

Construction noise and vibration Monthly Report – December 2024

London Borough of Hillingdon

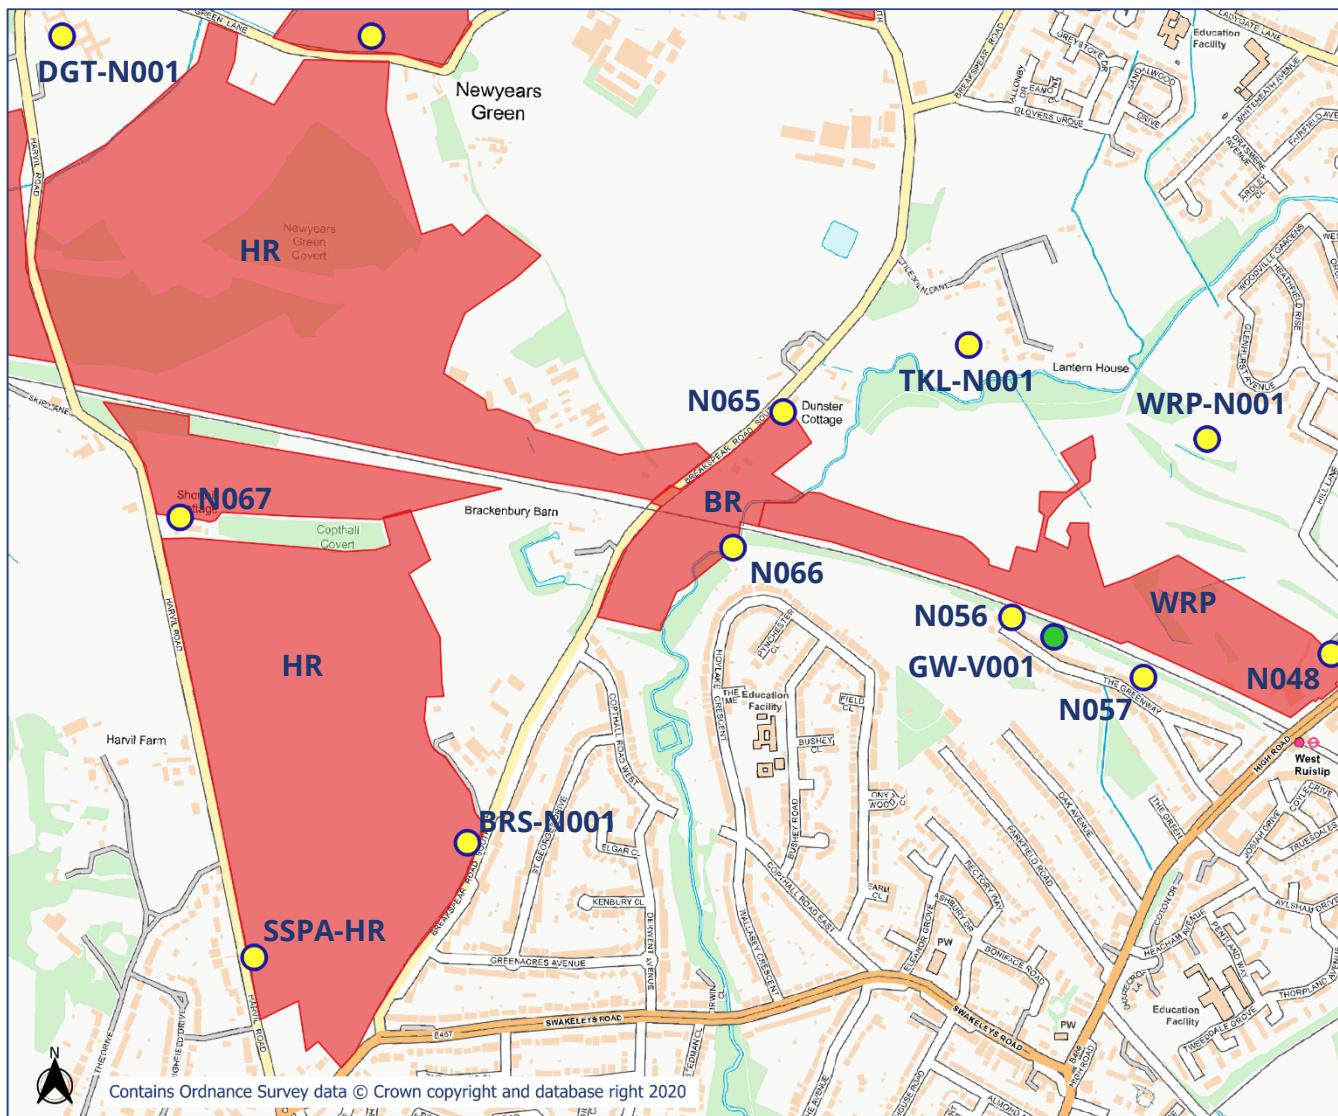
Noise and Vibration Monitoring Plan - 2

- Noise Monitor (Yellow circle)
- Vibration Monitor (Green circle)
- Active Worksites (Red shaded area)

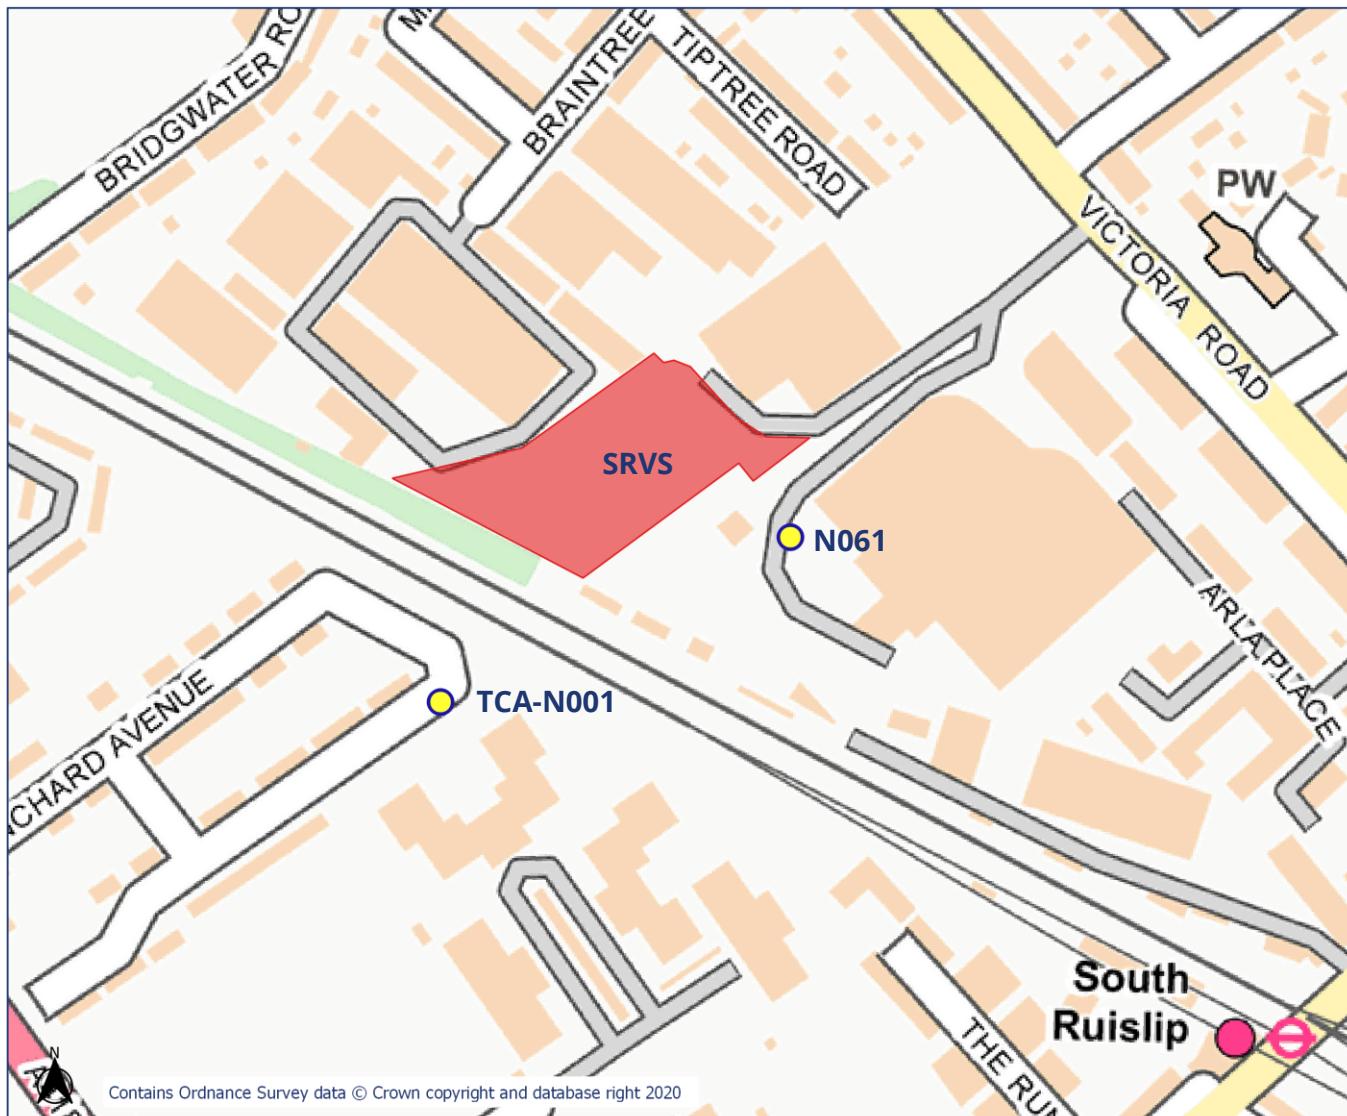
Noise and Vibration Monitoring Plan - 4

- Yellow circle: Noise Monitor
- Red shaded area: Active Worksites

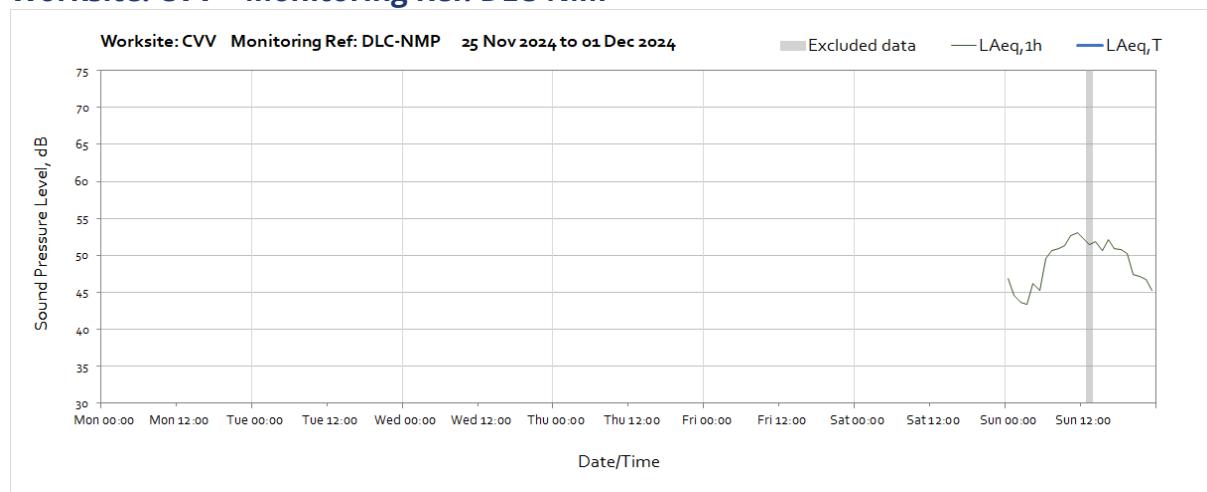
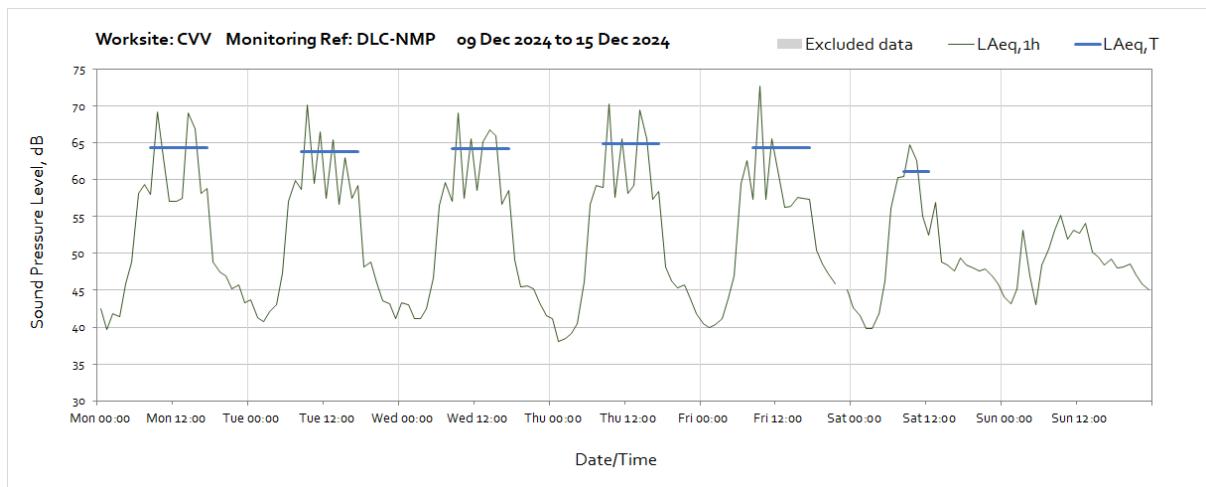
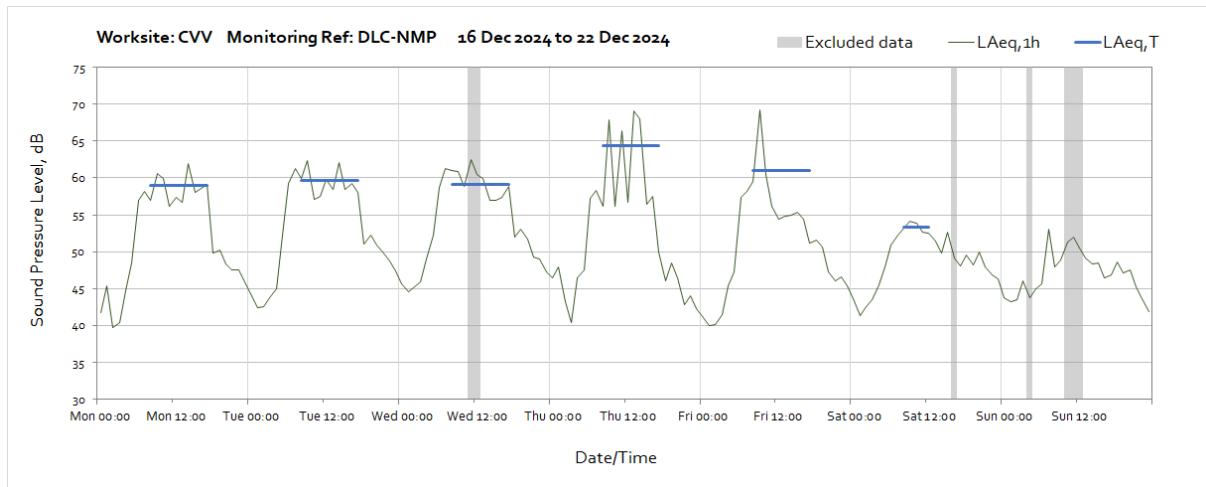
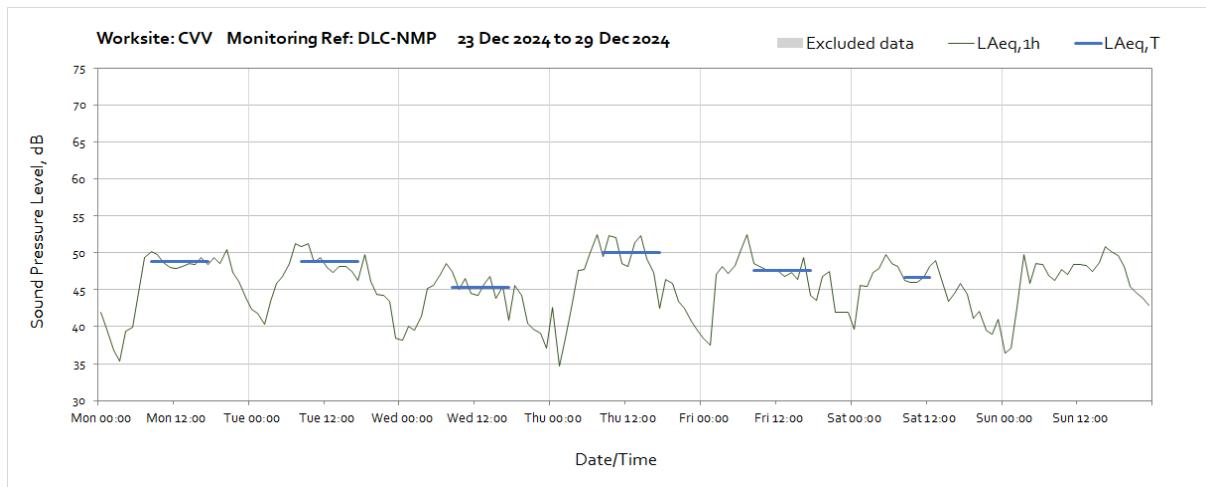
Worksite: CVV – Monitoring Ref: DLC-NMP

Note: Missing data between 22:00 and 23:00 on Friday 13th December was due to a transmission error at the monitoring station.

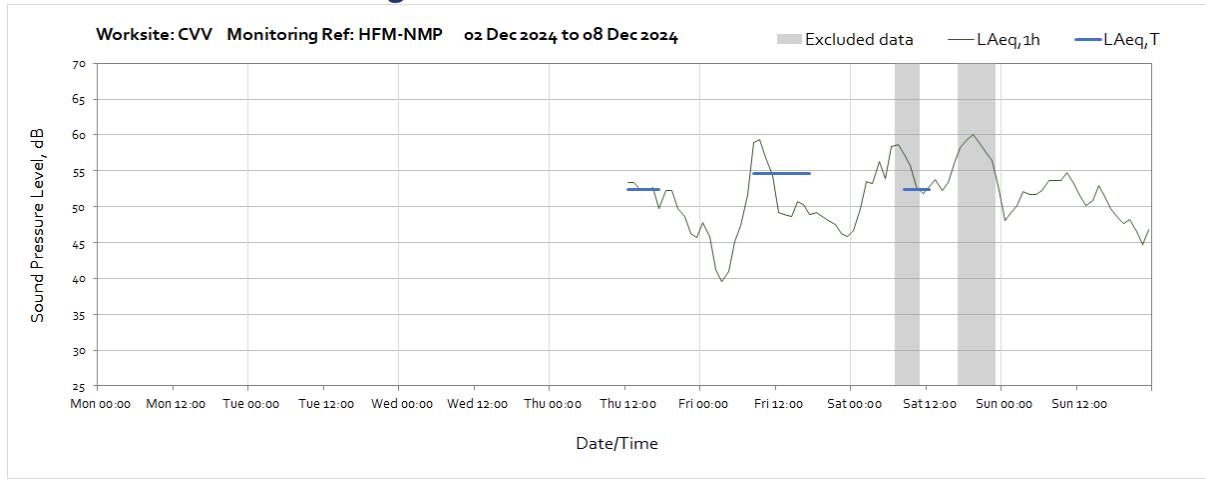
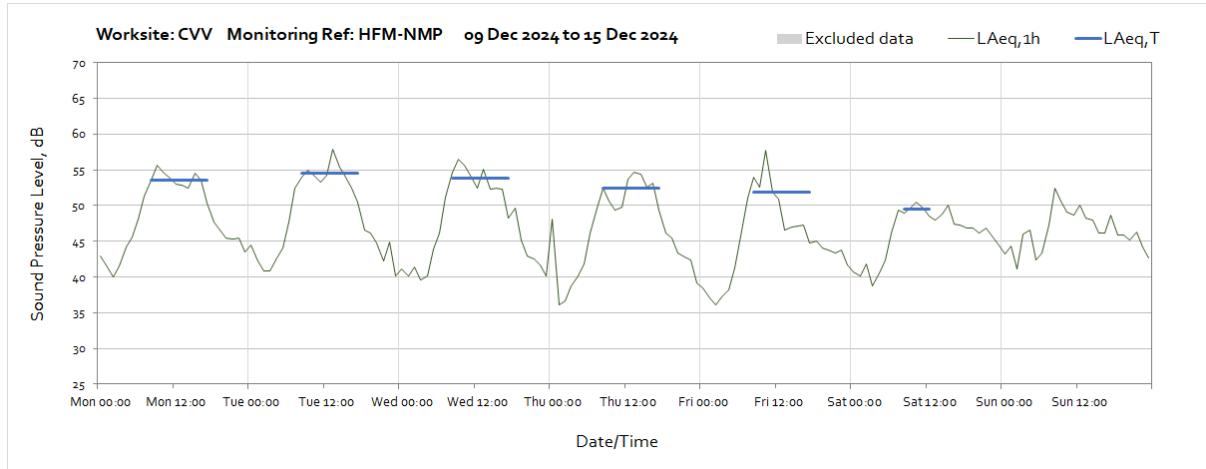
Worksite: CVV – Monitoring Ref: HFM-NMP

Note: Missing data between beginning of month and 12:00 on Thursday 5th December was due to a solar power issue at the monitoring station.

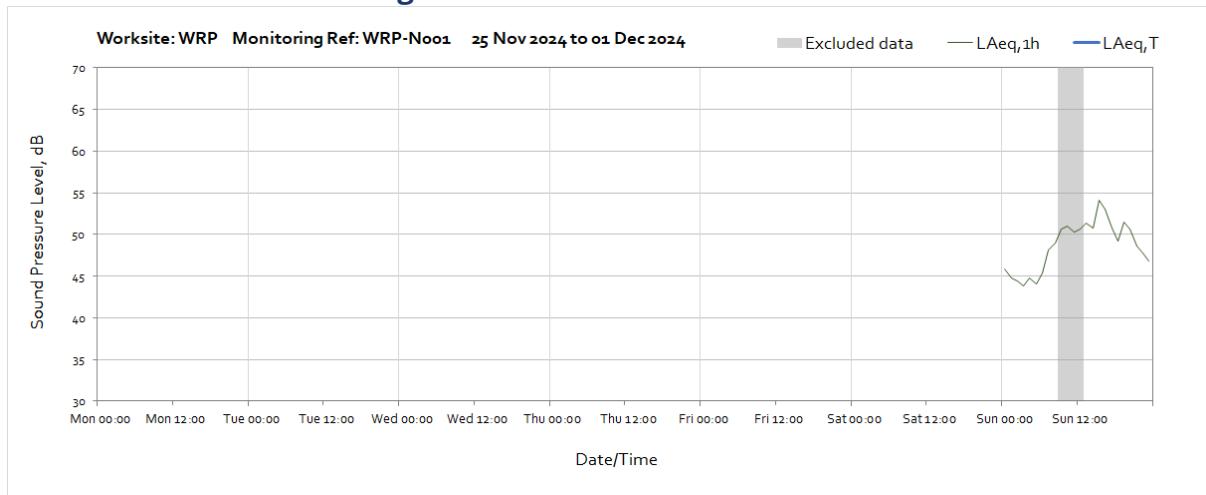
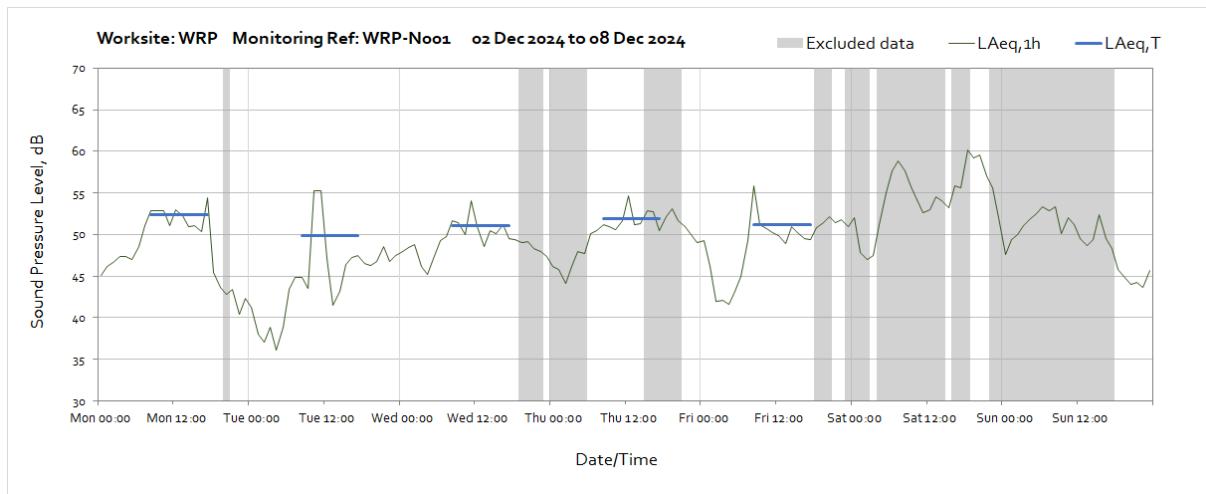
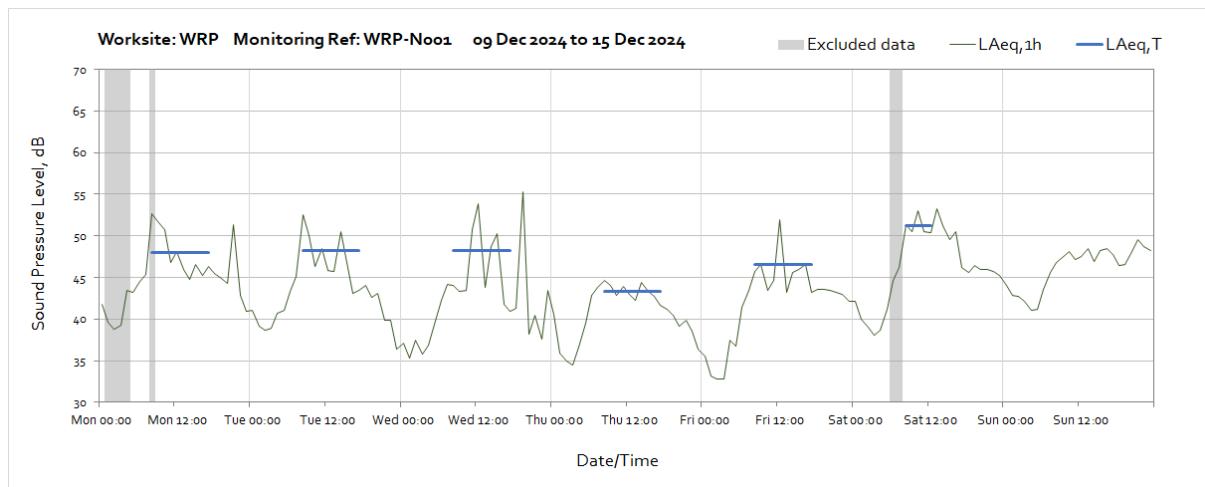
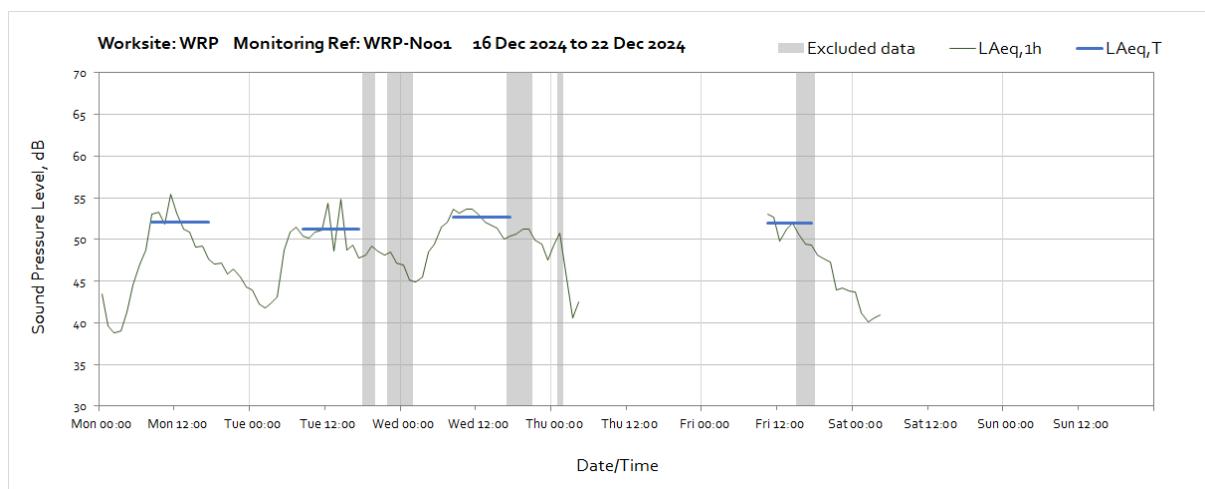
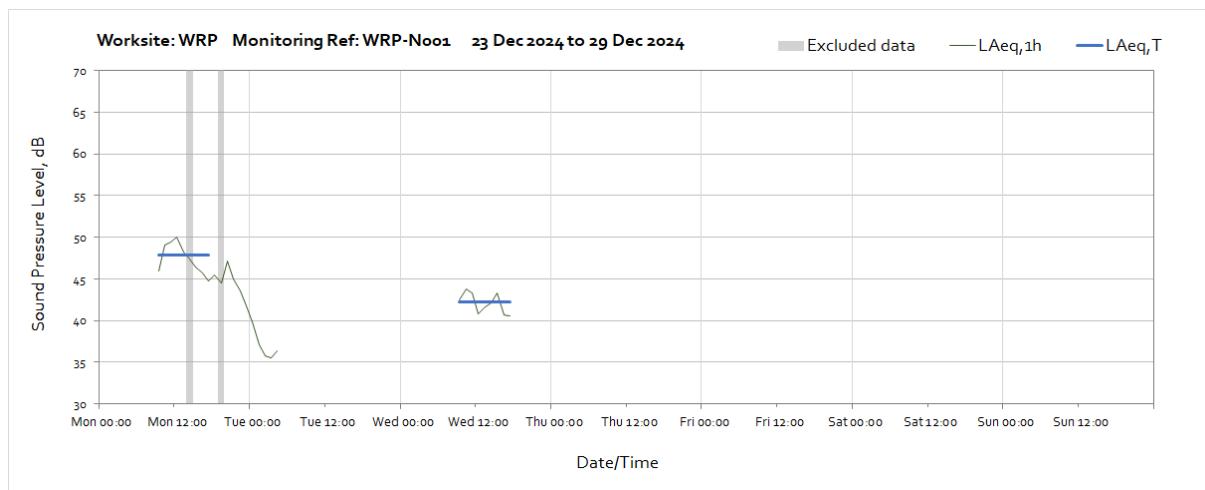
Worksite: WRP – Monitoring Ref: WRP-N001

Note: Missing data throughout the week was due to a depleted battery at the monitoring station.

Note: Missing data throughout the week and to the end of the month was due to a depleted battery at the monitoring station.

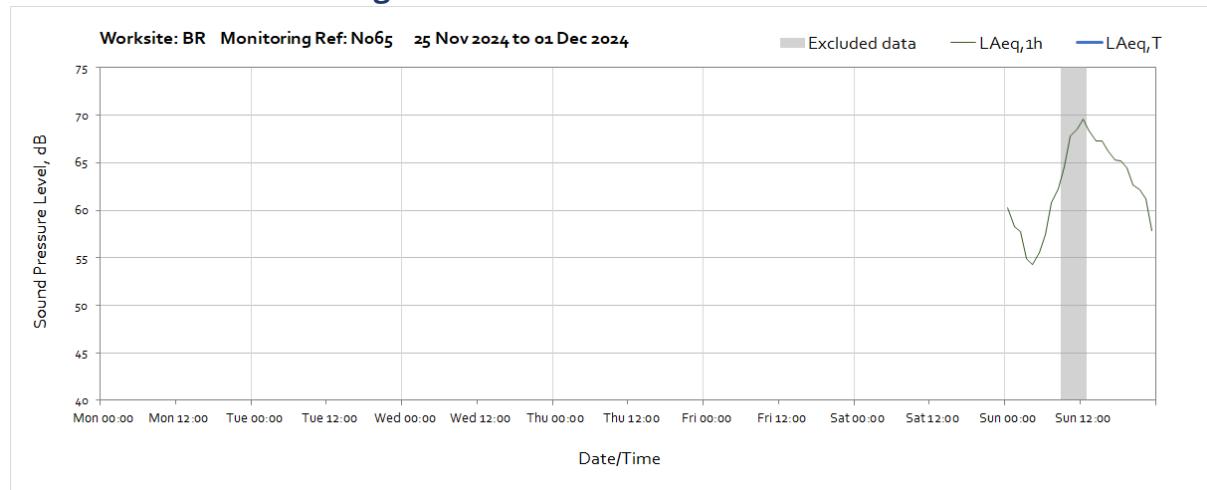
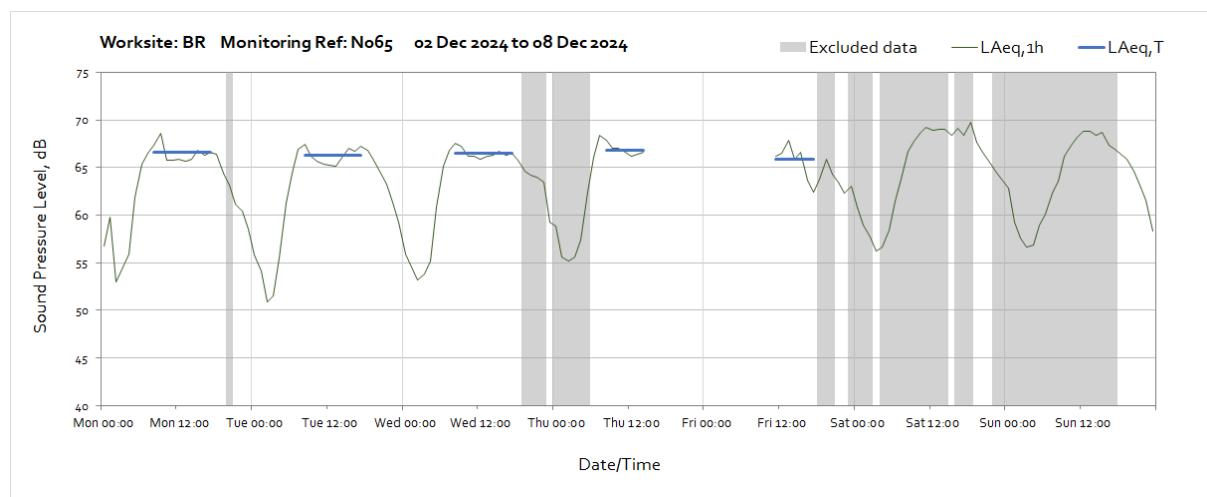
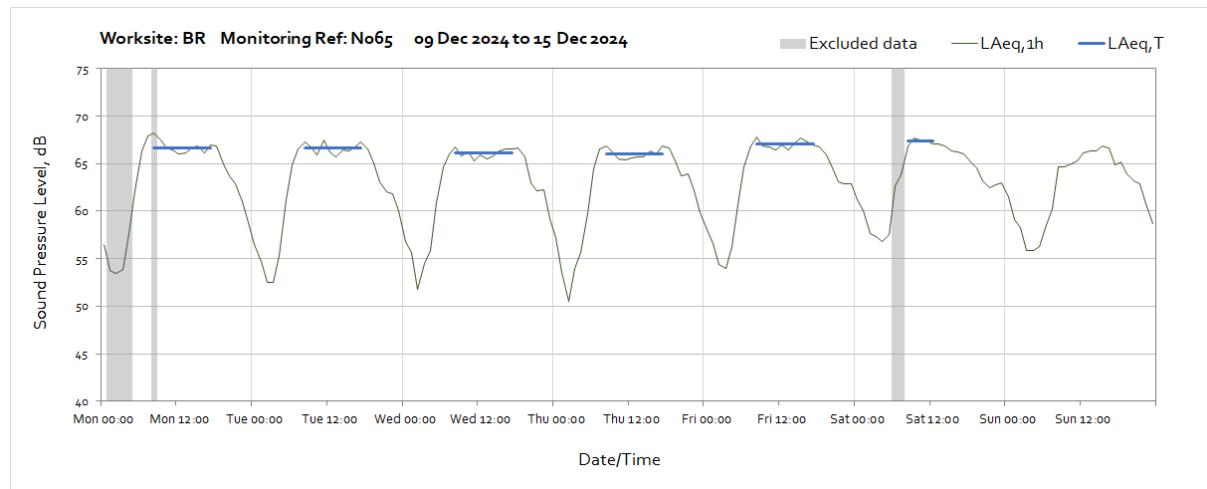
Worksite: BR – Monitoring Ref: N065

Note: Missing data between 15:00 on Thursday 5th December and 11:00 on Friday 6th December was due to a depleted battery at the monitoring station.

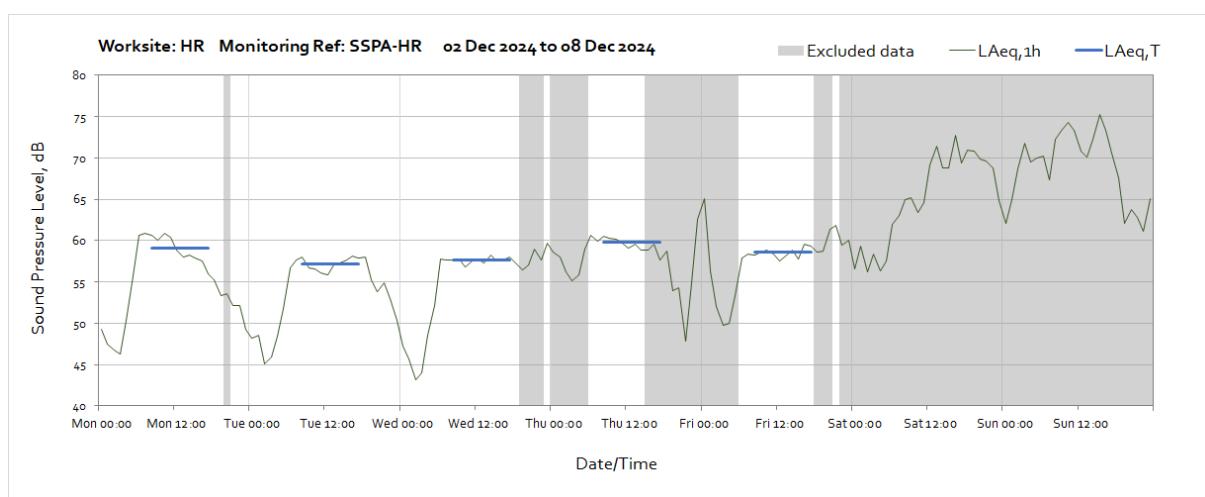
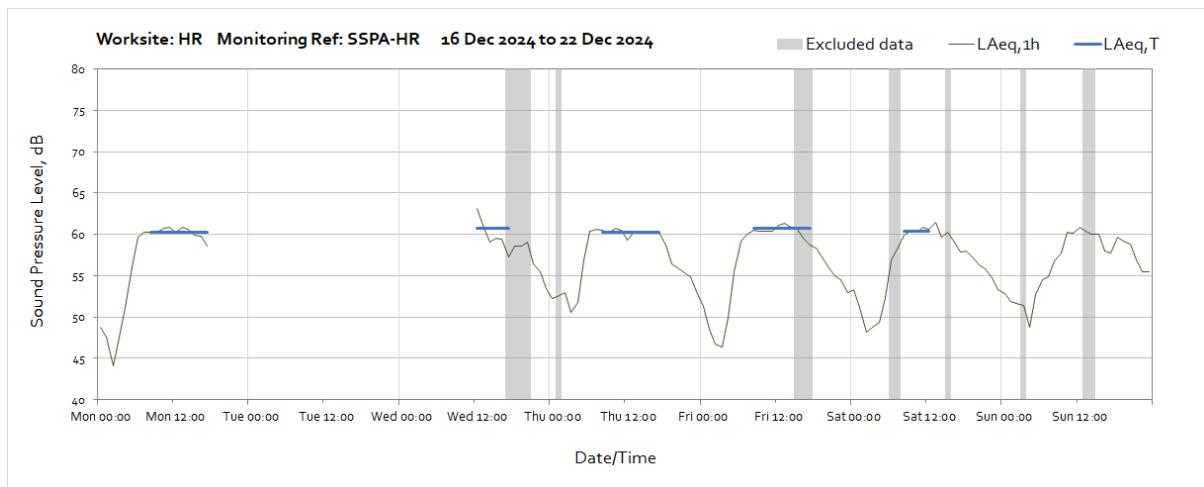
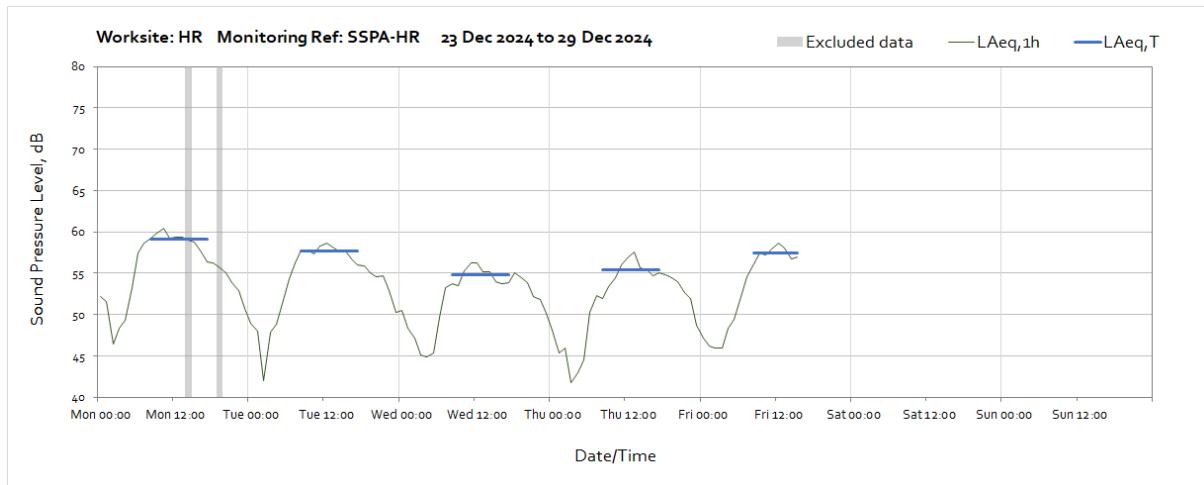
Worksite: HR – Monitoring Ref: SSPA-HR

Note: Missing data between 18:00 on Monday 16th December and 12:00 on Wednesday 18th December was due to a depleted battery at the monitoring station.

Note: Missing data between 16:00 on Friday 27th December and end of the month was due to a depleted battery at the monitoring station.

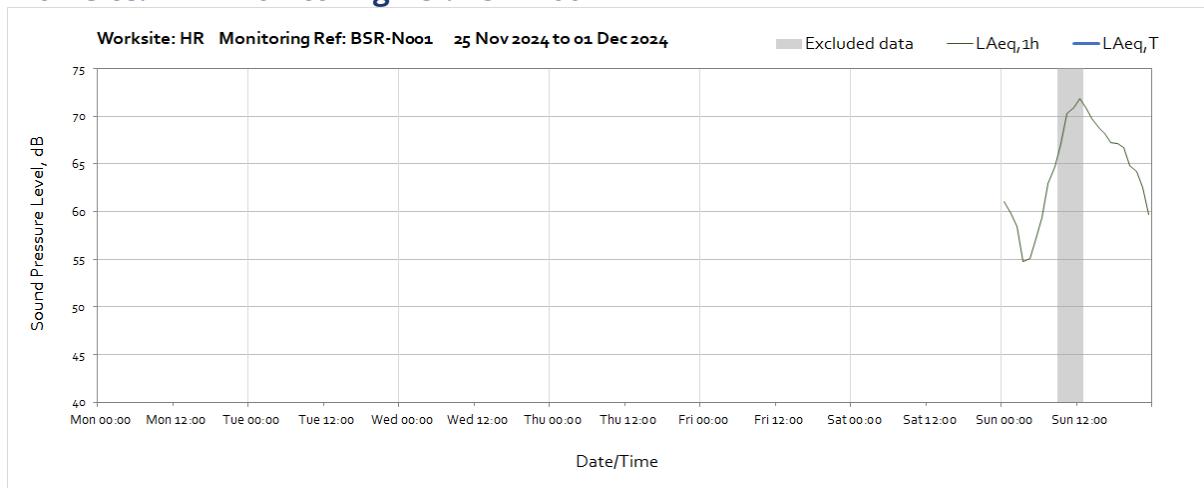
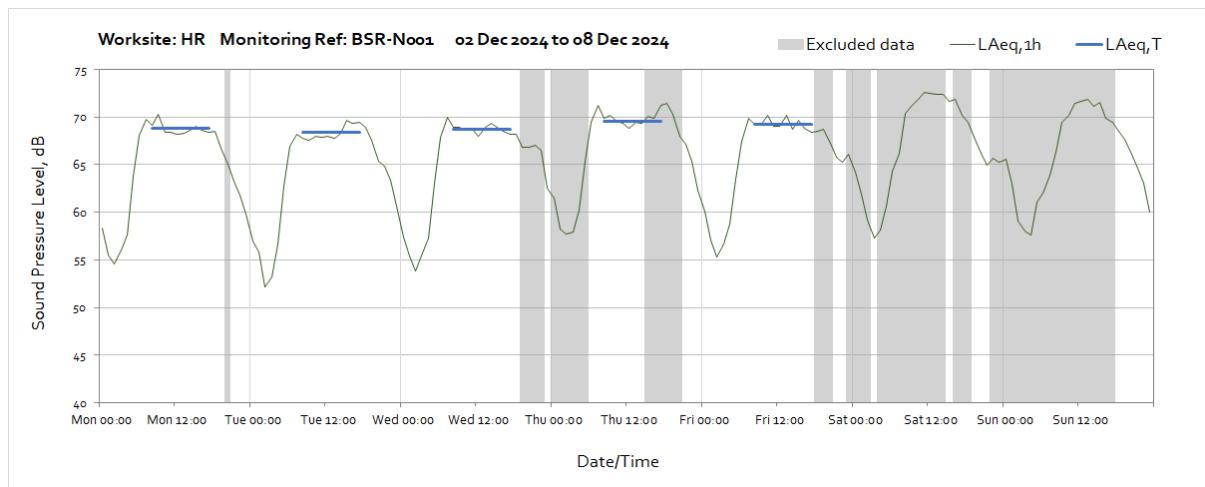
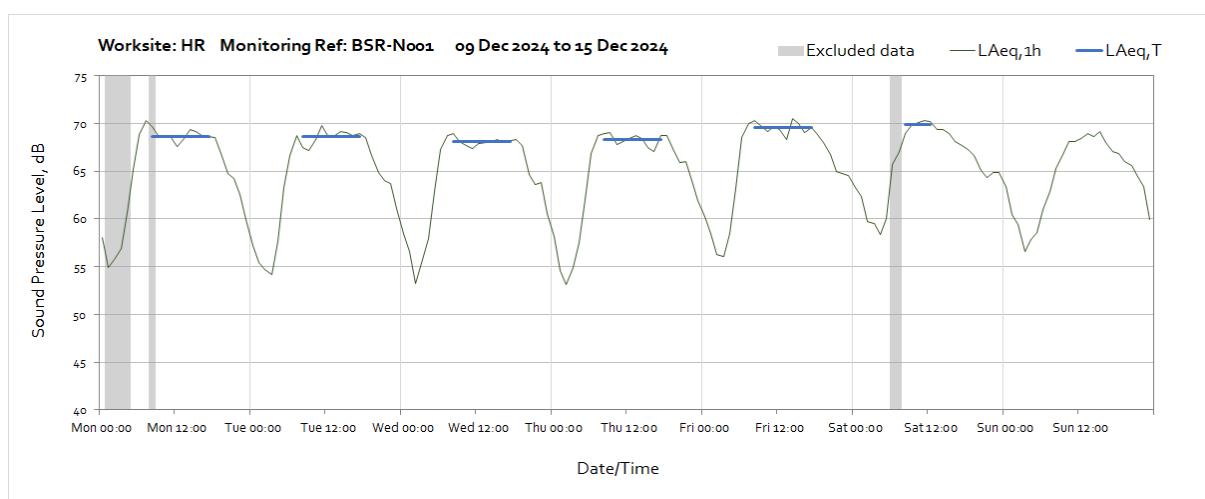
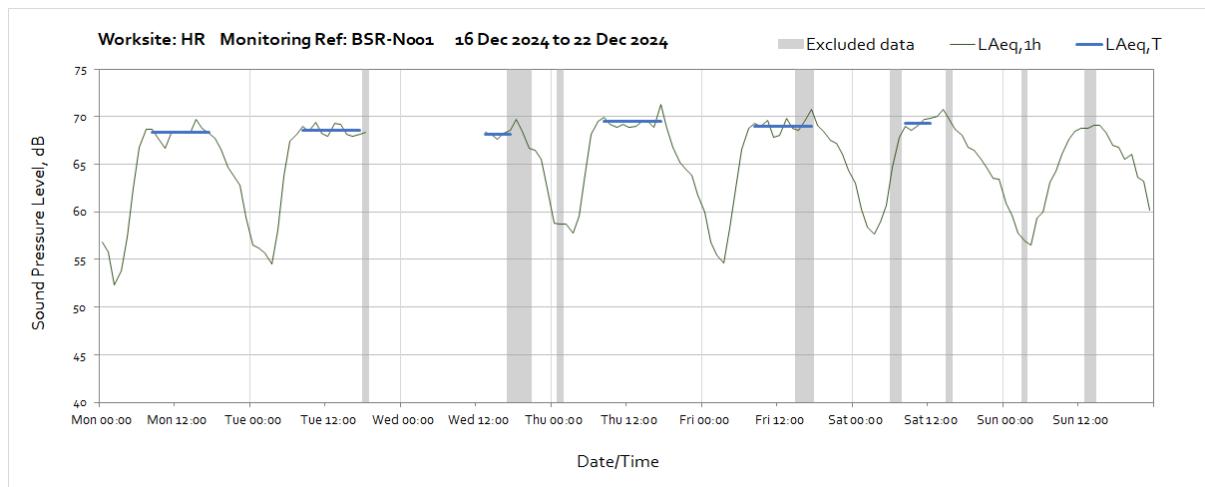
Worksite: HR – Monitoring Ref: BSR-N001

Note: Missing data between 19:00 on Tuesday 17th December and 13:00 on Wednesday 18th December was due to a depleted battery at the monitoring station.

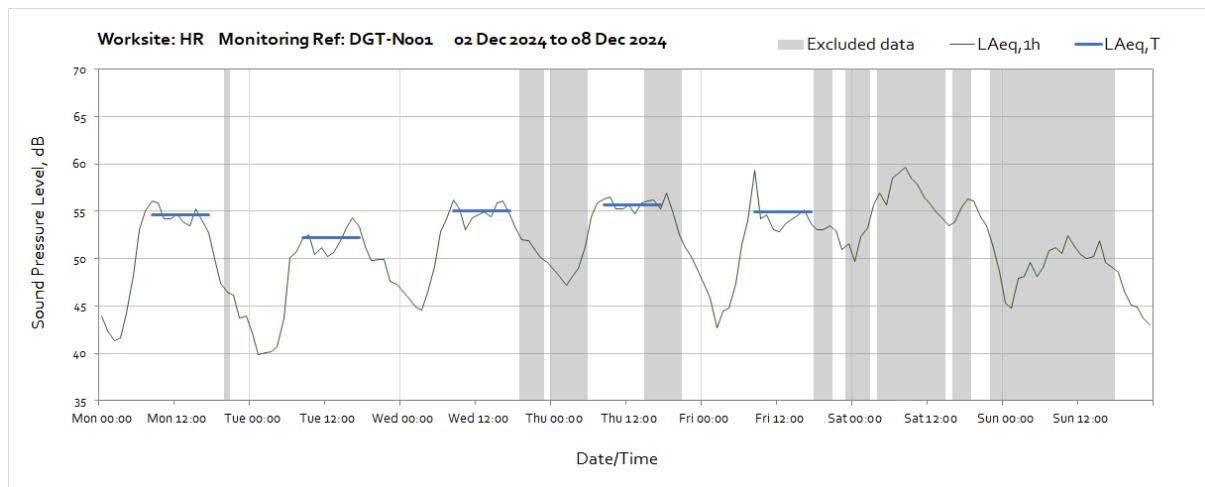
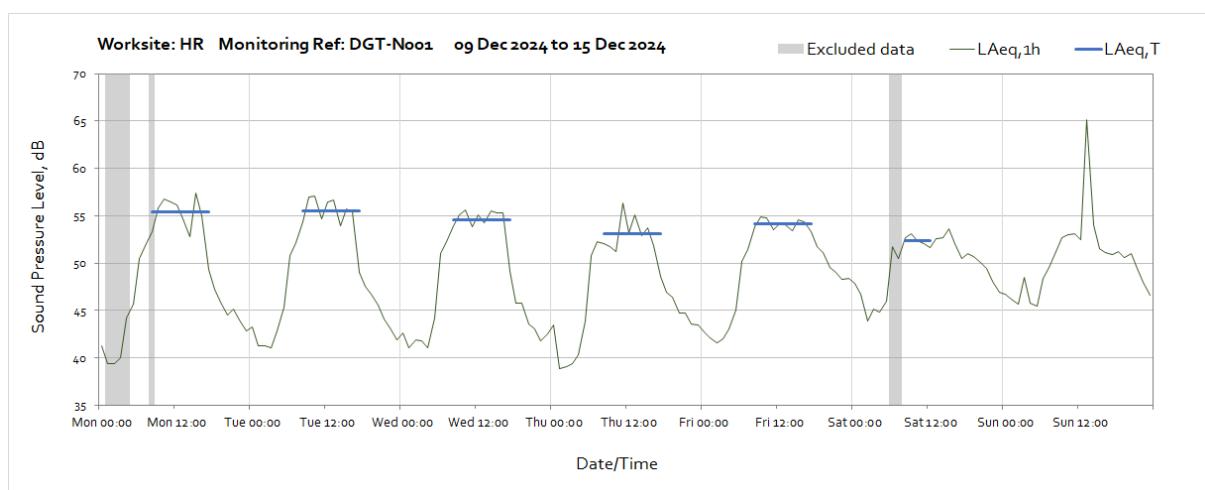
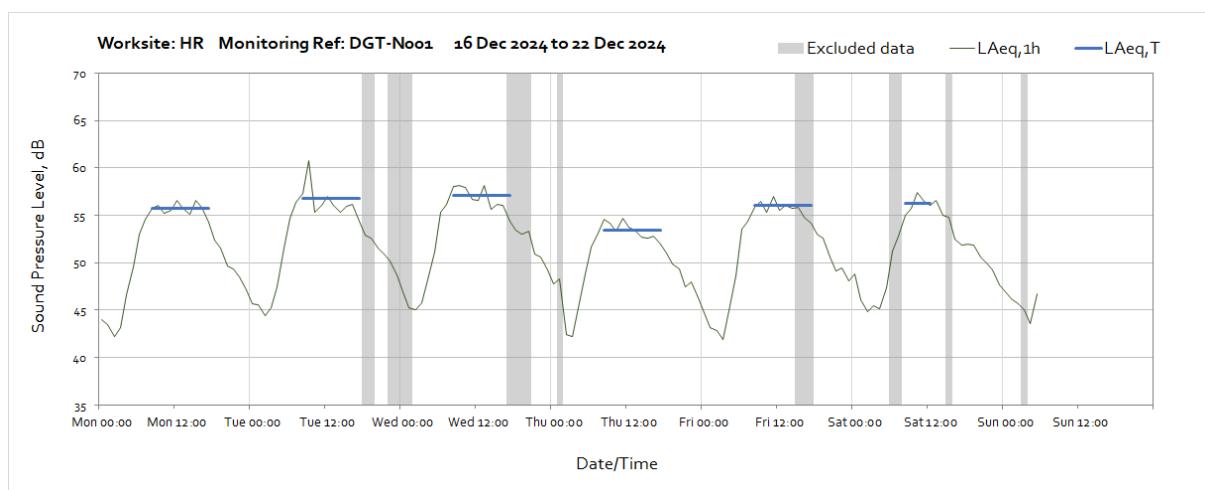
Worksite: HR – Monitoring Ref: DGT-N001

Note: Missing data between 06:00 on Sunday 22nd December and the end of the month was due to a depleted battery at the monitoring station.

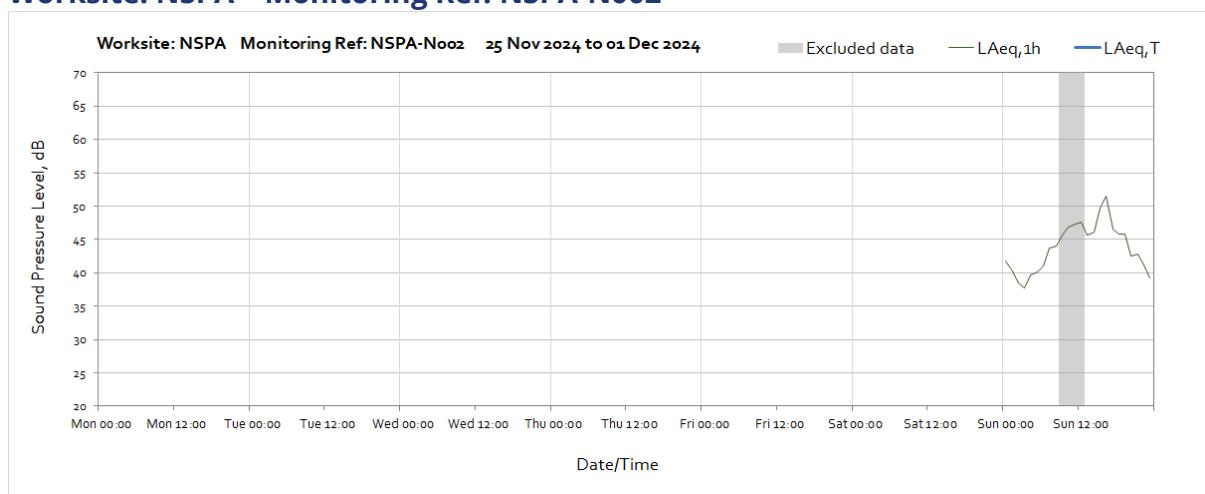
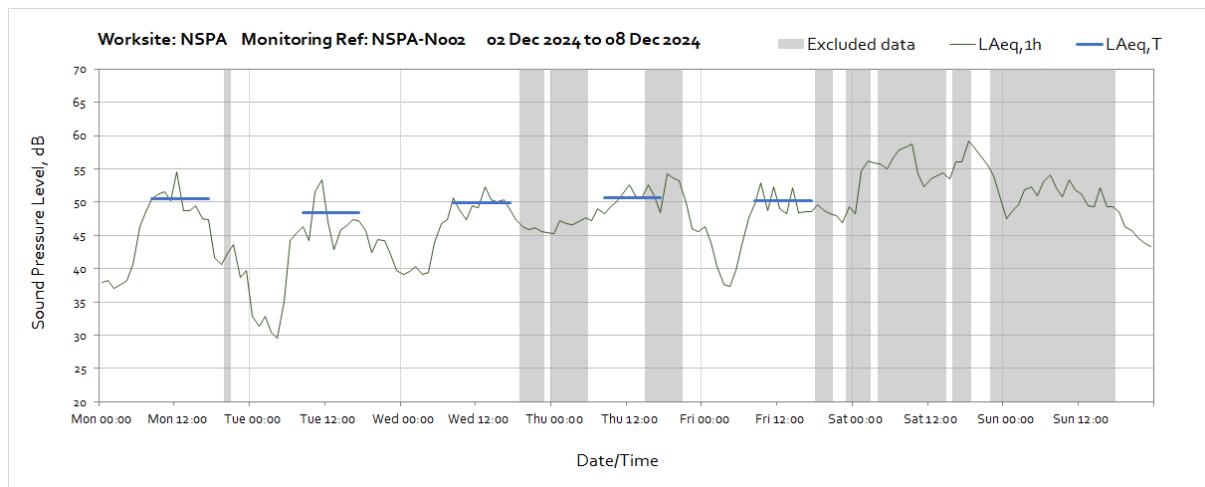
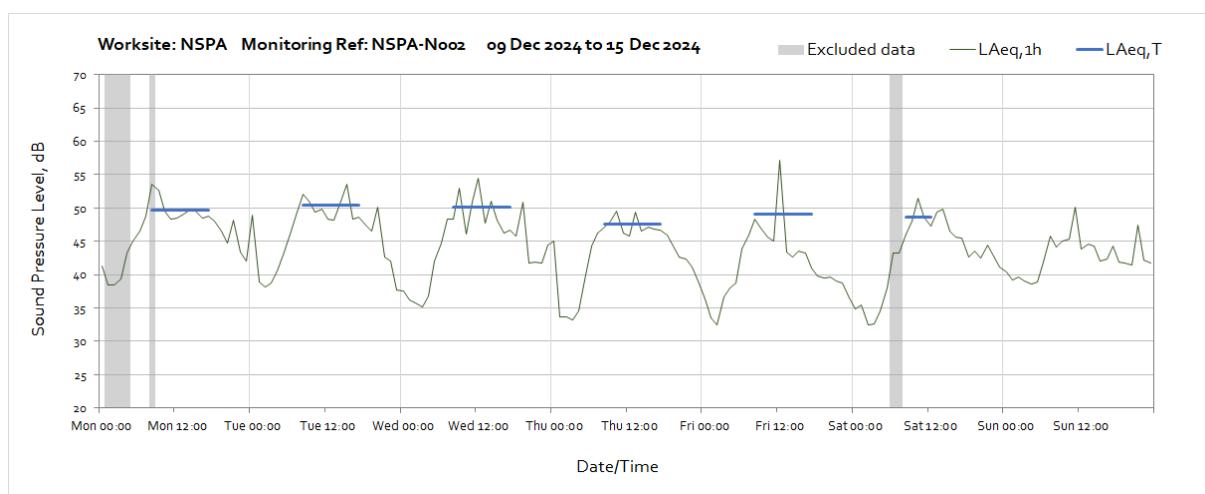
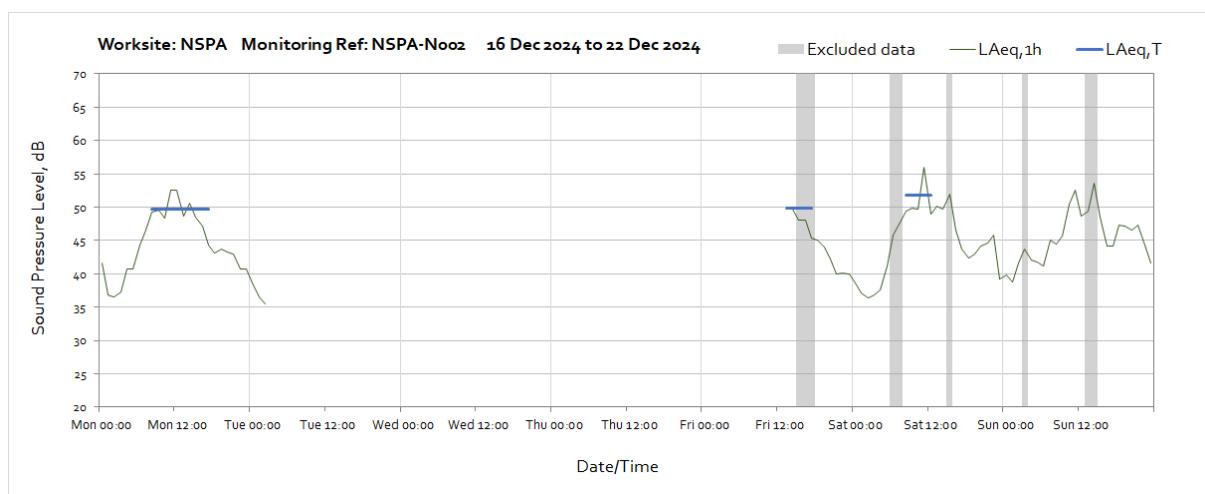
Worksite: NSPA - Monitoring Ref: NSPA-N002

Note: Missing data between 03:00 on Tuesday 17th December and 13:00 on Friday 20th December was due to a depleted battery at the monitoring station.

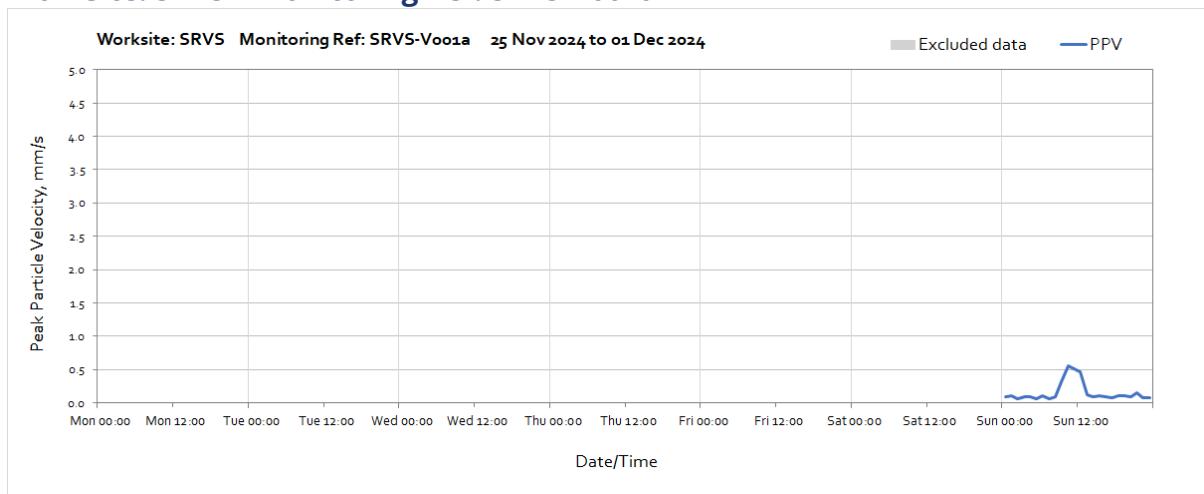
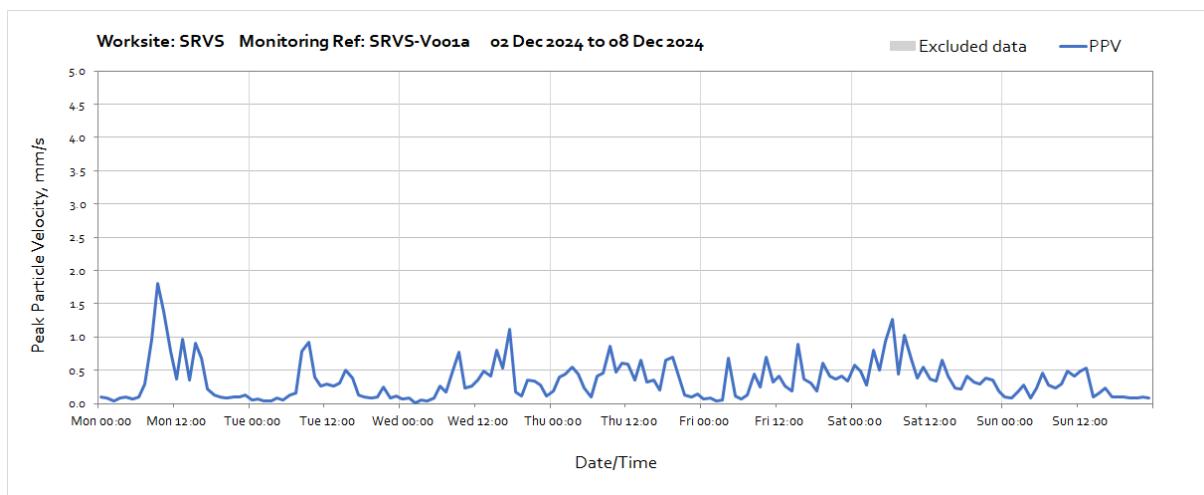
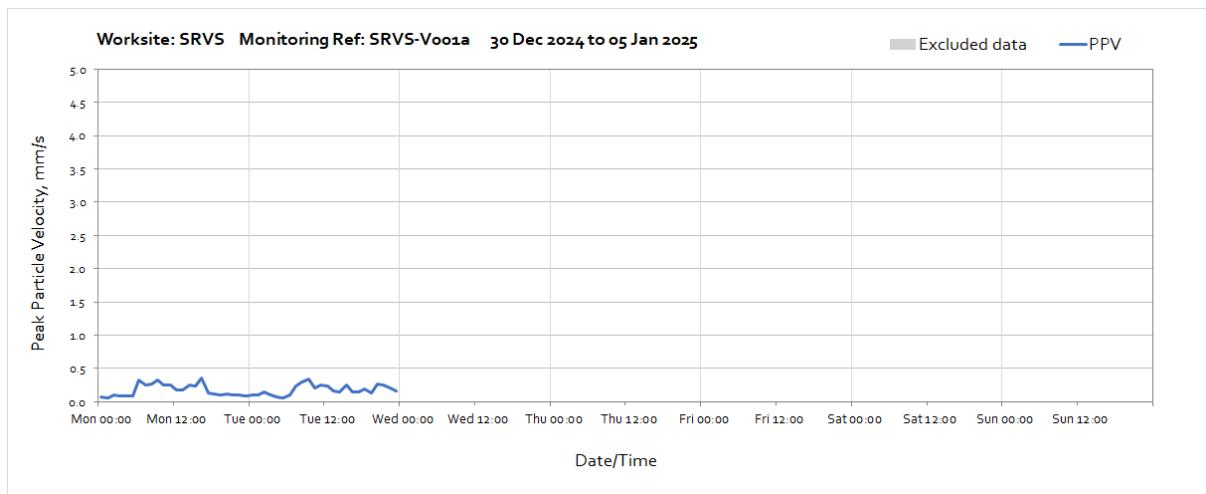
Worksite: SRVS – Monitoring Ref: SRVS-V001a

The following graphs show the hourly measured peak particle velocity PPV recorded during the monitoring period. The graphs show the highest PPV of the three orthogonal axis x, y, and z. Periods where PPV values have been affected by local interference with the vibration monitor or only measured for part of the period, which are not representative of HS2 construction works, have been greyed out and excluded when calculating values in Table 4 of the main report.

Worksite Reference	Measurement Reference	Monitor Address	Highest PPV measured in any axis, mm/s
WRP	GW-V001	95 The Greenway, Ickenham, Uxbridge	0.31 (Z-axis)
SRVS	SRVS-V001a	Braintree Road, Ruislip	2.11 (Z-axis)
