Construction Noise and Vibration Monthly Report – December 2024

Stratford-on-Avon District Council

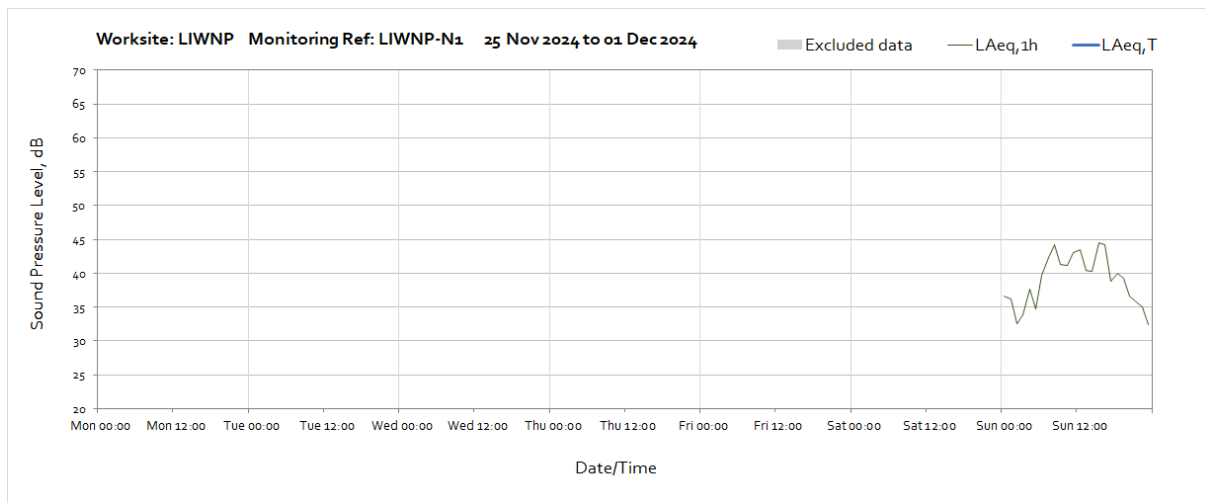
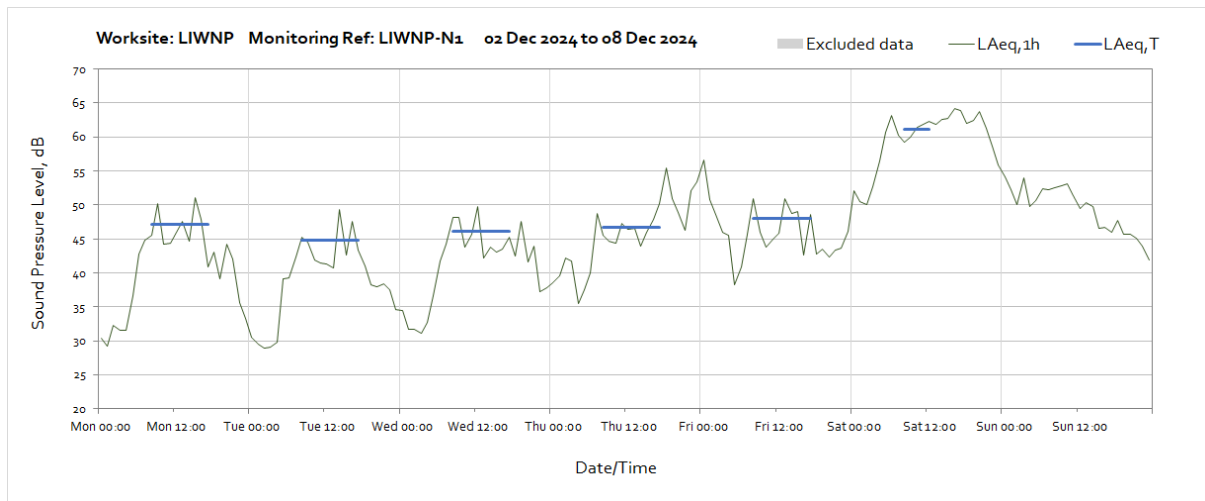
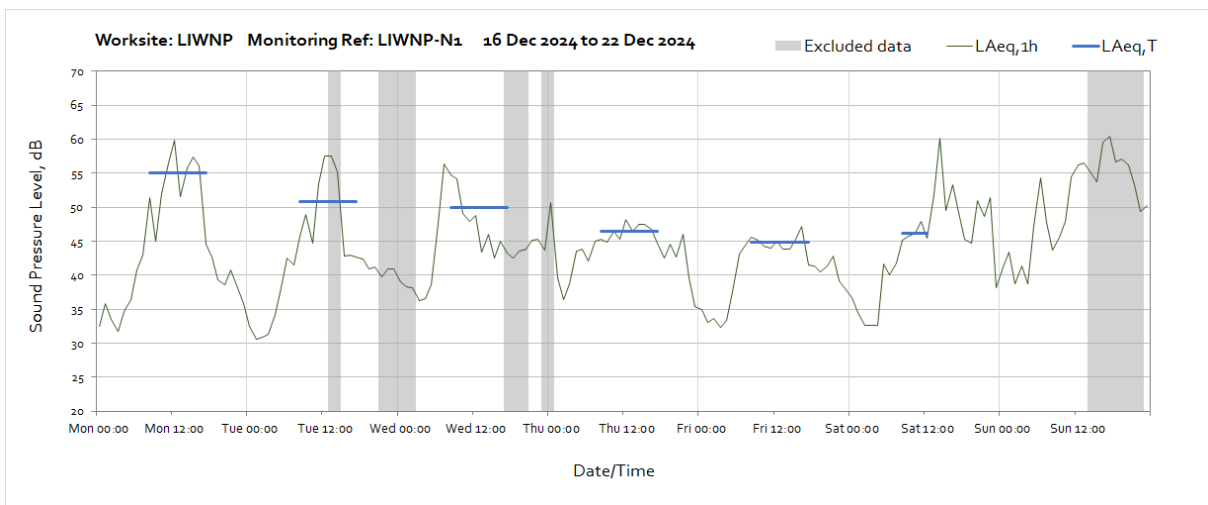
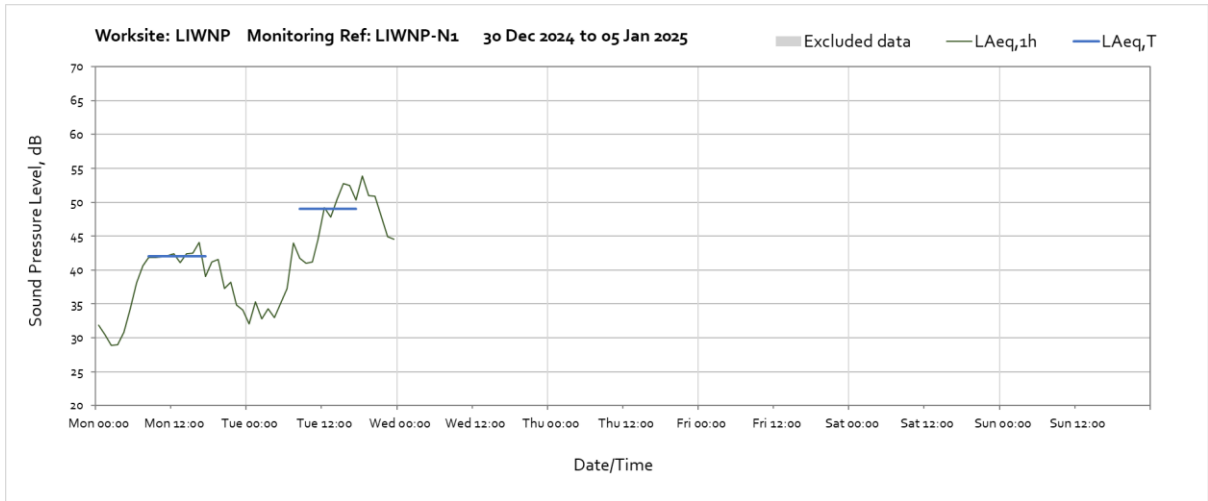
Worksite: LIWNP Monitoring Ref: LIWNP-N1

The following graphs show the hourly measured ambient noise level $L_{Aeq,1h}$ and, where relevant, the averaged noise level $L_{Aeq,T}$ values, where the time period T is as specified in Table 1 of HS2 Information Paper E23. Periods where noise levels are adversely affected by weather or only measured for part of the period, which are not representative of HS2 construction works, have been greyed out and excluded from the calculation of the $L_{Aeq,T}$ values in Table 3 of the main report.

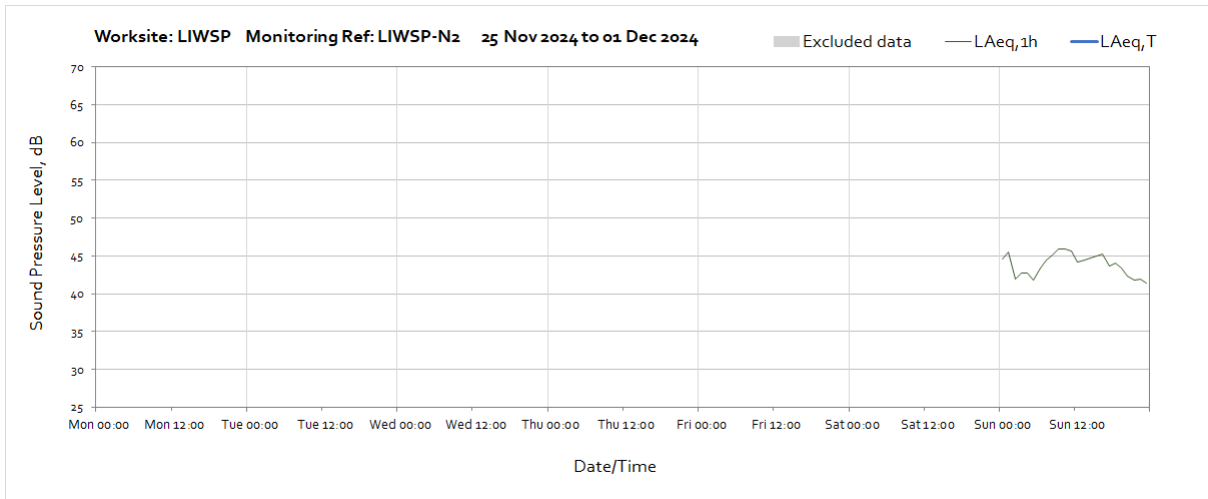
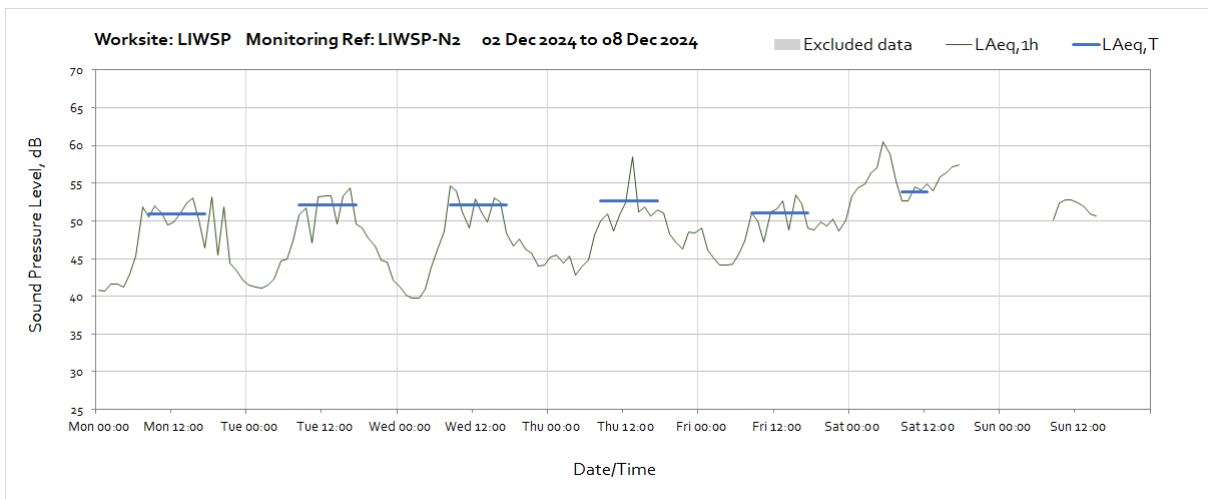
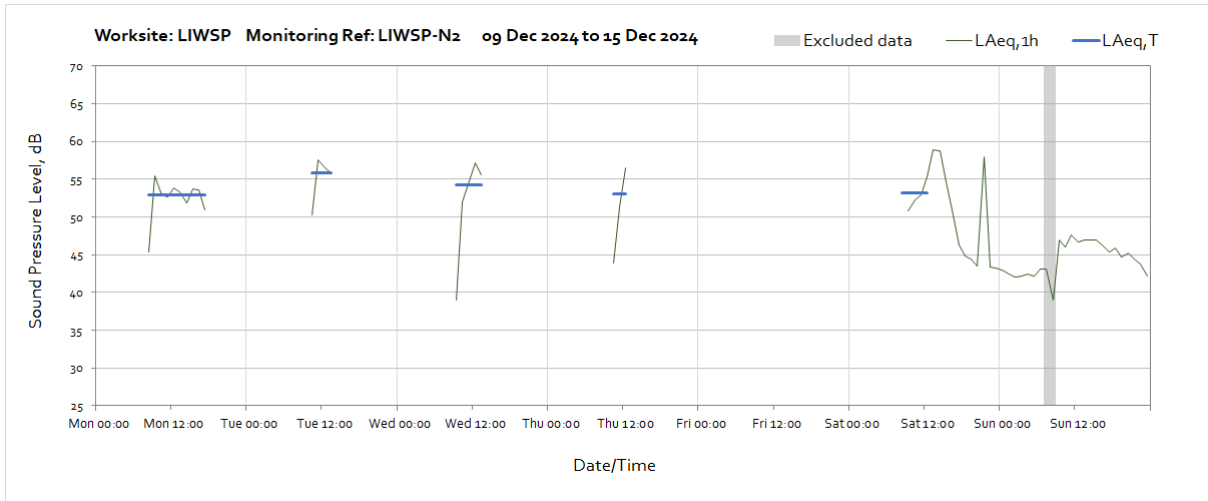
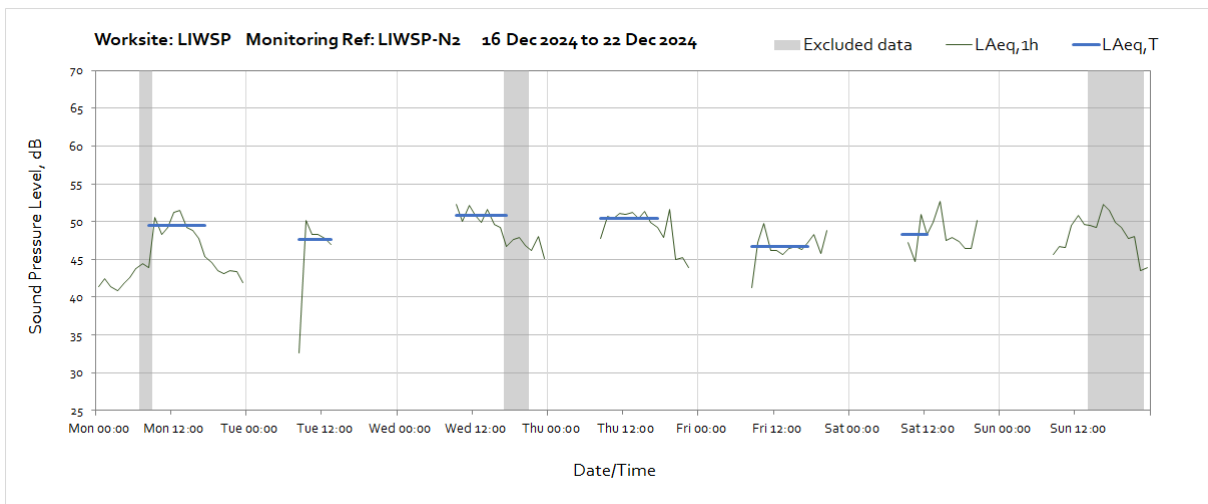
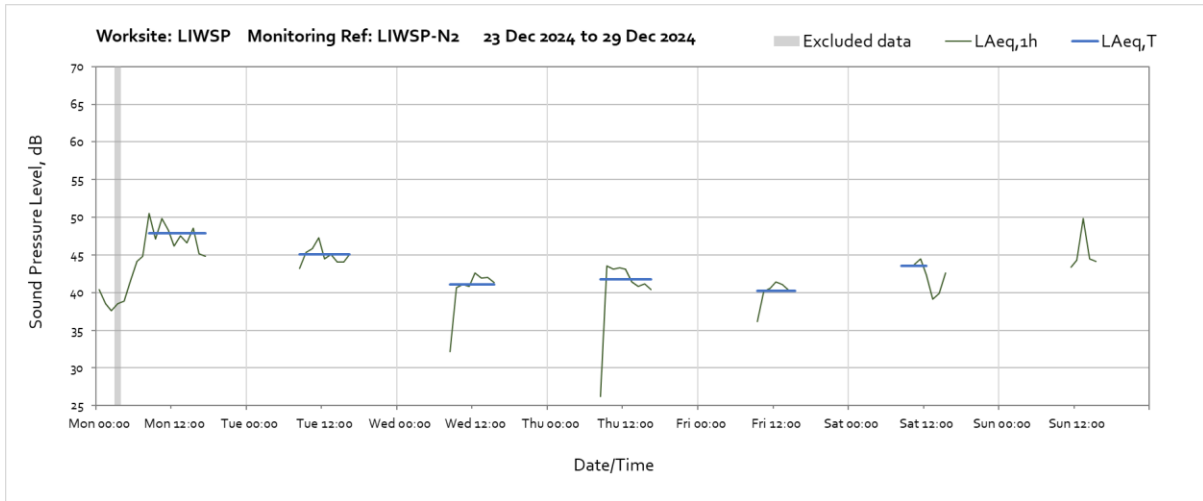
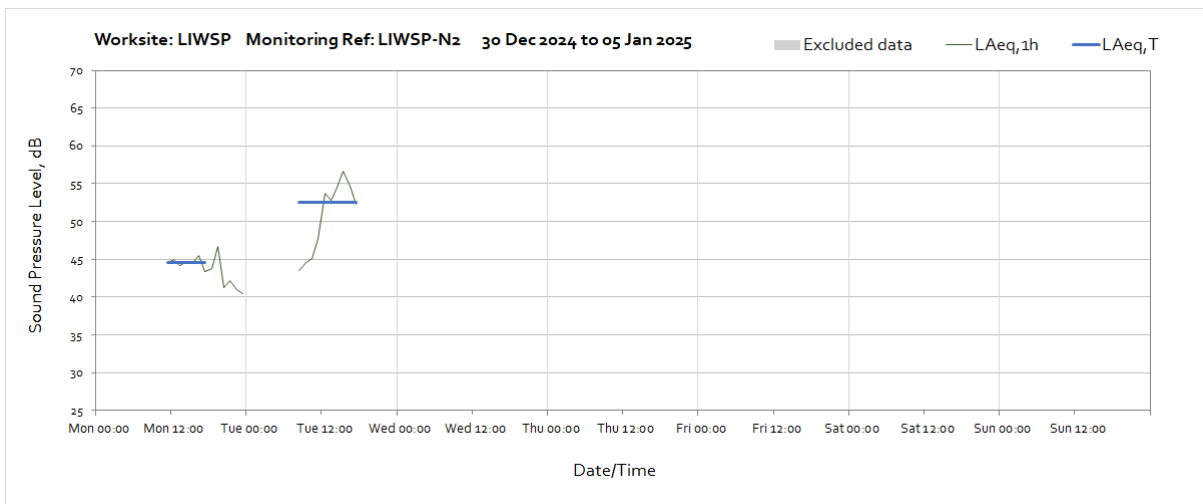
Worksite: LIWSP Monitoring Ref: LIWSP-N2

Note: Missing data throughout the month was due to a loss of power to the monitoring station caused by poor solar conditions.

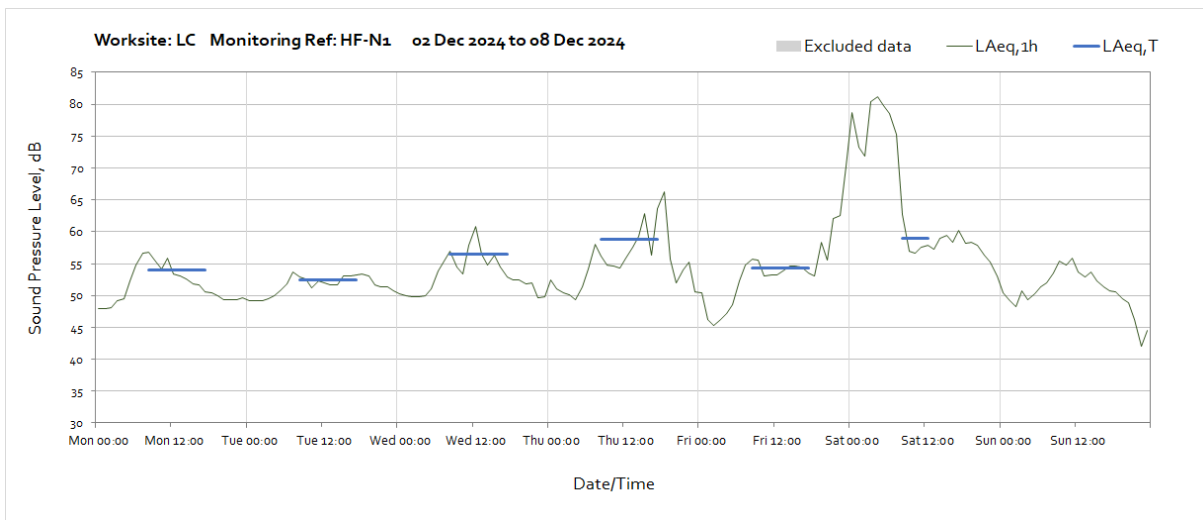
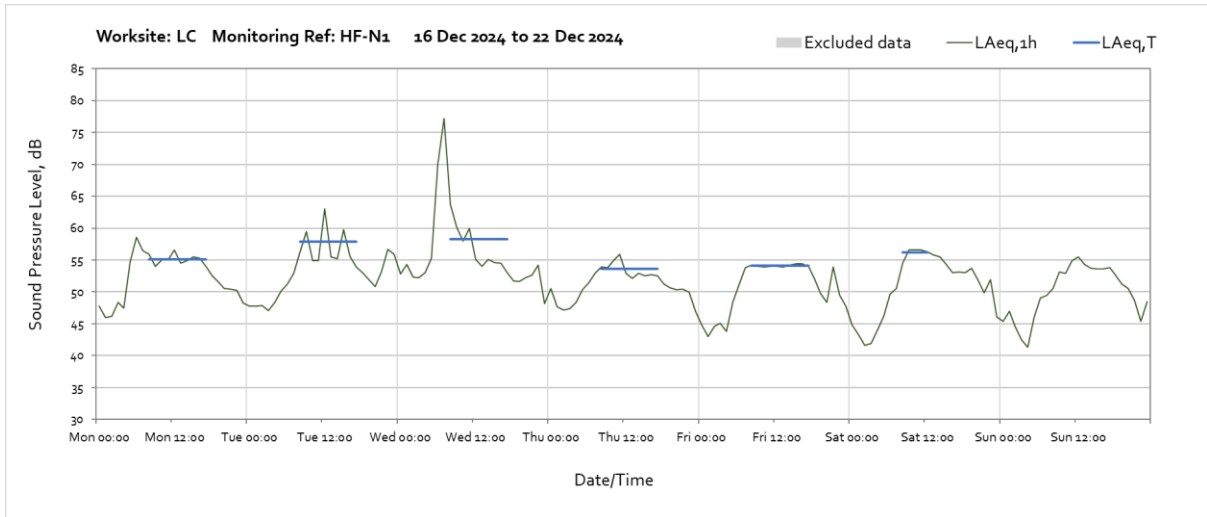
Worksite: LC Monitoring Ref: HF-N1

Note: Missing data from 03:00 on Monday 23rd December until the end of the month was due to a depleted battery at the monitoring station.

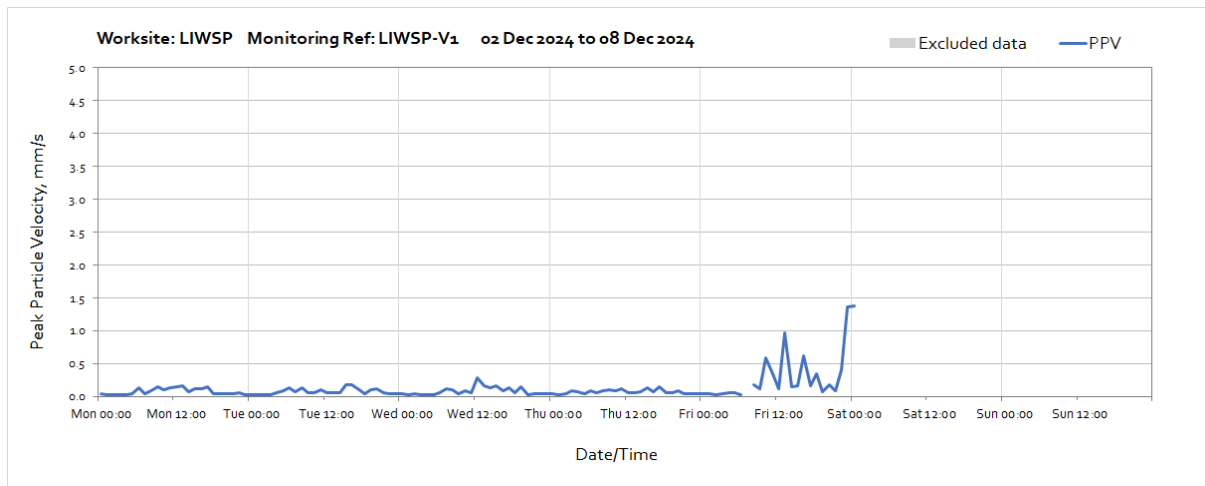
Worksite: LIWSP Monitoring Ref: LIWSP-V1

The following graphs show the hourly measured peak particle velocity PPV recorded during the monitoring period. The graphs show the highest PPV of the three orthogonal axes x, y and z. Periods where PPV values have been affected by local interference with the vibration monitor or only measured for part of the period, which are not representative of HS2 construction works, have been greyed out and excluded when calculating values in Table 4 of the main report.

Note: Missing data between 07:00 and 08:00 on Friday 6th December and from 01:00 on Saturday 7th December until the month was due to a loss of power to the monitoring station caused by poor solar conditions.
