Construction noise and vibration Monthly Report – January 2025

London Borough of Hillingdon

Non-Technical Summary

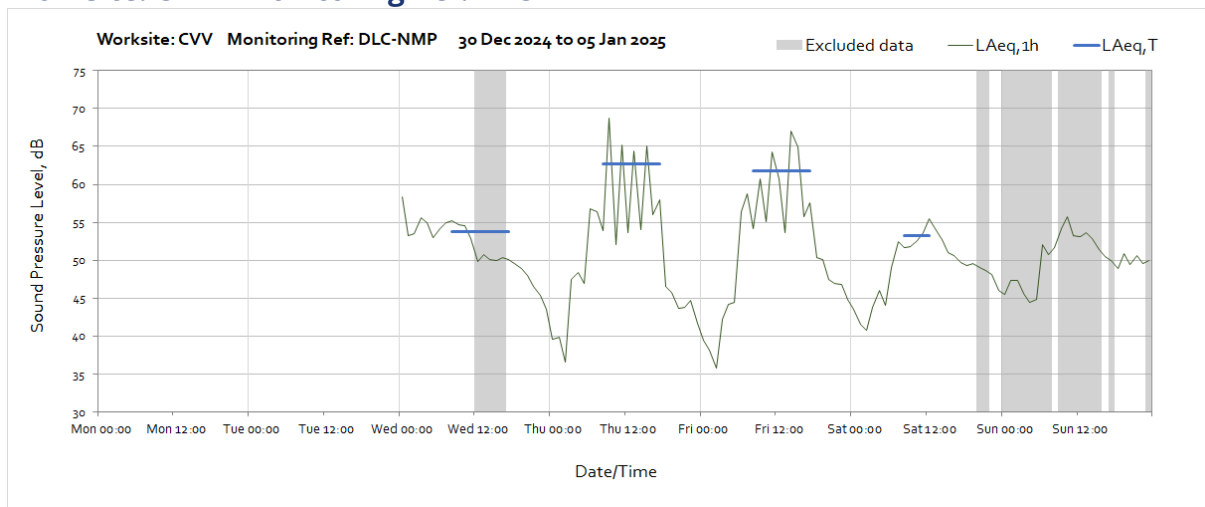
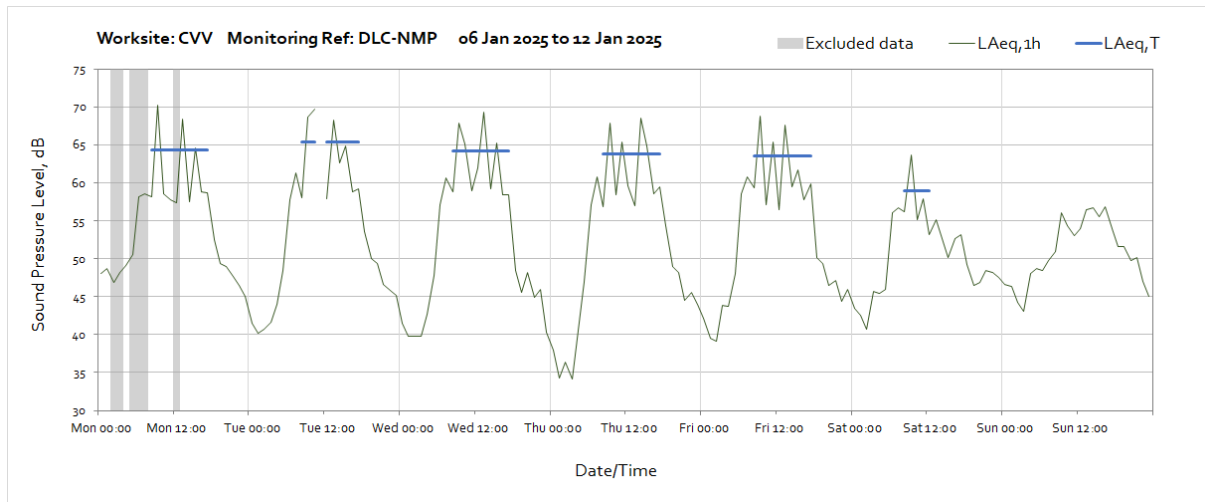
Worksite: CVV - Monitoring Ref: DLC-NMP

Note: Missing data between 11:00 and 12:00 on Tuesday 7th January was due to monitor field calibration.

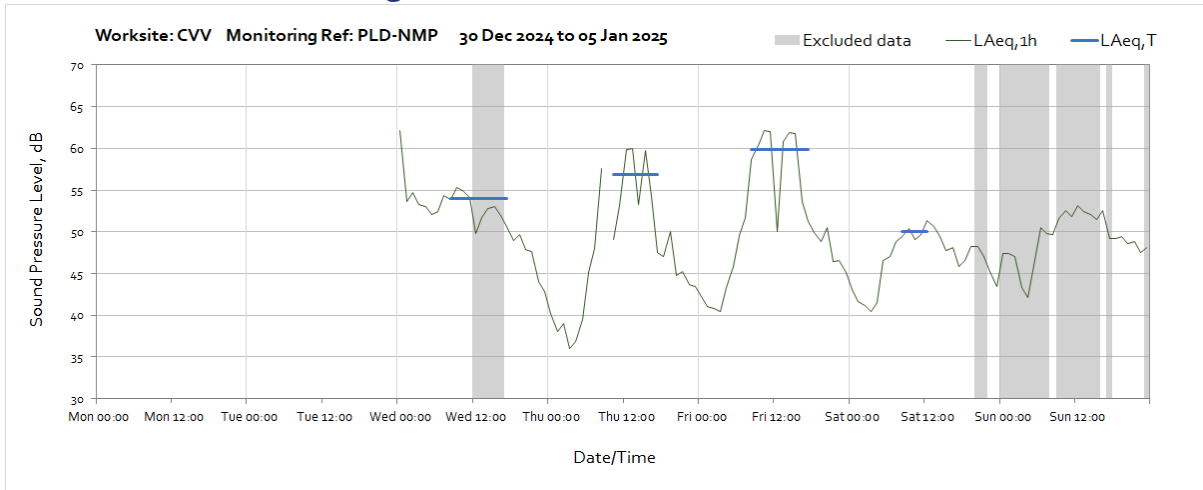
Worksite: CVV – Monitoring Ref: PLD-NMP

Note: Missing data between 09:00 and 10:00 on Thursday 2nd January was due to a transmission error.

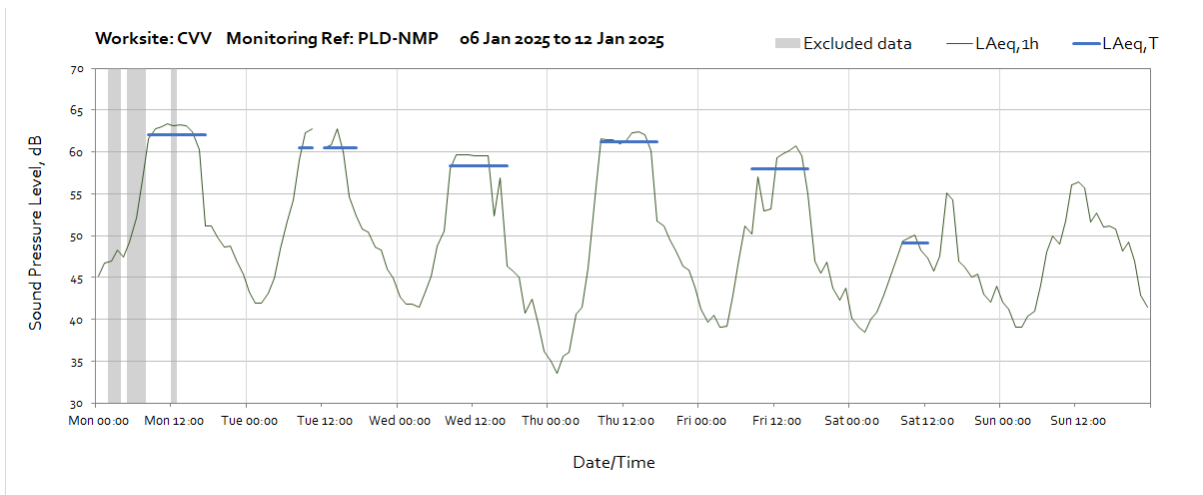
Note: Missing data between 11:00 and 12:00 on Tuesday 7th January was due to monitor field calibration.

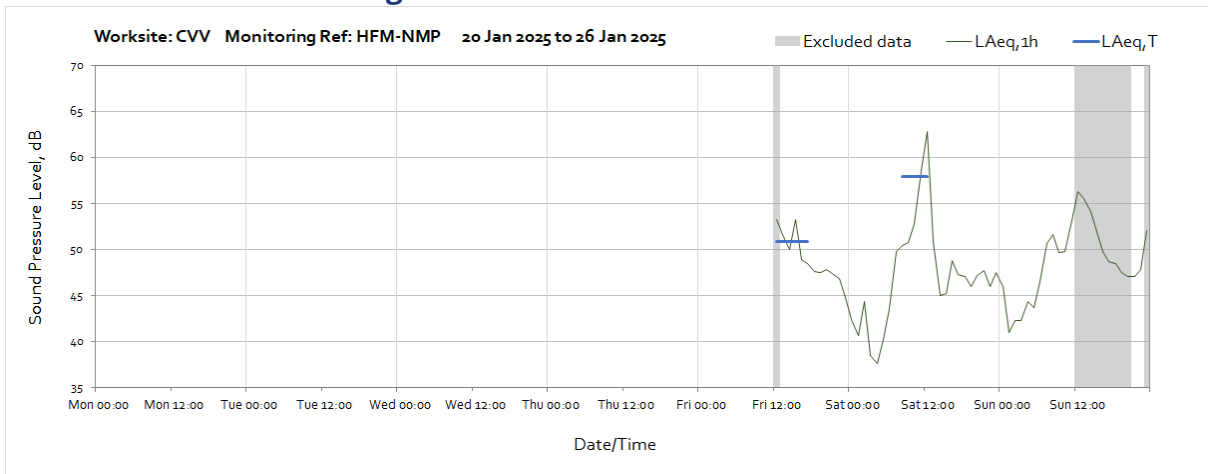
Worksite: CVV – Monitoring Ref: HFM-NMP

Note: Missing data from the beginning of the month until 12:00 on Friday 24th January was due to a loss of power to the monitoring station caused by poor weather conditions preventing sufficient light to reach the solar panel.

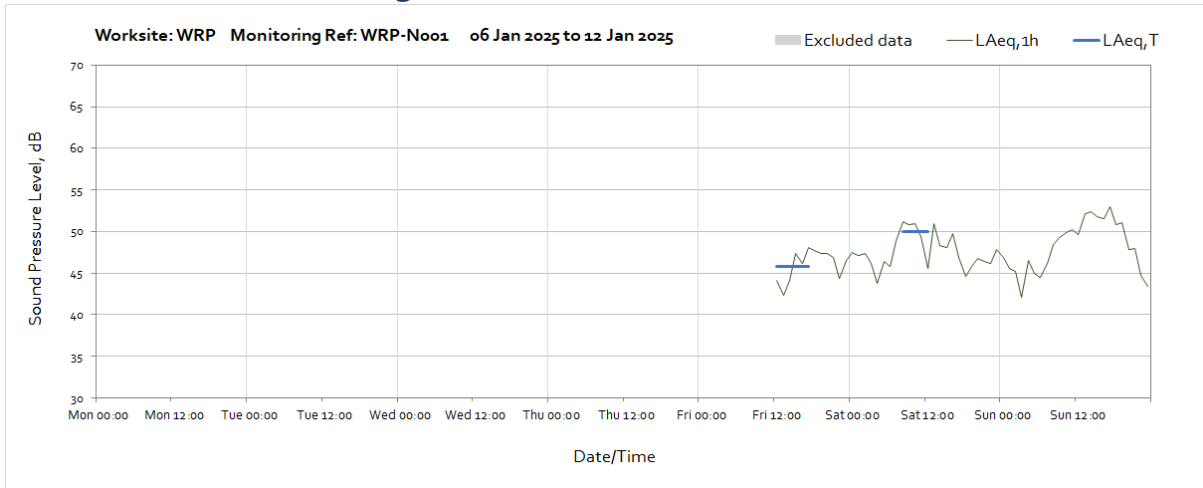
Worksite: WRP – Monitoring Ref: WRP-N001

Note: Missing data from the beginning of the month until 12:00 on Friday 10th January was due to a depleted battery at the monitoring station.

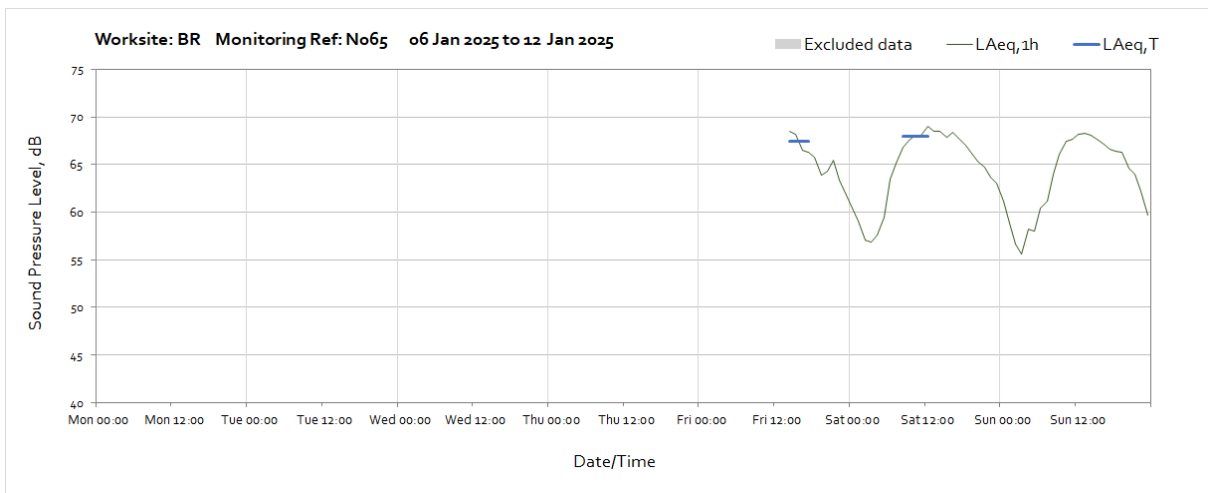
Note: Missing data between 17:00 on Thursday 2nd January and 14:00 on Friday 10th January was due to a depleted battery at the monitoring station.

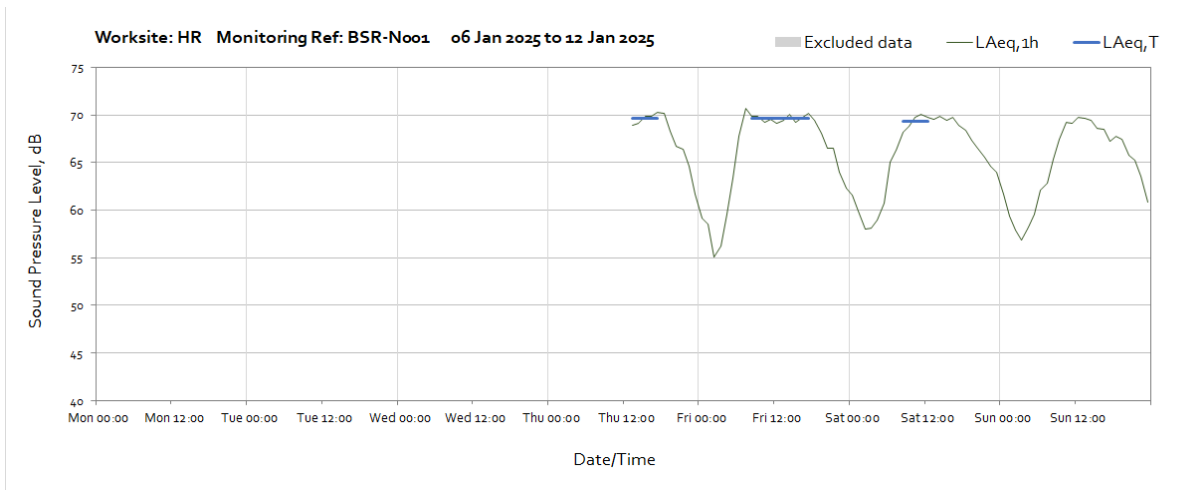
Note: Missing data between 02:00 on Friday 3rd January and 13:00 on Thursday 9th January was due to a depleted battery at the monitoring station.

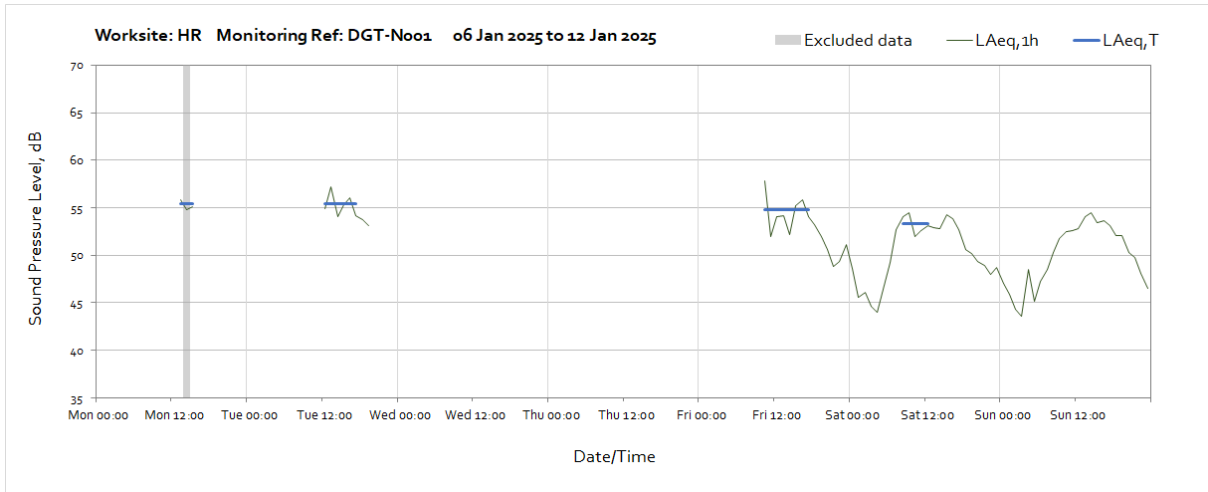
Note: Missing data throughout the week was due to a depleted battery at the monitoring station.

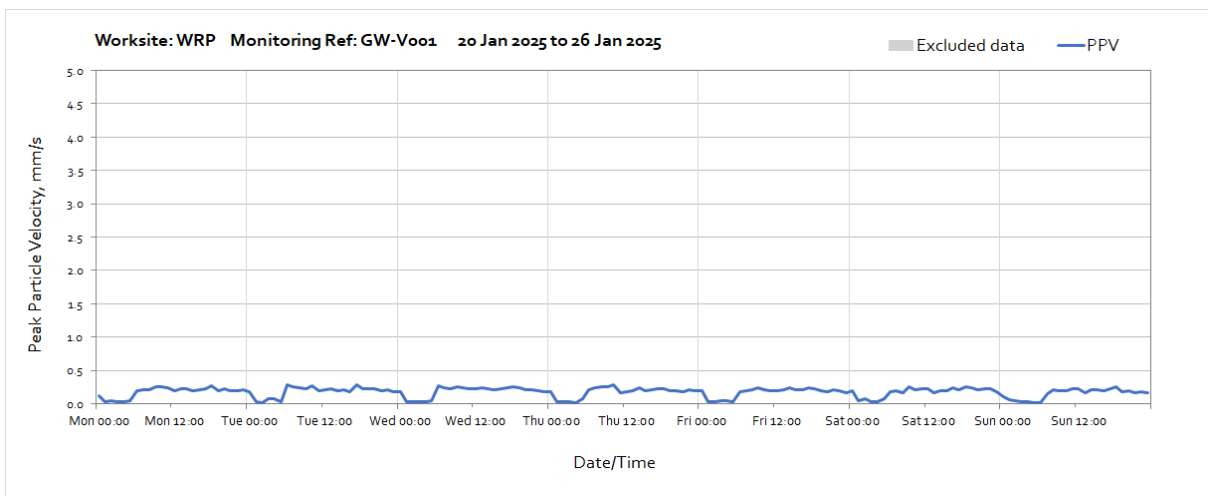
Worksite: WRP – Monitoring Ref: GW-V001

The following graphs show the hourly measured peak particle velocity PPV recorded during the monitoring period. The graphs show the highest PPV of the three orthogonal axis x, y, and z. Periods where PPV values have been affected by local interference with the vibration monitor or only measured for part of the period, which are not representative of HS2 construction works, have been greyed out and excluded when calculating values in Table 4 of the main report.

Worksite Reference	Measurement Reference	Monitor Address	Highest PPV measured in any axis, mm/s
WRP	GW-V001	95 The Greenway, Ickenham, Uxbridge	0.32 (Y-axis)
SRVS	SRVS-V001a	Braintree Road, Ruislip	1.85 (Z-axis)
