Construction Noise and Vibration Monthly Report – January 2025

North Warwickshire Borough Council

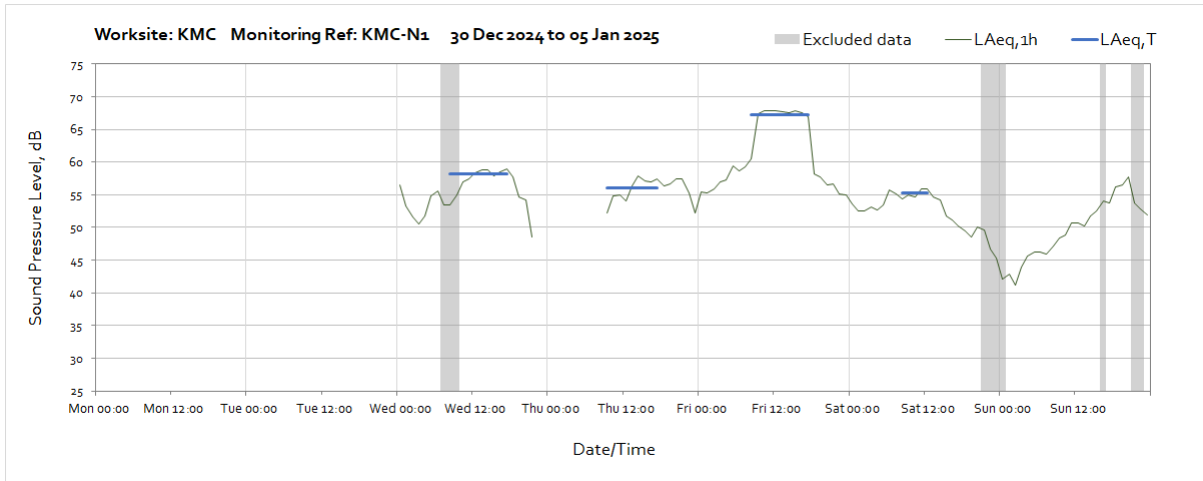
Worksite: KMC – Monitoring Ref: KMC-N1

Note: Missing data between 22:00 on Wednesday 1st and 09:00 on Thursday 2nd January was due to loss of power to the monitoring station caused by vegetation preventing sufficient light reaching the solar panel.

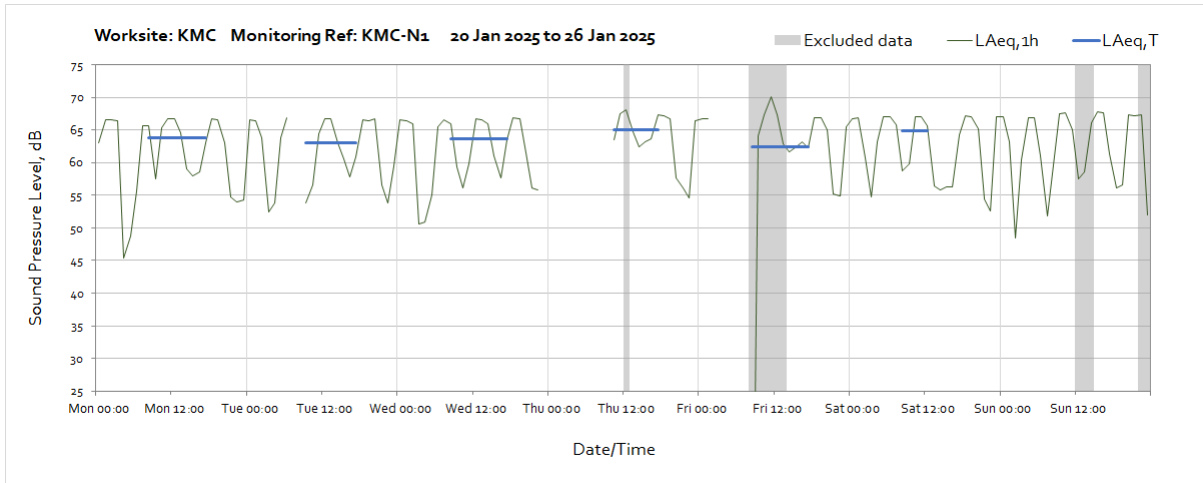
Note: Missing data throughout the week was due to loss of power to the monitoring station caused by vegetation preventing sufficient light reaching the solar panel.

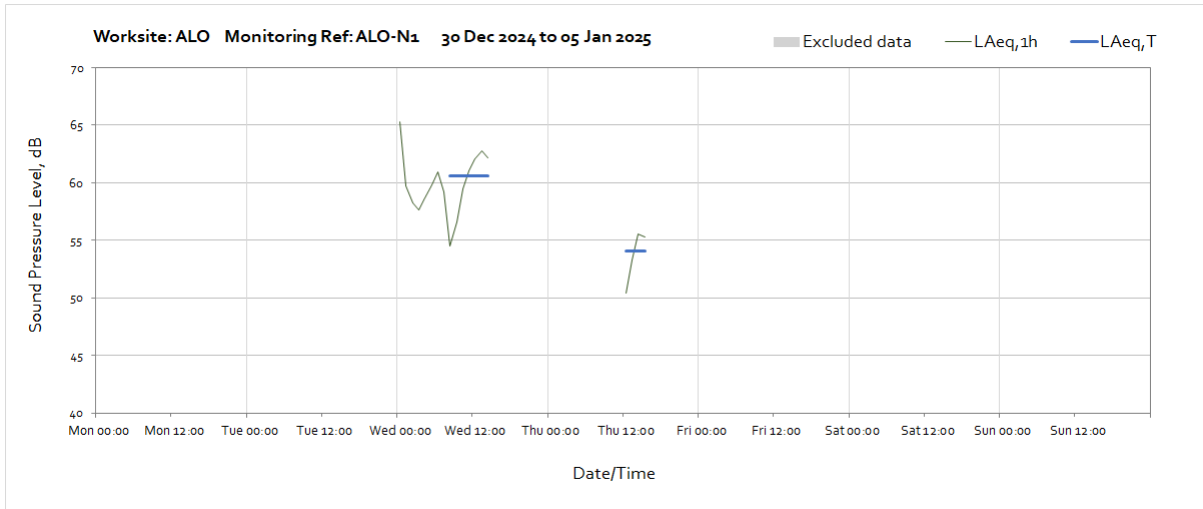
Worksite: ALO – Monitoring Ref: ALO-N1

Note: Missing data throughout the week was due to loss of power to the monitoring station caused by vegetation preventing sufficient light reaching the solar panel.

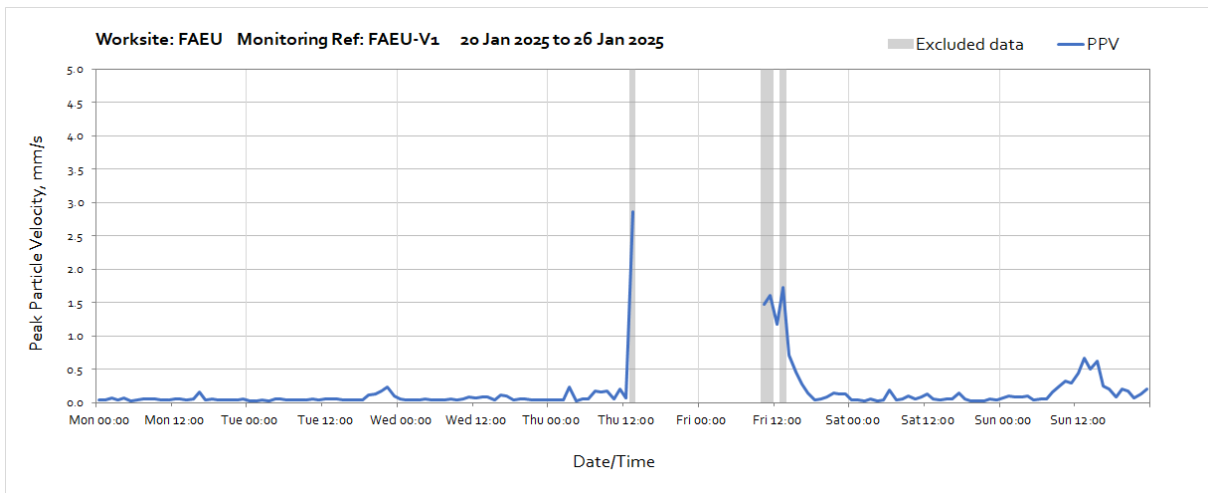
Note: Missing data between 14:00 on Thursday 23rd January and 10:00 on Friday 24th January was due to the monitoring station requiring replacement, which took place on Friday 24th January.

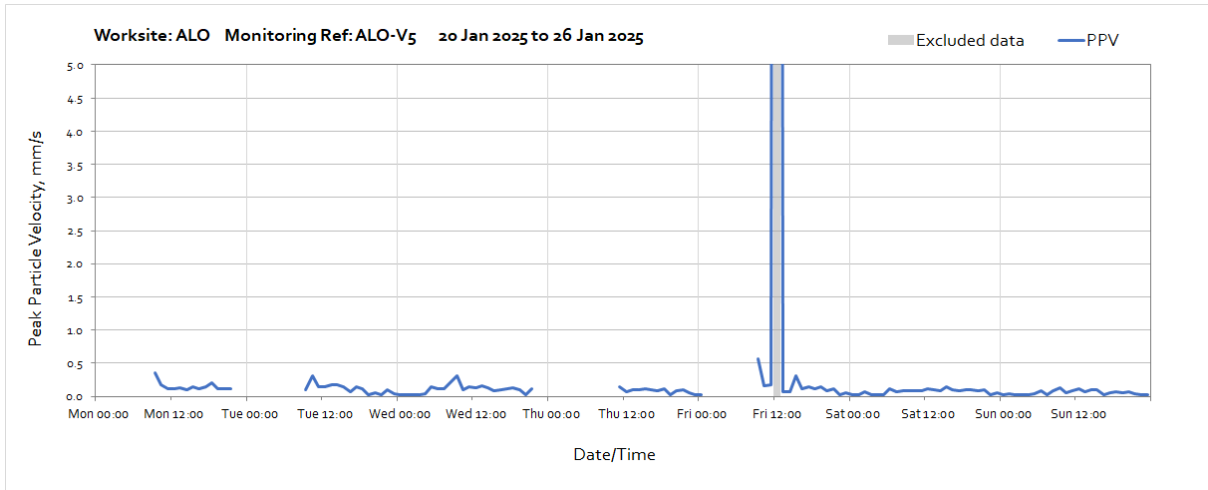
Note: Missing data throughout the week was due to loss of power to the monitoring station caused by vegetation preventing sufficient light reaching the solar panel.

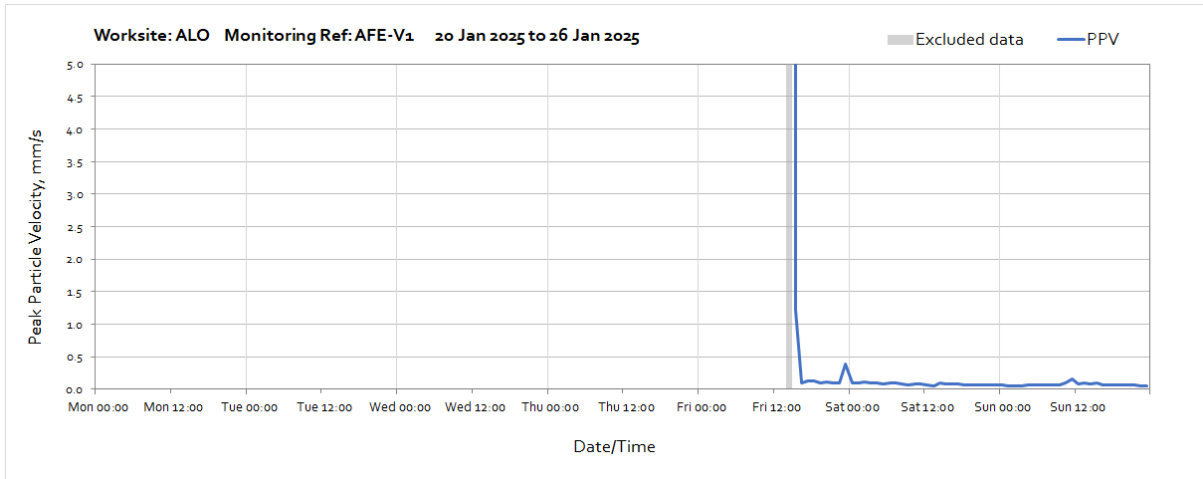
Worksite: ALO – Monitoring Ref: AFE-V1

Note: Missing data from the beginning of January until 14:00 on Friday 24th January was due to loss of power to the monitoring station caused by vegetation preventing sufficient light reaching the solar panel.
