Construction Noise and Vibration Monthly Report – January 2025

West Northamptonshire District Council

Non-Technical Summary

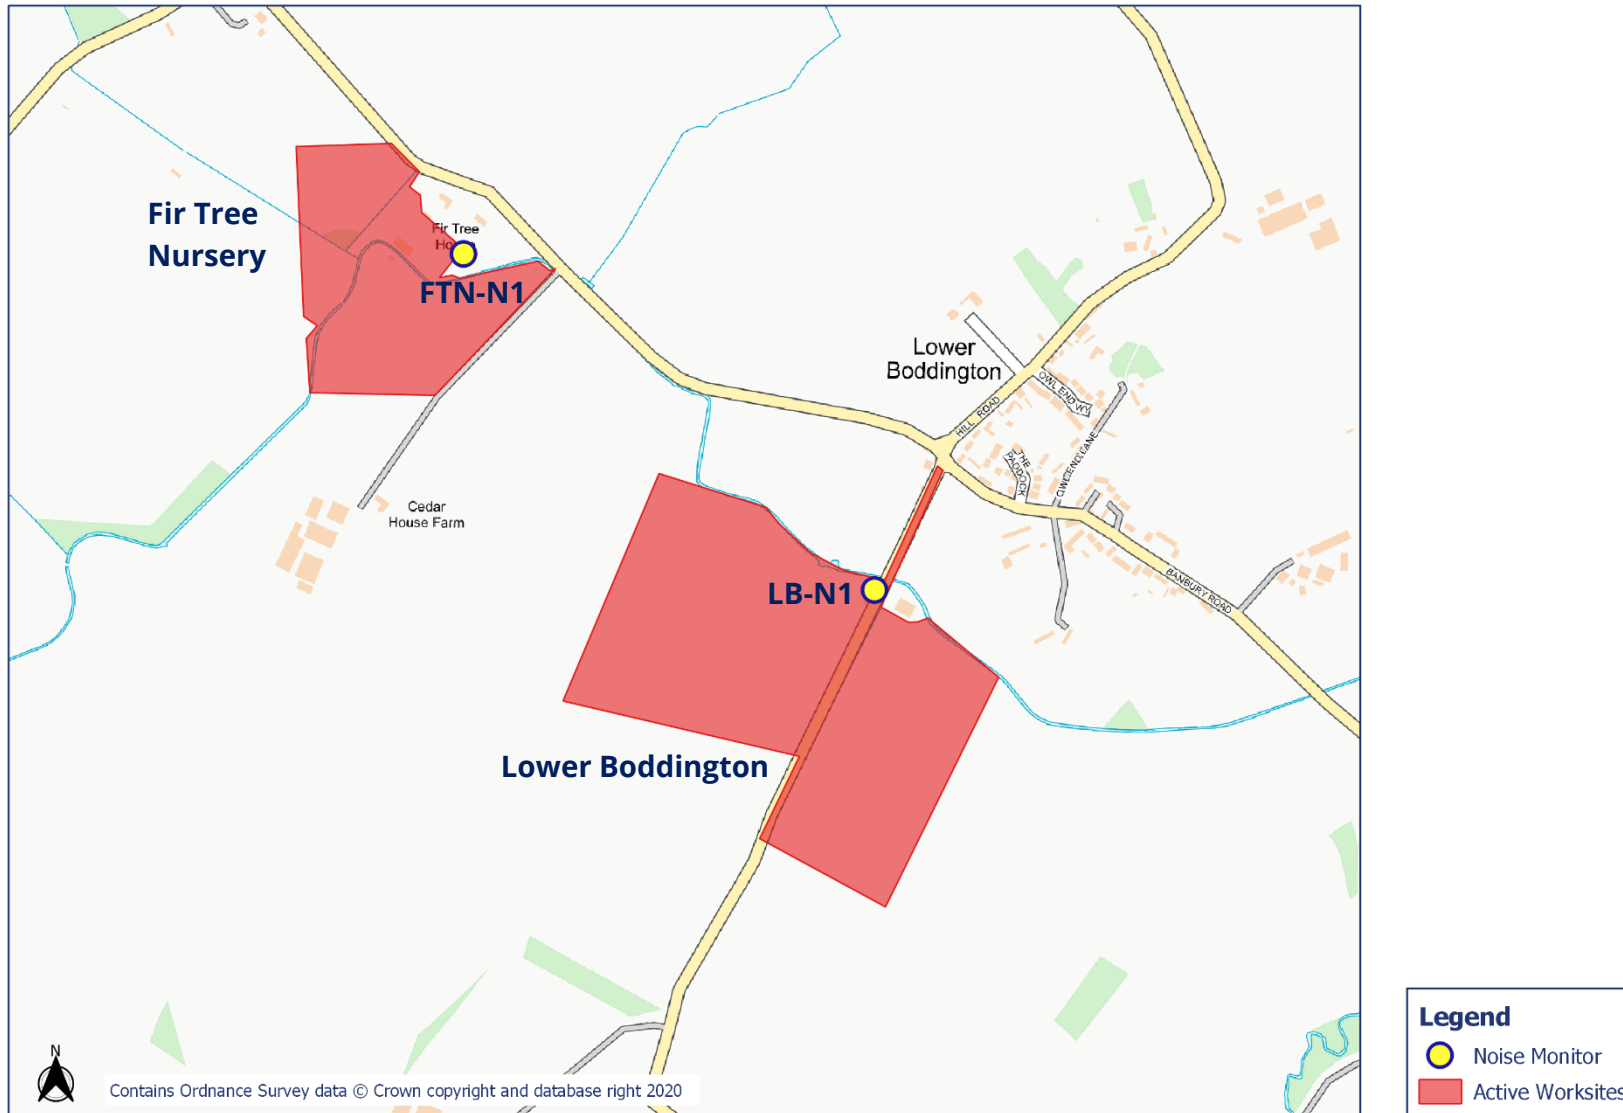
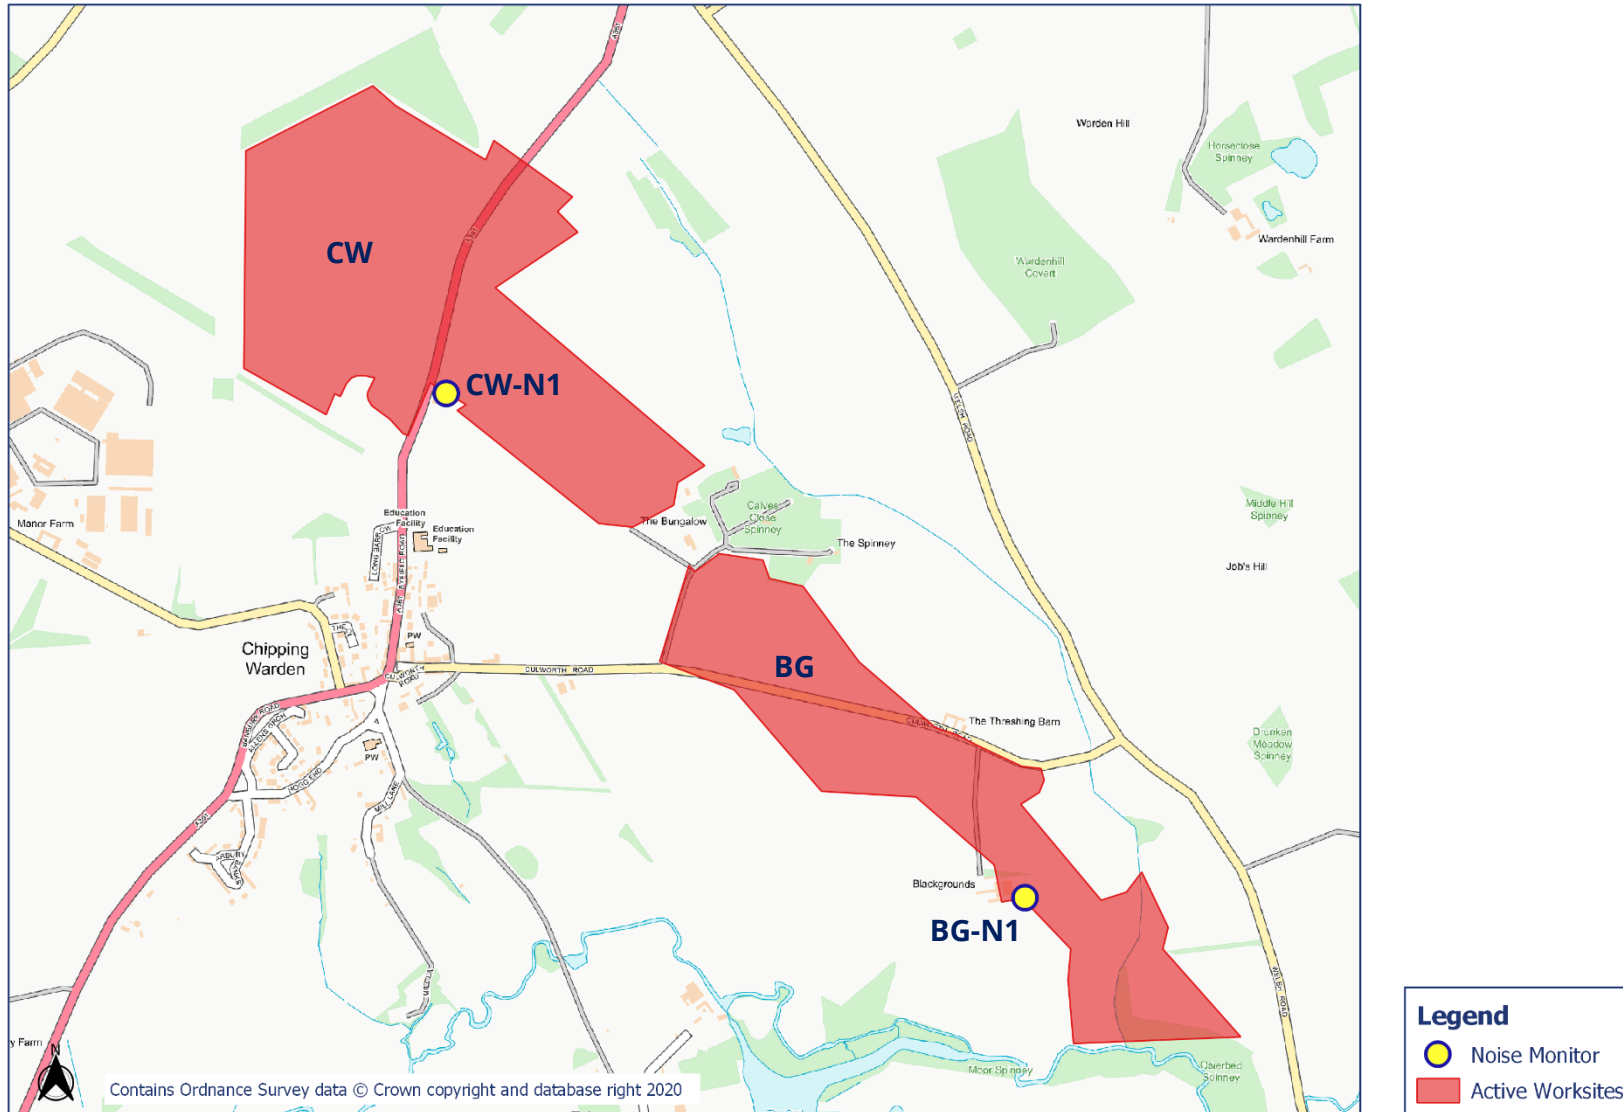
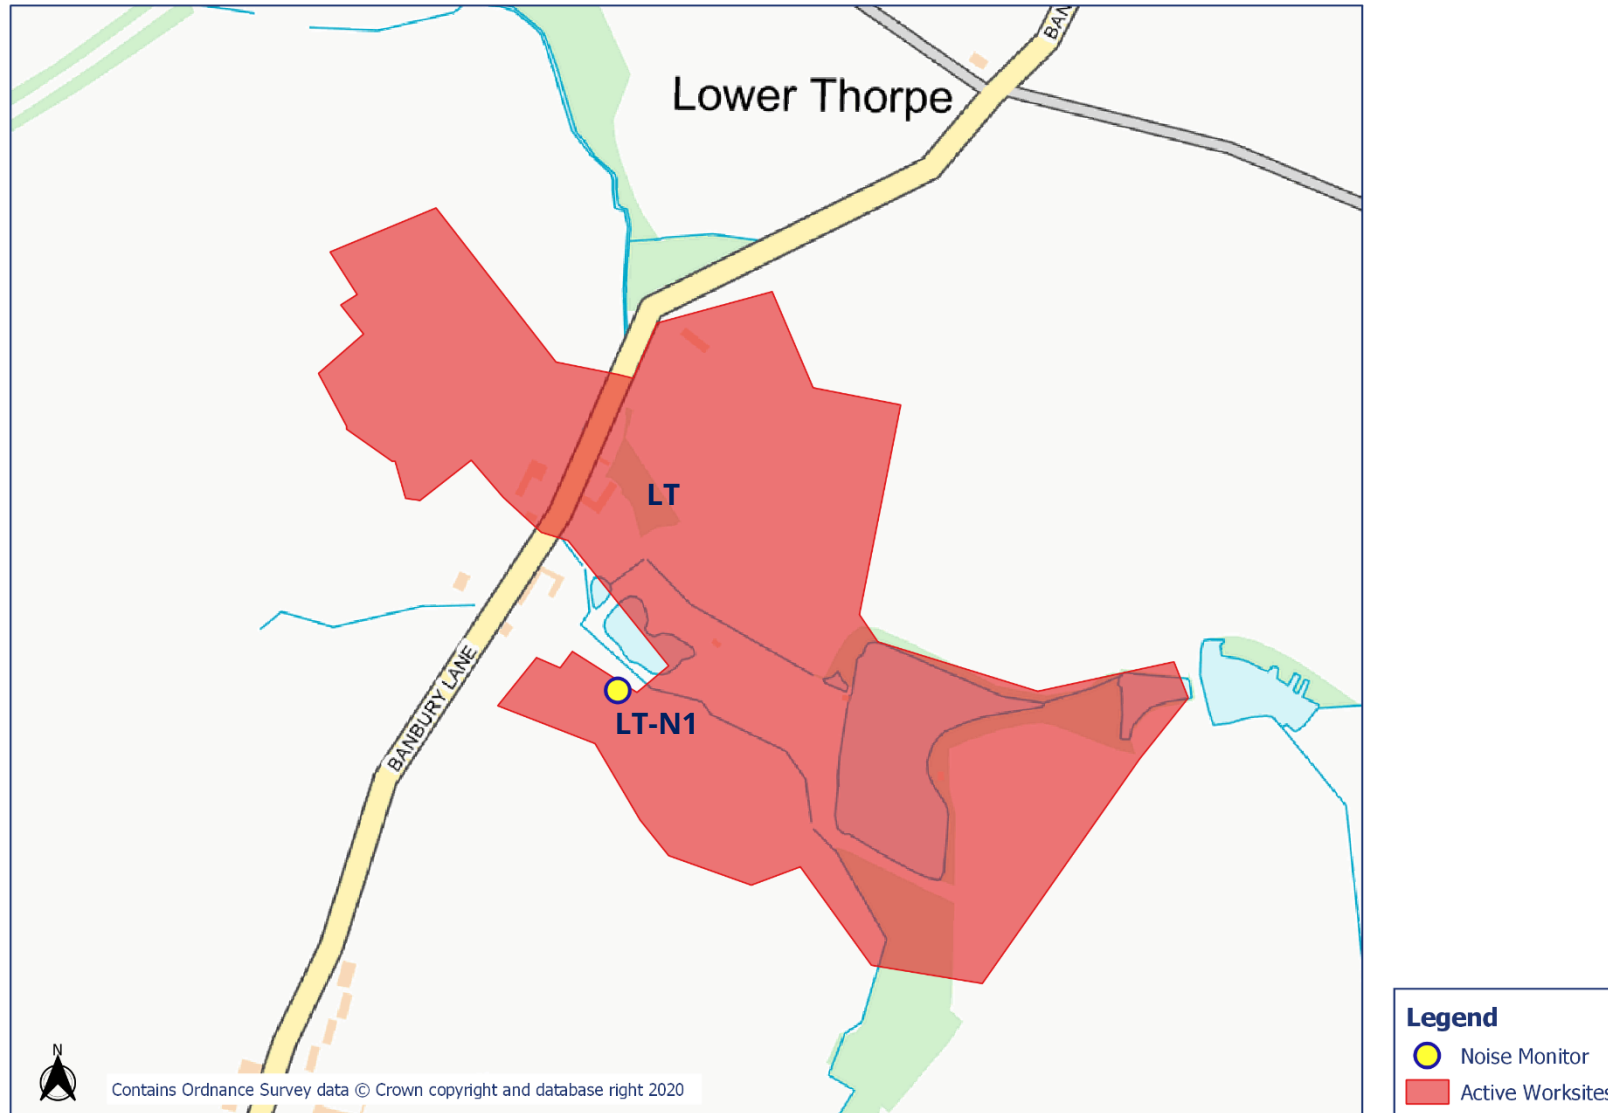
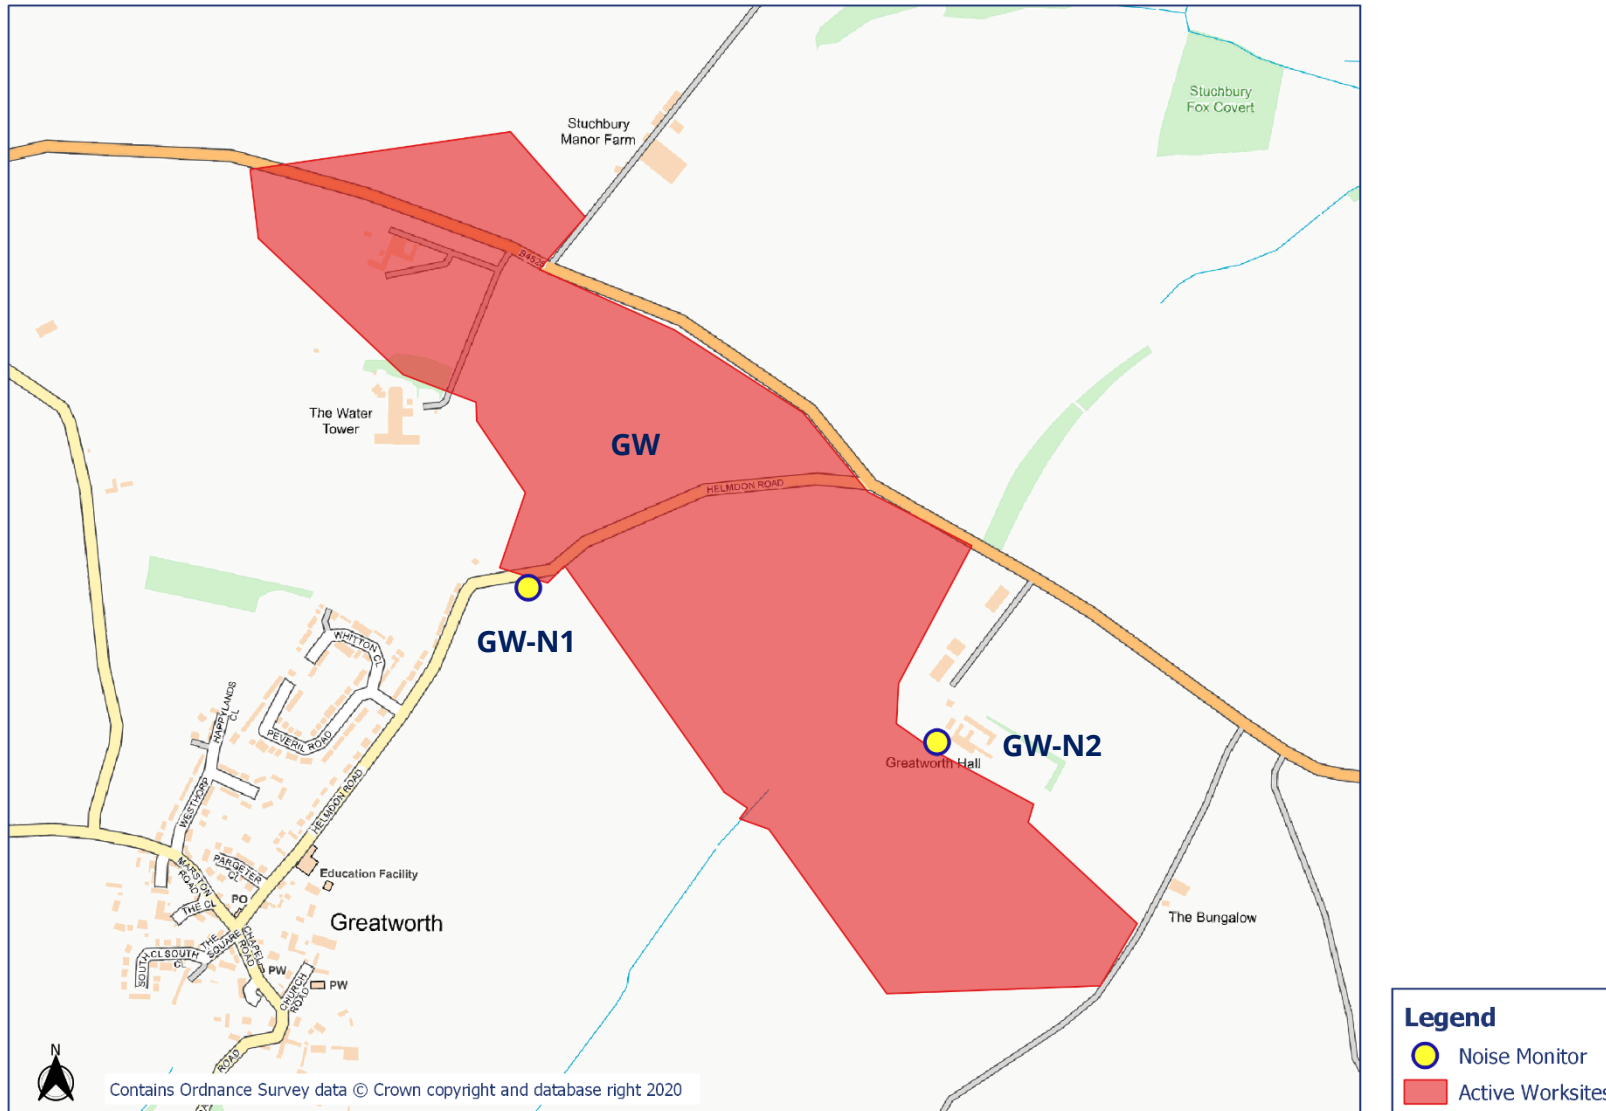
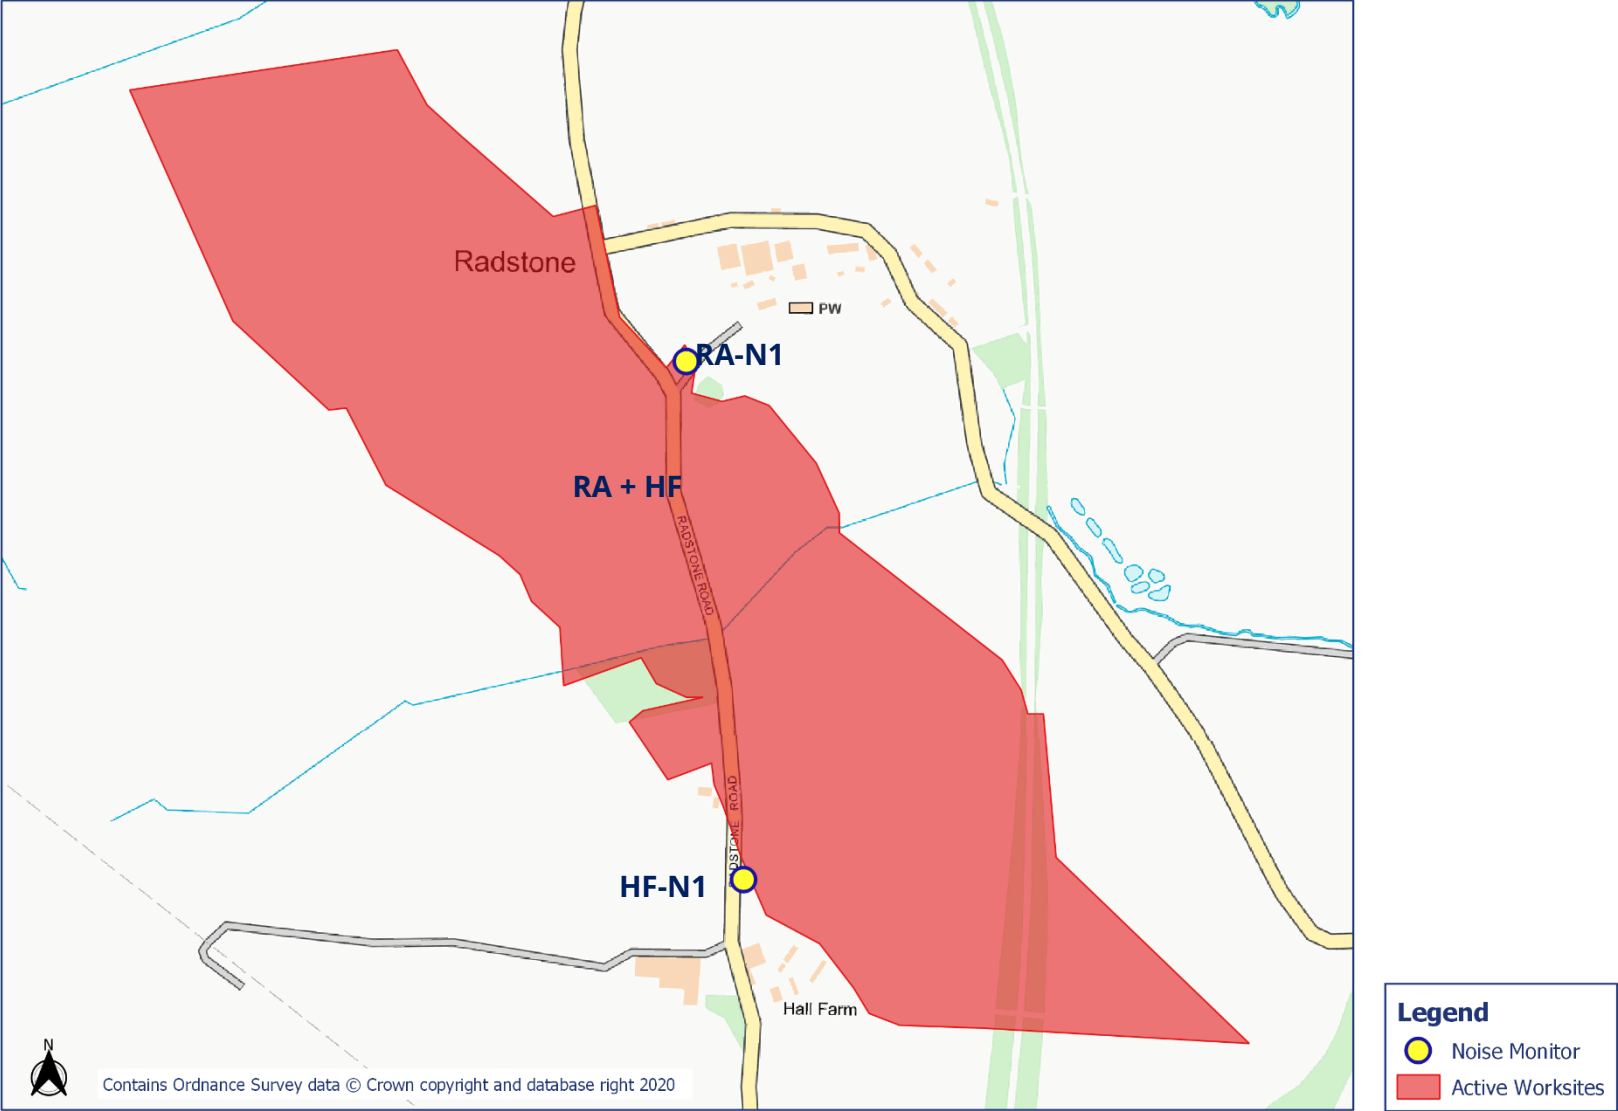
Appendix B Monitoring Locations

1.2.2 Maps showing the position of noise monitoring installations are presented in Appendix B.

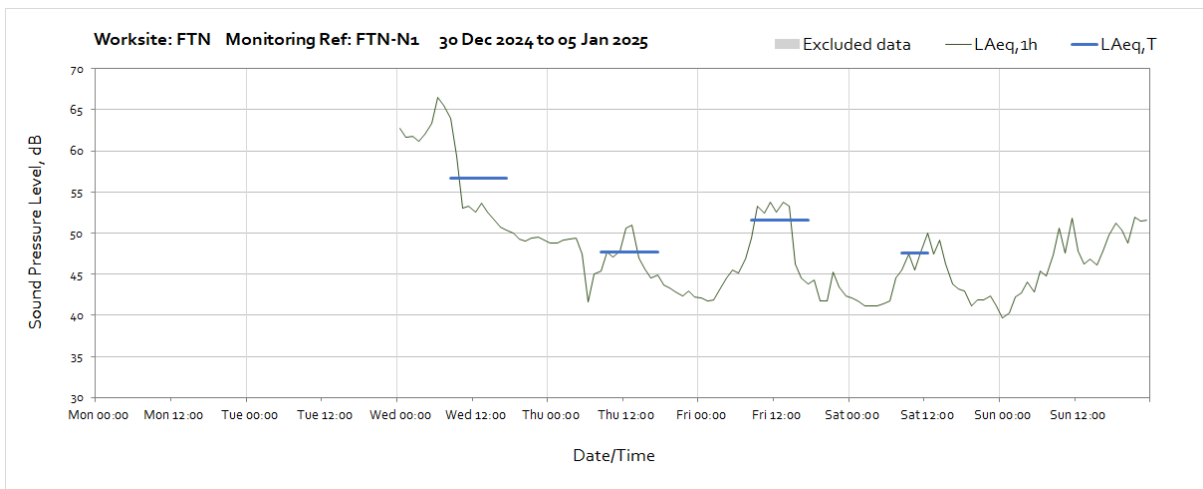
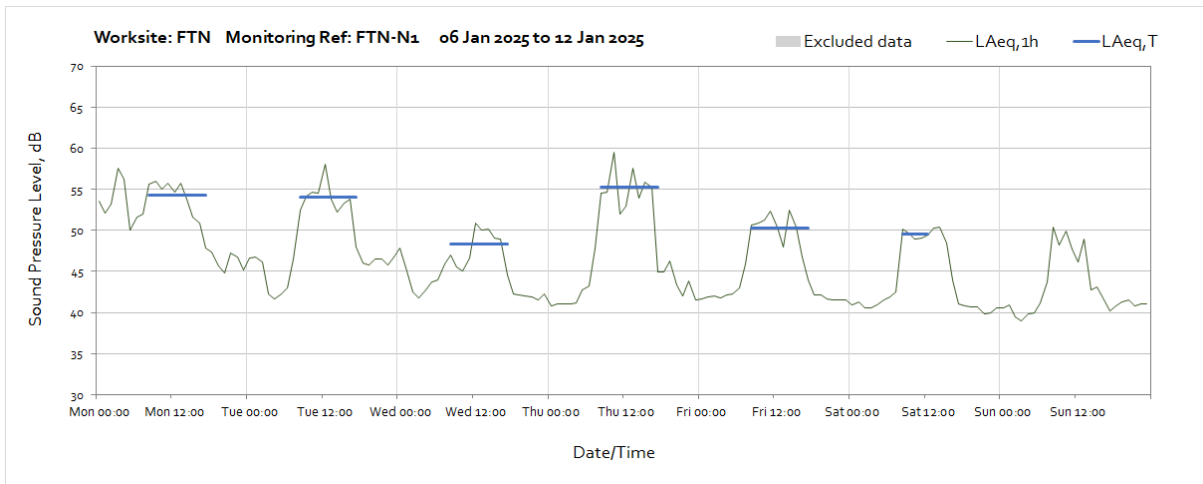
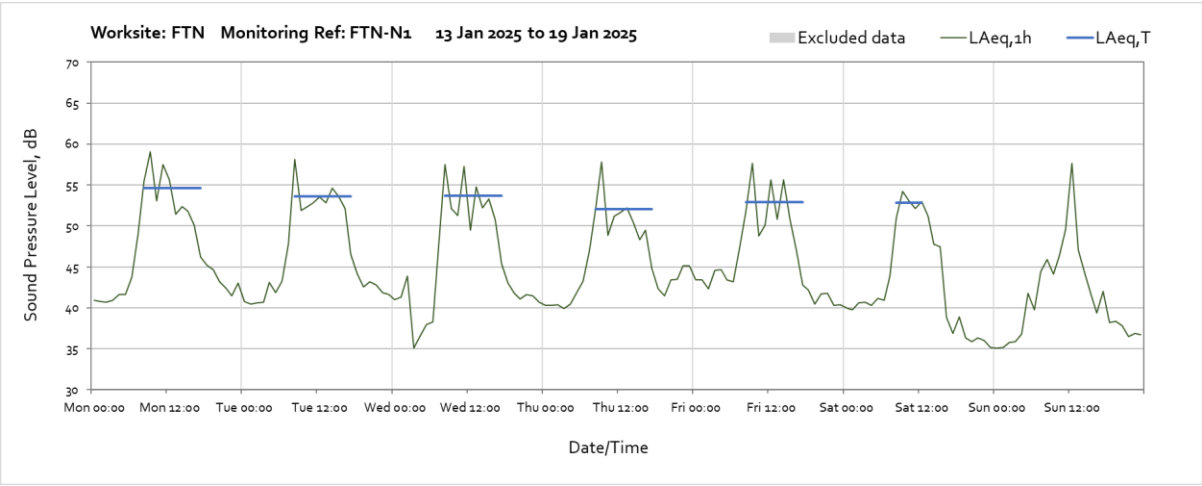
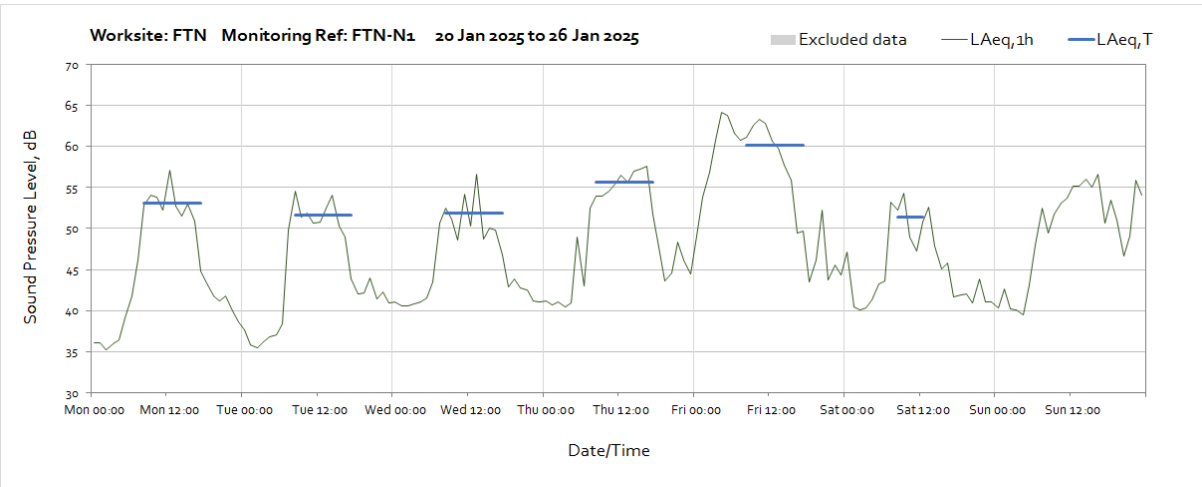
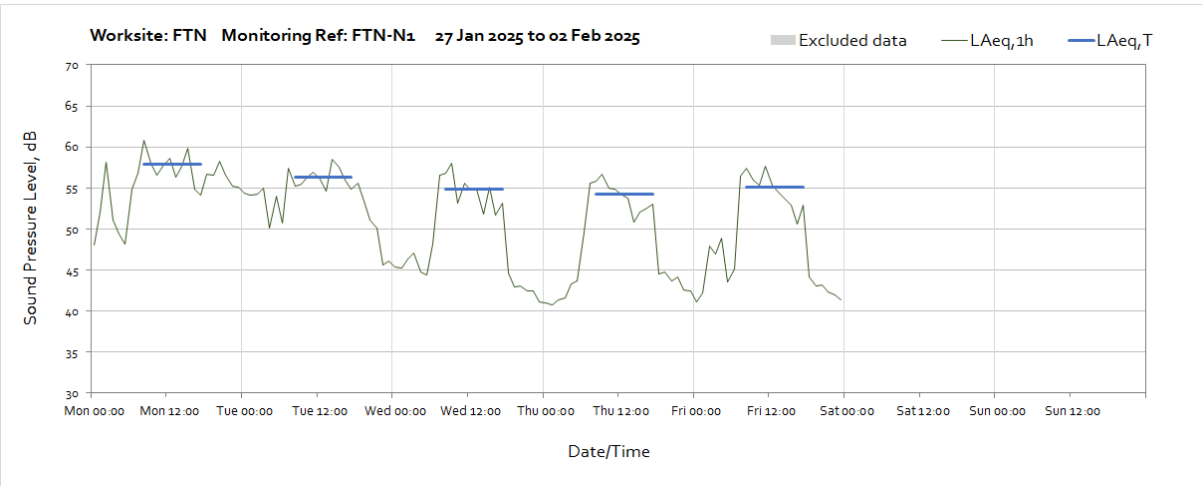
Worksite: FTN – Monitoring Ref: FTN-N1

The following graphs show the hourly measured ambient noise level $L_{Aeq,1h}$ and, where relevant, the averaged noise level $L_{Aeq,T}$ values, where the time period T is as specified in Table 1 of HS2 Information Paper E23. Periods where noise levels are adversely affected by weather or only measured for part of the period, which are not representative of HS2 construction works, have been greyed out and excluded from the calculation of the $L_{Aeq,T}$ values in Table 3 of the main report.

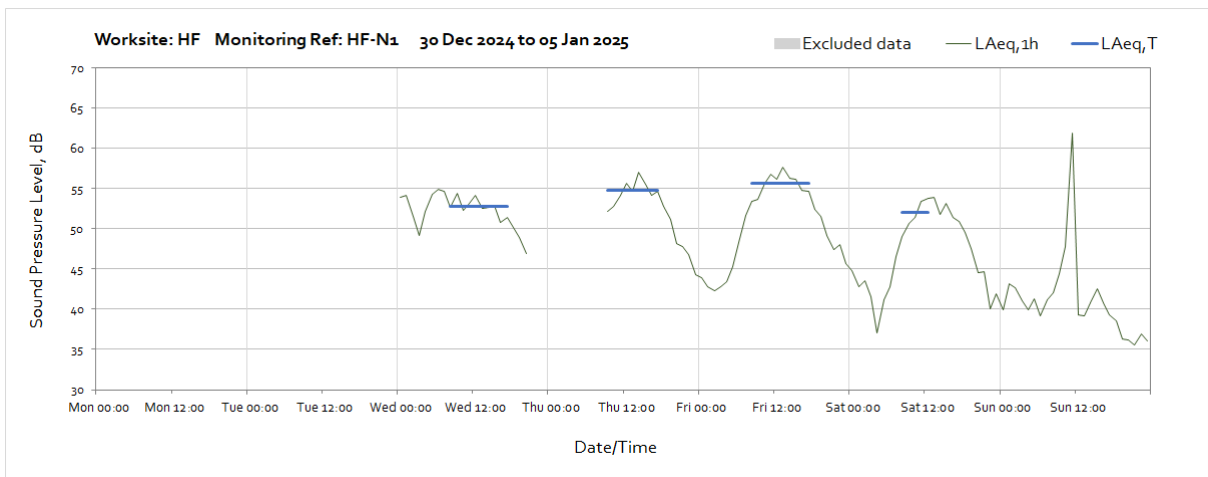
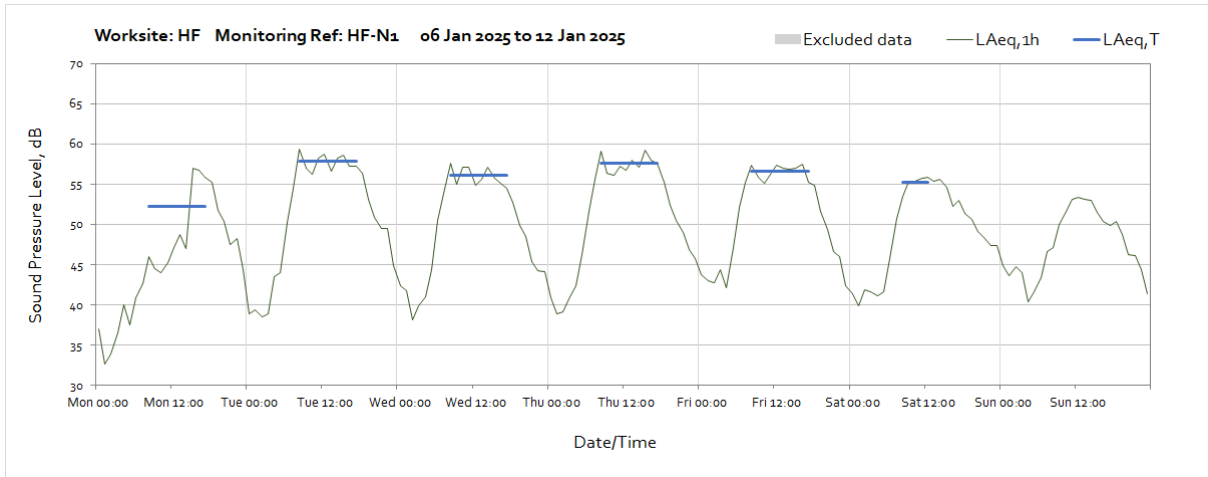
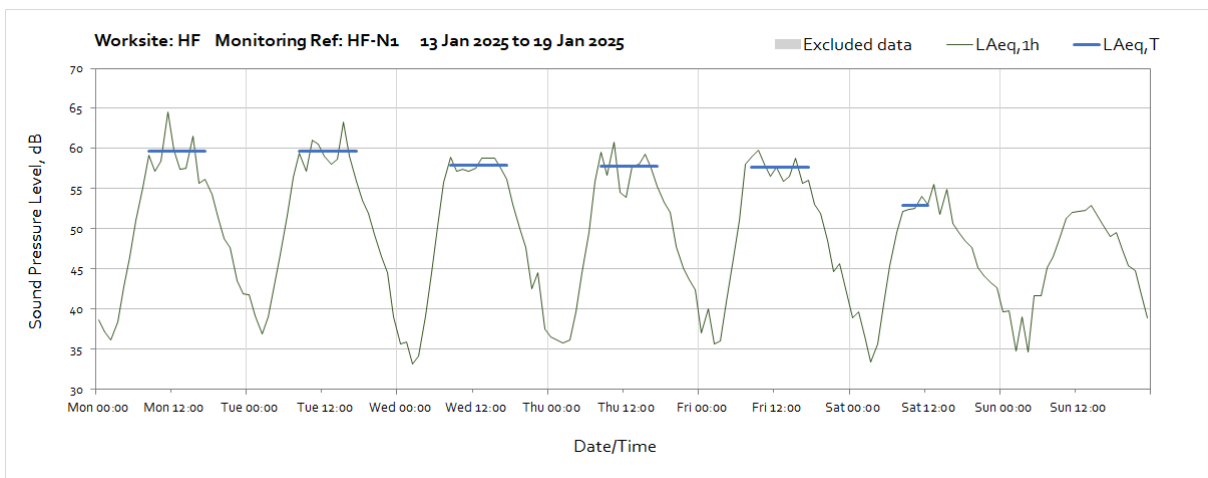
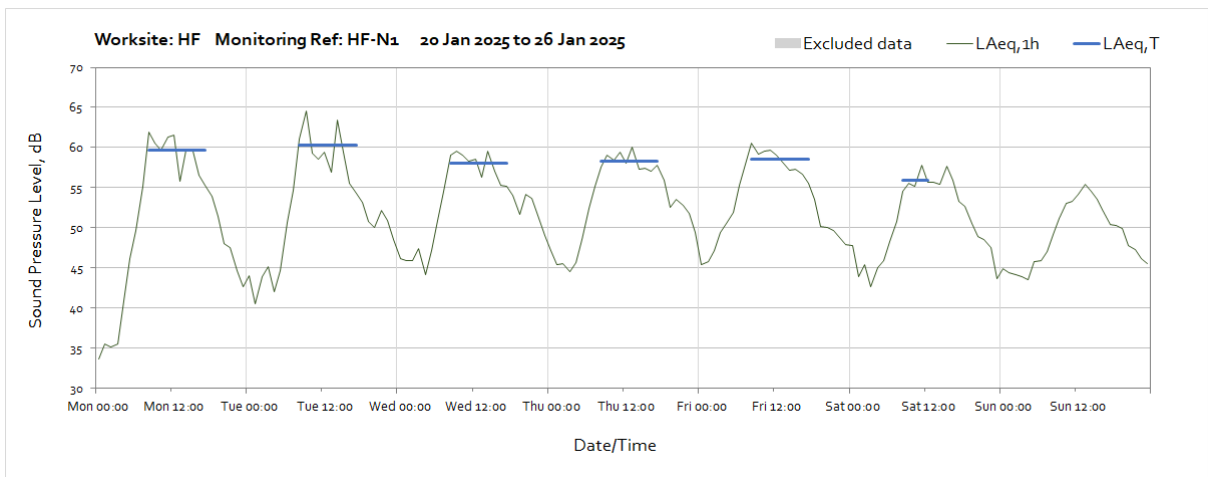
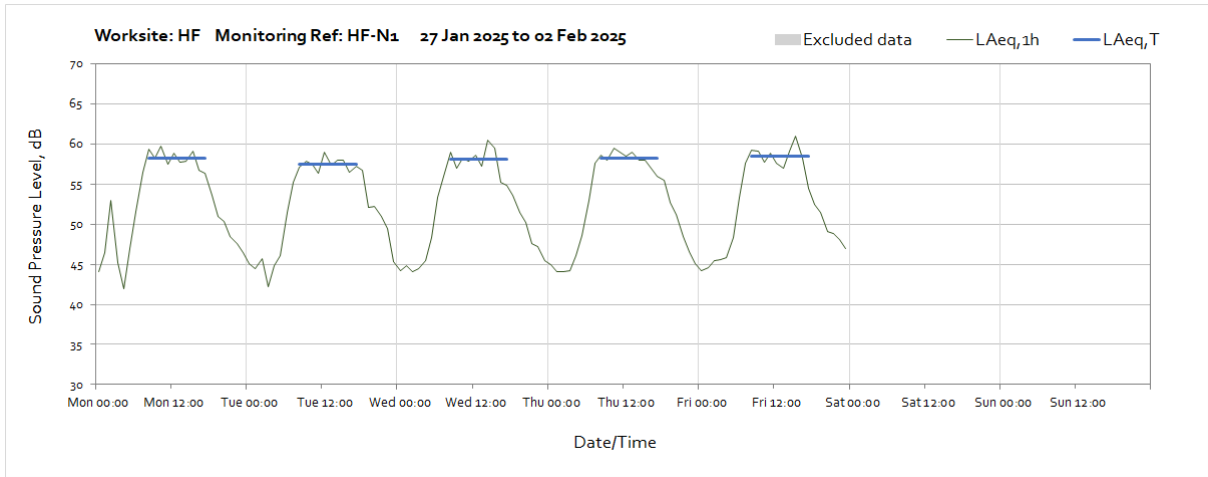
Worksite: HF – Monitoring Ref: HF-N1

Note: Missing data between 21:00 on Wednesday 1st and 09:00 on Thursday 2nd January was due to a depleted battery at the monitoring station.
