Air Quality and Dust Monitoring Monthly Report – February 2025

London Borough of Hammersmith and Fulham

A report prepared by EWCs and MWCCs on behalf of HS2 Ltd.

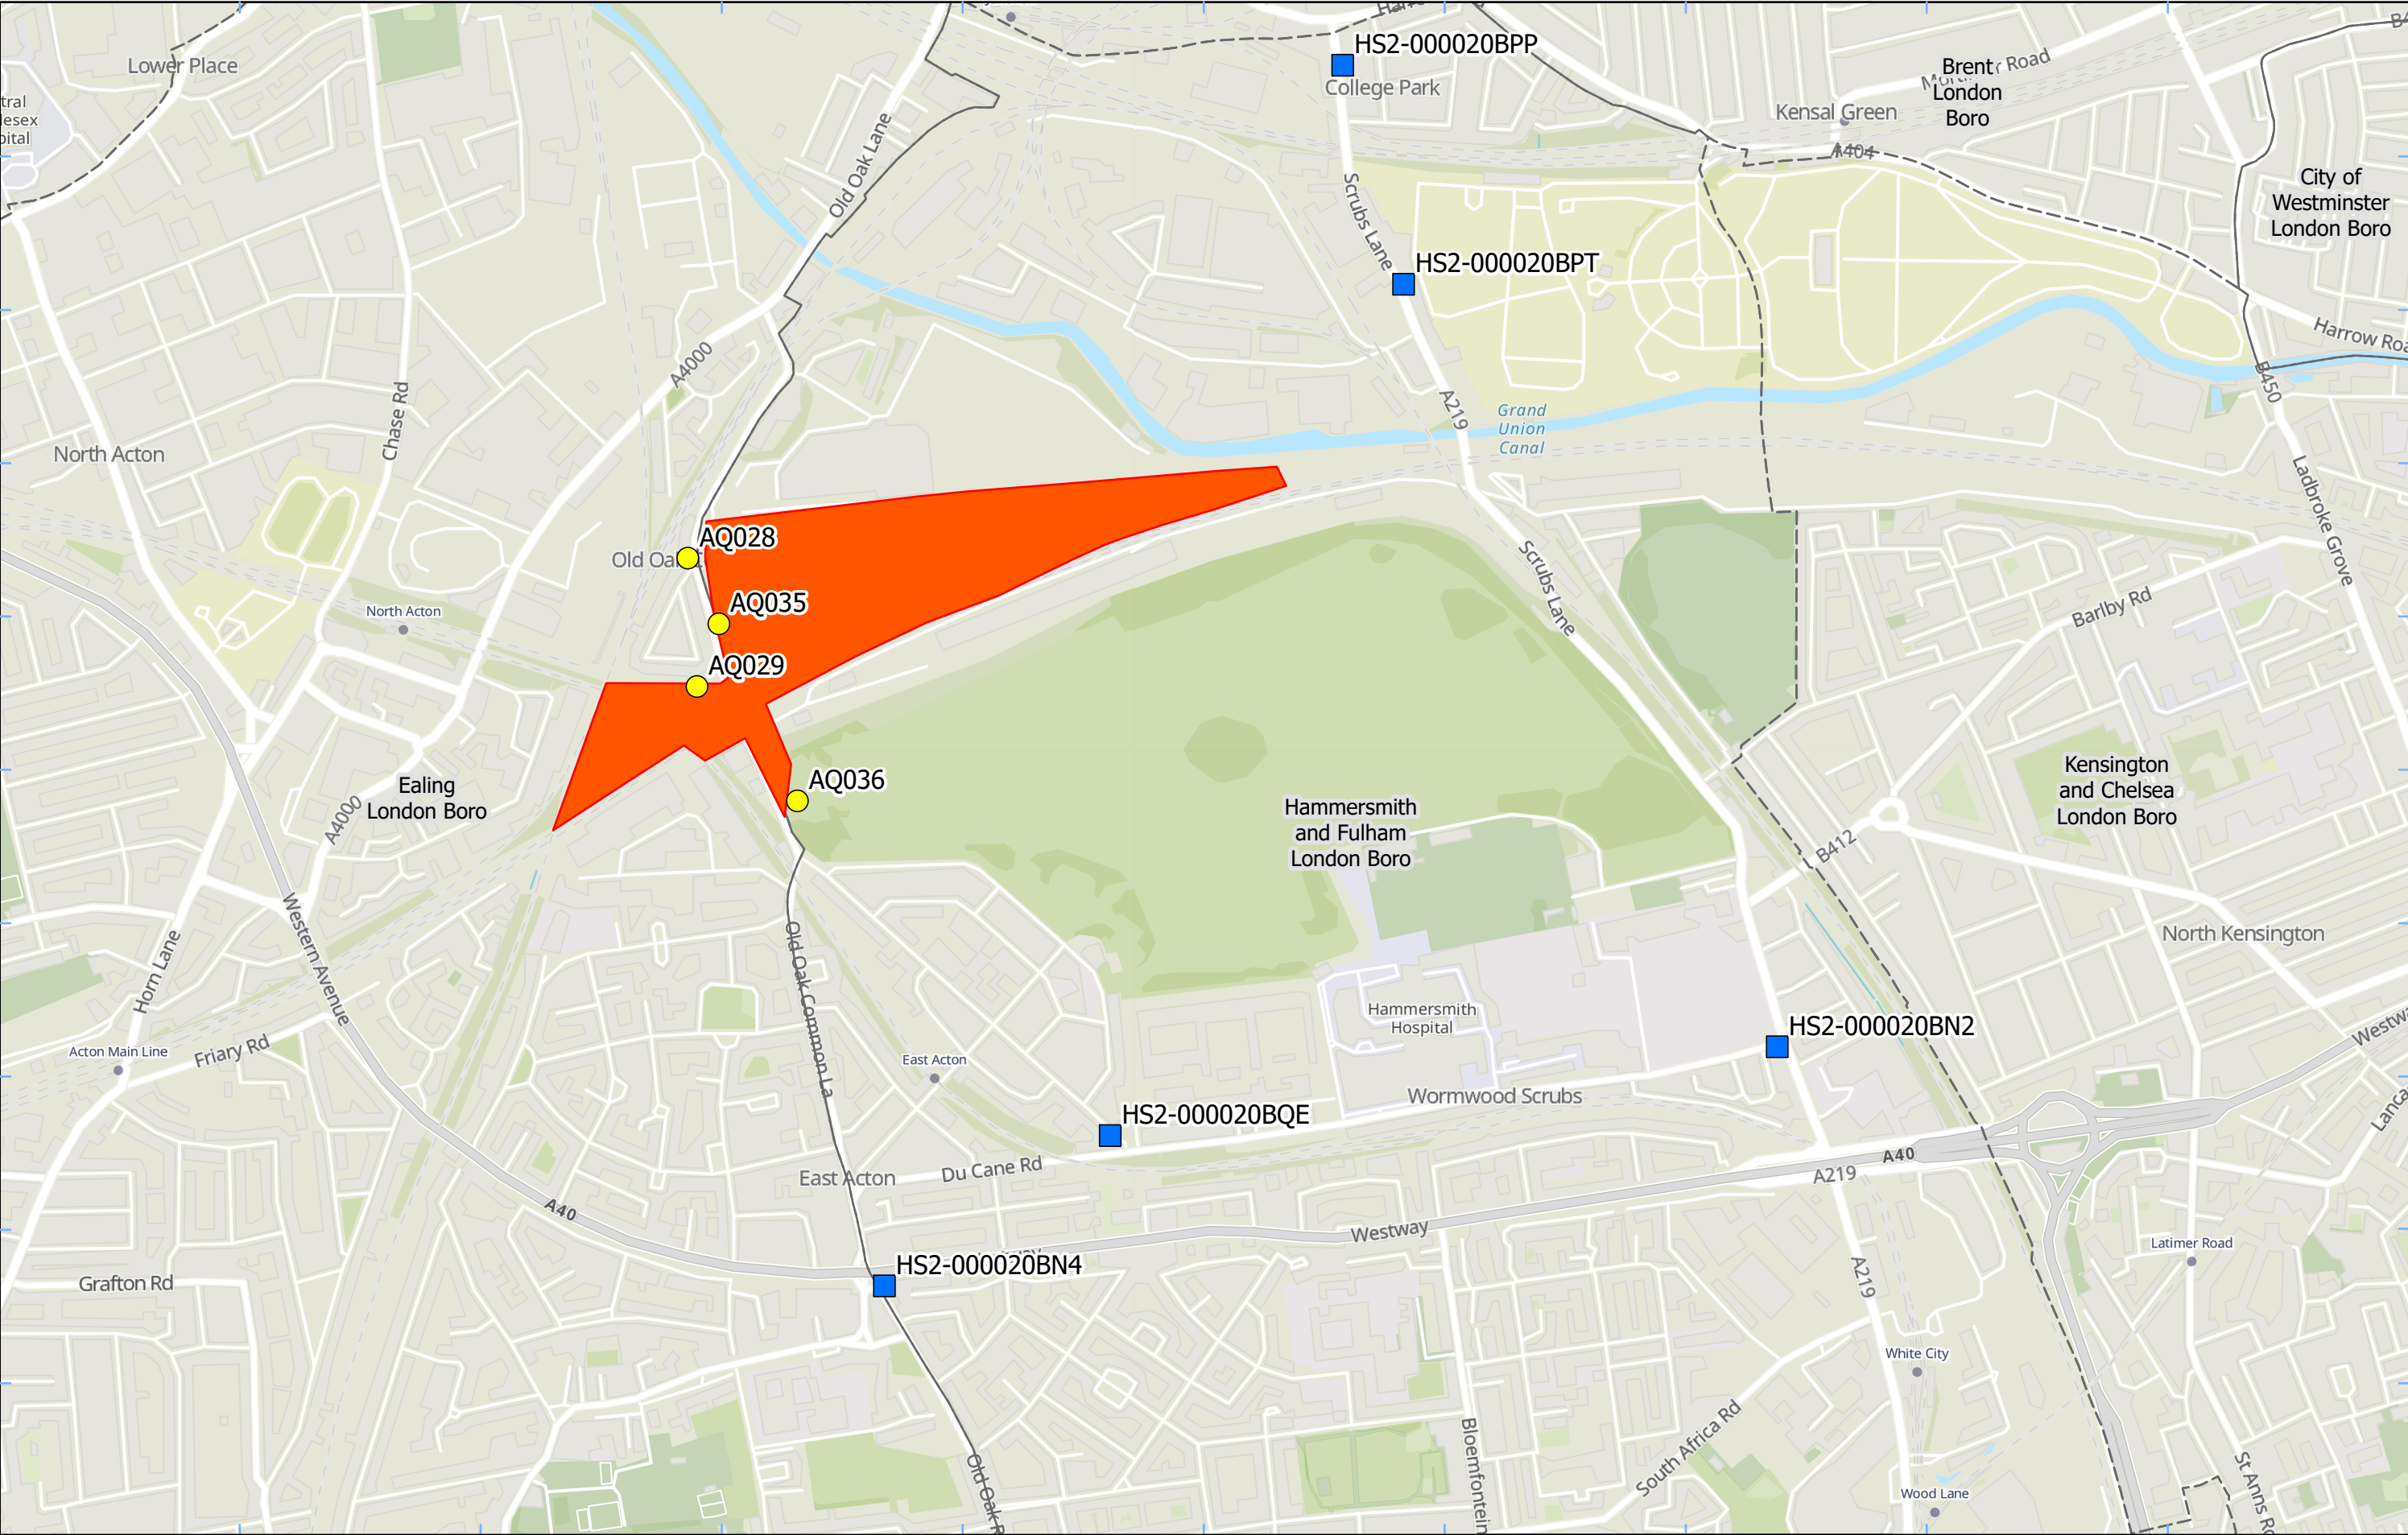
Figure 1 and 2: Worksites and monitoring locations within the LBHF

1.1.2 Figure 1 and Figure 2 in Appendix A present the current worksites together with air quality and dust monitoring locations.

1.1.4 The current worksites, as presented in Appendix A, Figure 1 and Figure 2, include:

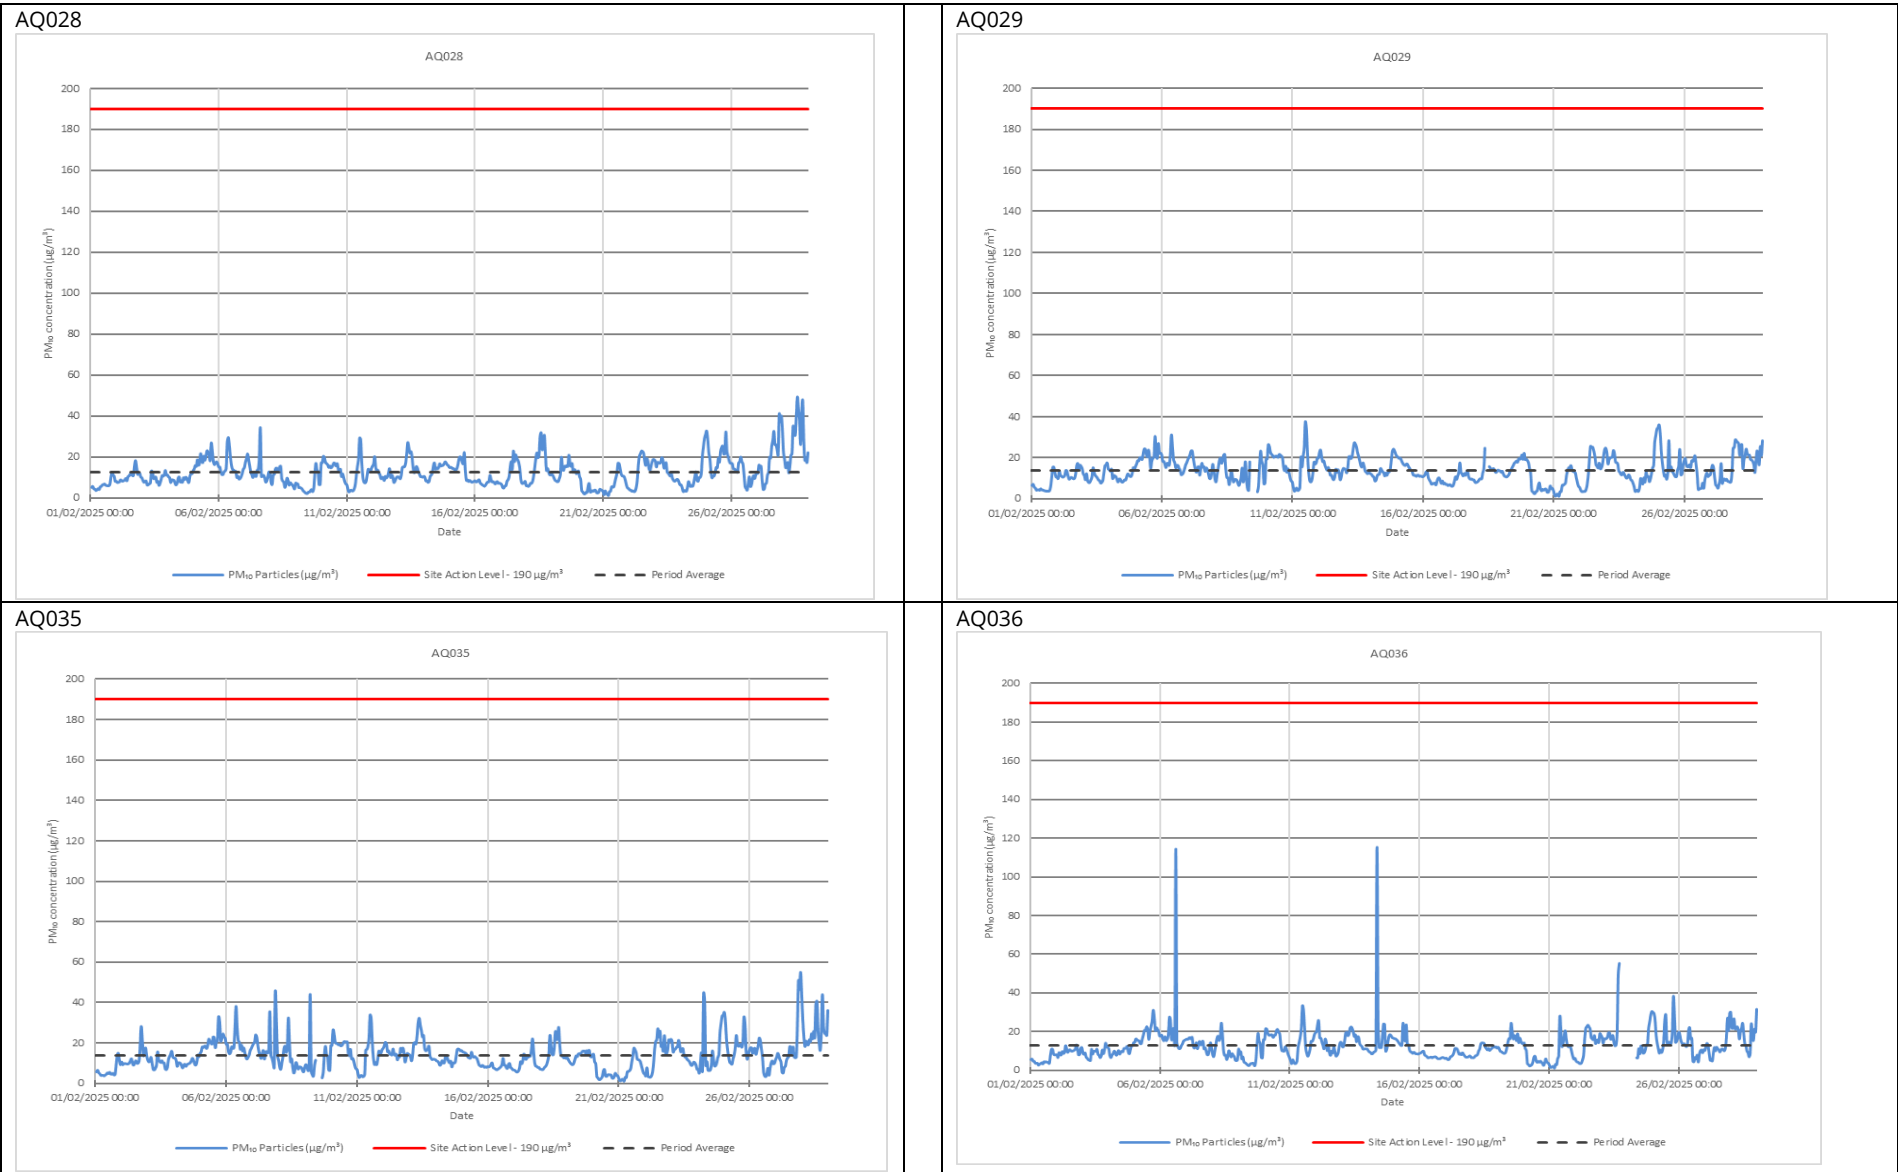
Figure 3: Construction dust 1-hour mean indicative PM₁₀ concentration for all dust monitors

1.1.6 Dust monitoring locations and results are presented in Appendix B, Table 1, together with line charts of monthly data from each dust monitor presented in Figure 3. All continuous dust monitoring is undertaken using indicative monitors. Despite being Environment Agency (MCERTS) certified, indicative monitors carry a higher level of uncertainty than reference monitors, and therefore cannot be strictly compared with Air Quality Standards

- 1.1.7 The trigger level for PM₁₀ concentrations of 190 µg/m³, over a 1-hour period, in accordance with the updated guidance document '*Guidance on Monitoring in the Vicinity of Demolition and Construction Sites – (October 2018)*' has been applied.

- 1.1.8 No (0) dust trigger alerts were recorded during the monitoring period (February 2025).
- 1.1.9 Diffusion tube monitoring of Nitrogen Dioxide (NO₂) is undertaken at seven (7) locations around highways within the LBHF as part of the management of air quality where significant effects may occur as a result of the scheme.
