## **Construction noise and vibration Monthly Report – February 2025**

**London Borough of Hillingdon**

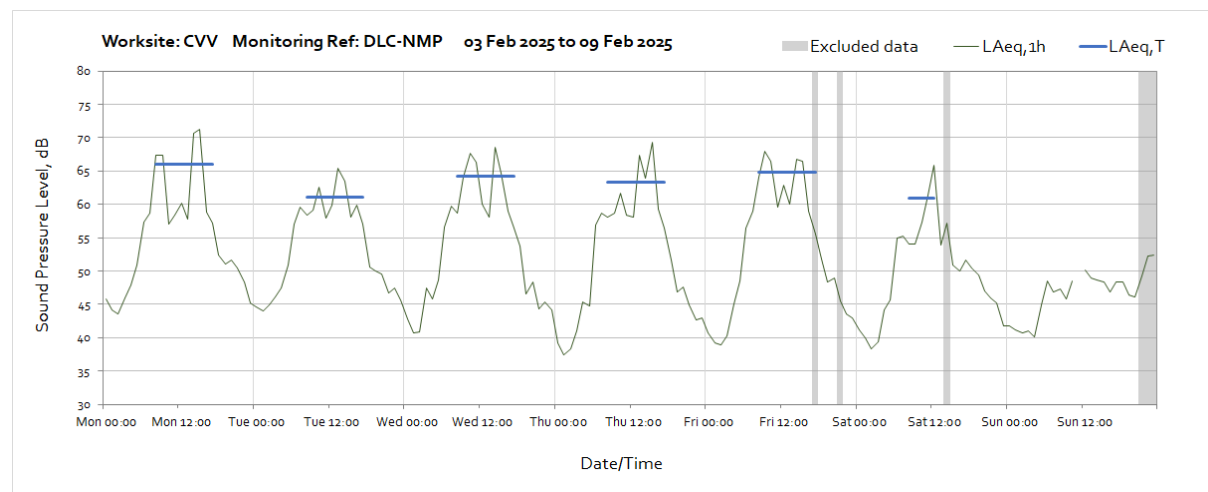
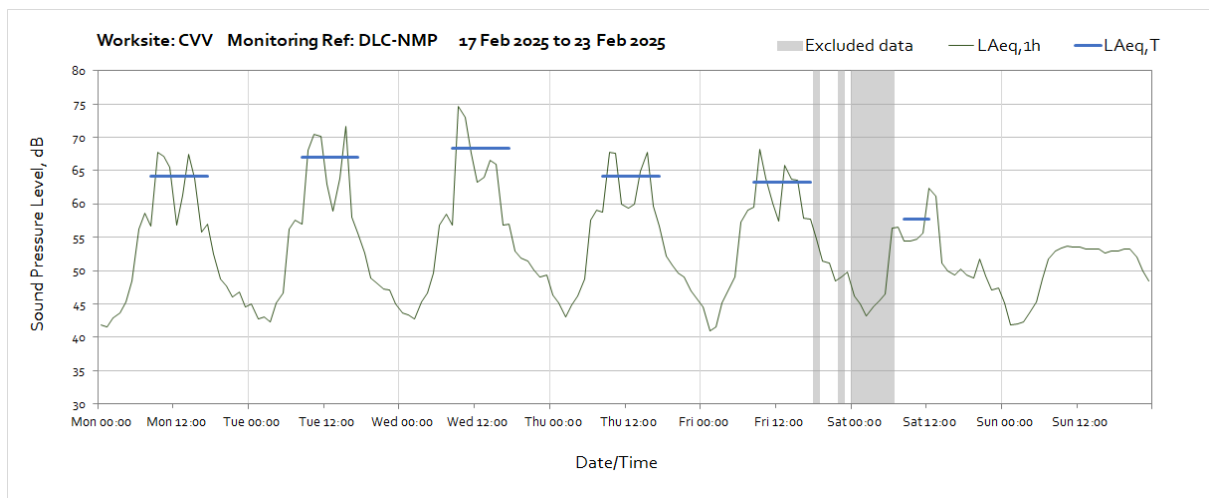
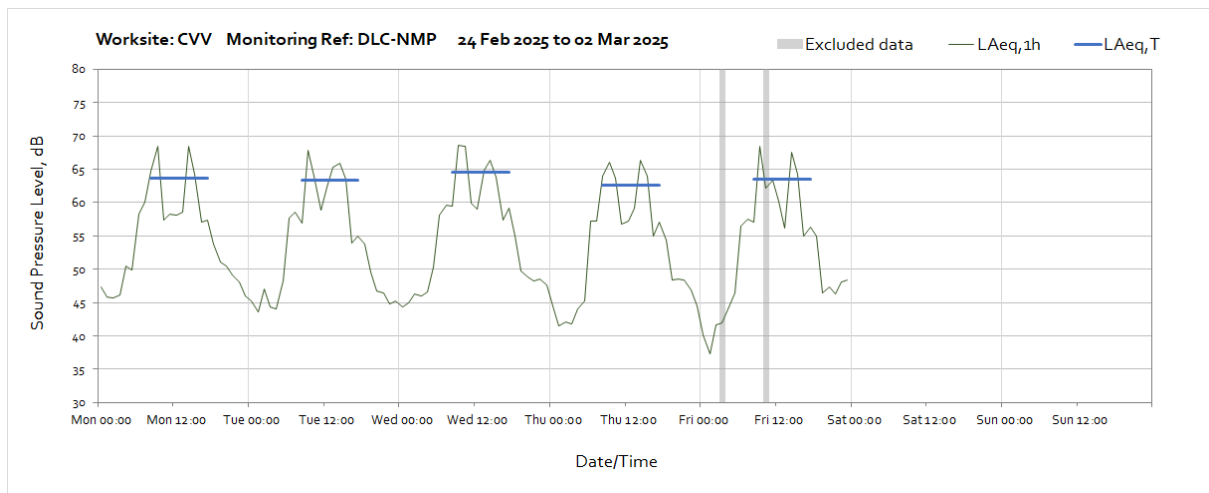
### Worksite: CVV – Monitoring Ref: DLC-NMP

Note: Missing data between 11:00 and 12:00 on Sunday 9<sup>th</sup> February was due to a transmission error.

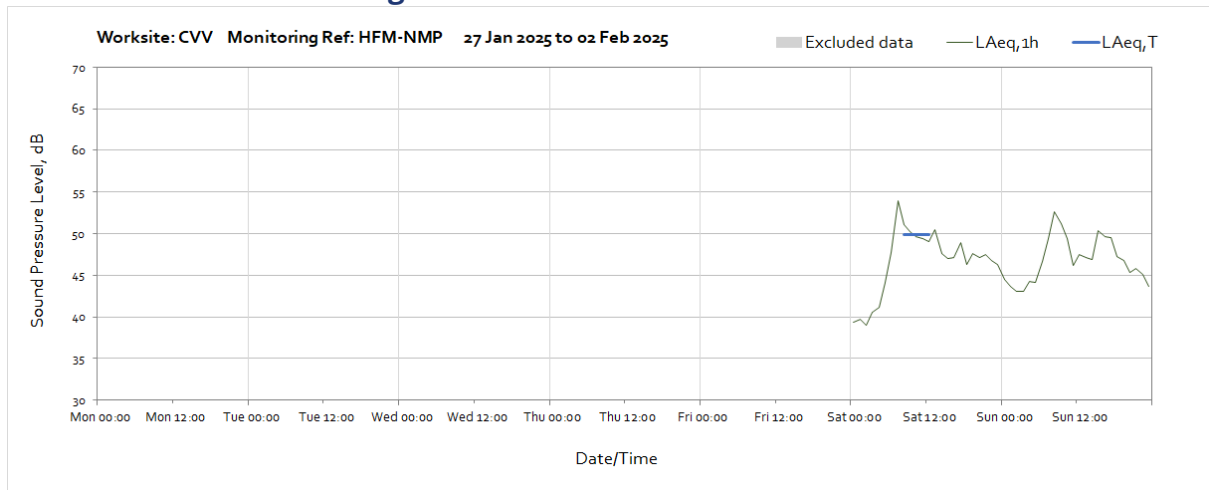
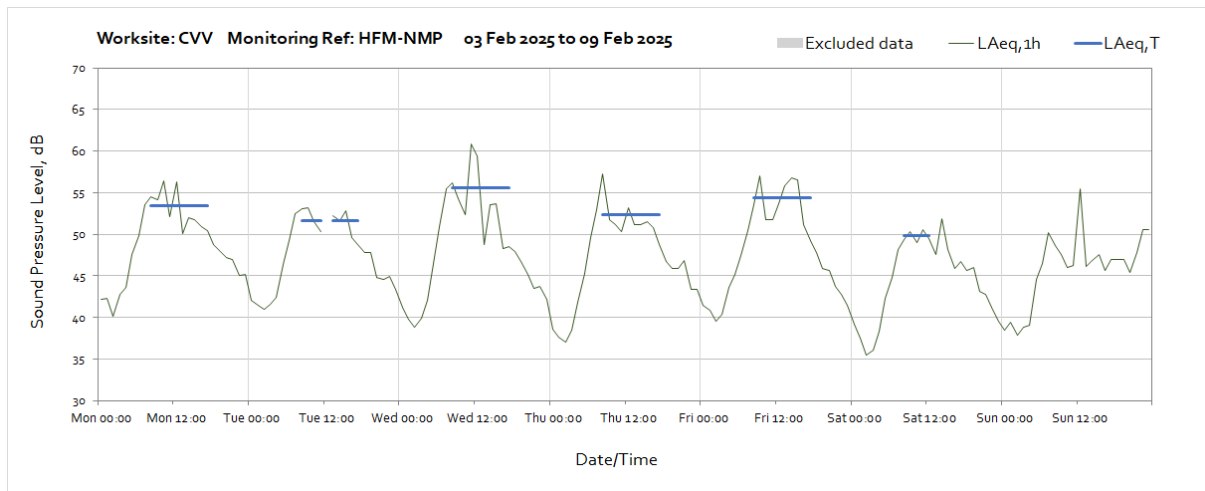
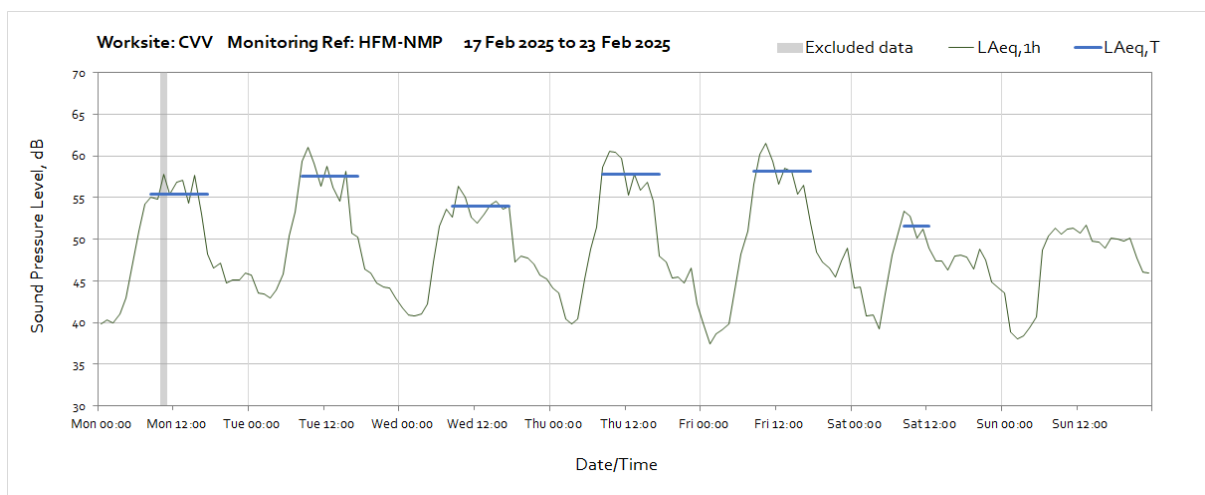
## Worksite: CVV – Monitoring Ref: HFM-NMP

Note: Missing data between 12:00 and 13:00 on Tuesday 4<sup>th</sup> February was due to field calibration.

Note: Missing data between 15:00 and 16:00 on Wednesday 26<sup>th</sup> February was due to a transmission error.
