## **Construction Noise and Vibration Monthly Report – February 2025**

**West Northamptonshire District Council**

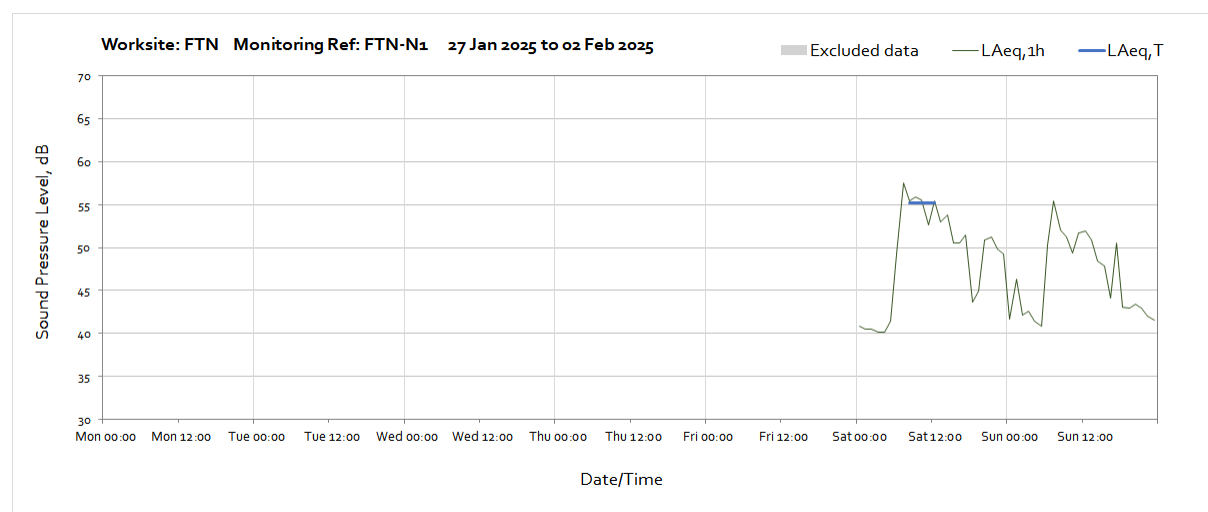
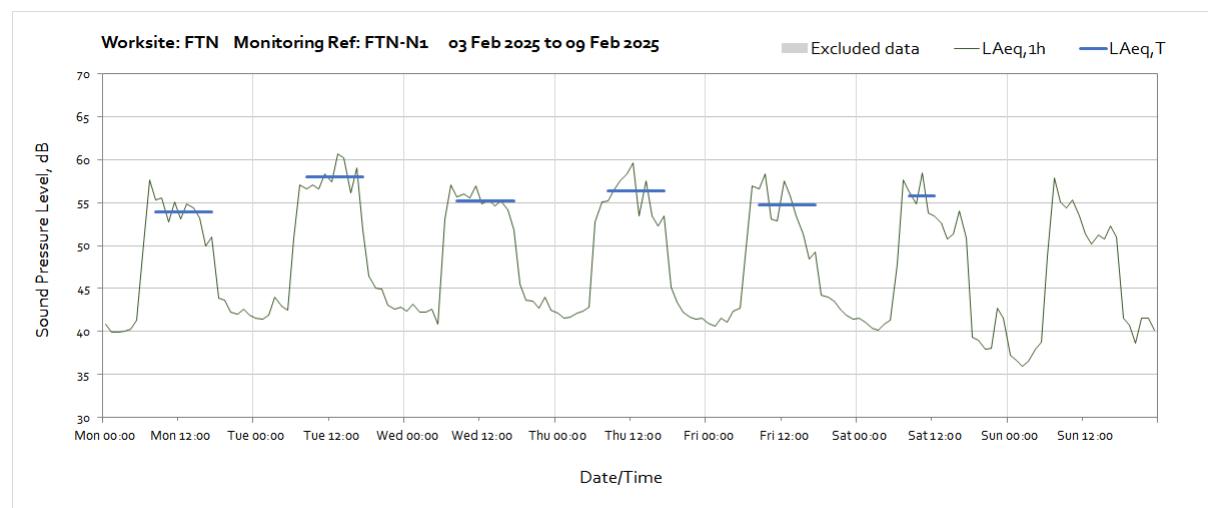
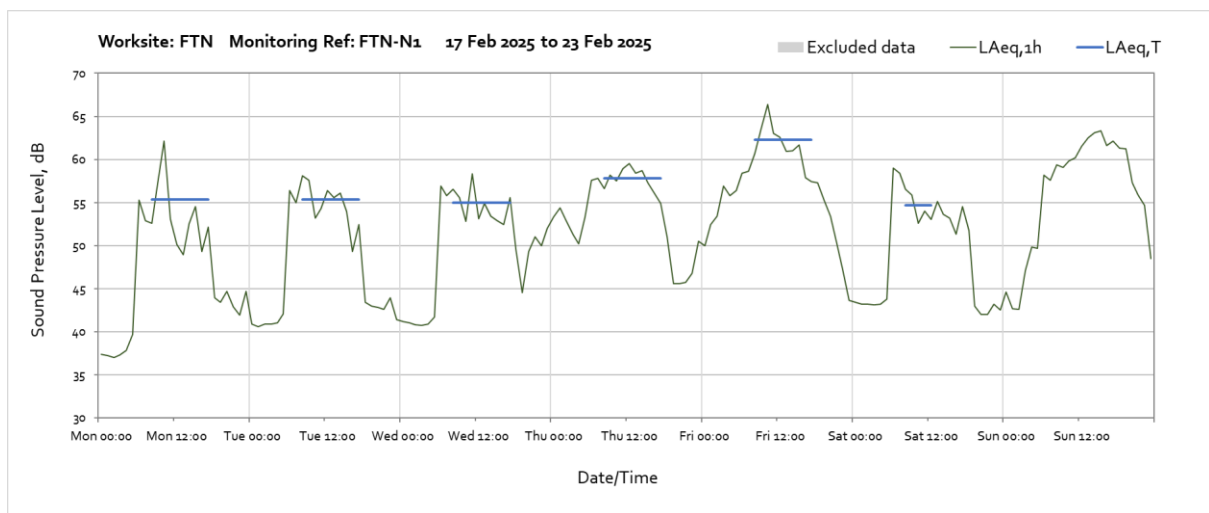
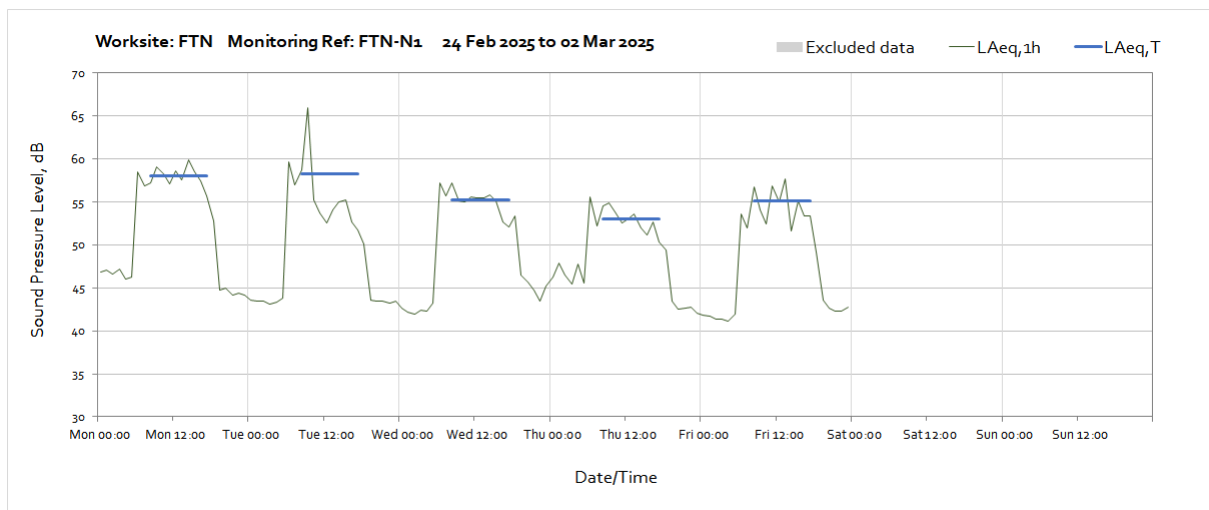
### Worksite: FTN – Monitoring Ref: FTN-N1

The following graphs show the hourly measured ambient noise level  $L_{Aeq,1h}$  and, where relevant, the averaged noise level  $L_{Aeq,T}$  values, where the time period T is as specified in Table 1 of HS2 Information Paper E23. Periods where noise levels are adversely affected by weather or only measured for part of the period, which are not representative of HS2 construction works, have been greyed out and excluded from the calculation of the  $L_{Aeq,T}$  values in Table 3 of the main report.

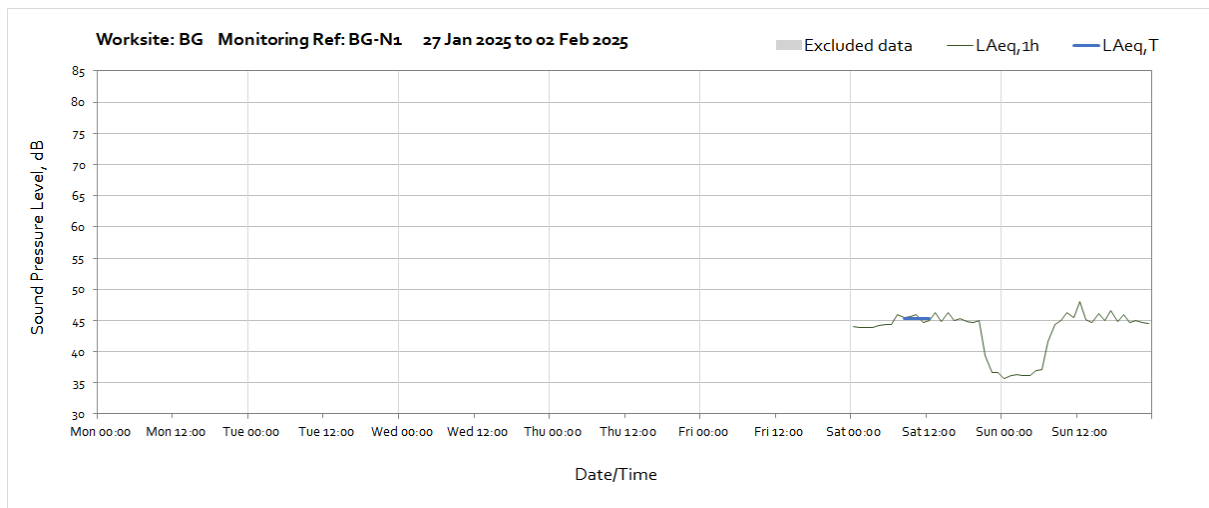
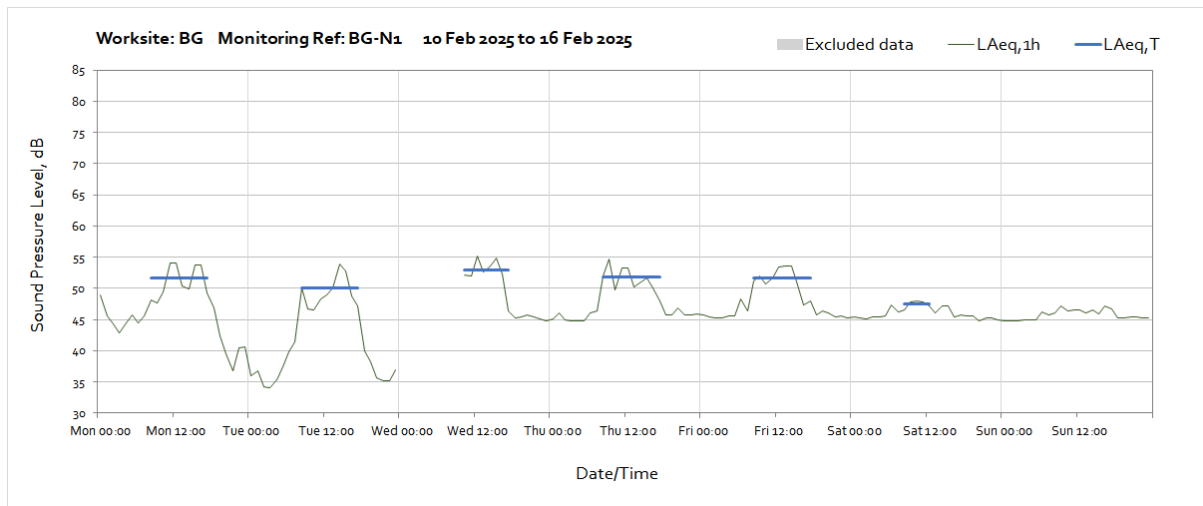
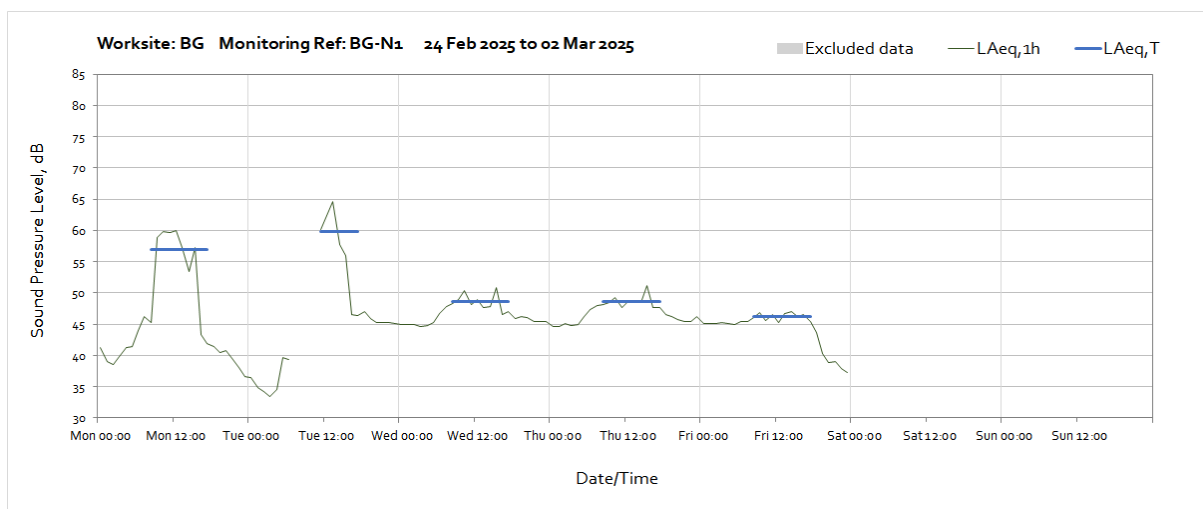
## Worksite: BG – Monitoring Ref: BG-N1

Note: Missing data between 00:00 and 10:00 on Wednesday 12<sup>th</sup> February was due to a loss of power to the monitoring station caused by poor weather conditions preventing sufficient light reaching the solar panel.

Note: Missing data between 07:00 and 11:00 on Tuesday 25<sup>th</sup> February was due to a loss of power to the monitoring station caused by poor weather conditions preventing sufficient light reaching the solar panel.

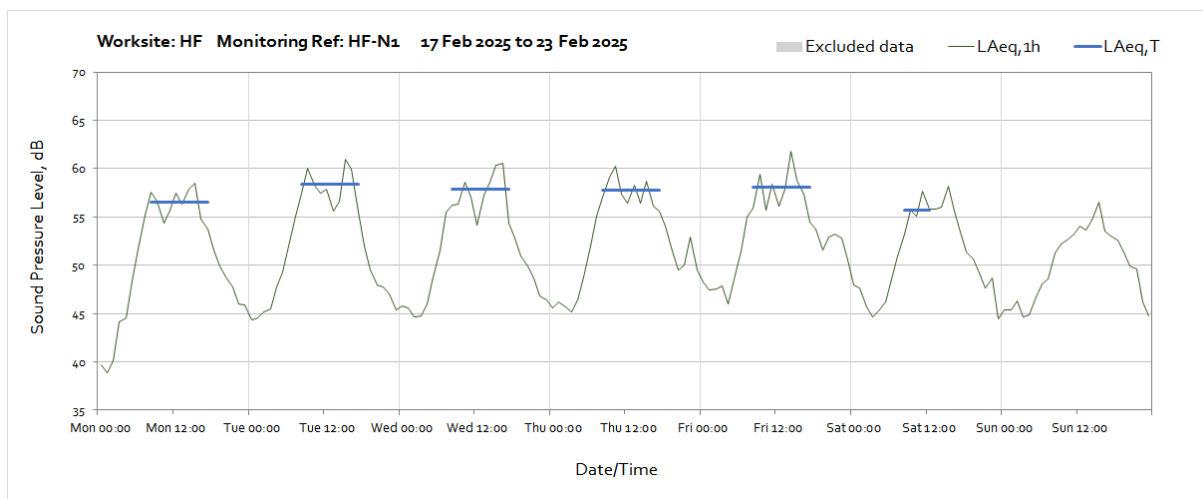
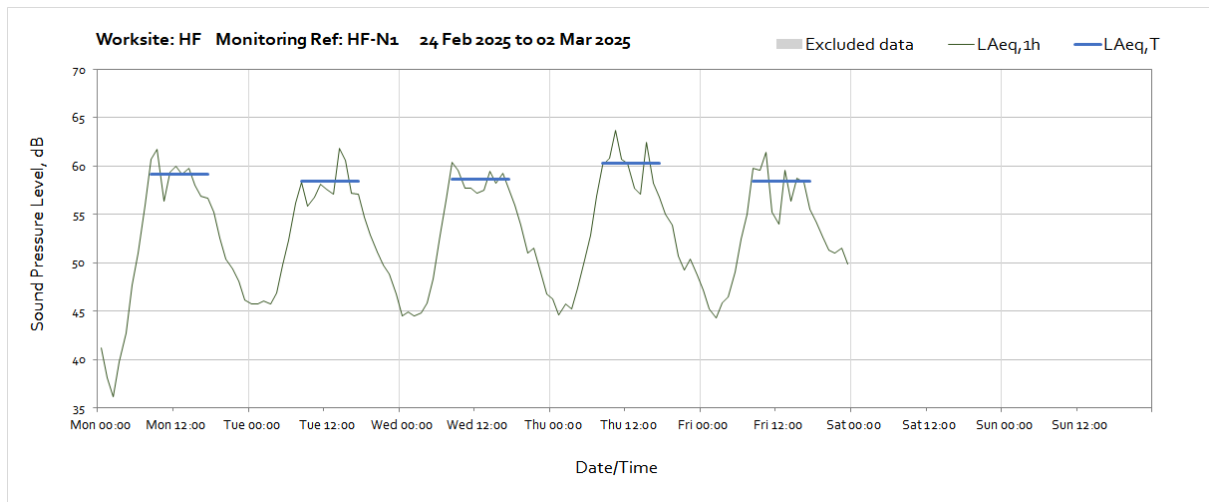
## Worksite: HF – Monitoring Ref: HF-N1

Note: Missing data between 18:00 on Monday 10<sup>th</sup> and 13:00 on Tuesday 11<sup>th</sup> February was due to a depleted battery at the monitoring station.
