Conservation Area 15

Montpelier

Character Appraisal

October 2008

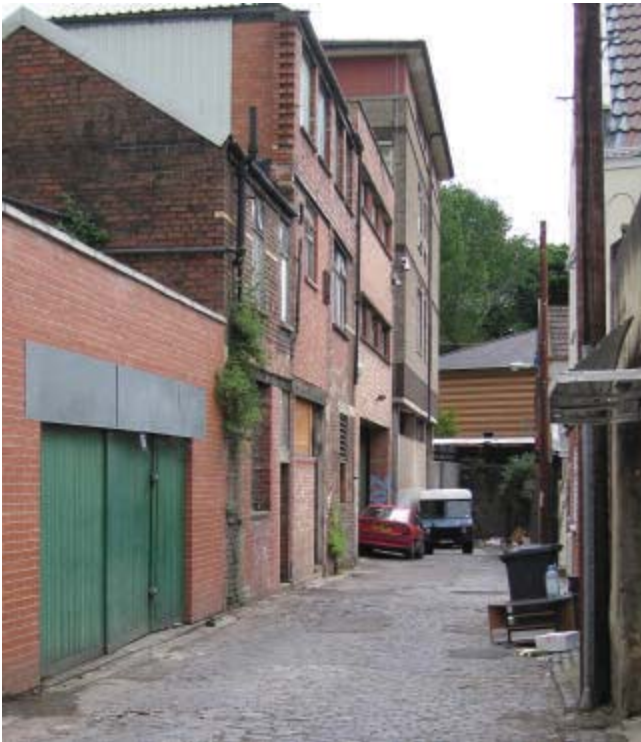
7.1.7 Cheltenham Lane is one of Montpelier's few surviving mews, which retains traditional Pennant setted street surface and a collection of coach-house and mews style buildings.

Figure 15: Cheltenham Lane

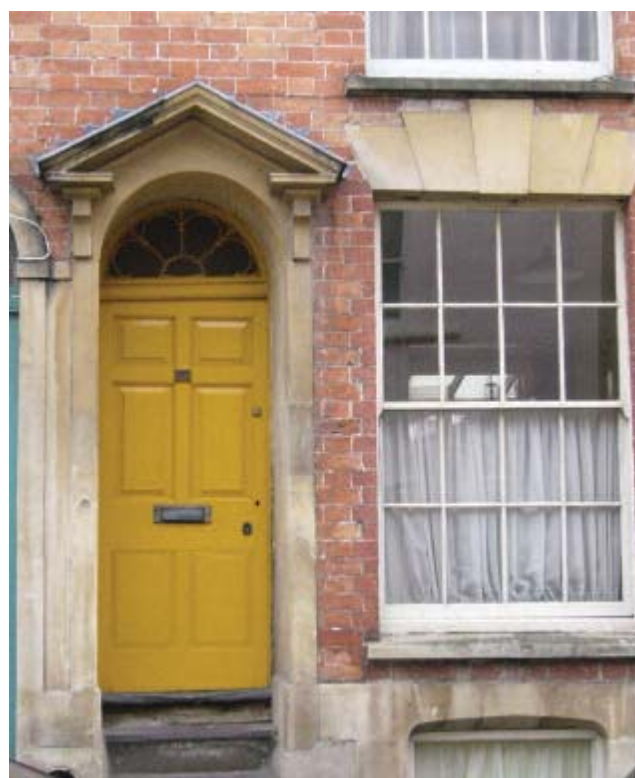
Figure 32: Limestone pedimented door surround, timber panelled door with decorative fanlight and eight-over-eight timber sash window, Picton Street

7.3.8 Doors and surrounds are the most elaborately detailed element of the facades. In Montpelier there are a variety of original 6-panel doors with traditional door furniture. These have a variety of limestone Classical surrounds.

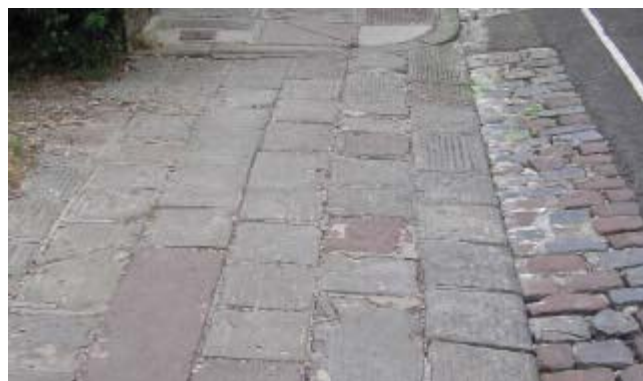
Figure 33: Traditional street surface on St Andrew's Road, north side

7.5.4 Many of the streets in the Conservation Area retain setted gutters and stone kerbs. It is likely that setted gutters remain in situ under tarmac in many other places. There are also a significant number of stone-paved haulingways across pavement, mostly outside premises which were formerly in industrial or commercial use.

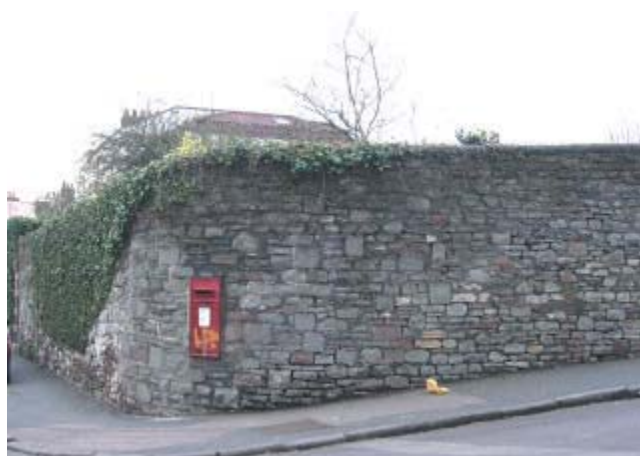
Figure 34: High Pennant stone boundary wall, Richmond Road

7.5.7 Railings and boundary walls contribute significantly to the character of the Montpelier Conservation Area. They add interest and variety of scale in the street scene and provide a sense of enclosure. Where they remain, traditional boundary walls, gates, gate piers and railings must be preserved, sympathetically restored or reinstated as and when the opportunity arises.

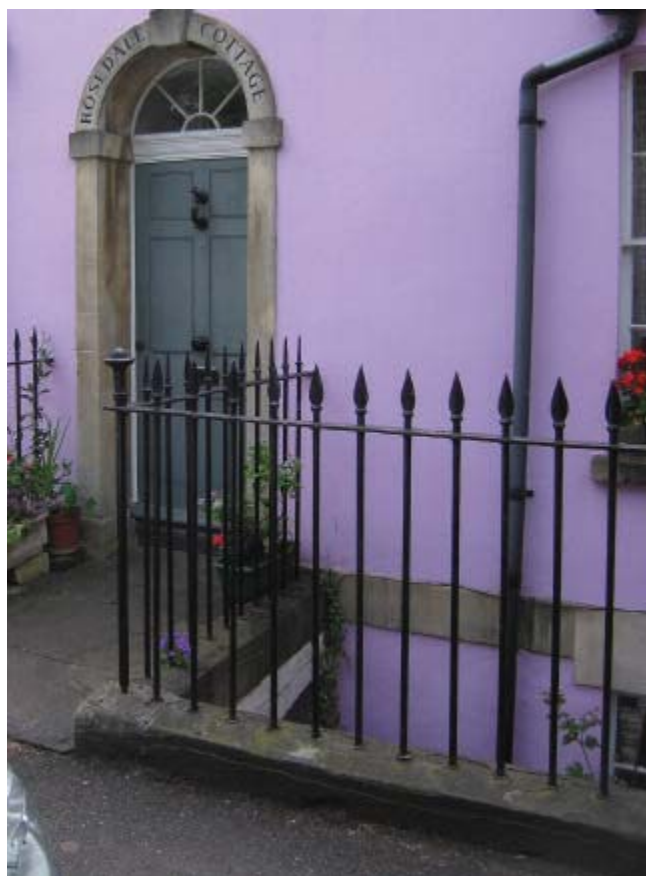
Figure 35: Wrought iron spear headed railings

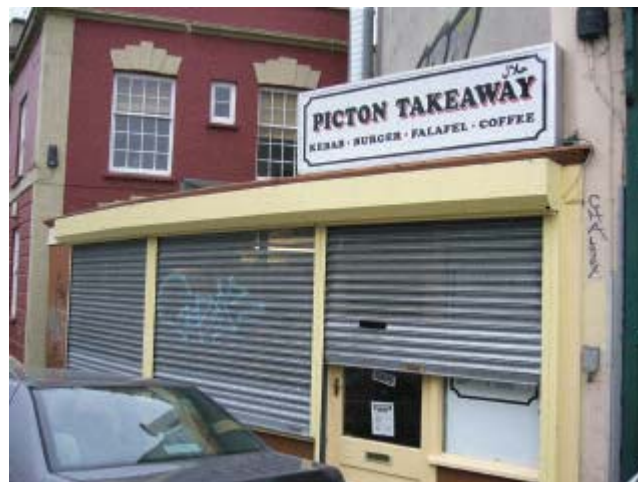
- 8.6 Shopfronts & Signage - Poor quality replacement shopfront and signage can have a dramatic effect on the quality of the street scene. This is particularly significant along Picton Street, Cheltenham Road and Sussex Place.

Figure 44: Poor quality shopfront and signage, Picton Street

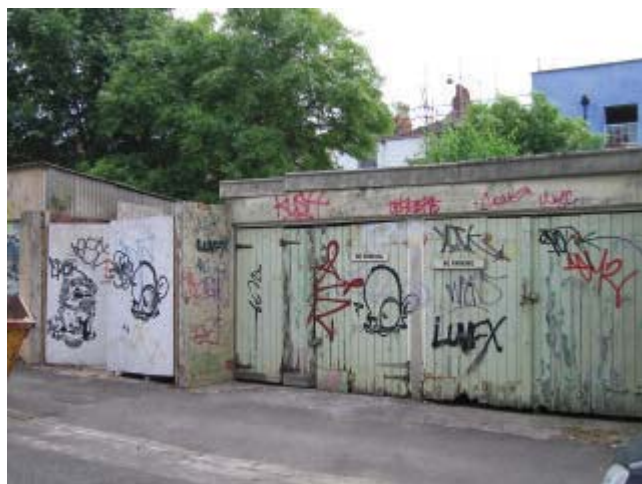
8.13 Refuse, litter & 'tagging' all undermine the quality of the environment and contribute to a sense of decay and neglect in areas. Tagging is especially problematic on garage doors along St Andrews Road. The proliferation of wheelie bins and recycling boxes clutter the pavements and impede pedestrian movement.

Figure 46: 'Tagging' on garages, St Andrew's Road
