HS2

May 2025

Construction Noise and Vibration Monthly Report – March 2025

London Borough of Ealing

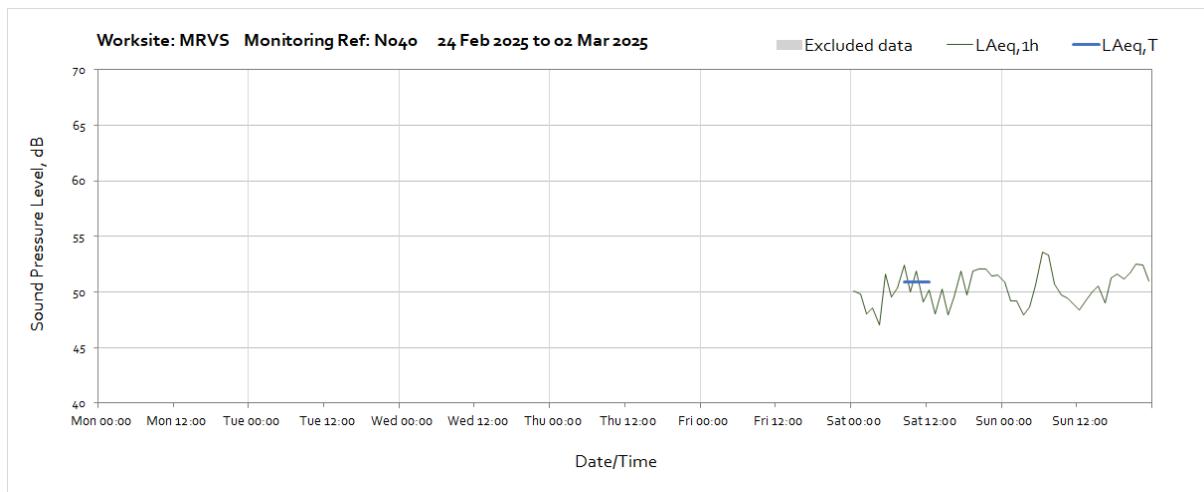
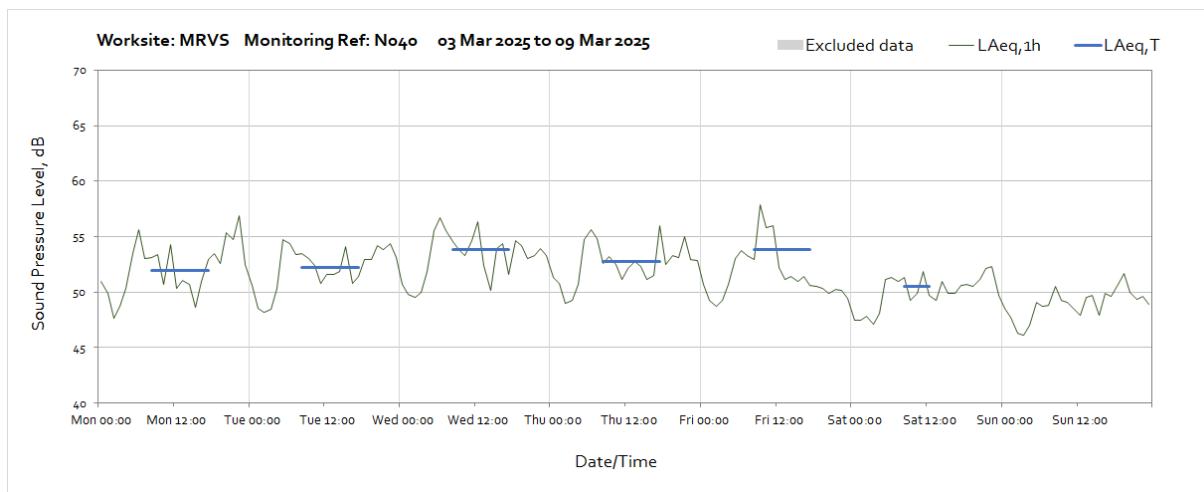
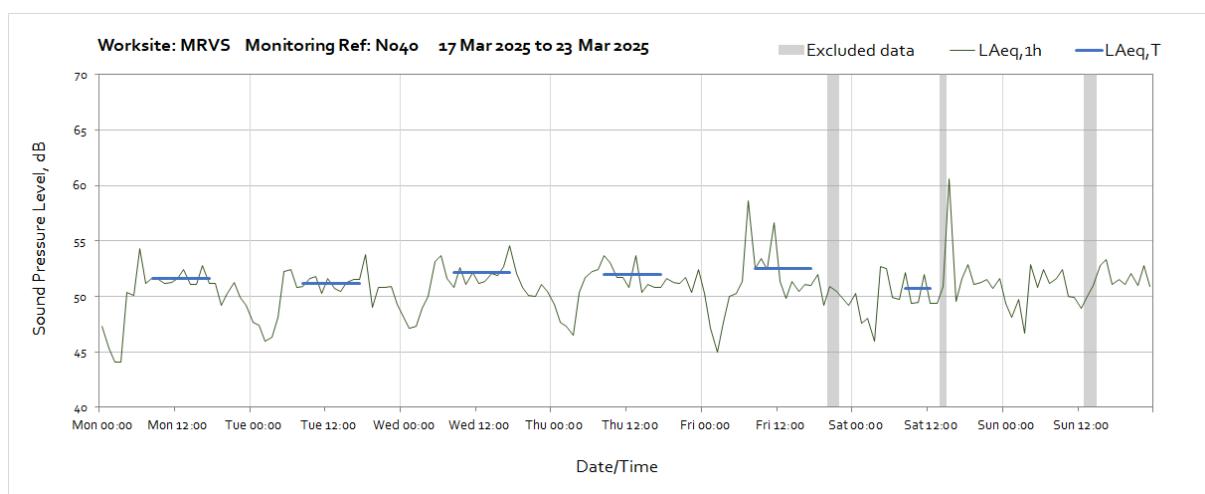
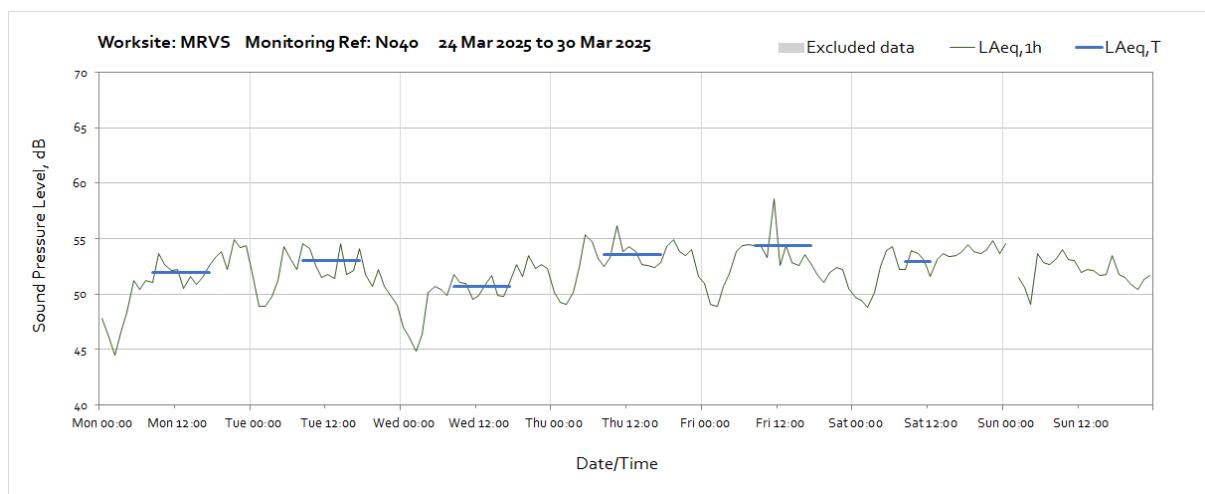
Worksite: MRVS – Monitoring Ref: N040

Note: Missing data between 01:00 and 02:00 on Sunday 30th March was due to the start of British Summer Time.

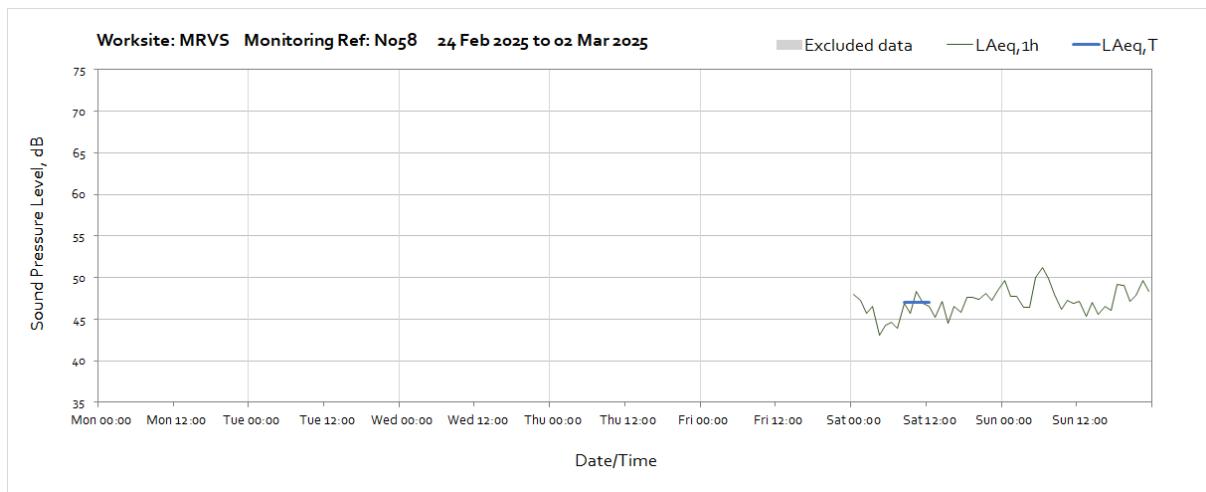
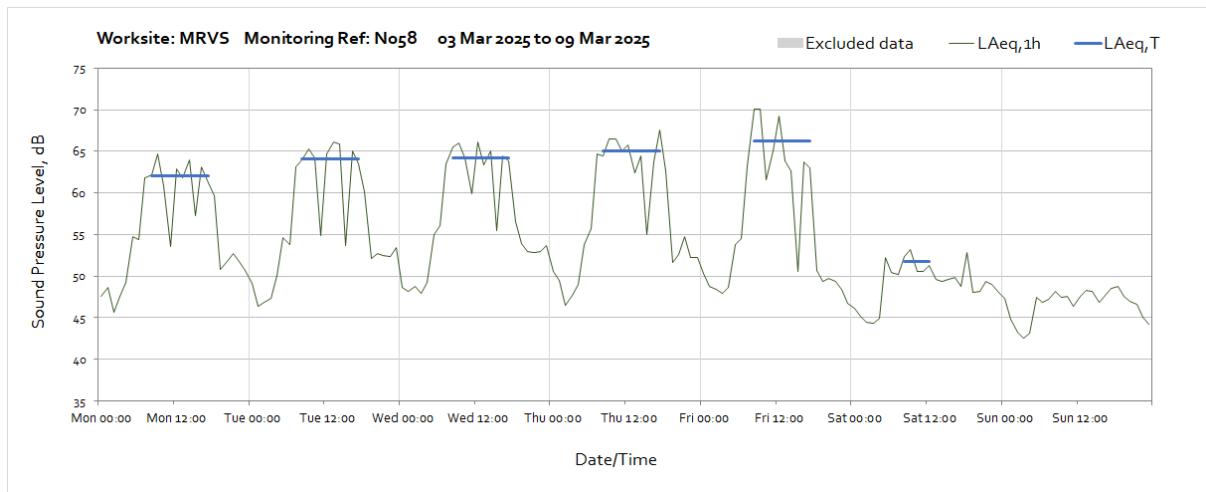
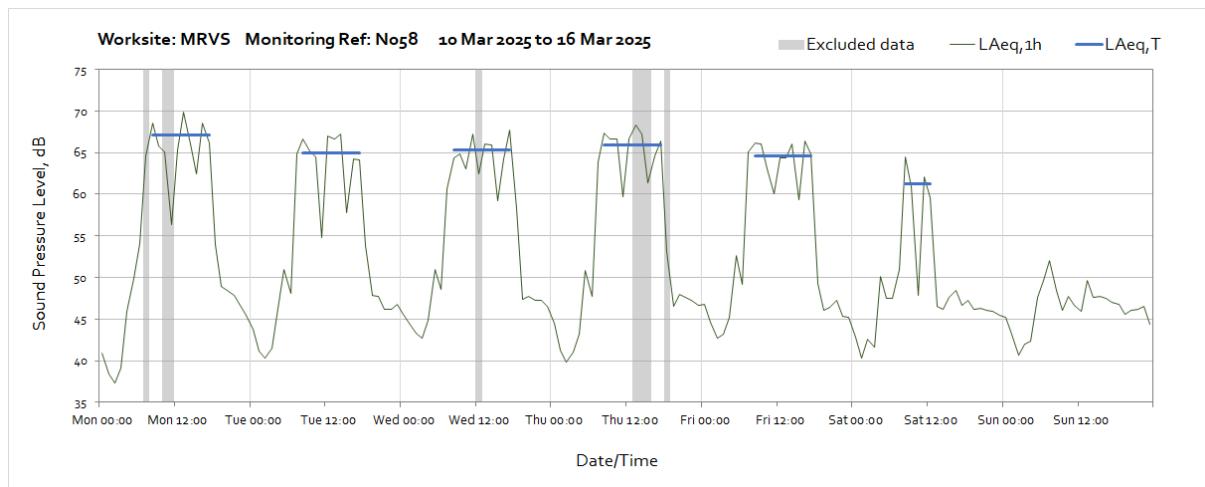
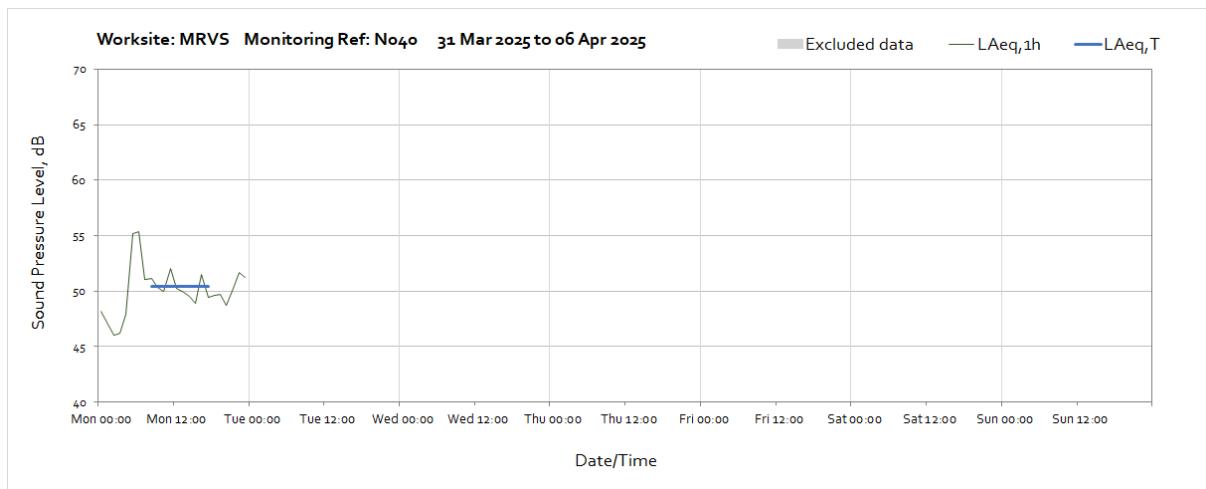
Worksite: MRVS – Monitoring Ref: N058

Note: Missing data between 01:00 and 02:00 on Sunday 30th March was due to the start of British Summer Time.

- 2.1.3 Appendix C presents graphs of the noise and vibration monitoring data over the month for each of the measurement locations. Noise data presented consists of the hourly L_{Aeq} values and, where relevant, the $L_{Aeq,T}$ values (where the time period T has been taken to be the averaging period as specified in Table 1 of HS2 Information Paper E23). Vibration data presented consist of hourly PPV values. The full data set for the monitoring equipment can be found at the following location:
<https://data.gov.uk/dataset/24542ae7-dd44-444f-b259-871c4cc43b5e/environmental-monitoring-data>.

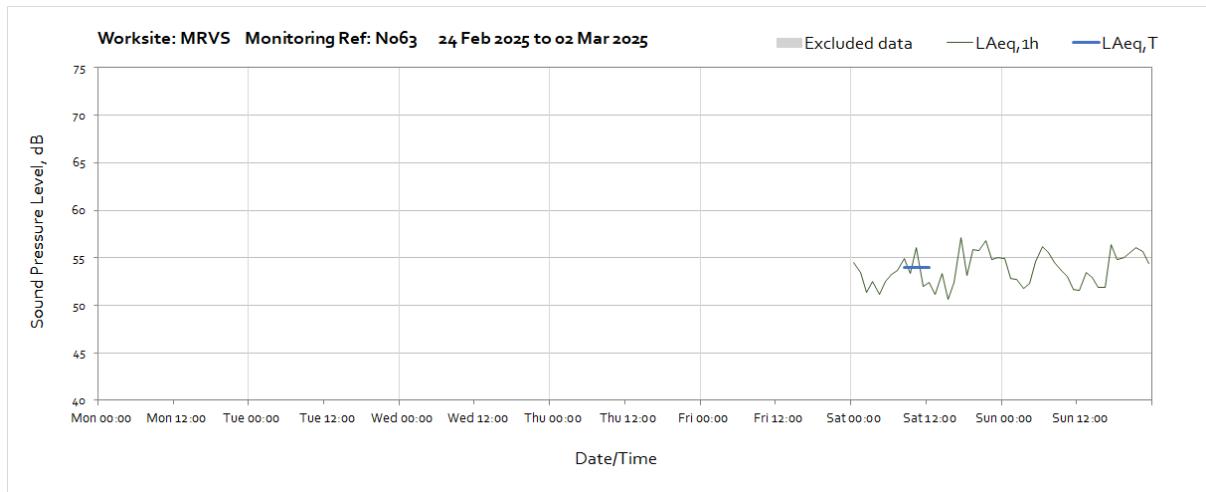
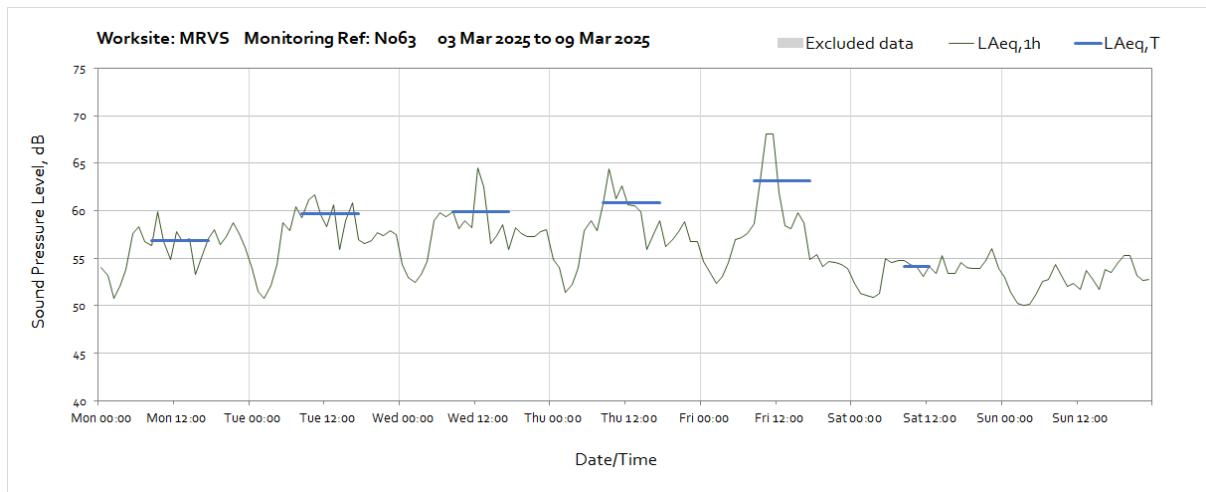
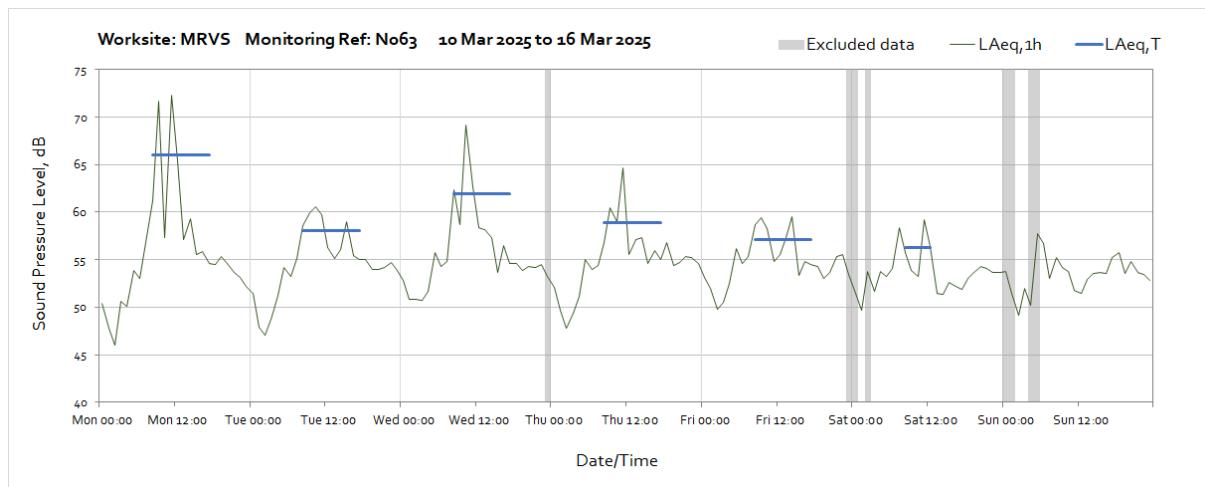
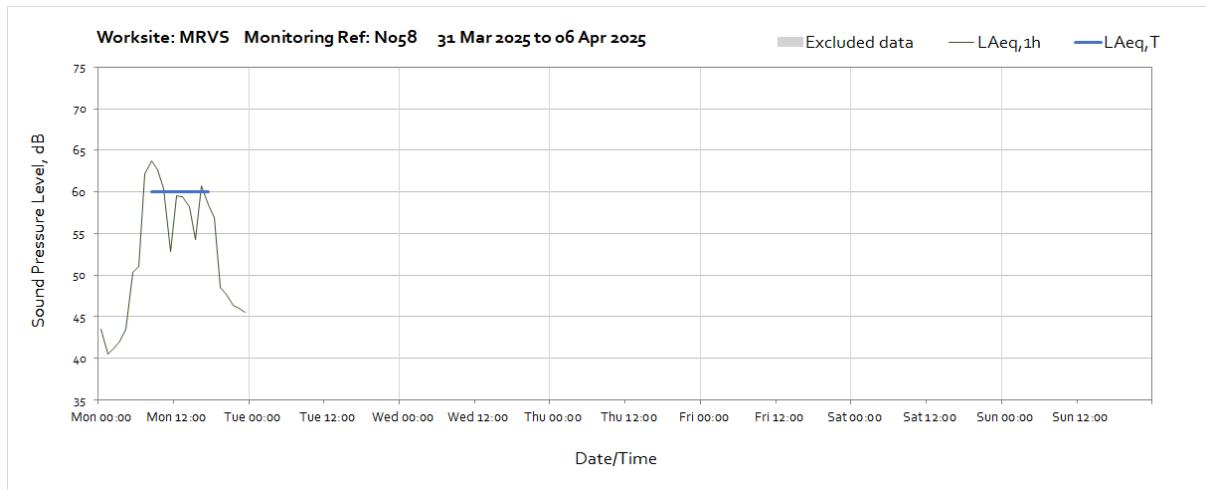
Worksite: MRVS – Monitoring Ref: N063

Note: Missing data between 01:00 and 02:00 on Sunday 30th March was due to the start of British Summer Time.

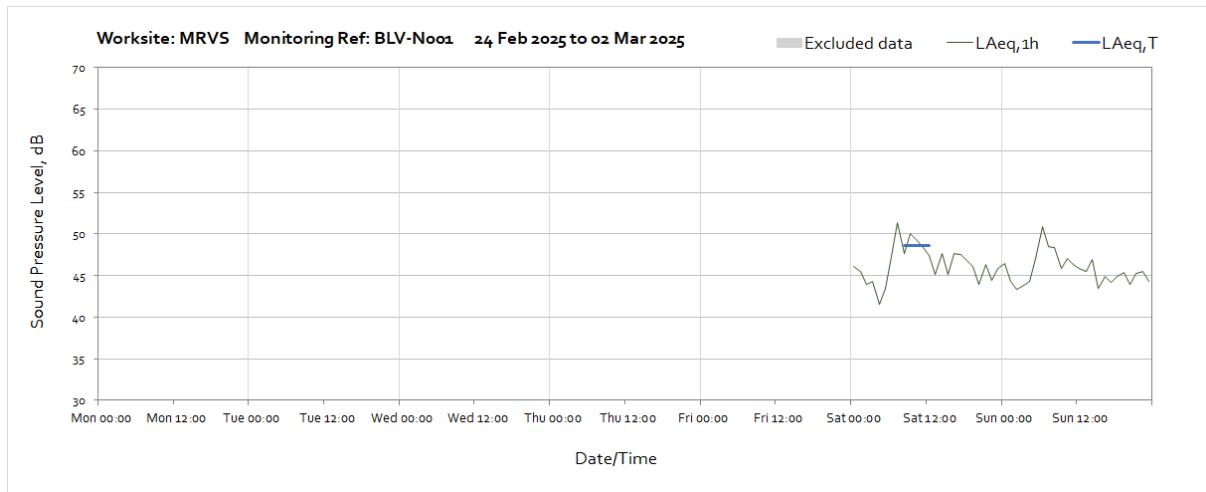
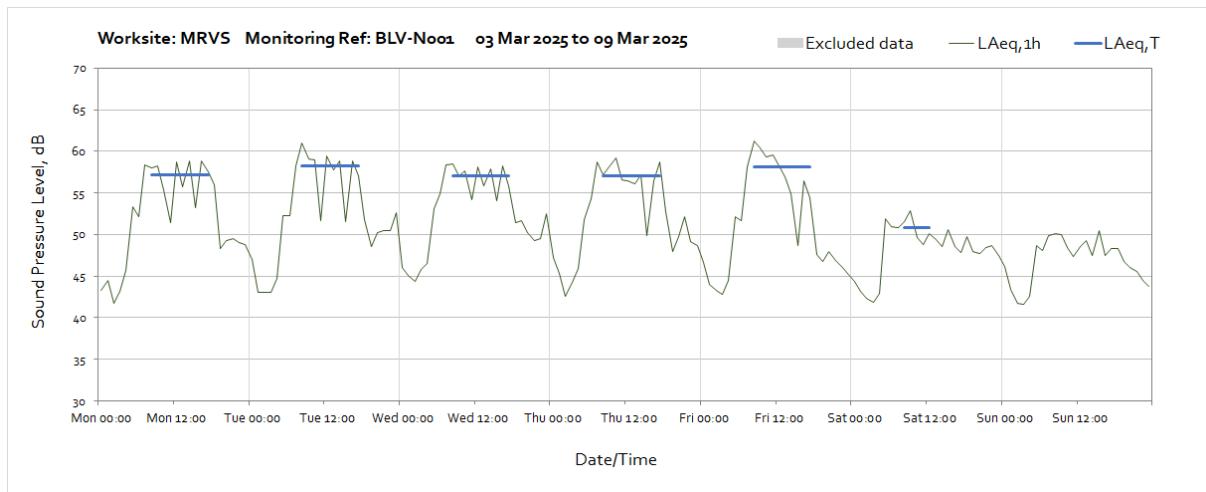
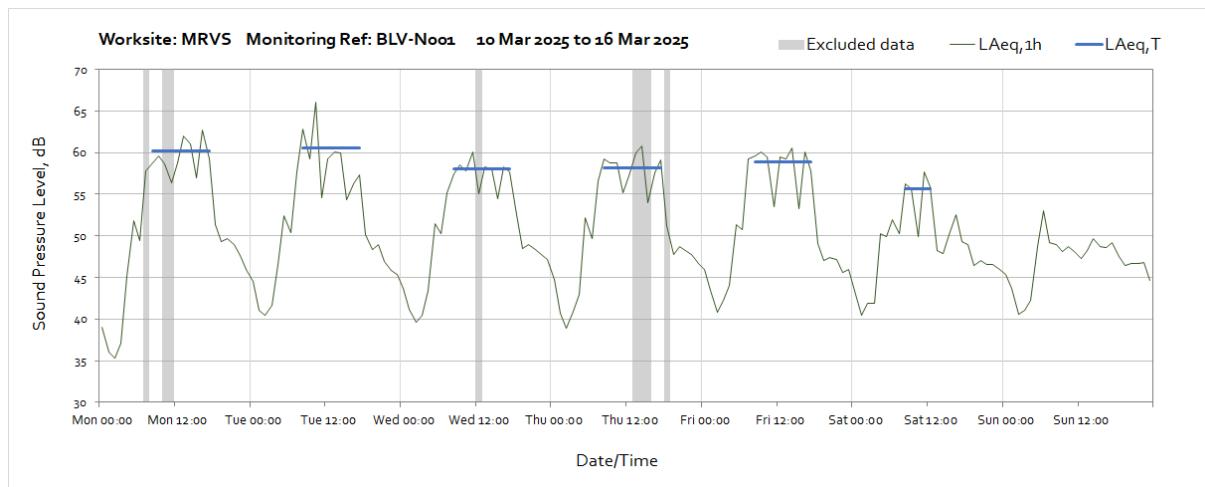
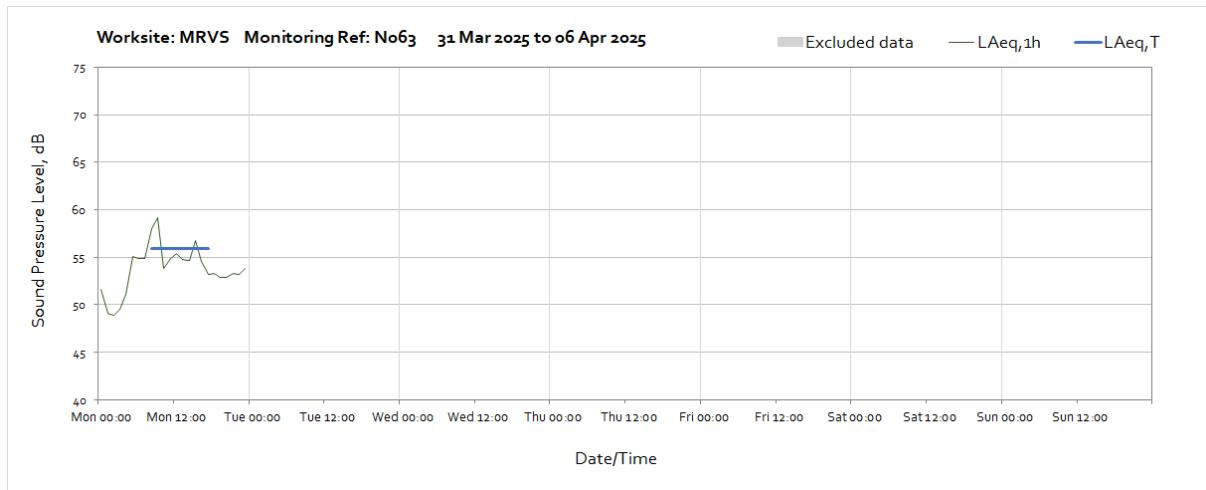
Worksite: MRVS – Monitoring Ref: BLV-N001

Note: Missing data between 01:00 and 02:00 on Sunday 30th March was due to the start of British Summer Time.

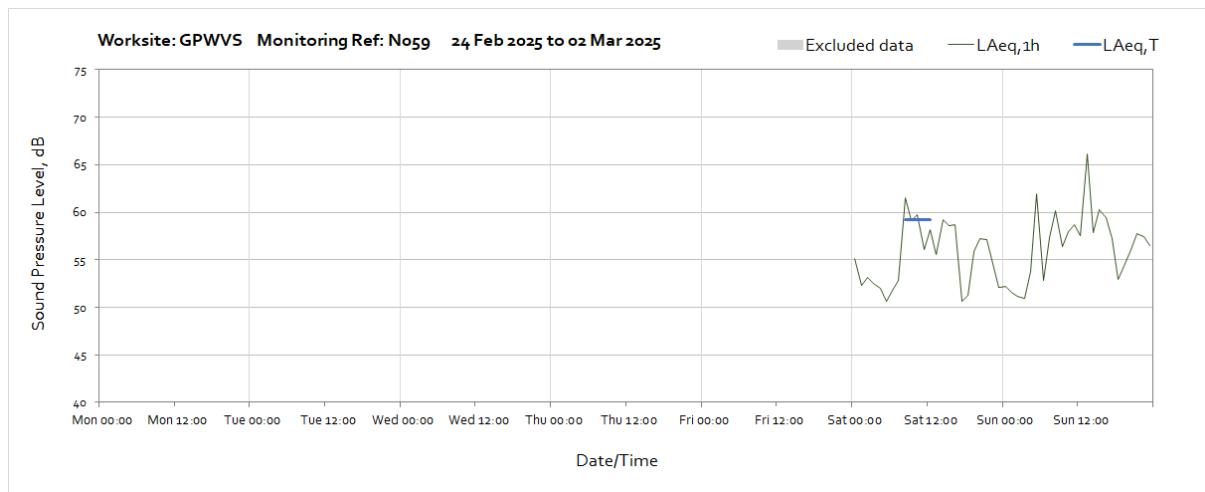
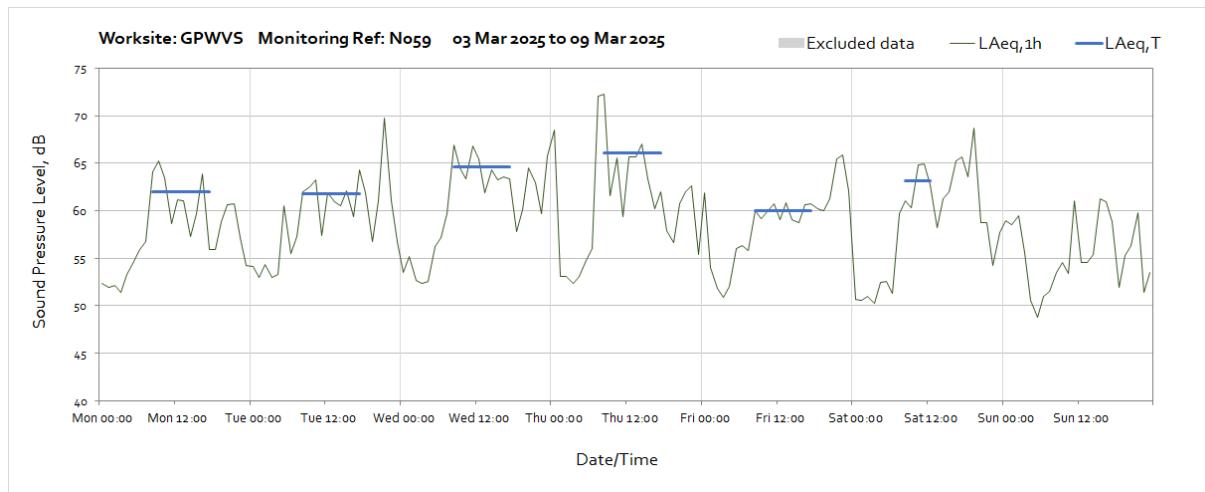
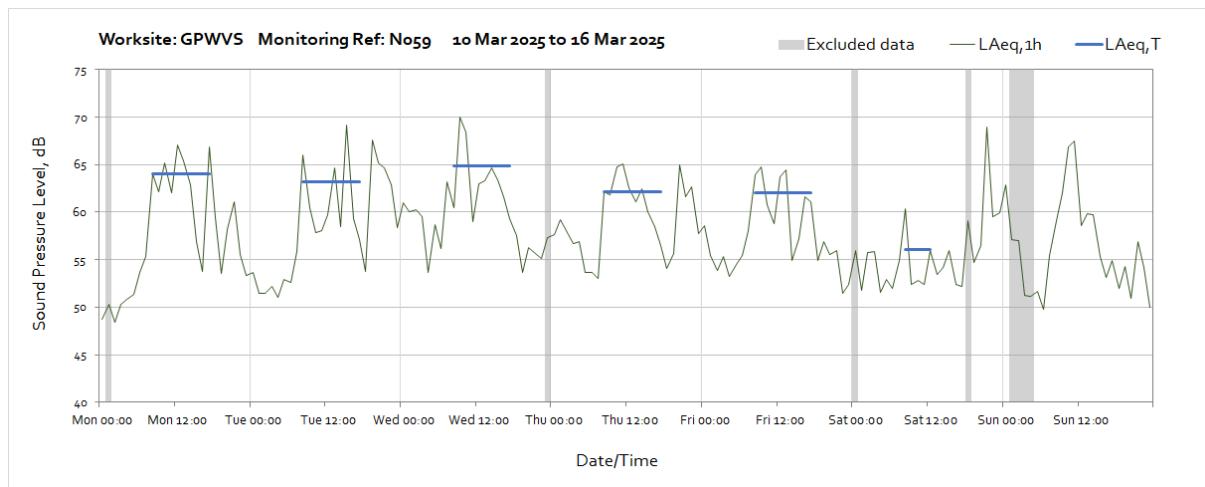
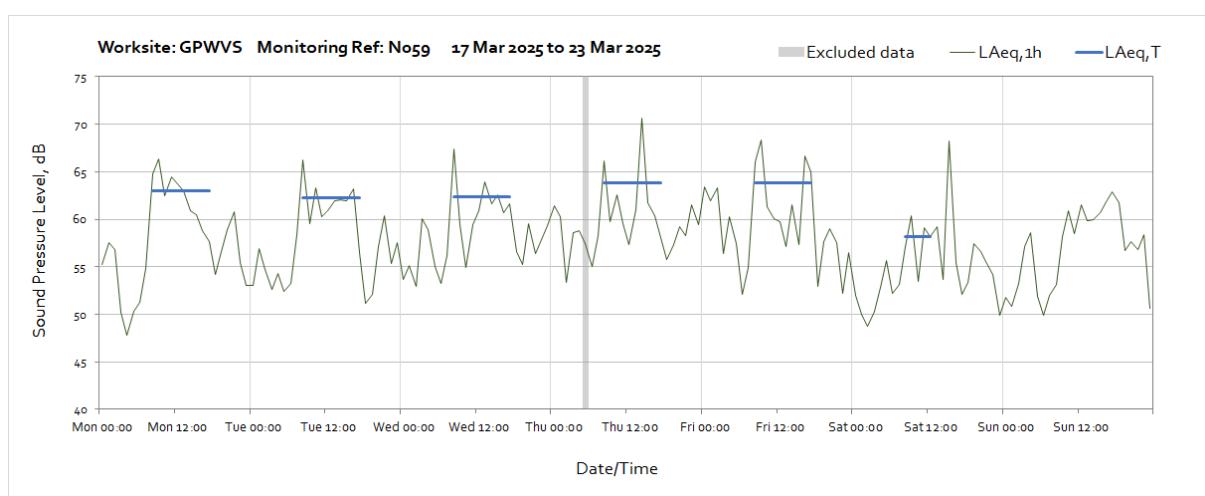
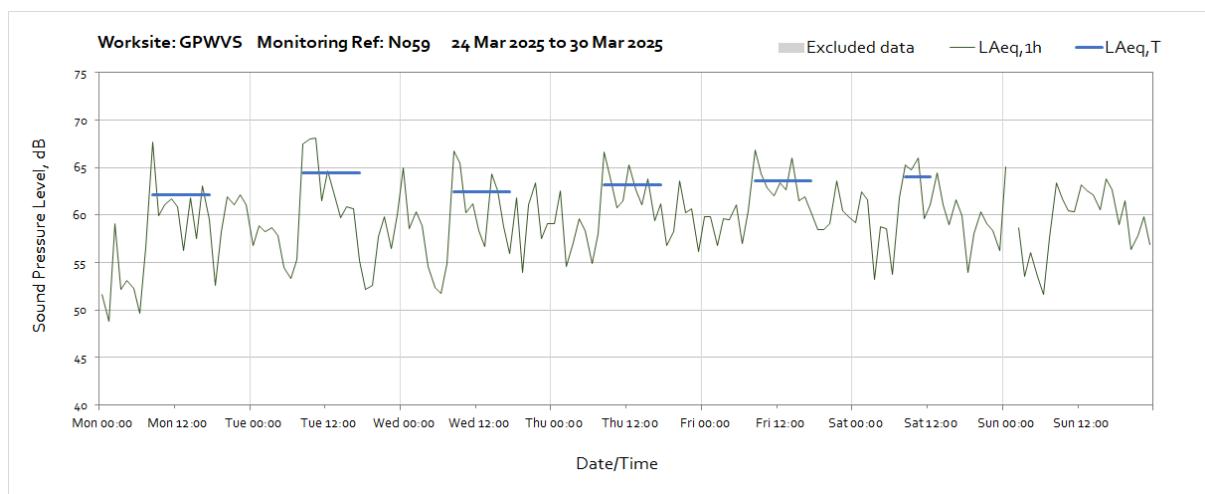
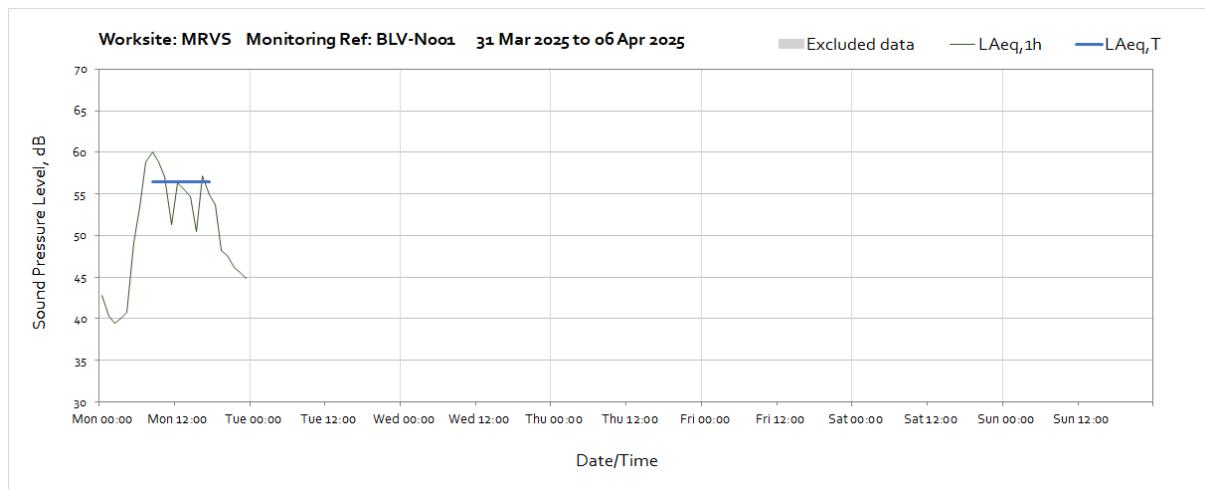
Worksite: GPWVS – Monitoring Ref: N059

Note: Missing data between 01:00 and 02:00 on Sunday 30th March was due to the start of British Summer Time.

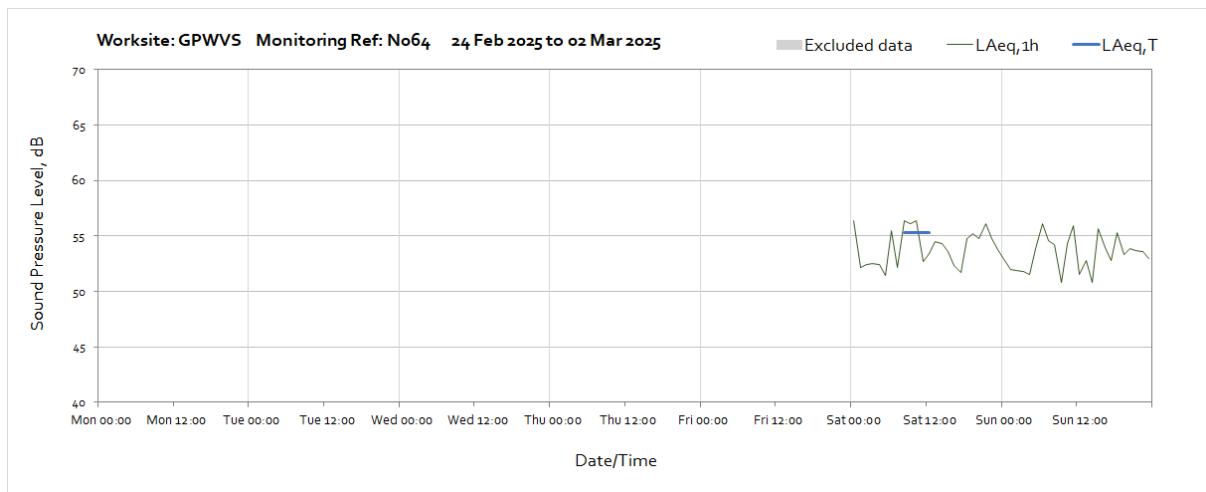
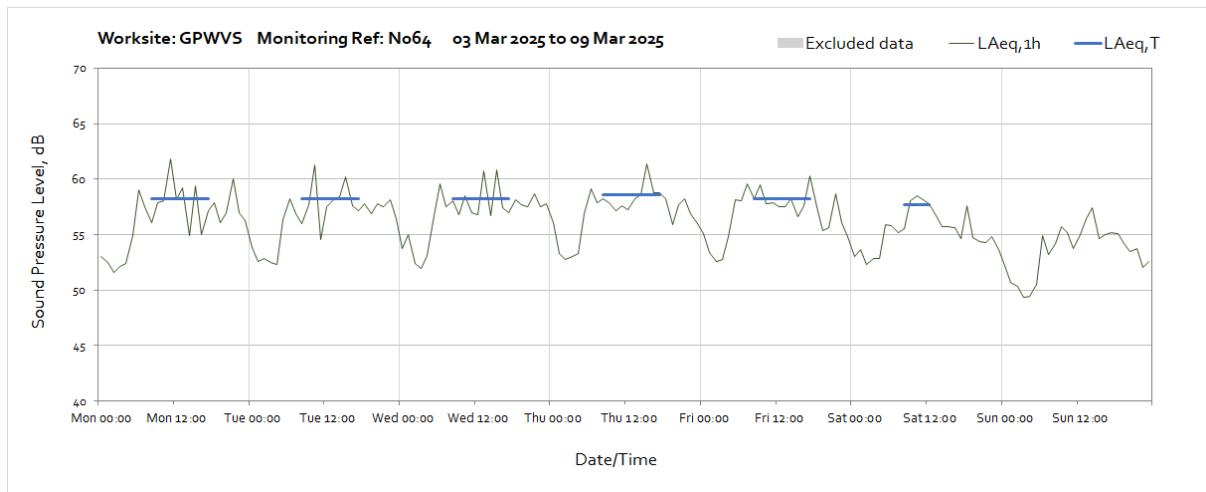
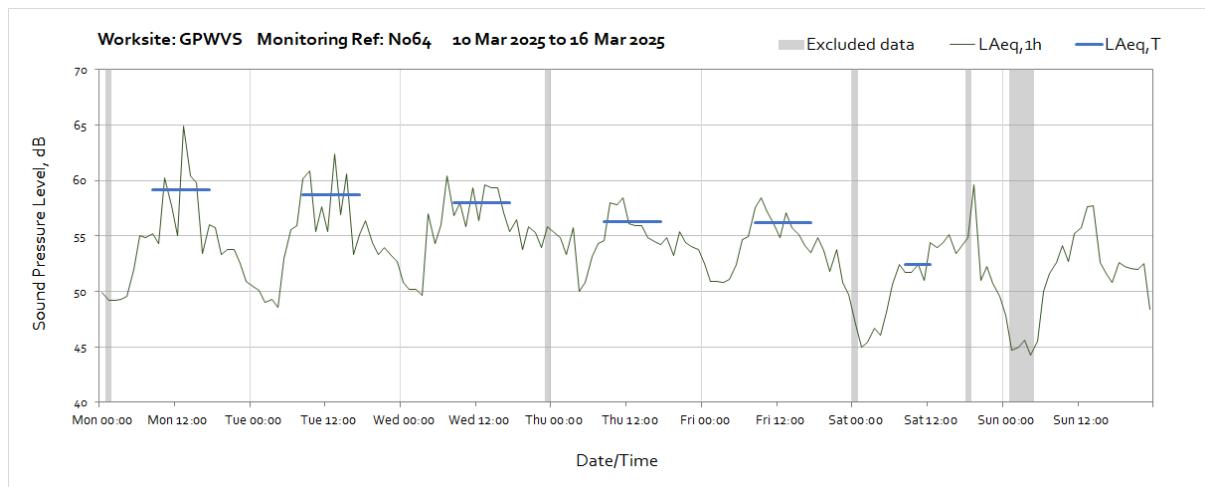
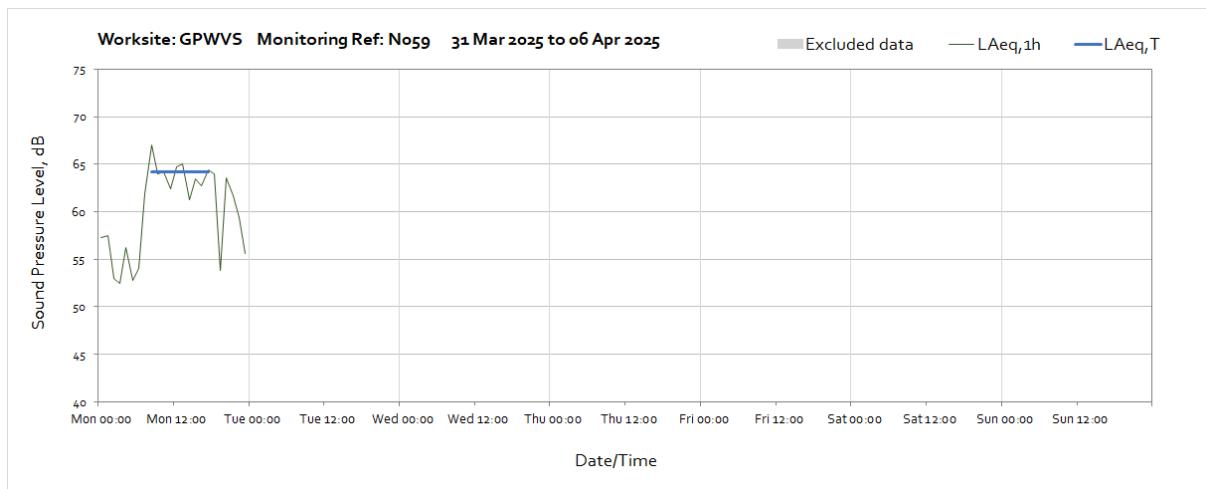
Worksite: GPWVS – Monitoring Ref: N064

Note: Missing data between 01:00 and 02:00 on Sunday 30th March was due to the start of British Summer Time.

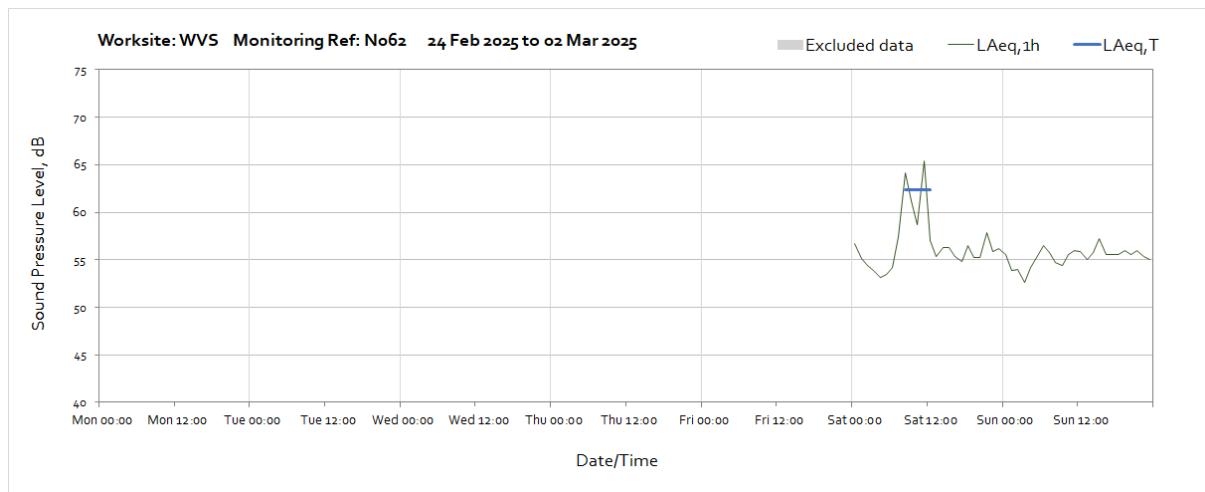
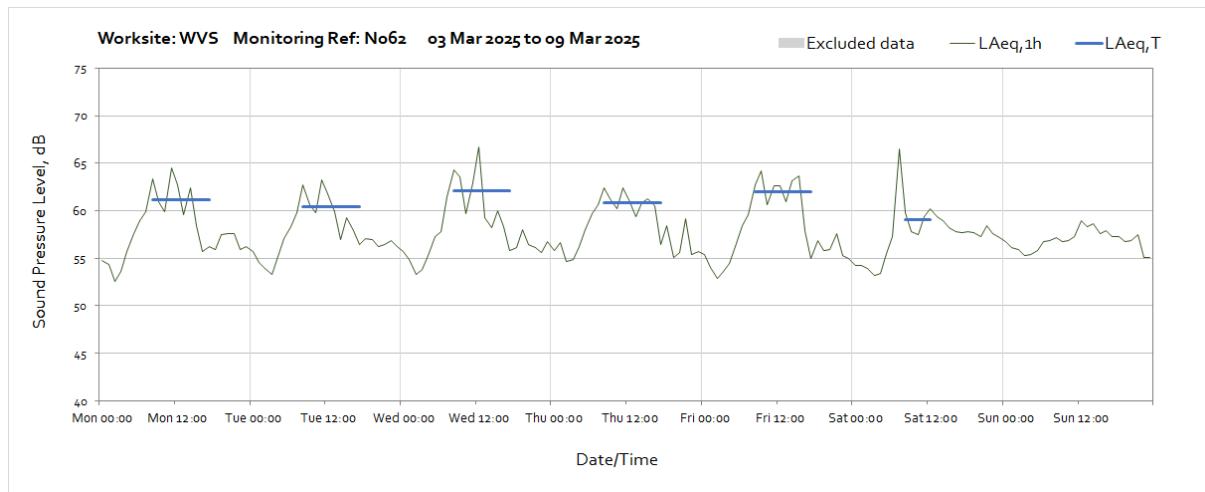
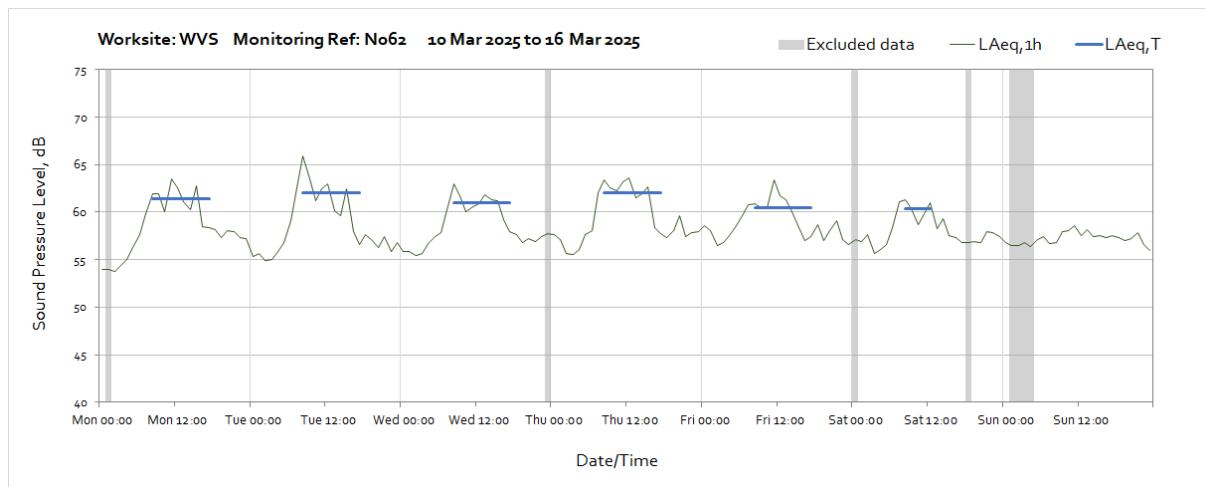
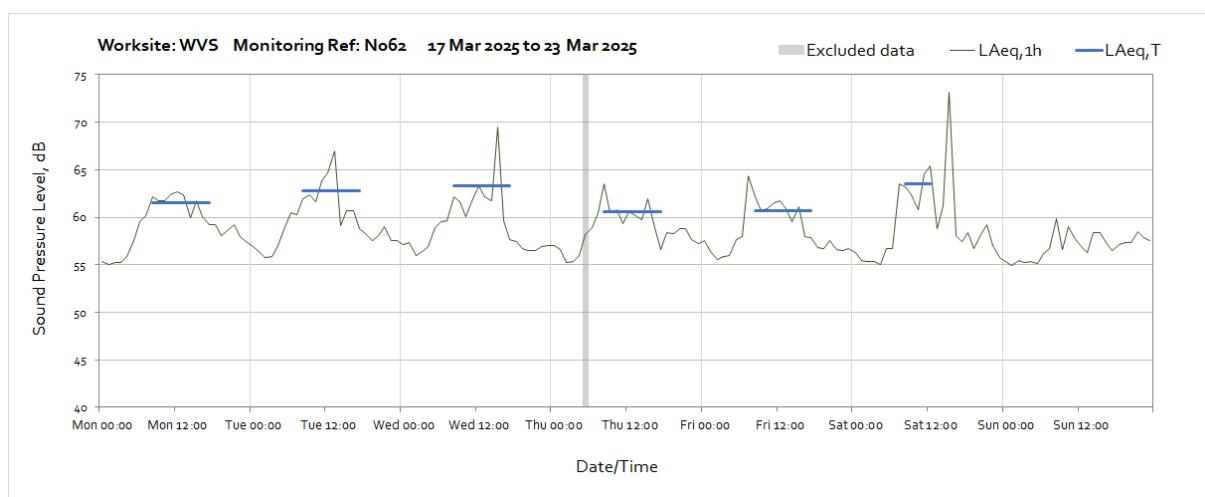
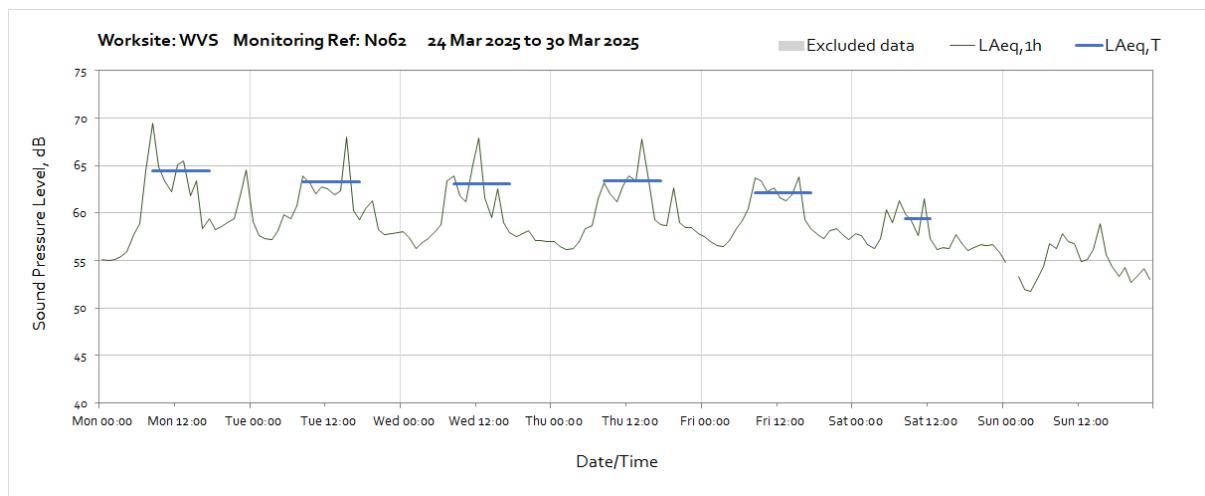
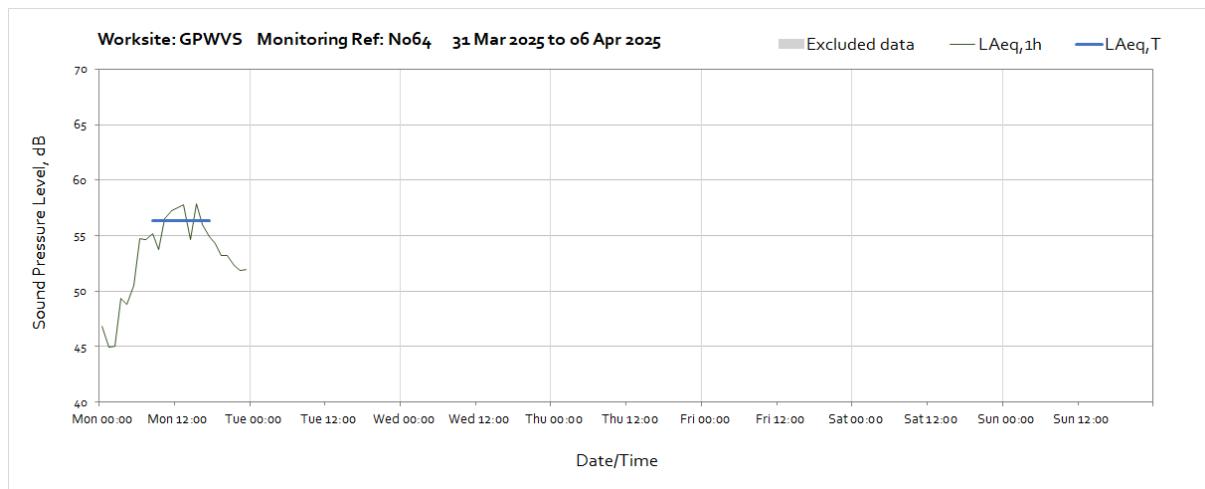
Worksite: WVS – Monitoring Ref: N062

Note: Missing data between 01:00 and 02:00 on Sunday 30th March was due to the start of British Summer Time.

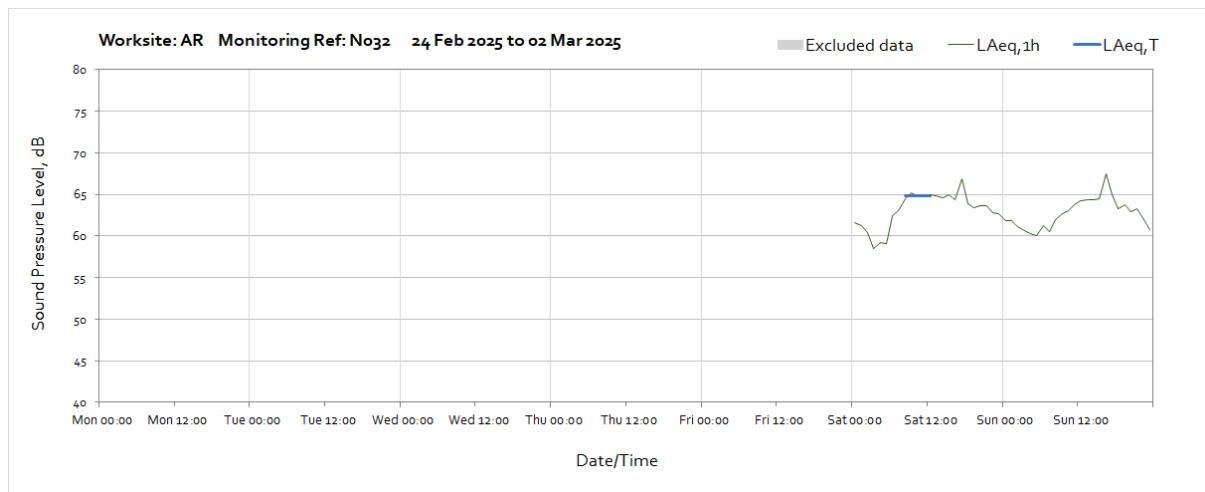
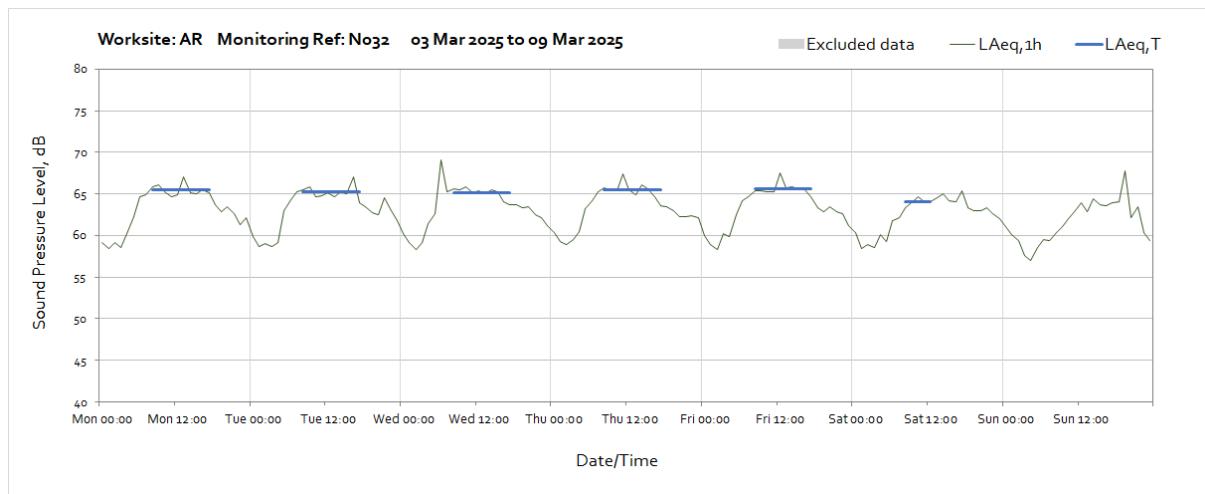
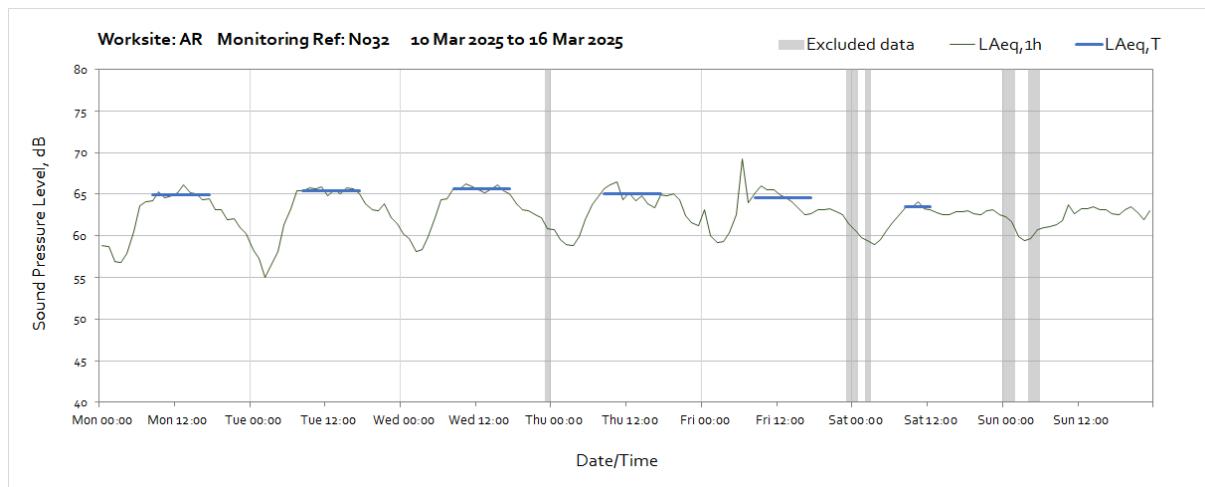
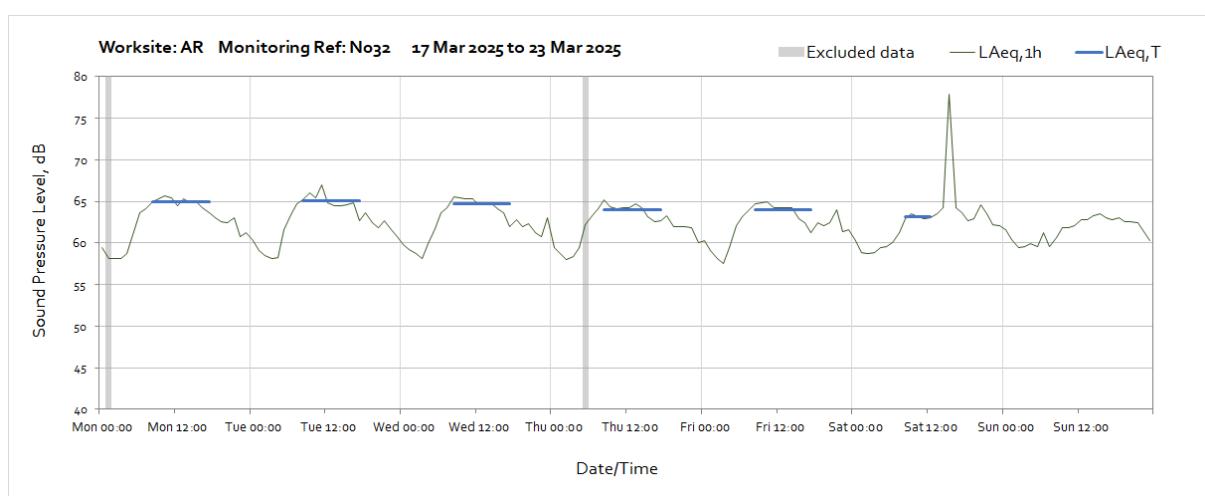
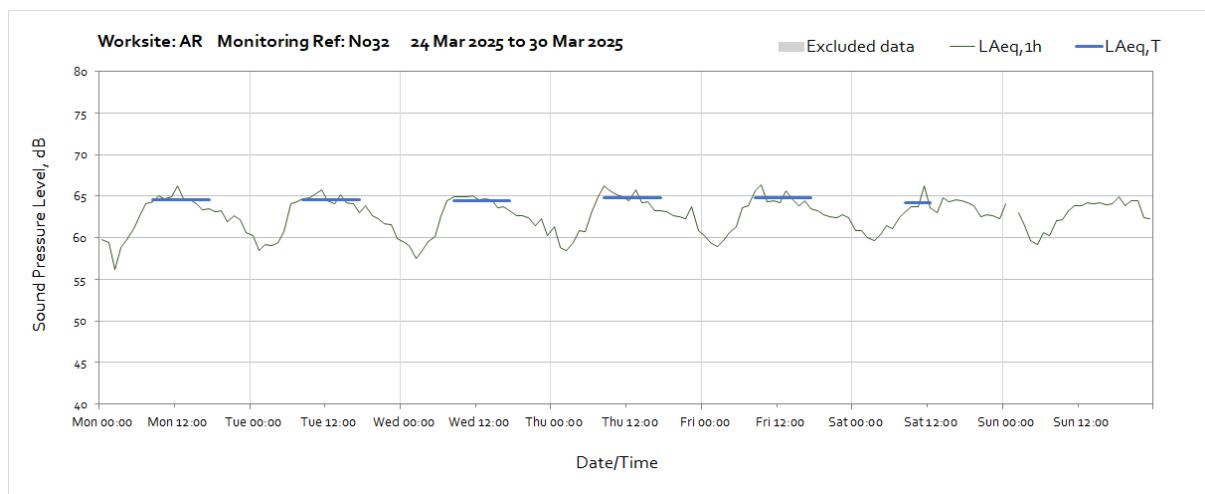
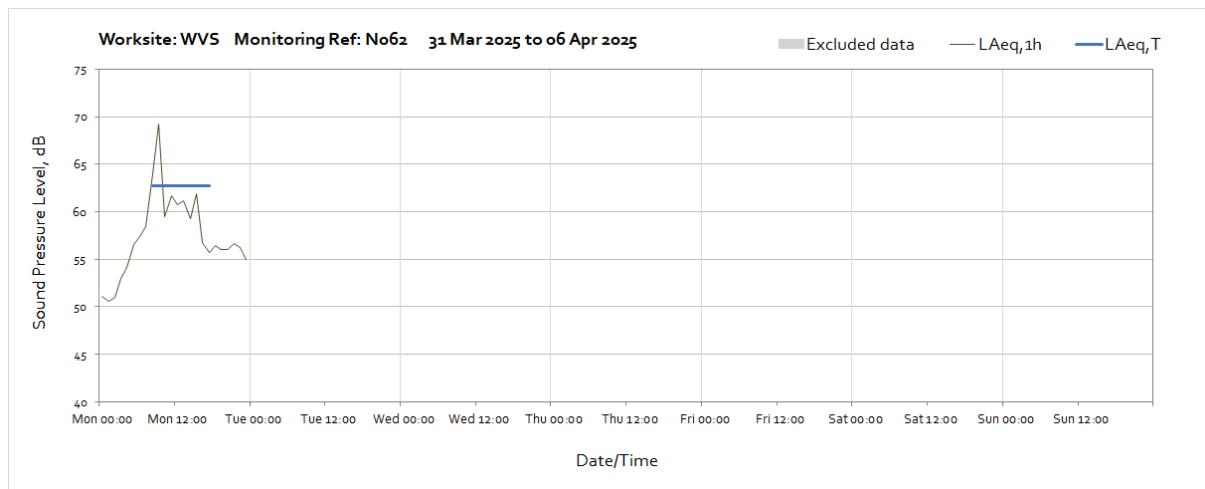
Worksite: AR - Monitoring Ref: N032

Note: Missing data between 01:00 and 02:00 on Sunday 30th March was due to the start of British Summer Time.
