HS2

May 2025

Construction Noise and Vibration Monthly Report – March 2025

London Borough of Ealing

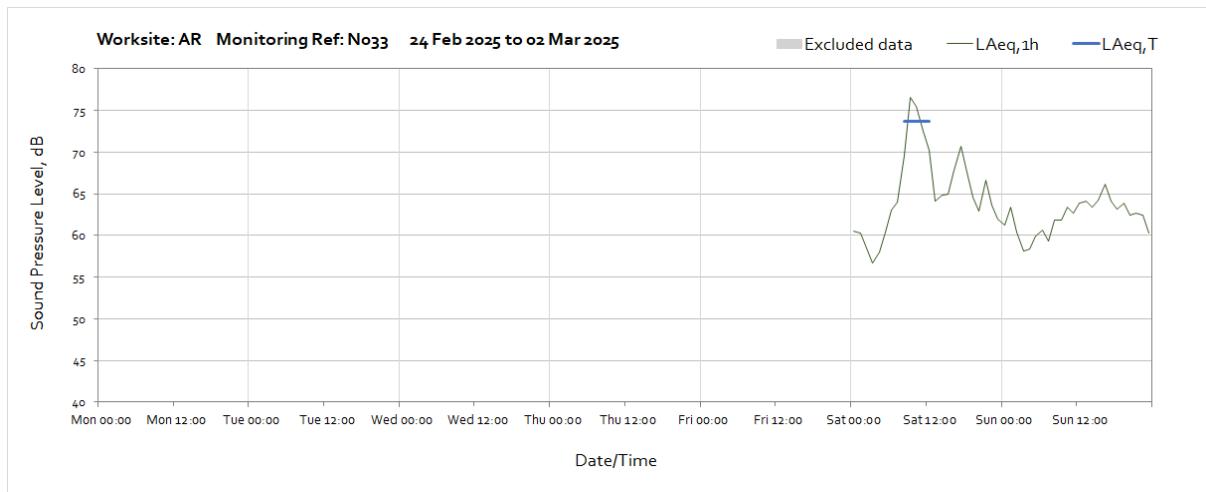
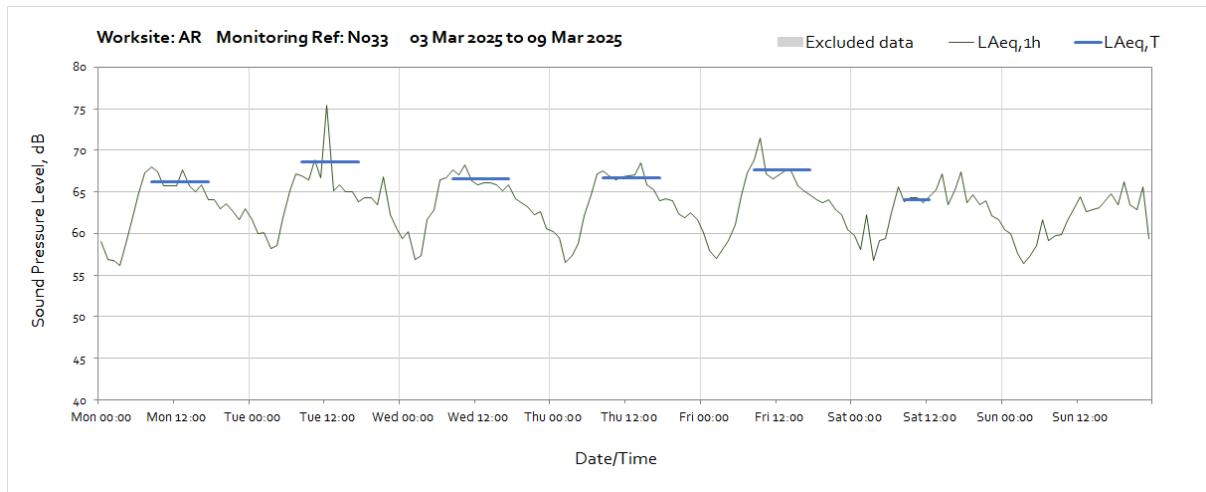
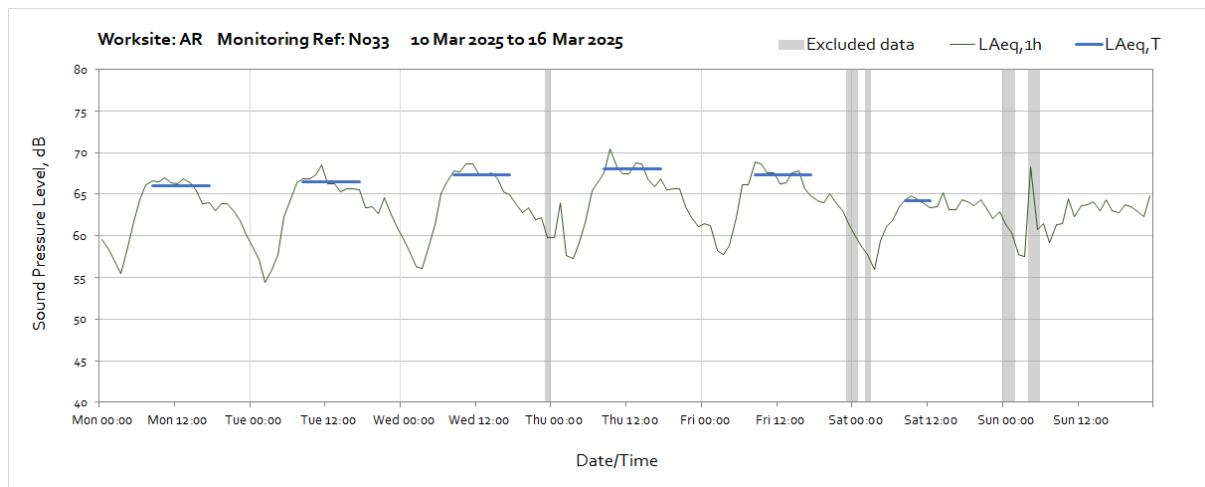
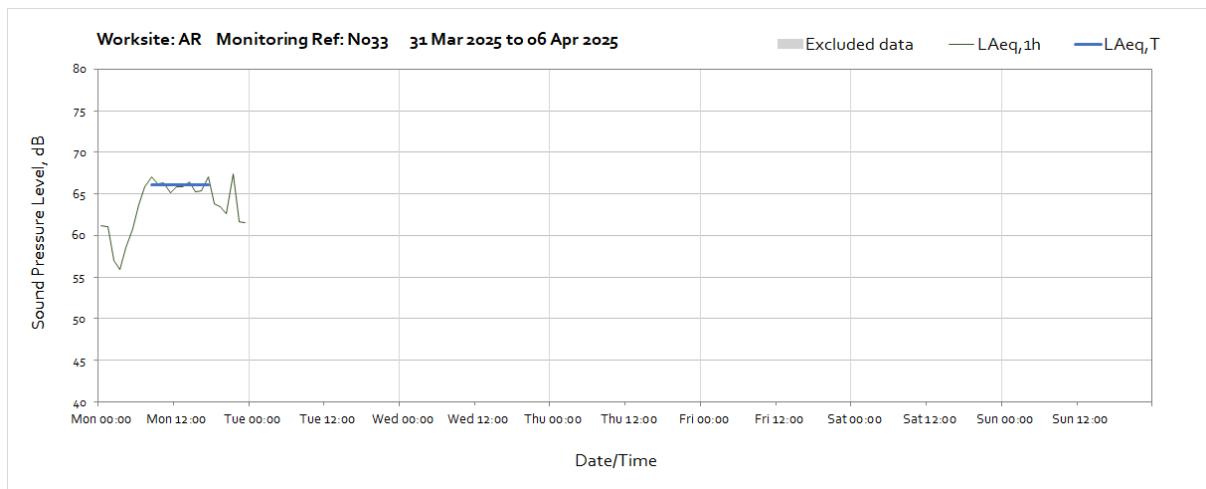
Worksite: AR - Monitoring Ref: N033

Note: Missing data between 01:00 and 02:00 on Sunday 30th March was due to the start of British Summer Time.

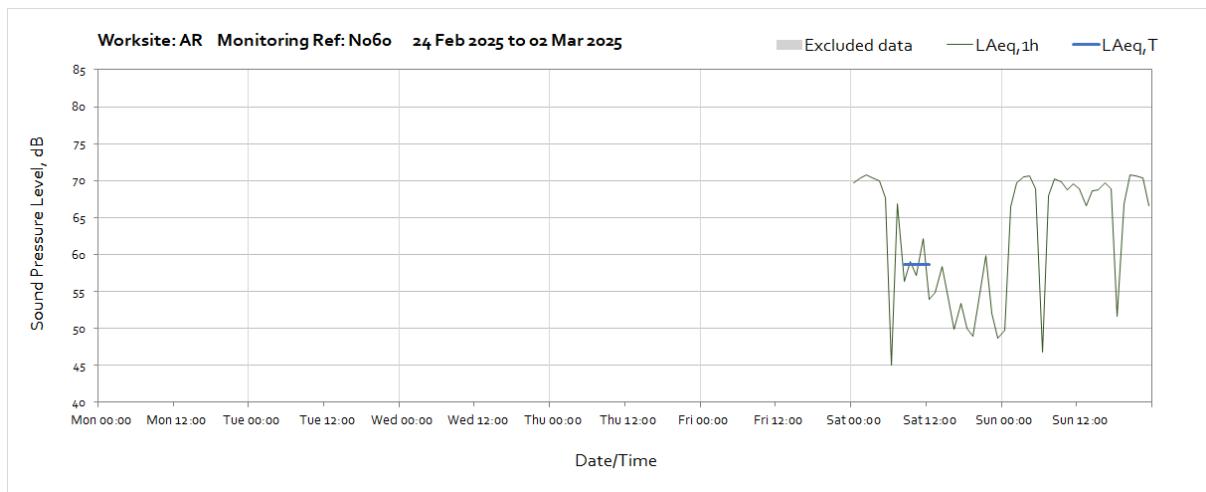
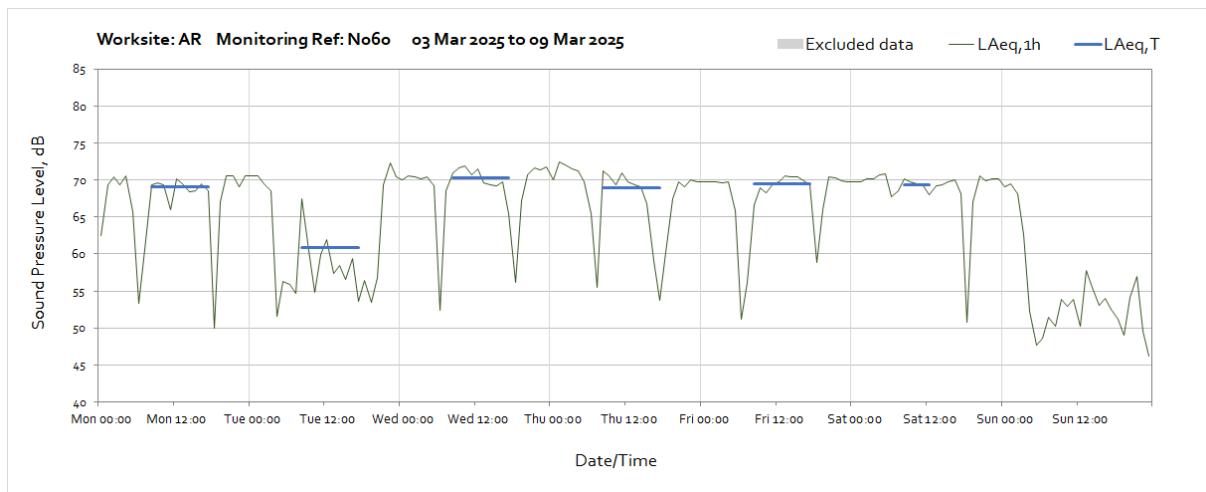
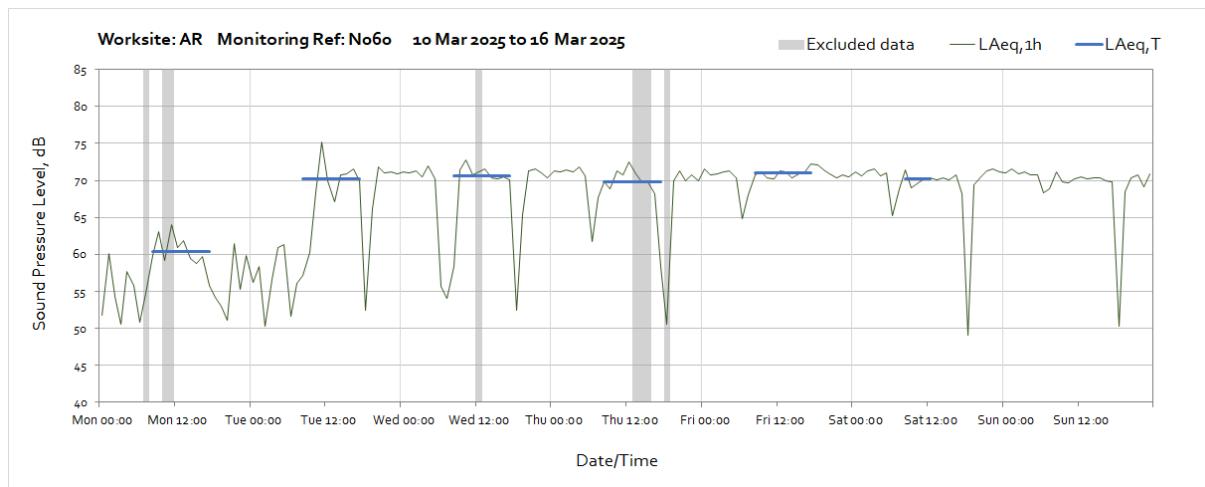
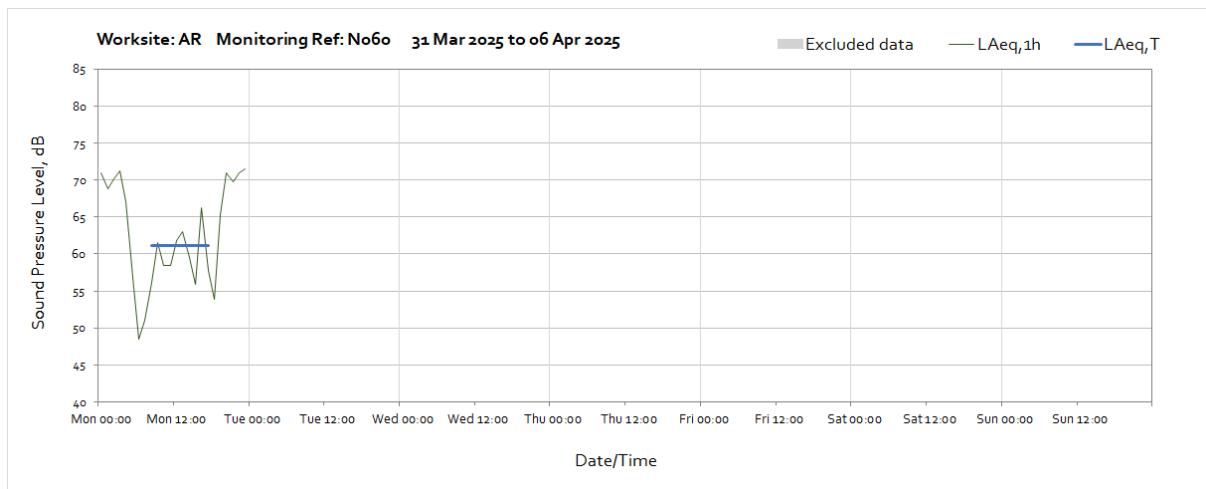
Worksite: AR - Monitoring Ref: N060

Note: Missing data between 01:00 and 02:00 on Sunday 30th March was due to the start of British Summer Time.

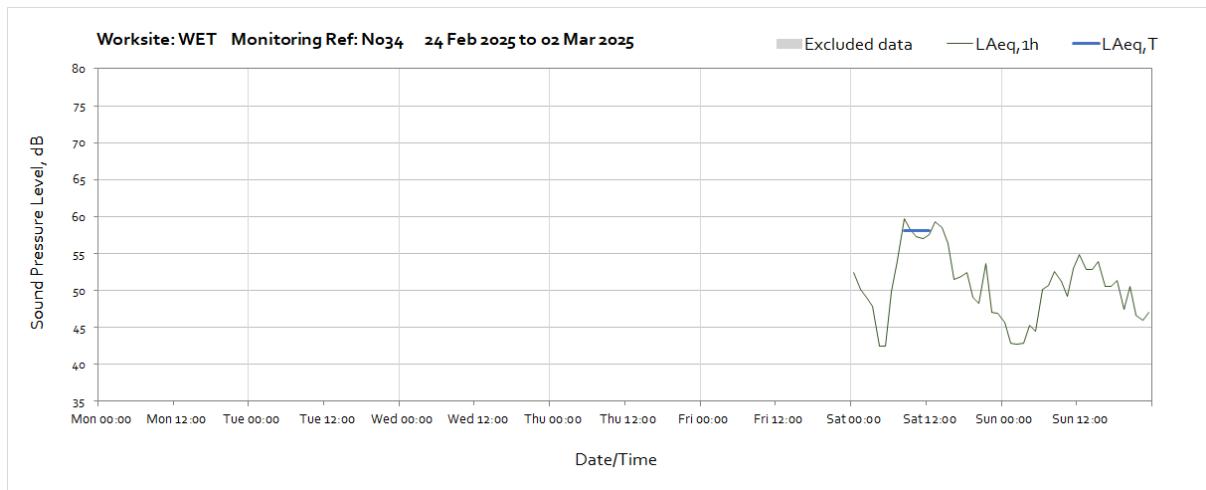
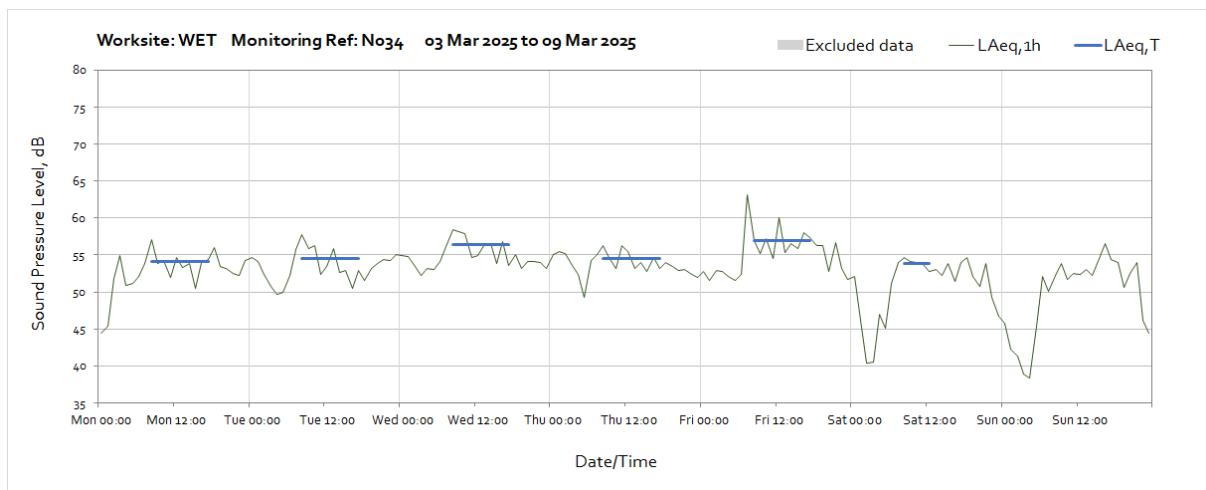
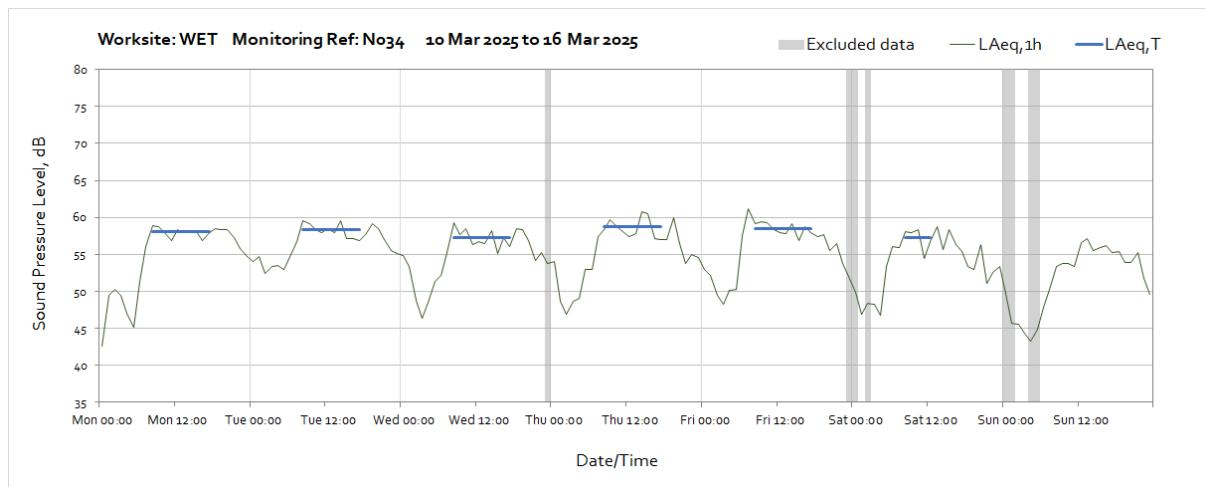
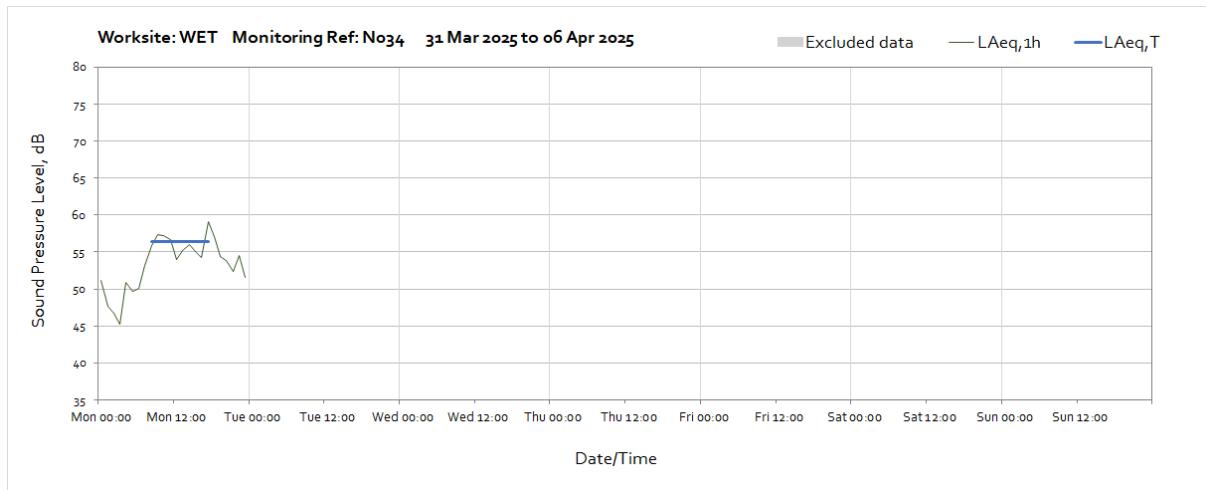
Worksite: WET – Monitoring Ref: N034

Note: Missing data between 01:00 and 02:00 on Sunday 30th March was due to the start of British Summer Time.

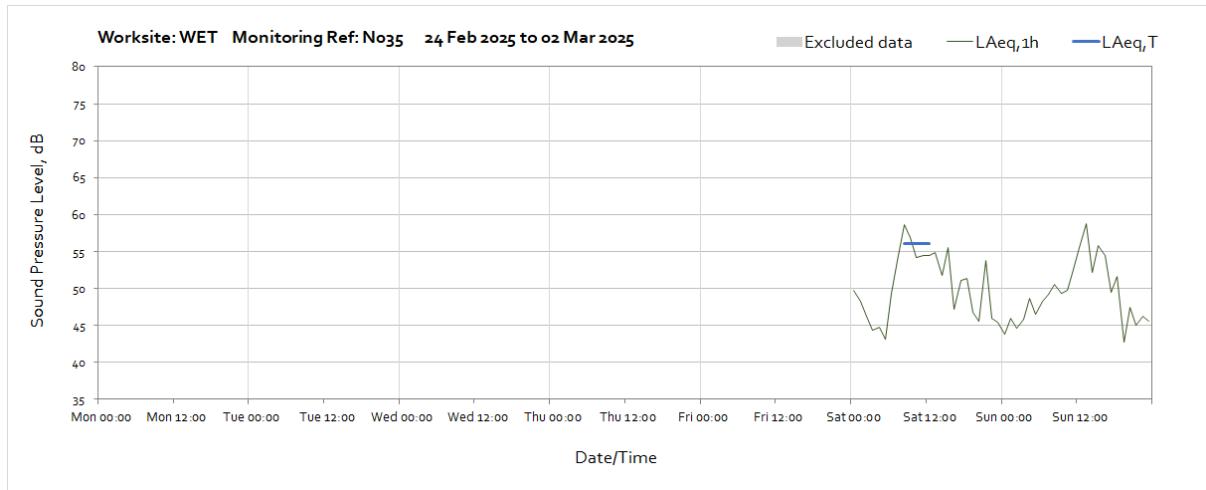
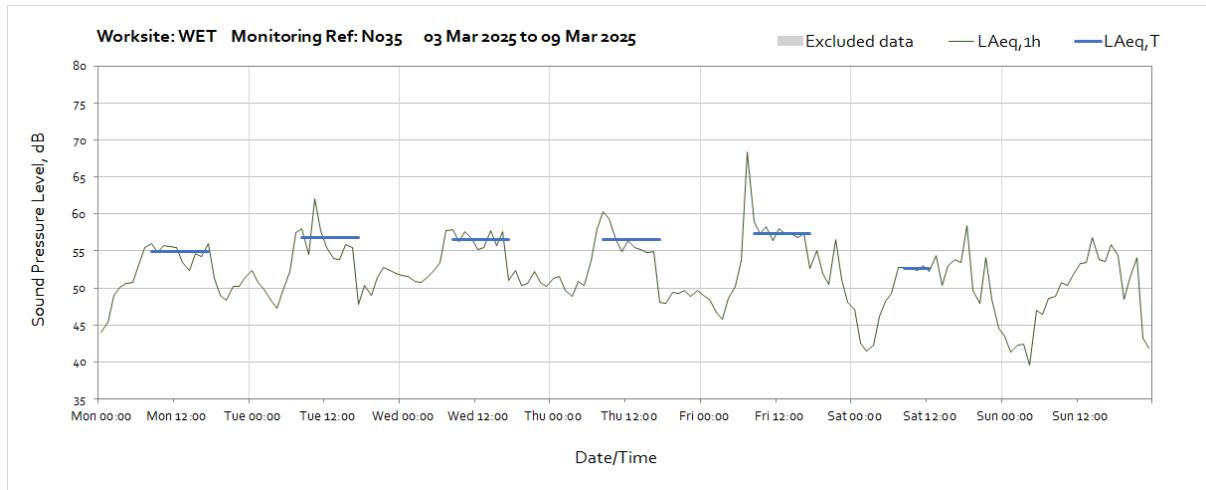
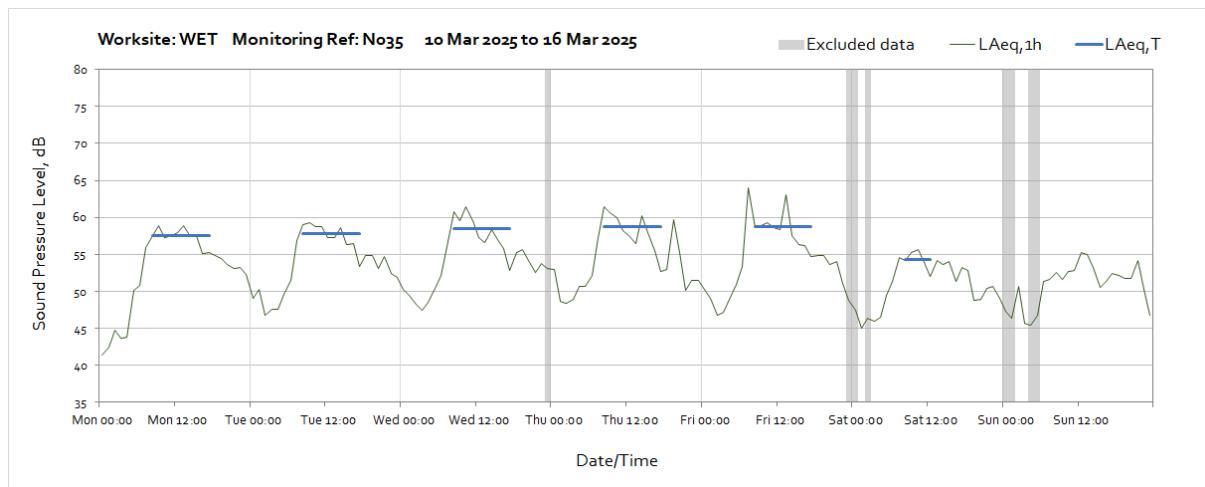
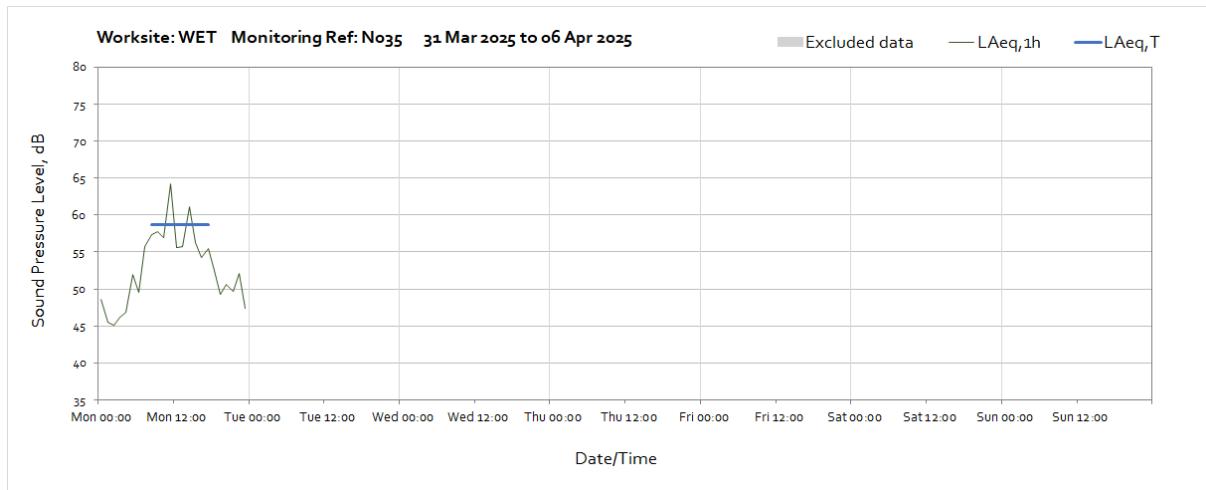
Worksite: WET – Monitoring Ref: N035

Note: Missing data between 01:00 and 02:00 on Sunday 30th March was due to the start of British Summer Time.

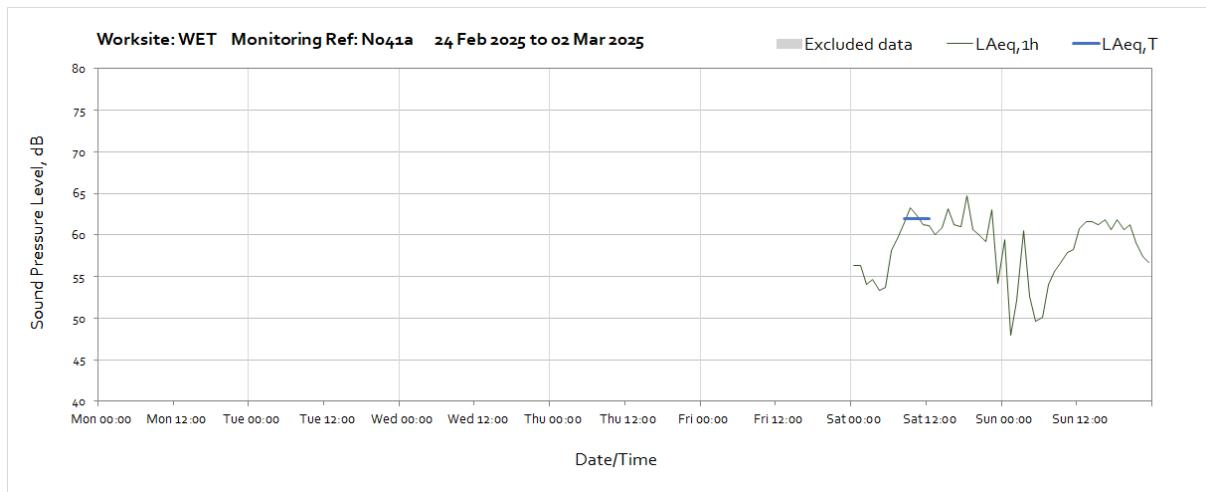
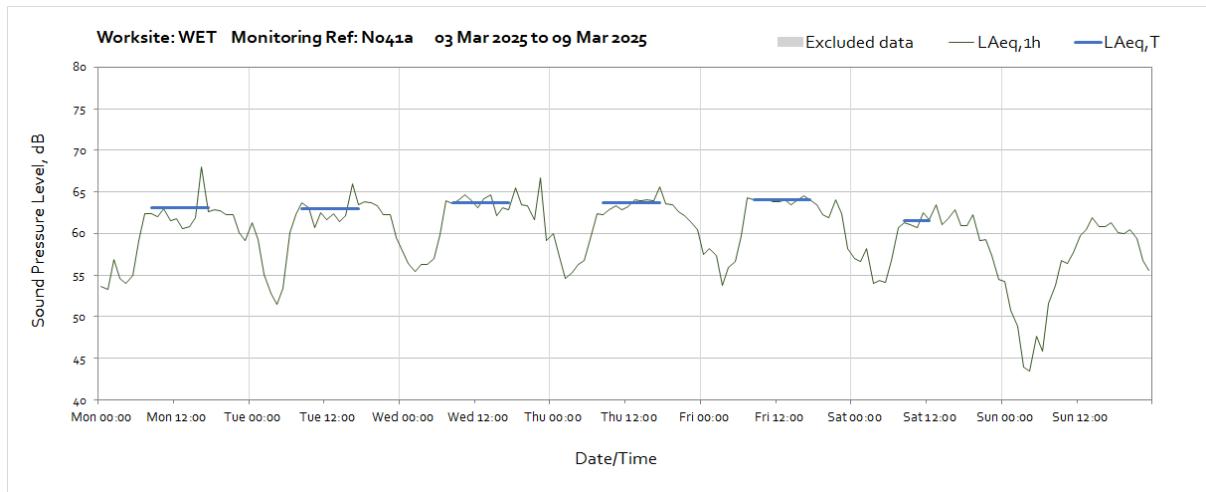
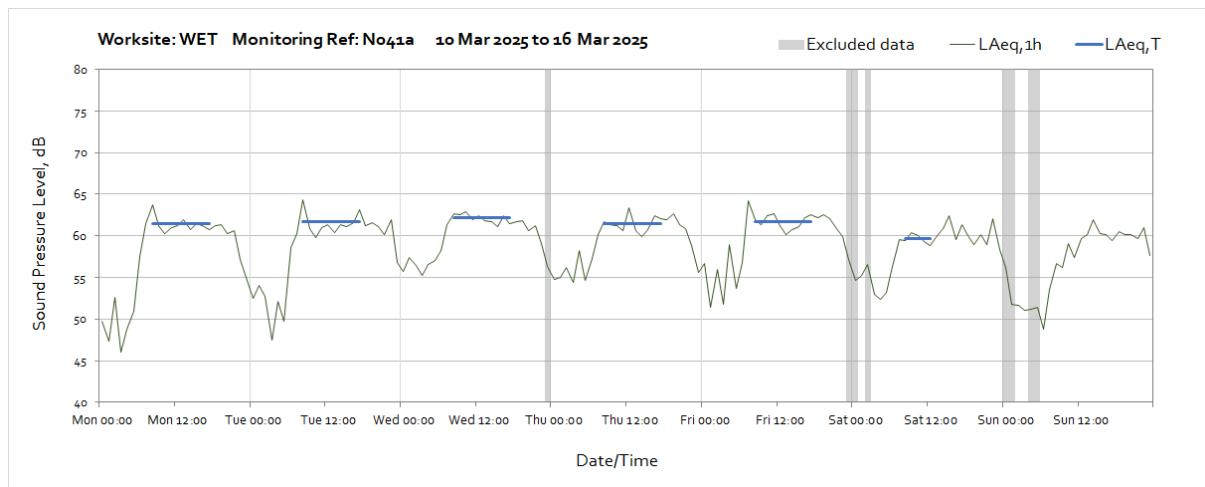
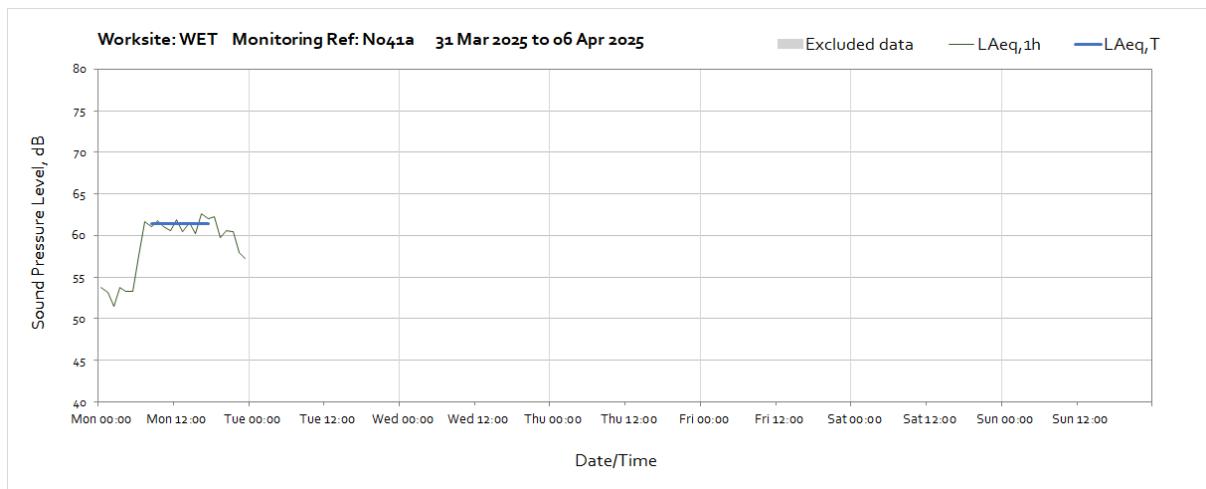
Worksite: WET – Monitoring Ref: N041a

Note: Missing data between 01:00 and 02:00 on Sunday 30th March was due to the start of British Summer Time.

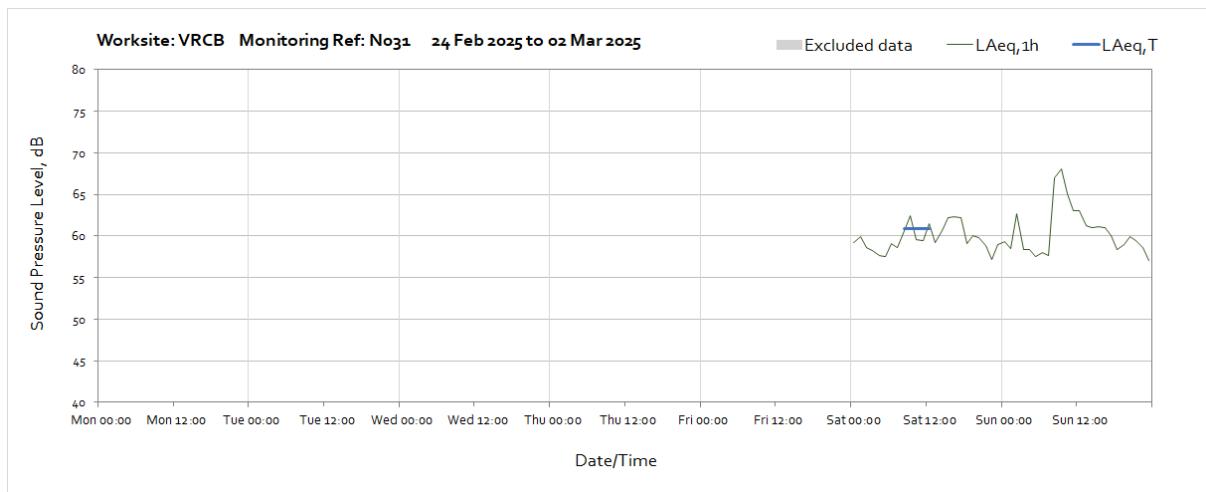
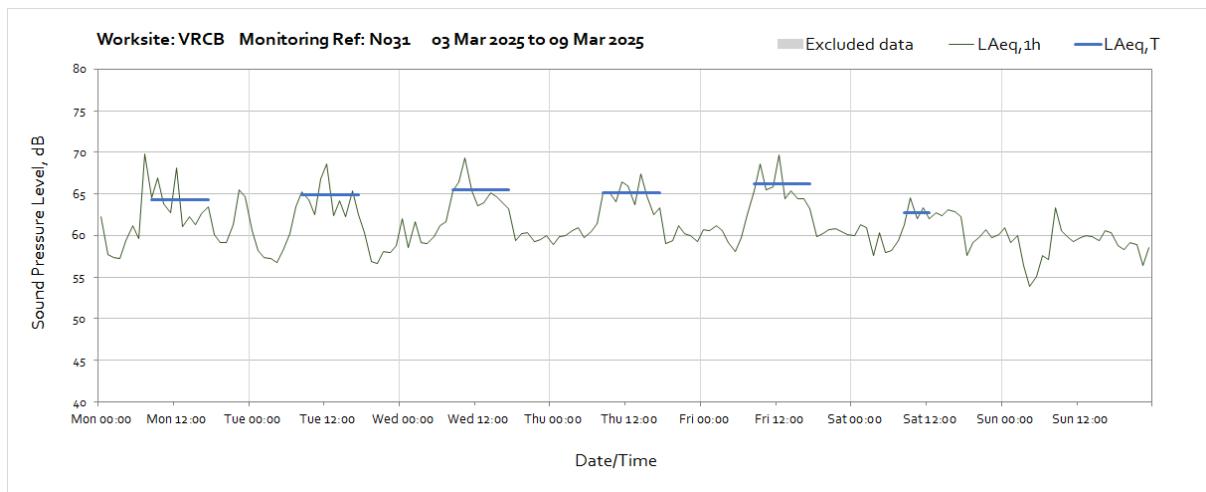
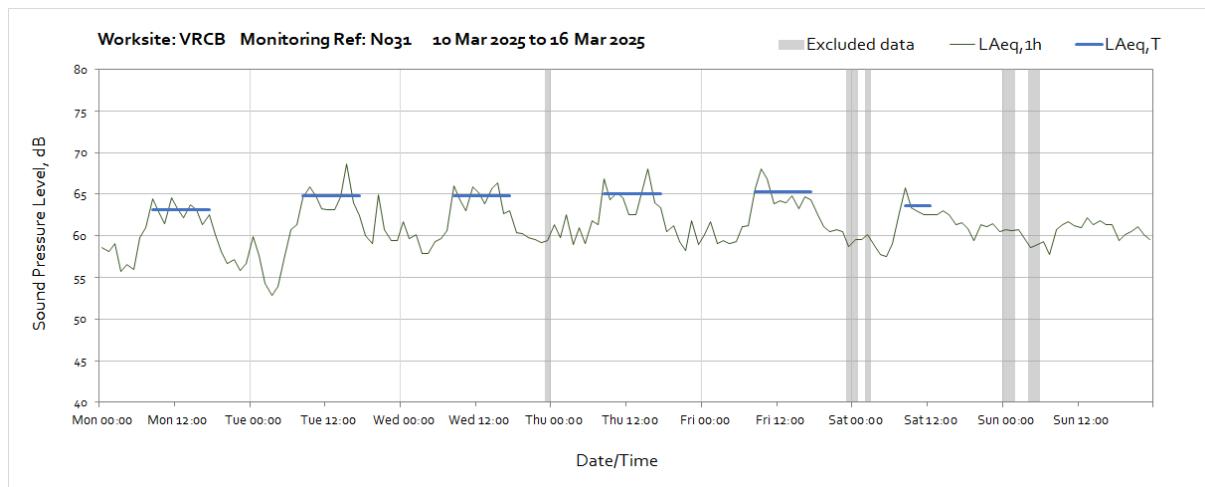
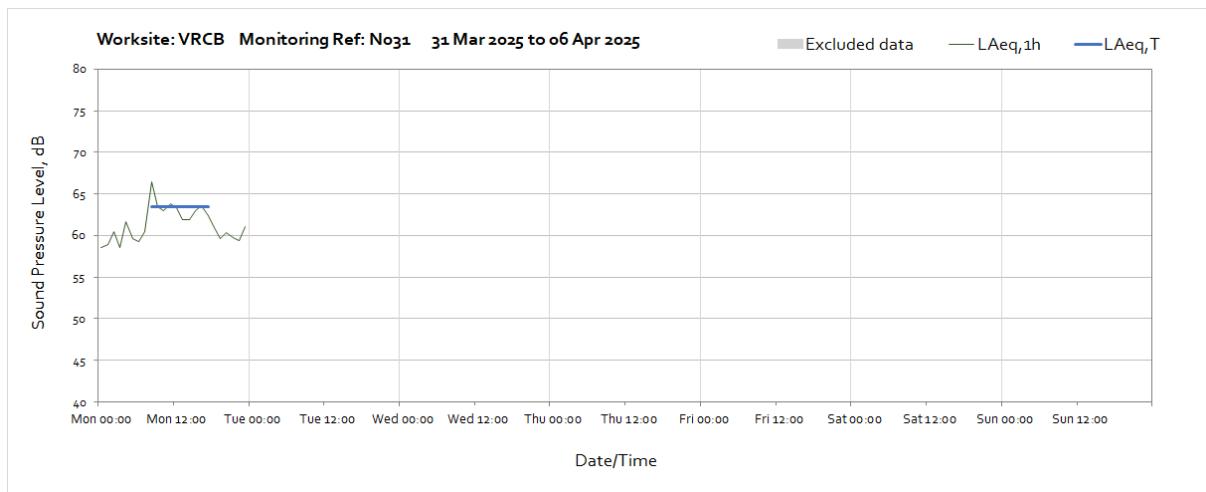
Worksite: VRCB – Monitoring Ref: N031

Note: Missing data between 01:00 and 02:00 on Sunday 30th March was due to the start of British Summer Time.

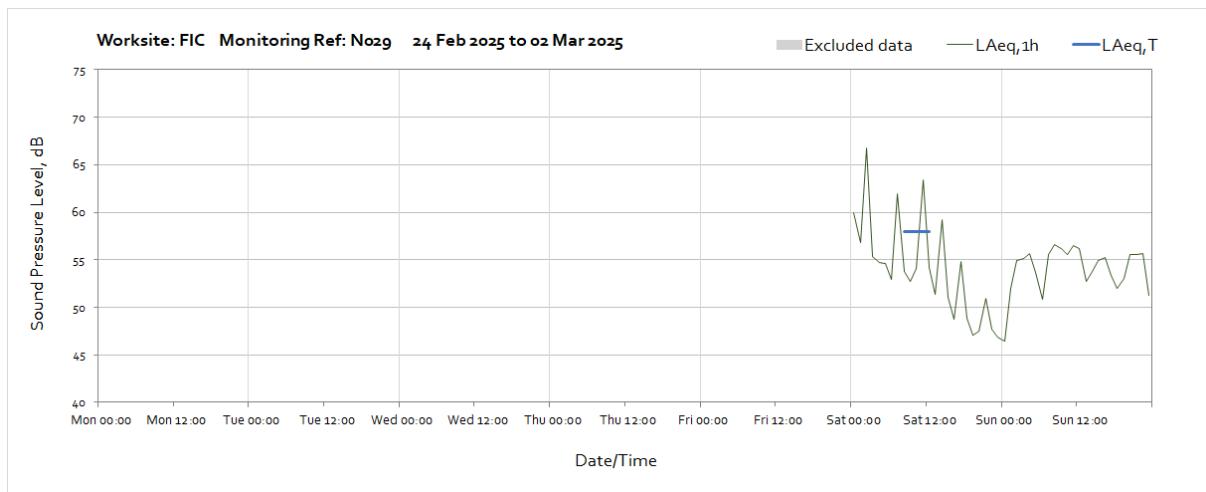
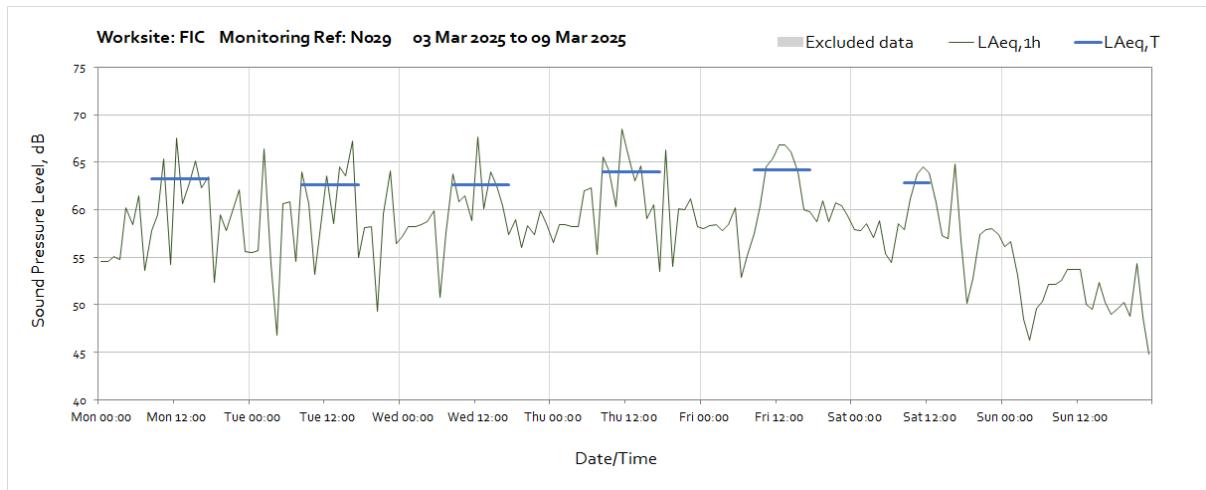
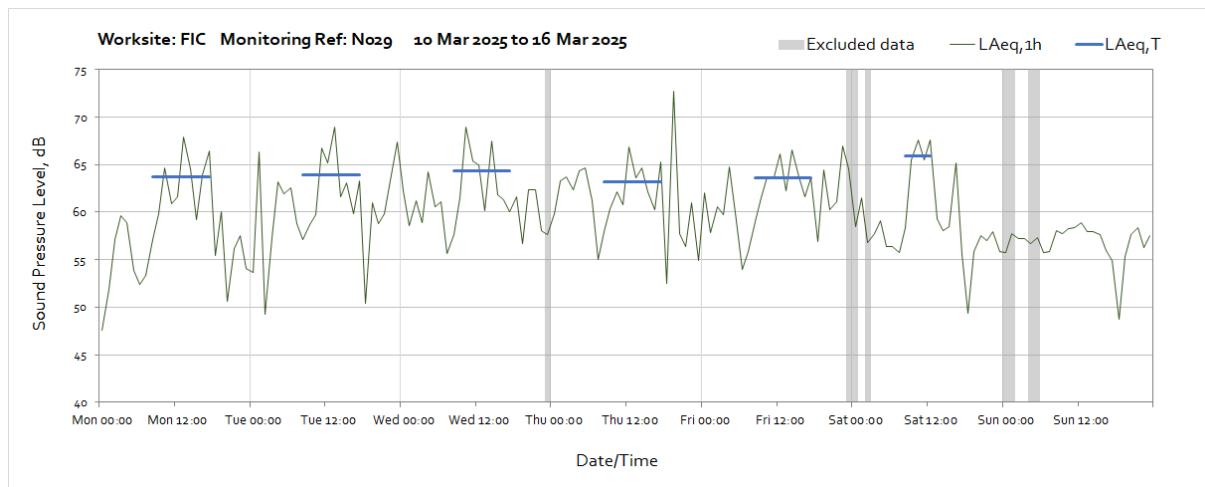
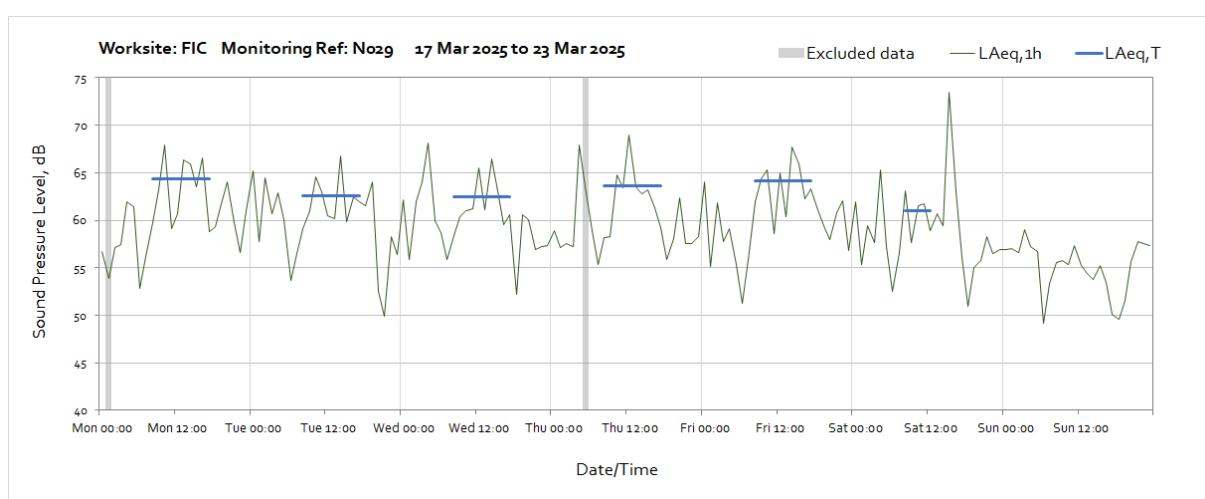
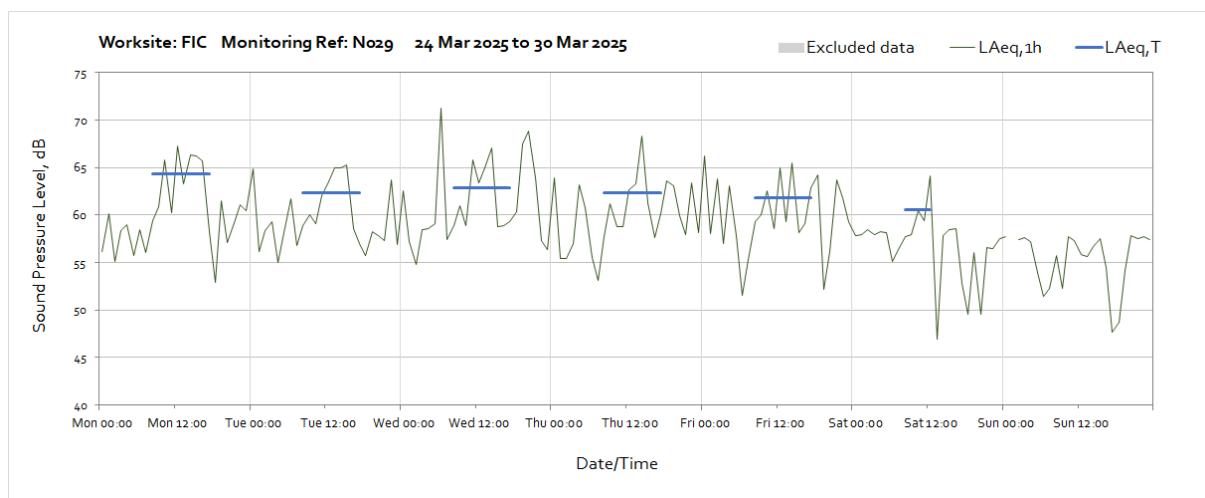
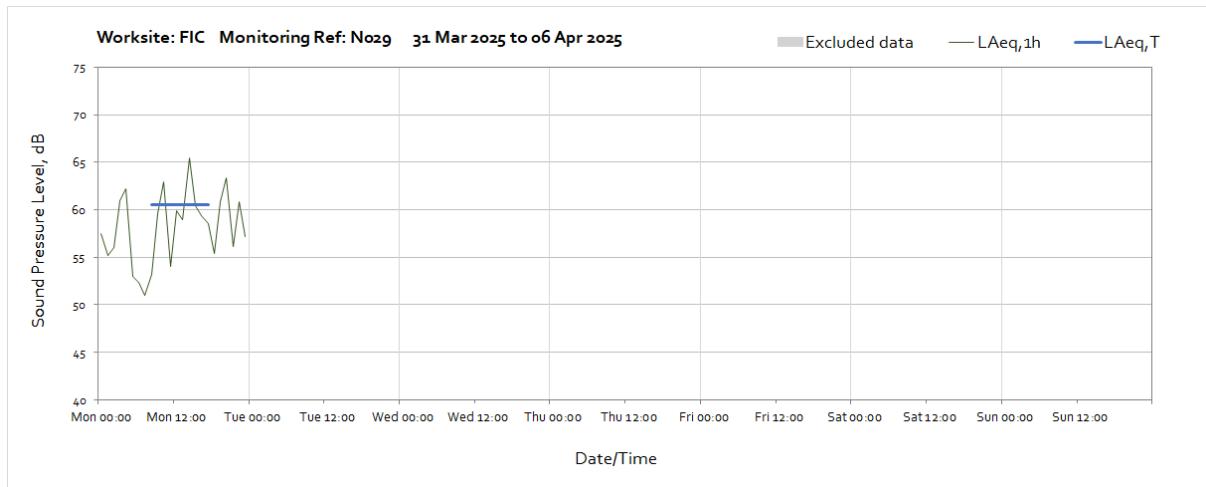
Worksite: FIC – Monitoring Ref: N029

Note: Missing data between 01:00 and 02:00 on Sunday 30th March was due to the start of British Summer Time.

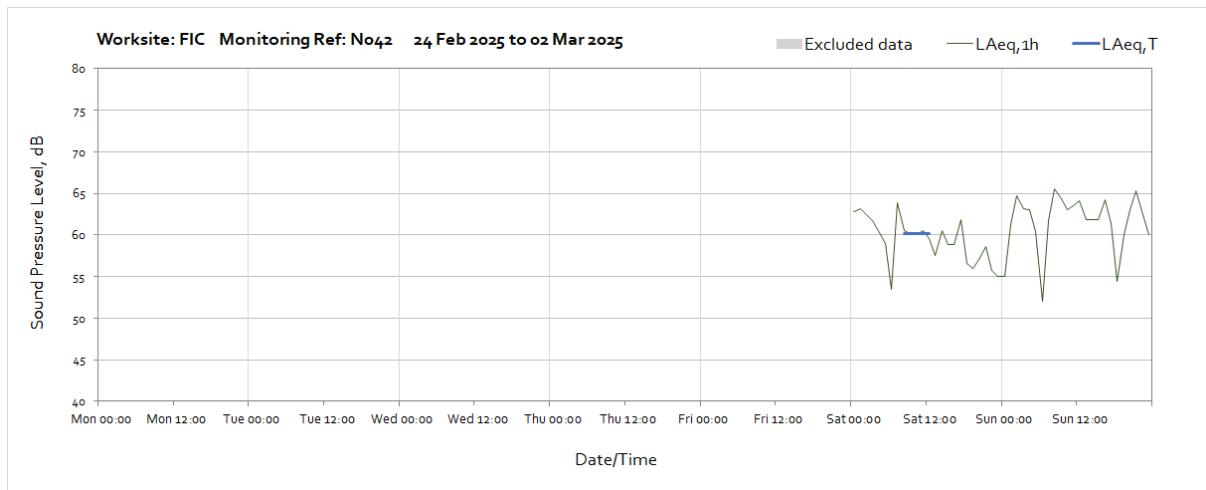
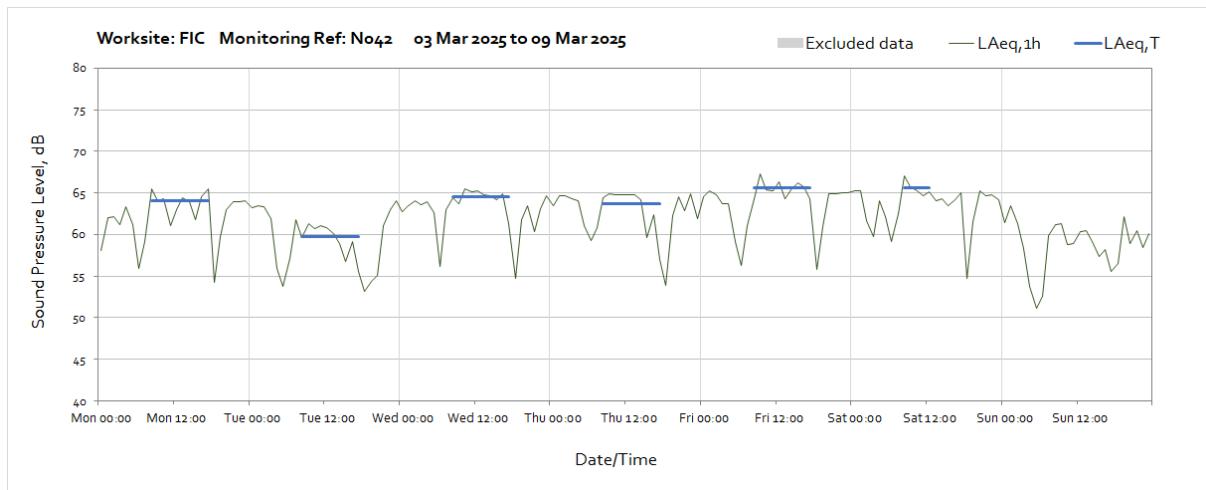
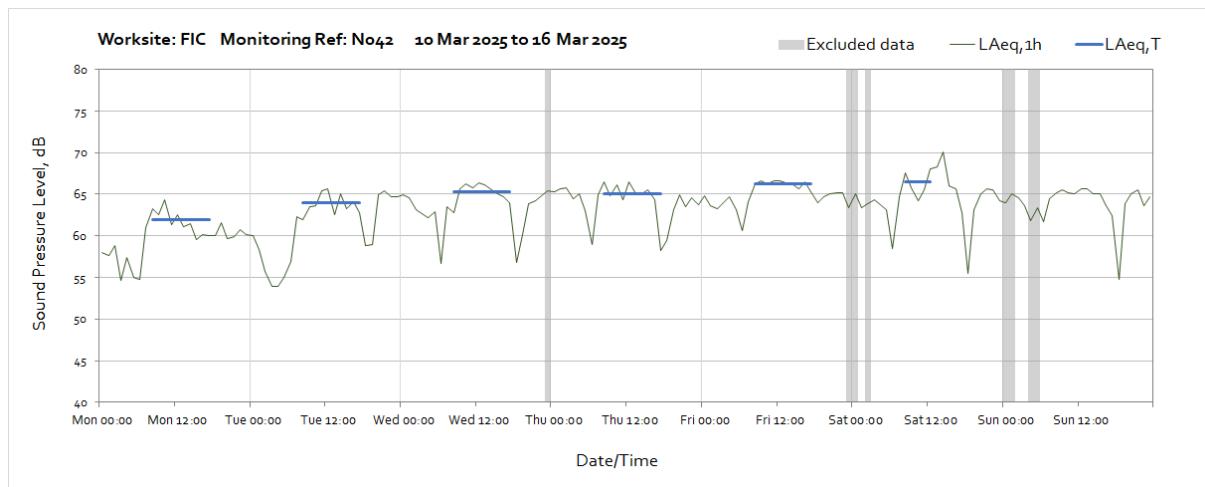
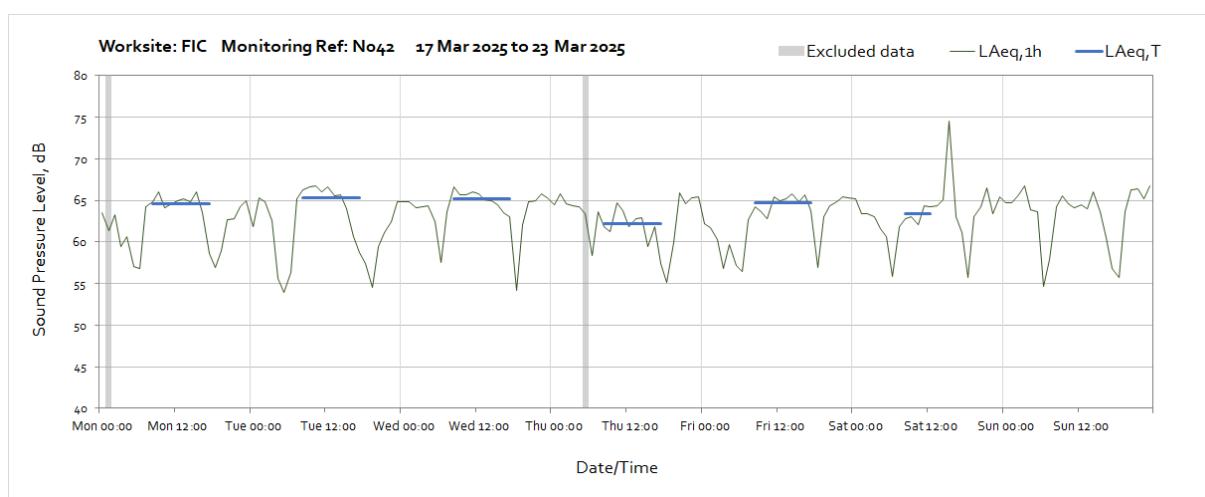
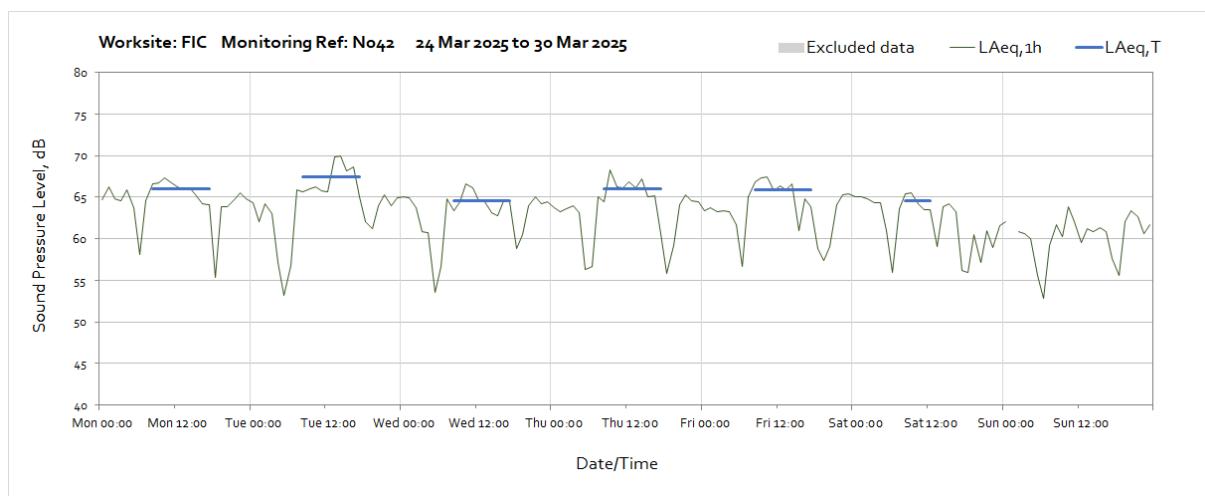
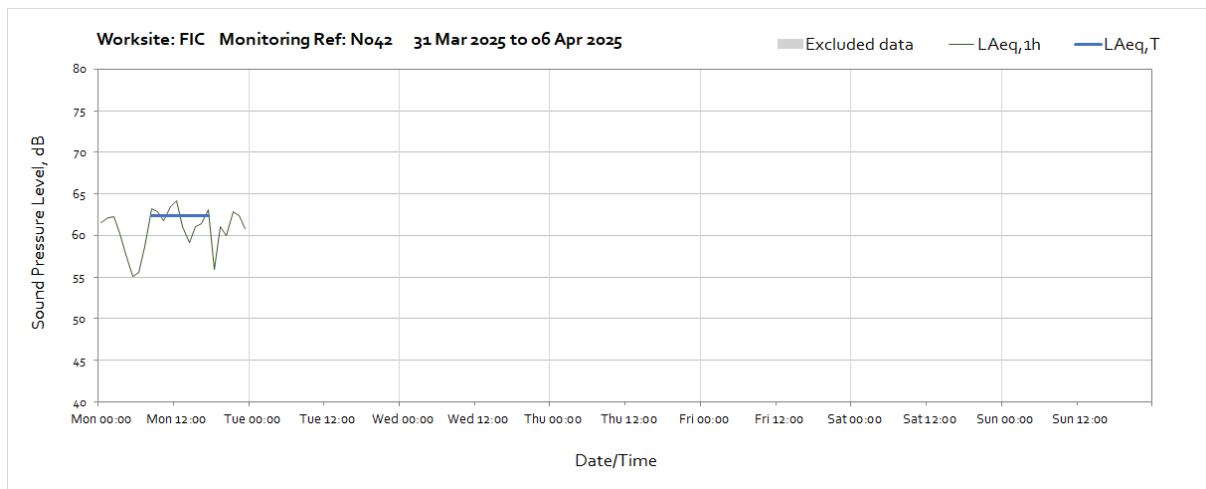
Worksite: FIC – Monitoring Ref: N042

Note: Missing data between 01:00 and 02:00 on Sunday 30th March was due to the start of British Summer Time.
