HS2

May 2025

Construction Noise and Vibration Monthly Report – March 2025

London Borough of Ealing

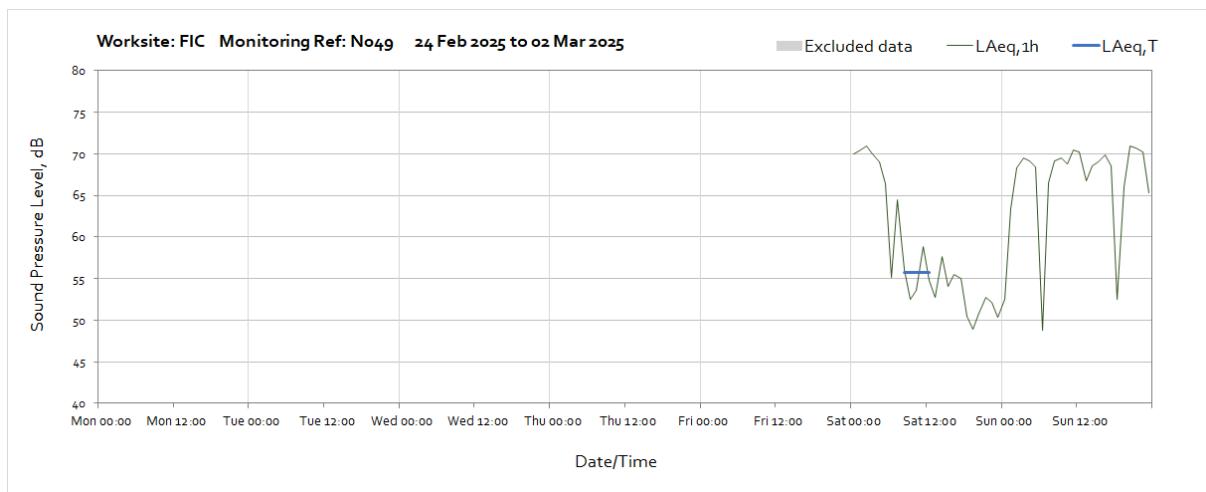
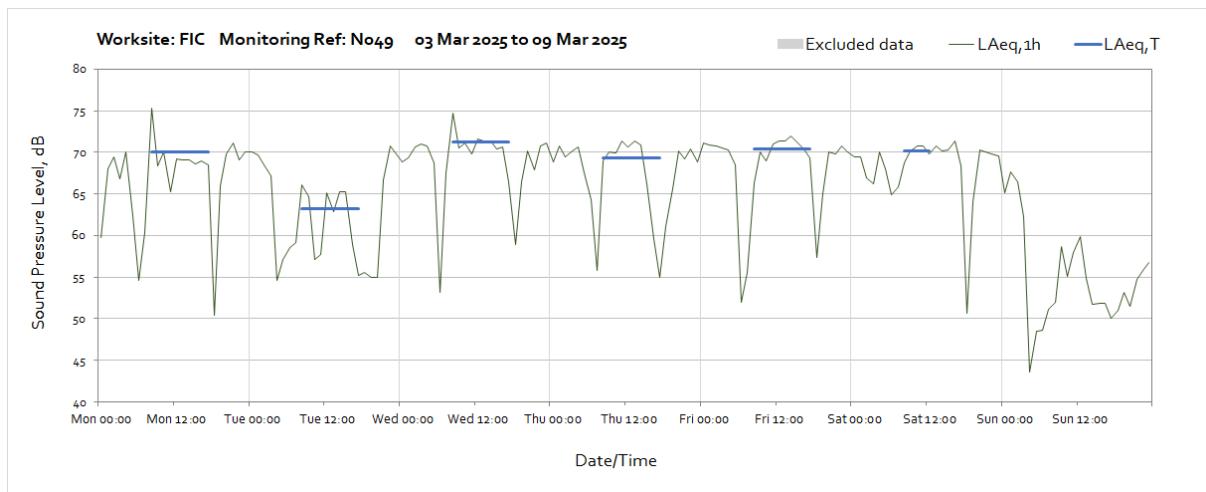
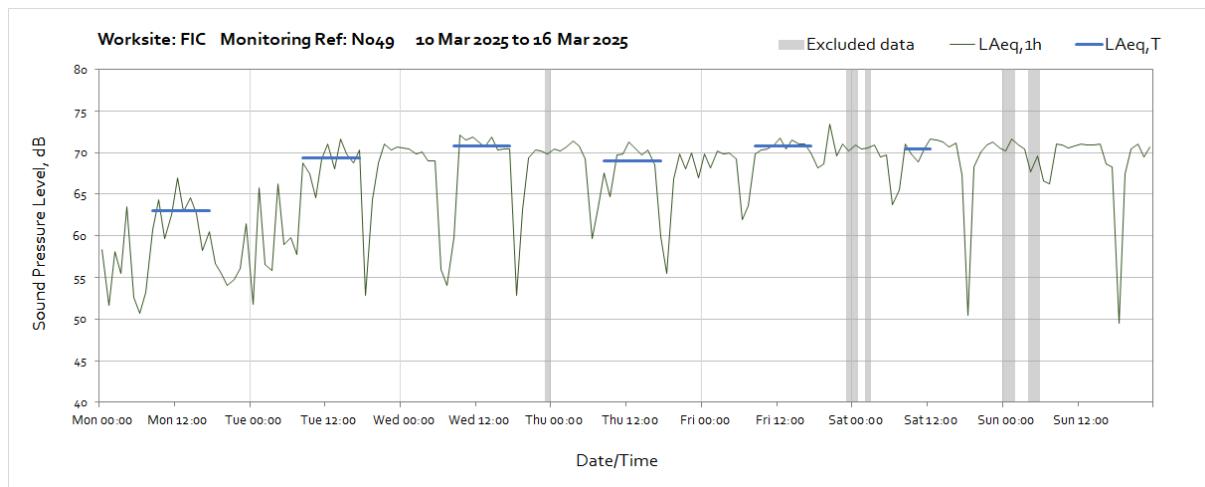
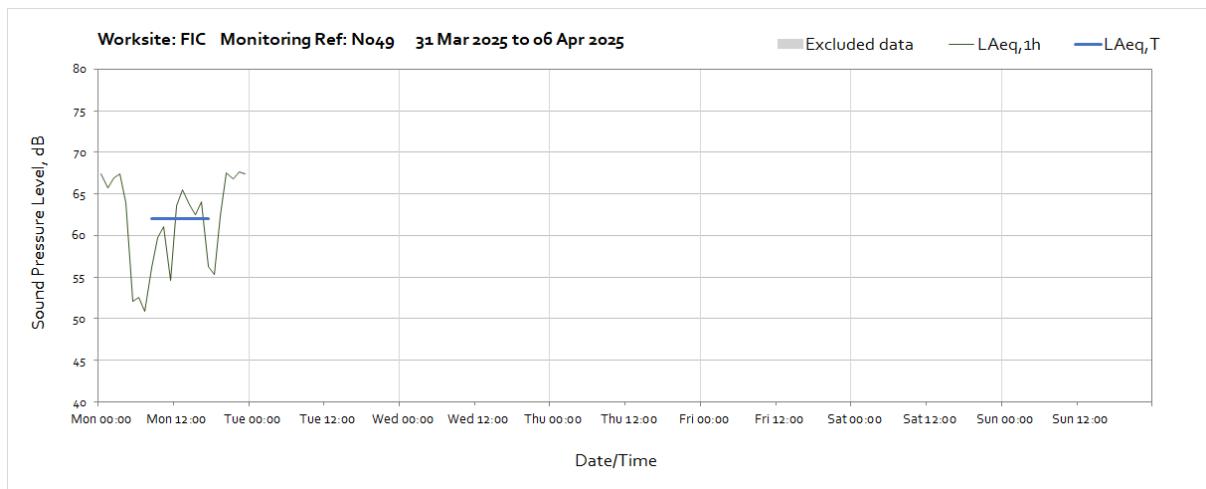
Worksite: FIC – Monitoring Ref: N049

Note: Missing data between 01:00 and 02:00 on Sunday 30th March was due to the start of British Summer Time.

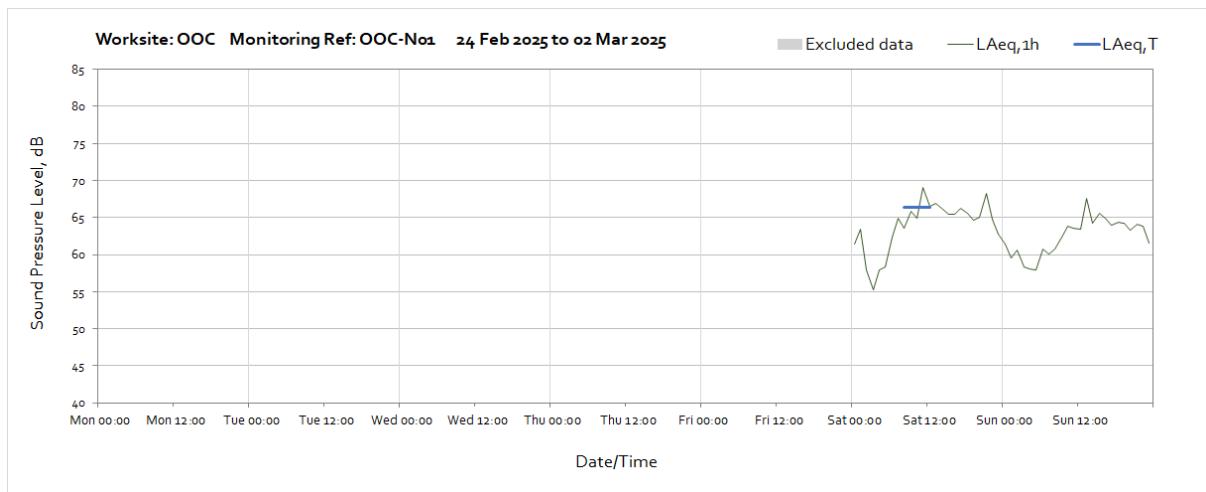
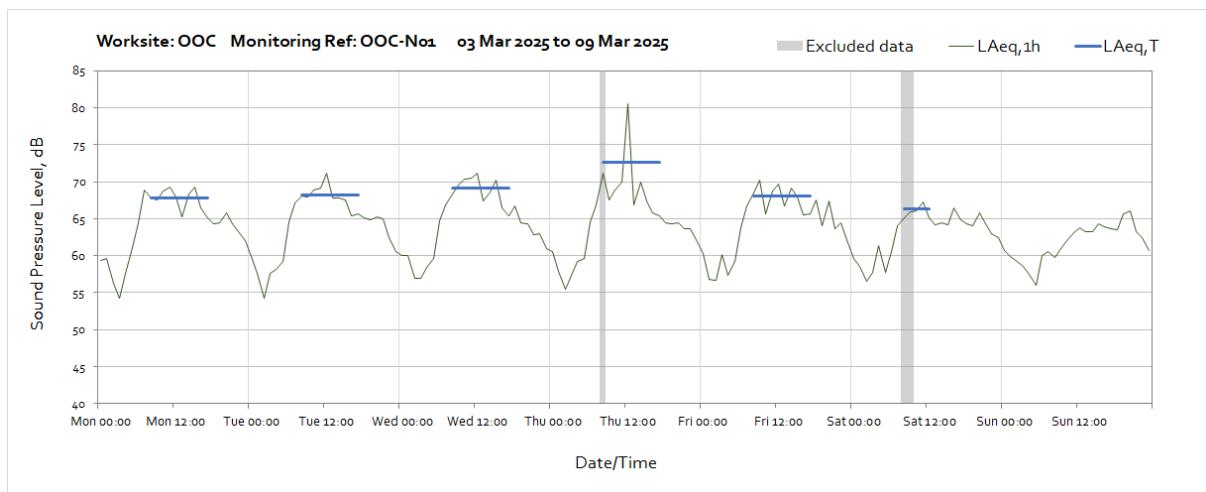
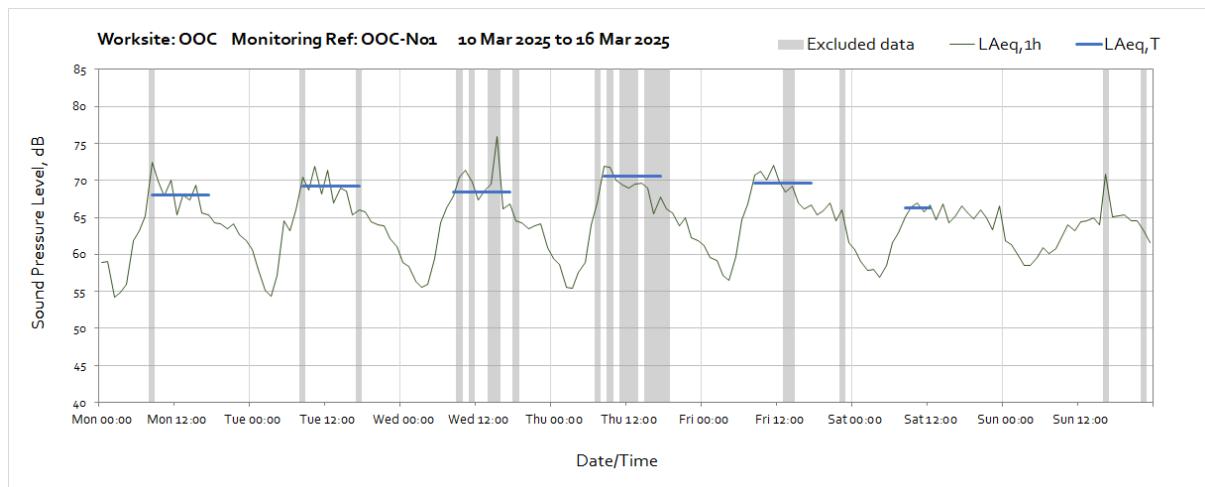
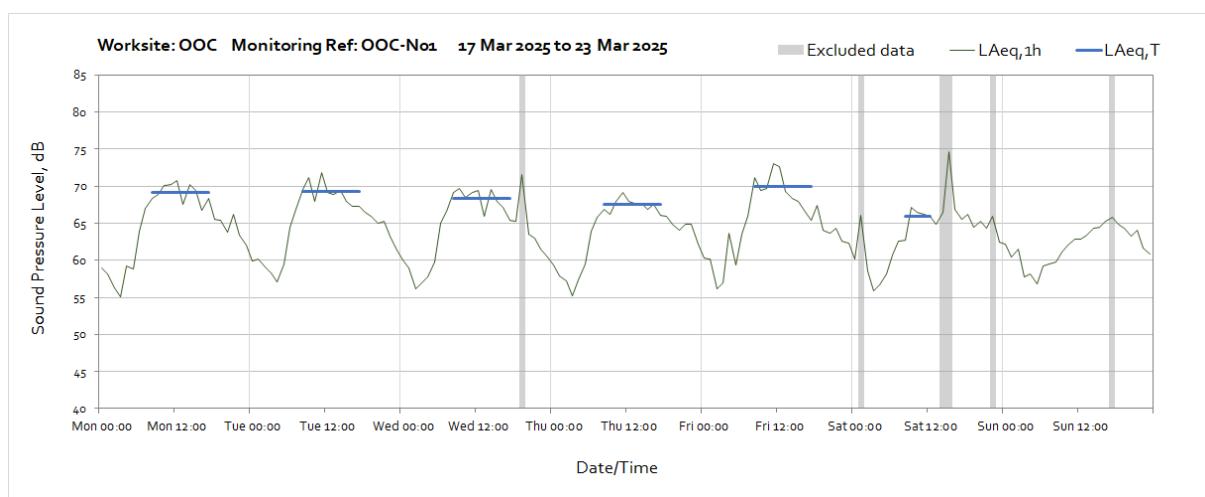
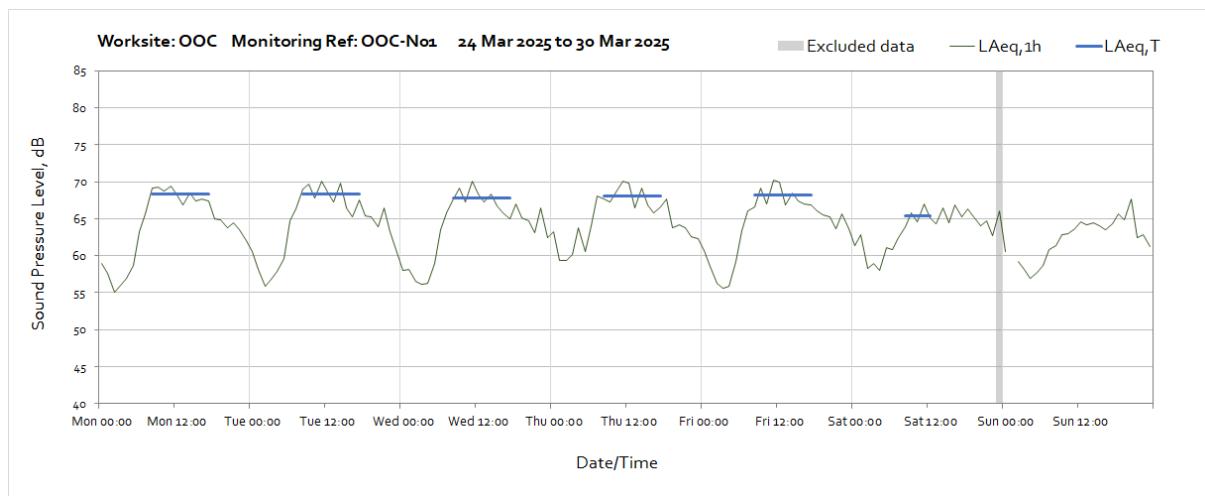
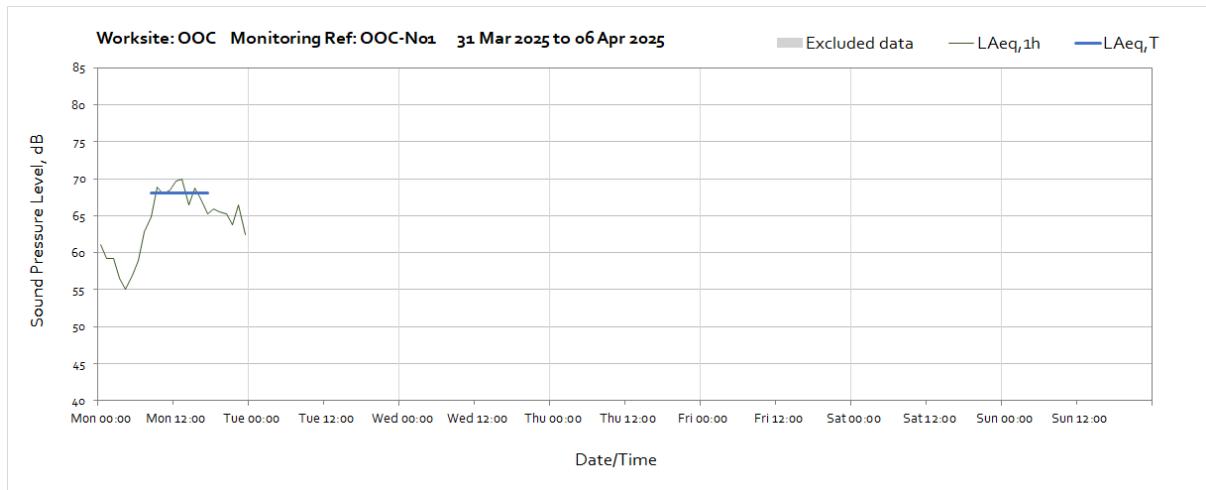
Worksite: OOC – Monitoring Ref: OOC-N01

- 2.1.3 Appendix C presents graphs of the noise and vibration monitoring data over the month for each of the measurement locations. Noise data presented consists of the hourly L_{Aeq} values and, where relevant, the $L_{Aeq,T}$ values (where the time period T has been taken to be the averaging period as specified in Table 1 of HS2 Information Paper E23). Vibration data presented consist of hourly PPV values. The full data set for the monitoring equipment can be found at the following location:
<https://data.gov.uk/dataset/24542ae7-dd44-444f-b259-871c4cc43b5e/environmental-monitoring-data>.

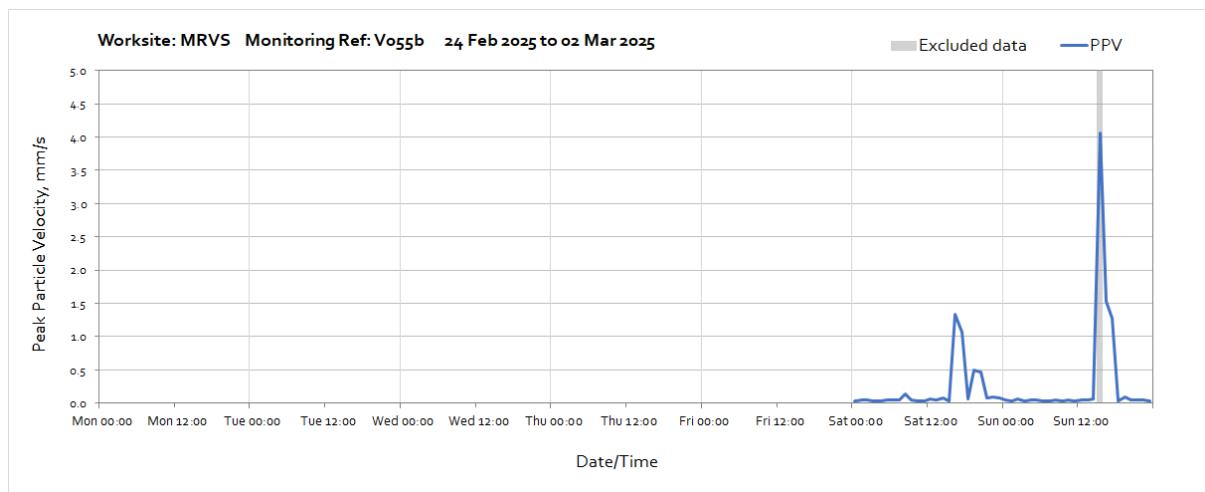
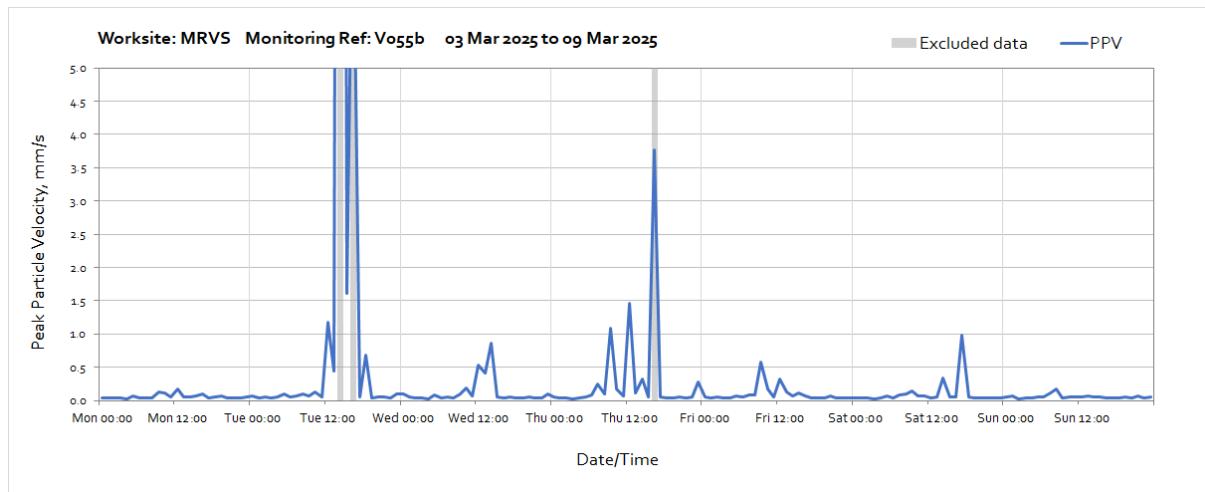
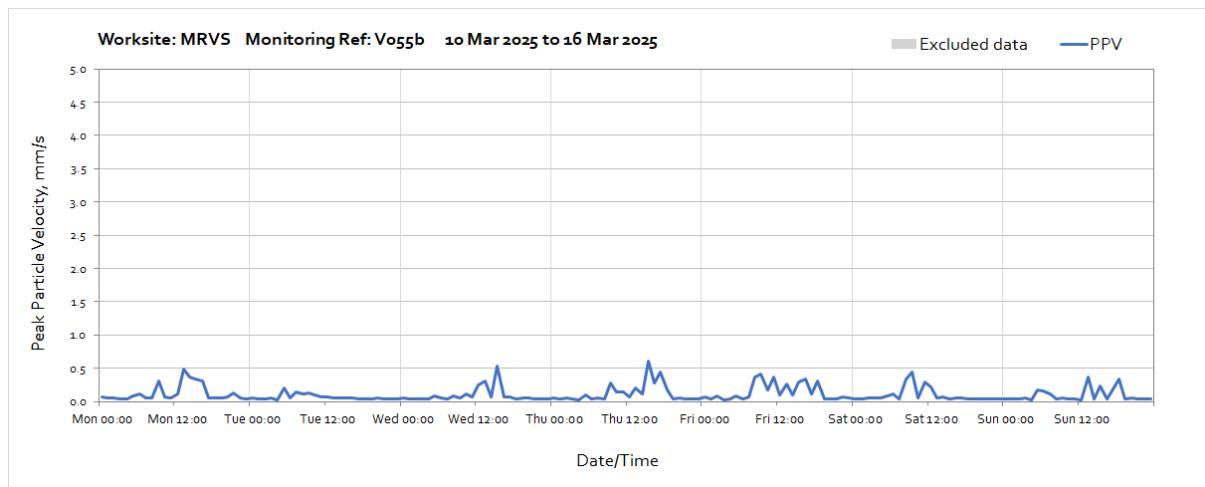
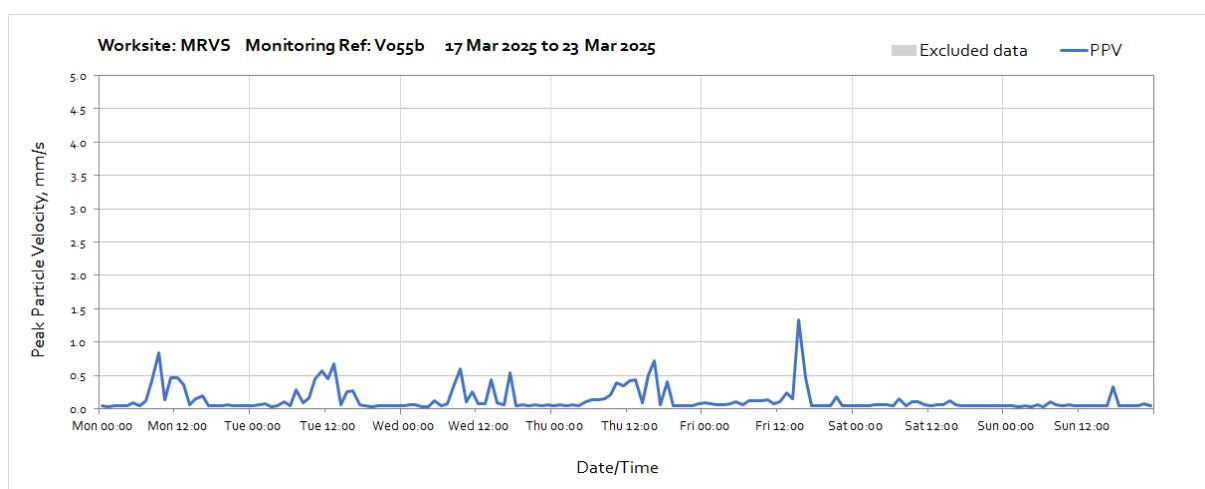
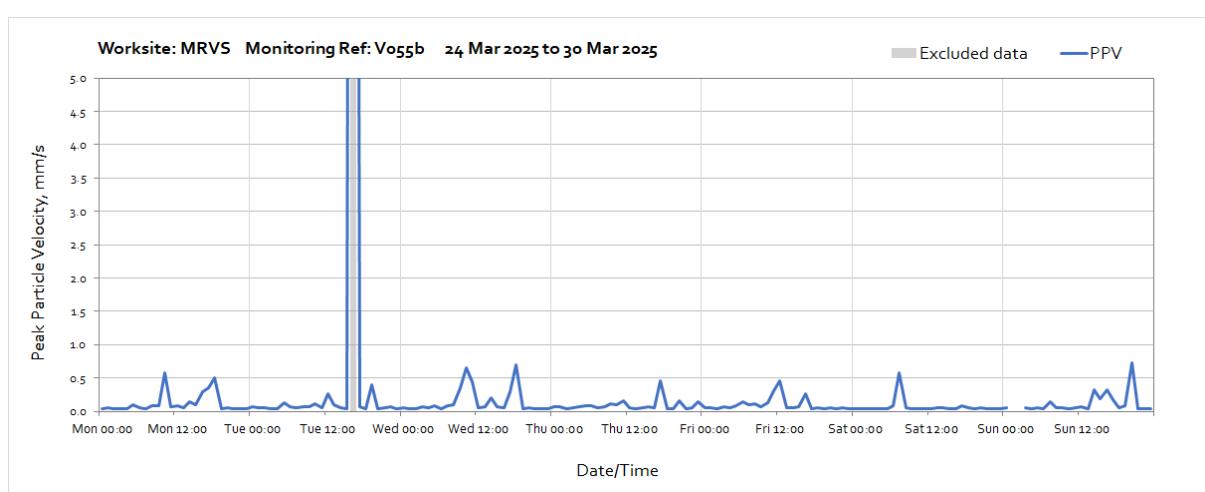
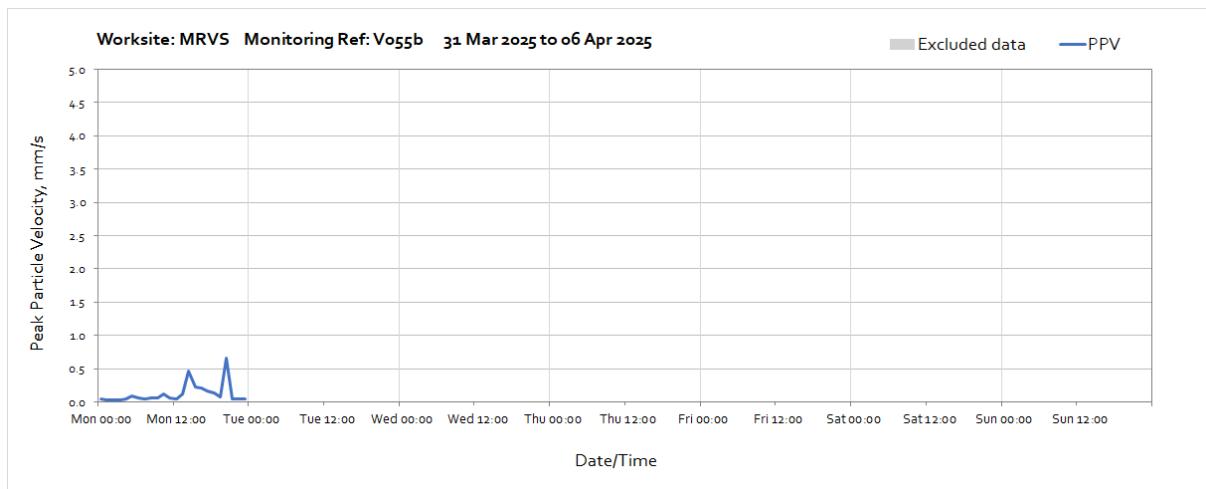
Worksite: MRVS – Monitoring Ref: V055b

The following graphs show the hourly measured peak particle velocity PPV recorded during the monitoring period. The graphs show the highest PPV of the three orthogonal axis x, y and z. Periods where PPV values have been affected by local interference with the vibration monitor or only measured for part of the period, which are not representative of HS2 construction works, have been greyed out and excluded when calculating values in Table 4 of the main report.

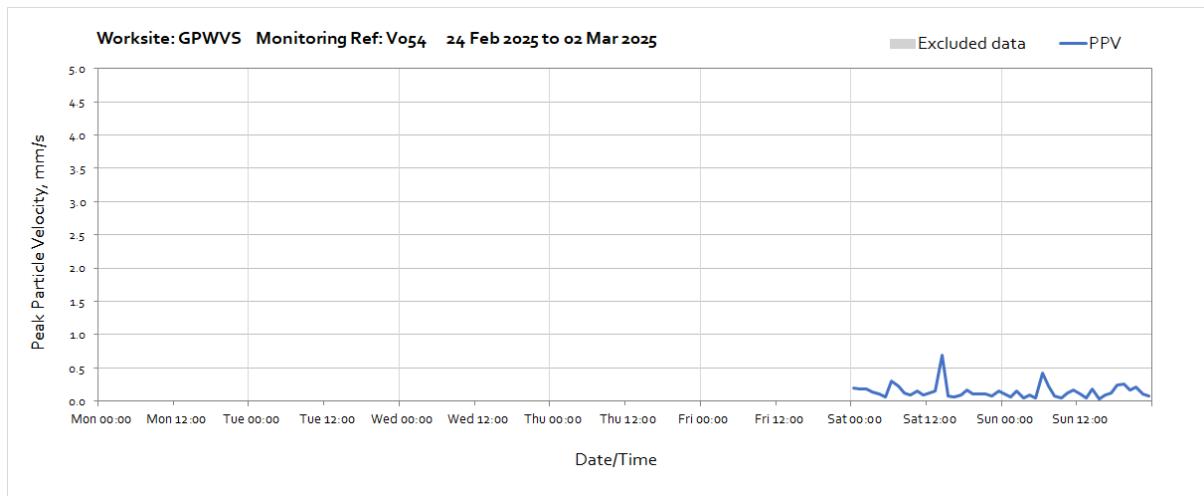
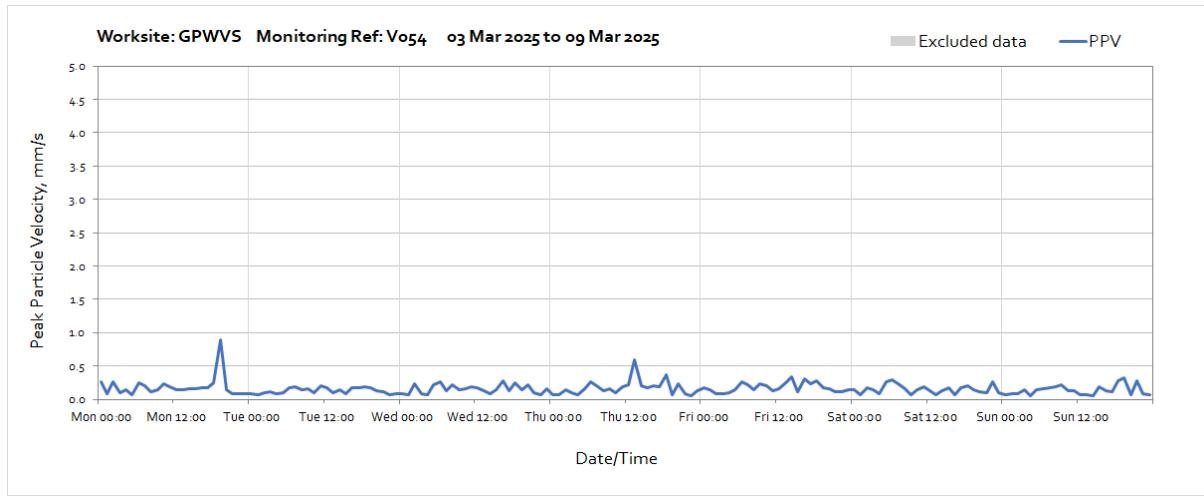
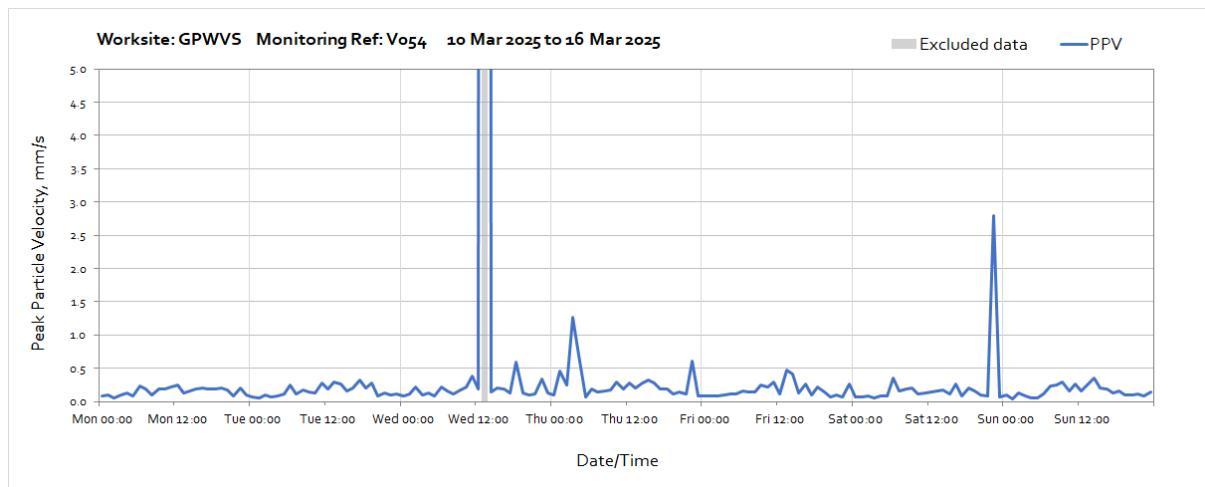
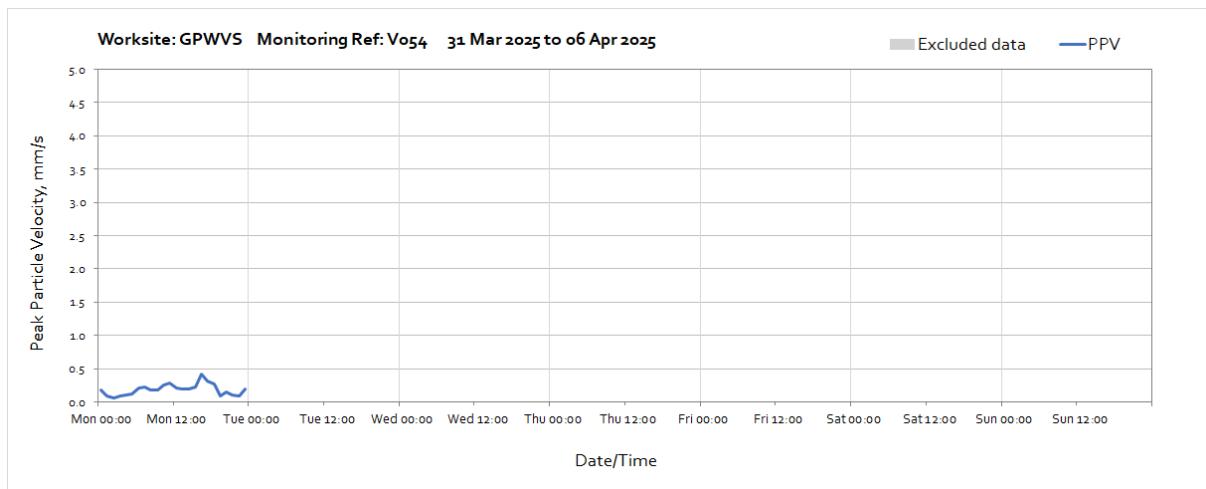
Worksite: GPWVS – Monitoring Ref: V054

Note: Missing data between 01:00 and 02:00 on Sunday 30th March was due to the start of British Summer Time.

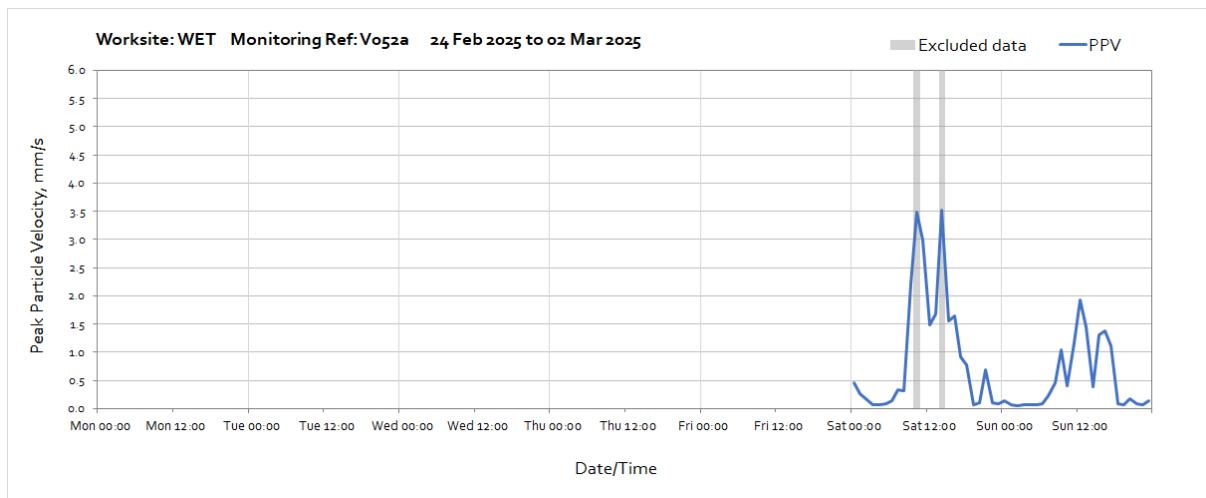
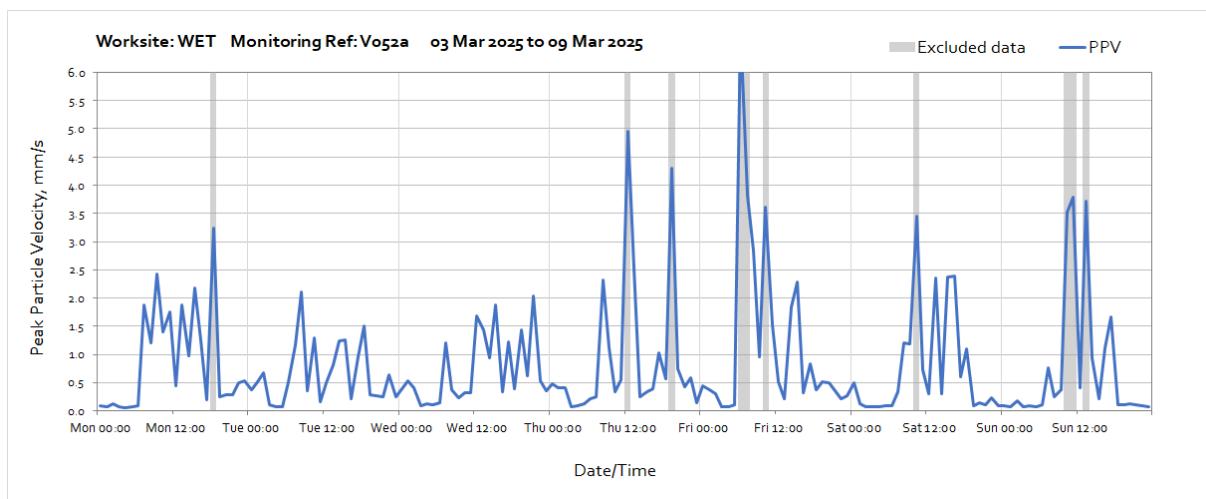
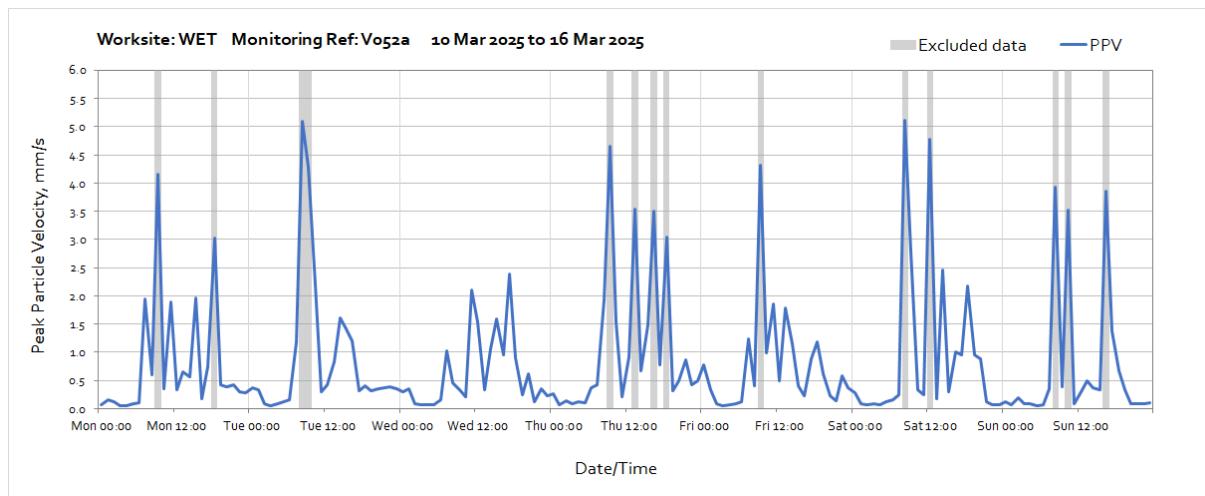
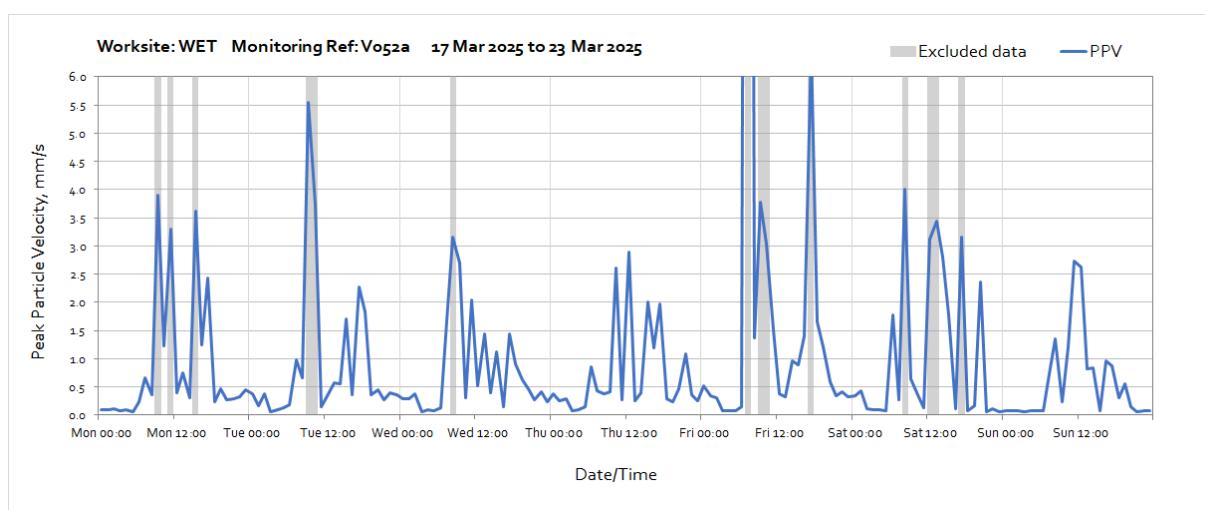
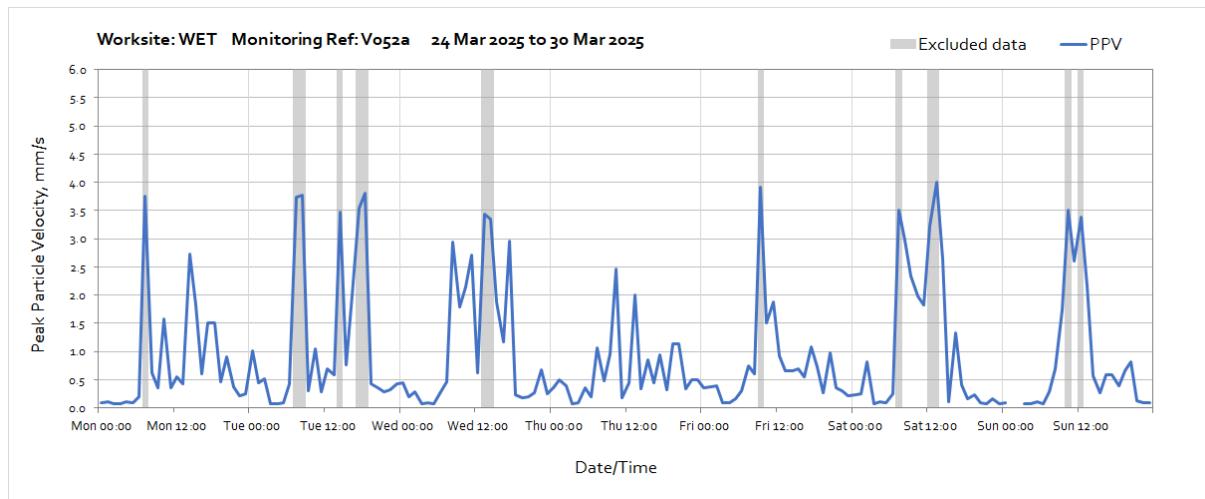
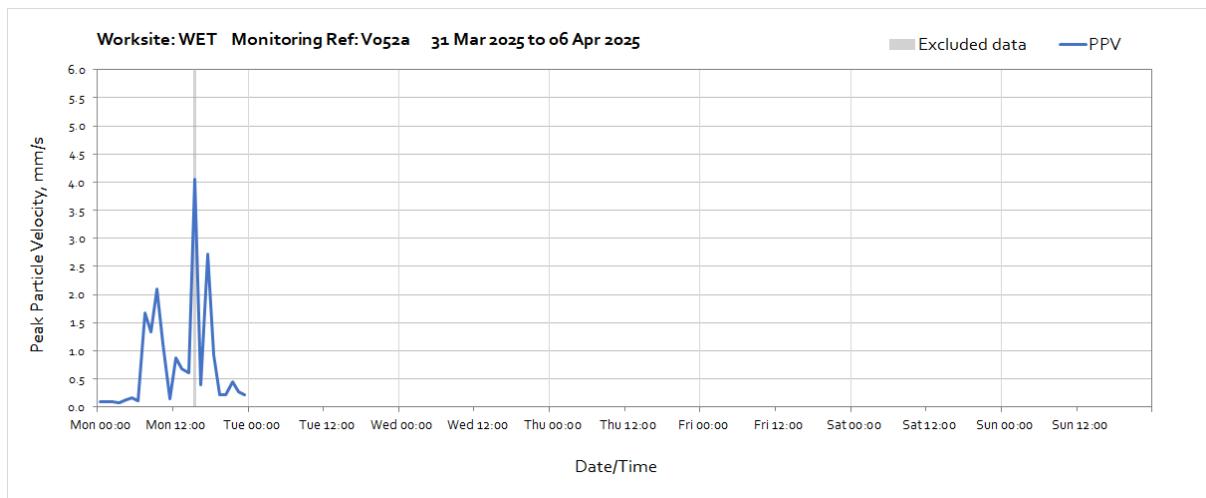
Worksite: WET – Monitoring Ref: V052a

Note: Missing data between 01:00 and 02:00 on Sunday 30th March was due to the start of British Summer Time.

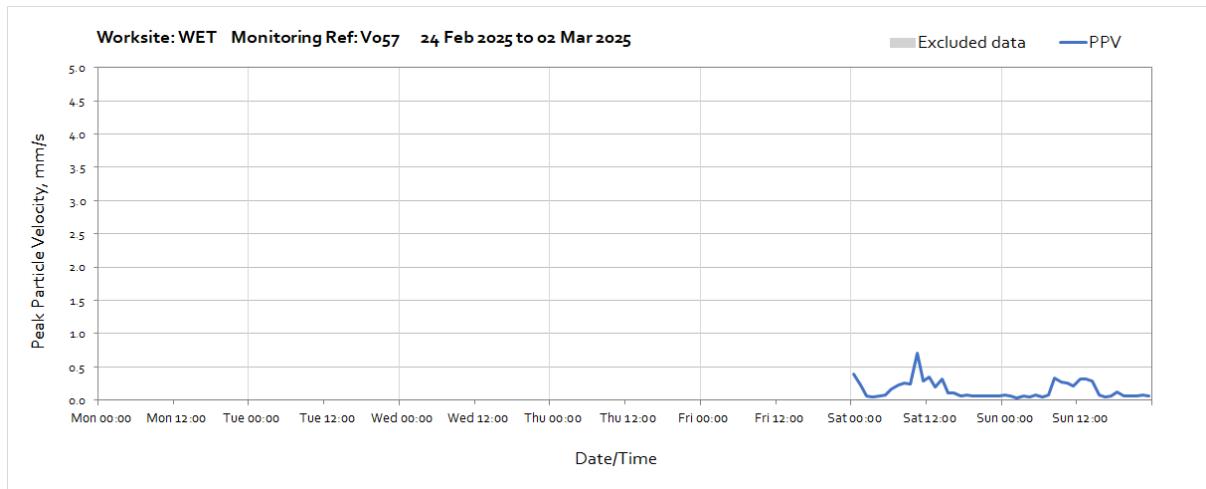
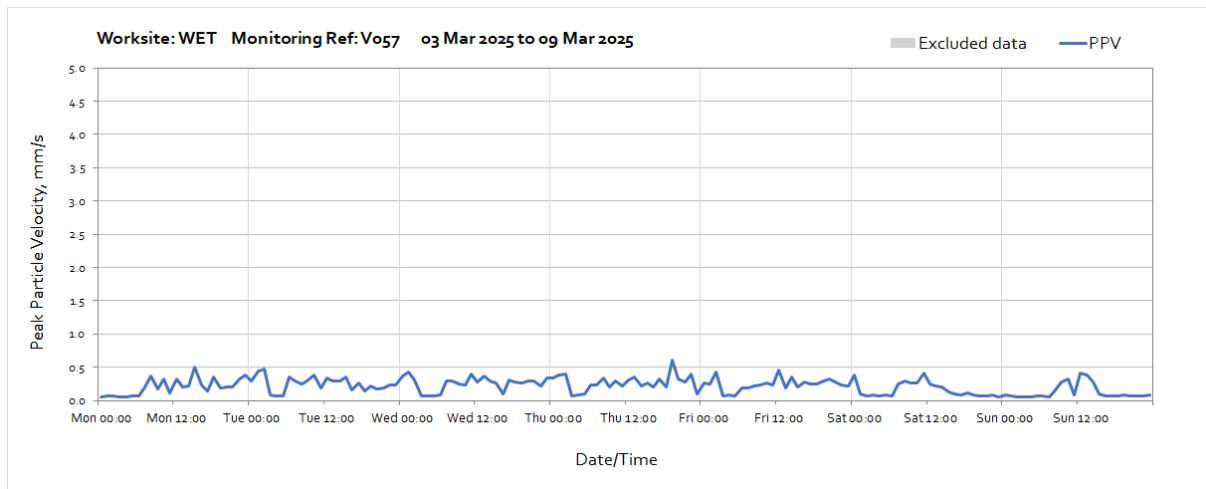
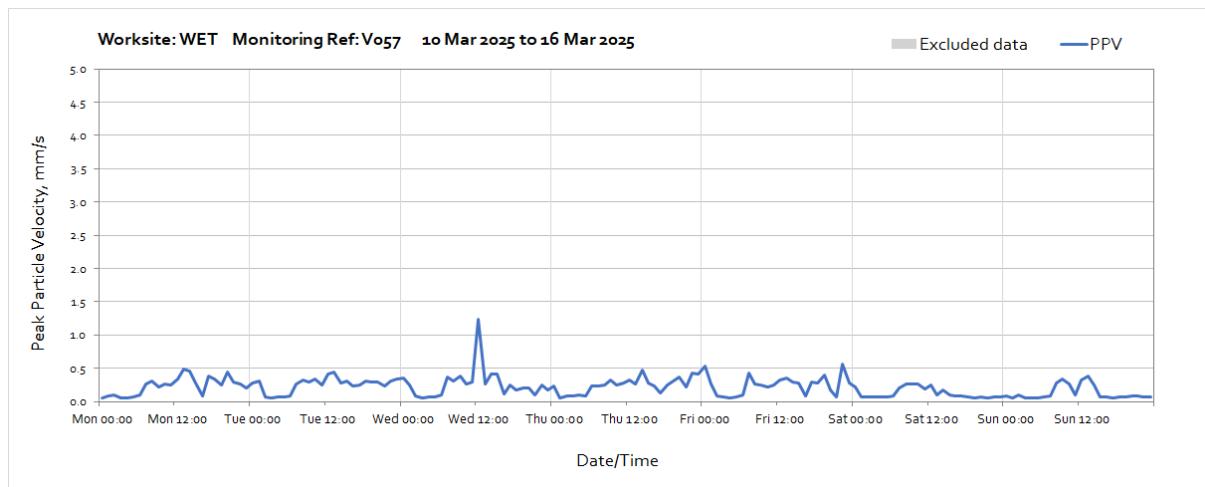
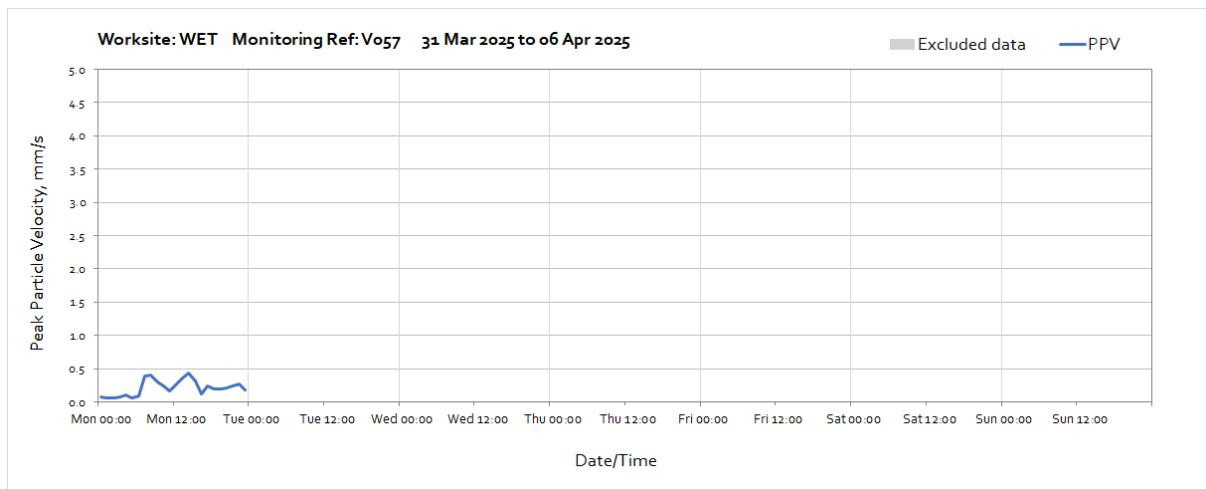
Worksite: WET – Monitoring Ref: V057

Note: Missing data between 01:00 and 02:00 on Sunday 30th March was due to the start of British Summer Time.

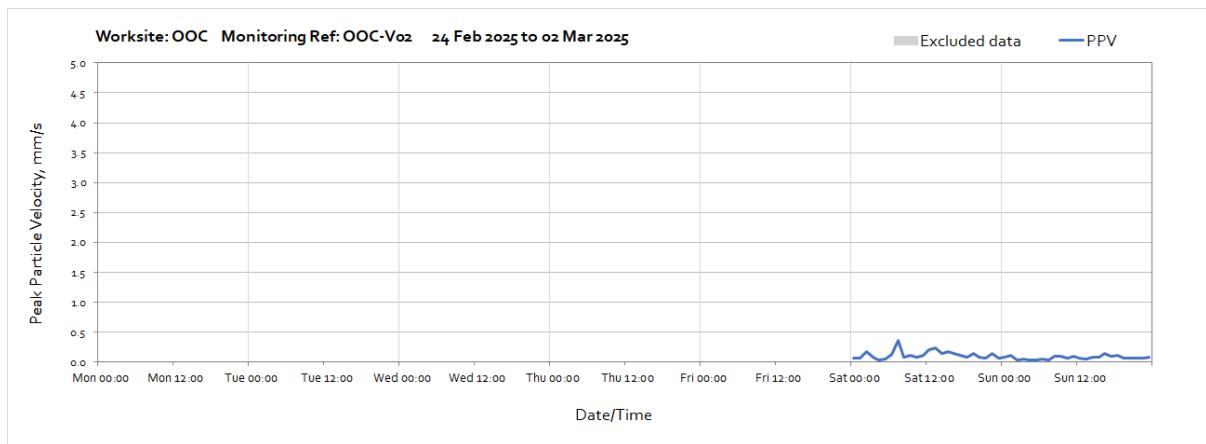
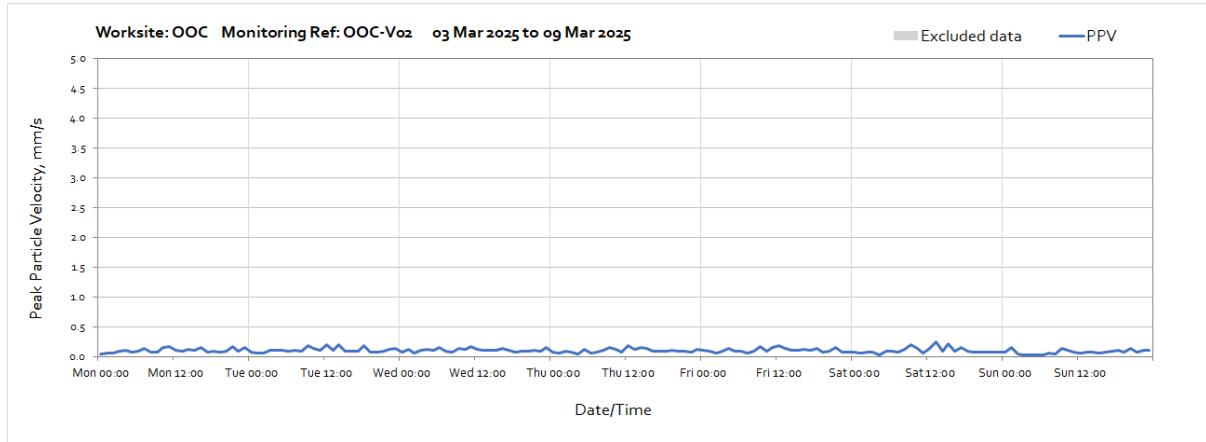
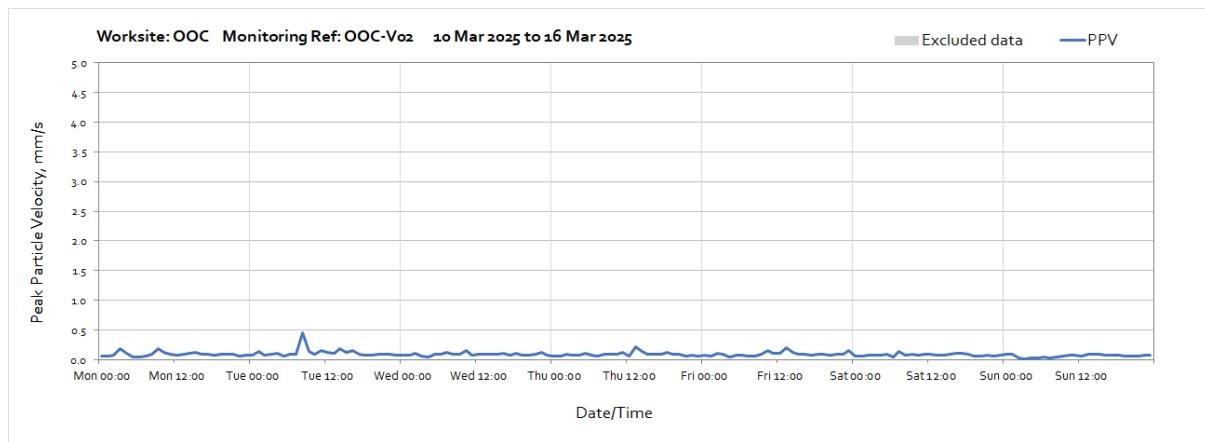
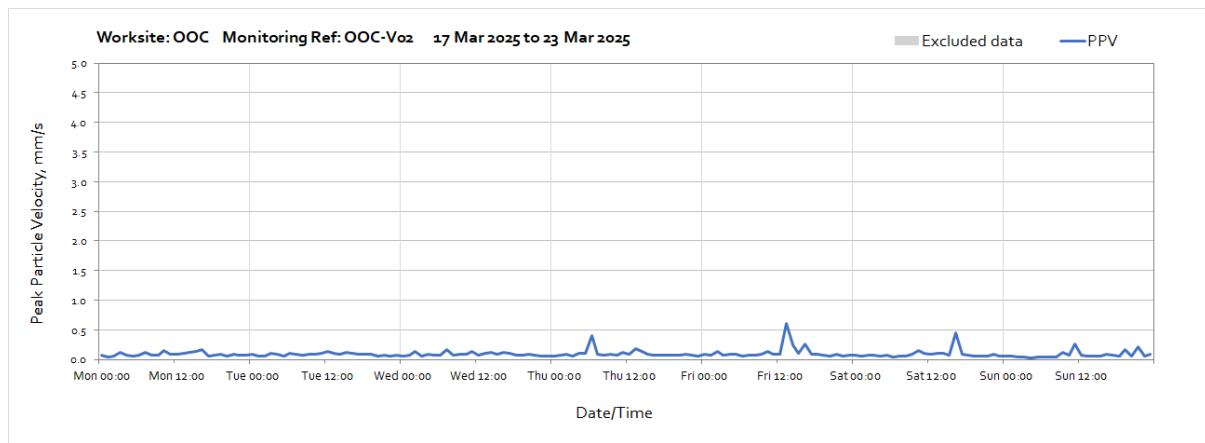
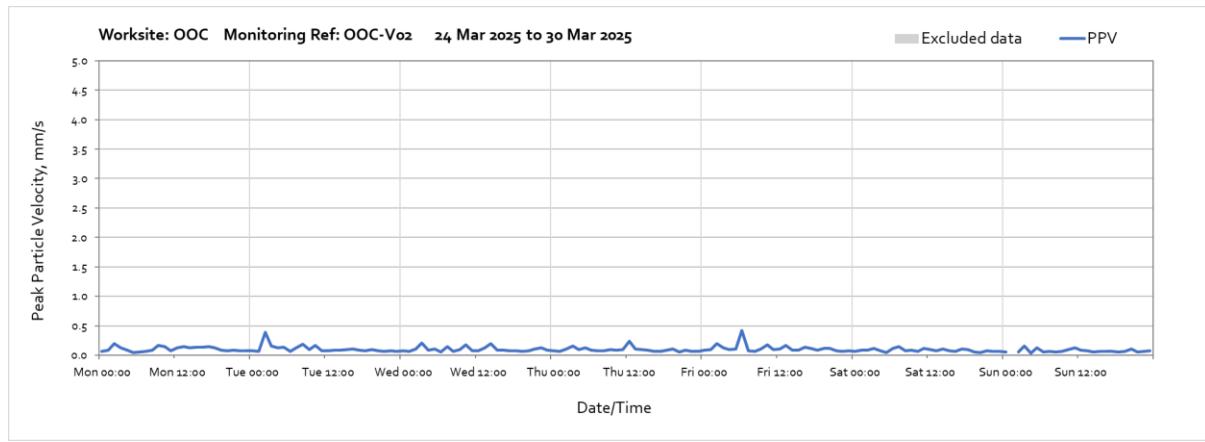
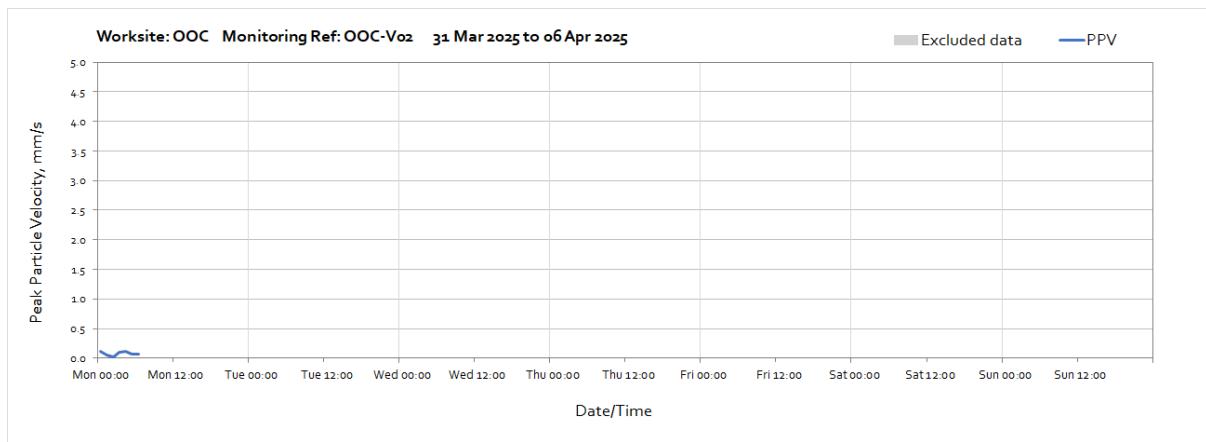
Worksite: OOC – Monitoring Ref: OOC-V02

Note: Missing data between 01:00 and 02:00 on Sunday 30th March was due to the start of British Summer Time.
