HS2

May 2025

Construction Noise and Vibration Monthly Report – March 2025

London Borough of Ealing

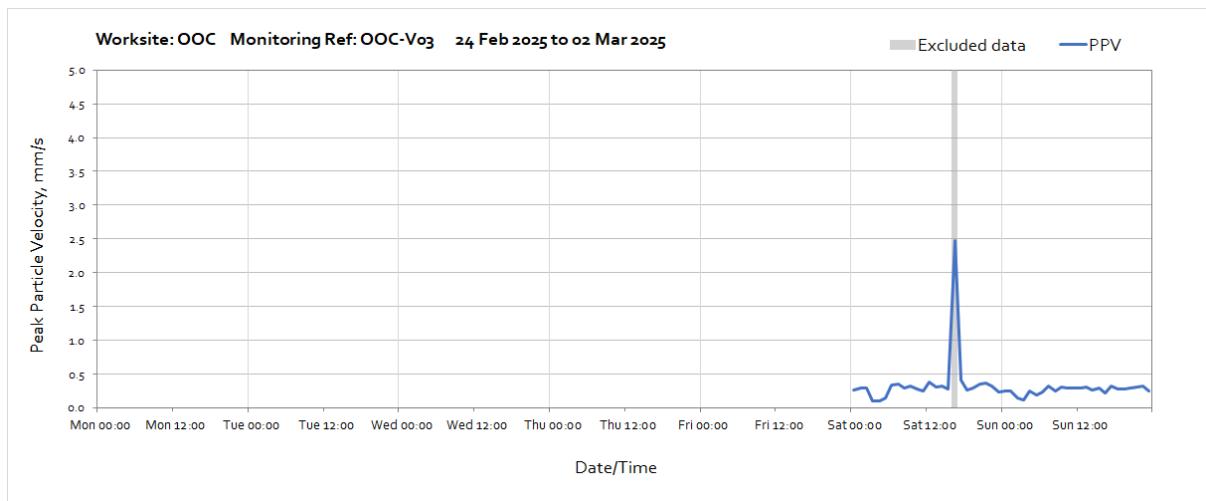
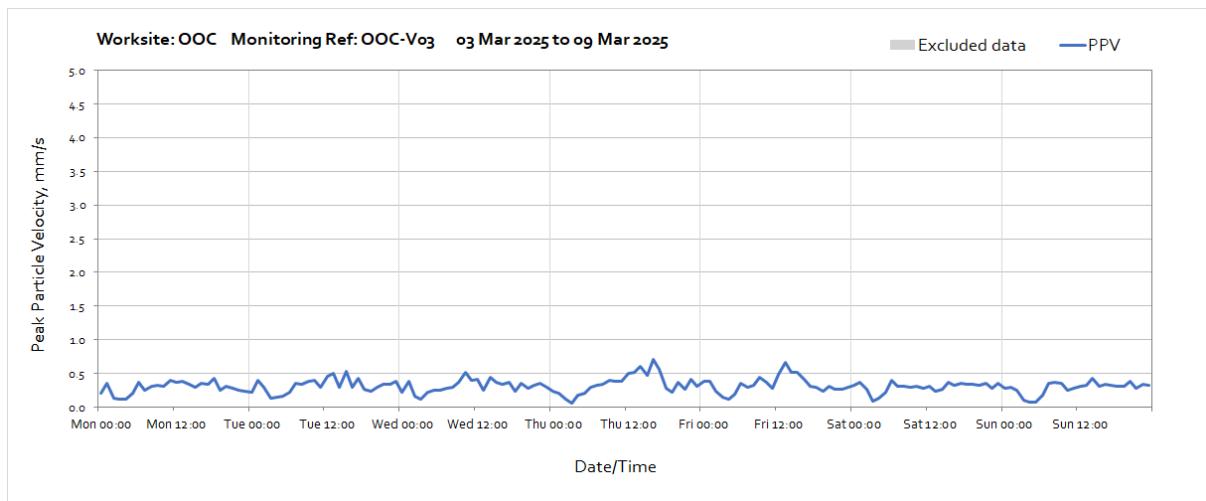
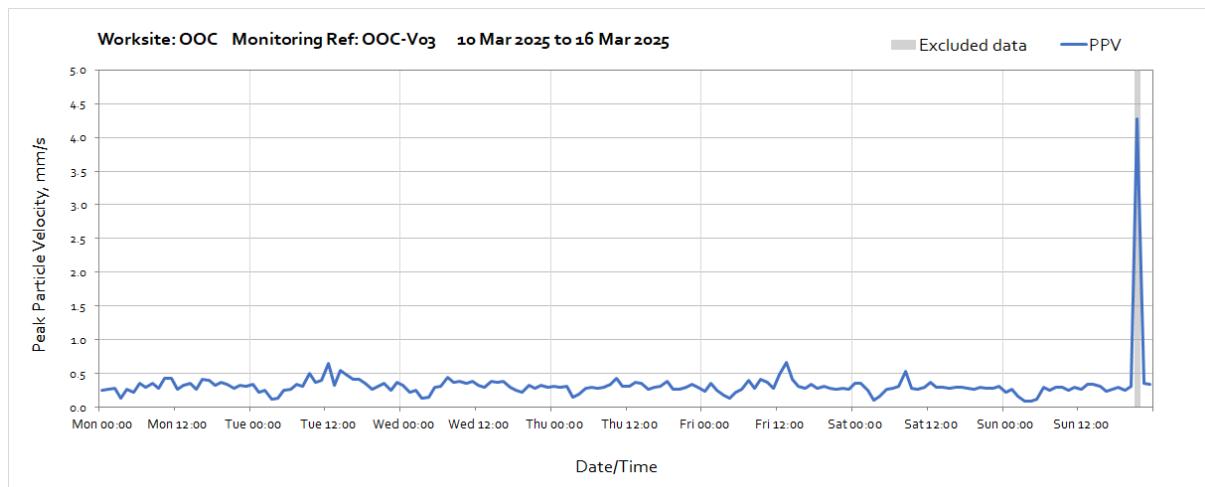
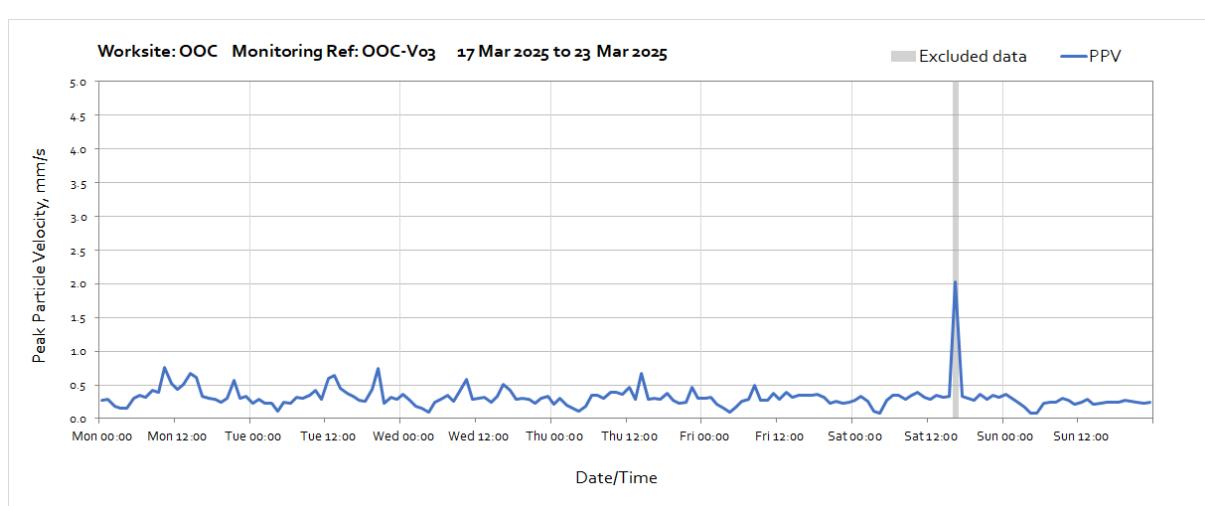
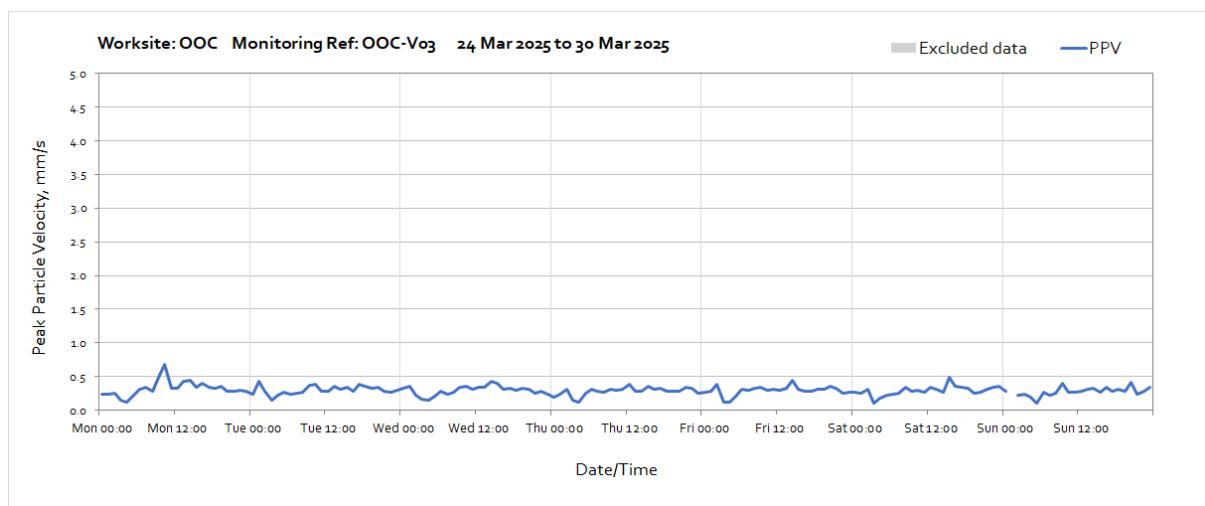
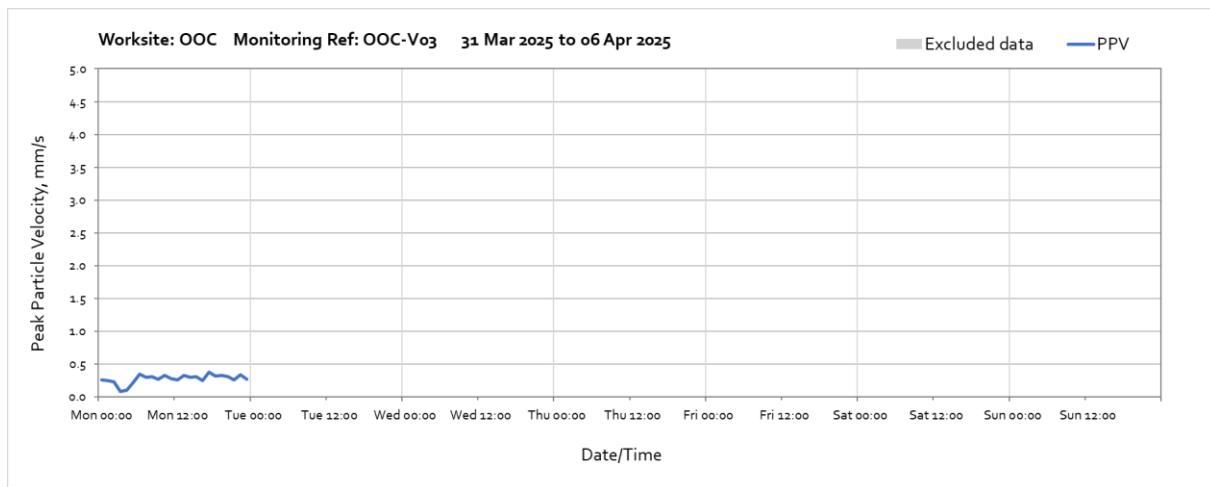
Worksite: OOC - Monitoring Ref: OOC-V03

Note: Missing data between 01:00 and 02:00 on Sunday 30th March was due to the start of British Summer Time.
