Construction noise and vibration Monthly Report – March 2025

London Borough of Hillingdon

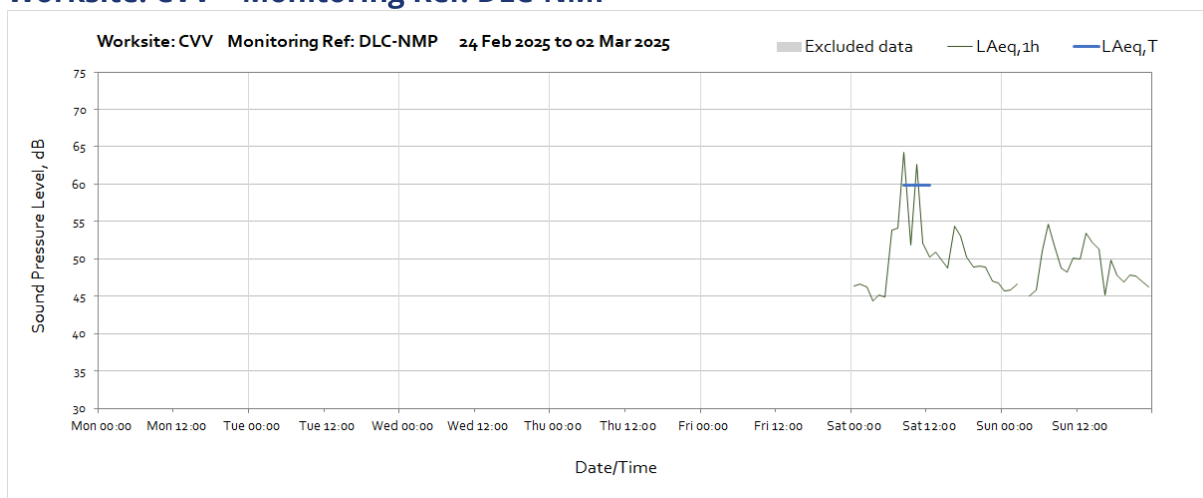
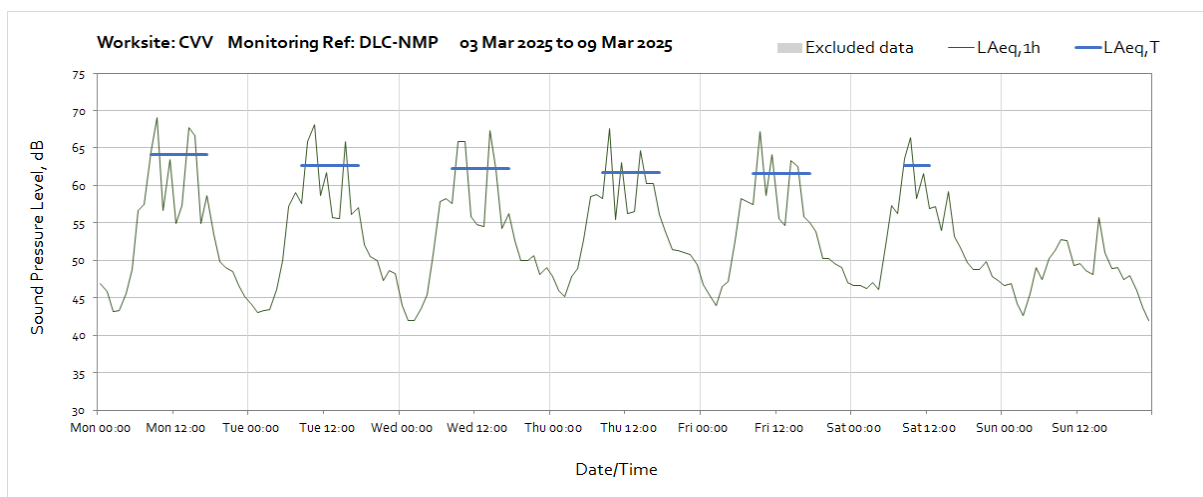
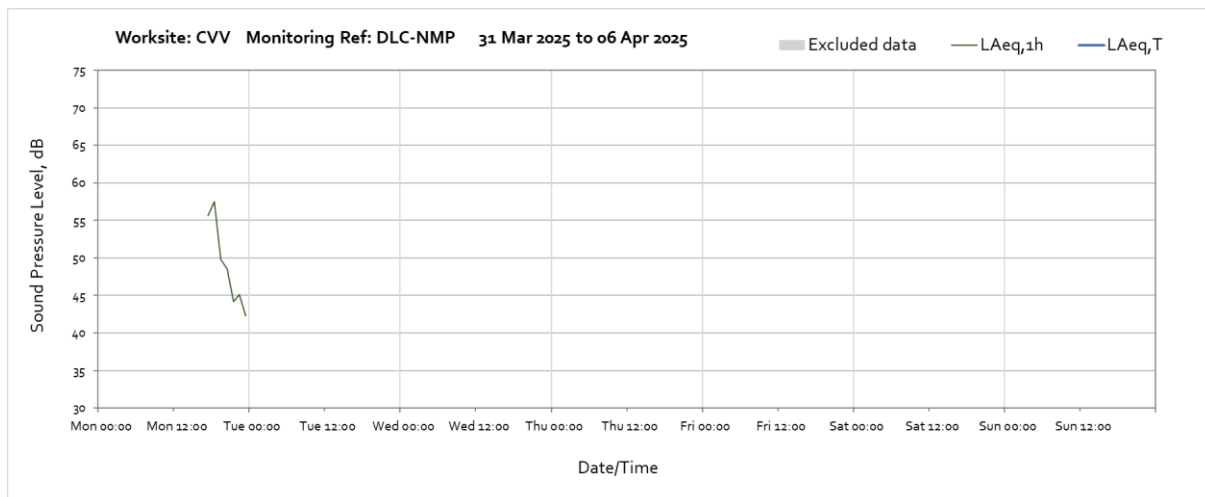
Worksite: CVV – Monitoring Ref: DLC-NMP

The following graphs show the hourly measured ambient noise level $L_{Aeq,1h}$ and, where relevant, the averaged noise level $L_{Aeq,T}$ values, where the time period T is as specified in Table 1 of HS2 Information Paper E23. Periods where noise levels are adversely affected by weather or only measured for part of the period, which are not representative of HS2 construction works, have been greyed out and excluded from the calculation of the $L_{Aeq,T}$ values in Table 3 of the main report.

Note: Missing data from 03:00 until 04:00 on Sunday 3rd March was due to a data transmission error within the monitoring station.

Note: Missing data from 18:00 on Friday 21st March until 17:00 on Monday 31st March was due to loss of mains power from the monitoring station.

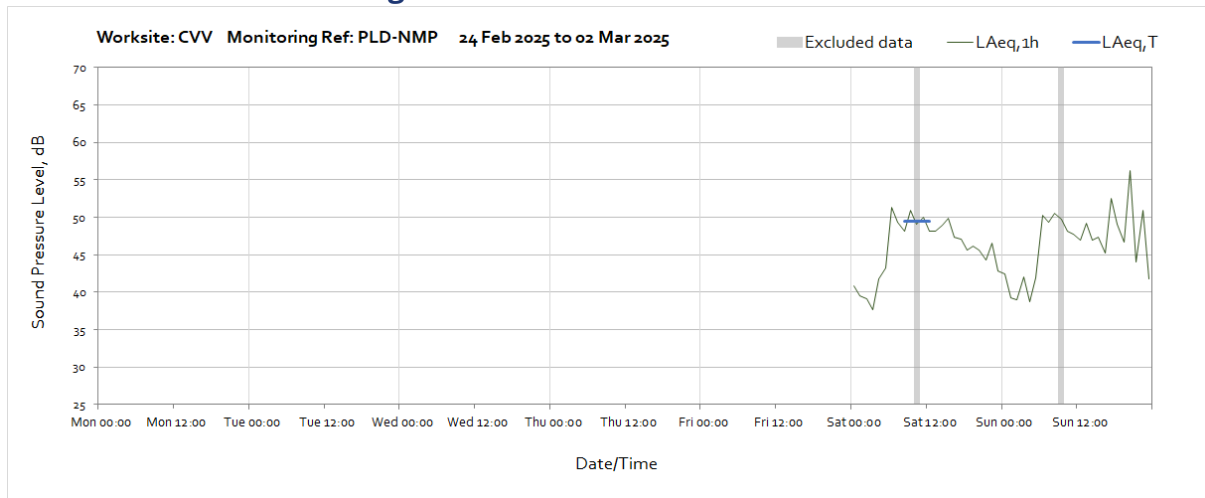
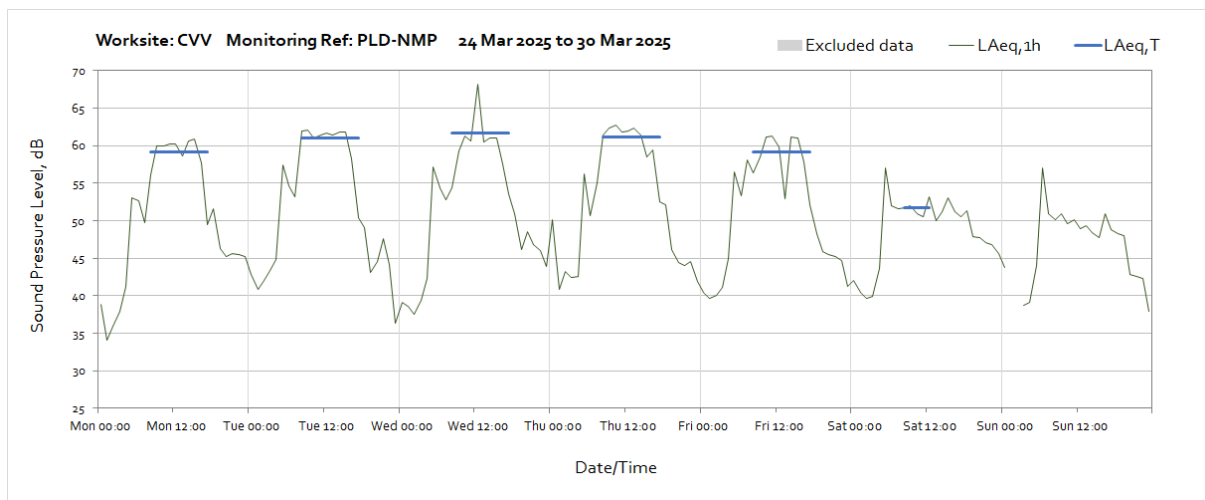
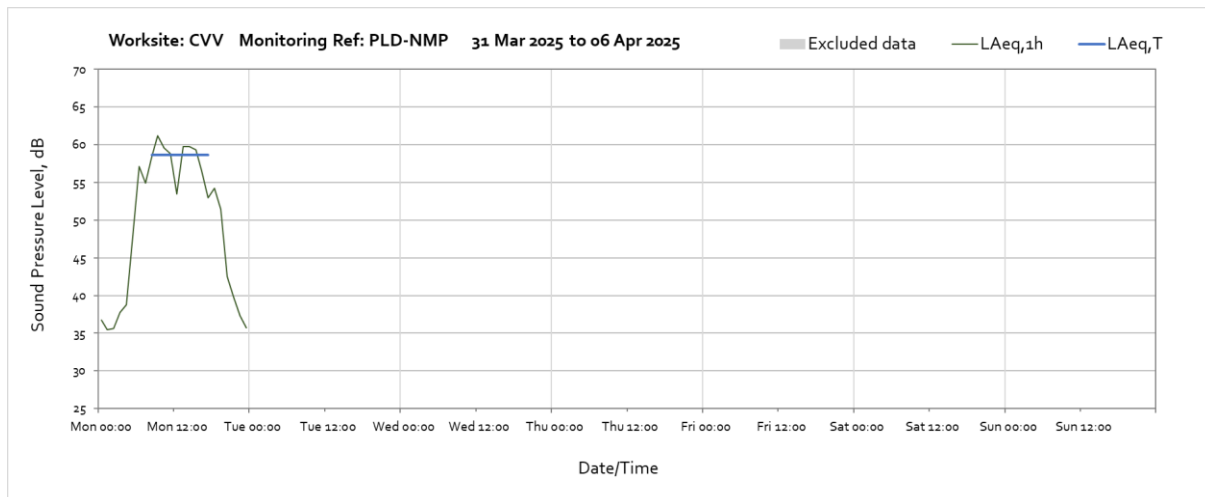
Worksite: CVV – Monitoring Ref: PLD-NMP

Note: Missing data from 01:00 until 02:00 on Sunday 30th March was due to the start of British Summer Time.

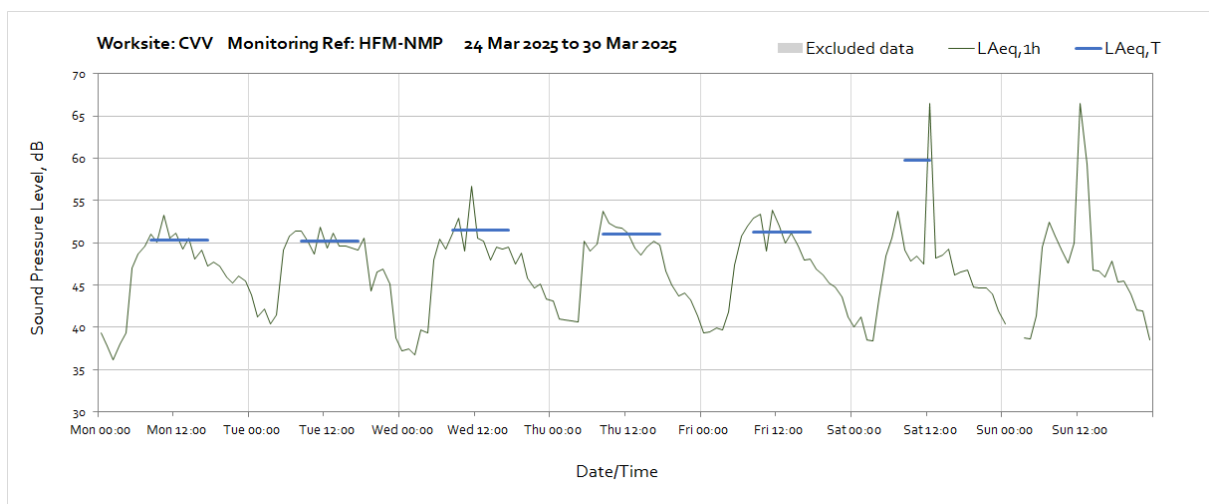
Worksite: CVV – Monitoring Ref: HFM-NMP

Note: Missing data from 01:00 until 02:00 on Sunday 30th March was due to the start of British Summer Time.

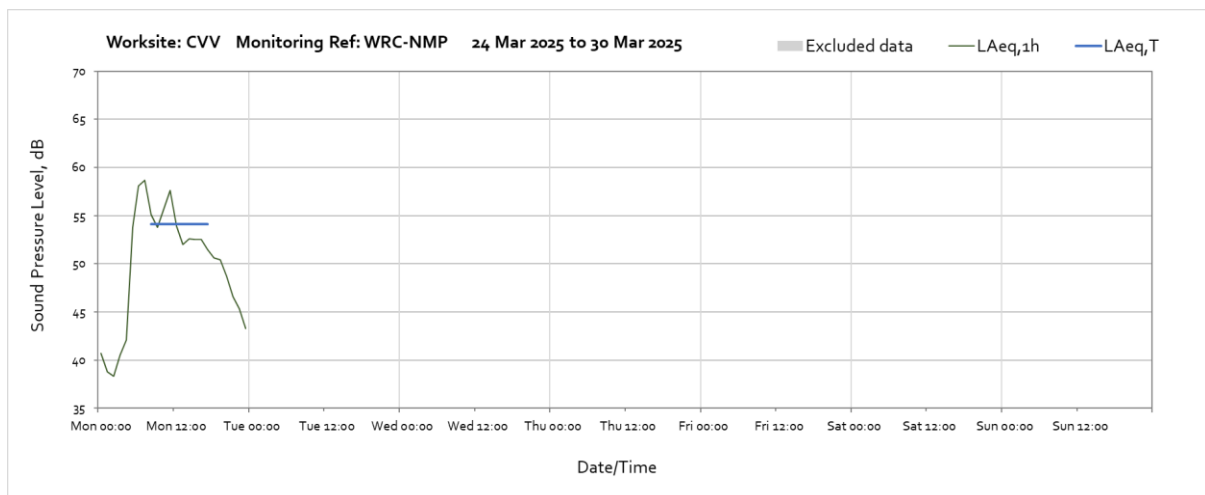
Worksite: CVV – Monitoring Ref: WRC-NMP

Note: Missing data from 01:00 until 02:00 on Sunday 30th March was due to the start of British Summer Time.

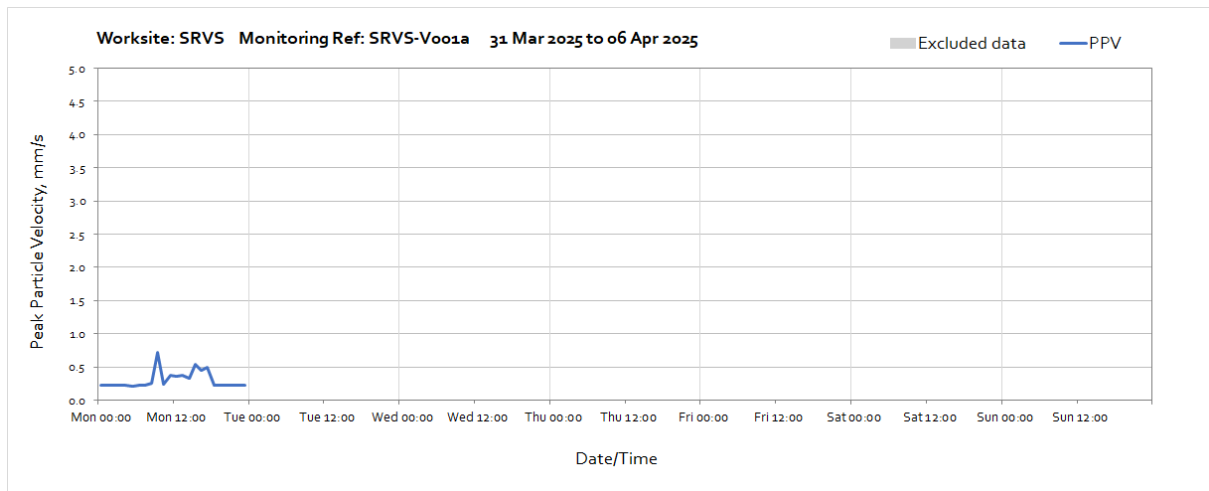
Worksite: SRVS – Monitoring Ref: SRVS-V001a

Note: Missing data from 01:00 until 02:00 on Sunday 30th March was due to the start of British Summer Time.
