## **Construction Noise and Vibration Monthly Report – March 2025**

**North Warwickshire Borough Council**

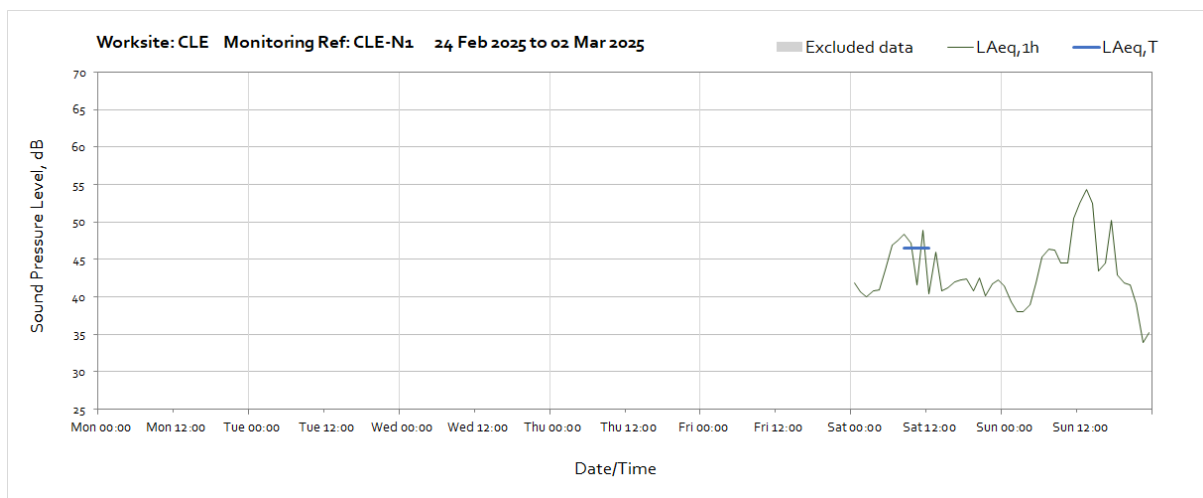
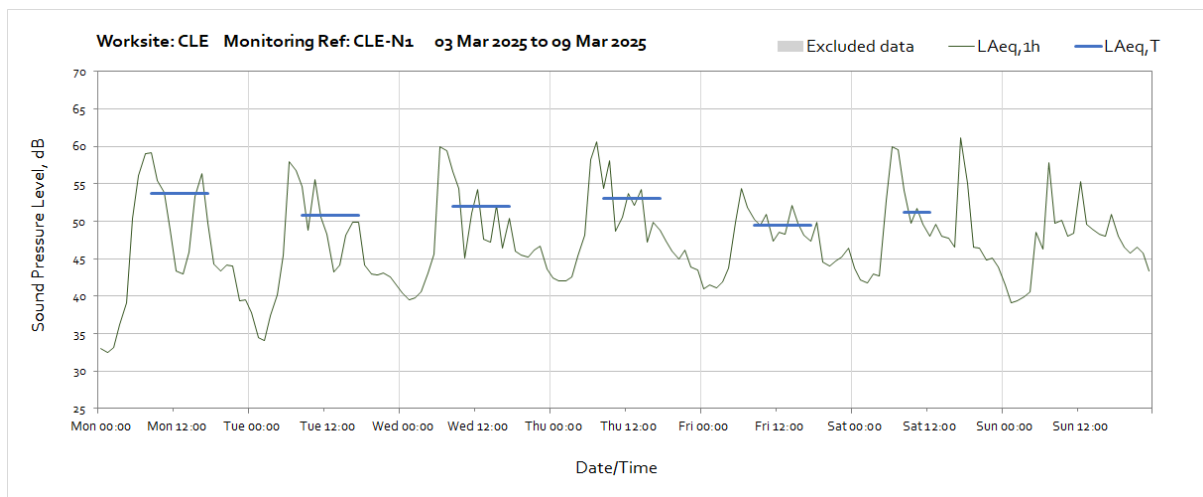
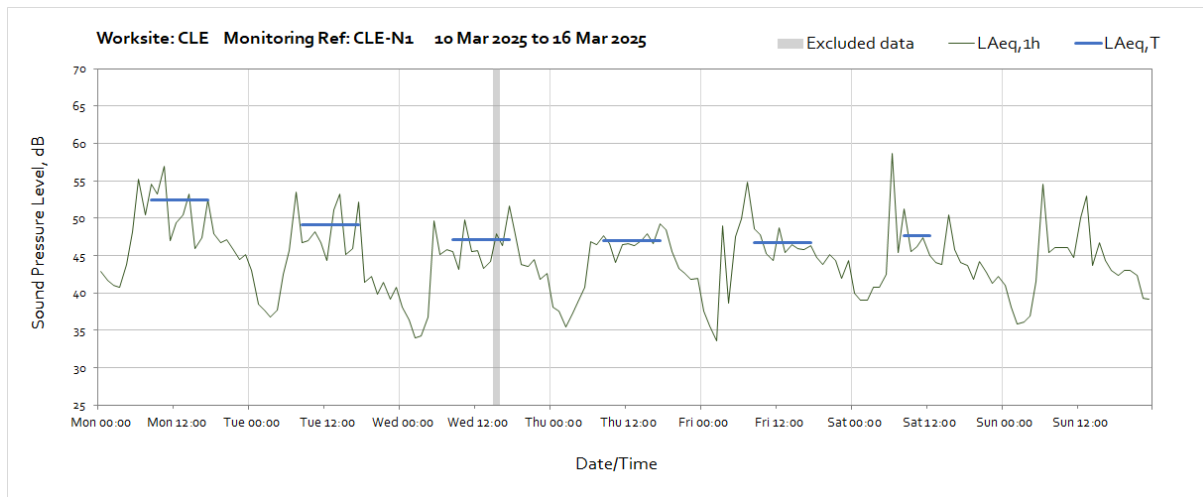
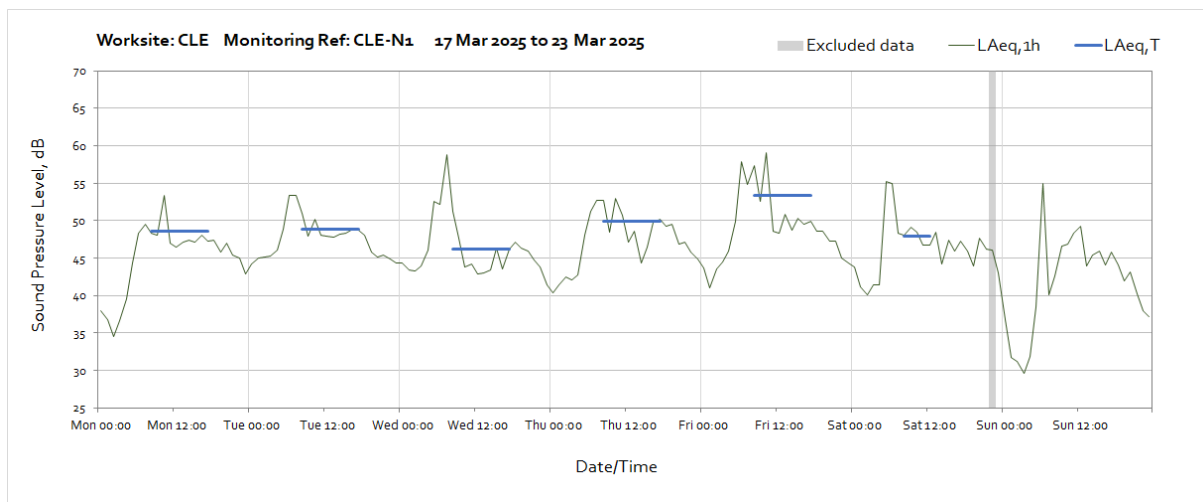
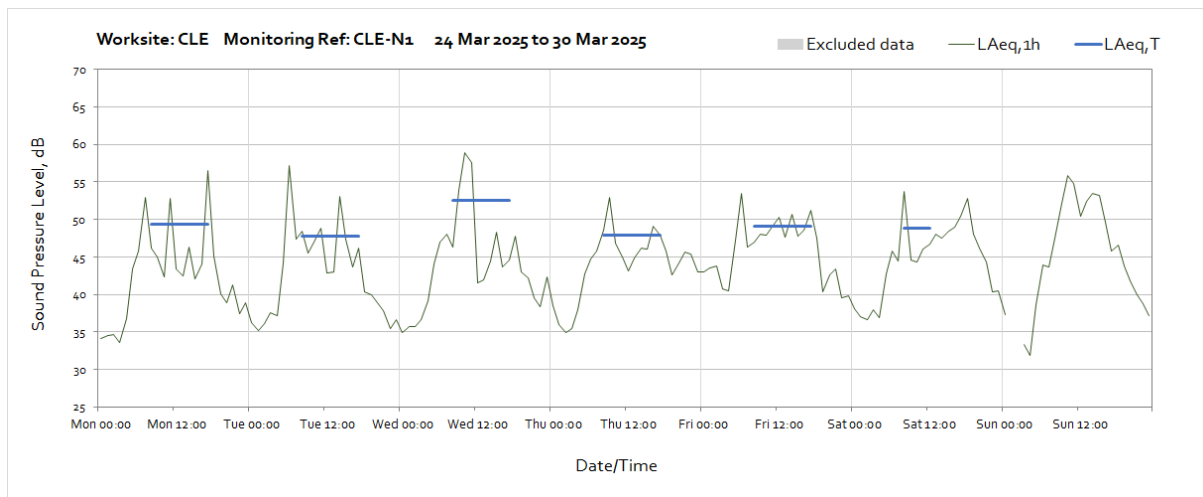
### Worksite: CLE – Monitoring Ref: CLE-N1

Note: Missing data between 01:00 and 03:00 on Sunday 30th March is due to a monitor time adjustment at the start of British Summer Time.

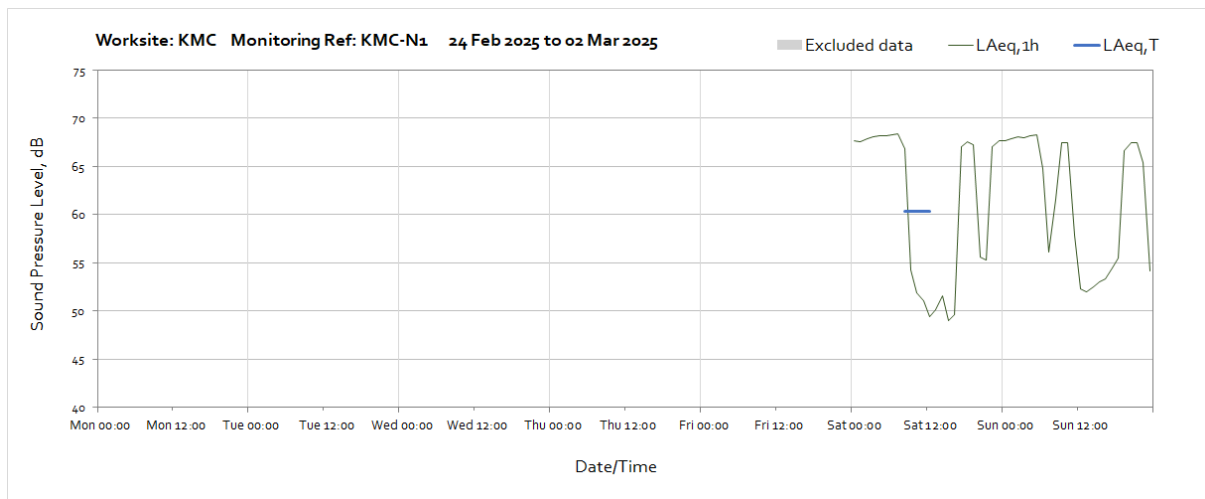
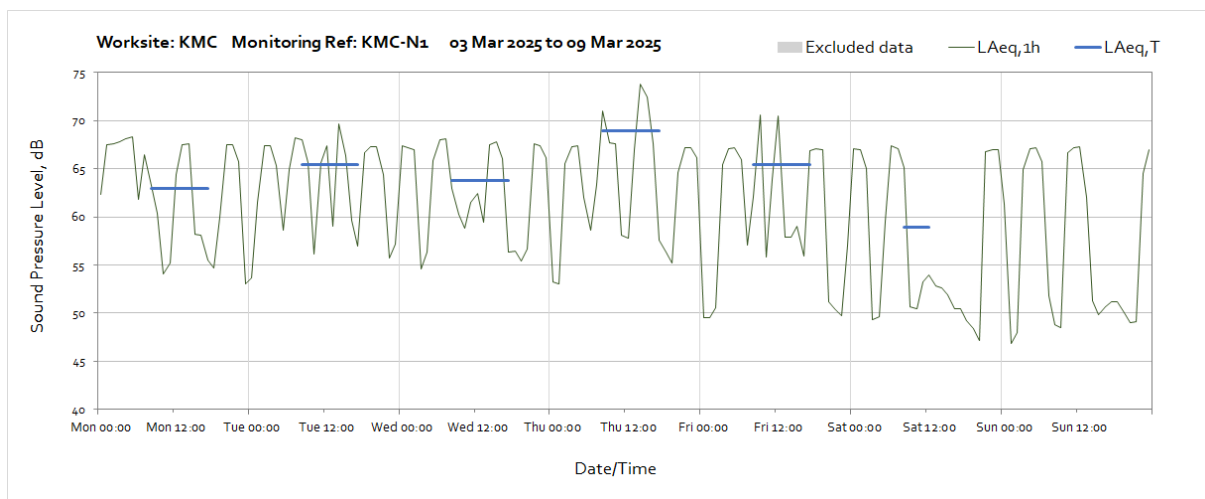
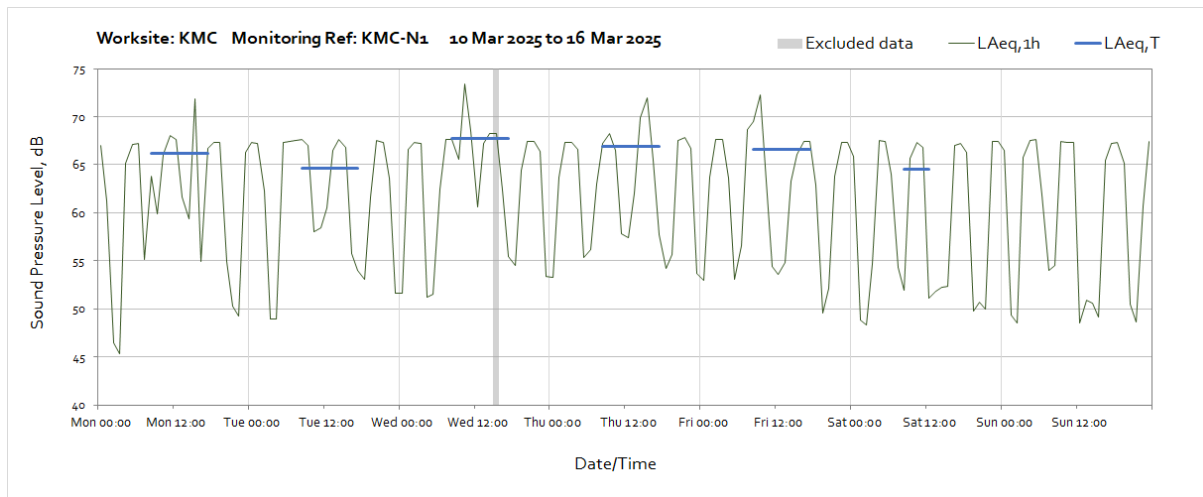
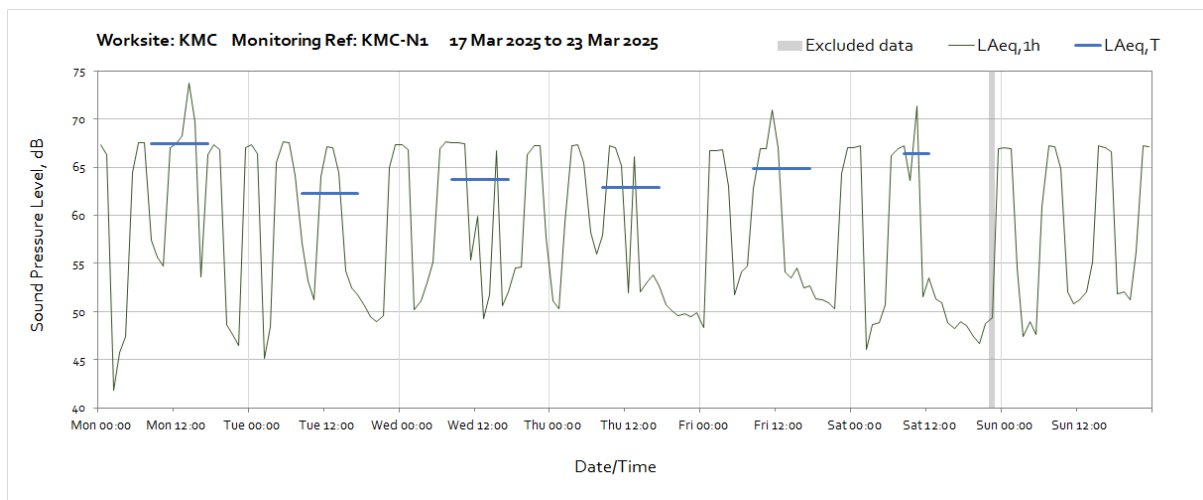
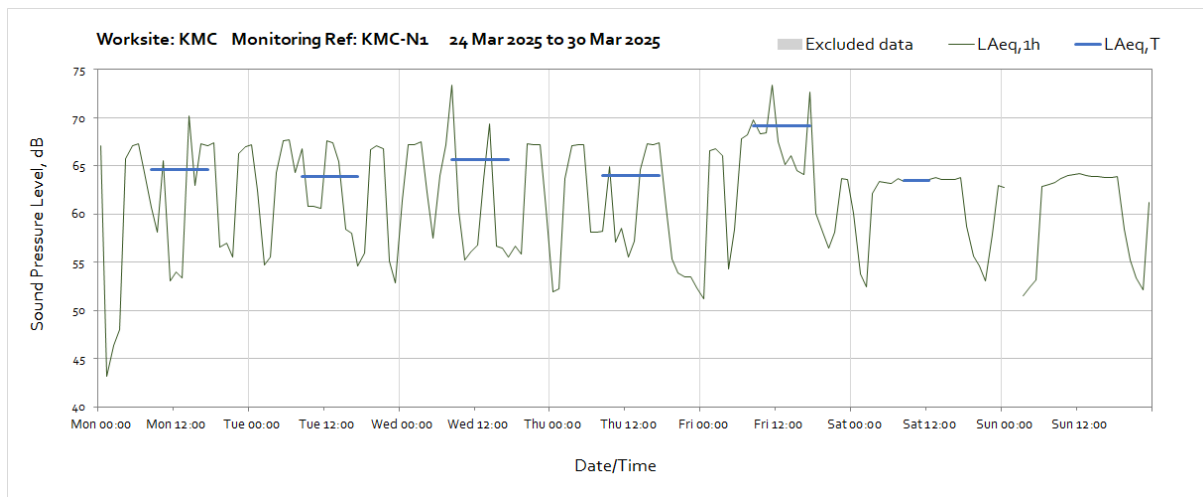
## Worksite: KMC – Monitoring Ref: KMC-N1

Note: Missing data between 01:00 and 03:00 on Sunday 30th March is due to a monitor time adjustment at the start of British Summer Time.

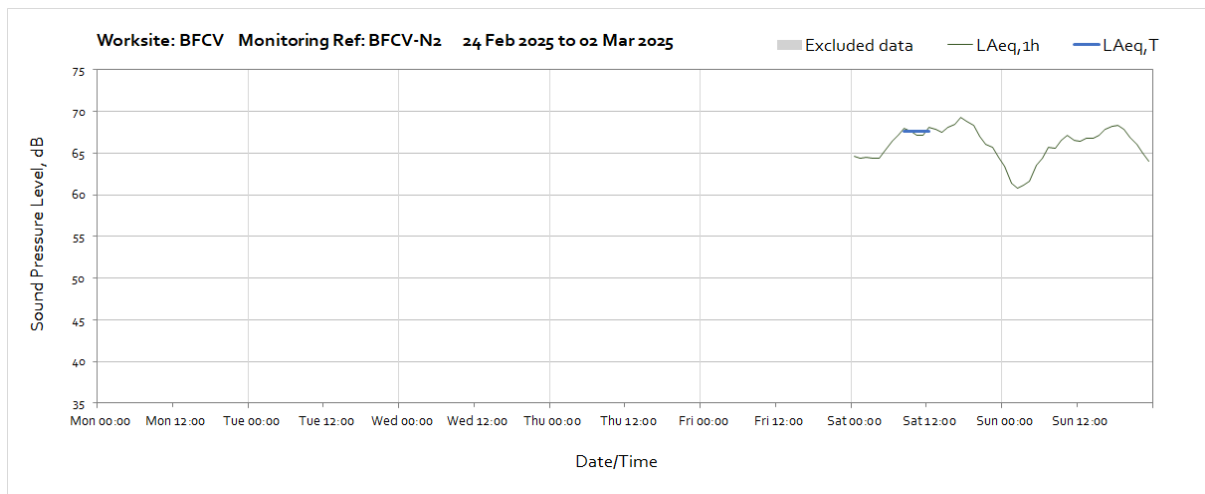
## Worksite: BFCV – Monitoring Ref: BFCV-N2

Note: Missing data from 22:00 on Monday 3<sup>rd</sup> March until the end of the month was due to tampering of the monitoring station.

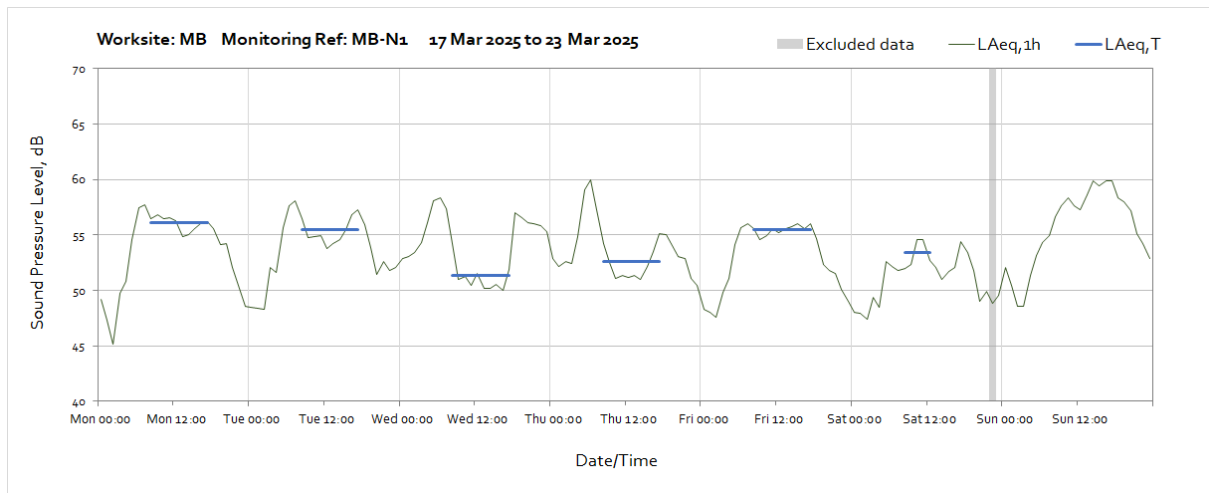
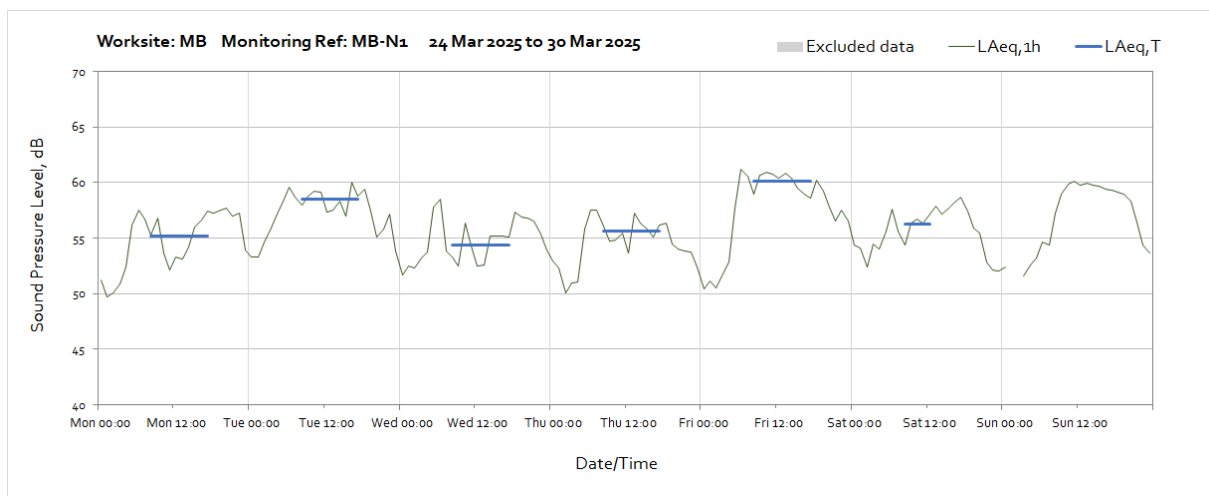
## Worksite: MB – Monitoring Ref: MB-N1

Note: Missing data between 01:00 and 03:00 on Sunday 30th March is due to a monitor time adjustment at the start of British Summer Time.

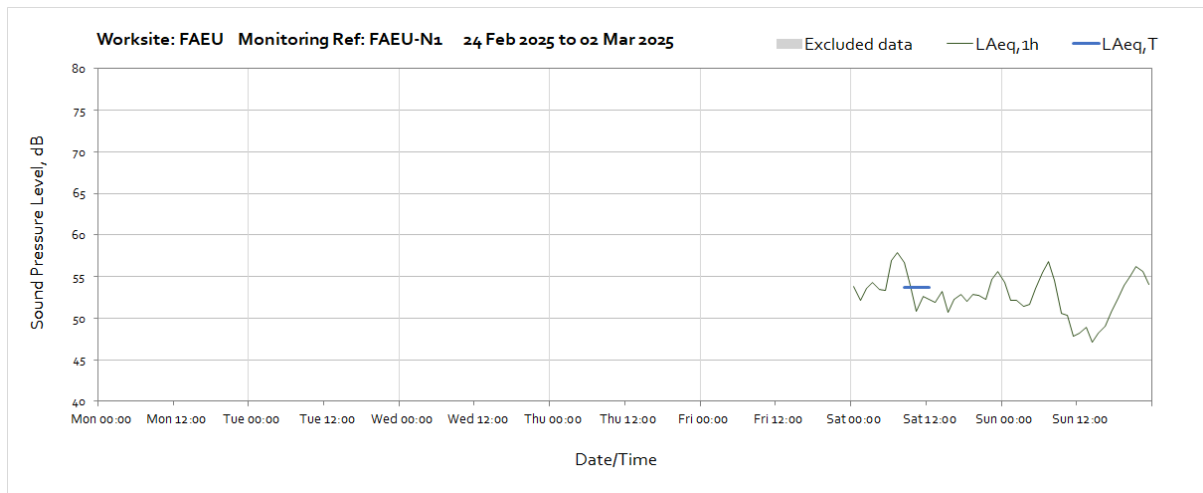
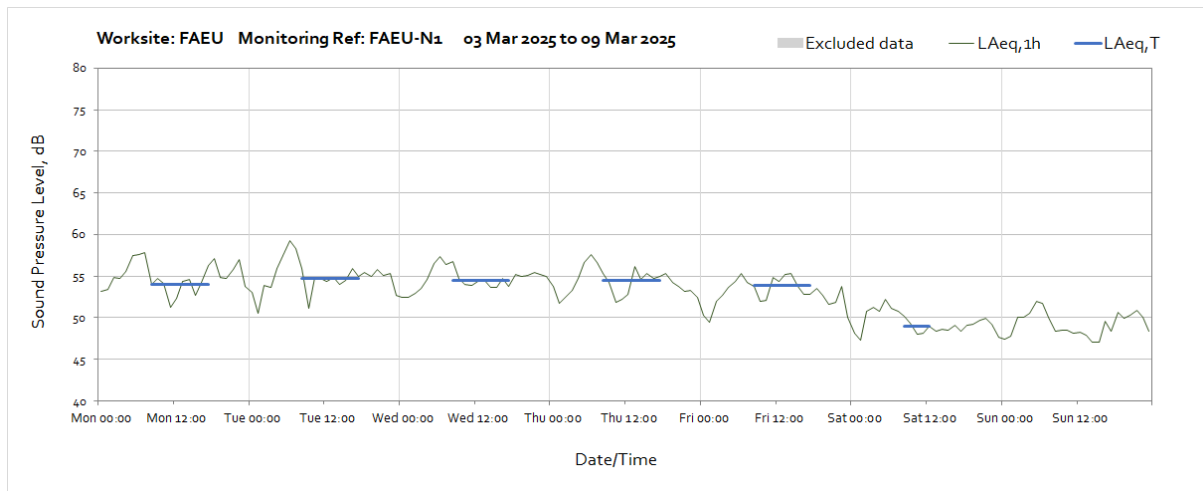
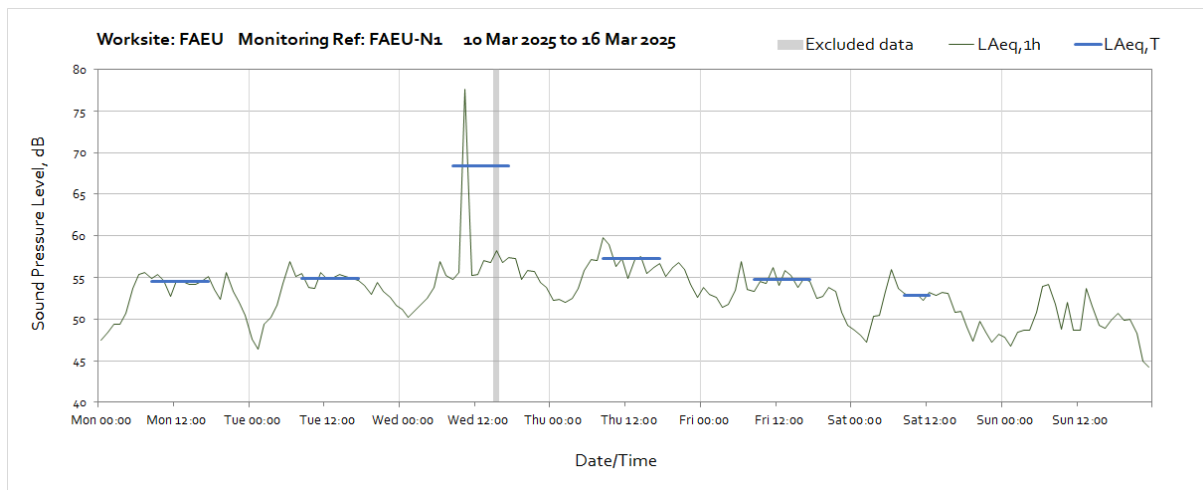
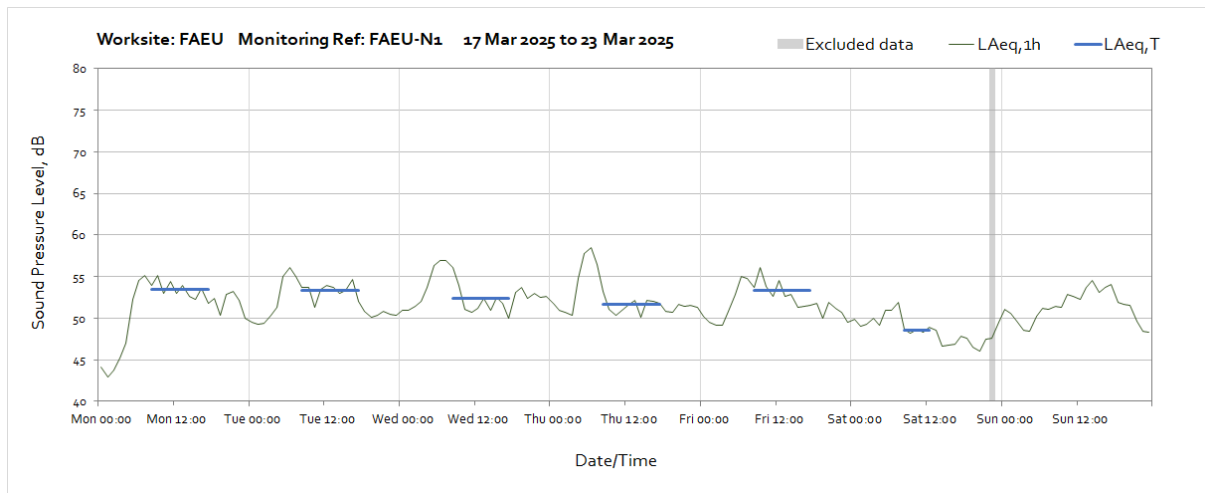
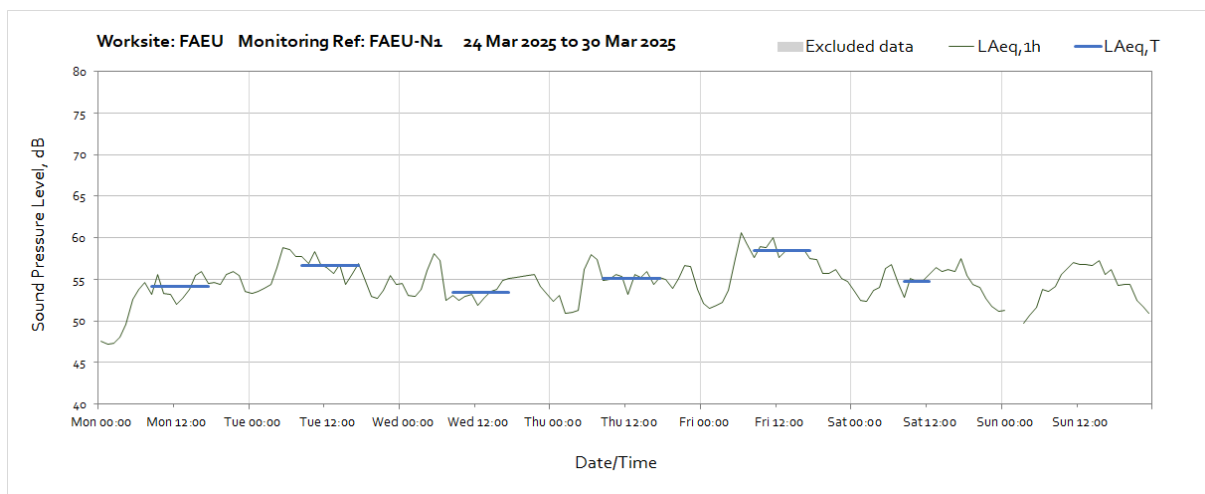
## Worksite: FAEU – Monitoring Ref: FAEU-N1

Note: Missing data between 01:00 and 03:00 on Sunday 30th March is due to a monitor time adjustment at the start of British Summer Time.

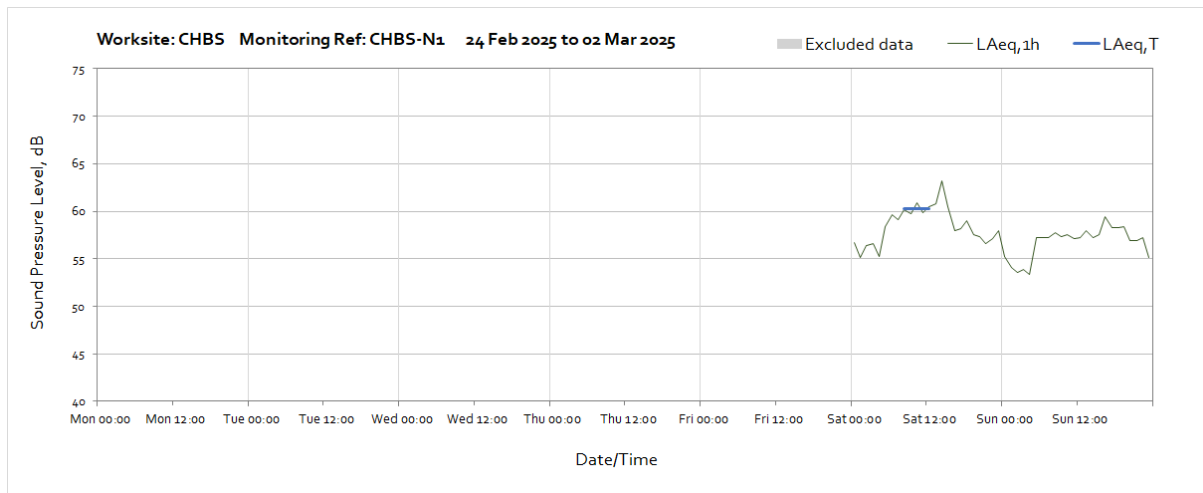
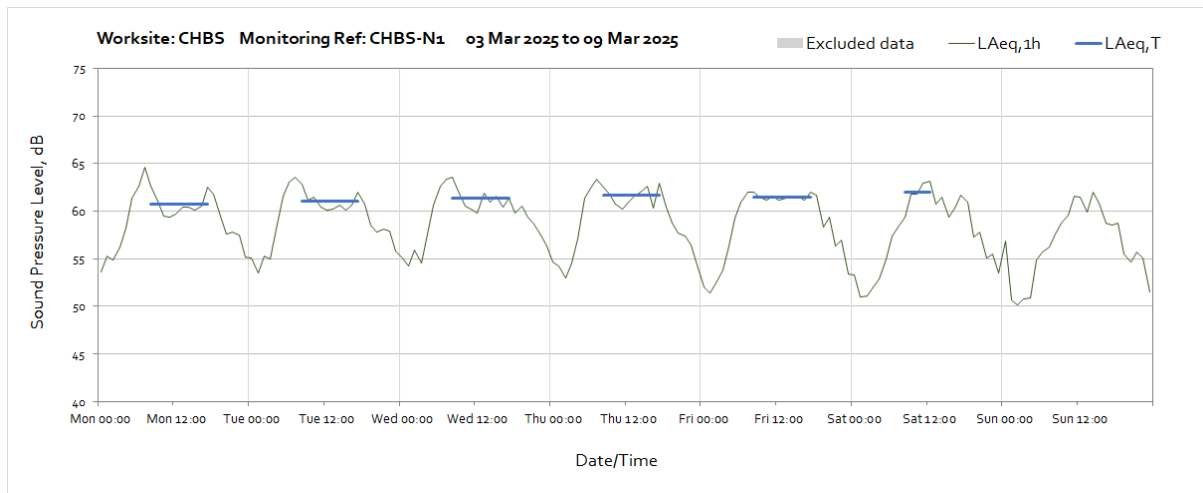
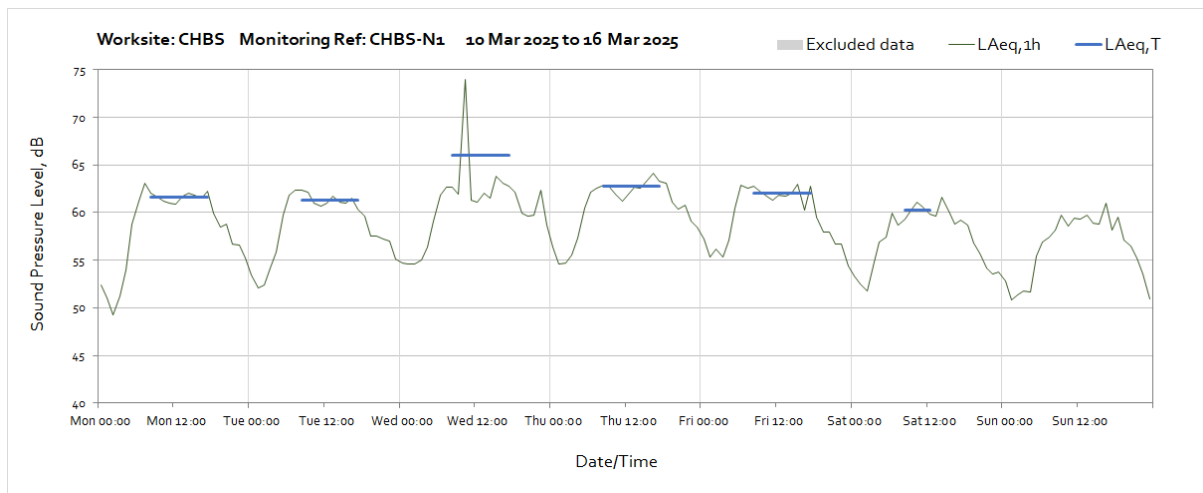
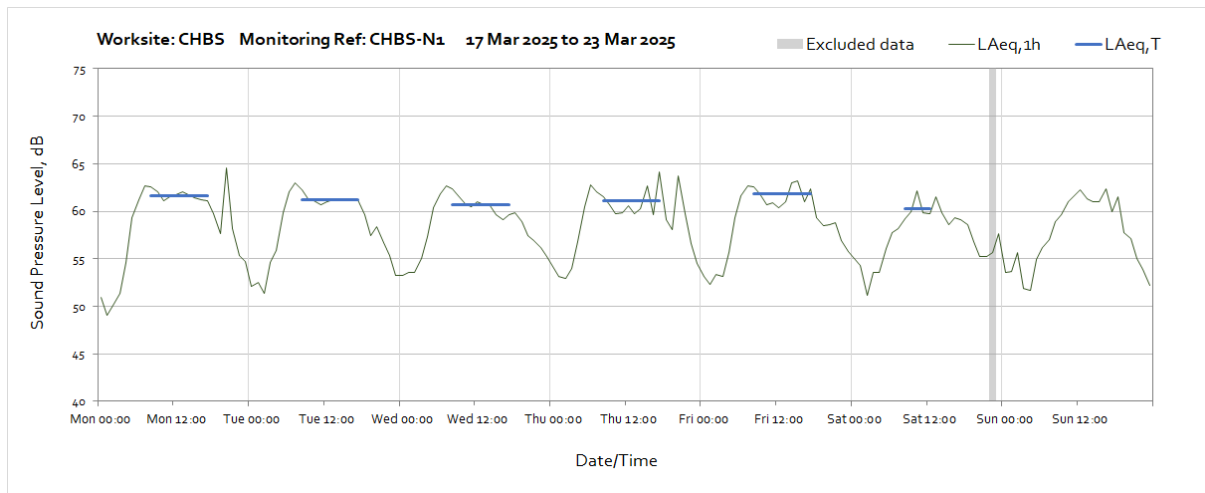
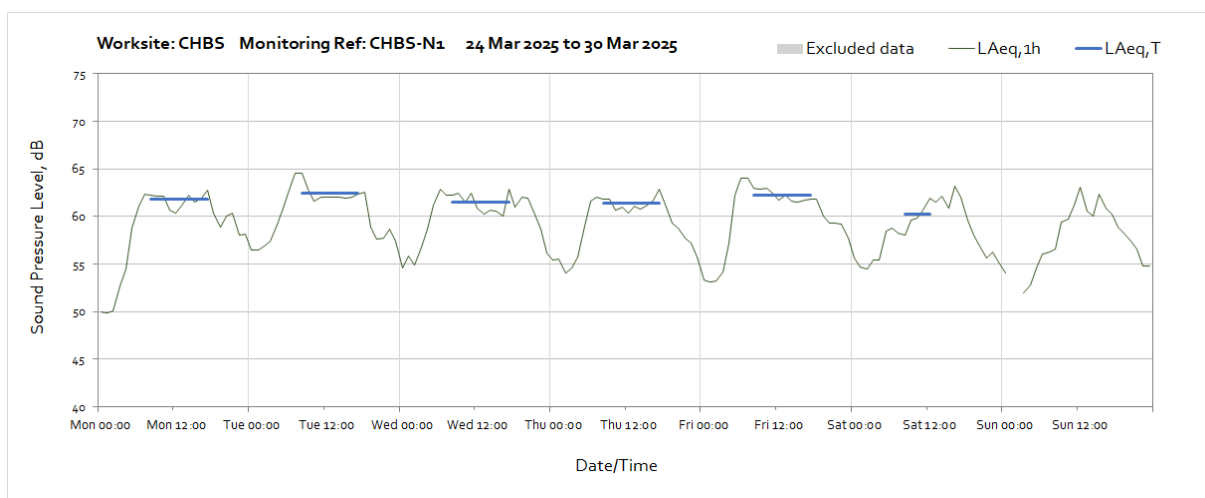
## Worksite: CHBS – Monitoring Ref: CHBS-N1

Note: Missing data between 01:00 and 03:00 on Sunday 30th March is due to a monitor time adjustment at the start of British Summer Time.

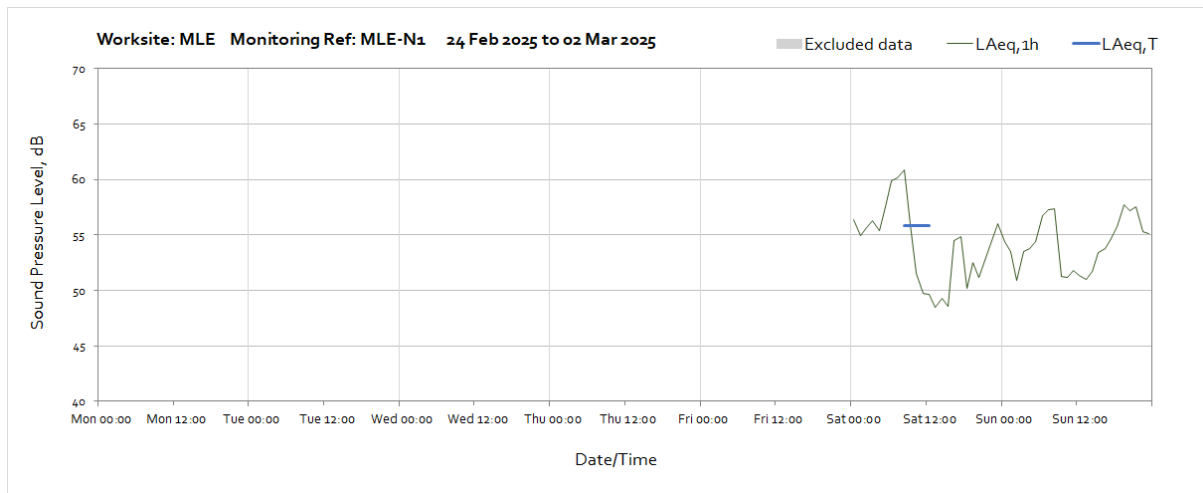
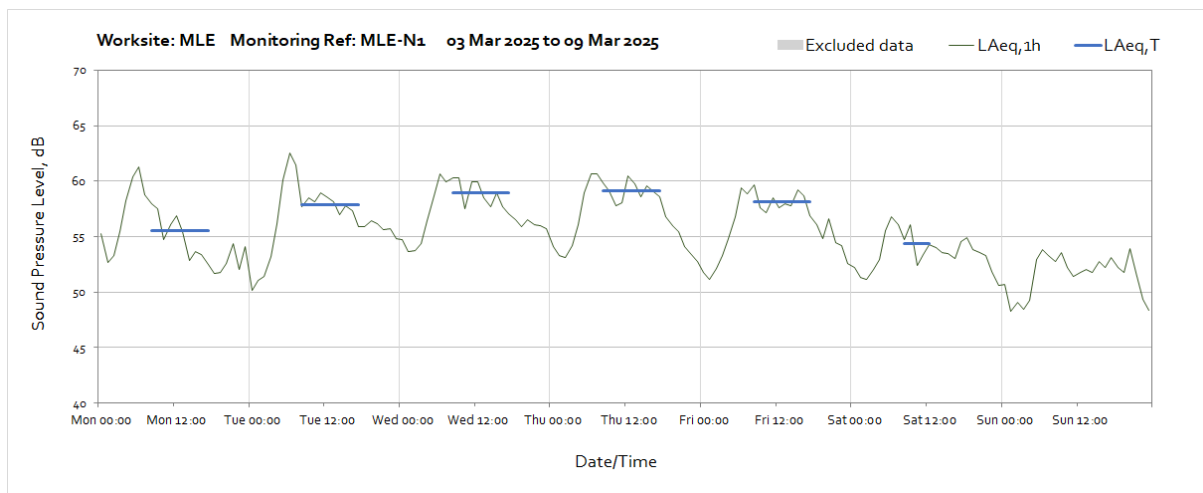
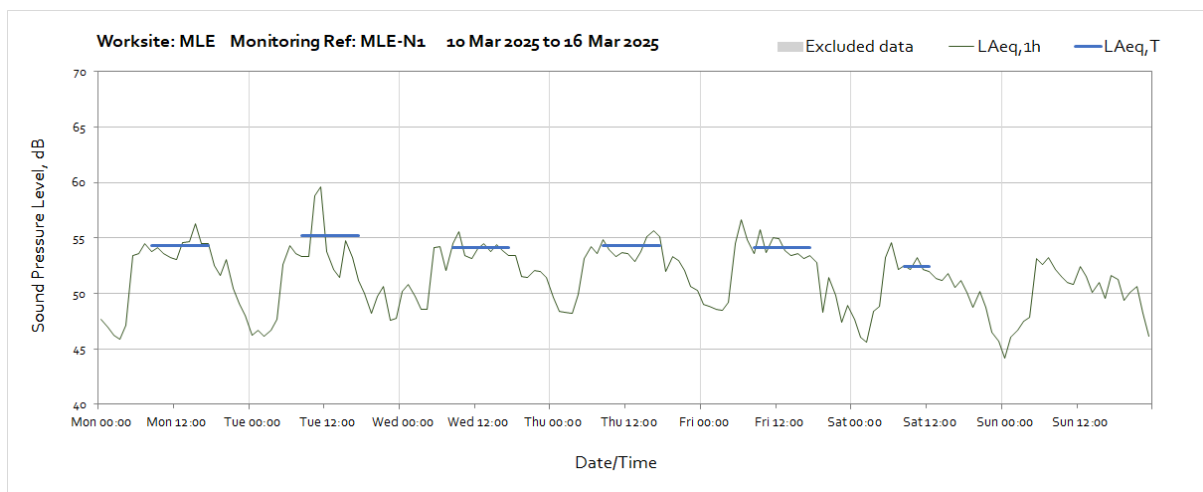
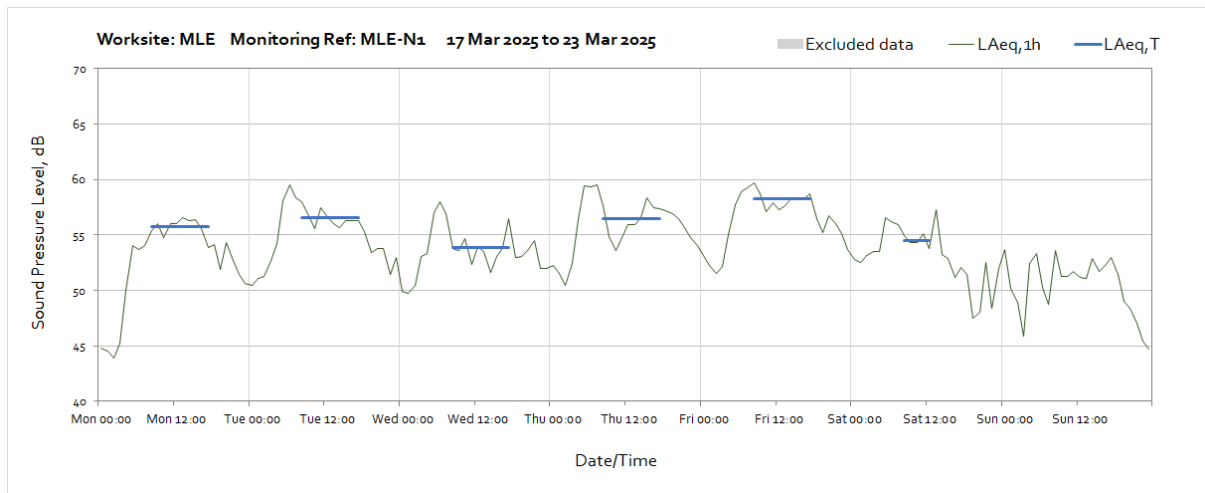
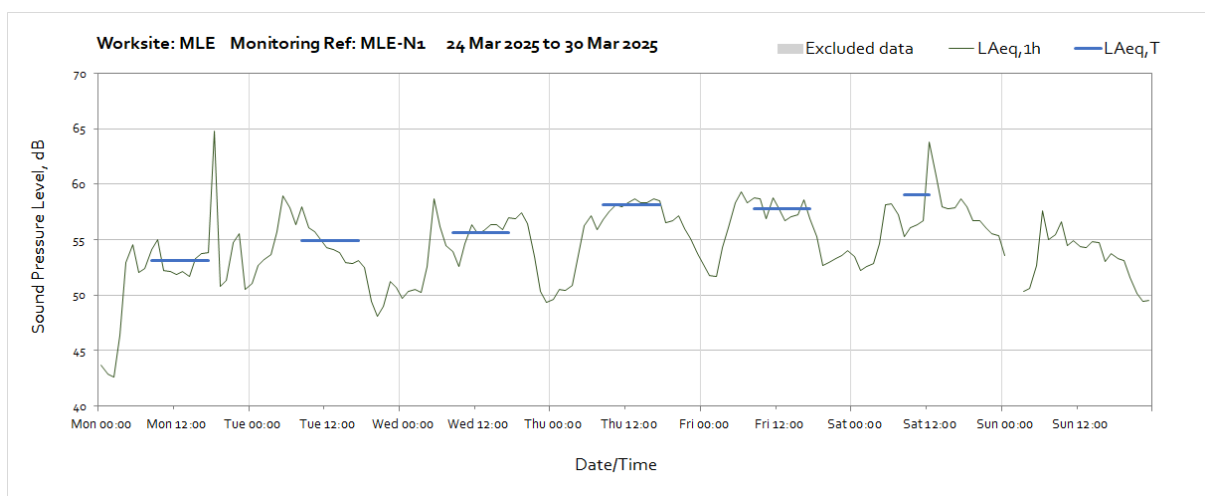
## Worksite: MLE – Monitoring Ref: MLE-N1

Note: Missing data between 01:00 and 03:00 on Sunday 30th March is due to a monitor time adjustment at the start of British Summer Time.

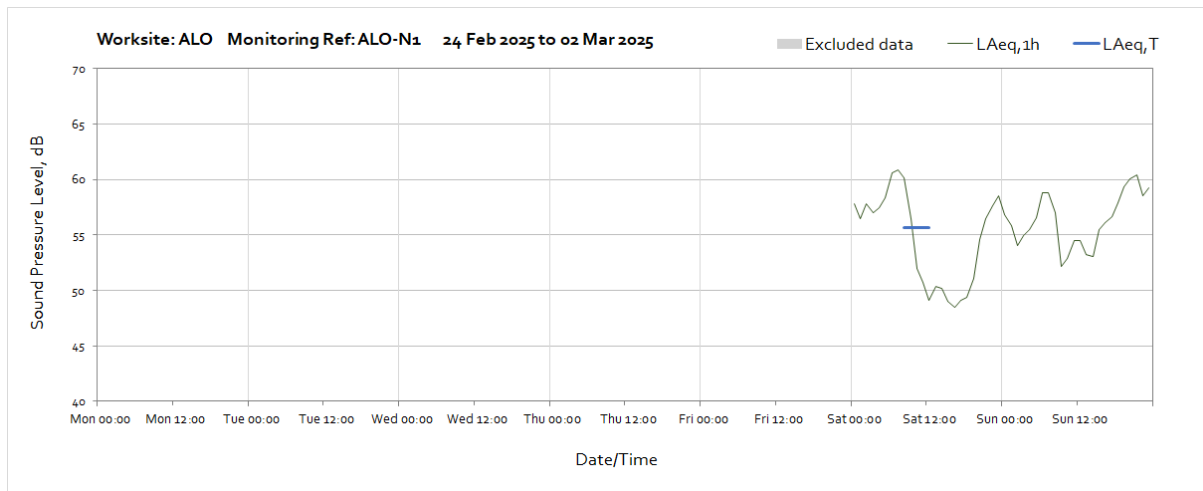
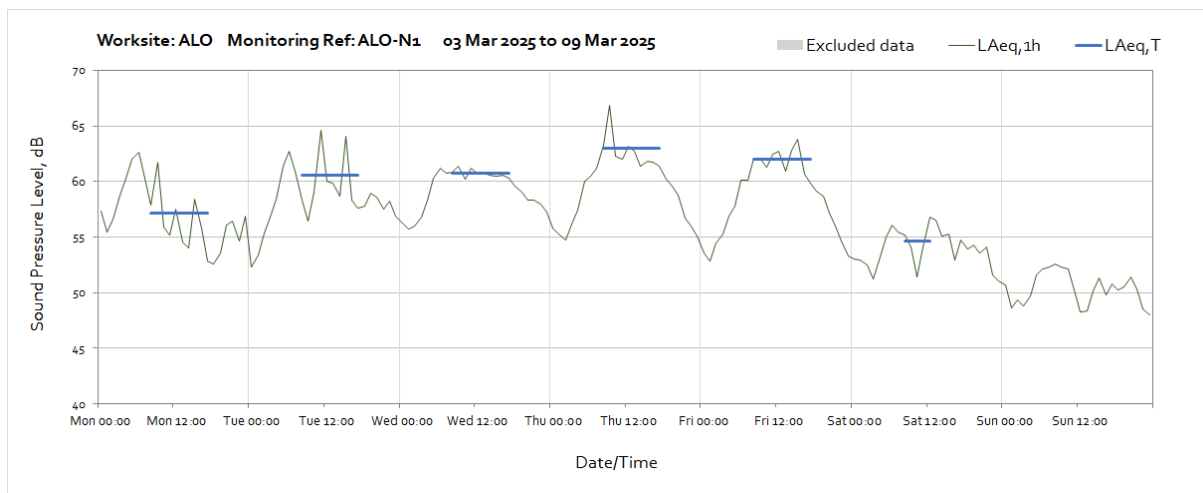
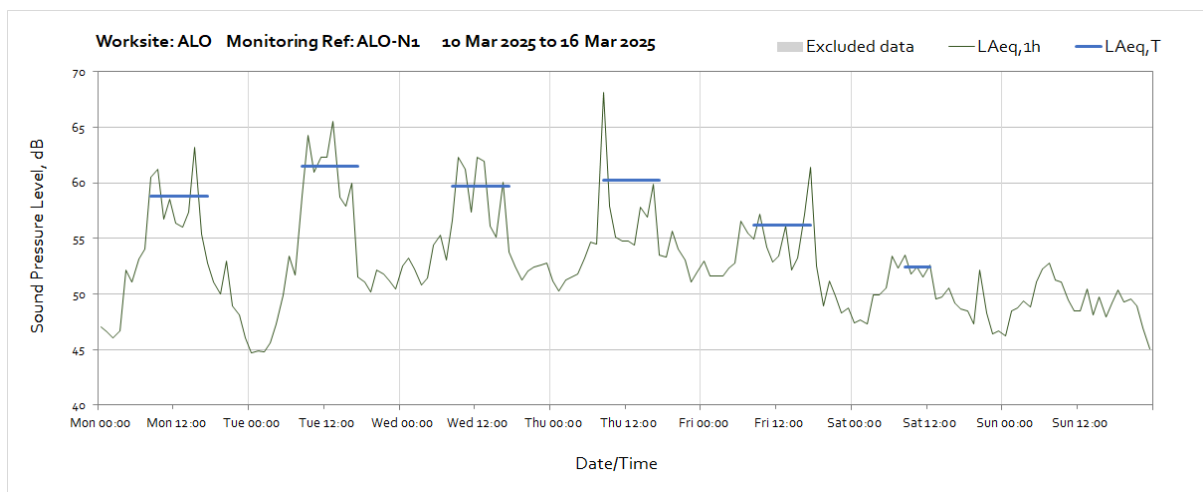
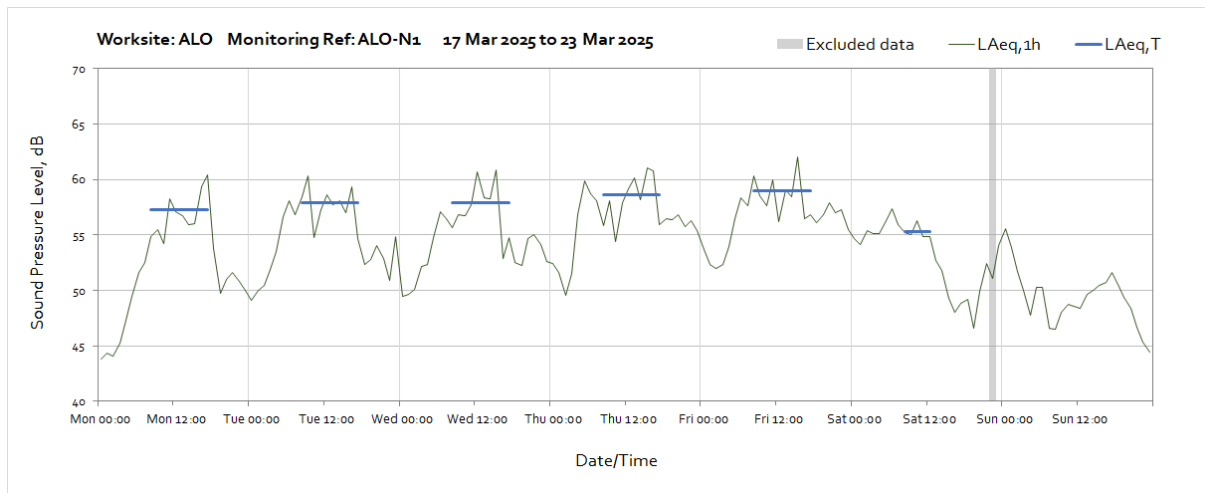
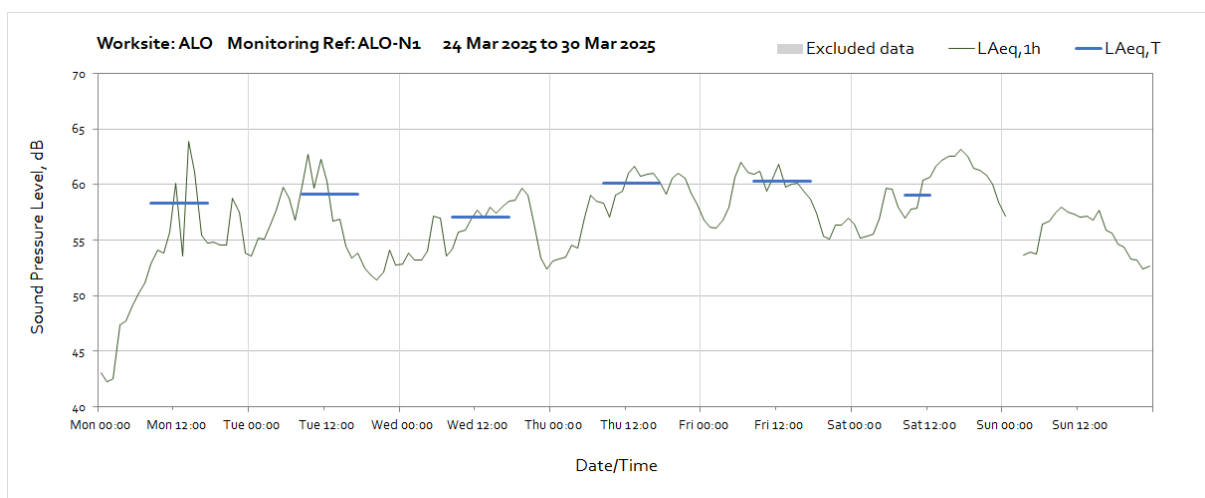
## Worksite: ALO – Monitoring Ref: ALO-N1

Note: Missing data between 01:00 and 03:00 on Sunday 30th March is due to a monitor time adjustment at the start of British Summer Time.
