## **Construction Noise and Vibration Monthly Report – March 2025**

**North Warwickshire Borough Council**

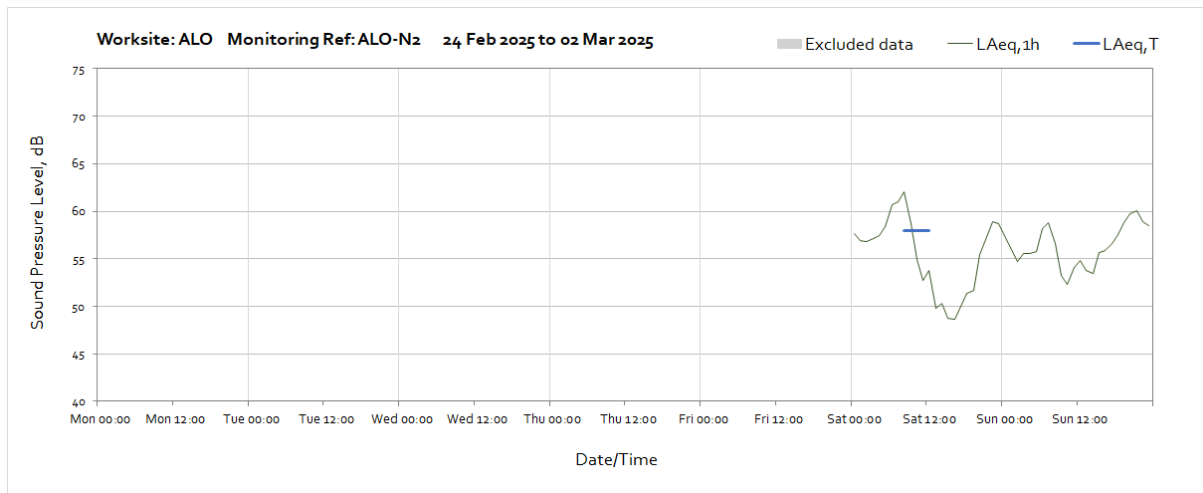
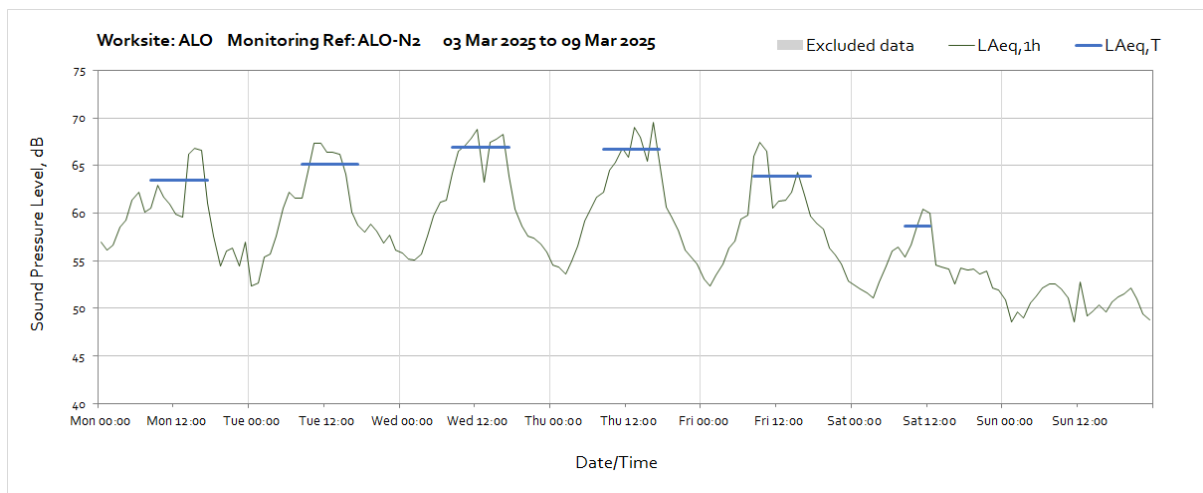
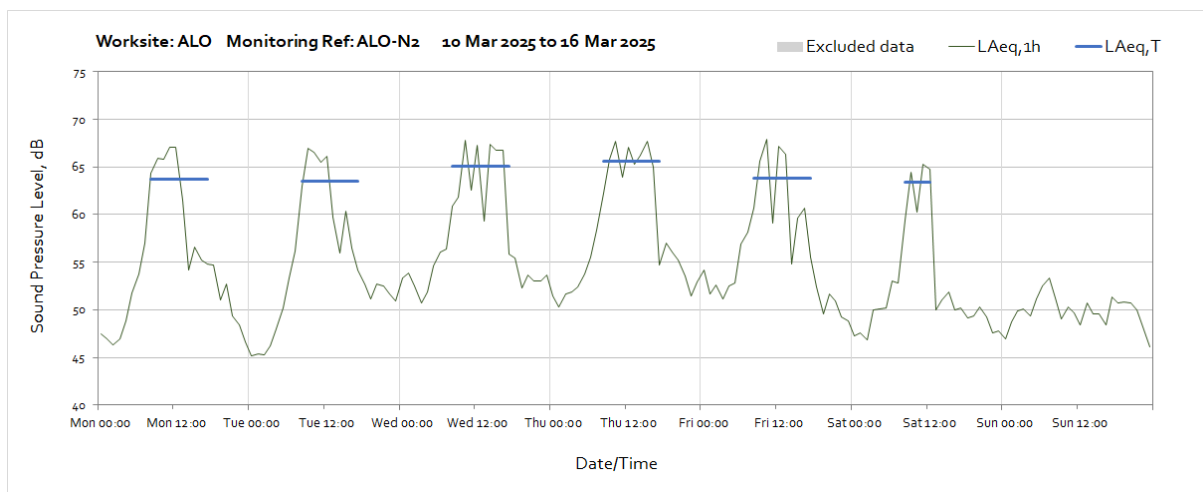
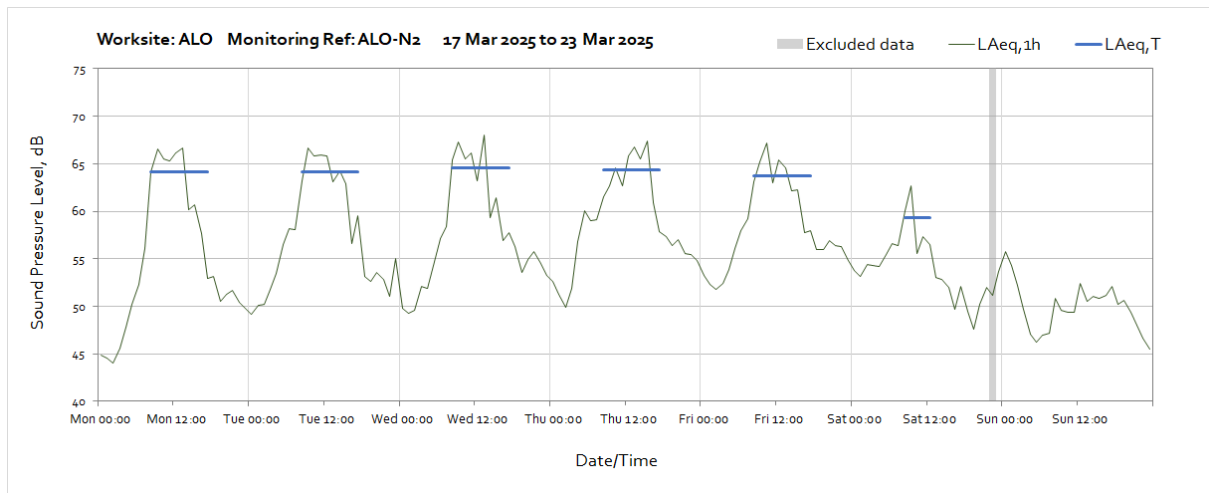
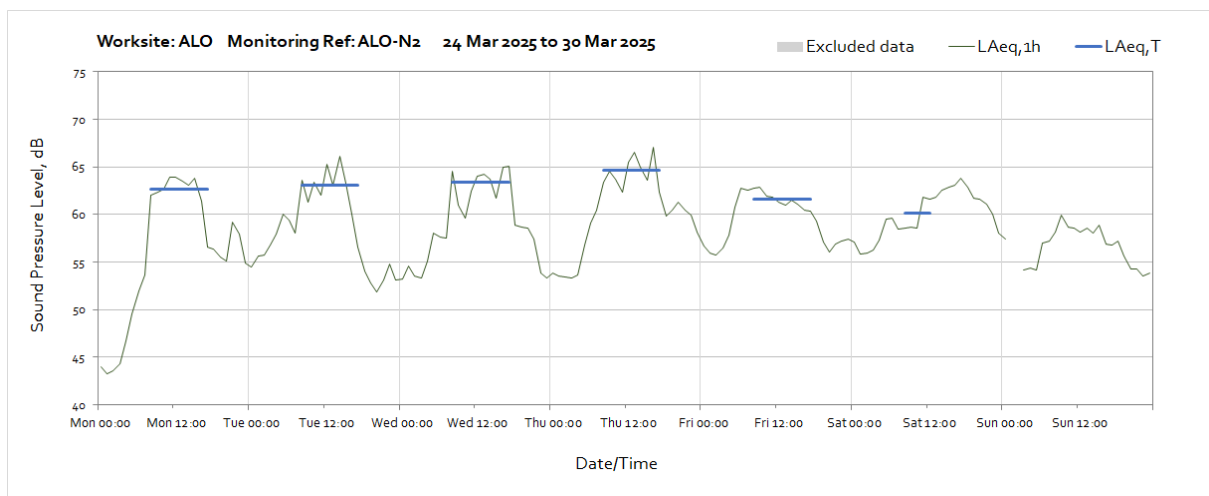
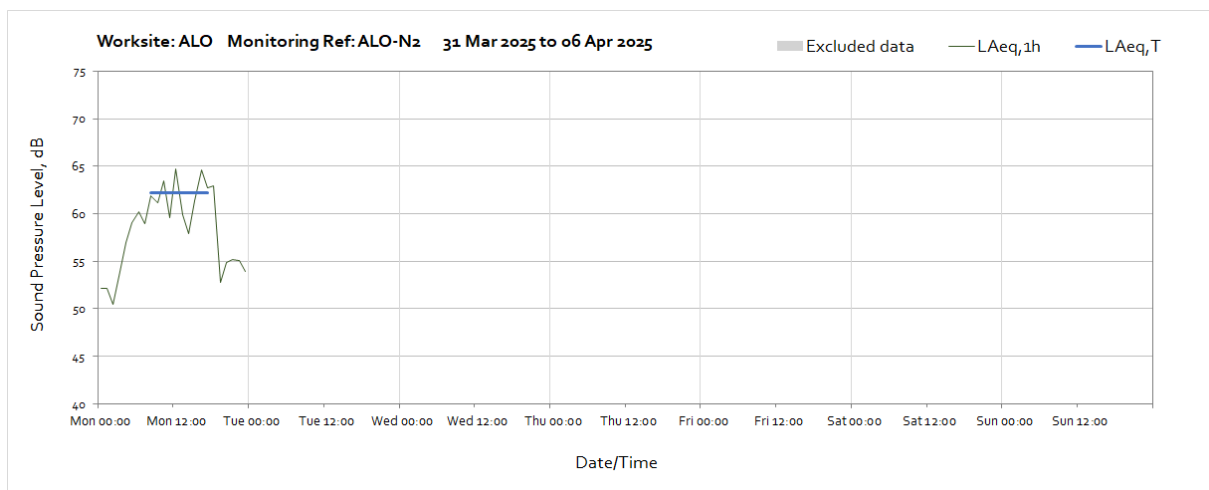
## Worksite: ALO – Monitoring Ref: ALO-N2

Note: Missing data between 01:00 and 03:00 on Sunday 30th March is due to a monitor time adjustment at the start of British Summer Time.

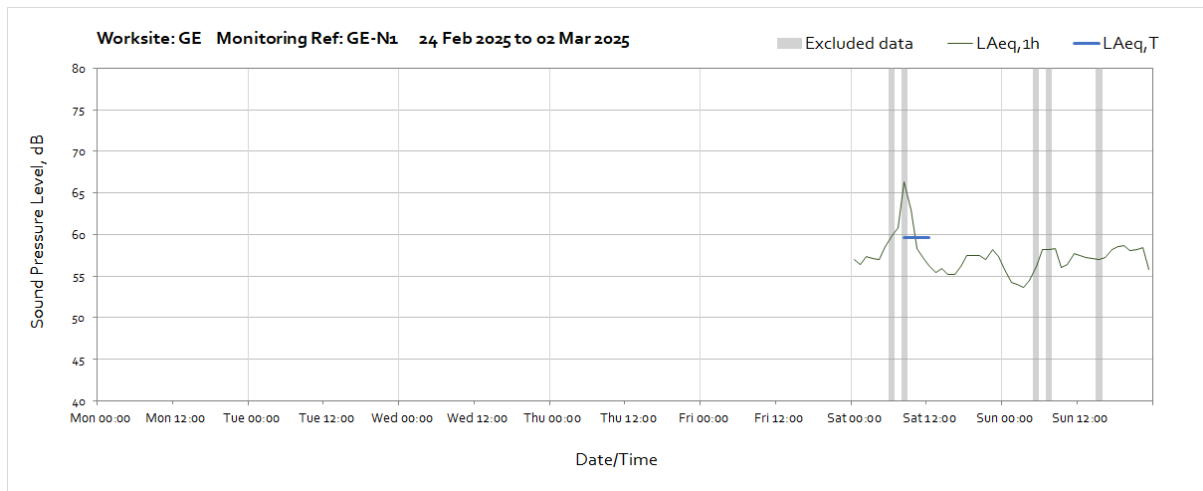
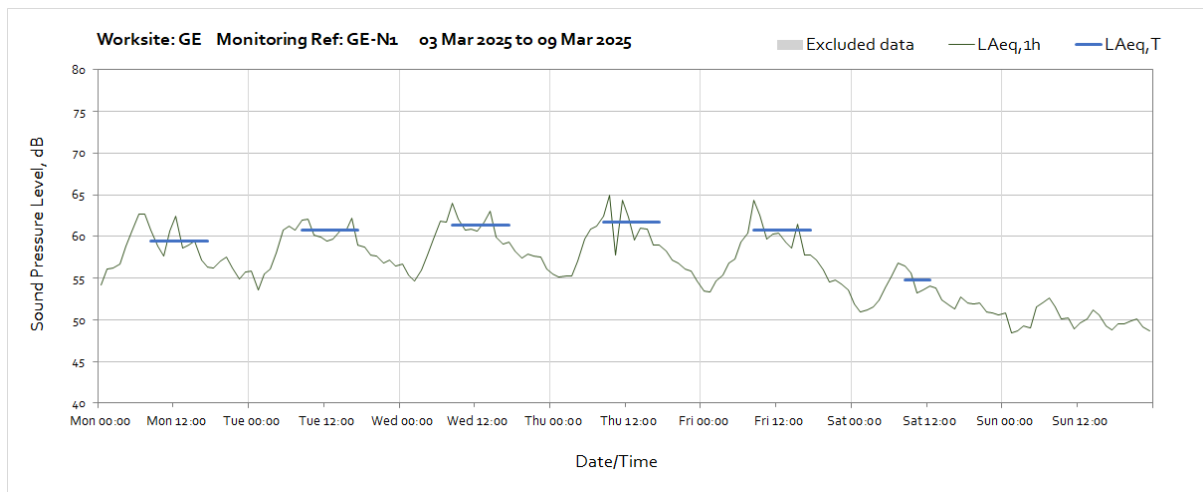
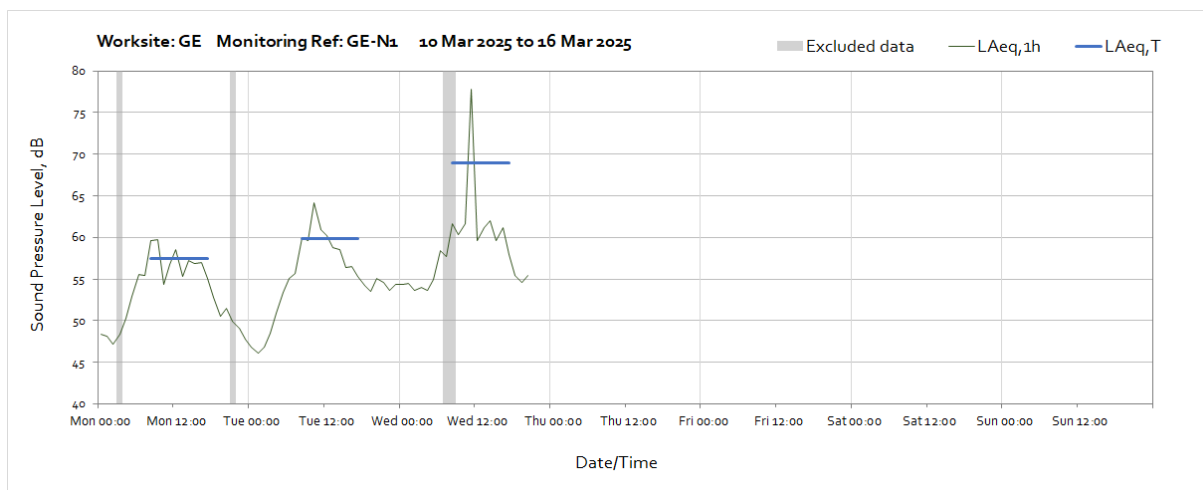
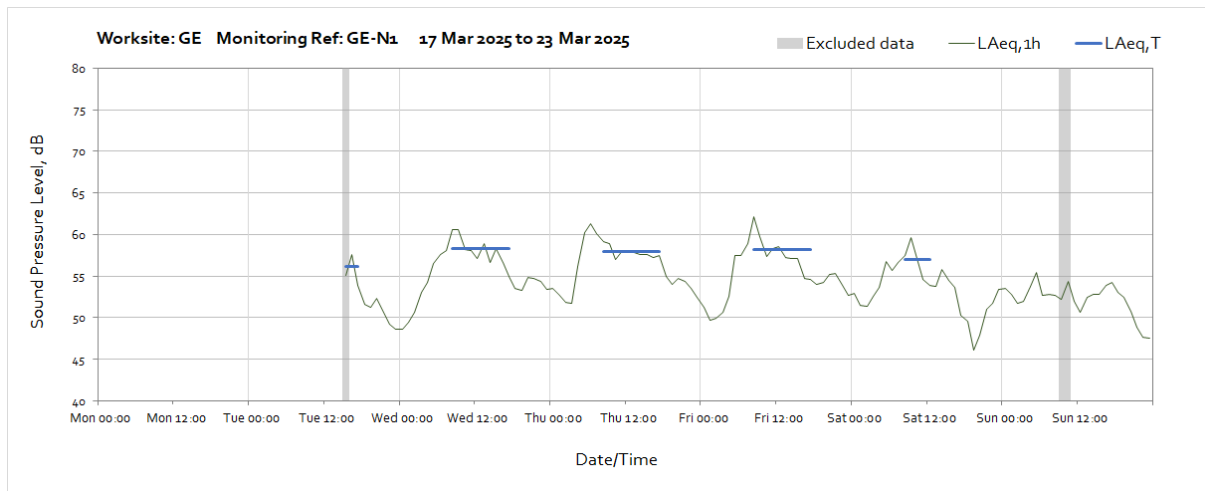
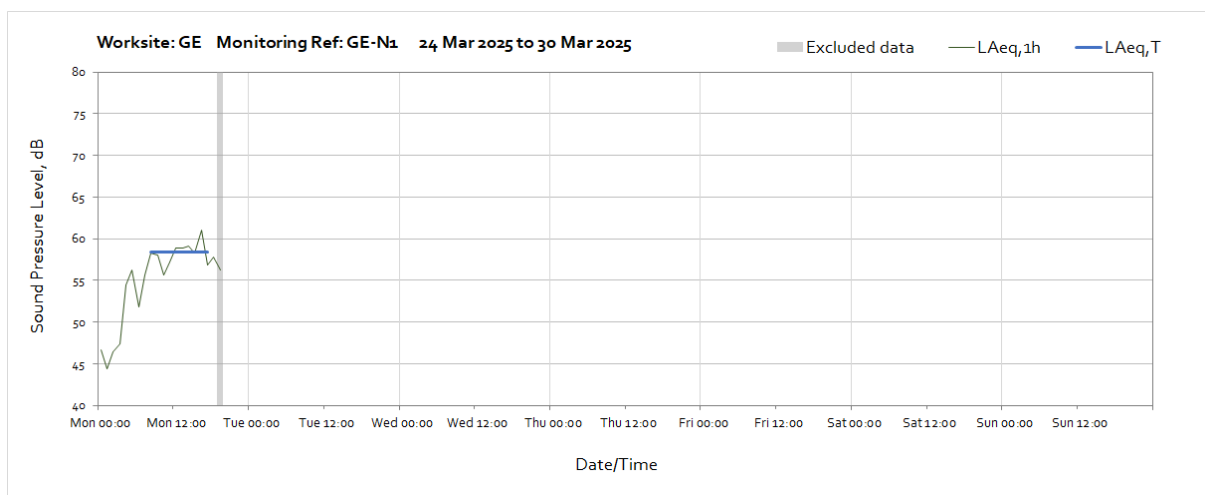
## Worksite: GE – Monitoring Ref: GE-N1

Note: Missing data from 21:00 on Wednesday 12<sup>th</sup> March until 15:00 on Tuesday 18<sup>th</sup> March was due to loss of mains power to the monitoring station.

Note: Missing data from 20:00 on Monday 24<sup>th</sup> March until the end of the month was due to loss of mains power to the monitoring station.

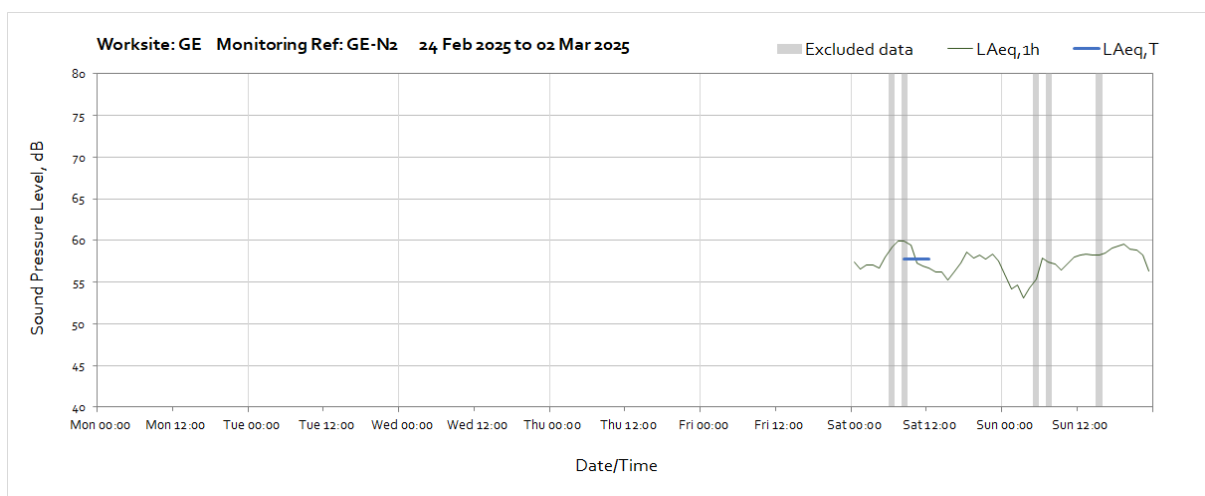
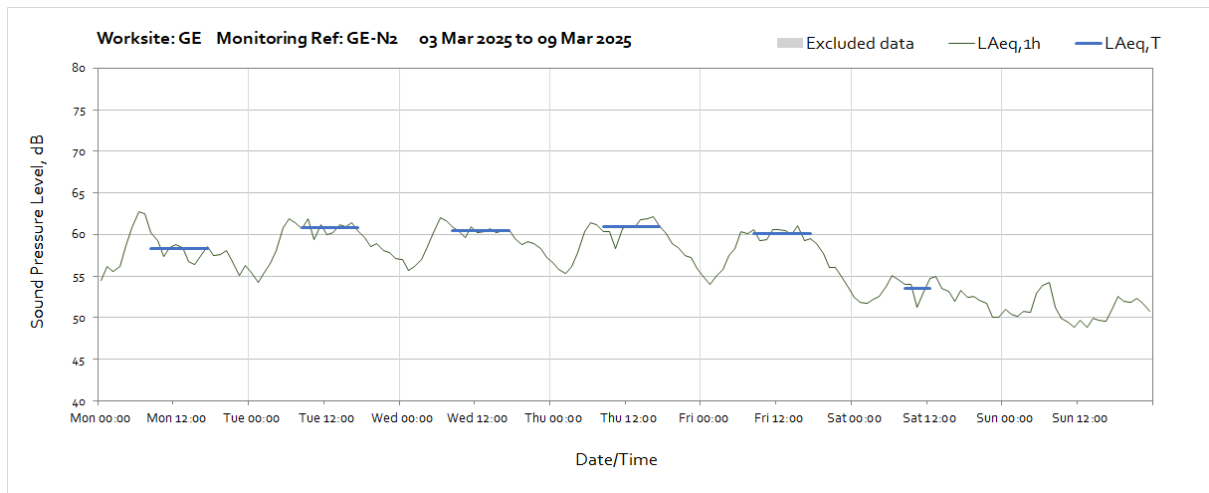
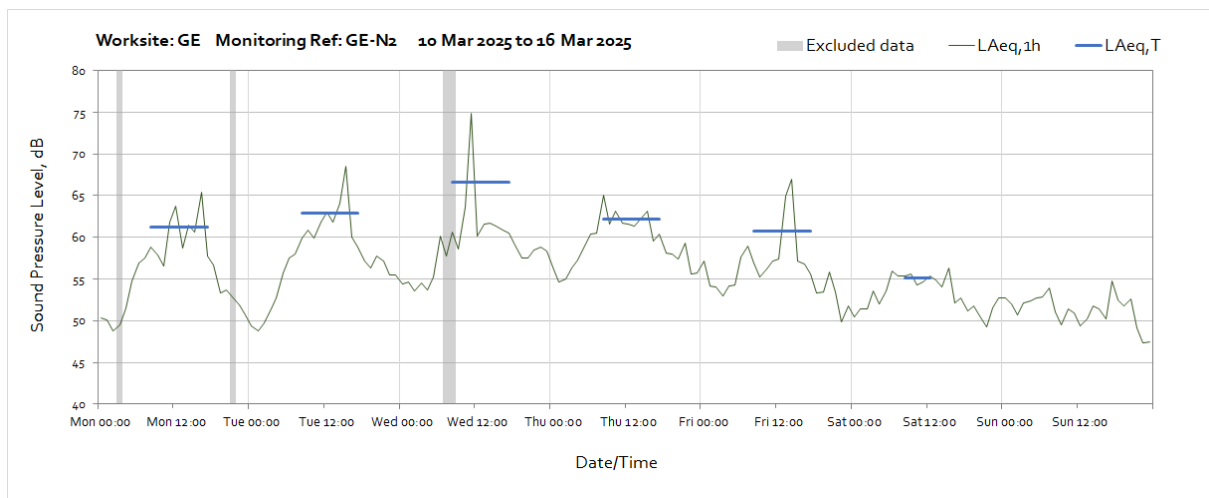
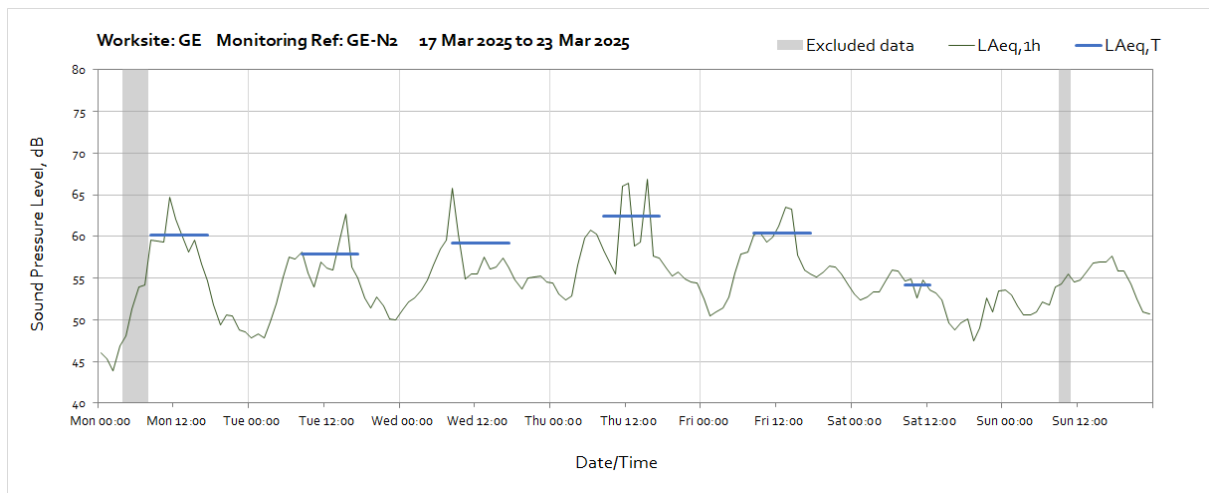
## Worksite: GE – Monitoring Ref: GE-N2

Note: Missing data between 01:00 and 03:00 on Sunday 30th March is due to a monitor time adjustment at the start of British Summer Time.

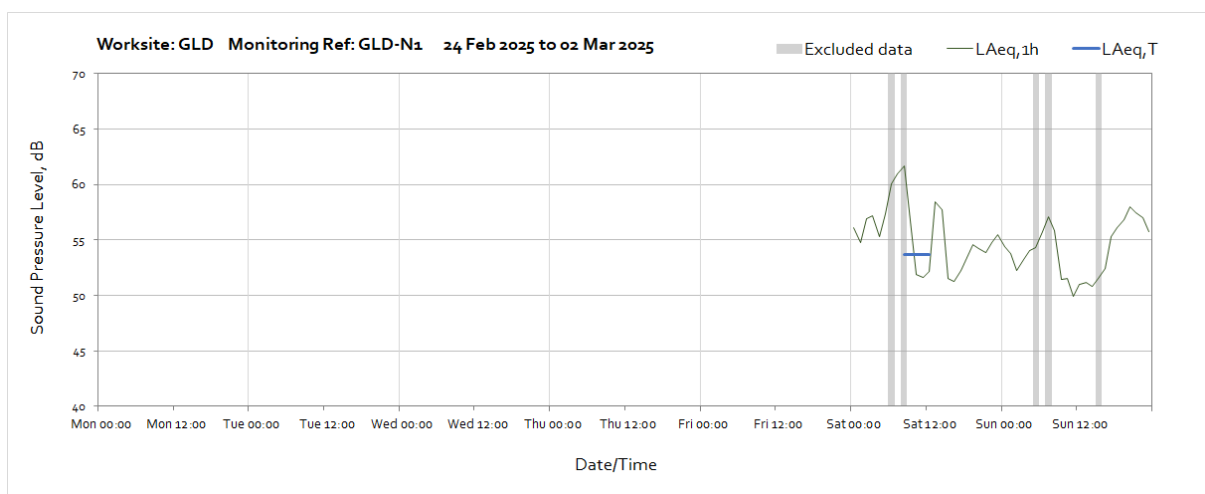
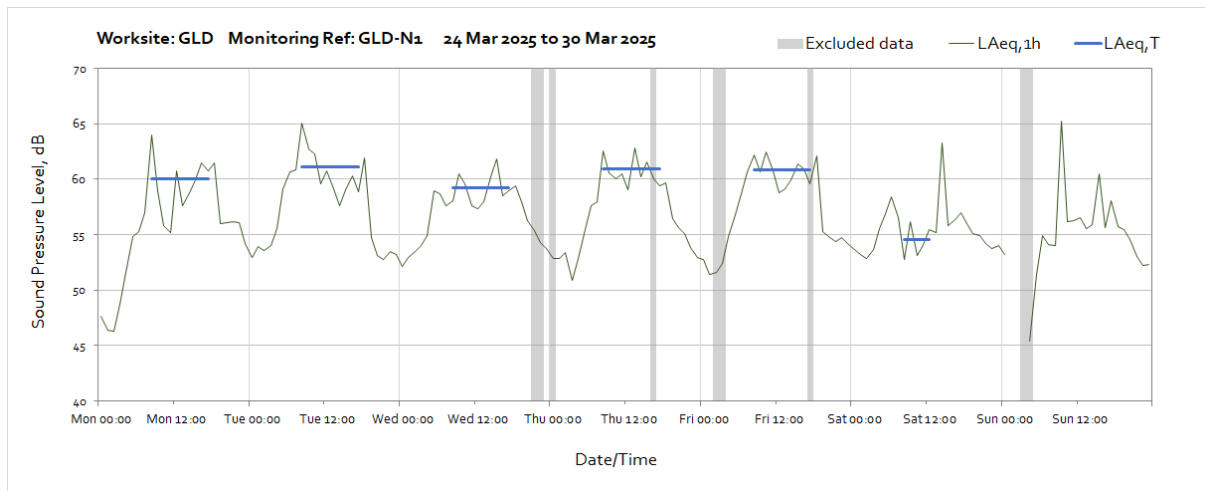
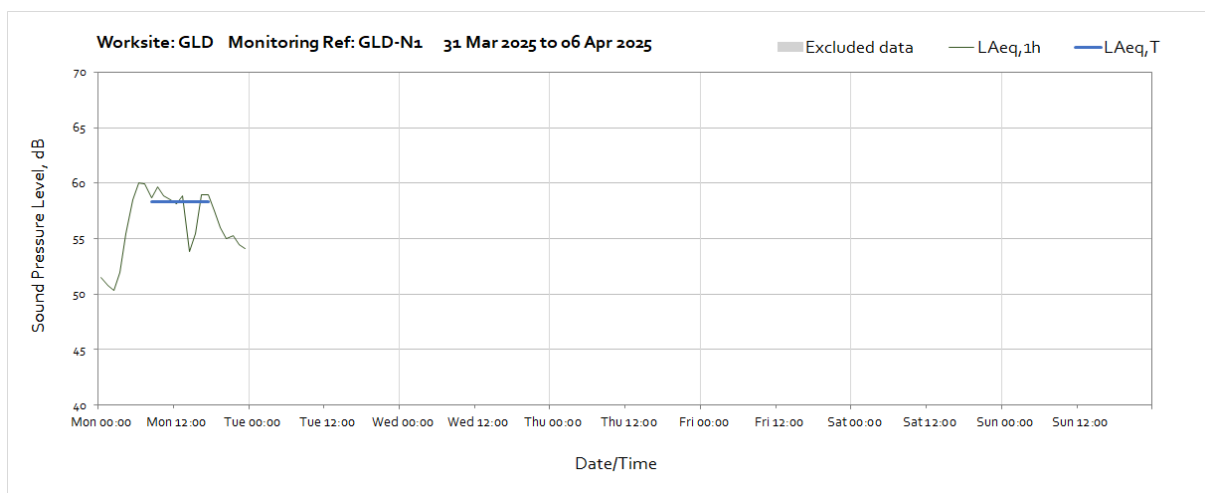
## Worksite: GLD - Monitoring Ref: GLD-N1

Note: Missing data between 01:00 and 03:00 on Sunday 30th March is due to a monitor time adjustment at the start of British Summer Time.

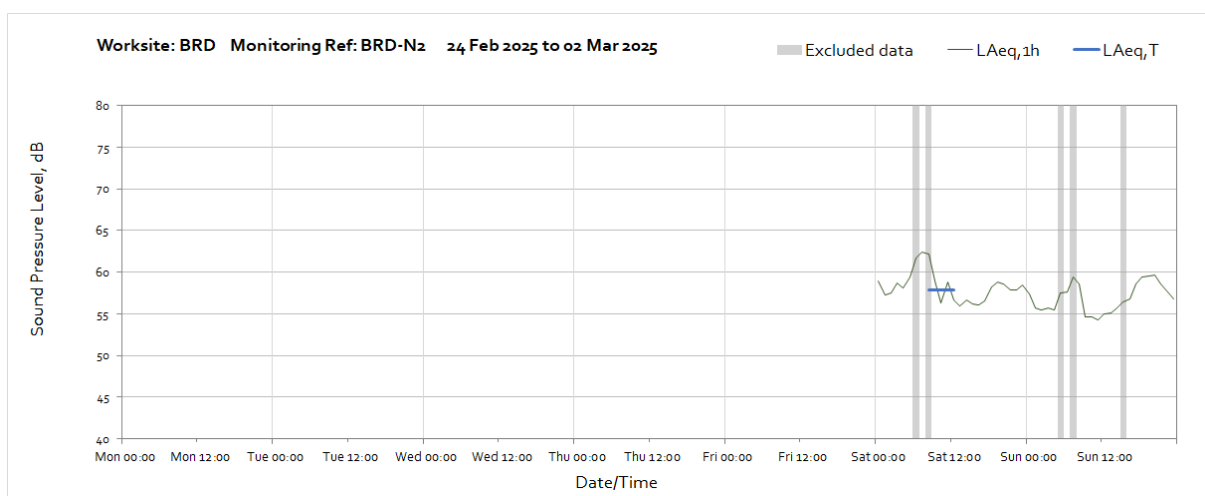
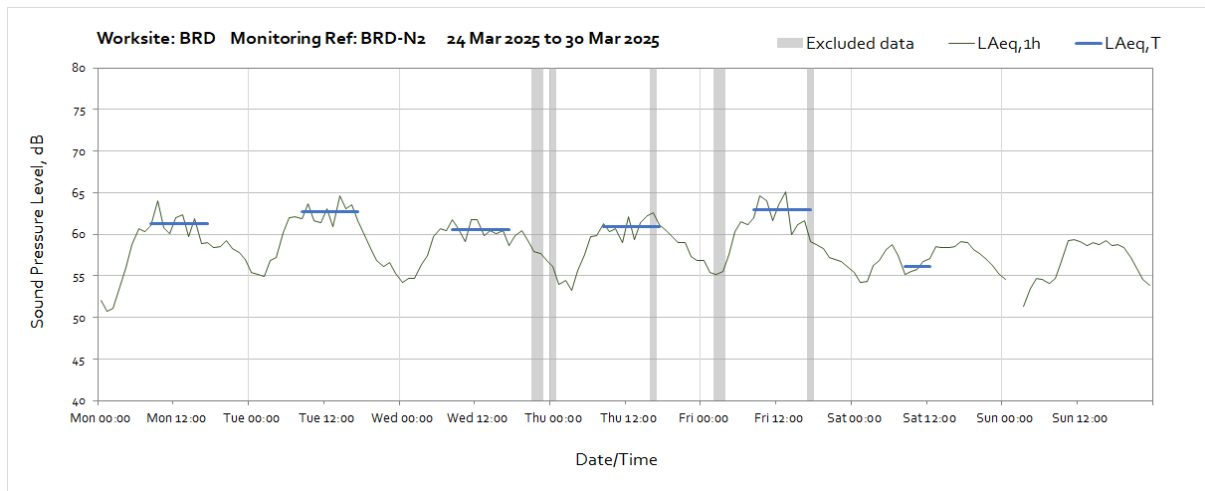
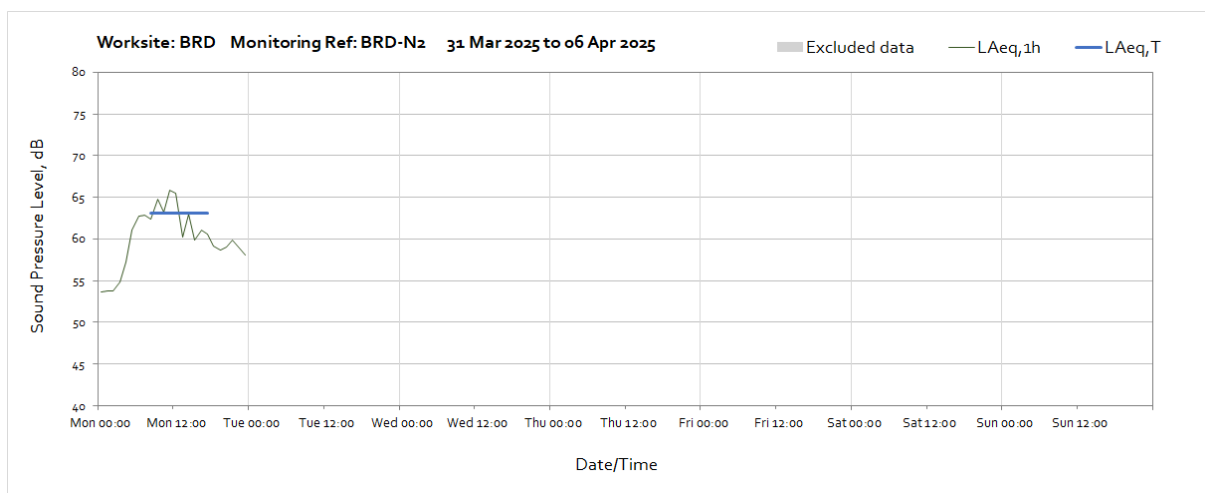
## Worksite: BRD - Monitoring Ref: BRD-N2

Note: Missing data between 01:00 and 03:00 on Sunday 30th March is due to a monitor time adjustment at the start of British Summer Time.

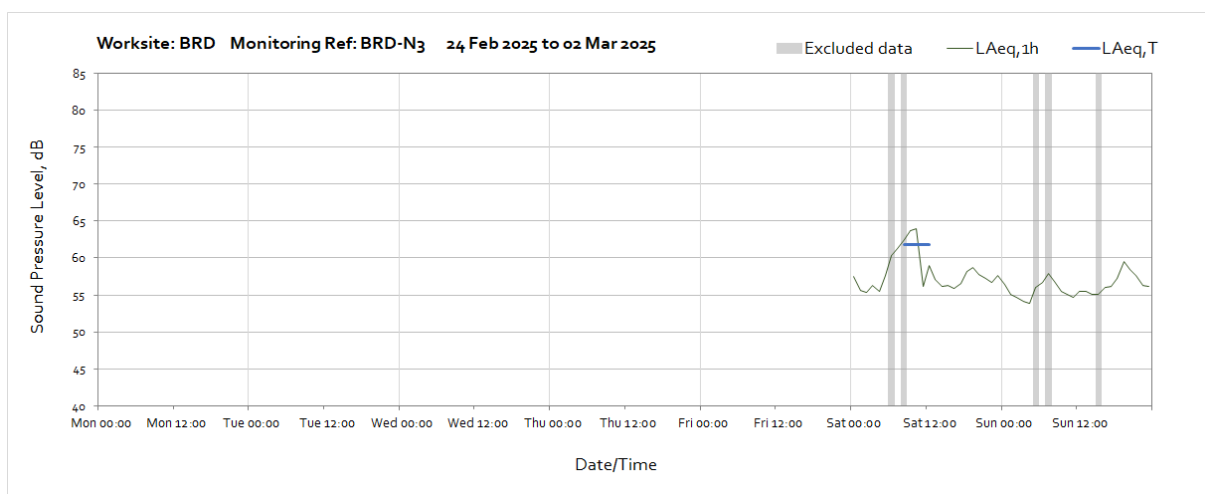
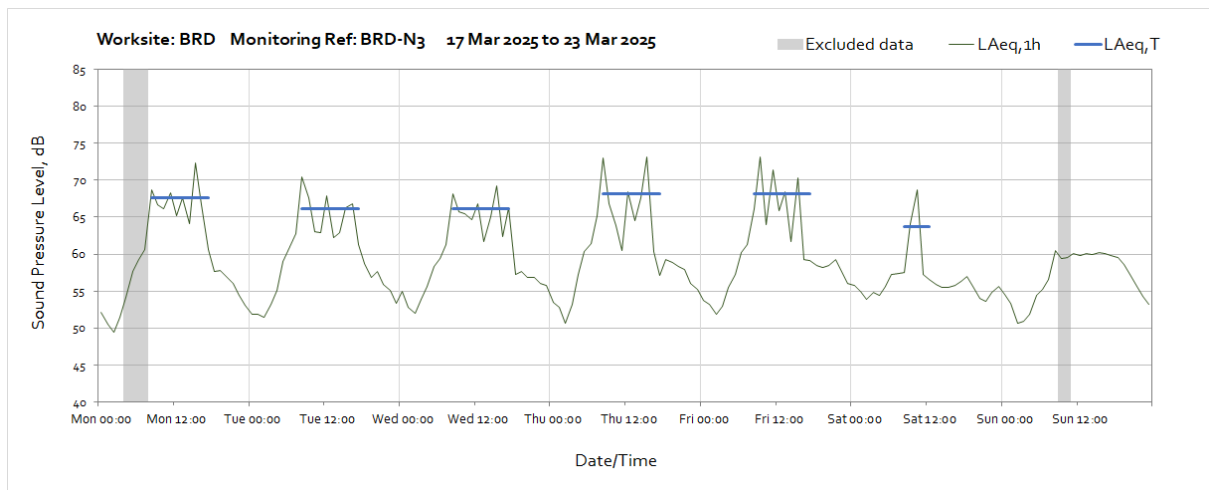
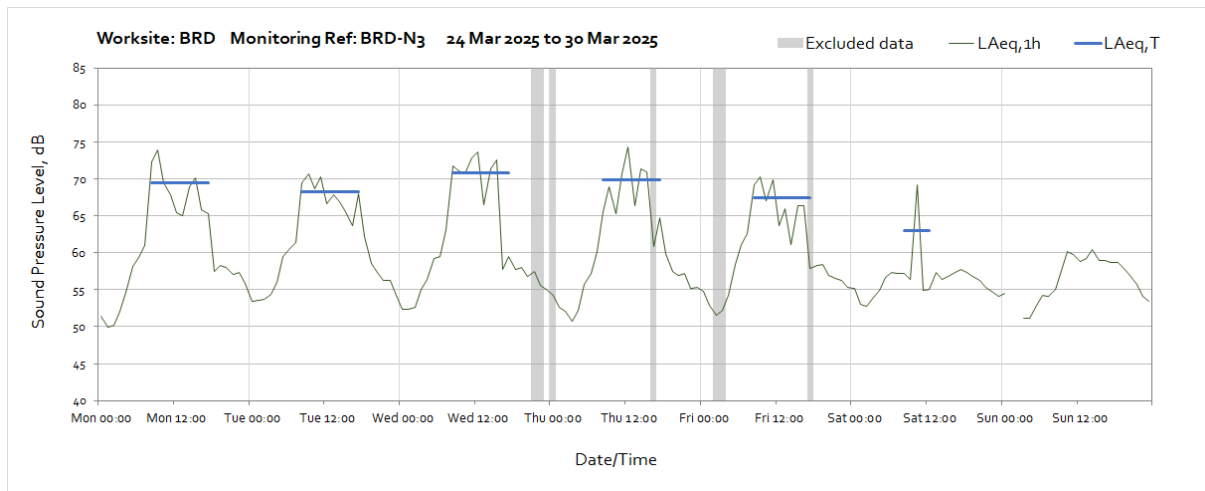
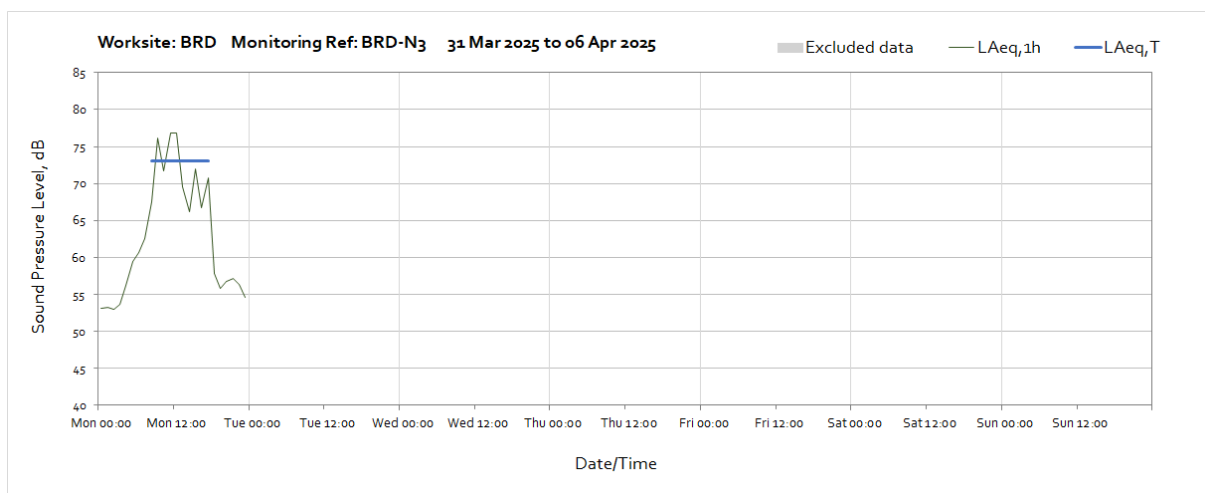
## Worksite: BRD - Monitoring Ref: BRD-N3

Note: Missing data between 01:00 and 03:00 on Sunday 30th March is due to a monitor time adjustment at the start of British Summer Time.

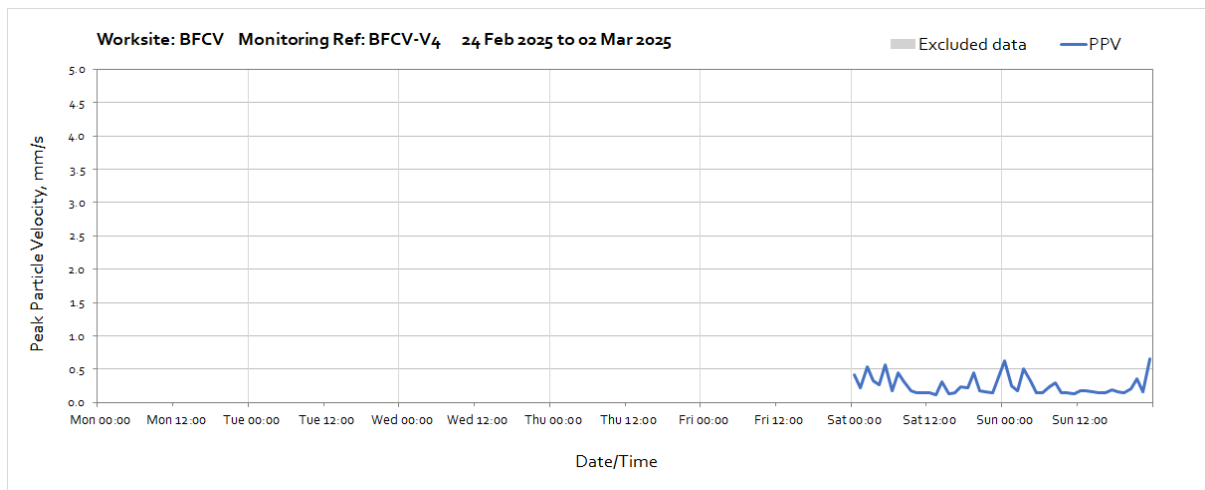
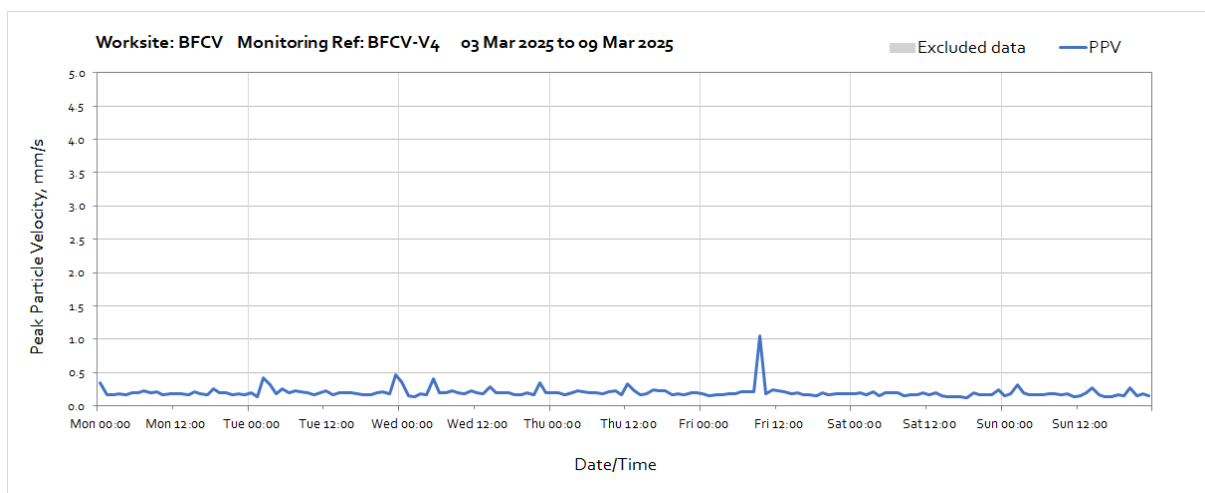
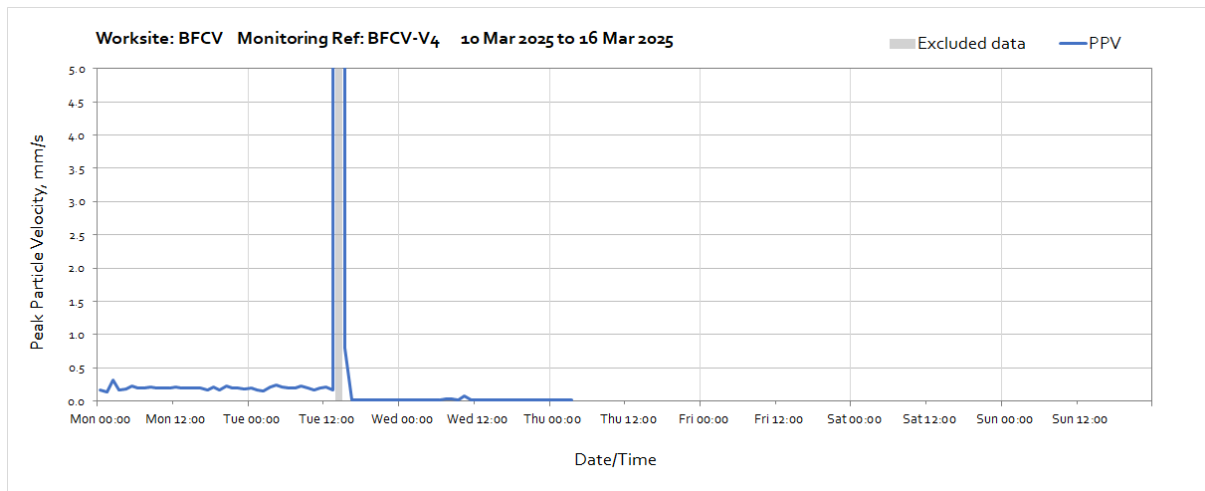
### Worksite: BFCV – Monitoring Ref: BFCV-V4

The following graphs show the hourly measured peak particle velocity PPV recorded during the monitoring period. The graphs show the highest PPV of the three orthogonal axes x, y and z. Where high values of PPV were caused by local interference with the vibration monitor, which are not representative of HS2 construction works, these values have been greyed out in the following charts and have been excluded to calculate values in Table 4 of the main report.

Note: Missing data 04:00 on Thursday 13<sup>th</sup> March until 10:00 on Tuesday 18<sup>th</sup> March was due to tampering of the monitoring station. Missing data from 10:00 on Tuesday 18<sup>th</sup> March was due to decommissioning of the monitoring station.

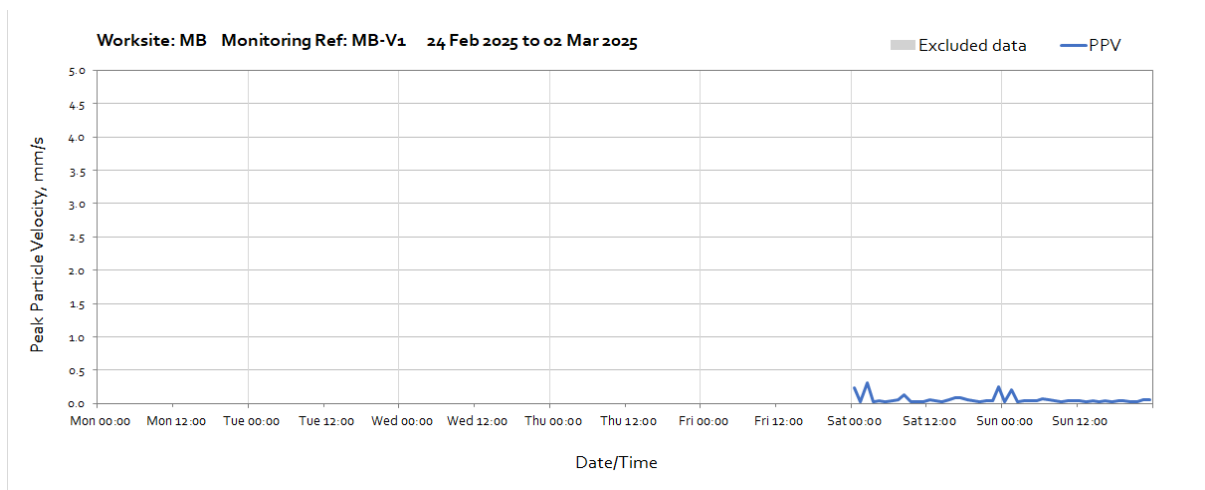
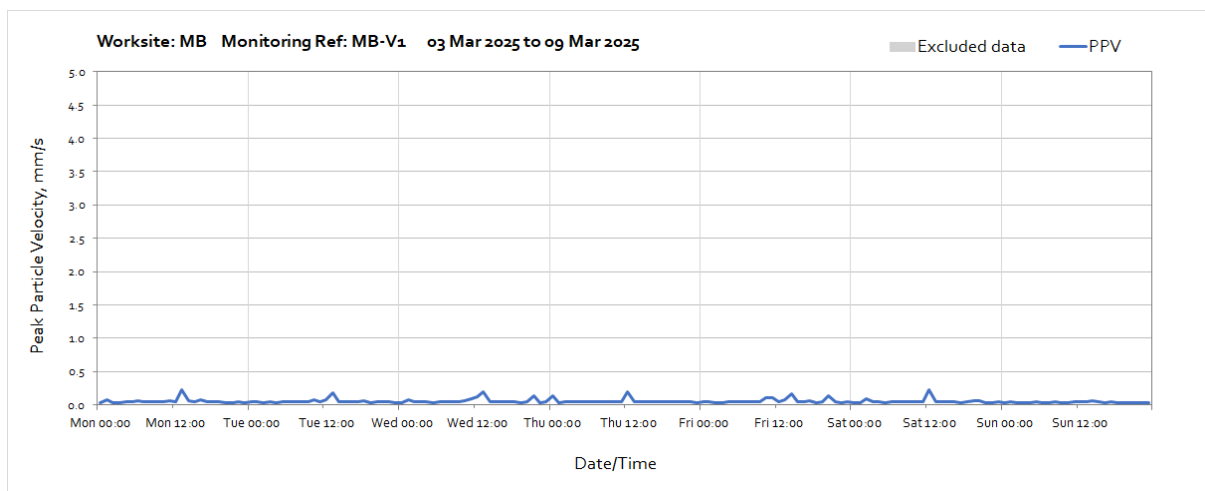
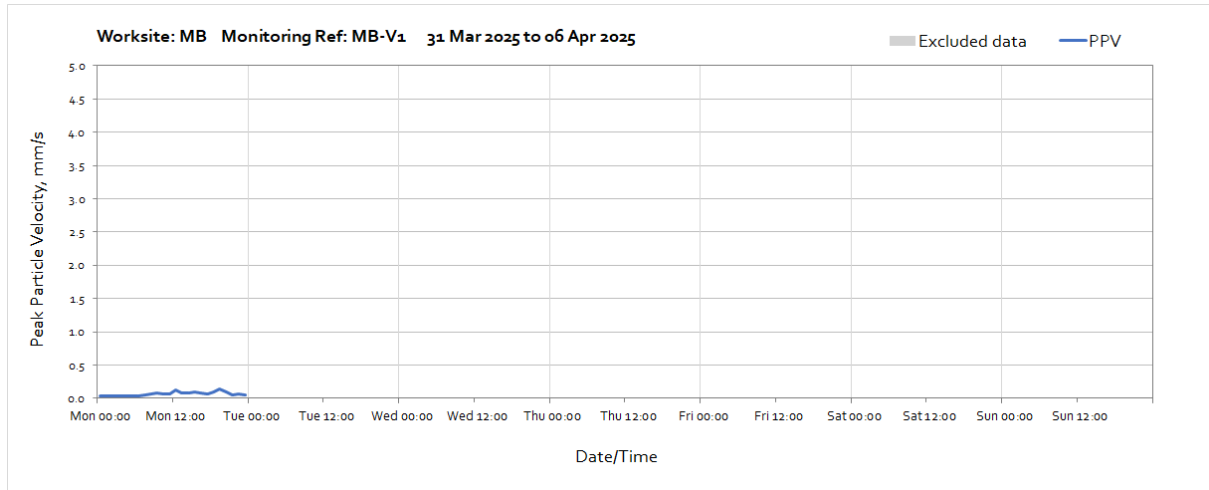
### Worksite: MB – Monitoring Ref: MB-V1

Note: Missing data between 01:00 and 03:00 on Sunday 30th March is due to a monitor time adjustment at the start of British Summer Time.

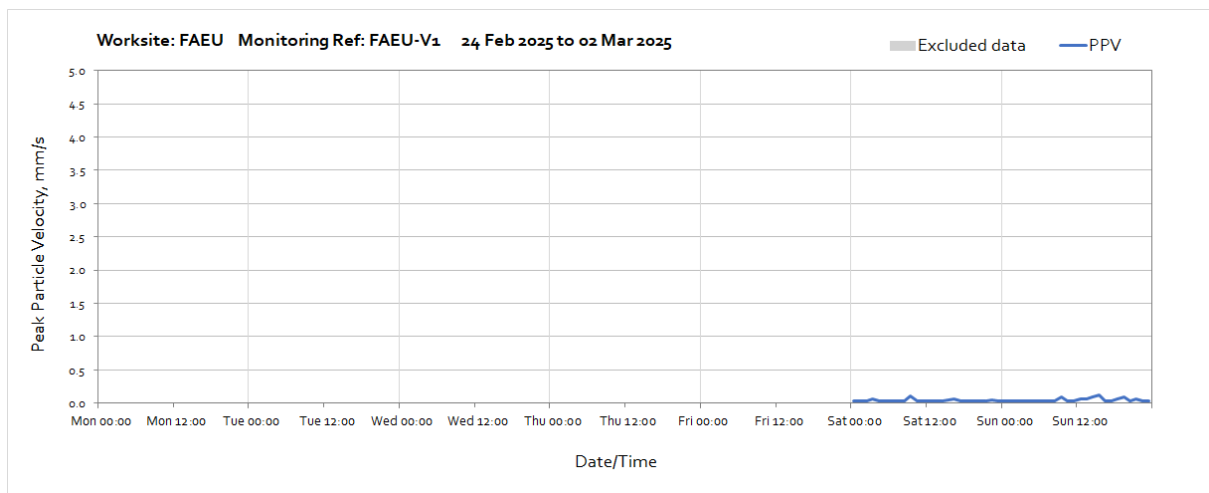
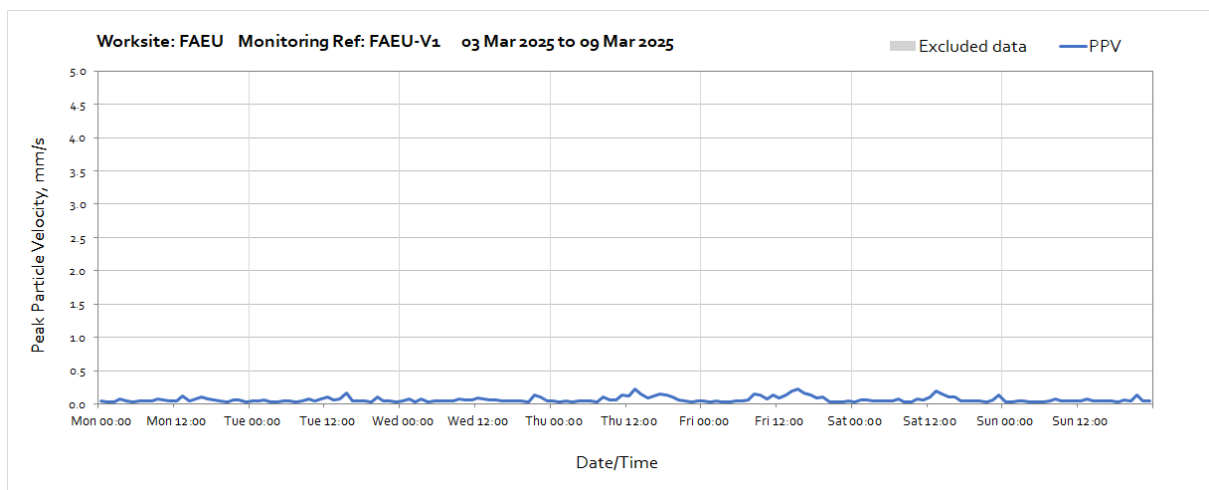
## Worksite: FAEU – Monitoring Ref: FAEU-V1

Note: Missing data between 01:00 and 03:00 on Sunday 30th March is due to a monitor time adjustment at the start of British Summer Time.

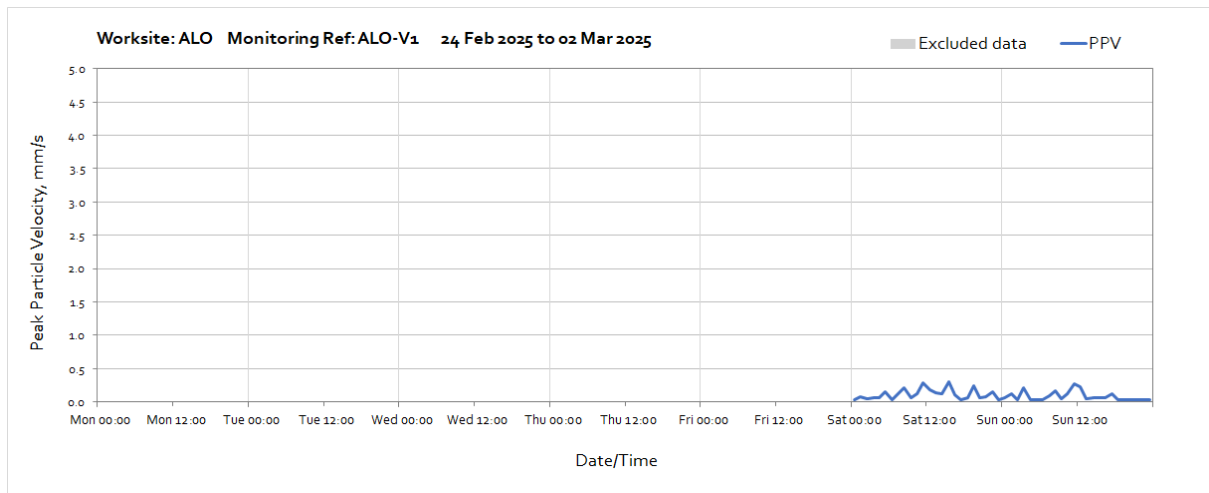
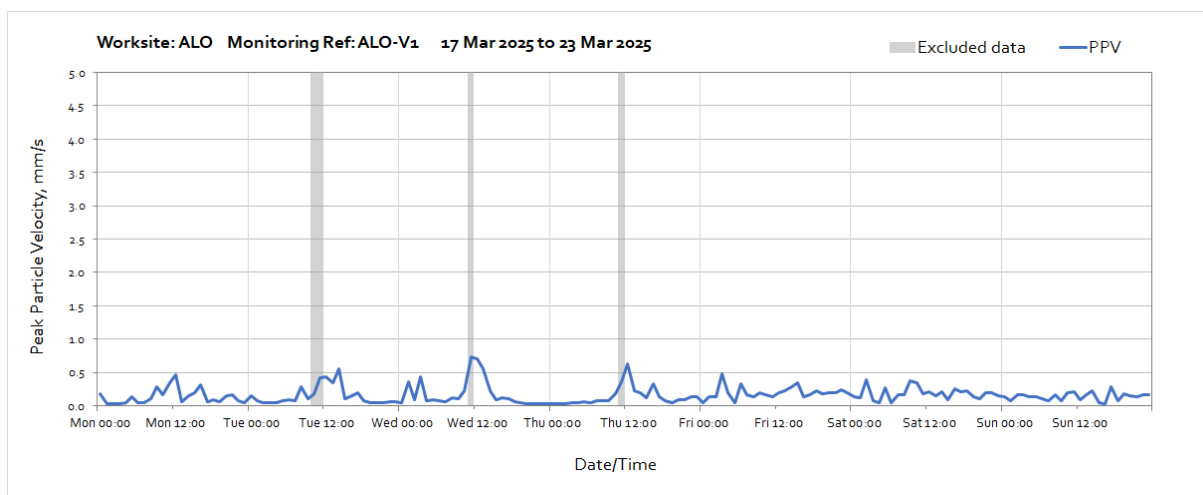
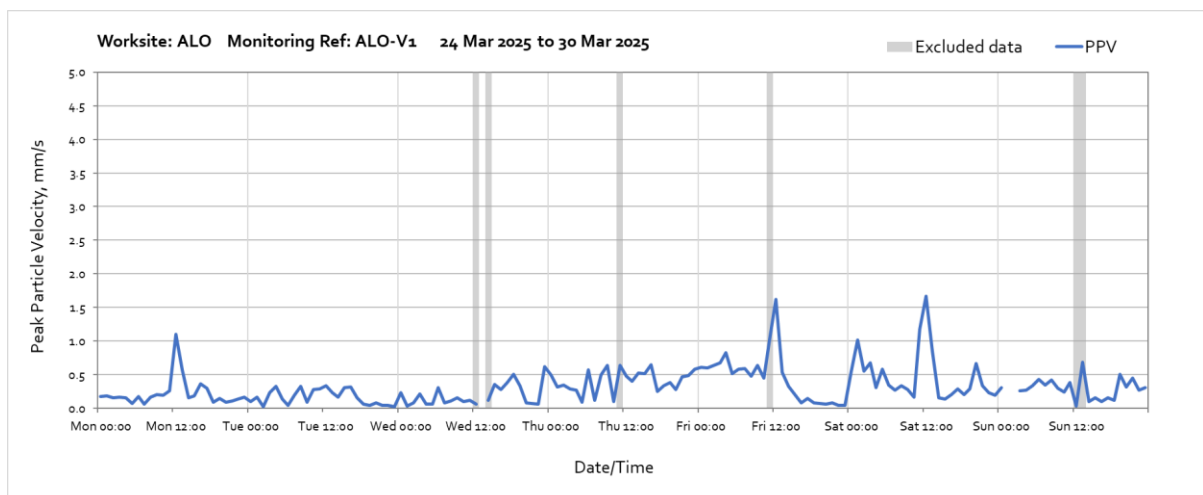
## Worksite: ALO – Monitoring Ref: ALO-V1

Note: Missing data between 13:00 and 14:00 on Wednesday 26<sup>th</sup> March was due to intermittent signal loss to the monitoring station. Missing data between 01:00 and 03:00 on Sunday 30<sup>th</sup> March is due to a monitor time adjustment at the start of British Summer Time.
