## **Construction Noise and Vibration Monthly Report – March 2025**

**North Warwickshire Borough Council**

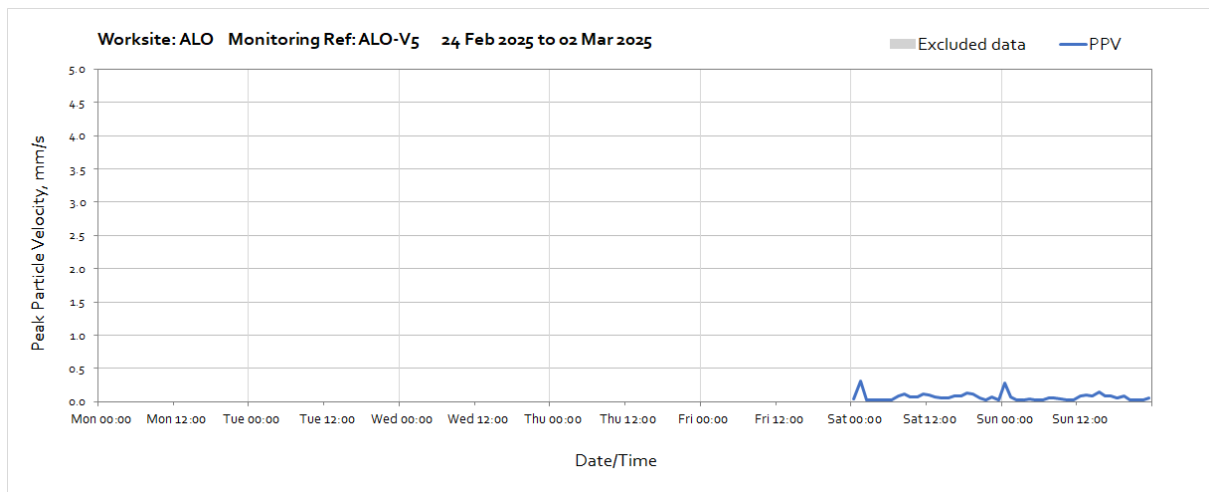
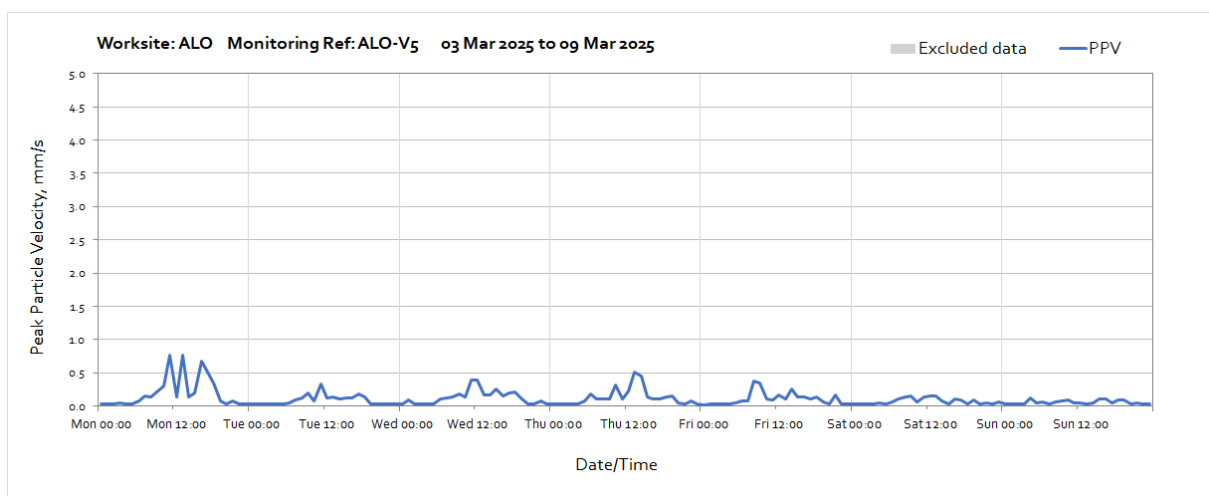
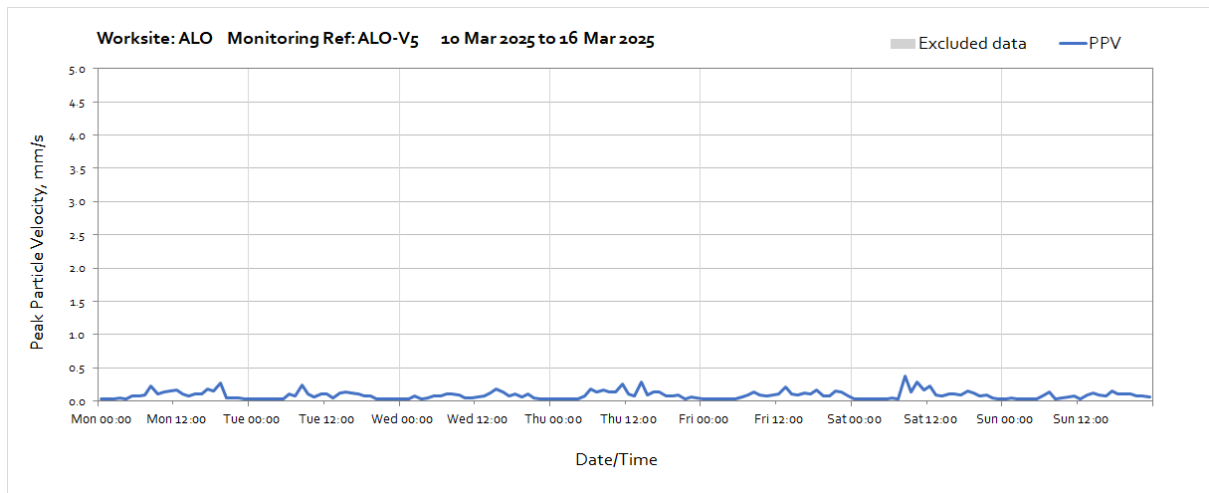
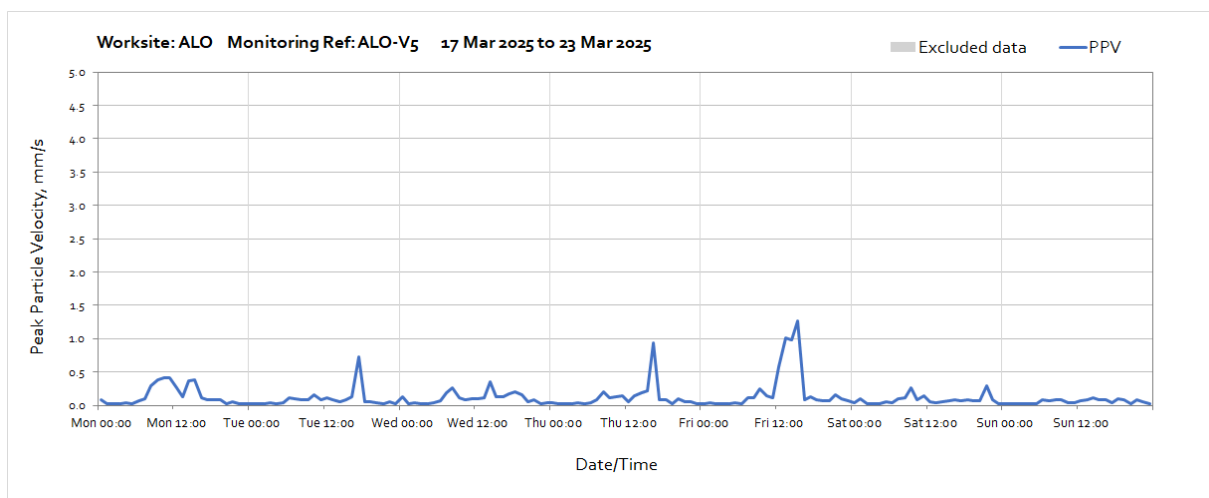
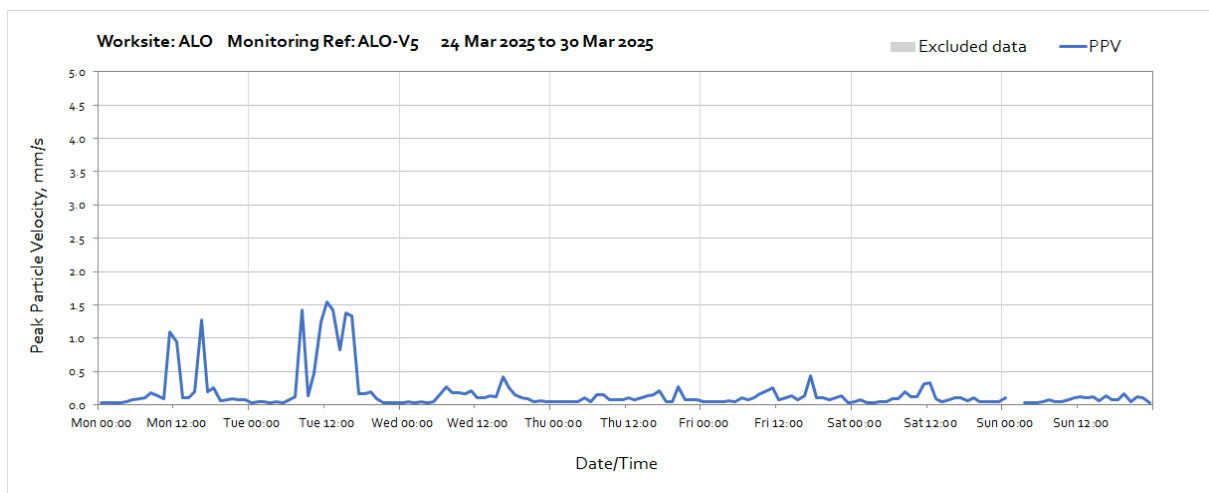
## Worksite: ALO – Monitoring Ref: ALO-V5

Note: Missing data between 01:00 and 03:00 on Sunday 30th March is due to a monitor time adjustment at the start of British Summer Time.

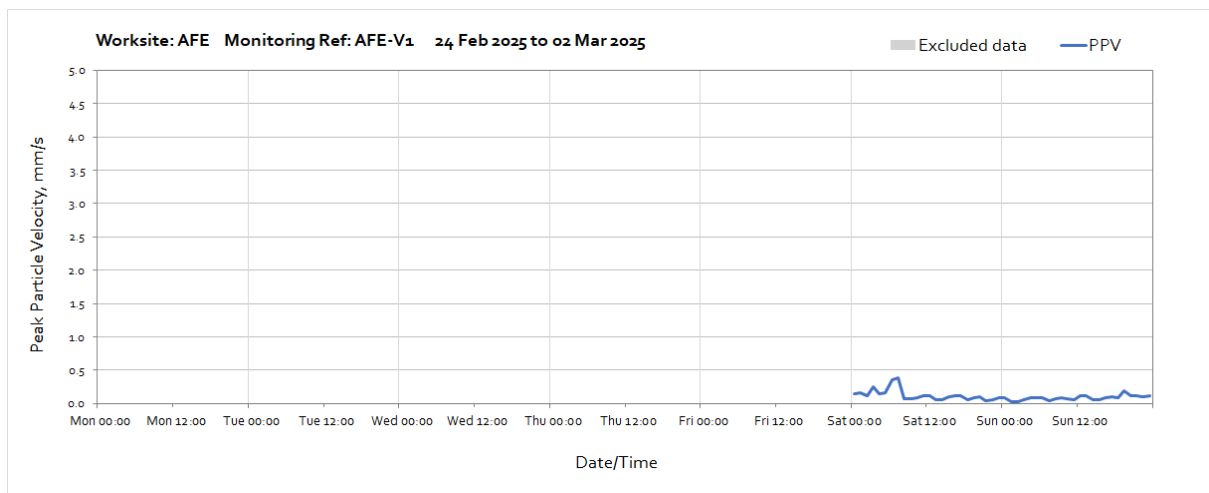
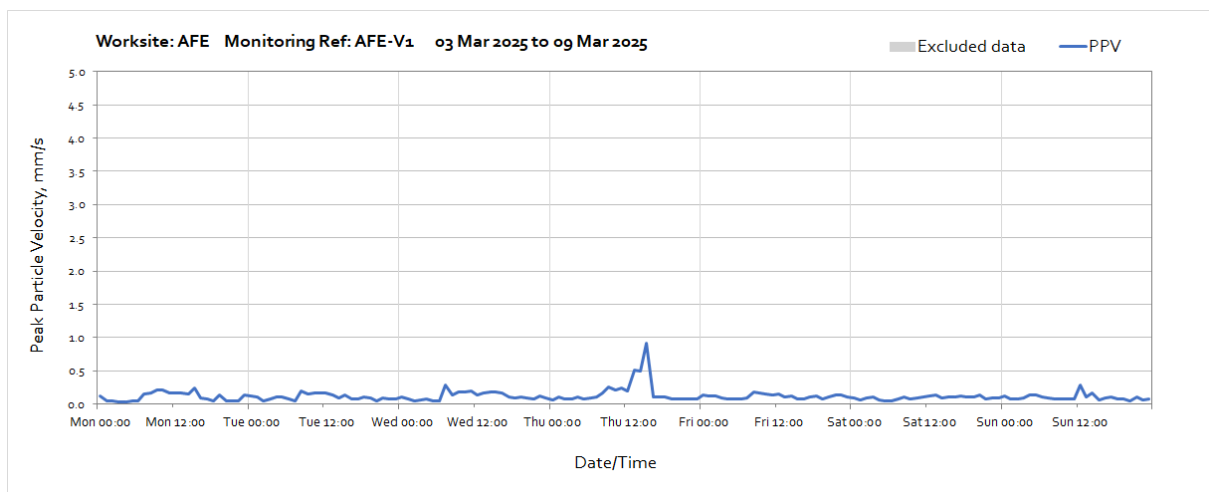
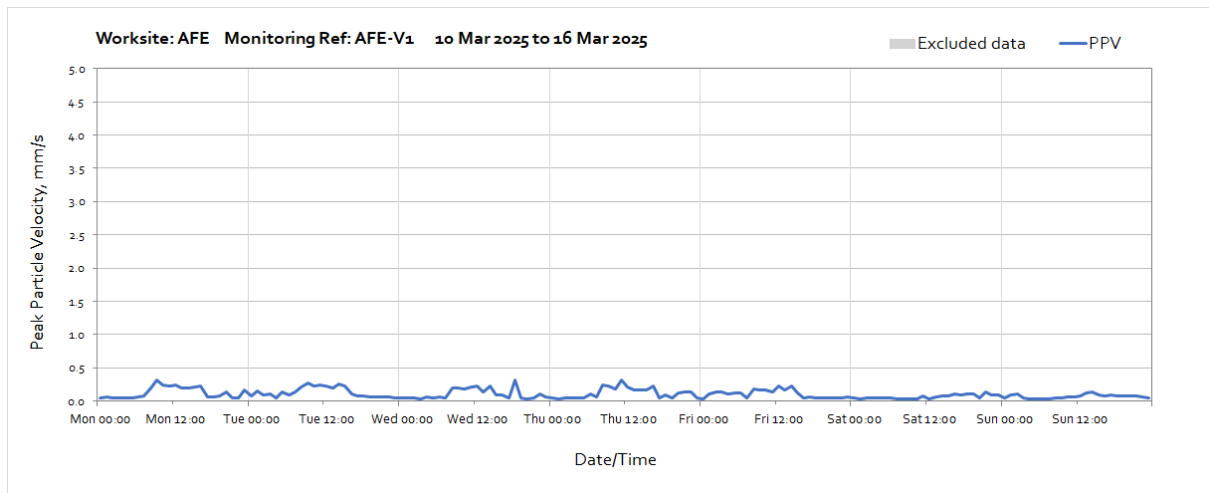
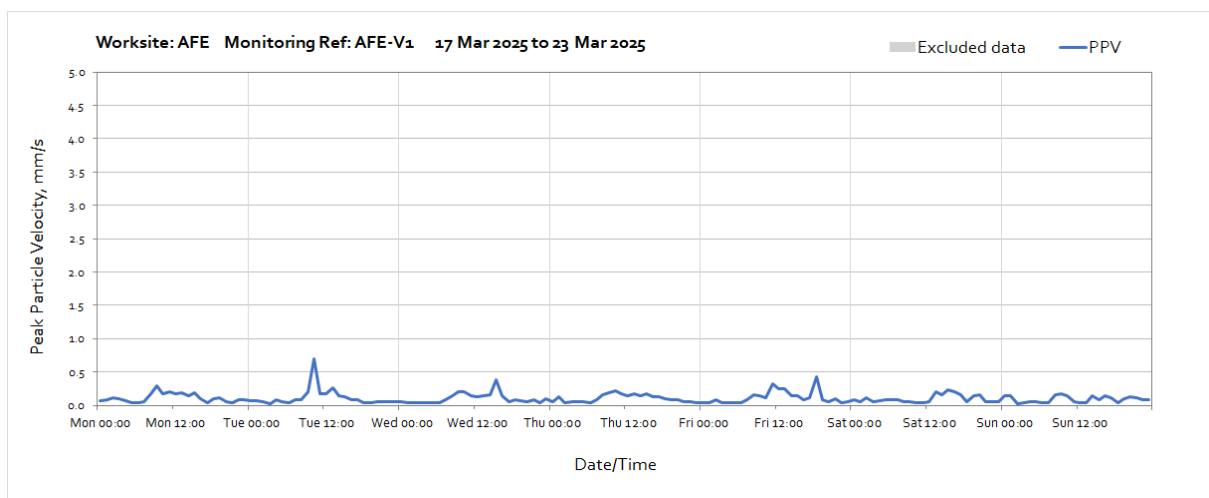
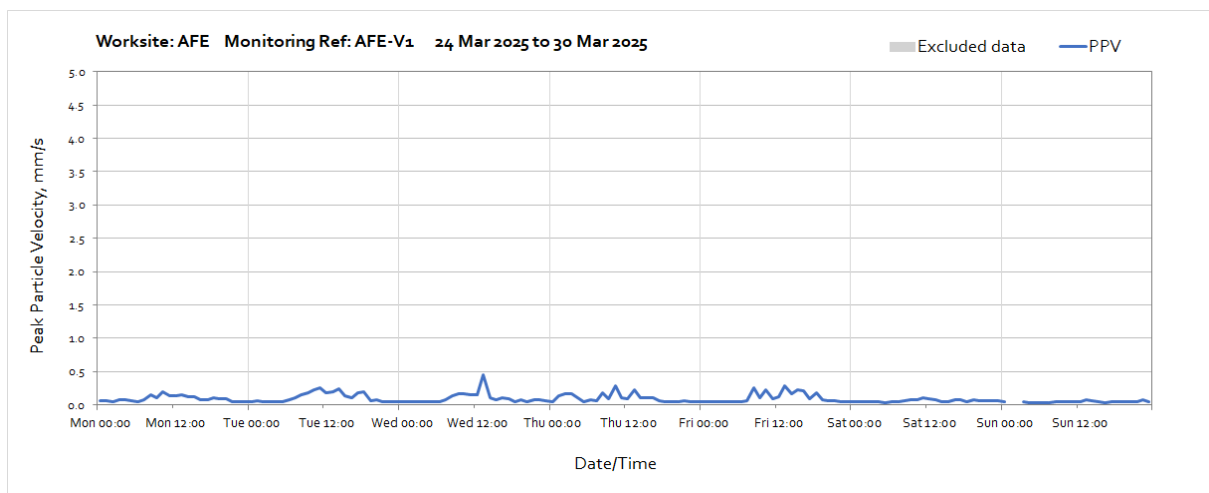
## Worksite: ALO – Monitoring Ref: AFE-V1

Note: Missing data between 01:00 and 03:00 on Sunday 30th March is due to a monitor time adjustment at the start of British Summer Time.

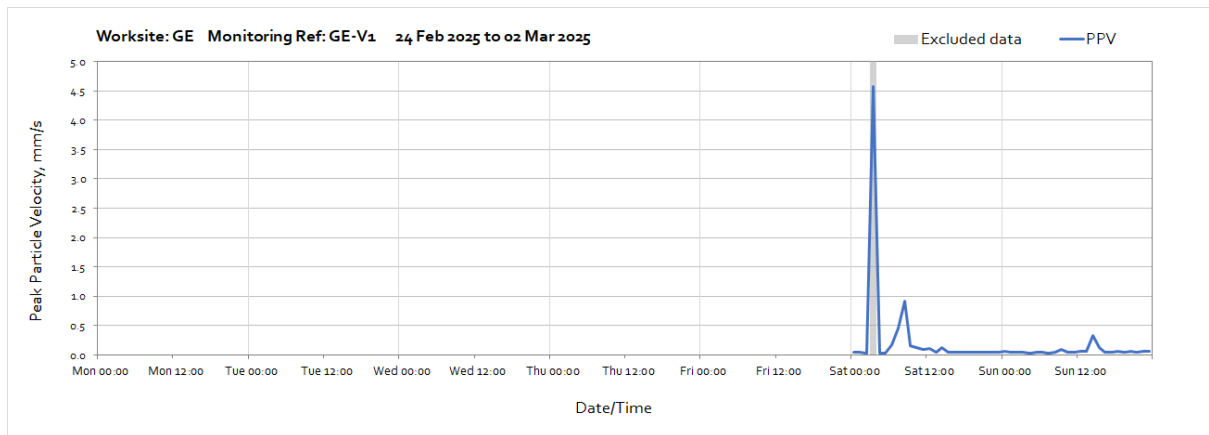
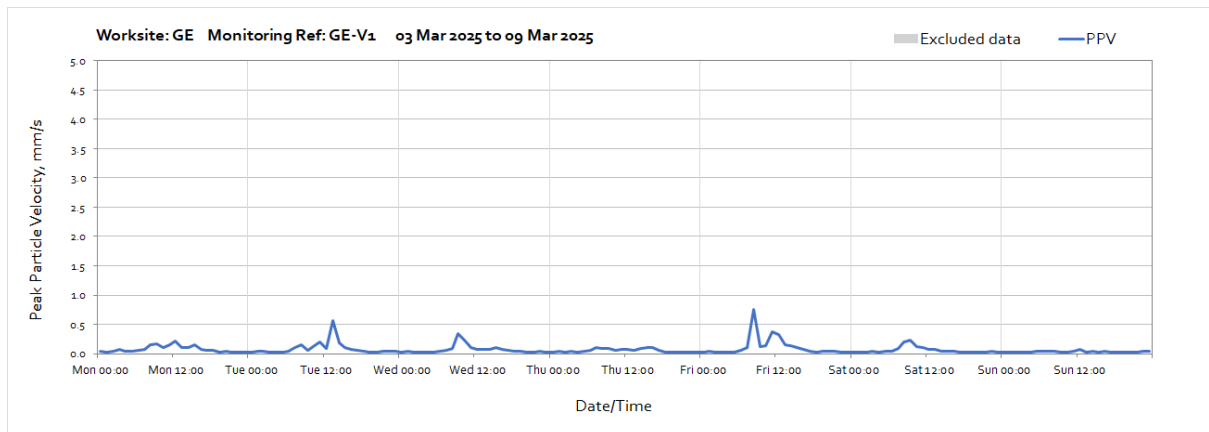
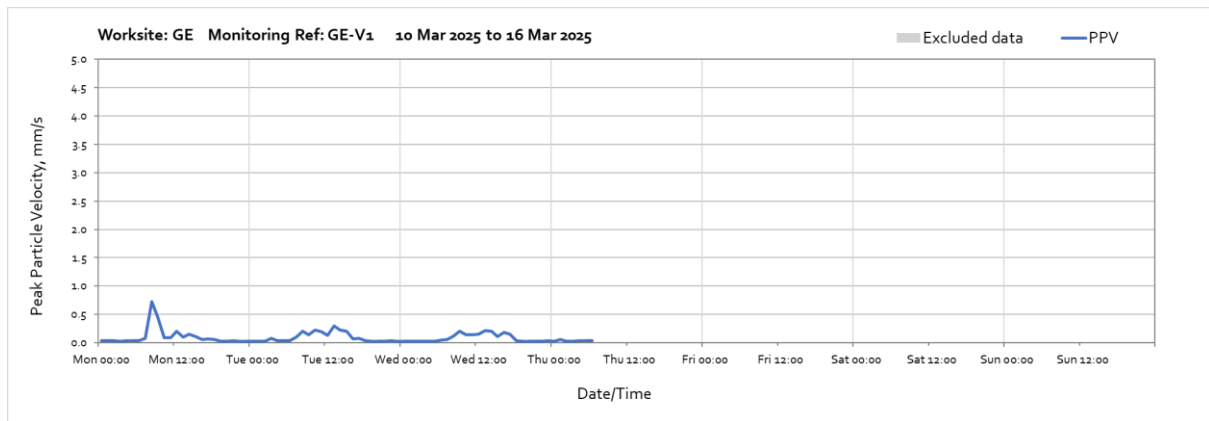
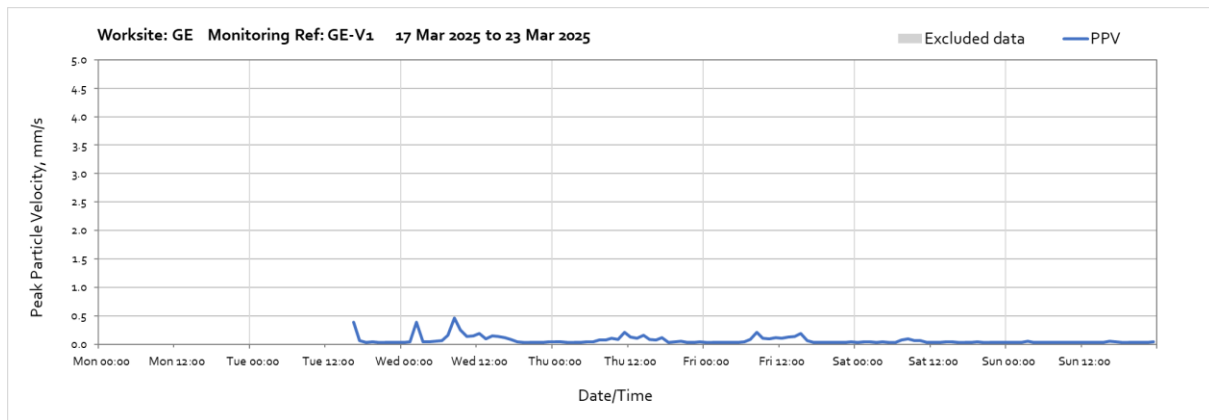
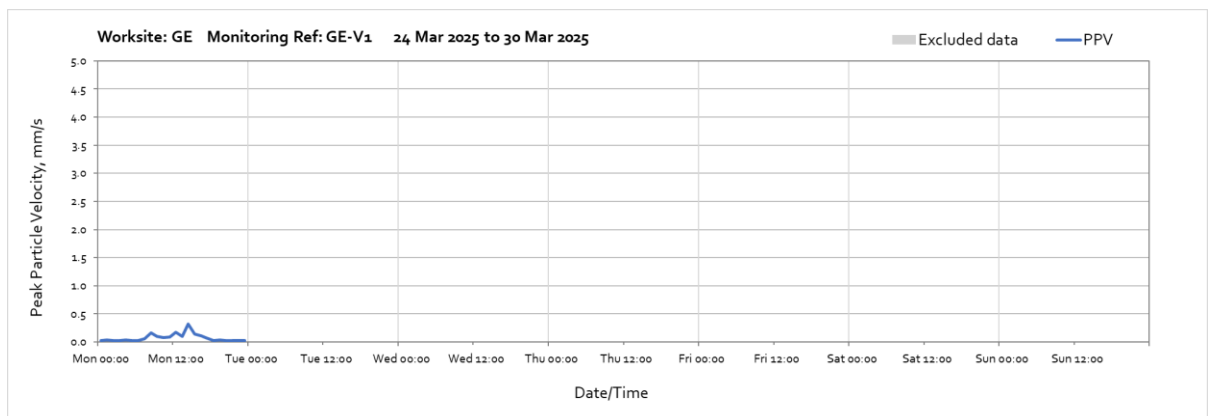
## Worksite: GE – Monitoring Ref: GE-V1

Note: Missing data from 08:00 on Thursday 8<sup>th</sup> March until 15:00 on Tuesday 18<sup>th</sup> March was due to loss of mains power to the monitoring station.

Note: Missing data from 01:00 on Tuesday 25<sup>th</sup> March until the end of the month was due to loss of power to the monitoring station.

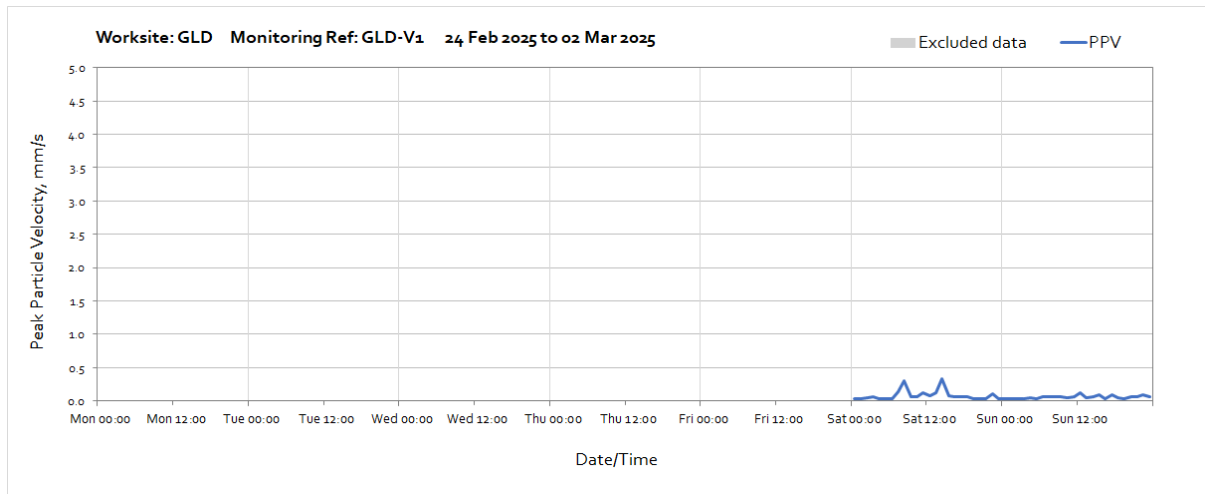
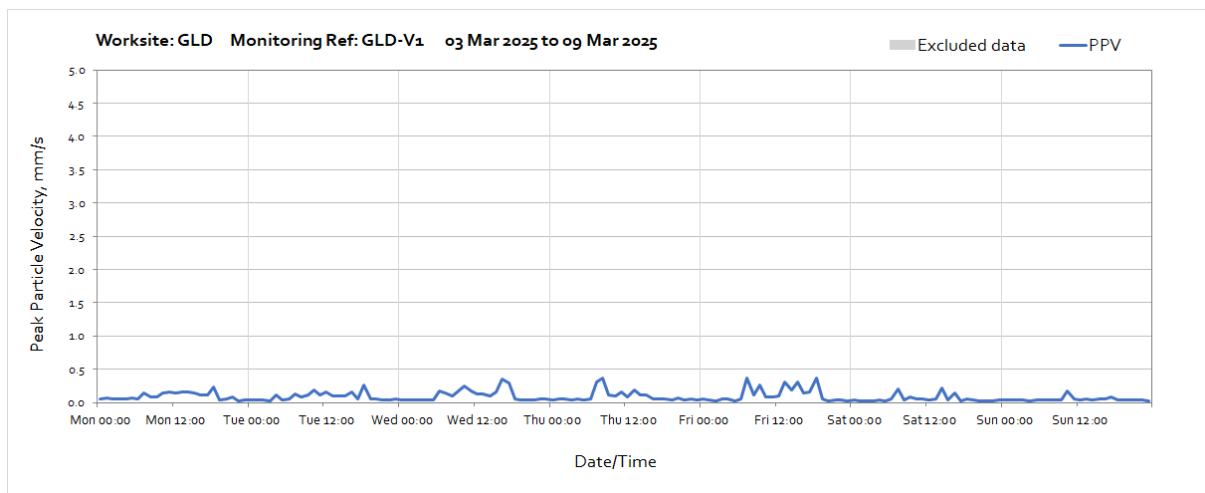
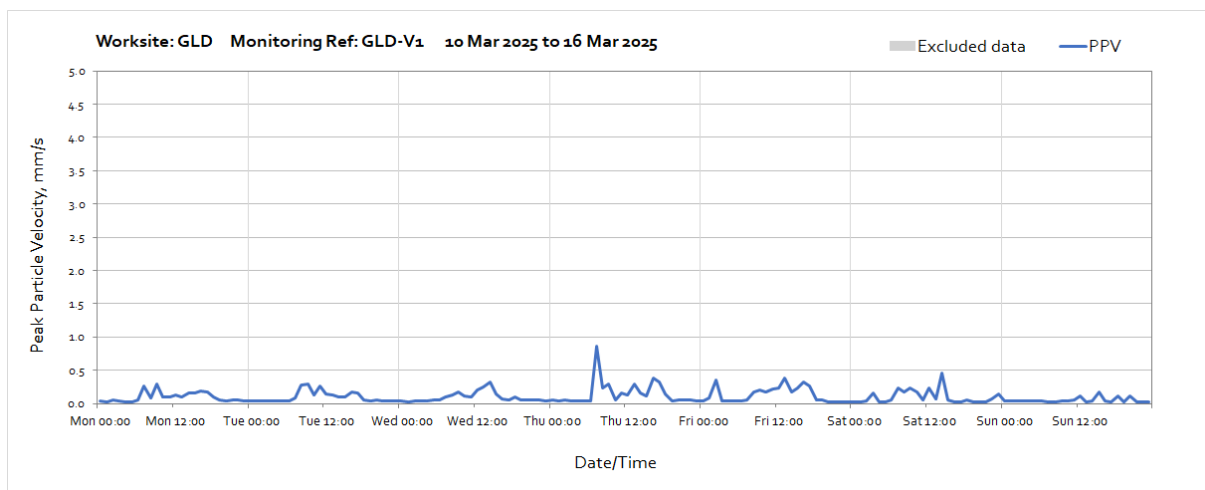
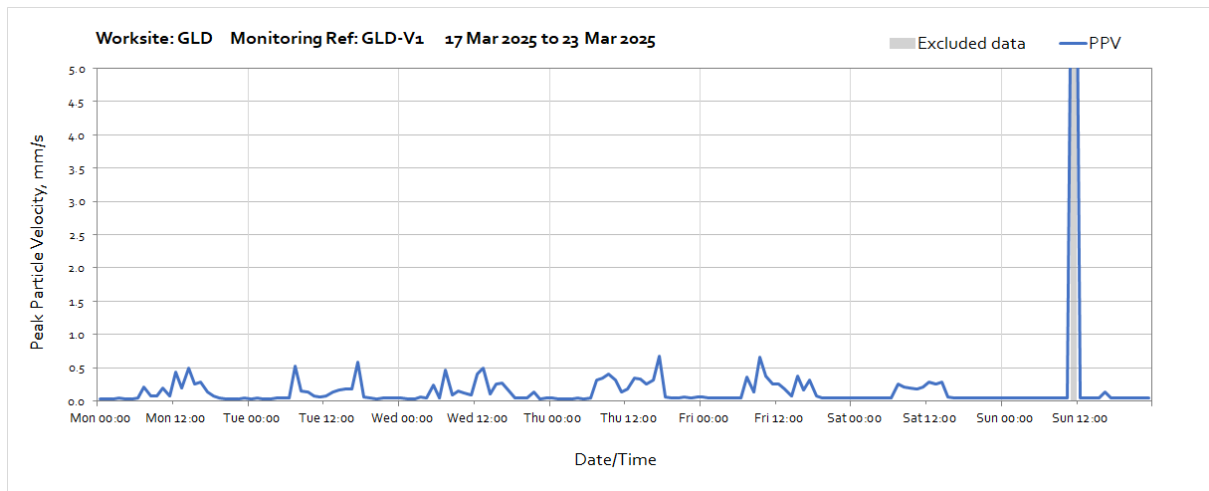
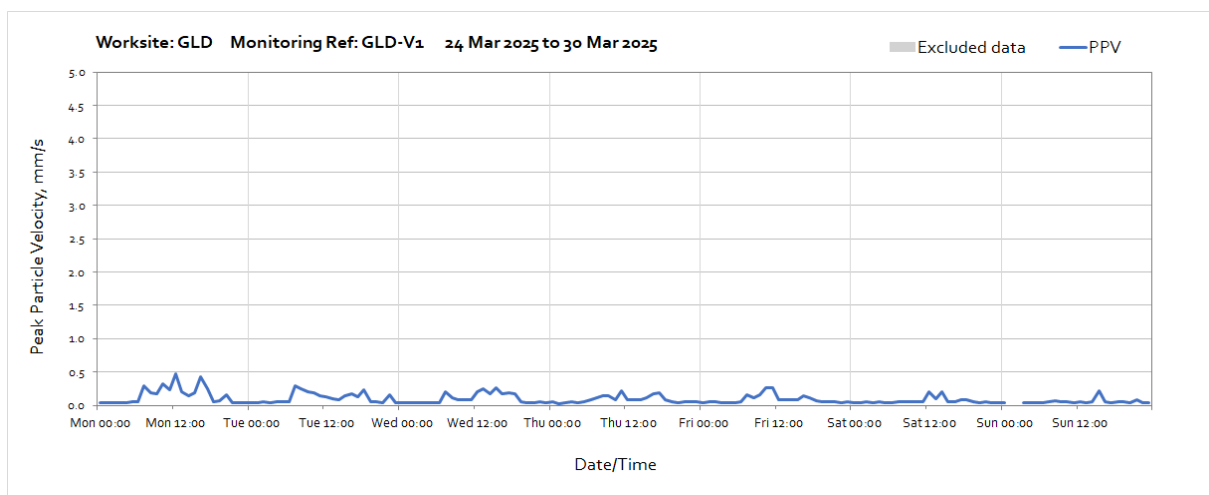
## Worksite: GLD – Monitoring Ref: GLD-V1

Note: Missing data between 01:00 and 03:00 on Sunday 30th March is due to a monitor time adjustment at the start of British Summer Time.

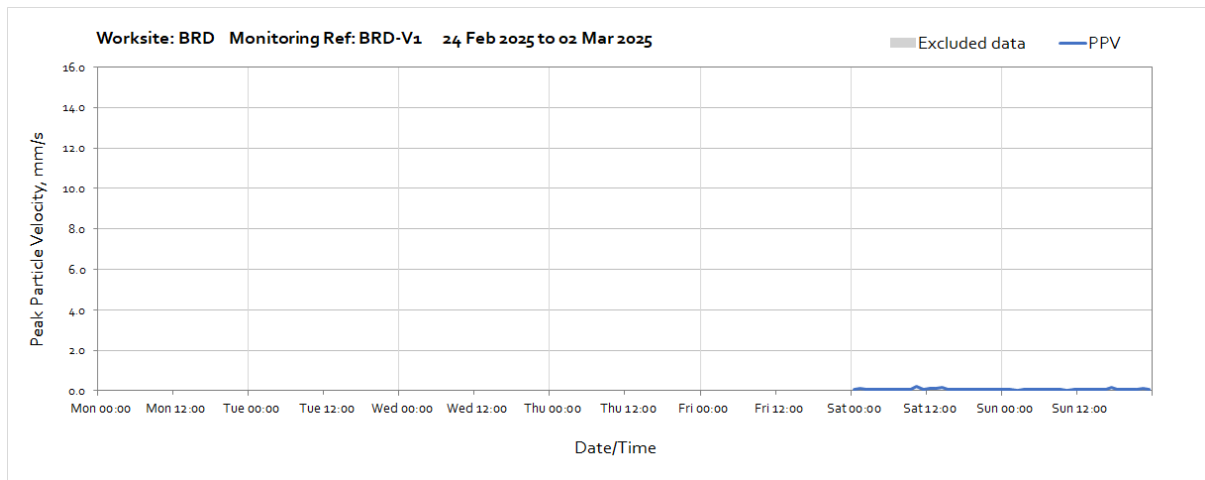
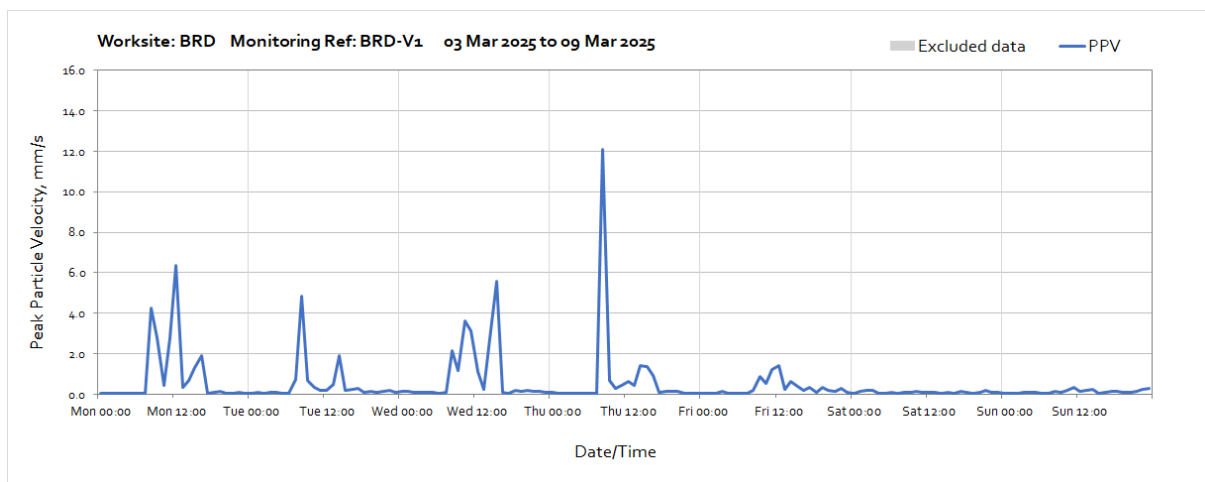
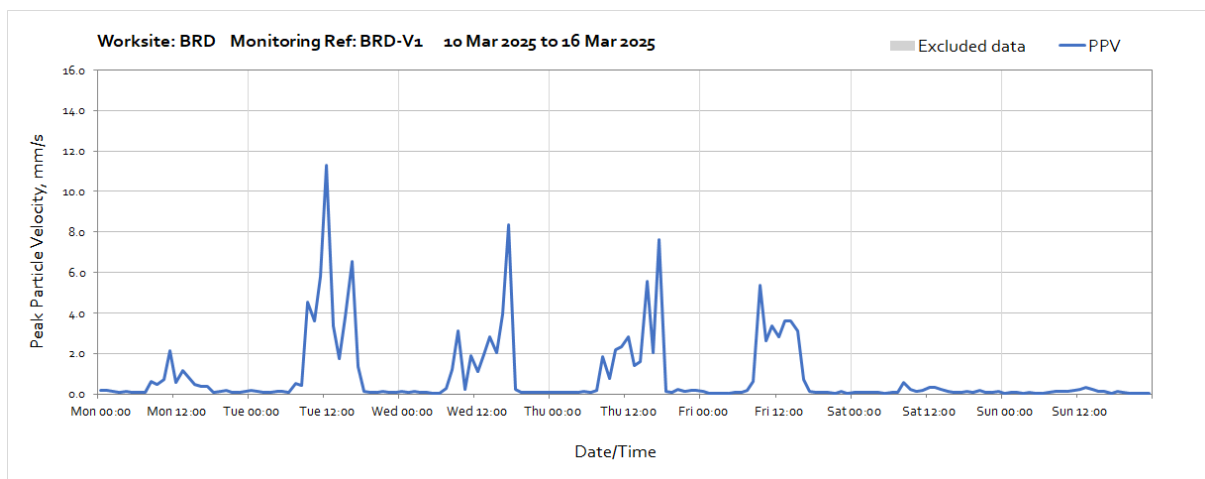
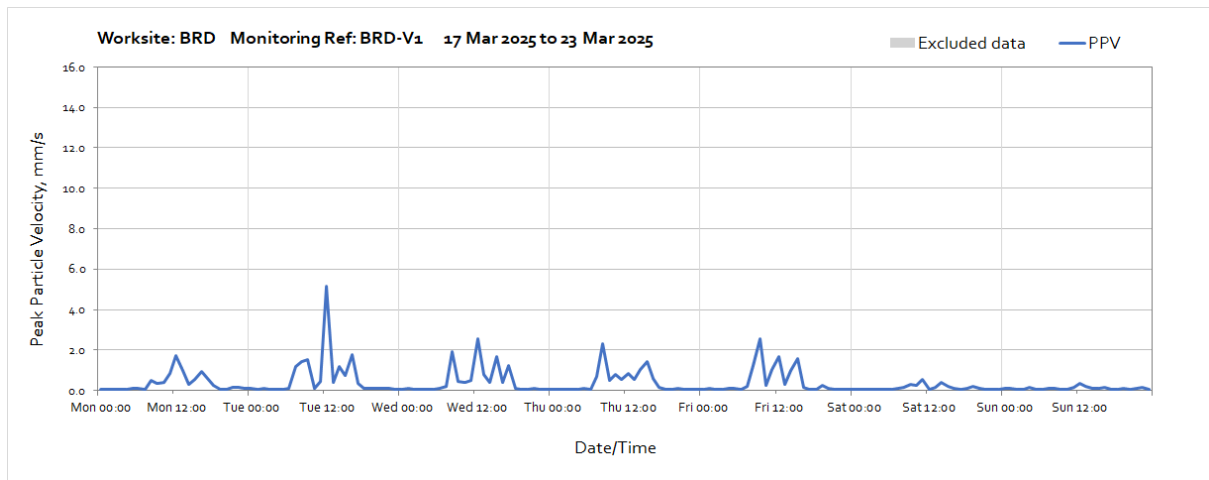
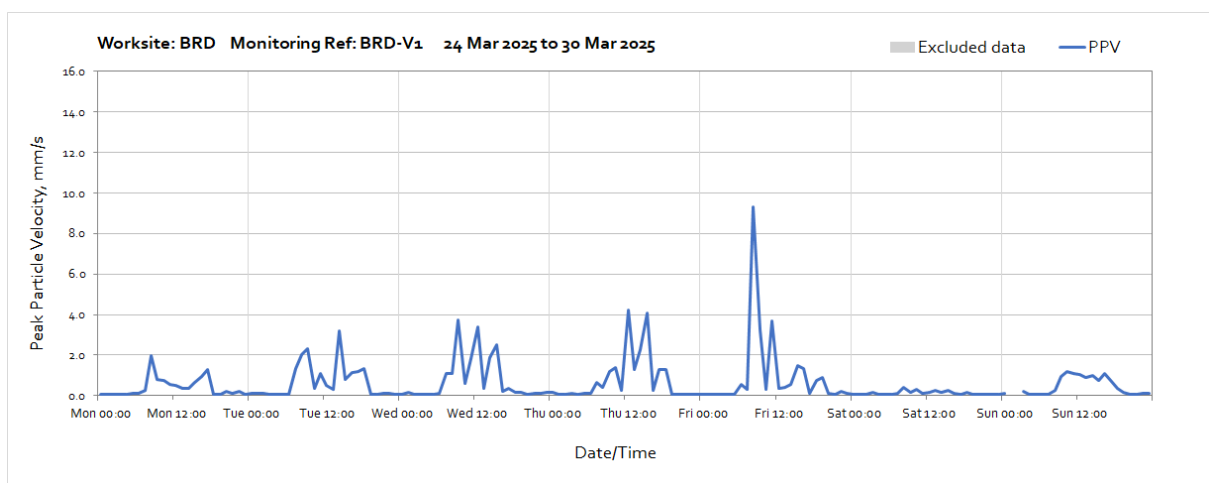
## Worksite: BRD – Monitoring Ref: BRD-V1

Note: Missing data between 01:00 and 03:00 on Sunday 30th March is due to a monitor time adjustment at the start of British Summer Time.
