7. CHARACTER ANALYSIS

7.1 Overview & Character Areas

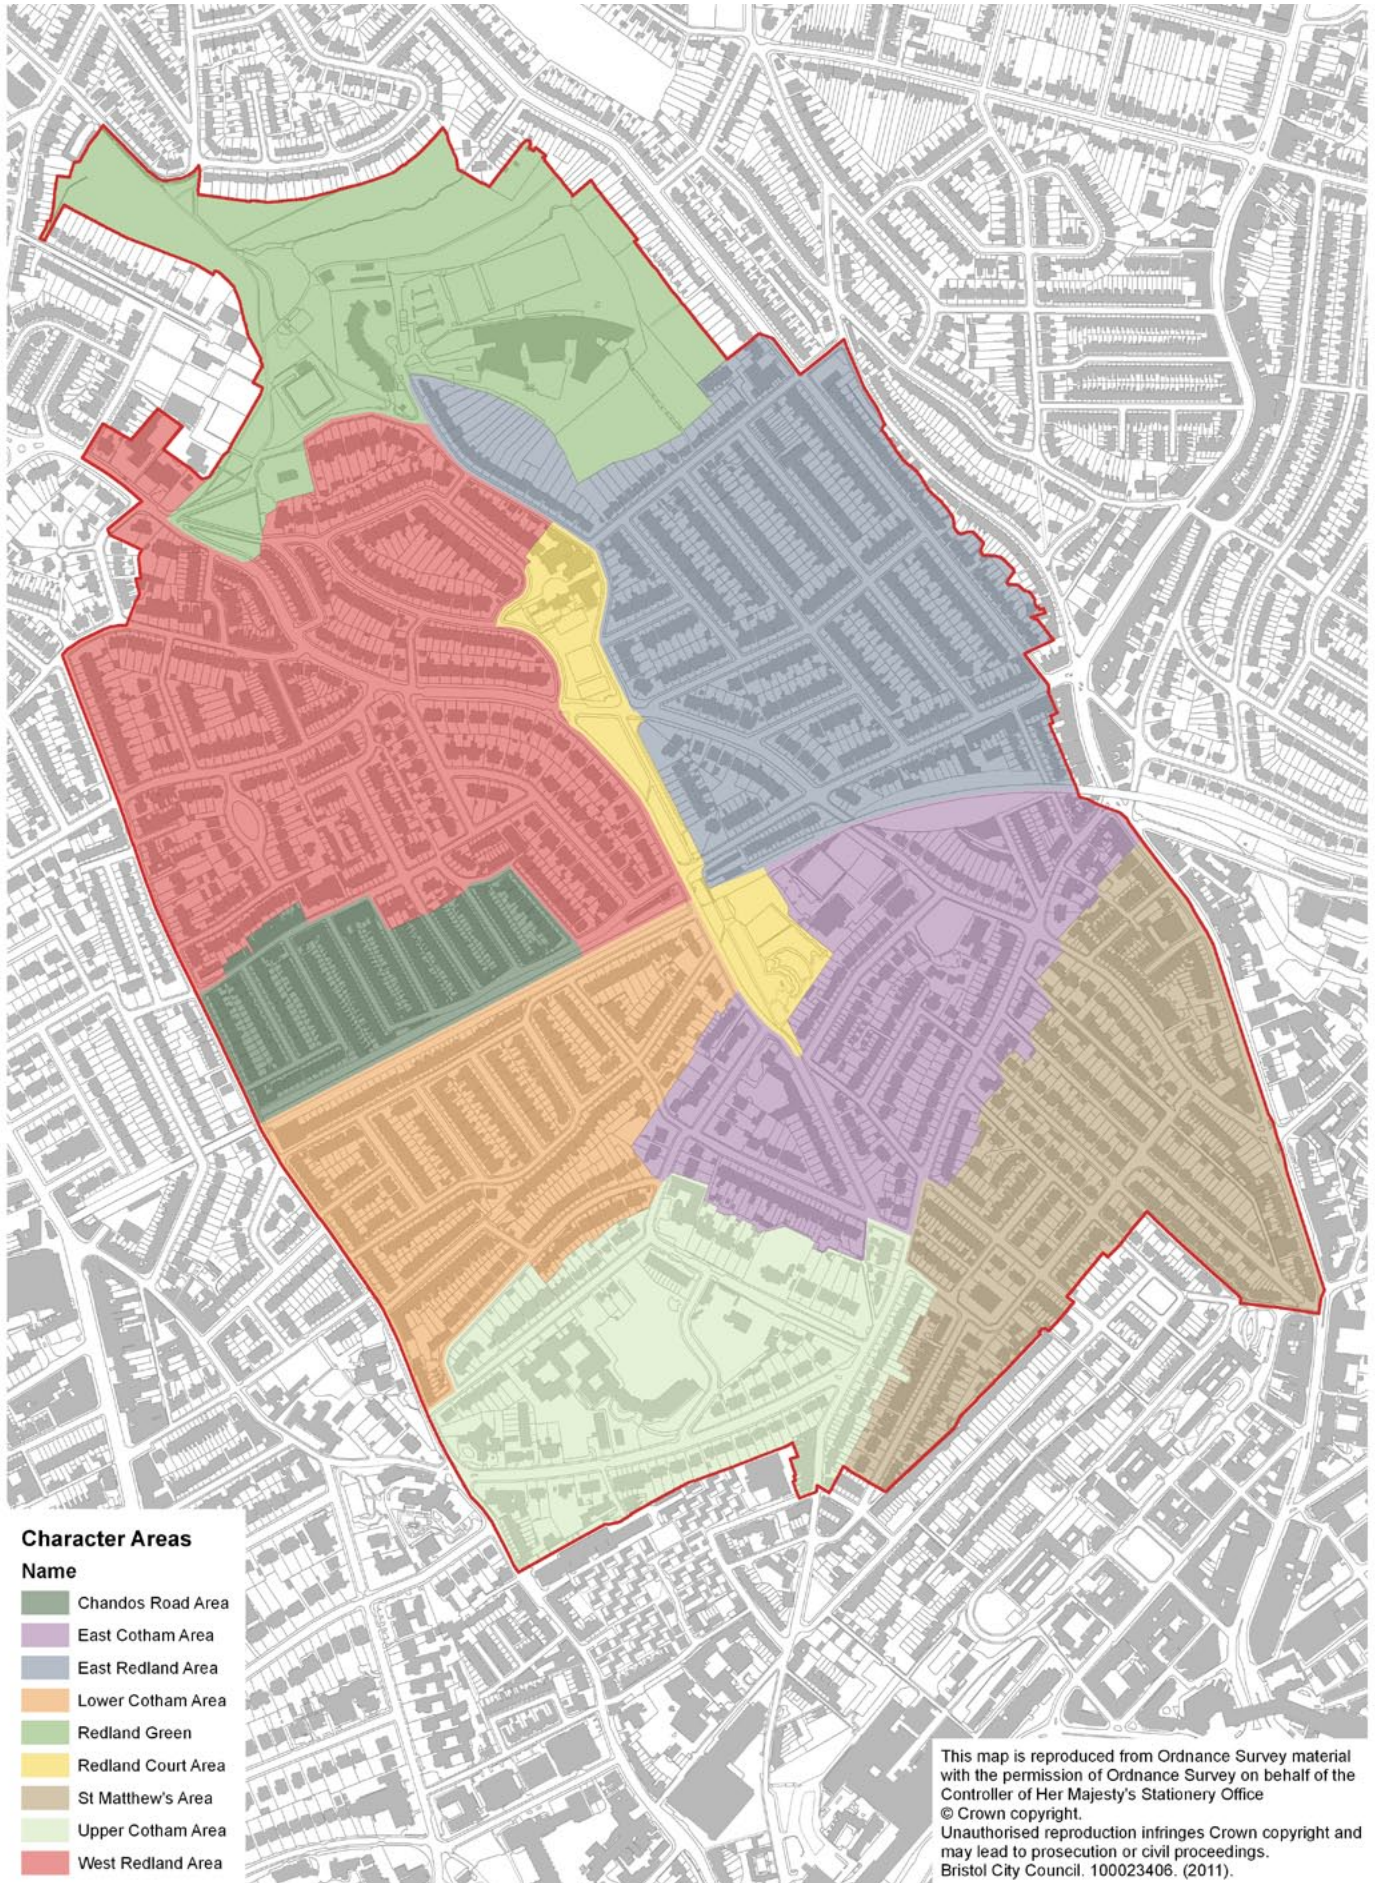
Map 5: Cotham & Redland Character Areas

7.1.6 The Conservation Area can be divided into a number of areas of distinct character, each reflecting a particular aspect that goes beyond planned layout and built form:

- **Character Area 1:** Upper Cotham
- **Character Area 2:** Lower Cotham
- **Character Area 3:** East Cotham
- **Character Area 4:** St Matthews
- **Character Area 5:** Chandos Road
- **Character Area 6:** West Redland
- **Character Area 7:** Redland Court & Redland Green
- **Character Area 8:** East Redland

An overview of Character Areas is shown at Map 5

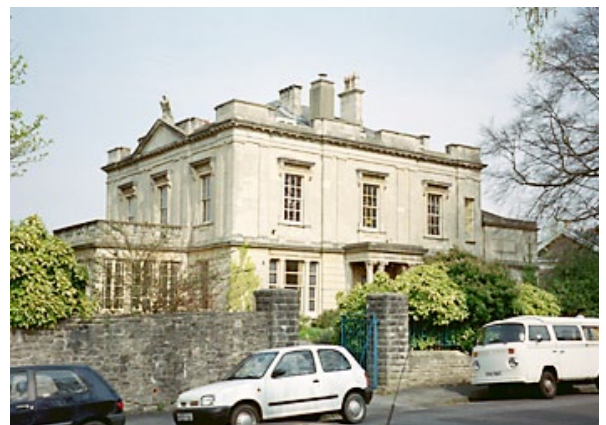
Figure 25: No. 16 Cotham Park

7.1.1d Cotham Road and Cotham Park contain a cluster of fine mid 19th century villas and detached houses, whose detail, size and execution is richer than the housing stock elsewhere. Containing over 20 listed villas, Cotham Road is of particular architectural significance. Architectural style ranges from Neoclassical (nos. 18 & 20 Cotham Road), Italianate (no. 16 Cotham Park) to Tudor Revival (no. 45 Cotham Road). Nos. 4 - 14 Cotham Park is a group of paired early Victorian villas (Grade II).

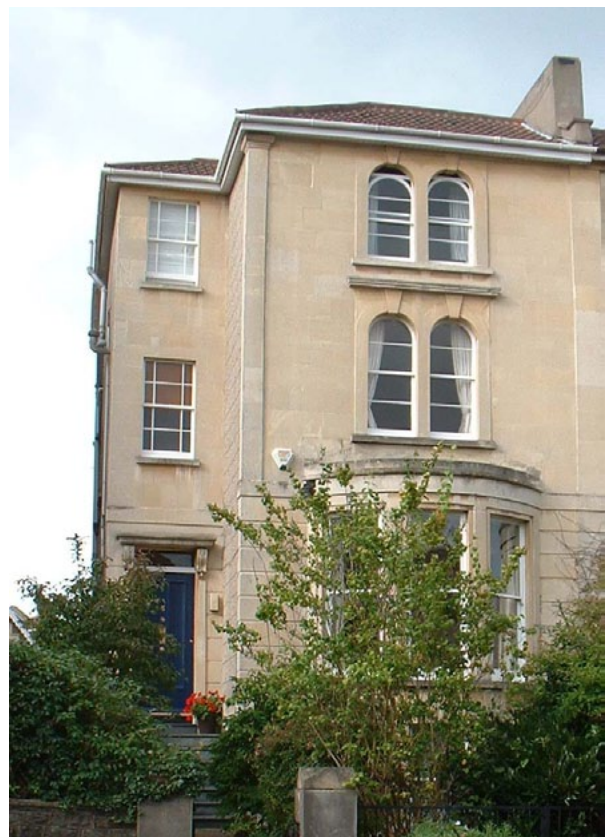
Figure 42: Typical semi-detached villa with side entrance and ground floor bay

7.1.3d Semi-detached villas predominate; typically four storey with side entrances. The consistency of materials is a strong character factor: oolitic limestone ashlar or rubble faced, with limestone dressings and decorative features; low pitched (originally slate) roofs; timber double-hung sash windows, with bay windows common to the ground floor.

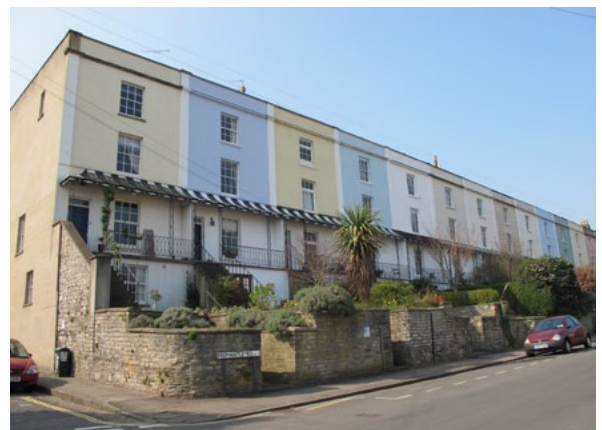
Figure 50: Fremantle Road, Grade II listed terrace

7.1.4d Of the relatively few listed buildings in the Conservation Area as a whole, a number populate this character area. (Including properties on Gibson Road, Fremantle Road, St Matthews Church). Beyond these, there is a high quality and unity of built fabric in the area, with a strong architectural character given by the consistent material palette and neo-Classical treatment.

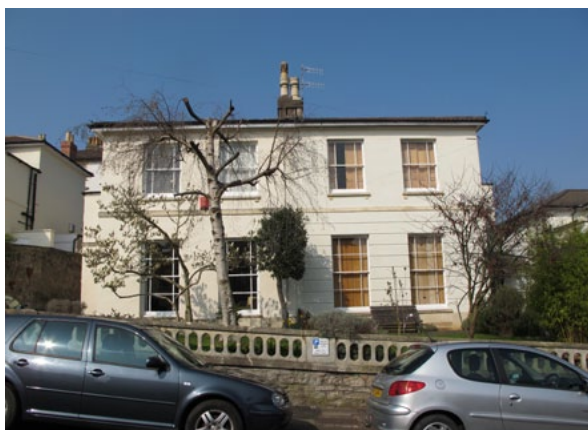
Figure 51: Typical Victorian semi, Clare Road

7.1.4e **Unlisted Buildings.** Most of the unlisted buildings in the area are character buildings, which make a positive contribution to the overall character and sense of place of the wider Conservation Area. Nos. 141 - 157 (odd) Cheltenham Road are a group of three early Victorian tripartite villas. Tamworth Place, a terrace at nos. 2 - 23 Arley Hill, is also a strong unlisted group. Drayton House, no. 54 Arley Hill, and the substantial paired neo-Classical villas at the corner of Cotham Brow/Arley Hill are of merit owing to their scale and richness of detail. The rubble and stone neo-Gothic villa with gabled roof and tall stone chimney stacks on the corner of Sydenham Road/Cotham Brow is also of particular merit.

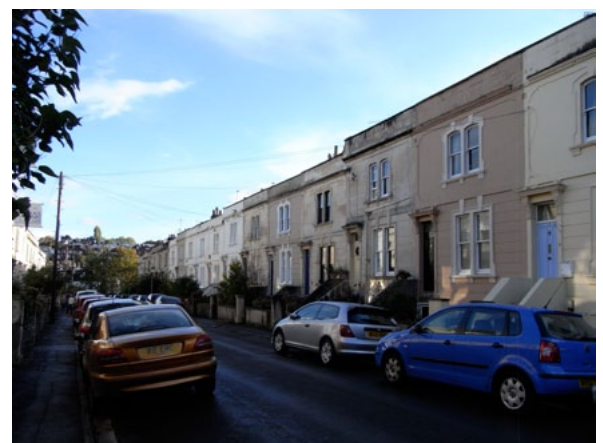
Figure 59: Stanley Road

7.1.5e **Unlisted Buildings.** An interesting group of single-storey shop units are at nos. 1a-d Chandos Road, c. 1900. Away from Chandos Road are the terraced streets extending southwards. Stanley Road has uniform terraces on both sides, of 2-storeys over semi-basements, built in limestone Ashlar. Collingwood Road, Cowper Road, Brighton Road, Lansdown road and Roslyn Road are non-uniform terraces of 2 and 3-storeys, with some bays, united by a strong building line and consistent palette of materials.

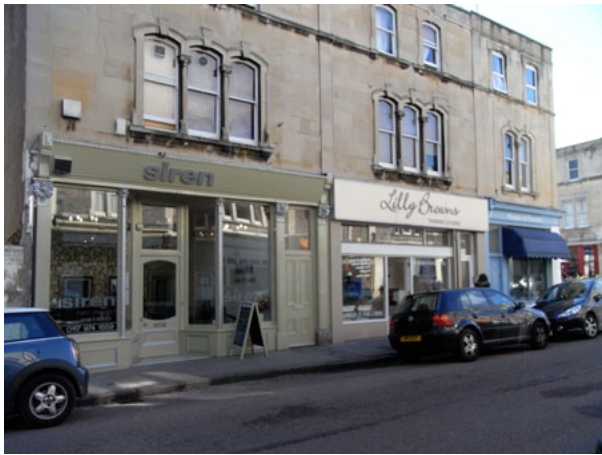
Figure 60: Traditional timber shopfronts

7.1.5f **Other Heritage Assets.** Surviving traditional shopfronts or surrounds and signage are a particular asset in this area. Front boundary treatments, typically walls of sandstone rubble with limestone dressings also give a strong line and add interest and variety of scale to the more residential streets. A number of buildings are enriched by carved architectural details e.g the carved decorative heads on the triangular pediments of nos. 5 - 11 Chandos Road, which give quality and interest to individual buildings and the wider street scene. The War Memorial on the north side, next to the church, is a historic landmark.

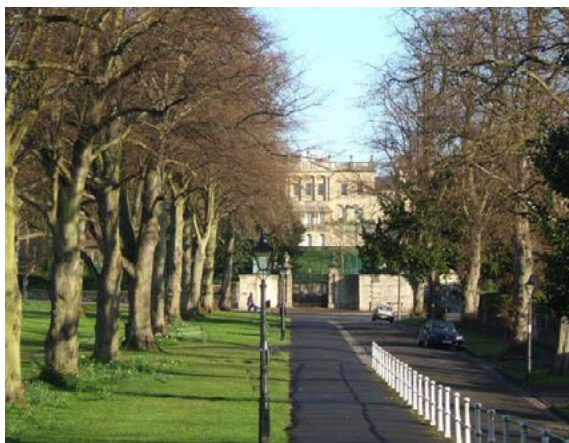
Figure 78: Redland Court viewed from Redland Grove

7.1.7n Redland Court (Grade II*) was built by John Coussins in 1732, who replaced the earlier manor house with the limestone ashlar Classical palace-fronted building of today. The central pediment and bottle balustraded parapet, with decorative urns, are particularly prominent in long views.

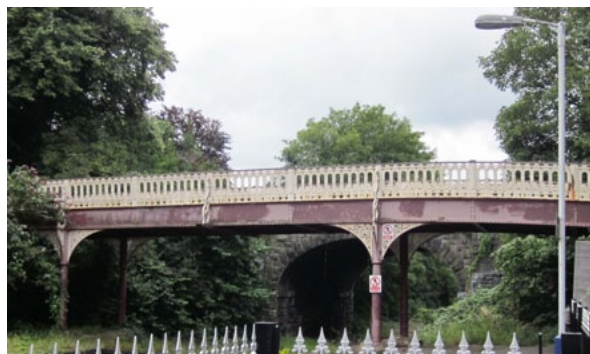
Figure 81: Cast iron footbridge over railway line, from Redland Station

7.1.7q **Other Heritage Assets.** The cast iron footbridge (Grade II) over the railway provides an attractive element in Lovers' Walk; it is also a historic landmark.

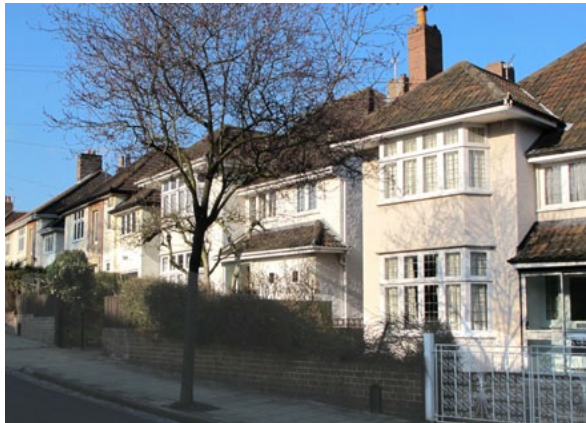
Figure 83: Redland Court Road

7.1.8h Redland Court Road was largely built in 1930s, some earlier buildings exist at the southern end. Houses are mostly 2-storey with tiled pitched roof; façades of rendered brick with timber casement windows with leaded lights. Front gardens are a good size, many have been partly converted into parking spaces while retaining most of the front wall and planting. On Redland Court Road the semi-detached villas have attached garages; many are now built over to form two-storey links.

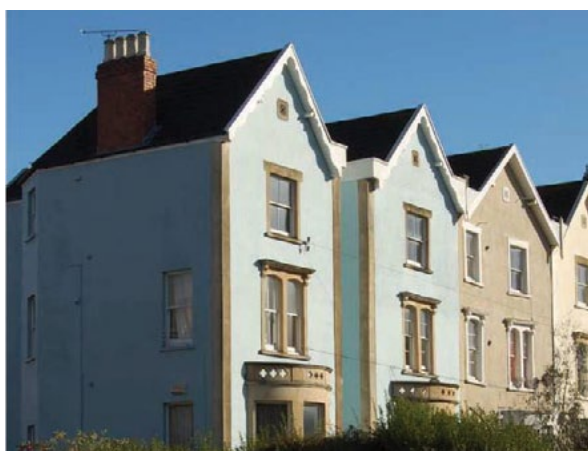
Figure 86: Grouped buildings of merit, Redland Road/Zetland Road

7.1.8p Other Heritage Assets. The four houses at the junction of Zetland Road with Redland Road stand out in amongst their context and are a group of merit. Walls are of stucco with Bathstone detailing; first floor windows have stone canopies.

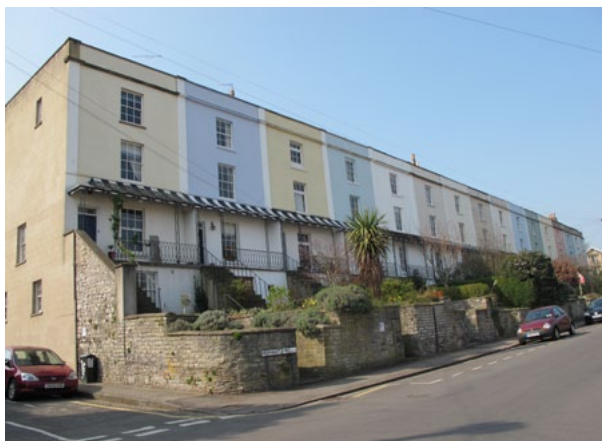
Figure 89: Fremantle Road terrace, 1840s

7.2.3 The earlier buildings in the Conservation Area are generally situated in the southern portion, where the c. 1840s terraces and grand villas, have their architectural style rooted in an earlier Regency heritage. The earliest style was the continuation of the terrace pattern, in an adaptation of the classical Regency architectural design (e.g Fremantle Road c. 1840). The earlier villas and terraces adopt symmetry and ordered detailing: continual parapet, string courses, piano nobile and a vertical emphasis are all used.

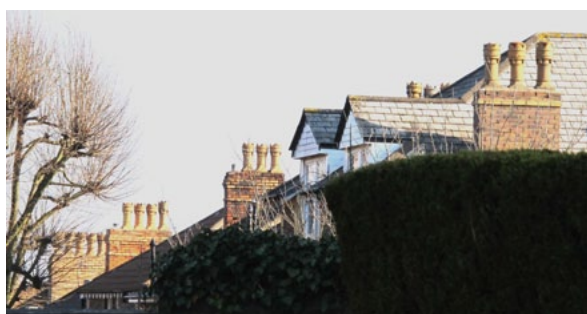
Figure 92: Woodstock Road roofs

7.3.4 **Chimney stacks and pots** form striking features when seen against the skyline. Replacement or removal of chimney pots and stacks is discouraged. The pairs of houses on Woodstock Road have grouped stacks, distinctive as the road drops down the contour of the hill, most of which retain their numerous clay pots.

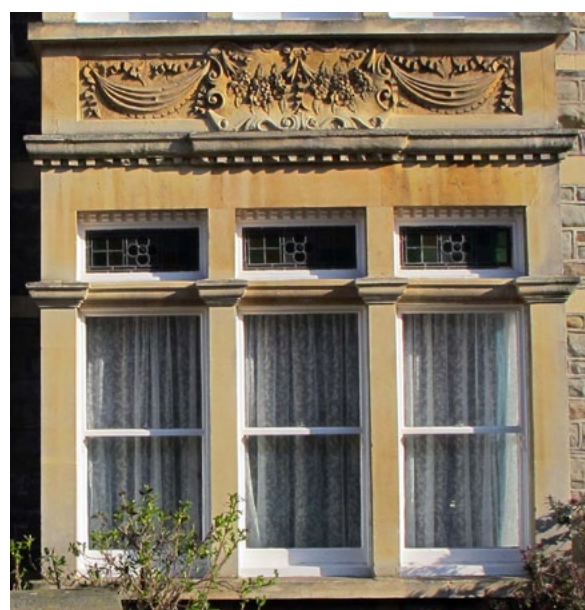
Figure 93: Late Victorian windows, Luccombe Hill

7.3.6 Typically, Victorian windows in the Conservation Area are single glazed, double hung, timber sashes, recessed within the window reveal and painted white. Sashes are usually six-over-six, though there are variations to this pattern. Victorian windows are heavier, one-over-one timber sashes with moulded window horns.

- 7.3.11 Regular maintenance and painting of traditional doors and windows is essential to ensure that problems of decay are not allowed to flourish. Other architectural details of special interest should be retained, and specialist advice sought on repair, to protect the character and special interest of the Conservation Area.

- 7.3.12 Where wholesale replacement is needed, the detail of doors and windows must match the originals in terms of glazing patterns and method of opening. Poor quality replacement doors and windows have a detrimental impact on the integrity of individual buildings, and the character of the Conservation Area as a whole as can be seen above (see Negative Features).

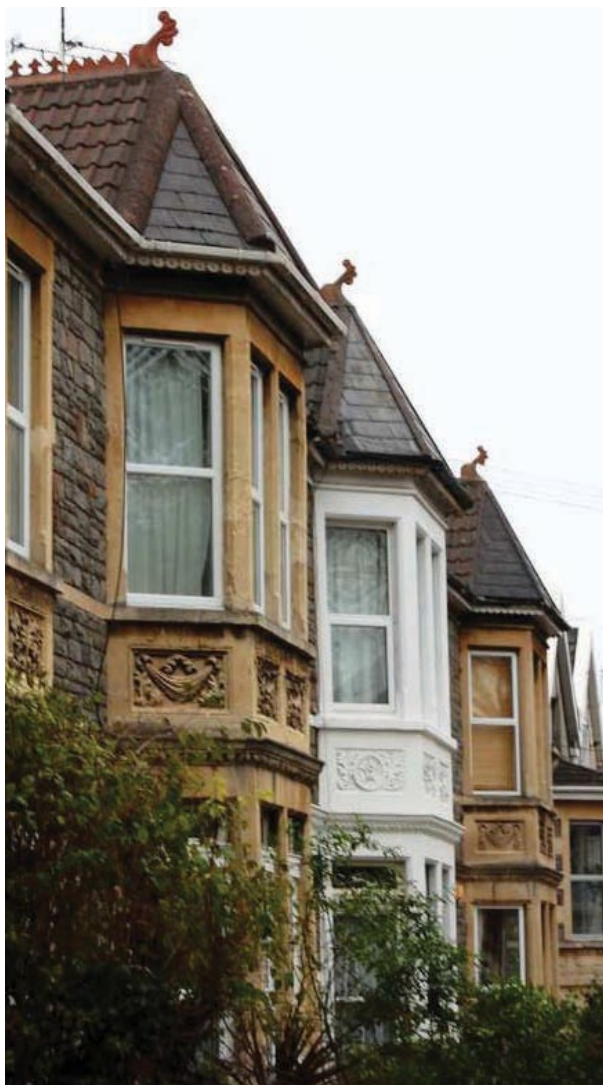
Figure 94: 2-storey canted bays

7.3.7 Throughout much of the Conservation Area, bay windows form a strong rhythmic verticality to the facades, which is balanced by the horizontal fenestration and various stone string courses. Bays vary considerably, the most common are the two-storey canted bays, with 3 or 4 double hung sashes per floor. Generally the older sash bays have stone mullions which the new casement windows don't have. A small proportion of sashes have high level stained glass panels.

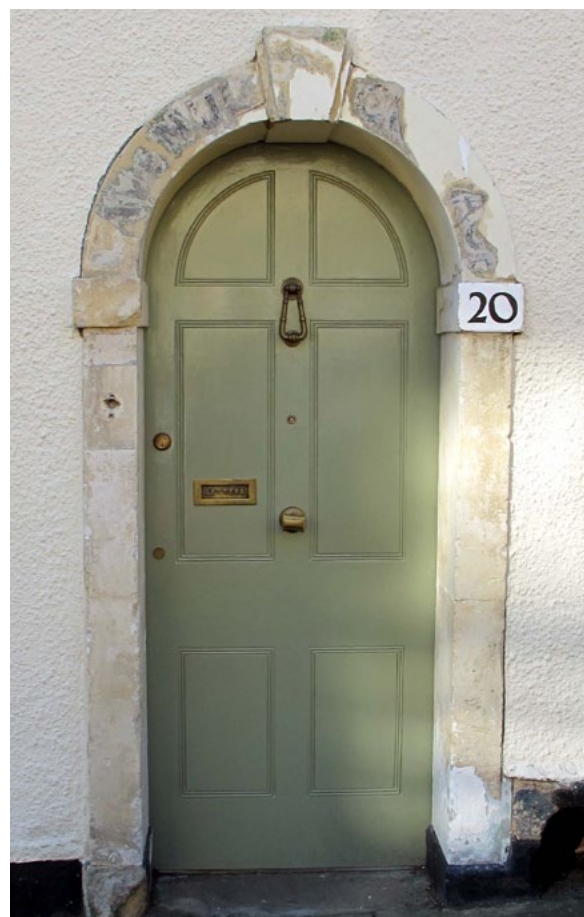
Figure 95: Flush-panel door with limestone surround, Luccombe Hill

7.3.7 **Doors and surrounds**, where the original has been retained and well maintained add greatly to the character and appearance of individual buildings and to the wider street scene. Front doors vary throughout the area, most common examples are 6-panels. Rectangular fanlights are a common feature, many later Victorian buildings have stained glass fanlights or side panels.

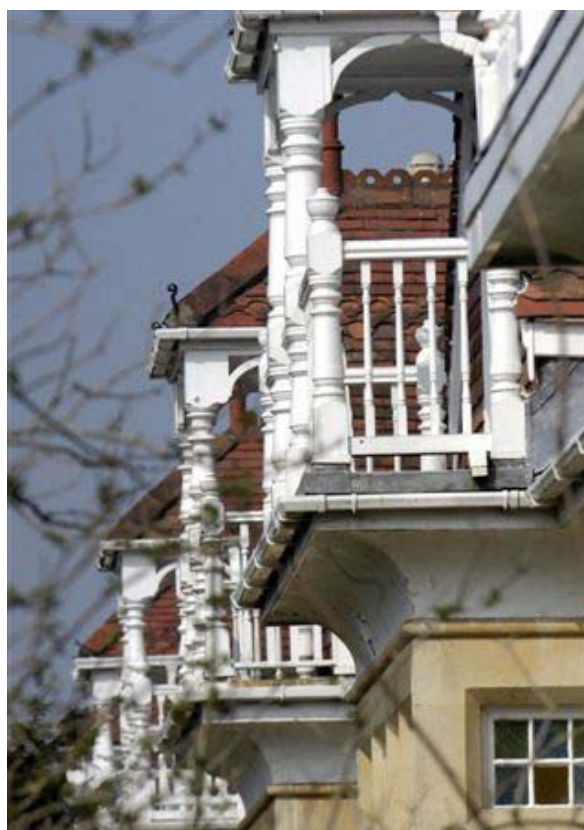
Figure 96: Timber balconies, Cotham Park

7.3.9 **Balconies** In a few instances, low level roofs over doors and windows have decorated timber brackets forming roof bearers, there are also a small number of timber balconies.

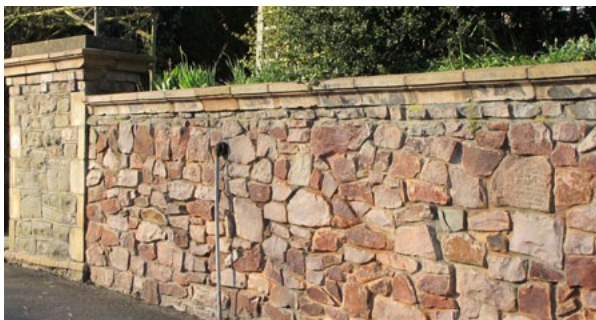
Figure 100: Brandon Hill stone retaining wall, Woodstock Road

7.6.7 In order to retain the character and special interest of the Conservation Area, listed or unlisted traditional boundary walls, gates, gate piers and railings should be preserved, sympathetically restored or reinstated. When railings are repaired, the posts should be lead soldered and individually set into the stone coping to prevent corrosion of the foot of the post. Stone should be left unpainted or rendered and failing walls sensitively repaired.
