Helping you stay safe on Britain's roads

About this Manual

A summary of the main requirements for each type of lamp is shown below.

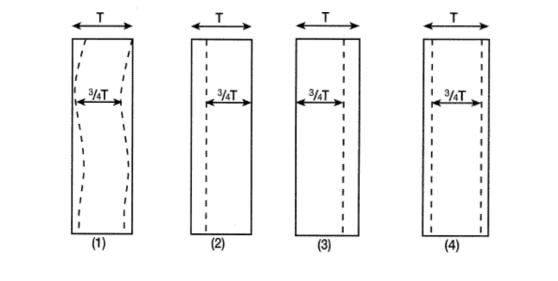
Figures (1), (2), (3) and (4) T= Breadth of Tread

$\frac{3}{4}$ T = Minimum width of continuous band.

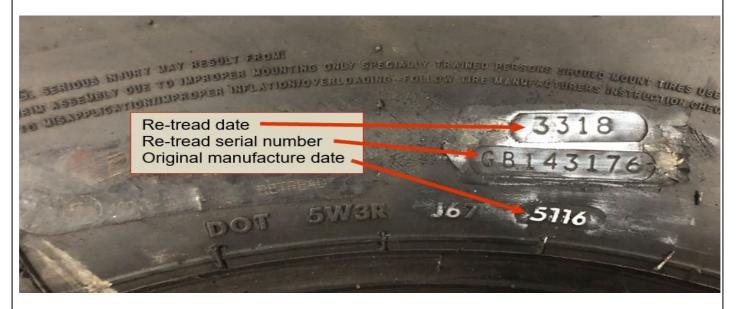
The date code is only required to be marked on one sidewall and can usually be found at the end of the DOT (Department of Transportation) marking on original manufactured tyres. Retread or recapped tyres may be marked with two date codes, the original manufacture date, and the date of remanufacture, the most recent date must be used when assessing tyre age.

Tyres not displaying a date code would normally be a deficiency. However, date codes are only required to be marked on one side of the tyre so it may not be possible to see the date code on some twin wheel fitments. Under these circumstances you should assume the date code is present and the tyre age is acceptable.

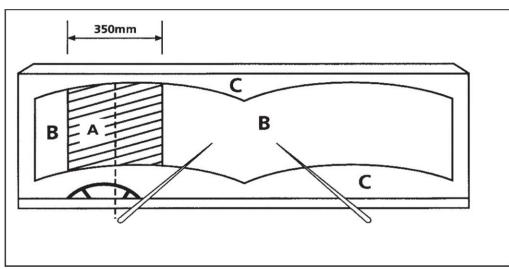
Windscreen

Zone "C" is the remainder of the screen outside the sweep of the wipers.

When checking the windscreen refer to the diagram below.

Examiners should have regard for the three separate "zones" when assessing damage or discolouration. A greater amount of damage or discolouration could be accepted in zone "C" than in zone "B". Likewise, a greater amount can be accepted in zone "B" than in zone "A" where relatively minor damage may be a deficiency.

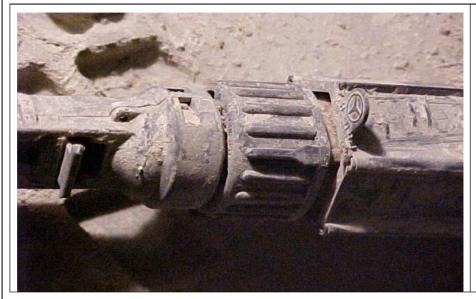
Plastic sleeve seals are acceptable but will require an embossed identification, (see example to left).

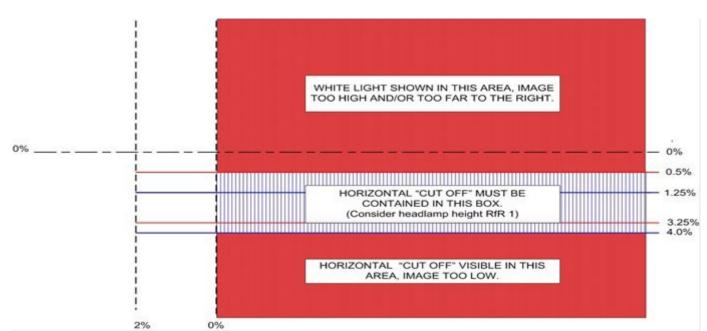
European checked on Dipped Beam

Align the headlamp aim testing equipment to the vehicle in accordance with the manufacturer's instructions.

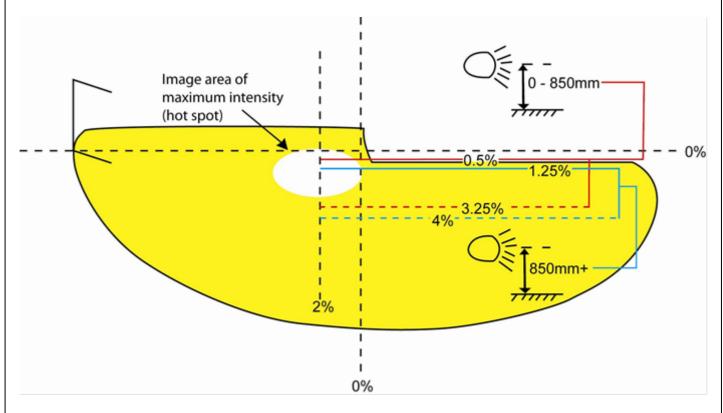
British American Checked on Dipped Beam

Align the headlamp aim testing equipment to the vehicle in accordance with the manufacturer's instructions.

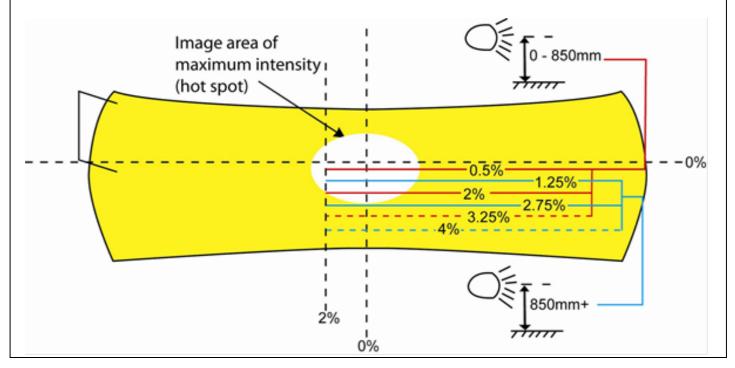
British American Checked on Main Beam

Align the headlamp aim testing equipment to the vehicle in accordance with the manufacturer's instructions.
