Construction Noise and Vibration Monthly Report – April 2025

London Borough of Camden

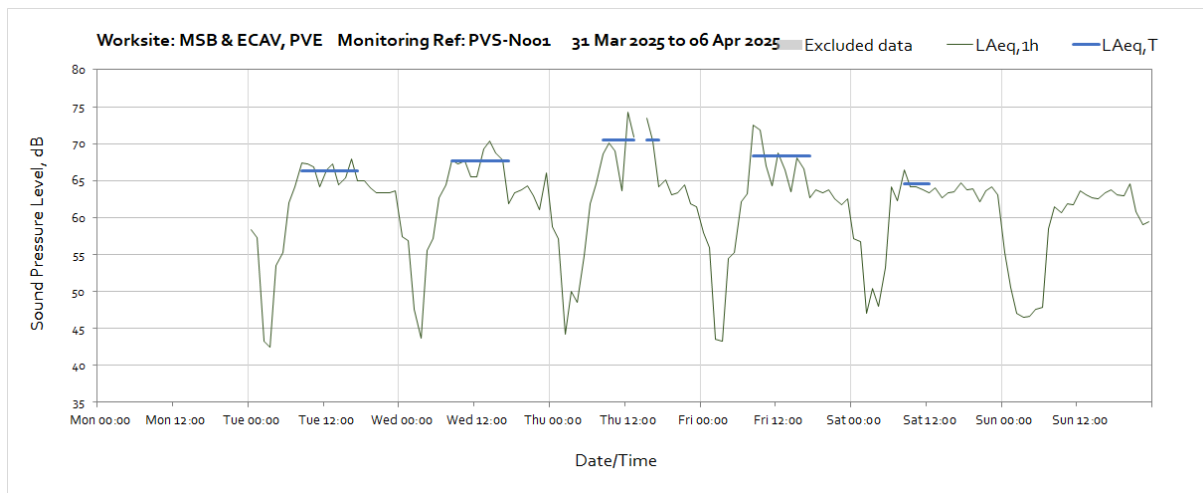
Worksite: MSB & ECAV, PVE – Monitoring Ref: PVS-N001

Note: Missing data between 14:00 and 15:00 on Thursday 3rd April was due to maintenance of the monitoring station.
