## **Construction noise and vibration Monthly Report – April 2025**

**London Borough of Hillingdon**

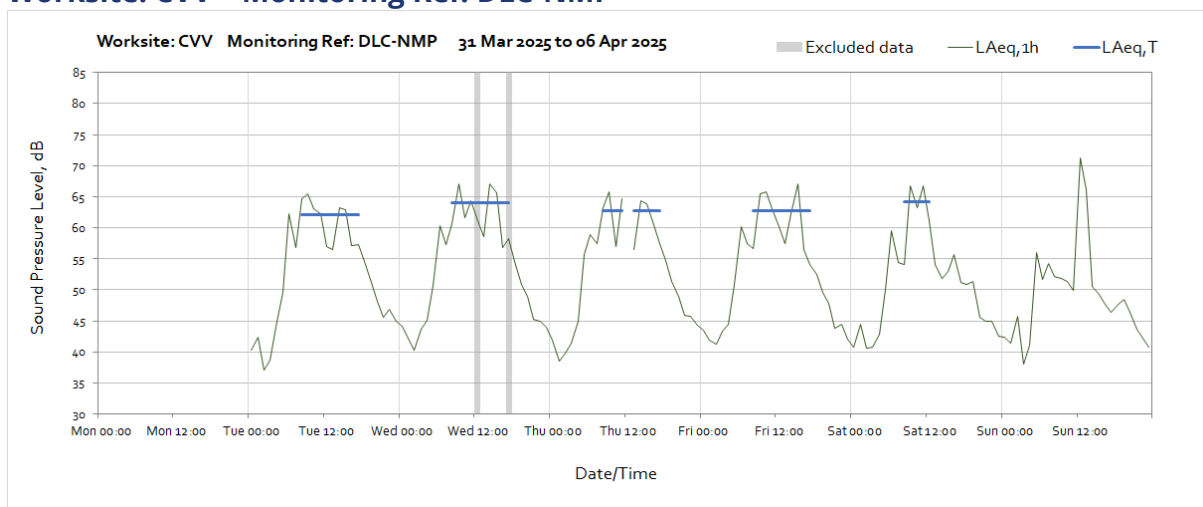
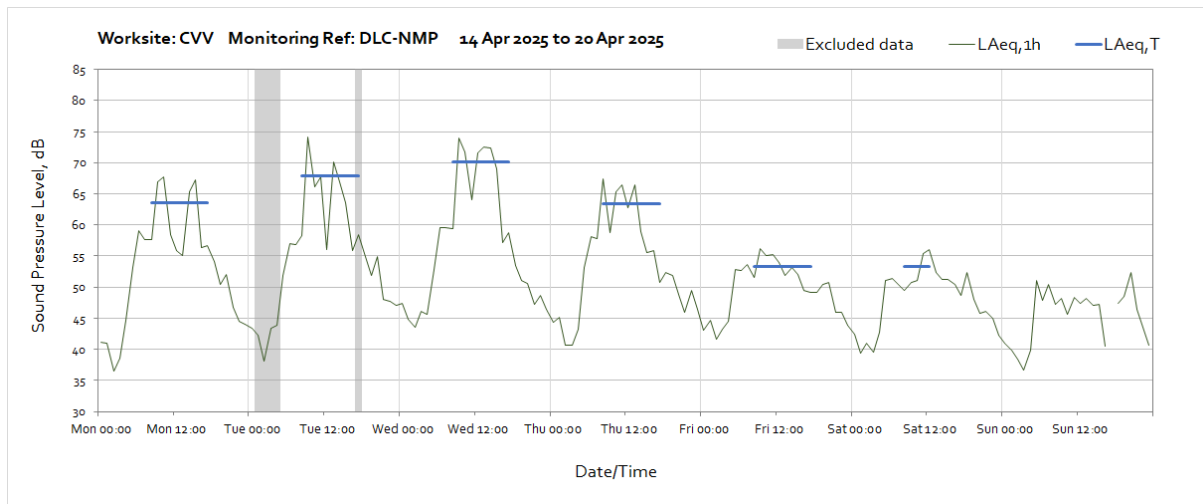
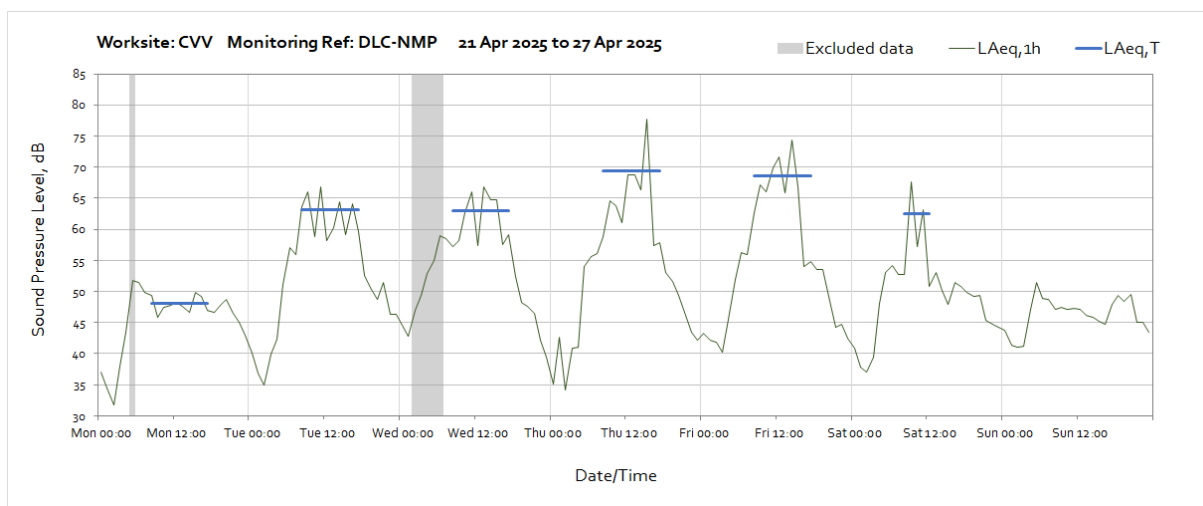
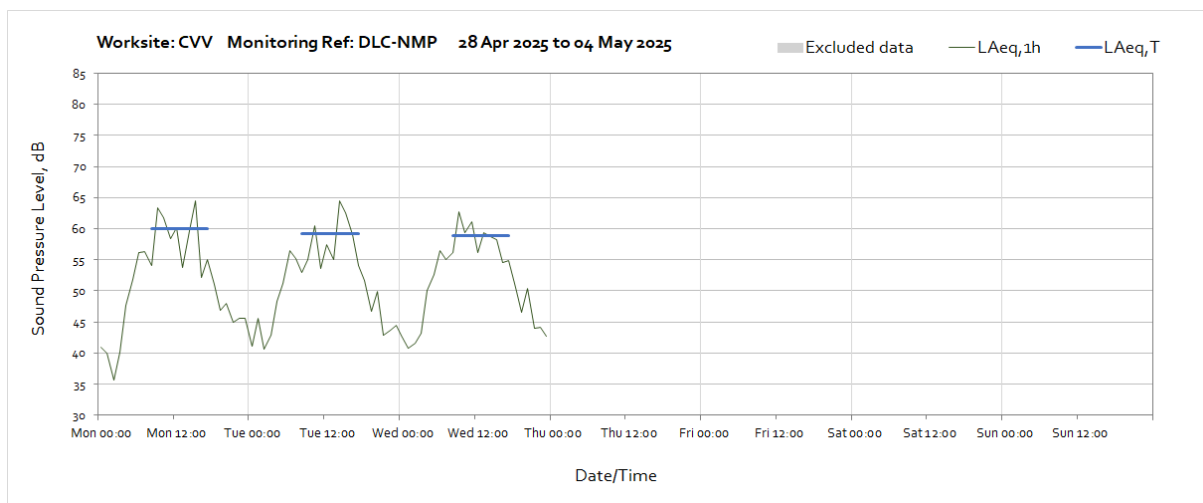
### Worksite: CVV – Monitoring Ref: DLC-NMP

Note: Missing data from 12:00 until 13:00 on Thursday 3<sup>rd</sup> April was due to field calibration of the monitoring station.

Note: Missing data from 17:00 until 16:00 on Sunday 20<sup>th</sup> April was due to a data transmission error within the monitoring station.

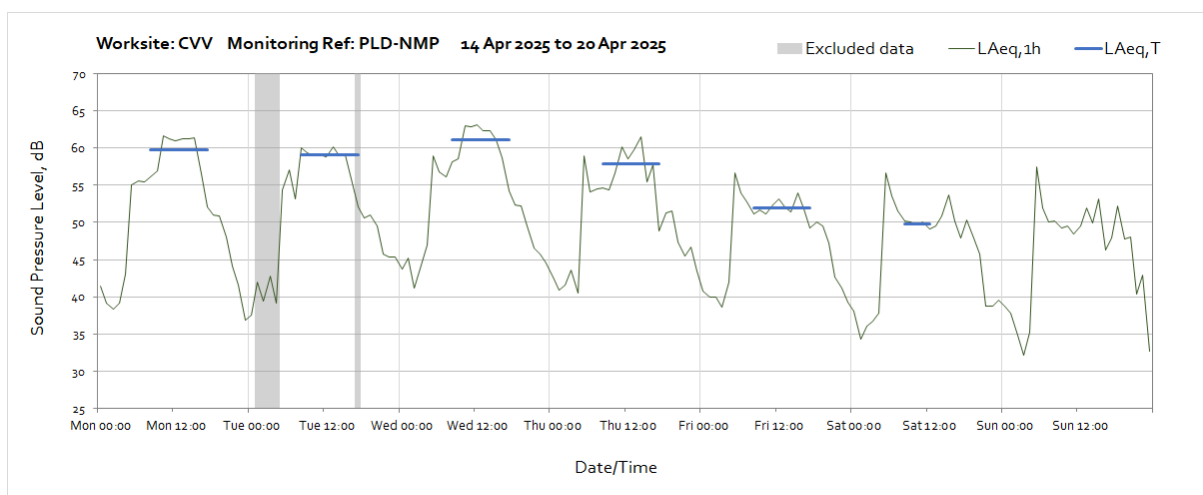
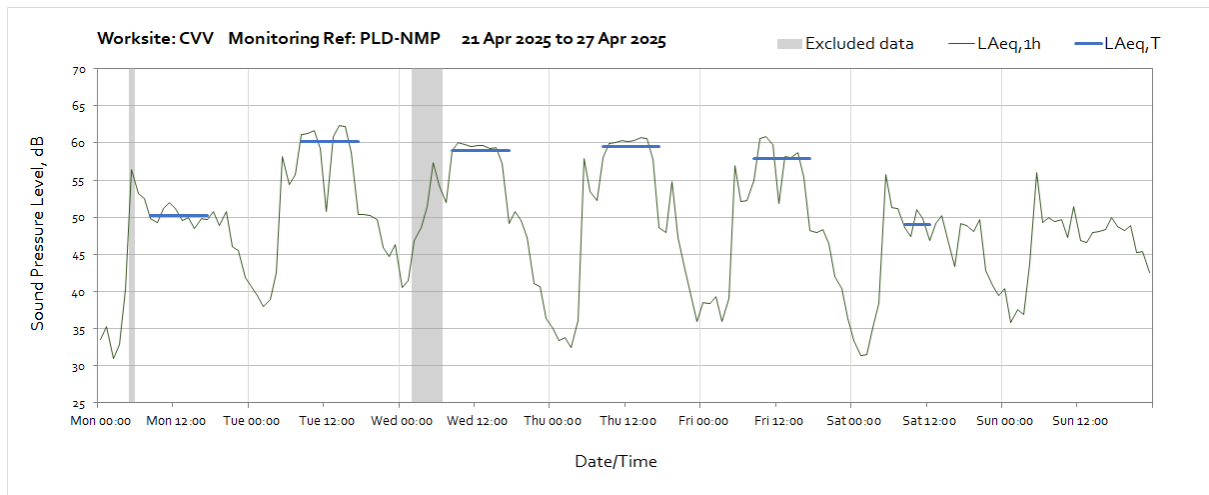
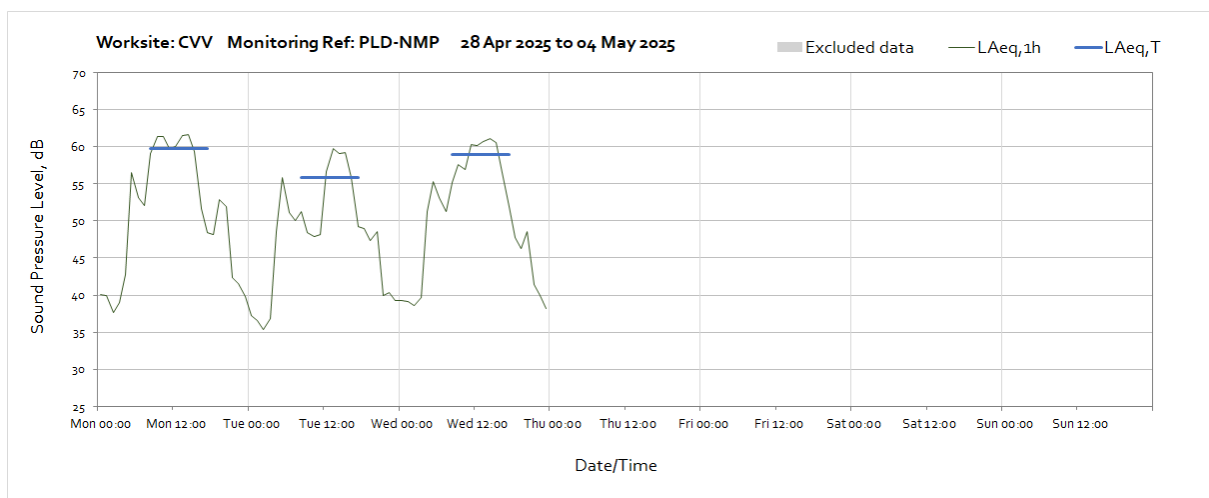
## Worksite: CVV – Monitoring Ref: PLD-NMP

Note: Missing data from 12:00 until 13:00 on Thursday 3<sup>rd</sup> April was due to field calibration of the monitoring station.

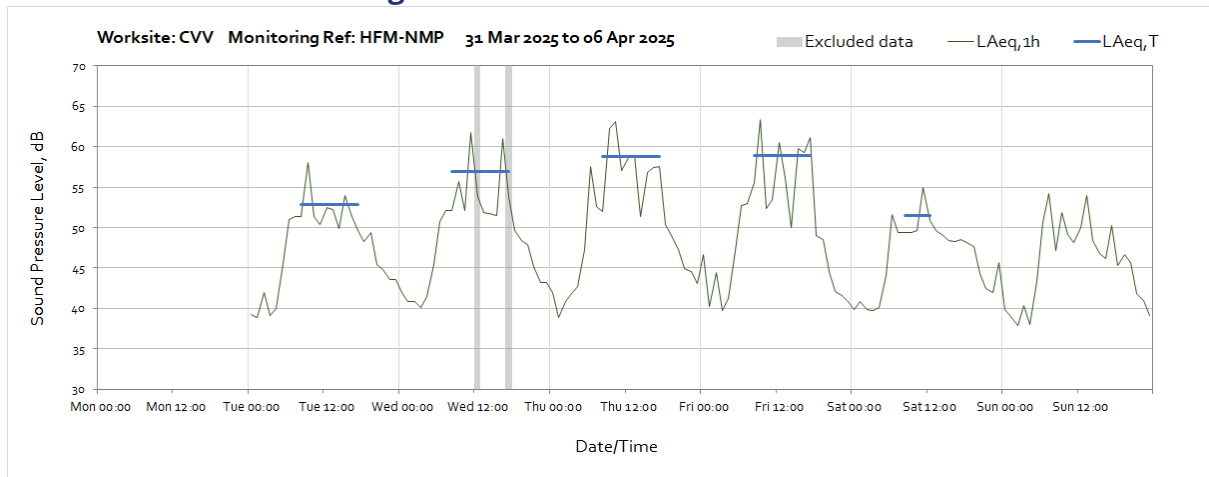
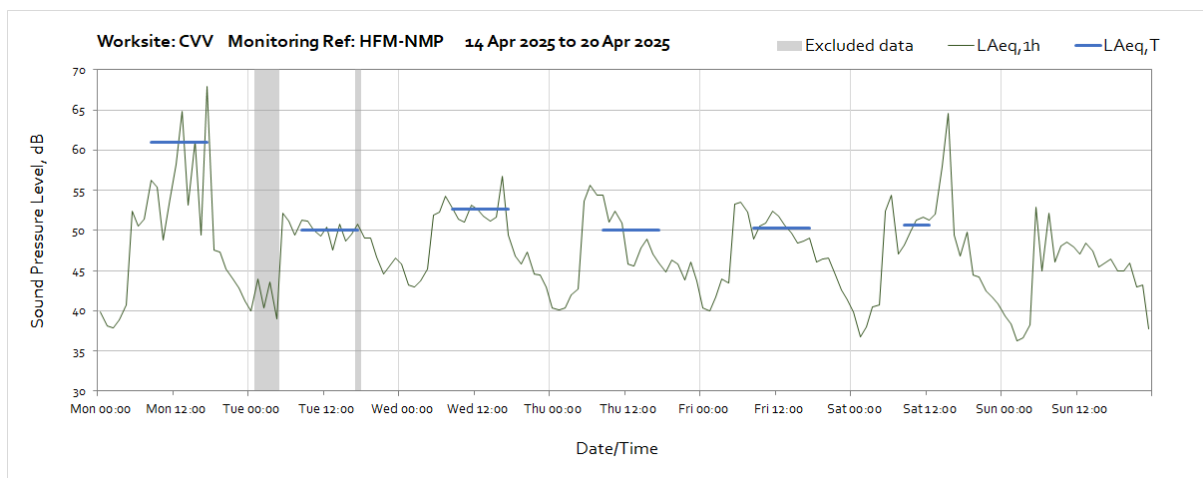
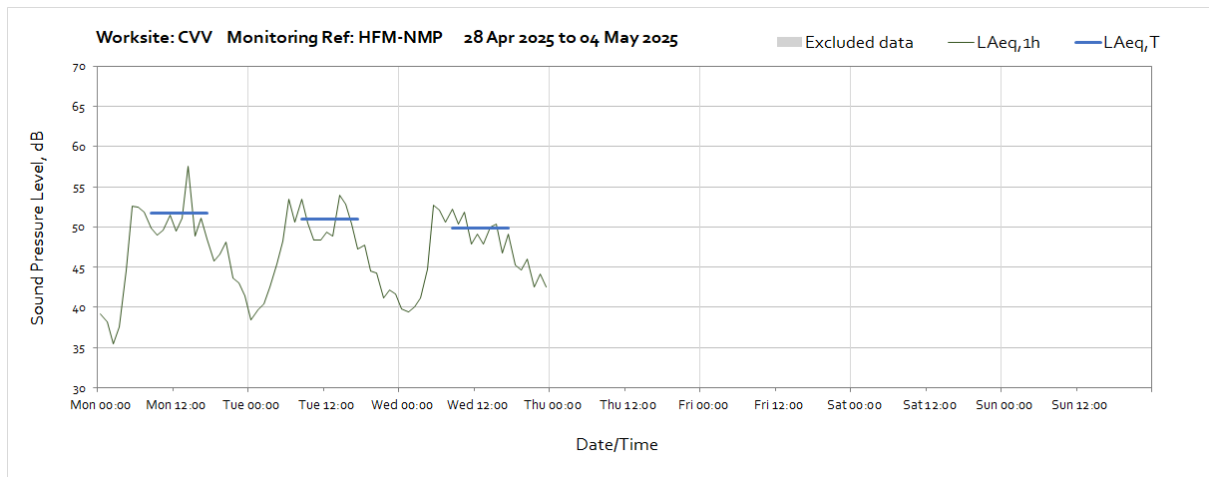
## Worksite: CVV – Monitoring Ref: HFM-NMP

Note: Missing data from 12:00 until 13:00 on Thursday 24<sup>th</sup> April was due to field calibration of the monitoring station.

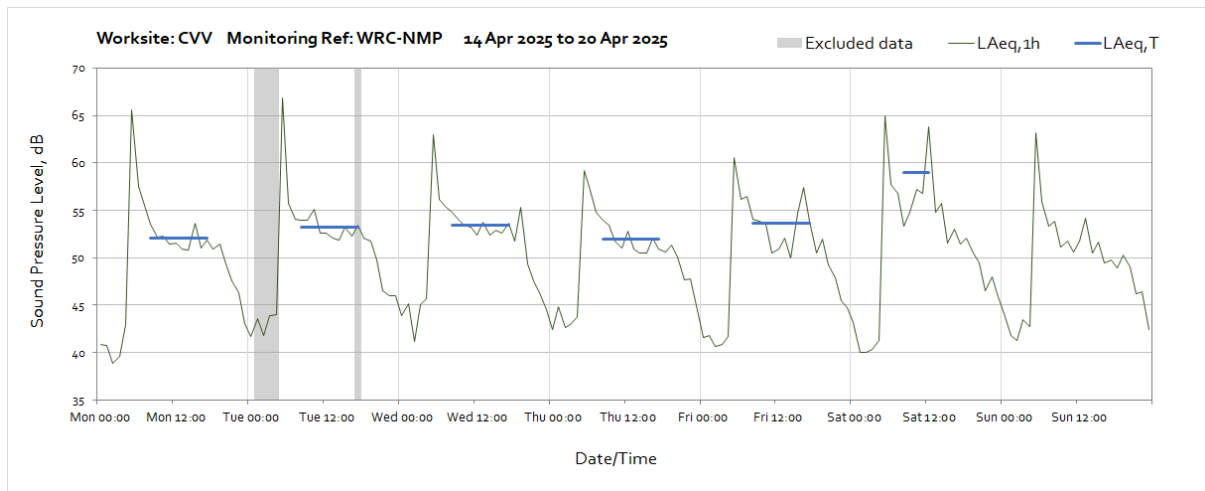
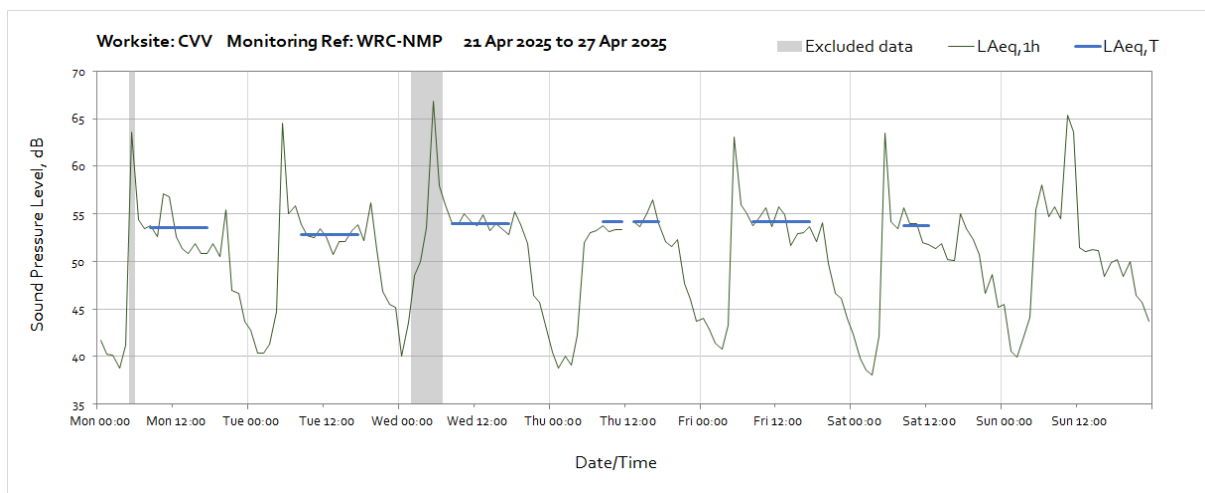
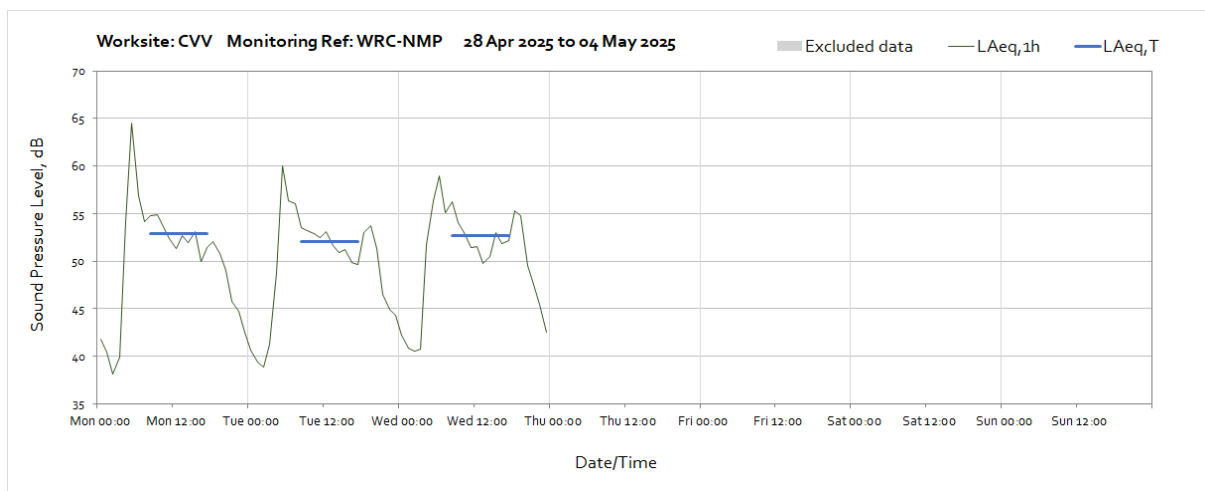
## Worksite: CVV – Monitoring Ref: WRC-NMP

WRC-NMP	Savay Lane, Denham, Uxbridge	Façade	55.0 (56.7)	53.3 (55.9)	52.6 (62.0)	50.4 (56.2)	52.5 (66.8)	53.7 (56.8)	54.6 (58.9)	53.2 (55.6)	51.6 (56.3)	53.1 (65.6)	54.2 (67.5)	52.5 (65.6)
WRP	WRP-N001	West Ruislip Golf Club, Ickenham Rd, Ruislip	Free-field	48.0 (52.7)	47.1 (52.9)	46.2 (52.5)	44.8 (48.1)	44.2 (51.6)	46.5 (48.9)	48.2 (50.5)	50.5 (58.6)	45.7 (49.7)	43.1 (50.2)	45.5 (49.4)	43.9 (53.4)
	N048	West Ruislip Golf Club, Ickenham Rd, Ruislip	Free-field	58.1 (64.5)	59.0 (61.2)	53.1 (56.2)	52.1 (55.4)	50.3 (58.8)	55.6 (57.5)	54.0 (55.6)	55.1 (60.6)	52.1 (54.5)	48.9 (53.0)	52.5 (56.0)	50.3 (58.5)
	N056	83 The Greenway, Ickenham, Ruislip	Façade	61.5 (62.8)	60.6 (62.4)	61.2 (64.1)	59.9 (62.8)	56.1 (63.4)	59.2 (60.2)	60.4 (60.8)	60.3 (62.1)	60.2 (61.7)	50.6 (59.4)	59.6 (61.9)	55.2 (61.0)
	N057	123 The Greenway, Ickenham, Ruislip	Façade	57.1 (58.2)	56.0 (58.8)	56.4 (57.9)	55.0 (57.4)	51.5 (57.3)	55.1 (56.3)	56.4 (56.5)	56.1 (59.2)	55.4 (57.2)	47.6 (54.3)	54.7 (58.1)	50.8 (56.5)

Note: Missing data from 12:00 until 13:00 on Thursday 24<sup>th</sup> April was due to field calibration of the monitoring station.
