Construction Noise and Vibration Monthly Report – April 2025

Lichfield District Council

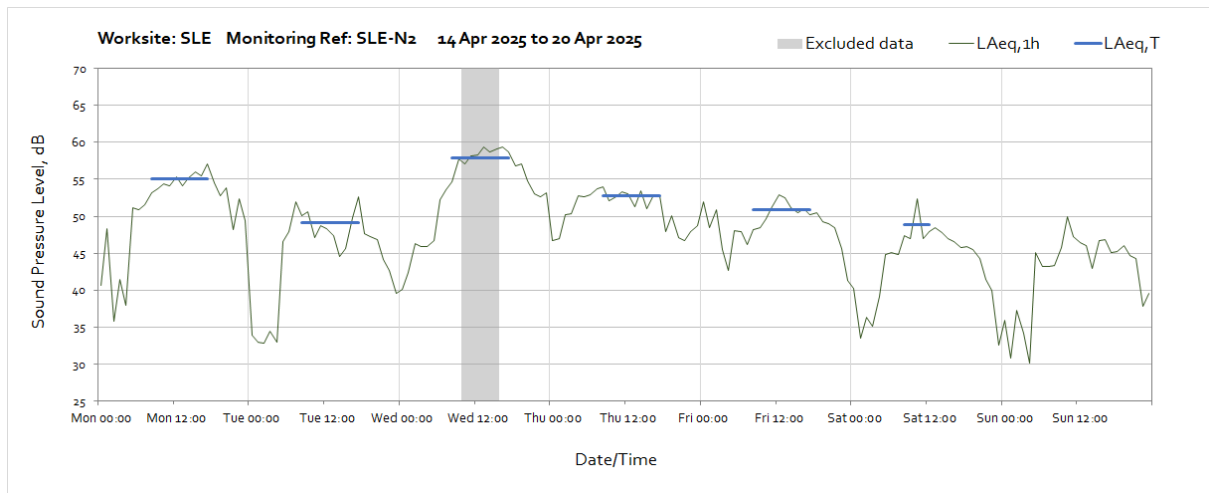
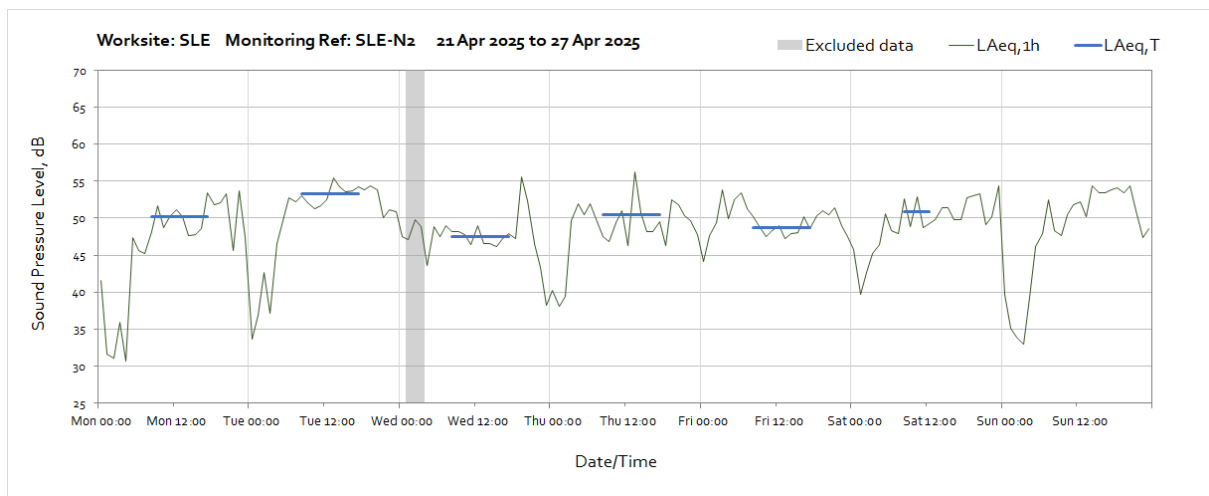
Worksite: SLE – Monitoring Ref: SLE-N2

The following graphs show the hourly measured ambient noise level $L_{Aeq,1h}$ and, where relevant, the averaged noise level $L_{Aeq,T}$ values, where the time period T is as specified in Table 1 of HS2 Information Paper E23. Periods where noise levels are adversely affected by weather or only measured for part of the period, which are not representative of HS2 construction works, have been greyed out and excluded from the calculation of the $L_{Aeq,T}$ values in Table 3 of the main report.
