## **Construction Noise and Vibration Monthly Report – April 2025**

**North Warwickshire Borough Council**

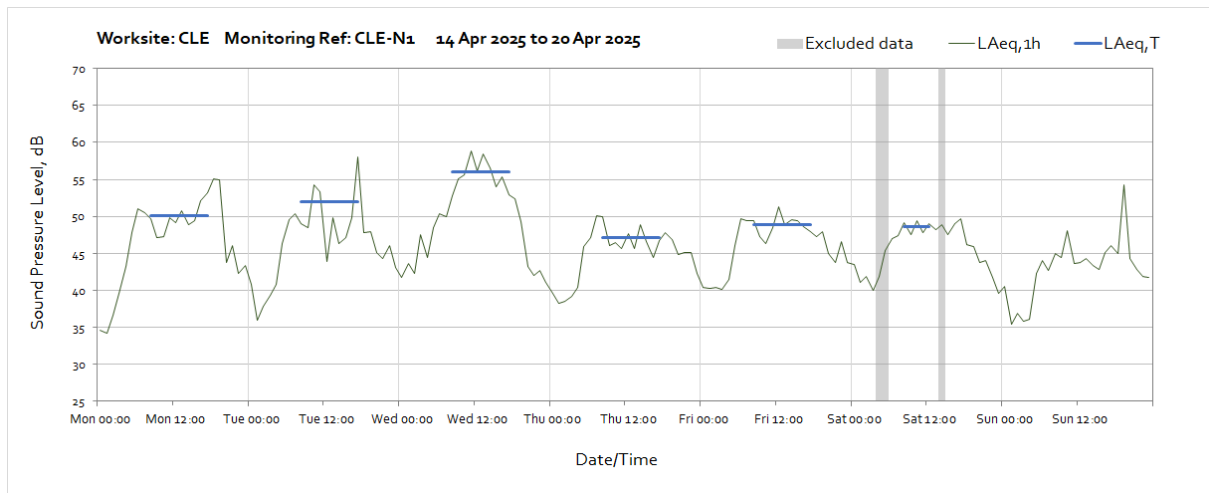
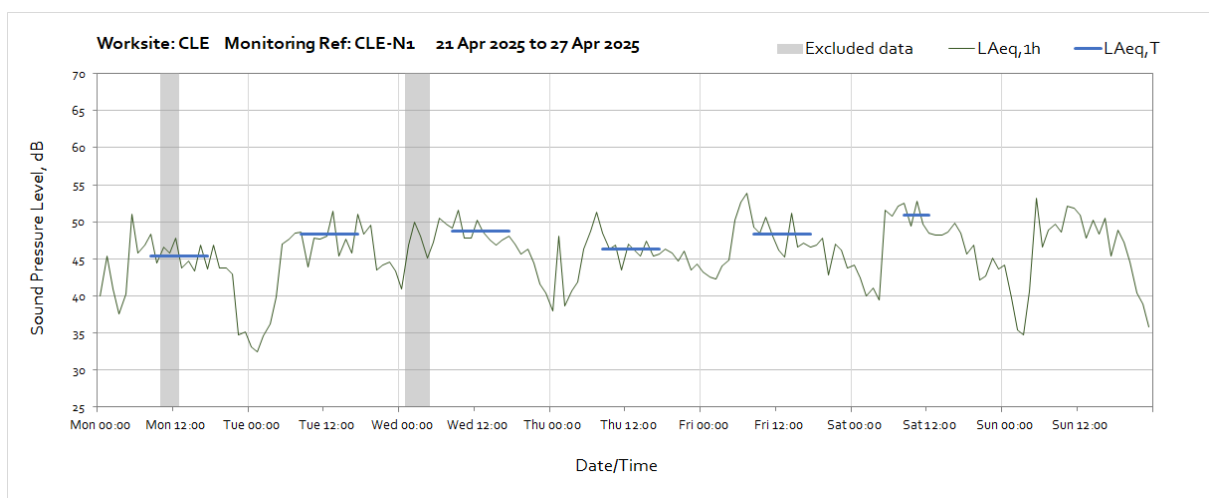
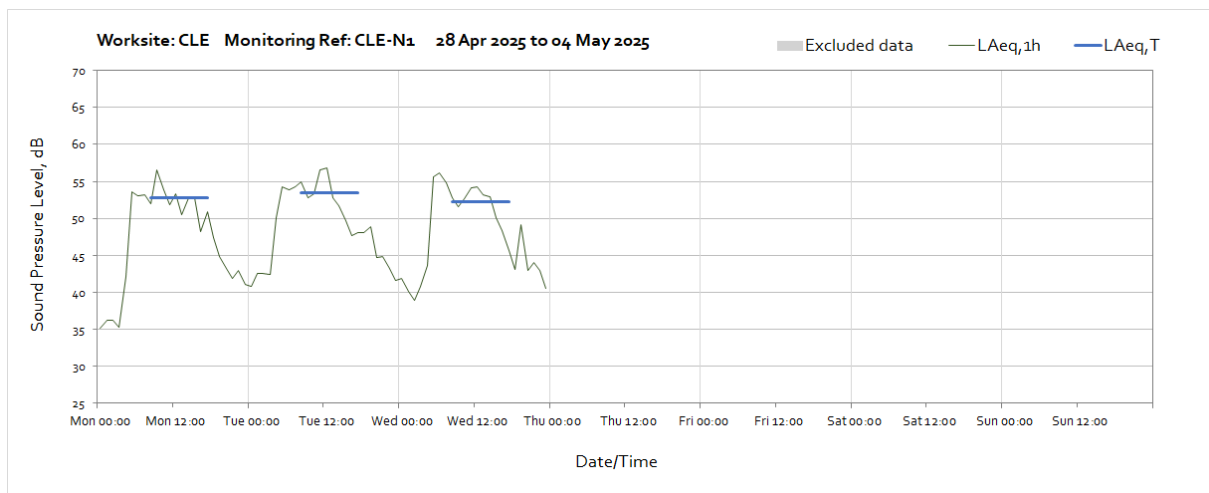
### Worksite: CLE – Monitoring Ref: CLE-N1

The following graphs show the hourly measured ambient noise level  $L_{Aeq,1h}$  and, where relevant, the averaged noise level  $L_{Aeq,T}$  values, where the time period T is as specified in Table 1 of HS2 Information Paper E23. Periods with adversely weather affected noise levels are greyed out and have been excluded from the calculation of the  $L_{Aeq,T}$  values in Table 3 of the main report.:

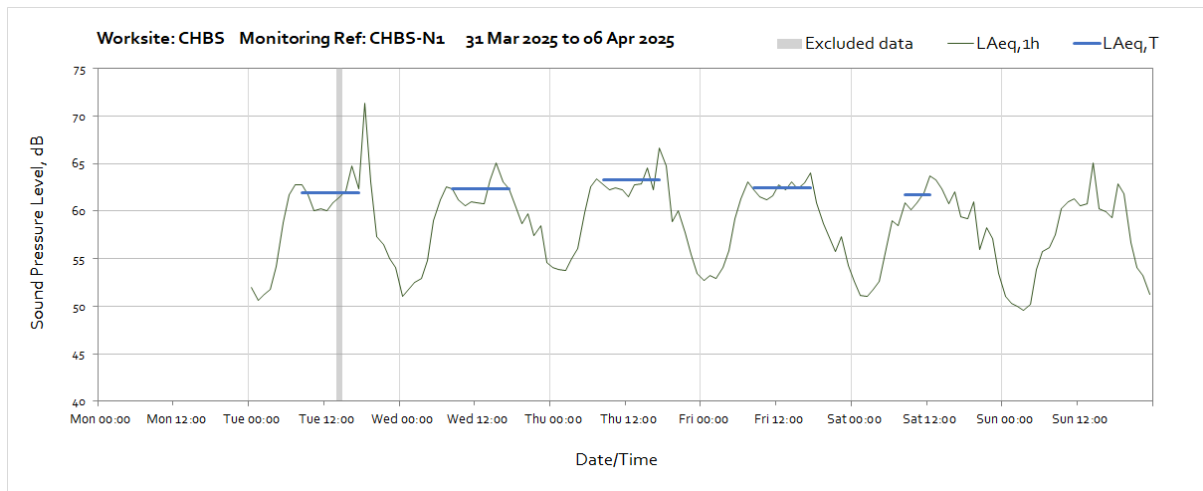
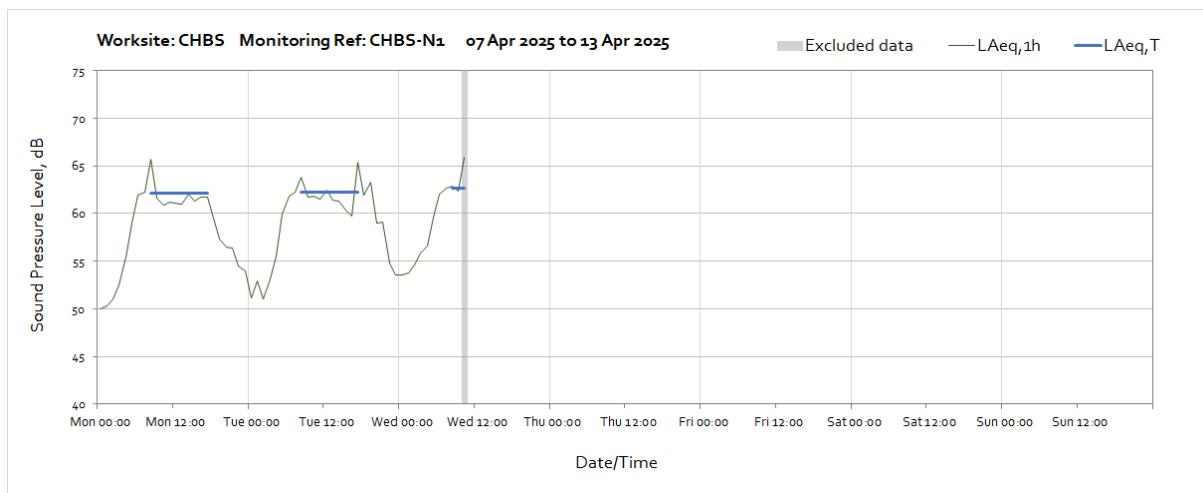
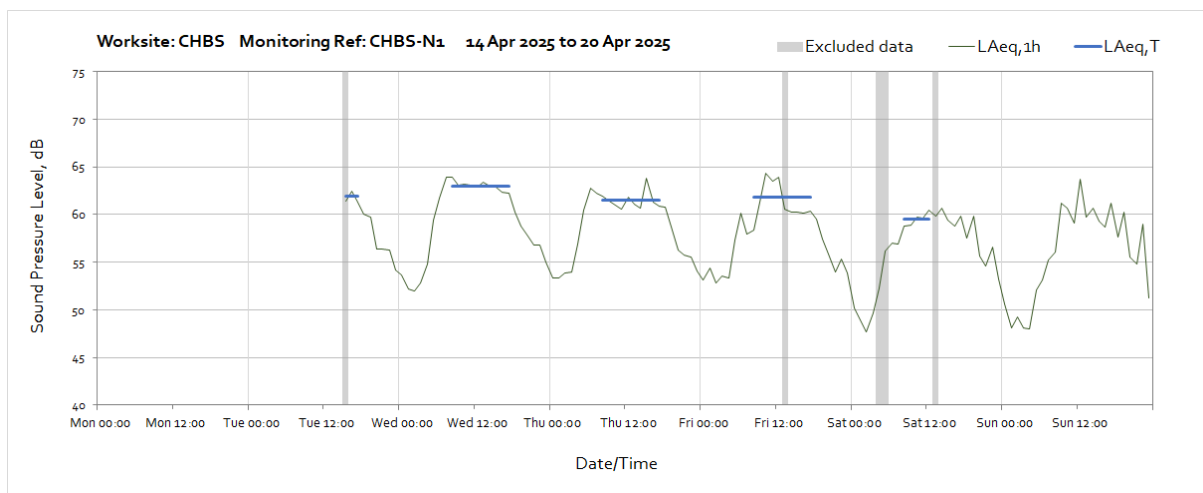
## Worksite: CHBS – Monitoring Ref: CHBS-N1

Note: Missing data between 11:00 on Wednesday 9<sup>th</sup> April until 15:00 on Tuesday 15<sup>th</sup> April was due to damage of the monitoring station caused by a cut cable. The cable was repaired on Tuesday 15<sup>th</sup> April.

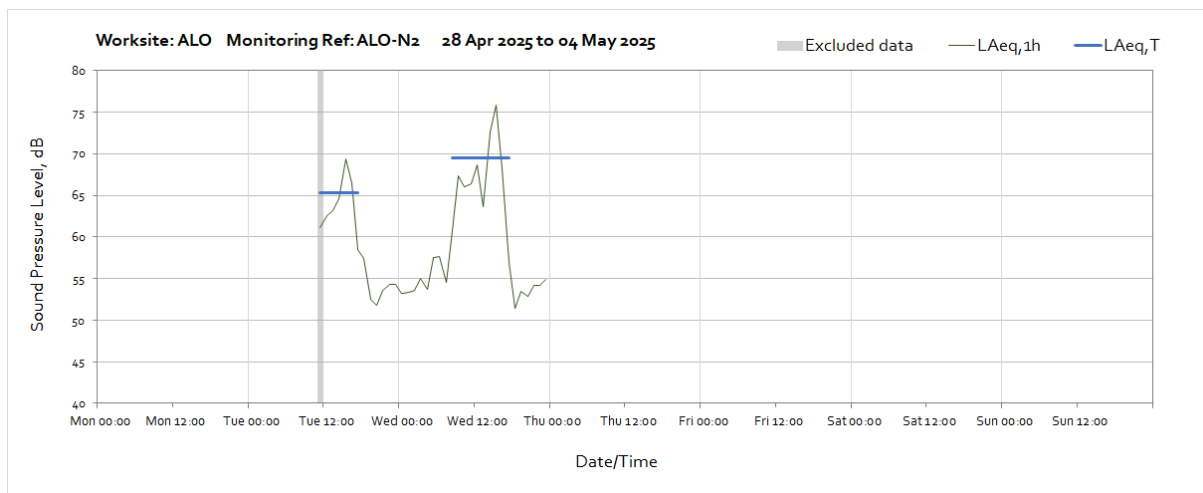
## Worksite: ALO – Monitoring Ref: ALO-N2

Note: Missing data from the start of the month until 11:00 on 29<sup>th</sup> April was due to a monitoring station system error.

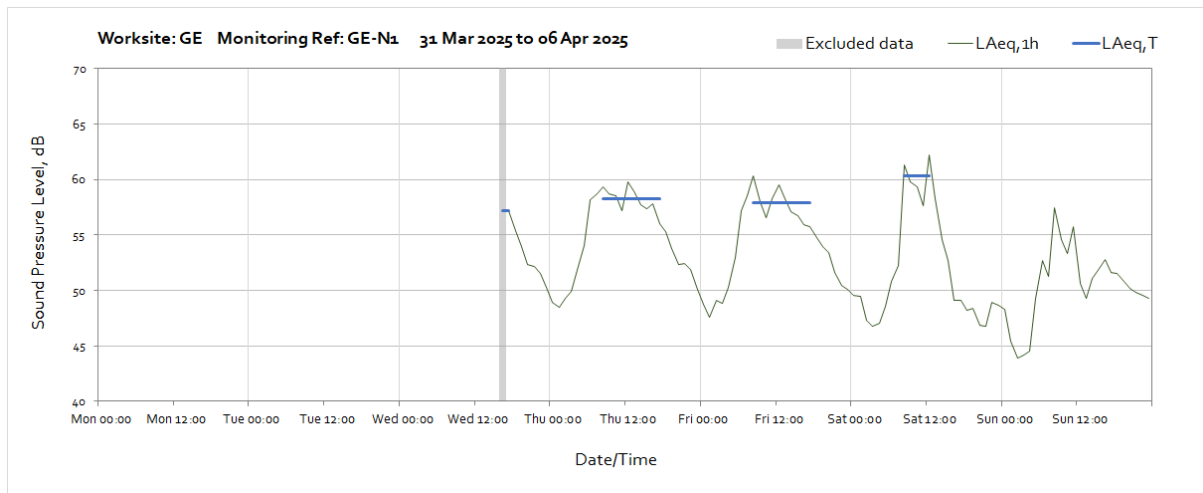
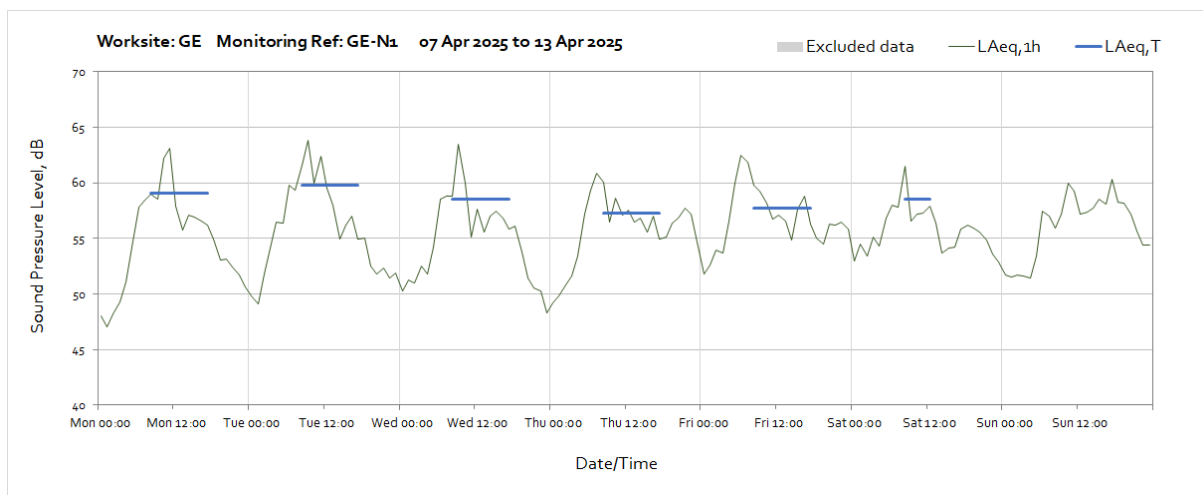
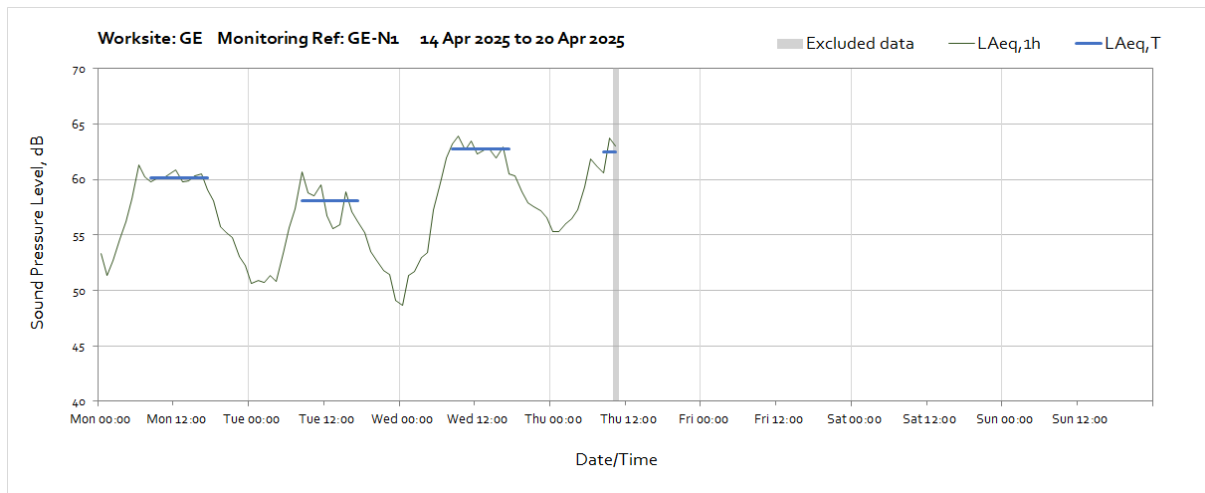
## Worksite: GE – Monitoring Ref: GE-N1

Note: Missing data from the start of the month until 16:00 on Wednesday 2<sup>nd</sup> April was due to loss of power to the monitoring station.

Note: Monitoring station was removed from site at 11:00 on Thursday 17<sup>th</sup> April as works within the vicinity have finished.

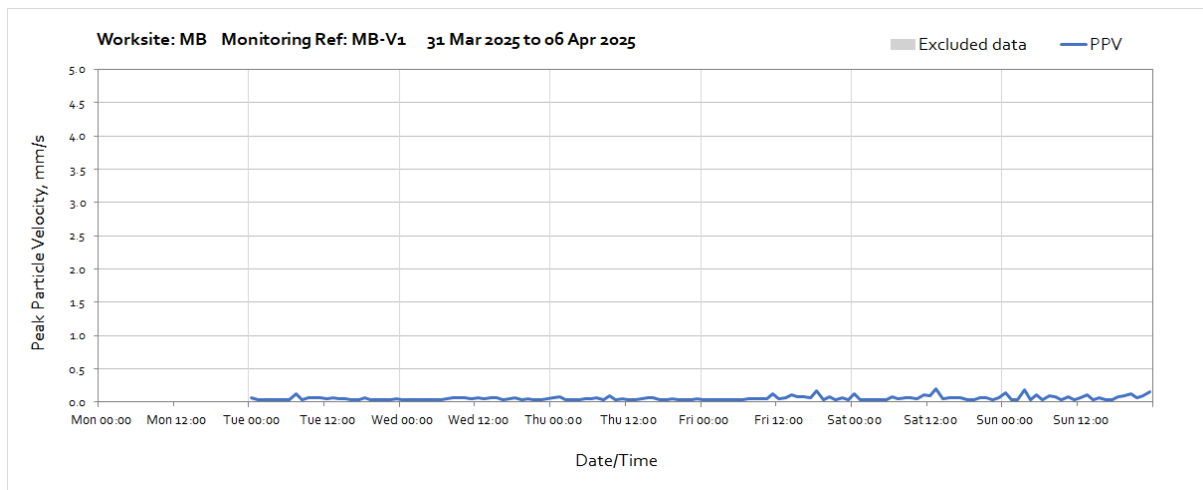
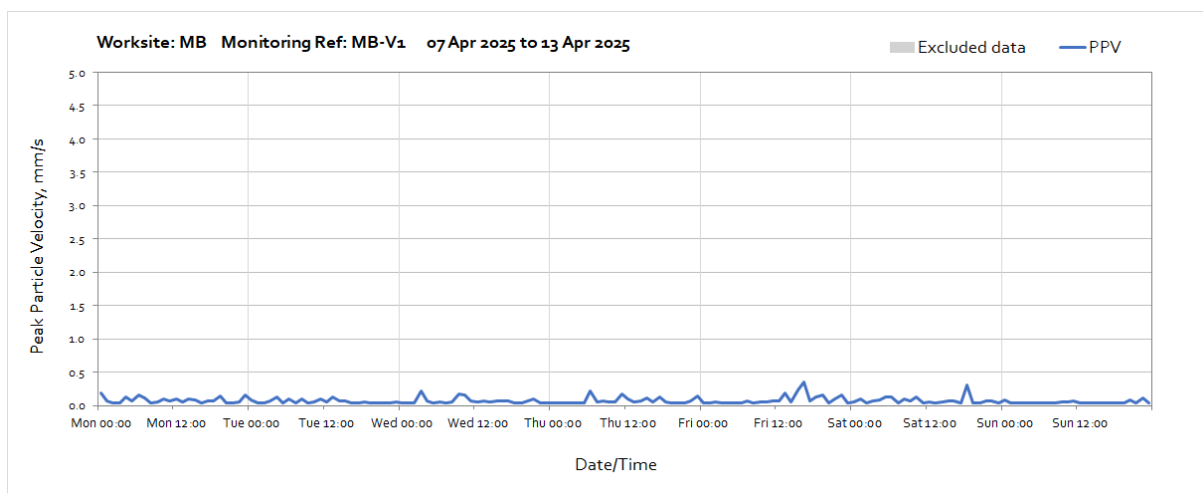
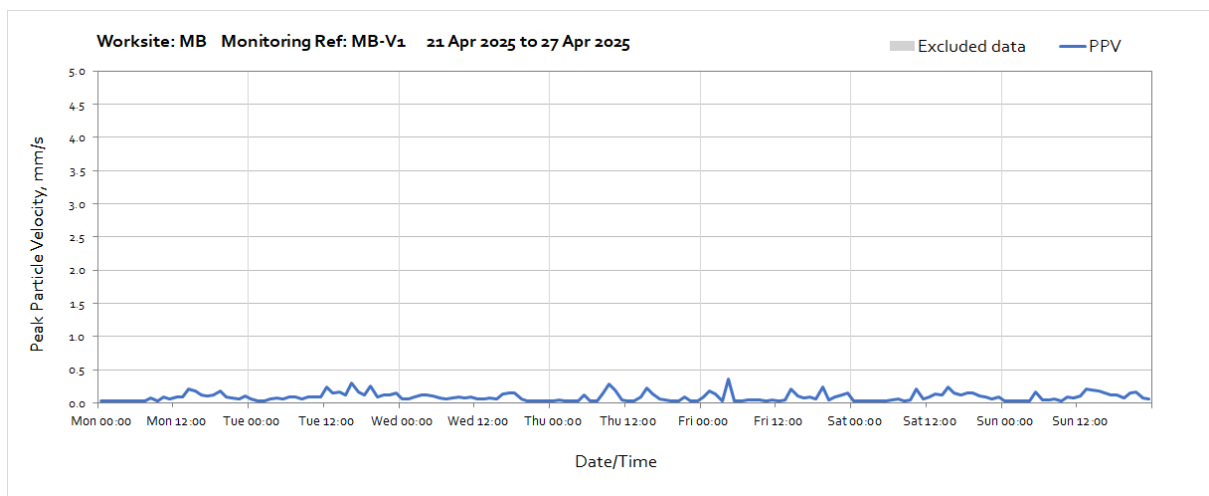
### Worksite: MB – Monitoring Ref: MB-V1

The following graphs show the hourly measured peak particle velocity PPV recorded during the monitoring period. The graphs show the highest PPV of the three orthogonal axes x, y and z. Where high values of PPV were caused by local interference with the vibration monitor, which are not representative of HS2 construction works, these values have been greyed out in the following charts and have been excluded to calculate values in Table 4 of the main report.

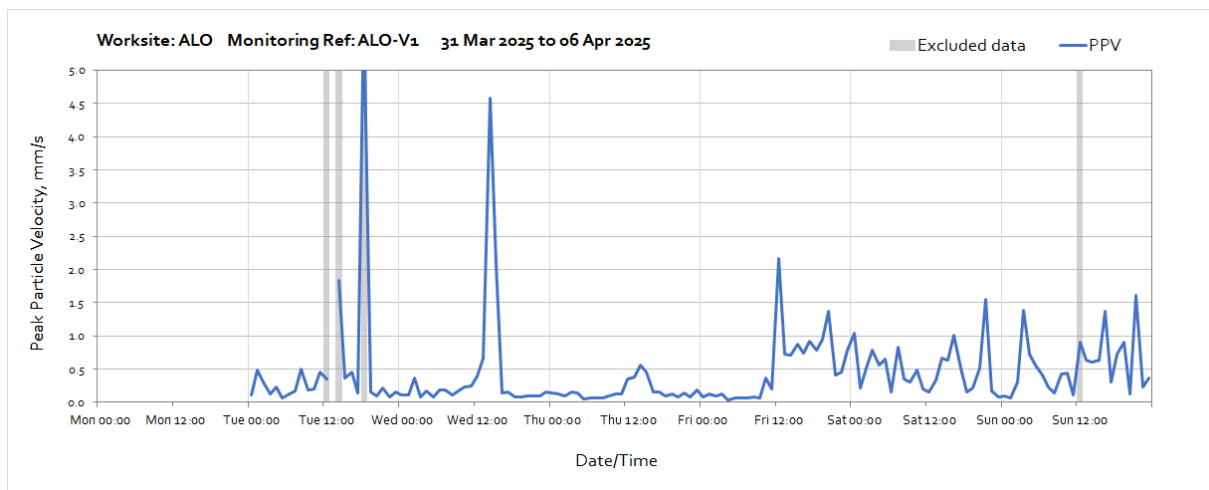
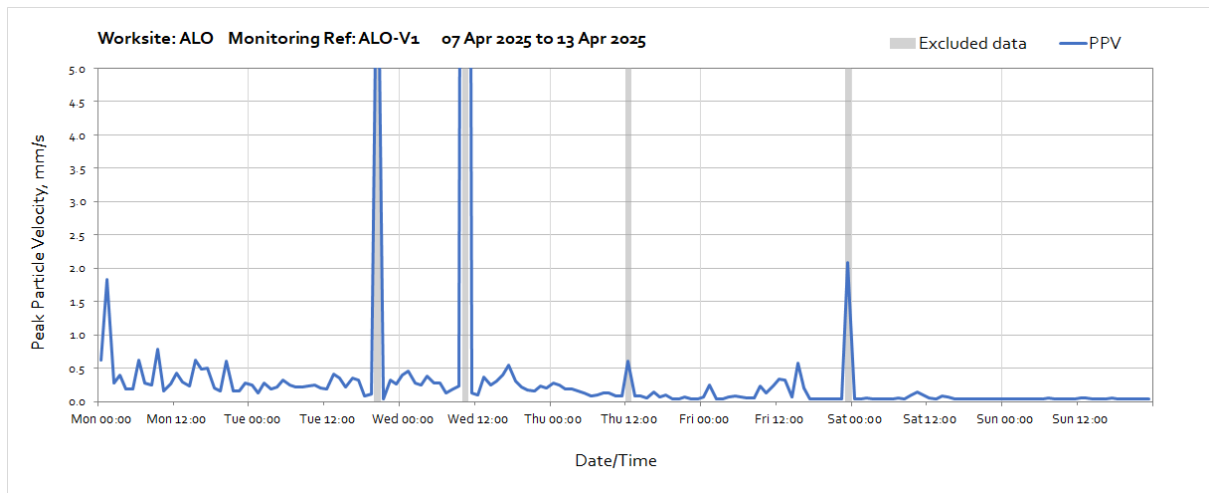
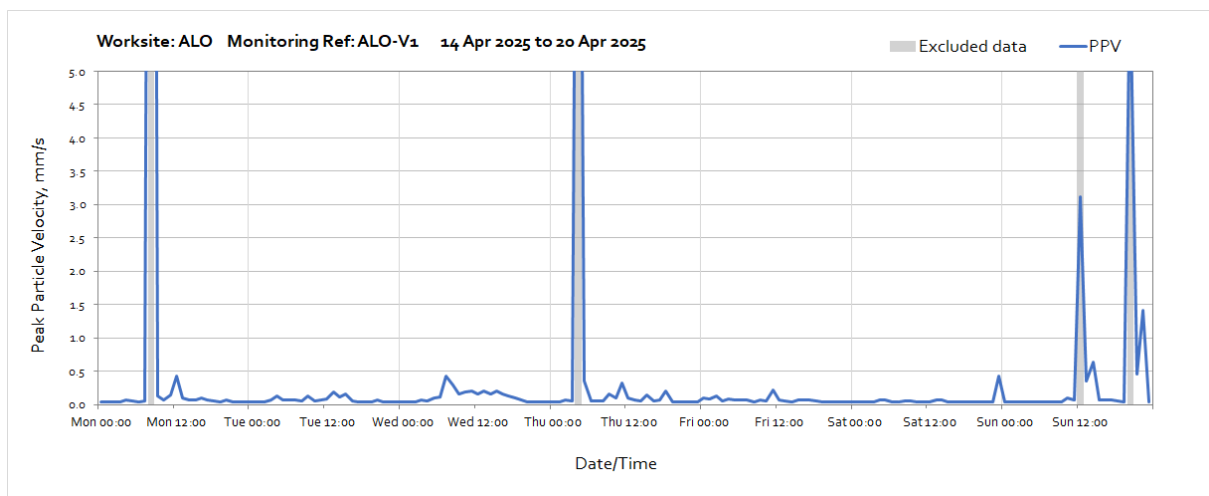
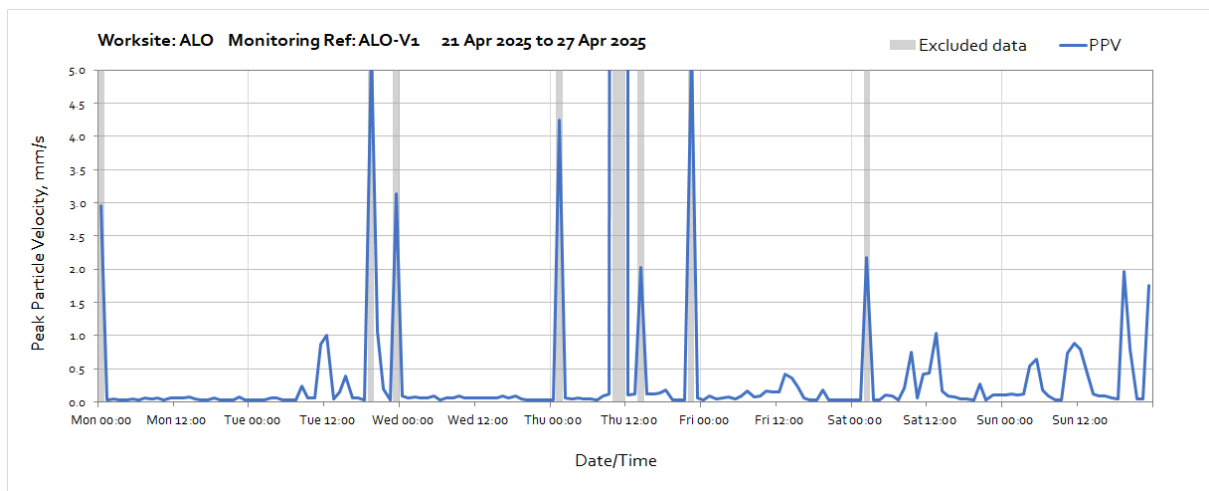
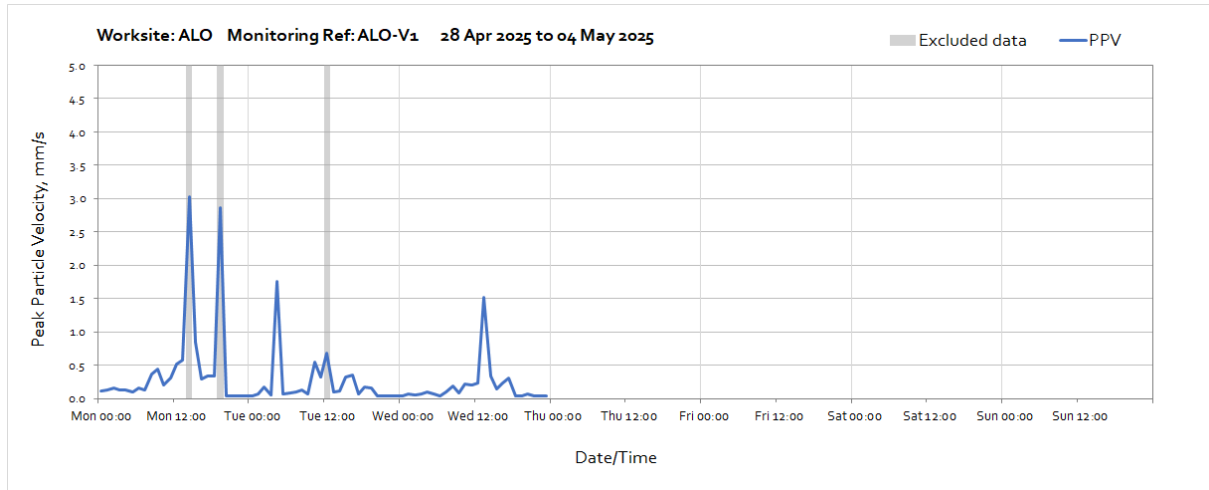
## Worksite: ALO – Monitoring Ref: ALO-V1

Note: Missing data from 13:00 until 14:00 on Tuesday 1<sup>st</sup> April was due to a monitoring station system error. The monitor was swapped out on 10<sup>th</sup> April for investigation.

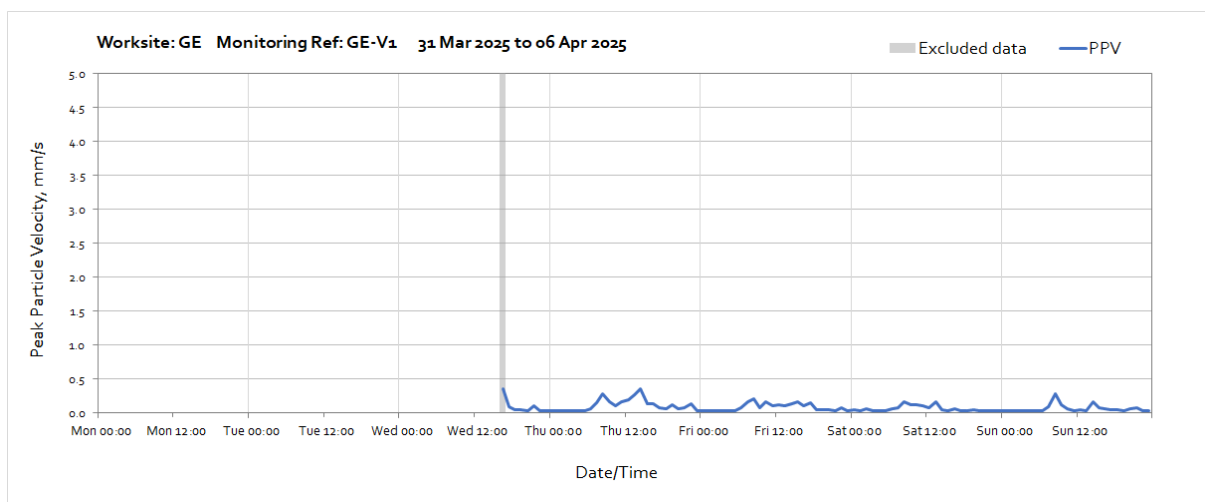
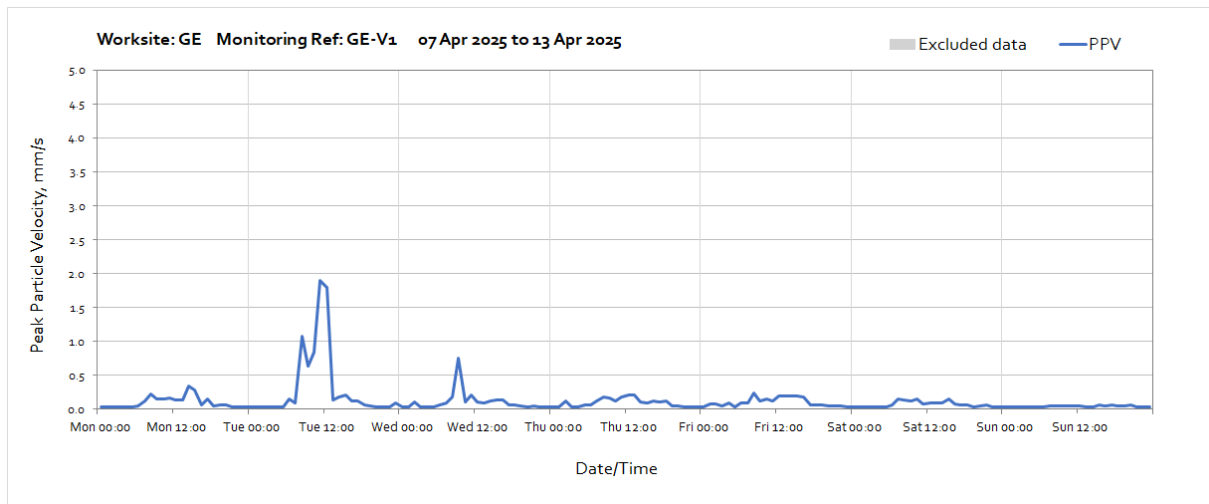
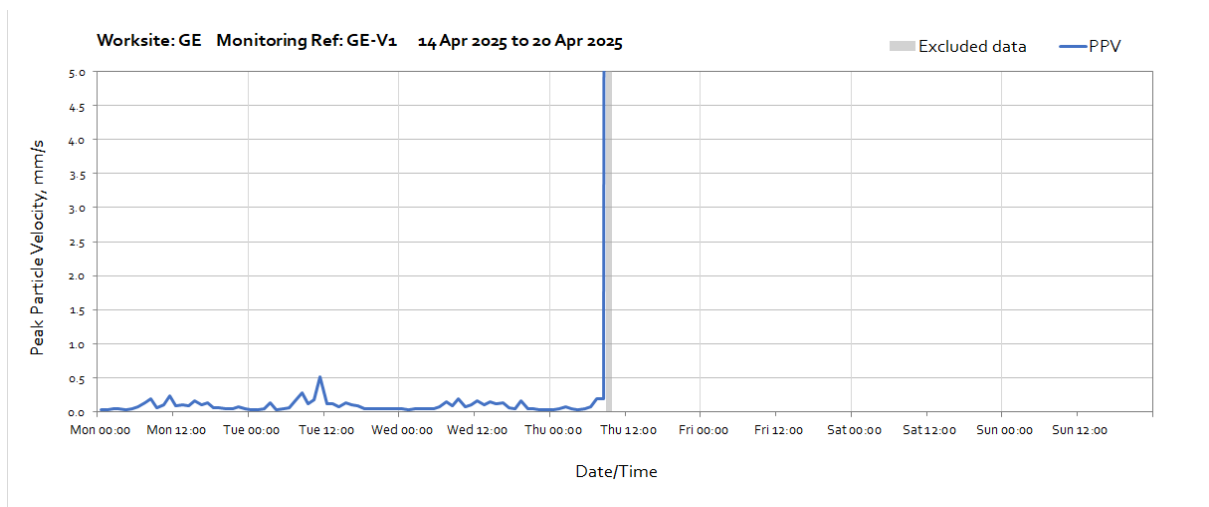
## Worksite: GE – Monitoring Ref: GE-V1

Note: Missing data from the start of the month until 16:00 on Wednesday 2<sup>nd</sup> April was due to loss of power to the monitoring station.

Note: Monitoring station was removed from site at 10:00 on Thursday 17<sup>th</sup> April as works within the vicinity have finished.
