Air Quality and Dust Monitoring Monthly Report – April 2025

London Borough of Camden

A report prepared by EWCs and MWCCs on behalf of HS2 Ltd.

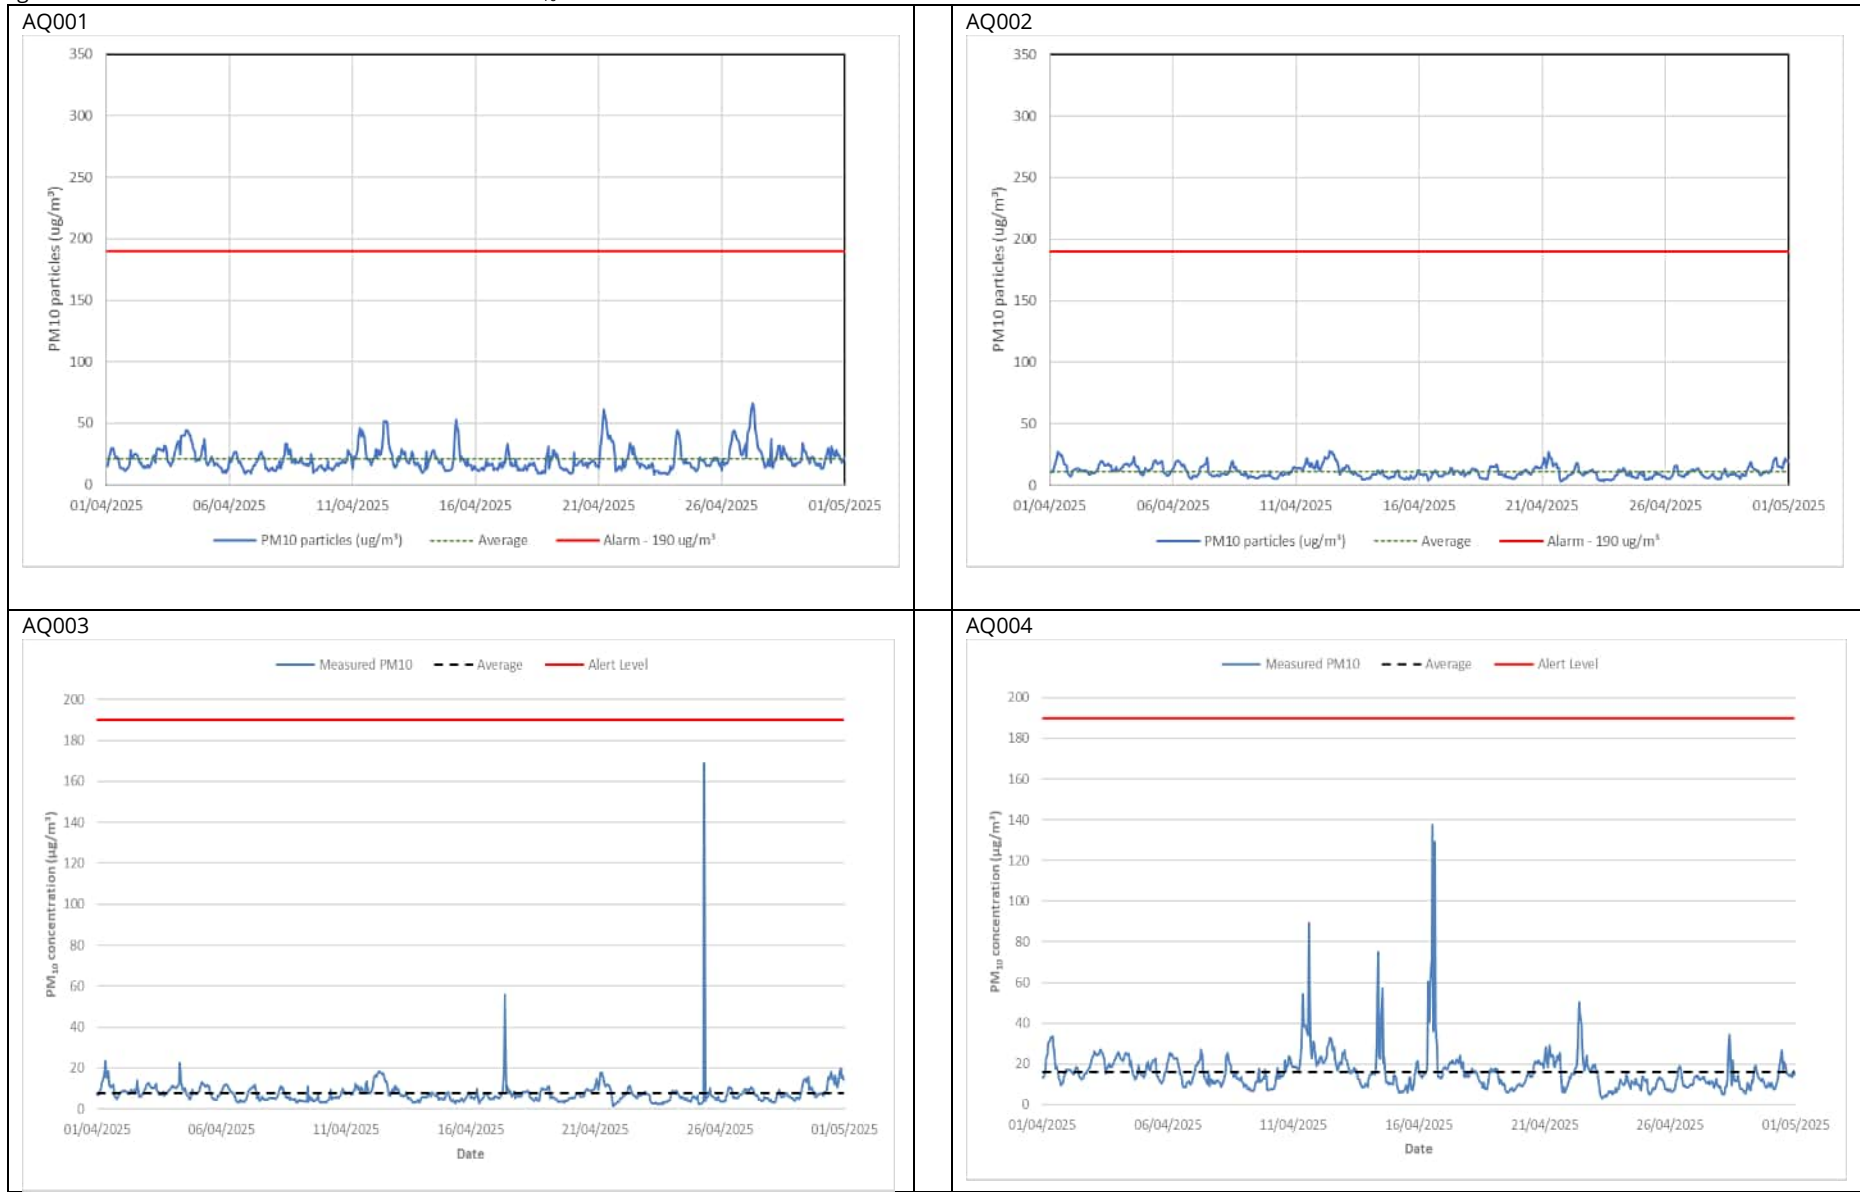
Figure 6: Construction dust 1-hour mean indicative PM₁₀ concentration for all dust monitors

1.1.6 Dust monitoring locations and results are presented in Appendix B, Table 1, together with line charts of monthly data from each dust monitor in Figure 6. All continuous dust monitoring is undertaken using indicative monitors. Despite being Environment Agency

- 1.1.7 The trigger level for PM₁₀ concentrations of 190 µg/m³, over a 1-hour period, in accordance with the updated guidance document '*Guidance on Monitoring in the Vicinity of Demolition and Construction Sites – (October 2018)*' has been applied.

Monitoring site ID	Period exceeding trigger level	Investigation	Outcomes / Resolution / Remedial measures implemented
AQ021	09/04/2025 12:01 – 13:00; 300.1 µg/m ³	At the time of the exceedance there were no dusty works taking place in the vicinity of the monitor. Operatives were installing water pipework nearby but nothing that would generate excessive dust nor cause such a high reading, and no dust was observed. Area was damped down as a matter of course. It is considered that the trigger was false, especially given the high reading, probably due to a tiny piece of debris dislodged in the monitor's inlet tube.	Monitor was subsequently serviced on 22nd April.
