Construction Noise and Vibration Monthly Report – May 2025

Buckinghamshire

Non-Technical Summary

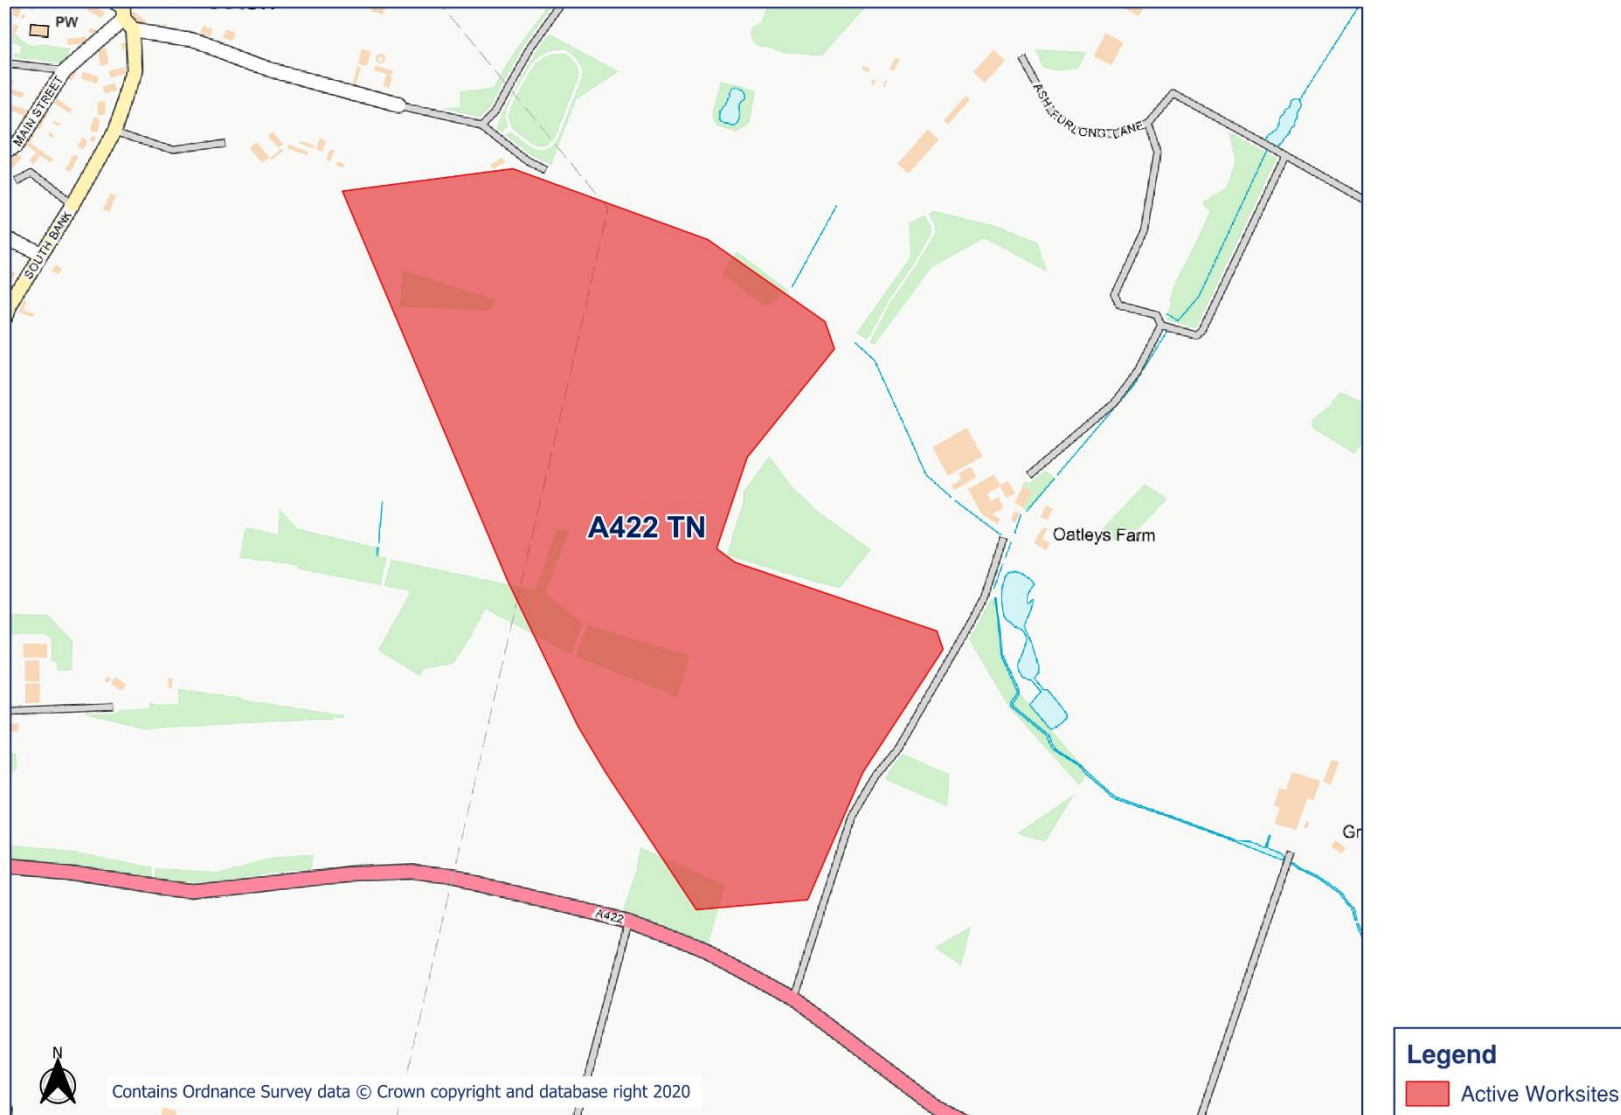
Worksite Identification Plan - 2

- School End worksite, ref.: SE (see Plan 2 in Appendix A) and Hermitage Chetwode Worksite ref.: HC (see plan 2 in Appendix A), where works activities included:

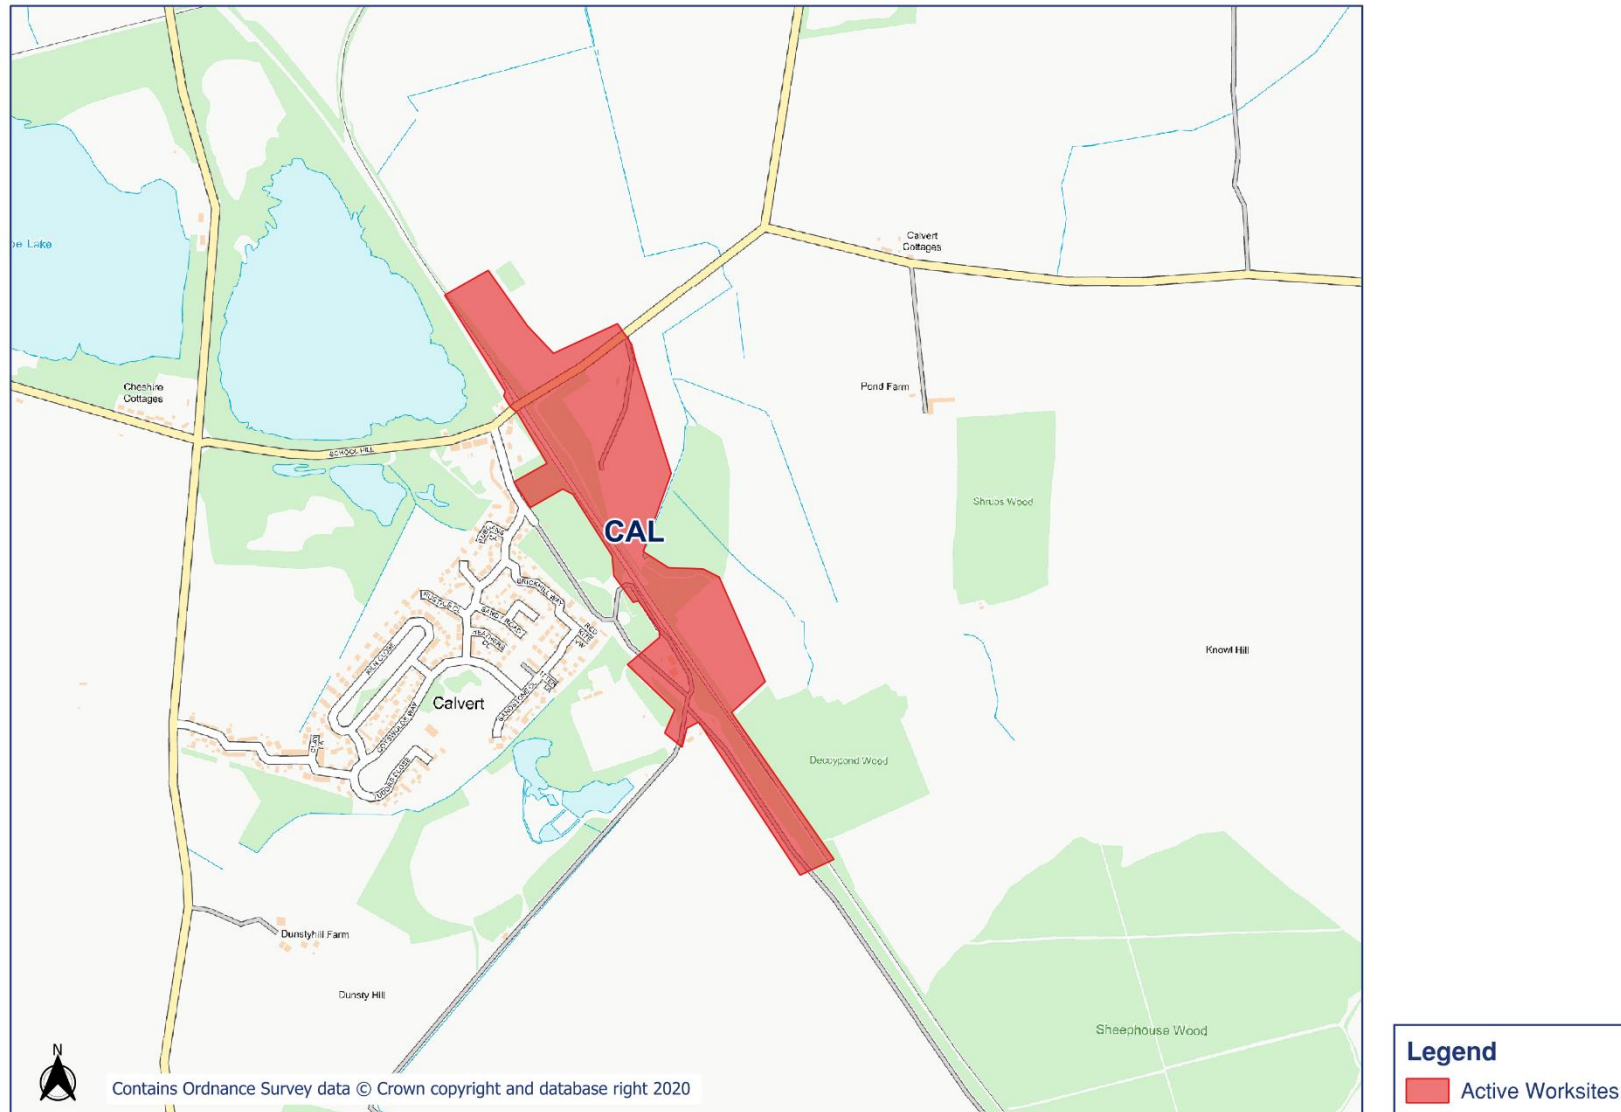
Worksite Identification Plan - 4

- Material movements.
 - Drainage works.
- Woodlands worksite, ref.: WDL (see Plan 4 in Appendix A) where works activities included:
 - Concrete repairs.

- Waterproofing.
- Technical backfill.
- Material movements.
- Concrete pours.
- Formwork reinforced concrete works.
- Quainton worksite, ref.: QAR (see Plan 4 in Appendix A) where works activities included:

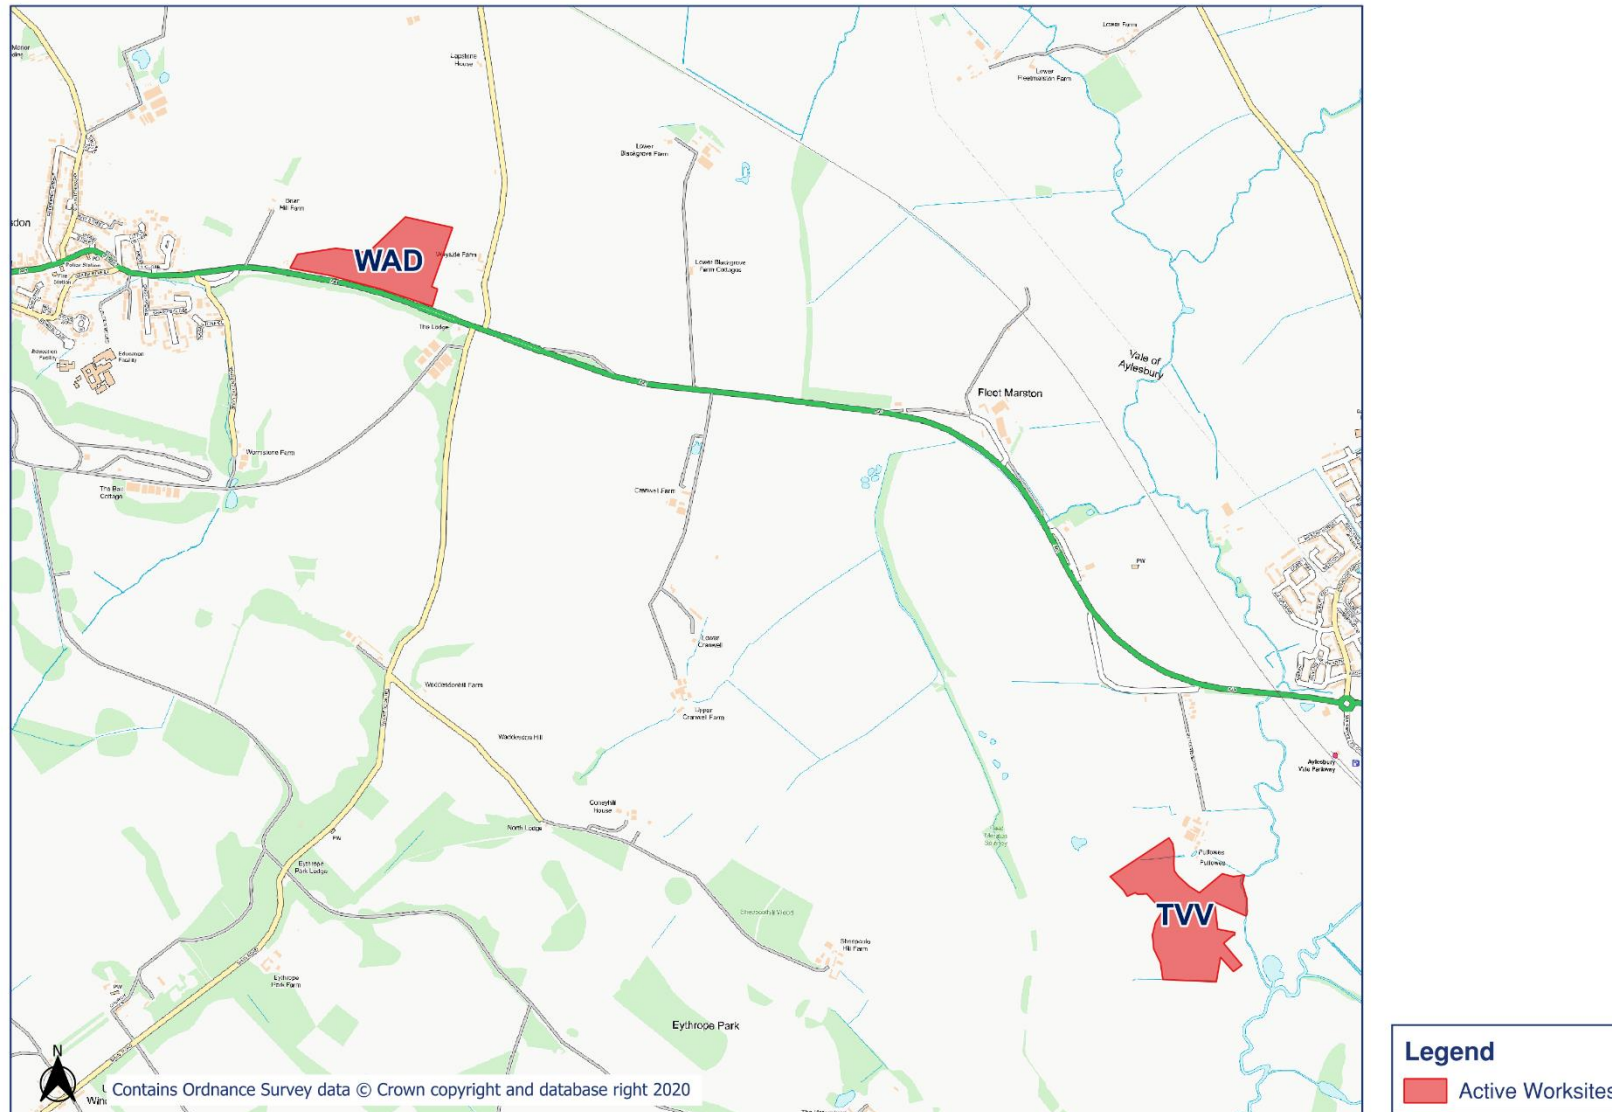
Worksite Identification Plan - 6

- Earthworks.
 - Embankment filling.
 - Utility works.
- Oat Close worksite, ref.: OC (see Plan 6 in Appendix A), where works activities included:
 - Overbridge works including reinforced concrete works.

- Construction of site access road.
- Risborough Road worksite, ref.: RR (see Plan 6 in Appendix A), where works activities included:
 - Overbridge works including formwork reinforced concrete works.

- Earthworks.
 - Drainage.
 - Boring.
 - Utility works.
- Aylesbury Gold Course worksite, ref.: GC (see Plan 6 in Appendix A), where works activities included:

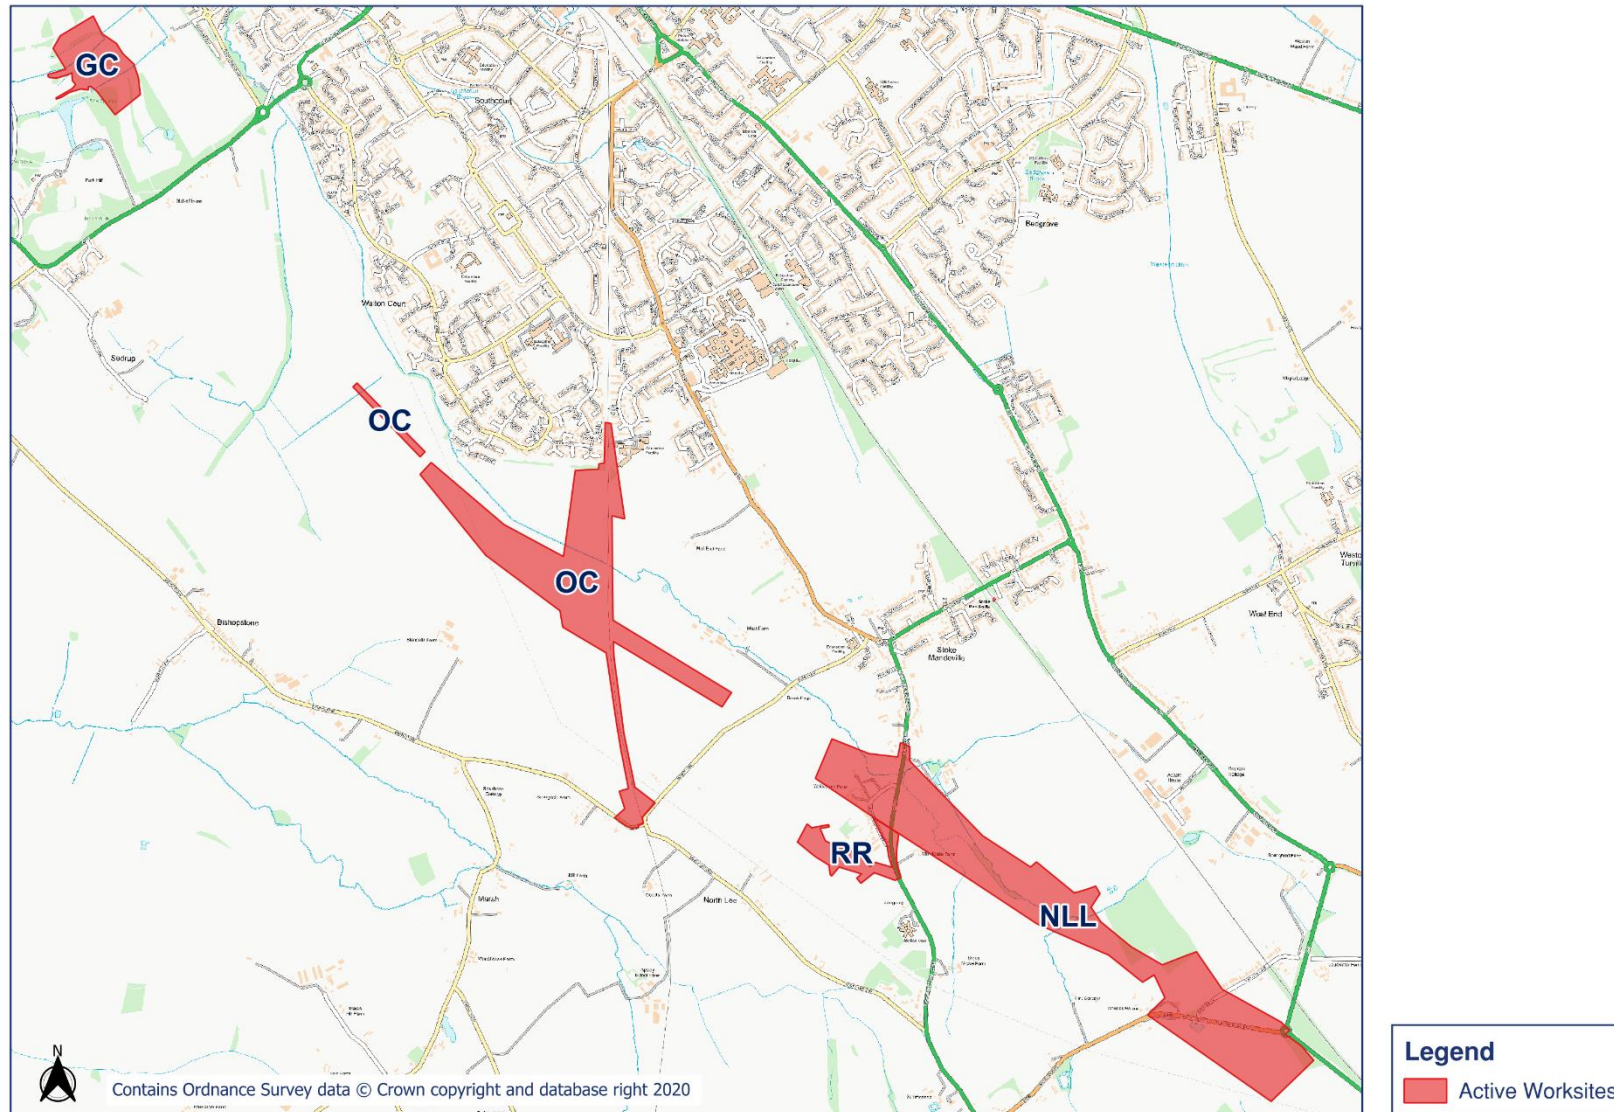
Worksite Identification Plan - 7

- Overbridge works.
 - Concrete pours.
 - Wingwall construction including fixing and reinforcement.
 - Preparation for beam installation.
 - Backfilling.
- Wendover Green Tunnel worksite, ref.: WGT (see Plan 7 in Appendix A), where works activities included:

- Grove Farm worksite, ref.: GF (see Plan 7 in Appendix A), where works activities included:
 - Underbridge works including pile cropping, excavation, striking of shutters, reinforced bar cutting and wall and scaffolding dismantling.

- Small Dean Viaduct Compound worksite, ref.: SDVC (see Plan 7 in Appendix A), where works activities included:
 - Viaduct deck works including slab installation.

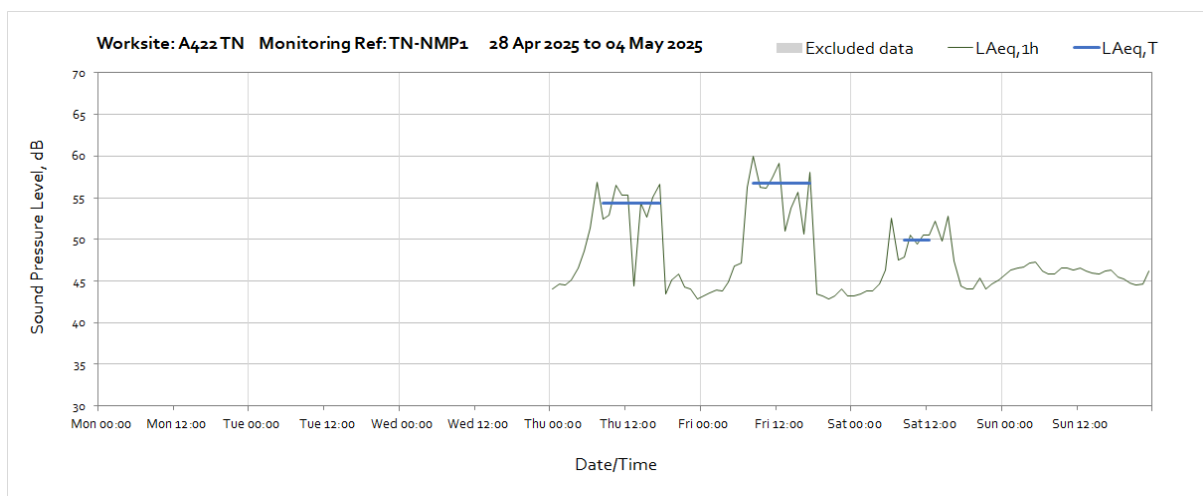
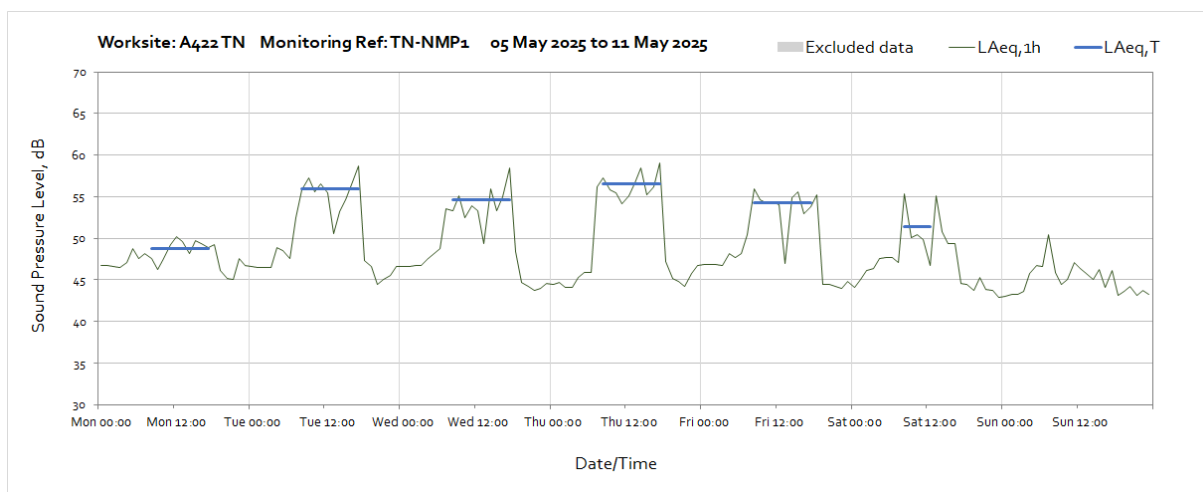
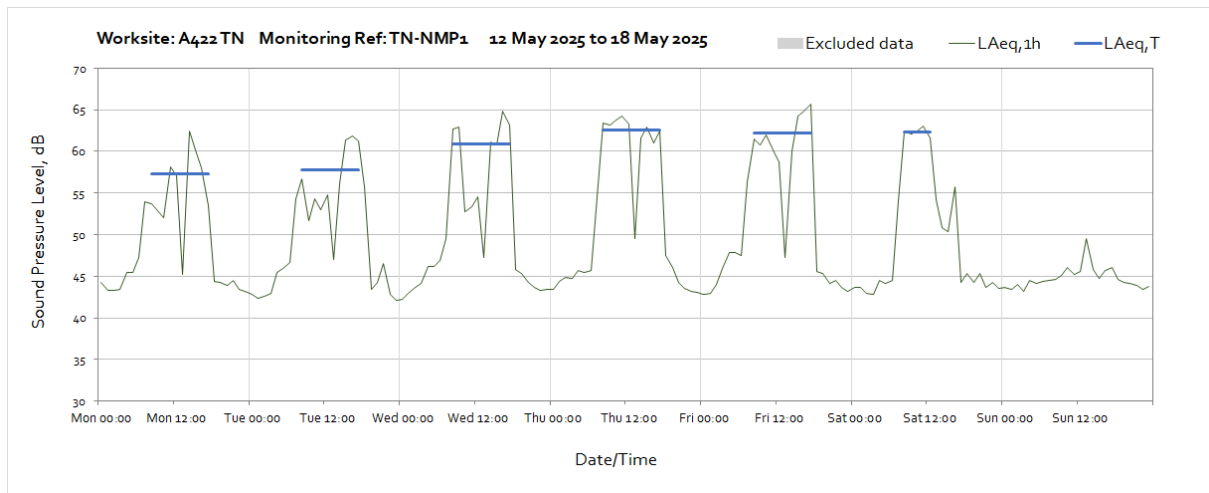
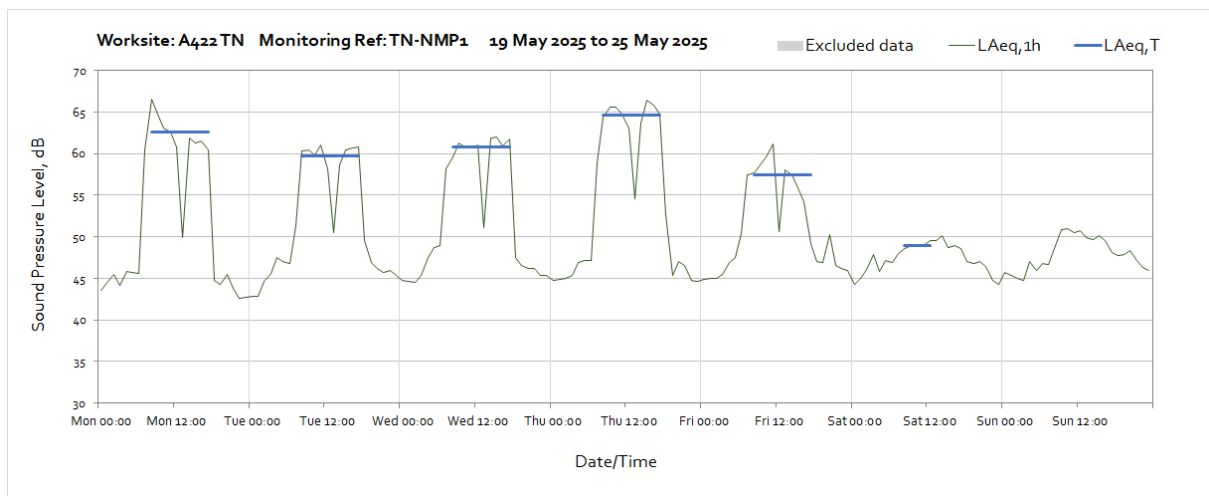
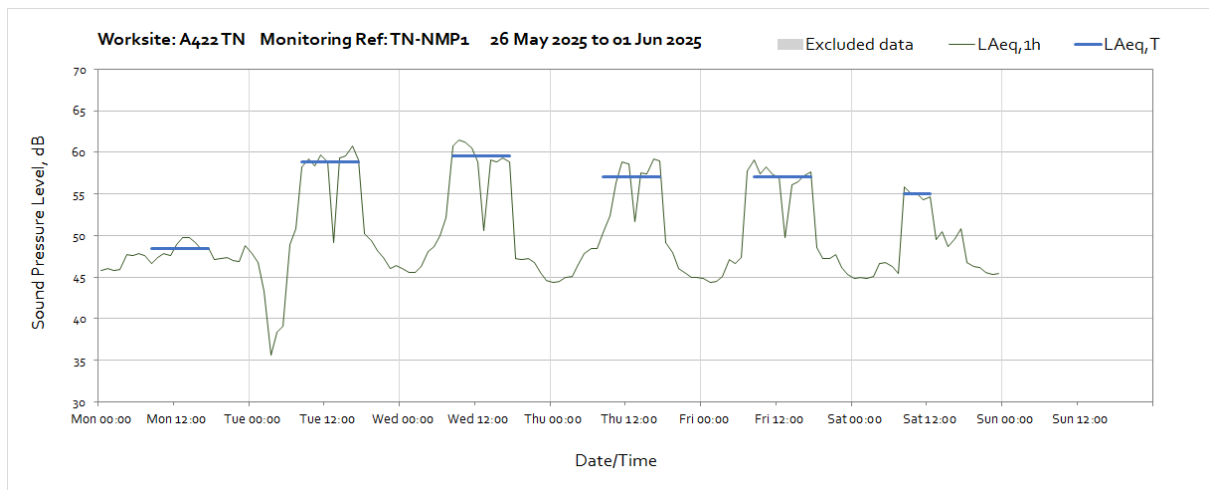
Worksite: A422 TN – Monitoring Ref: TN-NMP1

- Noise and vibration were undertaken in the vicinity of A422 Turweston North worksite (ref.: A422 TN), where overbridge construction and earthworks were underway.

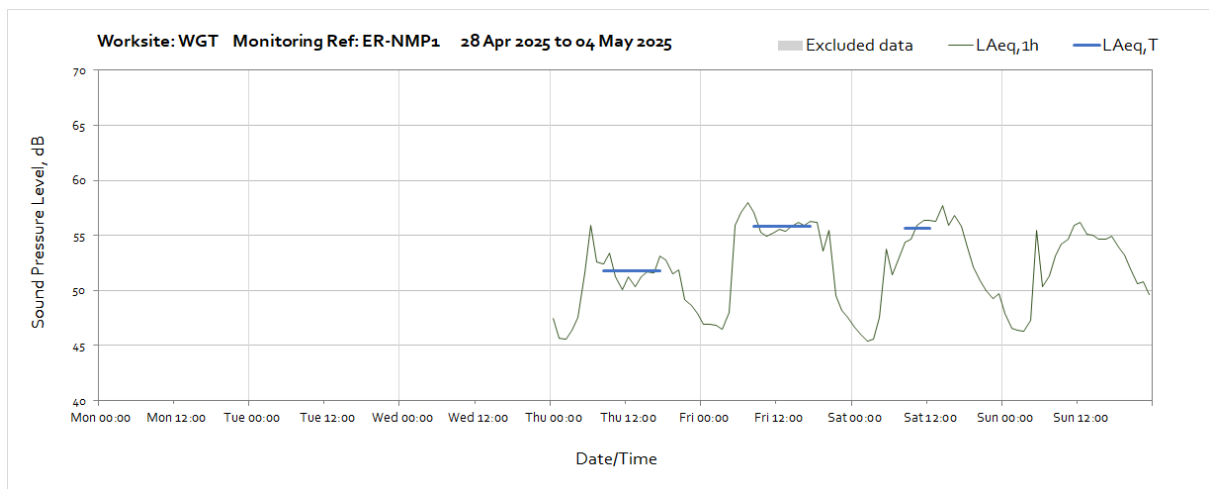
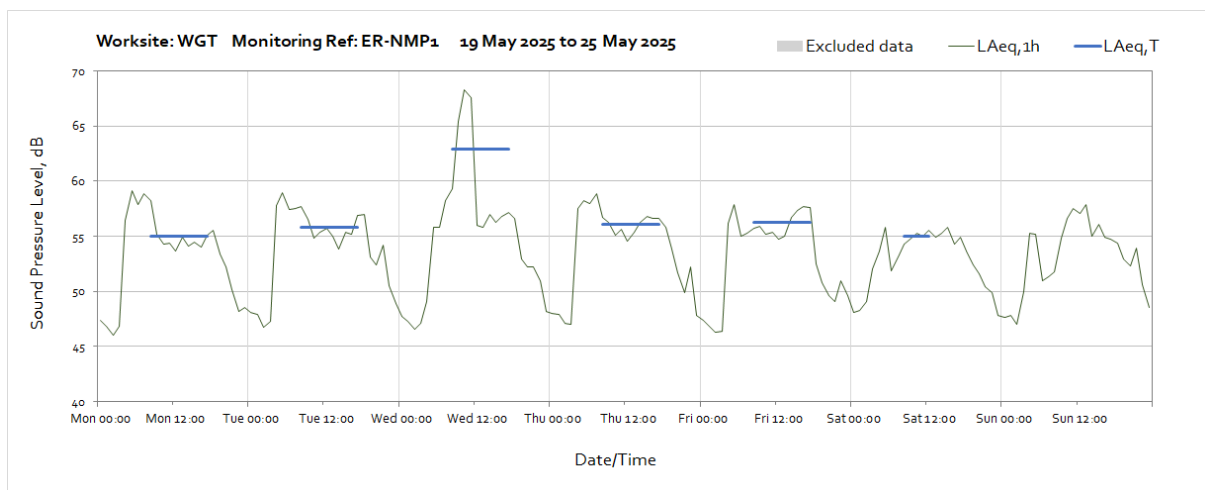
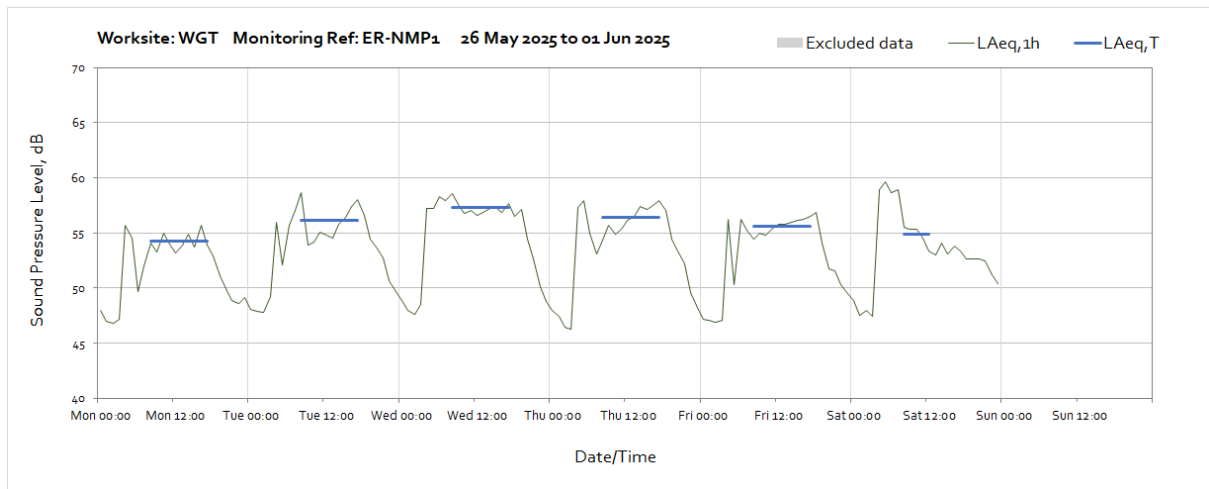
Worksite: WGT – Monitoring Ref: ER-NMP1

Note: Missing data between 13:00 and 14:00 on Tuesday 13th May was due to monitor maintenance.

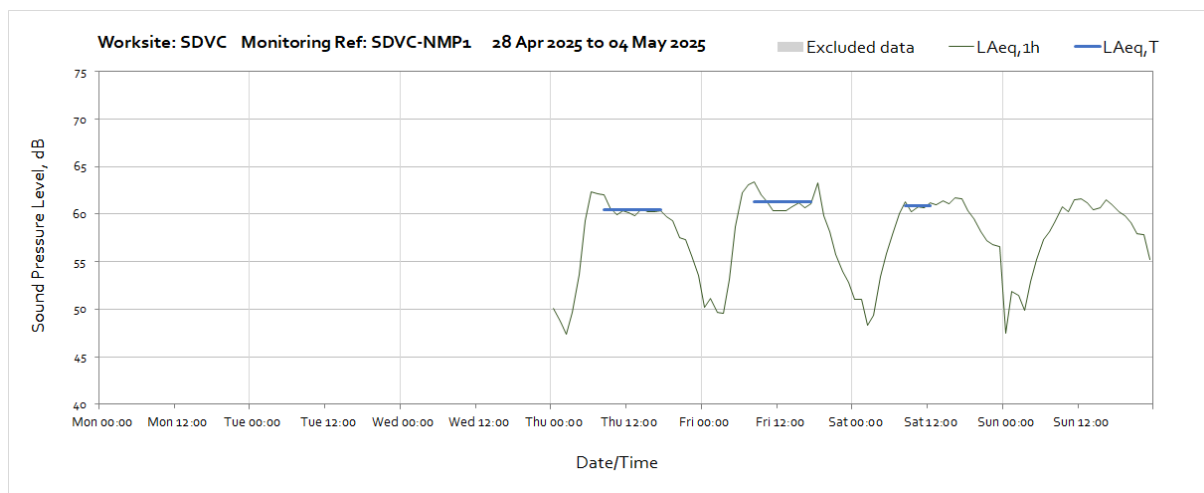
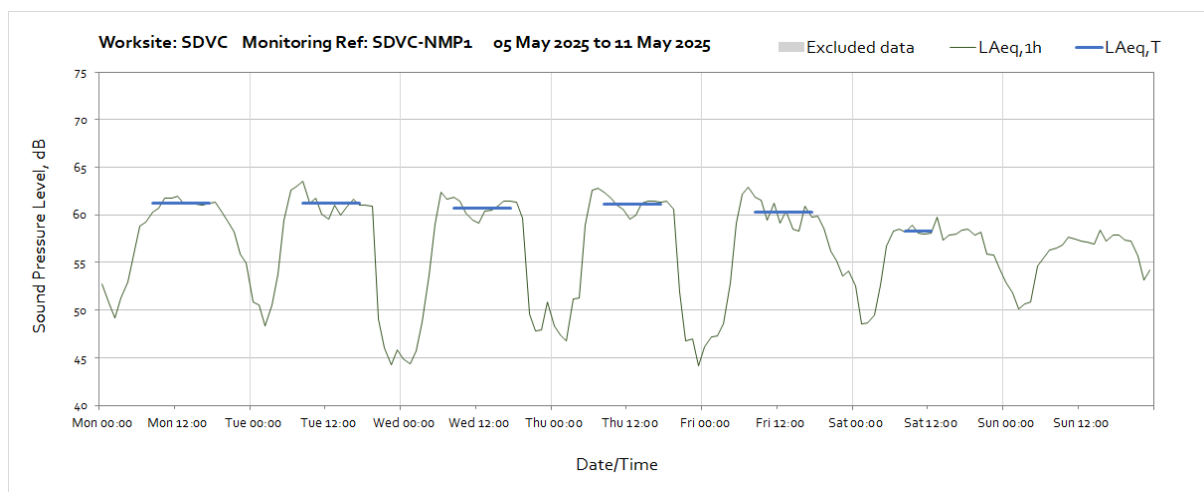
Worksite: SDVC – Monitoring Ref: SDVC-NMP1

Note: Missing data between 10:00 and 12:00 on Tuesday 13th May was due to monitor maintenance.

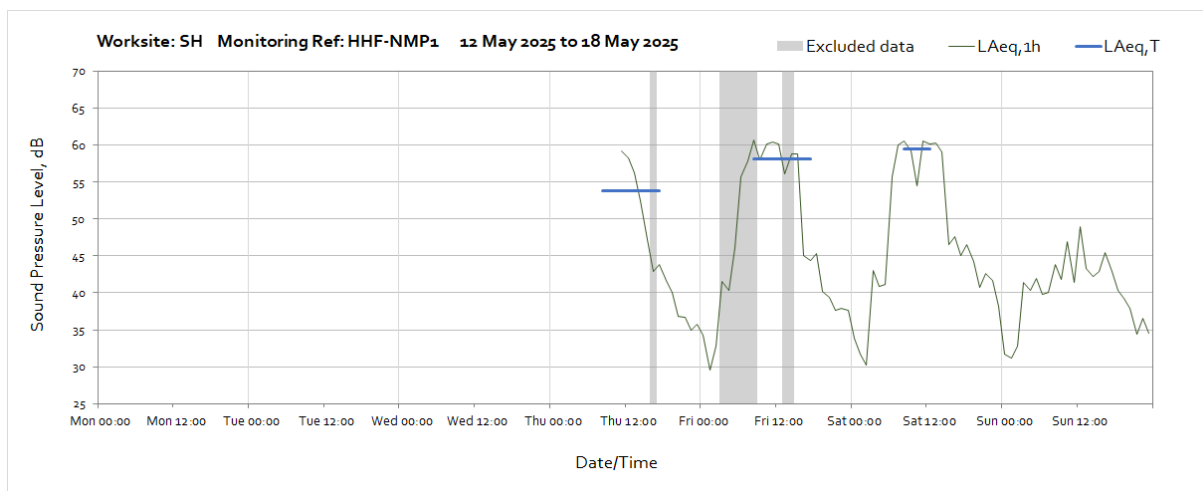
Worksite: SH – Monitoring Ref: HHF-NMP1

Note: Monitor was installed at 11:00 on Thursday 15th May.

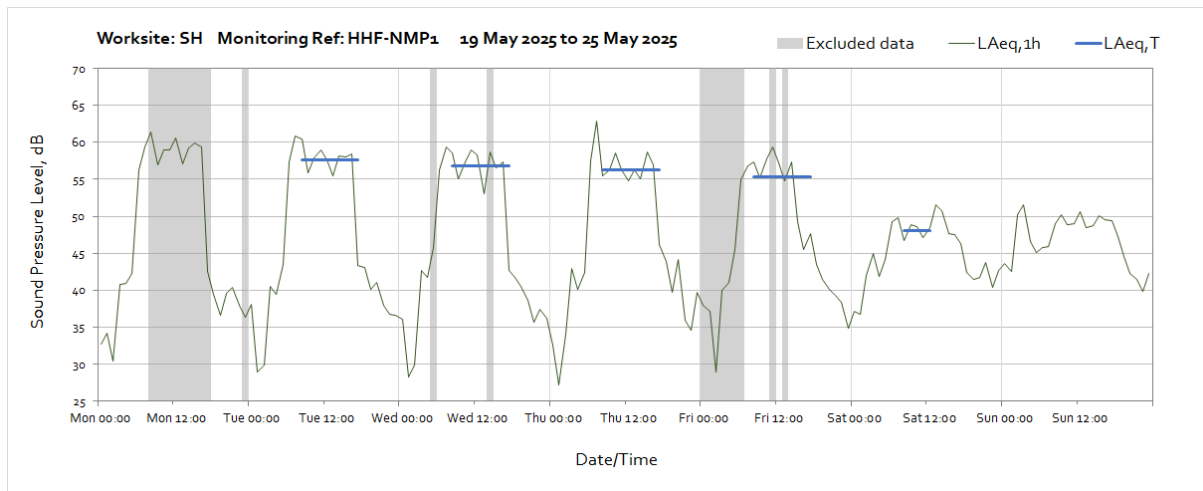
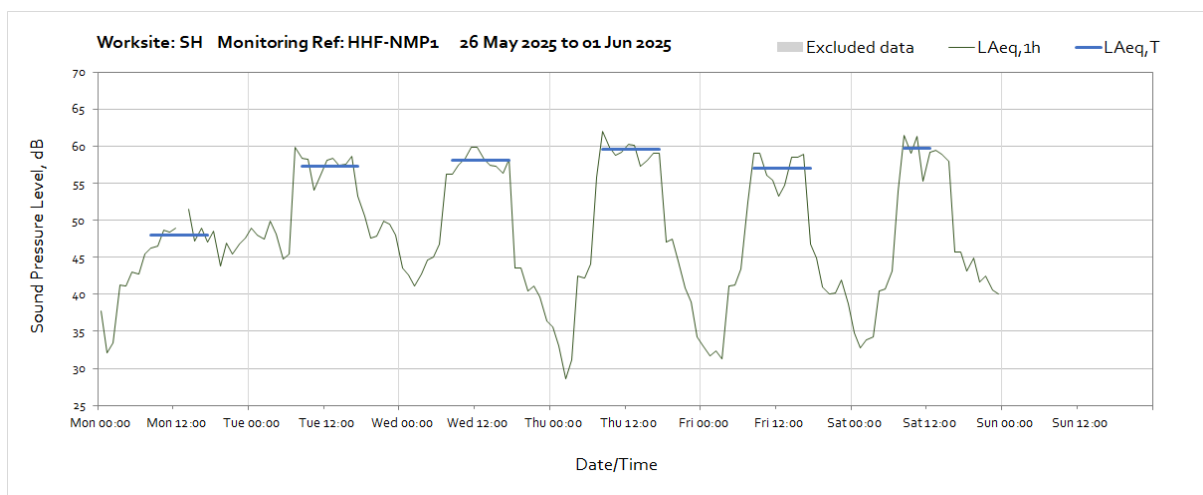
Note: Missing data between 13:00 and 14:00 on Monday 26th May was due to monitor maintenance.

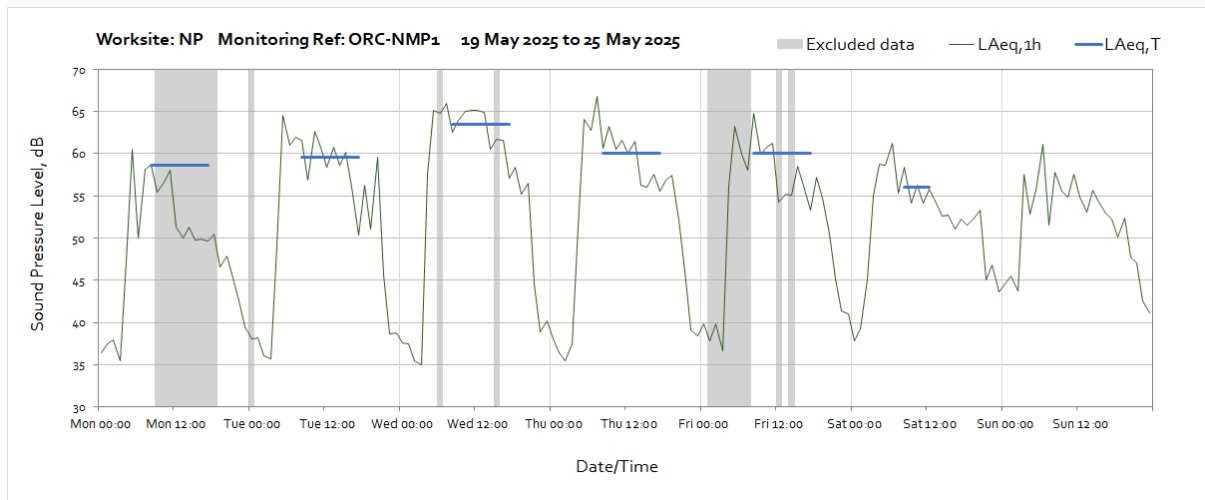
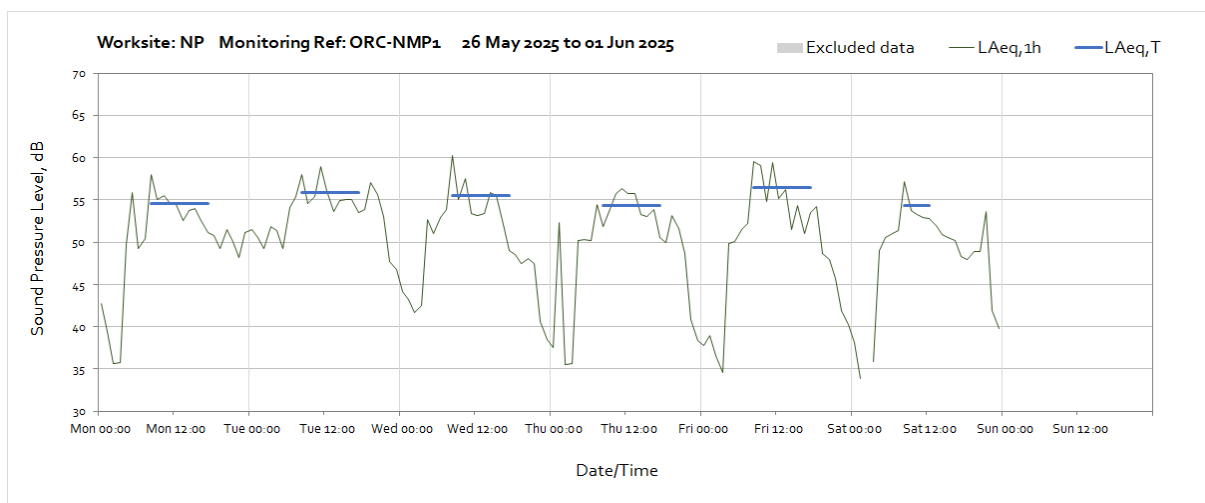
Note: Missing data between 02:00 and 03:00 on Saturday 31st May was due to a communication error between the monitoring station and server.

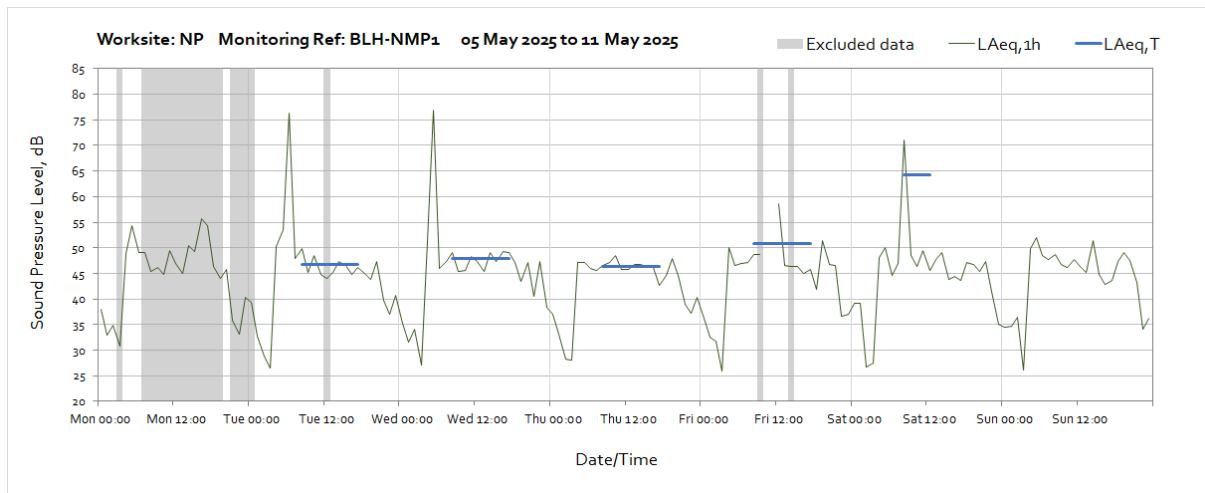
Worksite: NP – Monitoring Ref: BLH-NMP1

Note: Missing data between 10:00 and 12:00 on Friday 9th May was due to replacing of monitoring station.

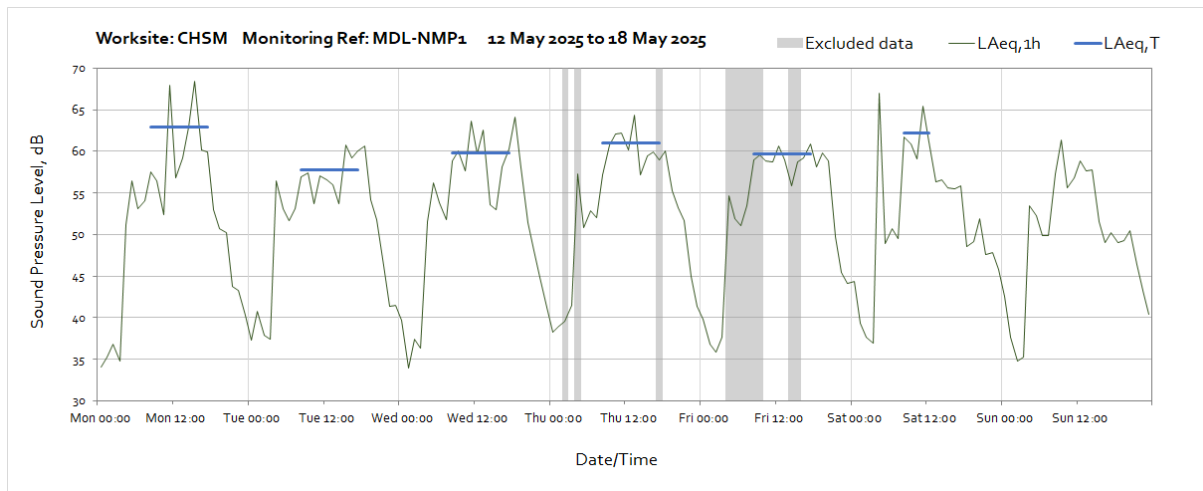
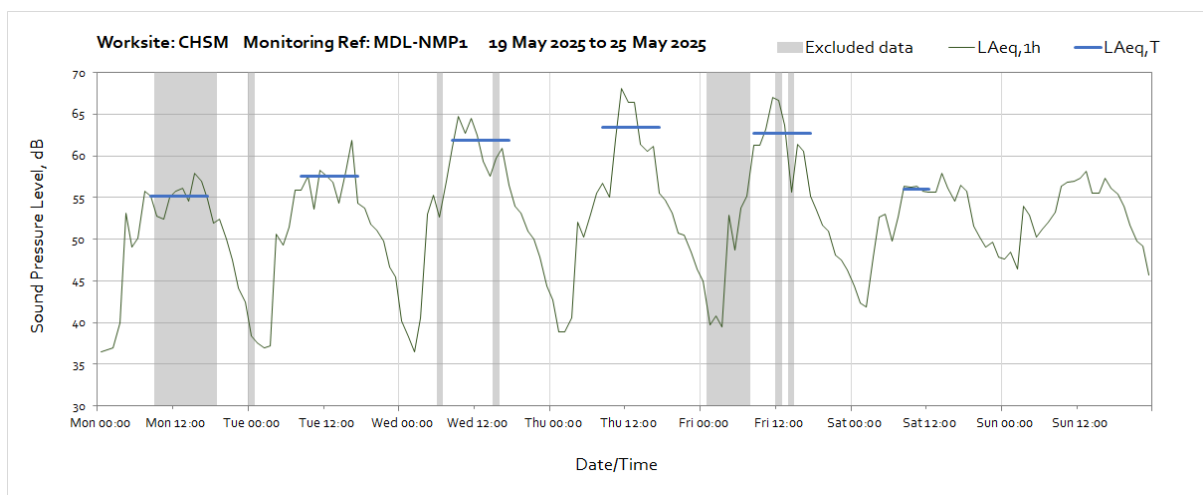
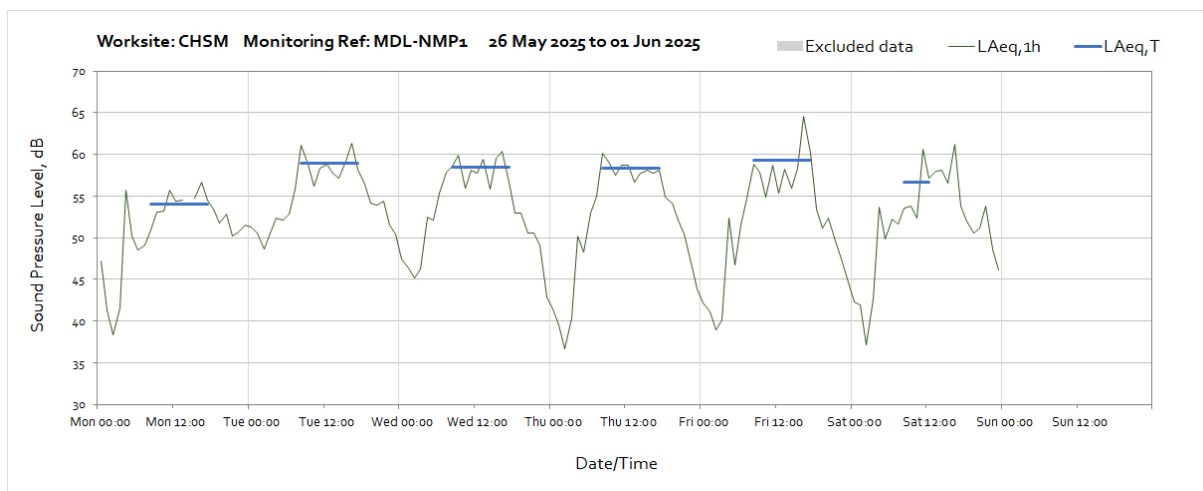
Note: Missing data between 14:00 and 15:00 on Monday 26th May was due to monitor field calibration.

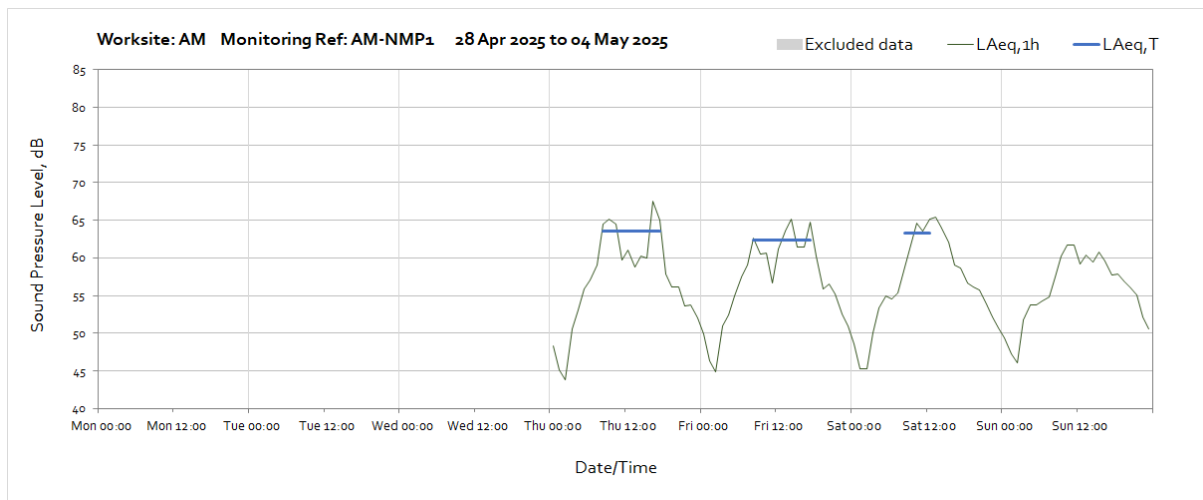
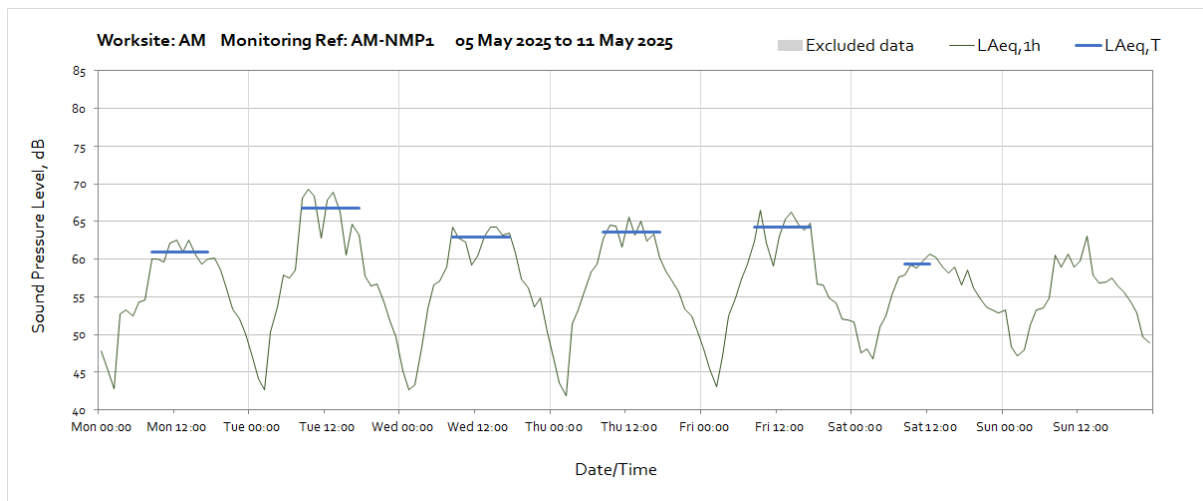
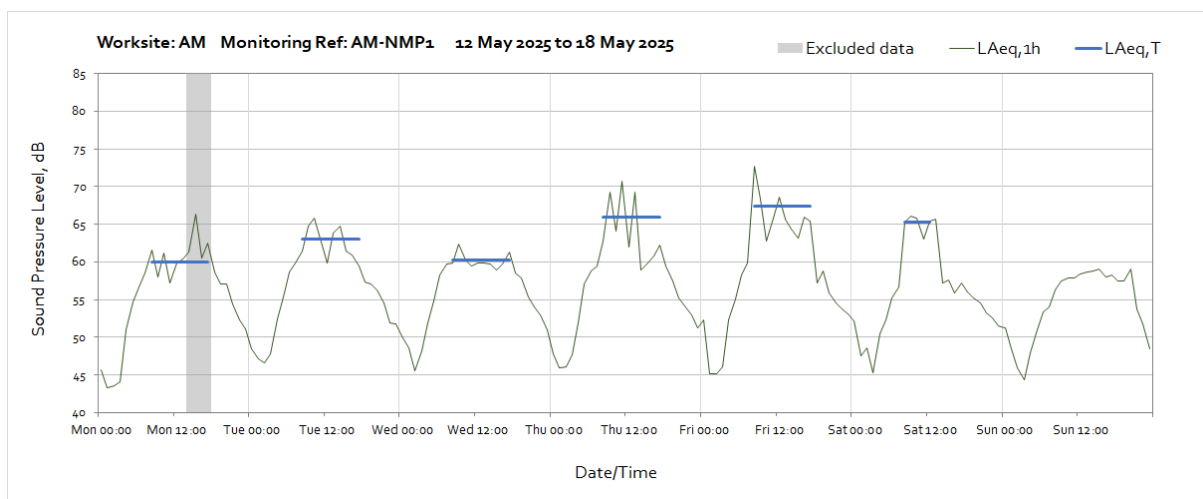
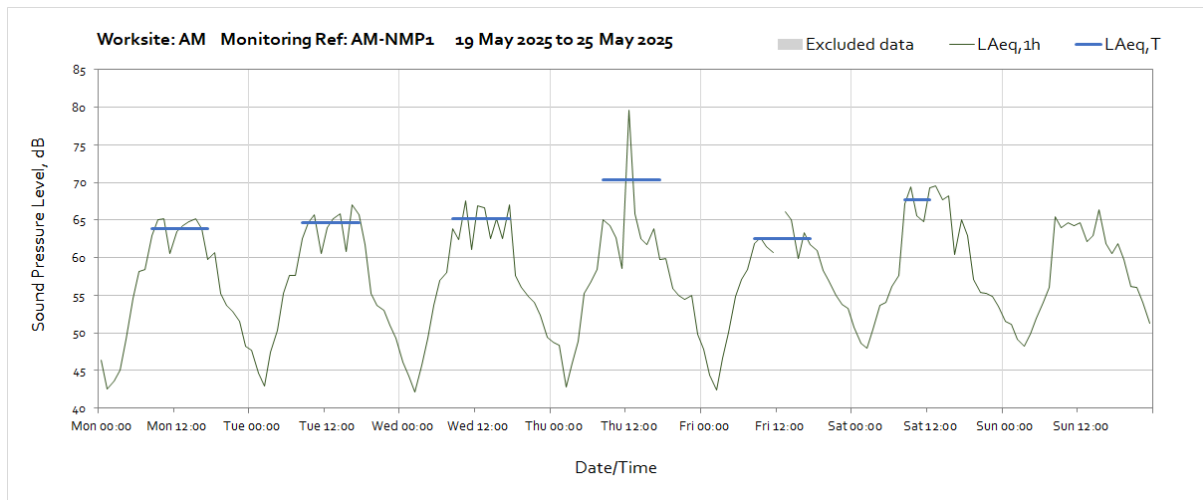
Worksite: AM – Monitoring Ref: AM-NMP1

Note: Missing data between 12:00 and 13:00 on Friday 23rd May was due to was due to a communication error between the monitoring station and server.
