Construction Noise and Vibration Monthly Report – May 2025

Buckinghamshire

Non-Technical Summary

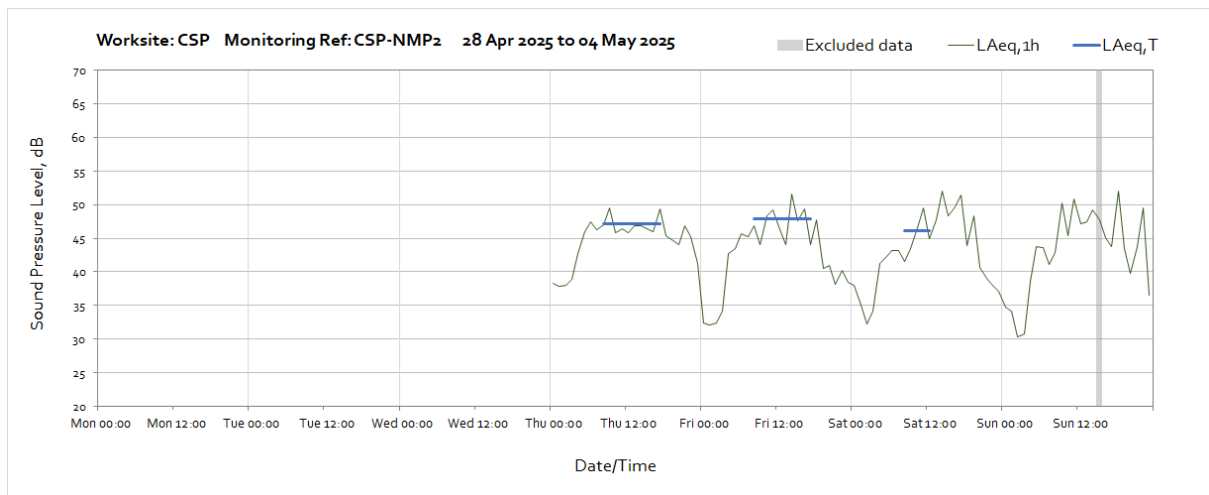
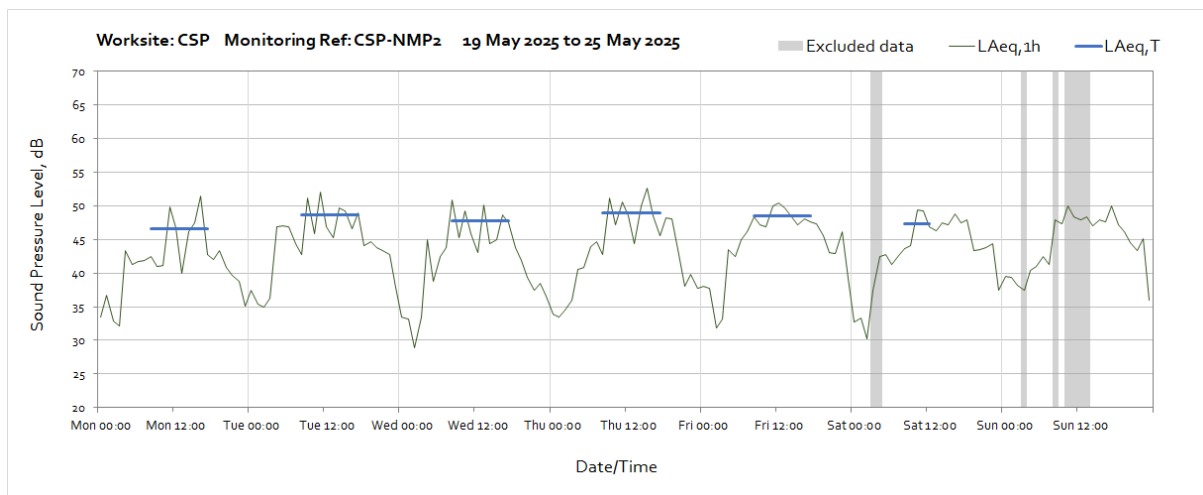
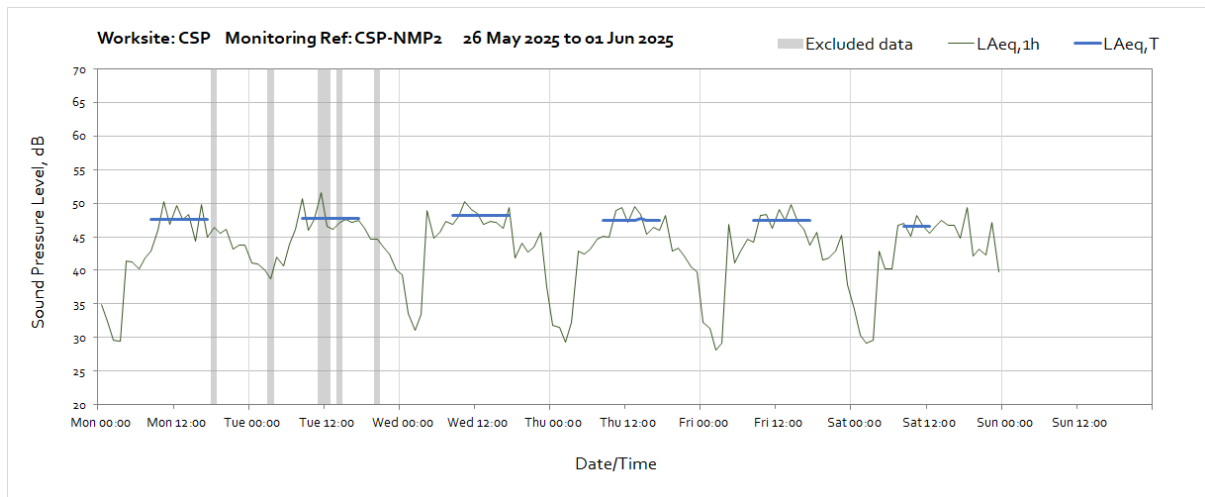
Worksite: CSP – Monitoring Ref: CSP-NMP2

Note: Missing data between 12:00 and 16:00 on Thursday 15th May was due to replacing of monitoring station.

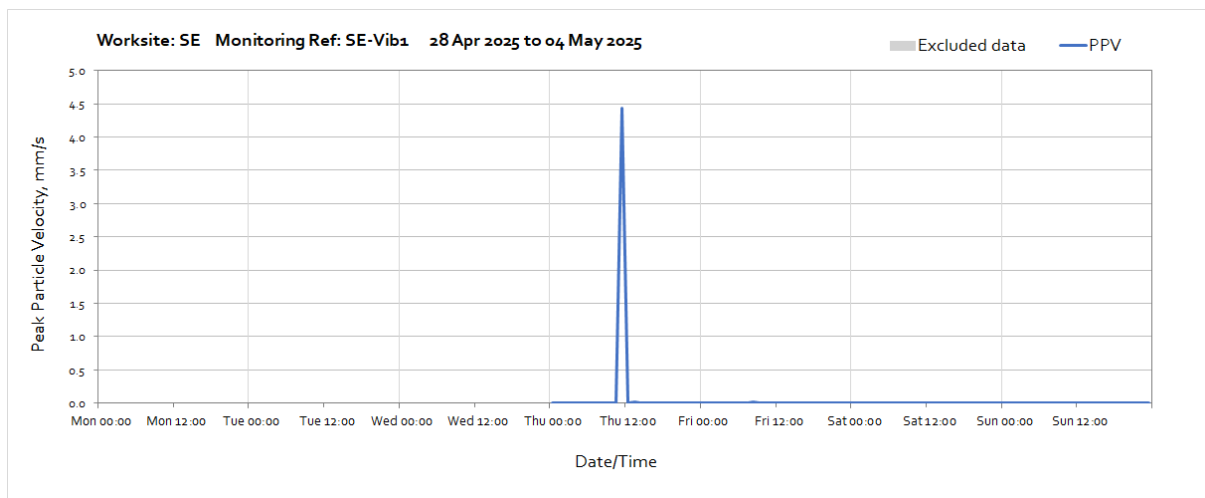
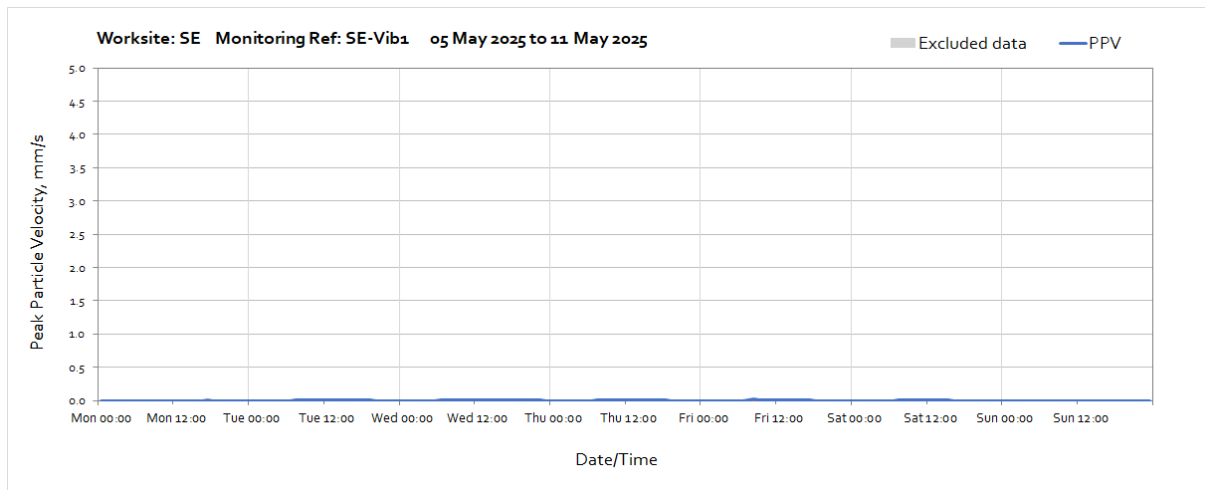
Worksite: SE – Monitoring Ref: SE-Vib1

The following graphs show the hourly measured peak particle velocity PPV recorded during the monitoring period. The graphs show the highest PPV of the three orthogonal axes x, y and z. Periods where PPV values have been affected by local interference with the vibration monitor or only measured for part of the period, which are not representative of HS2 construction works, have been greyed out and excluded when calculating values in Table 4 of the main report.

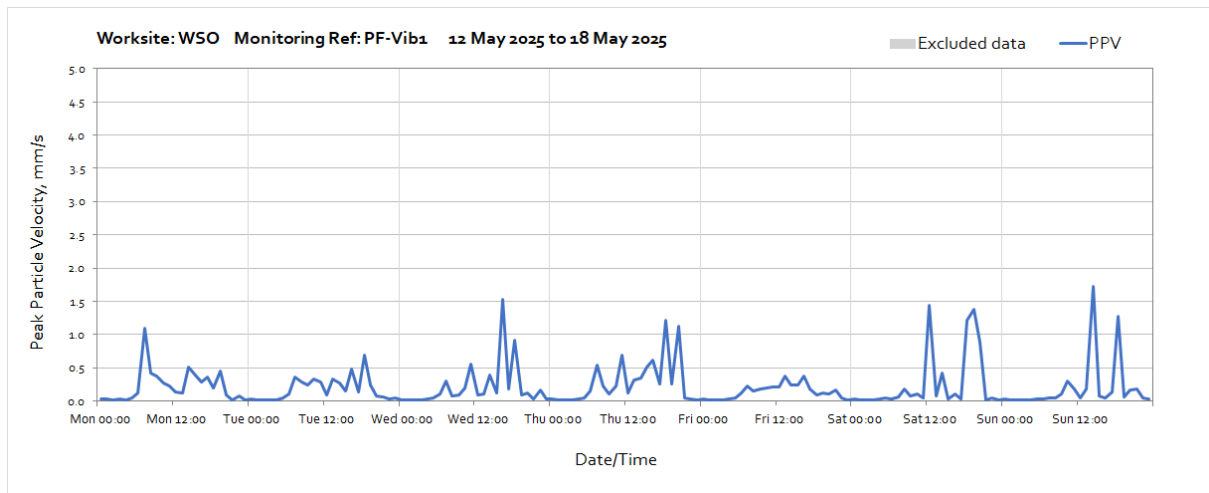
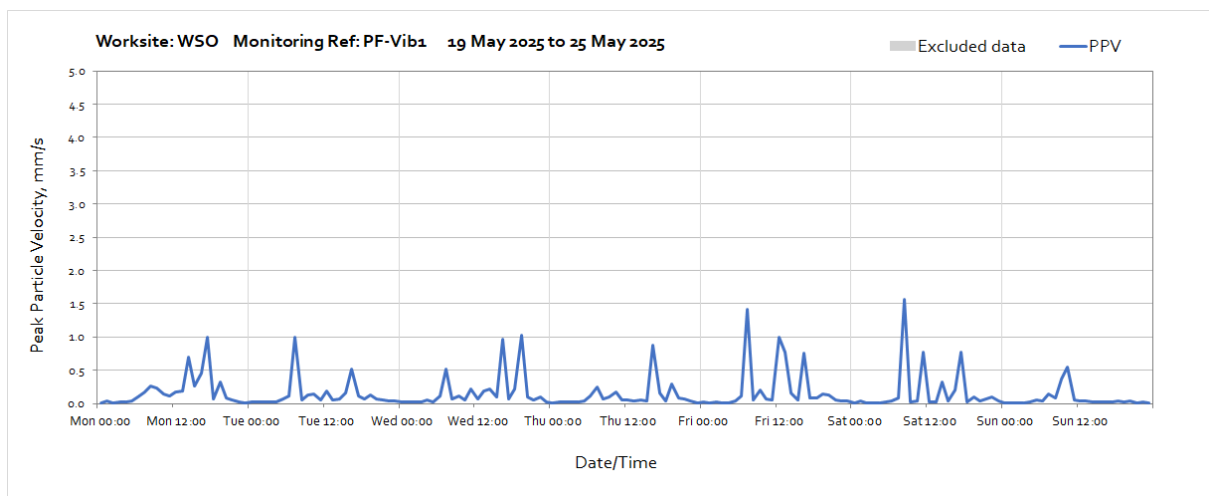
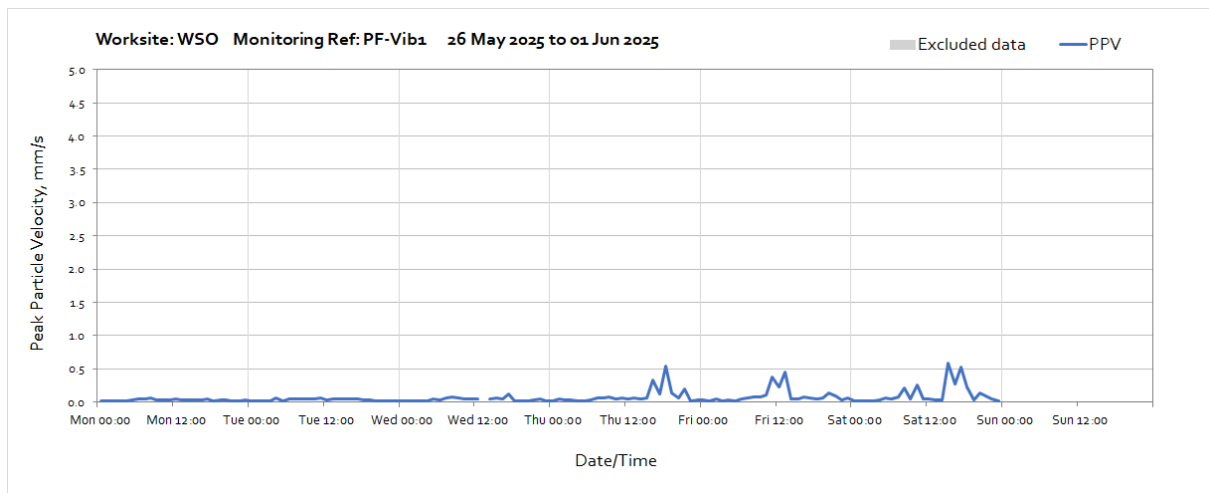
Worksite: WSO – Monitoring Ref: PF-Vib1

Note: Missing data between 13:00 and 14:00 on Wednesday 28th May was due to monitor maintenance.
