## **Construction Noise and Vibration Monthly Report – May 2025**

**Lichfield District Council**

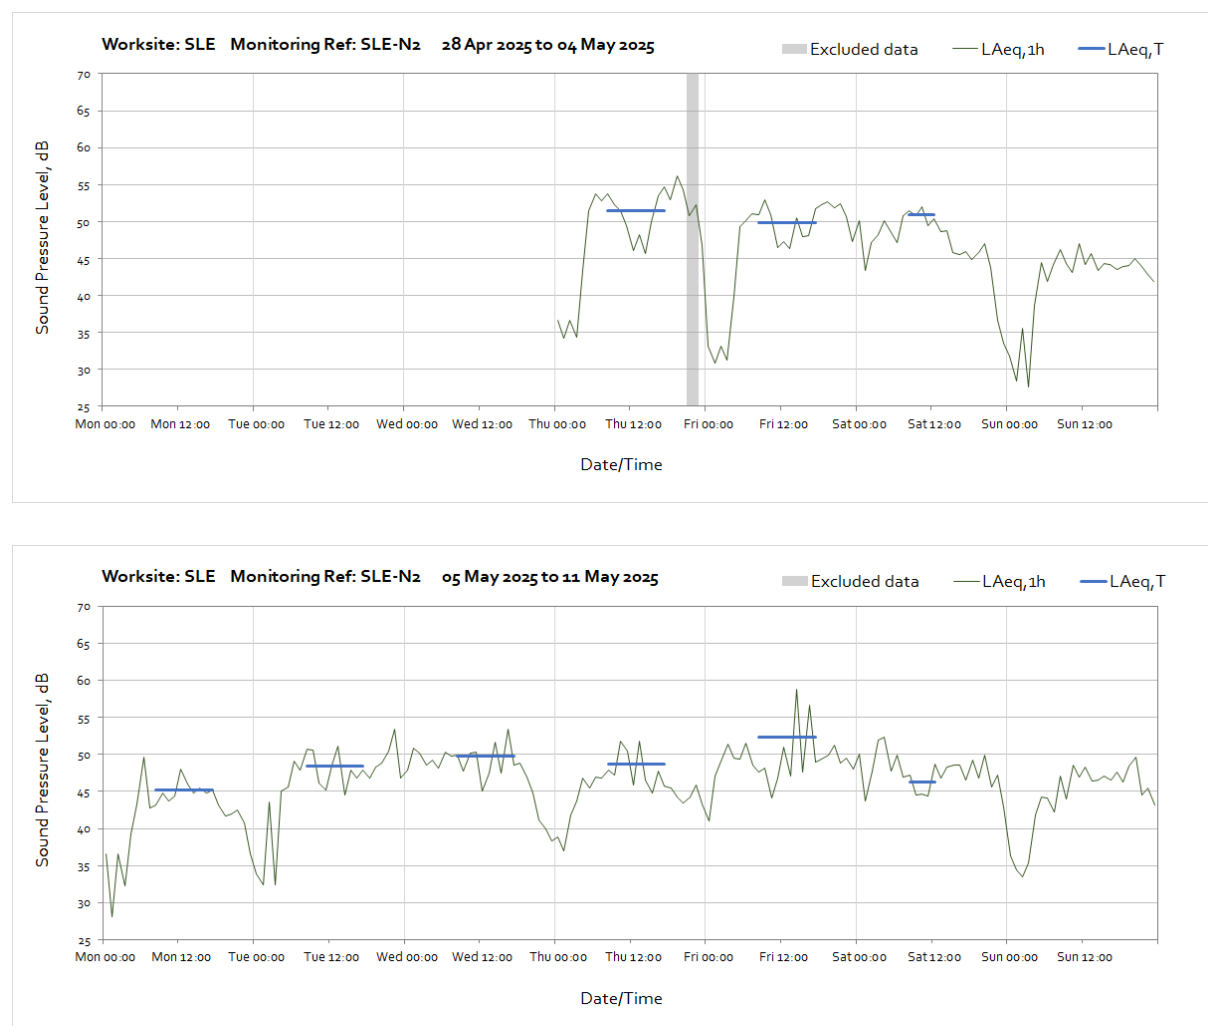
### Worksite: SLE – Monitoring Ref: SLE-N2

The following graphs show the hourly measured ambient noise level  $L_{Aeq,1h}$  and, where relevant, the averaged noise level  $L_{Aeq,T}$  values, where the time period T is as specified in Table 1 of HS2 Information Paper E23. Periods where noise levels are adversely affected by weather or only measured for part of the period, which are not representative of HS2 construction works, have been greyed out and excluded from the calculation of the  $L_{Aeq,T}$  values in Table 3 of the main report.
