## Coal Mining Risk Assessment

66 Church Road

Report Ref: B4918/25

April 2025

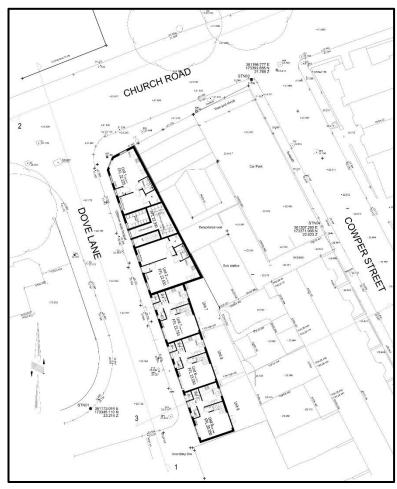
Figure 1 – Proposed Development Details

1.3 It is proposed to build new residential development on the site. The proposed development details are shown in Figure 1 below.

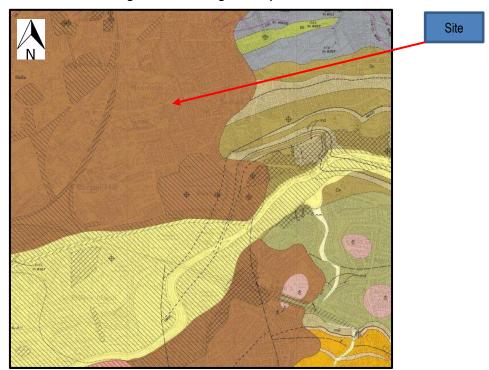
Figure 3 – Geological Map Extract

- 3.1 The geology of the site has been determined from acquisition of geological maps for the area and examination of Coal Authority records.
- 3.2 The British Geological Survey (BGS) map indicates the site is directly underlain by the Redcliffe Sandstone Member of Triassic age, which unconformably overlies Coal Measures strata at depth. The Redcliffe Sandstone Member is described as distinctive fine to medium grained, deep red, calcareous and ferruginous sandstone, commonly decalcified at shallow depths below the surface, giving rise to an uncemented sand.

- 3.3 There are no faults indicated close to the site.
- Two boreholes (ST67SW81 & ST67SW45), close to the site, shown on the BGS database, reveal Triassic sandstones near to the surface to a depth of 11.25m and 18.36m respectively.

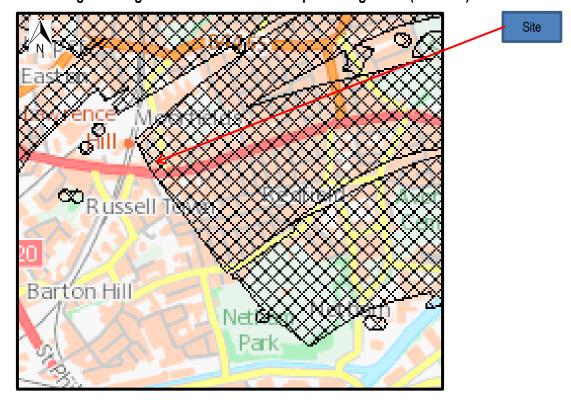
Figure 4 – Drawing Showing Site Location and Development High Risk (Hatched) Area

- 3.7 The site is within an area where the Coal Authority believes there is coal at or close to the surface which may have been worked at some time in the past. The potential presence of coal workings at or close to the surface should be considered, particularly prior to any site works or future development activity, as ground movement could still be a risk.
- 3.8 Examination of the Coal Authority online interactive map viewer indicates the site is located on the margin of a Development High Risk Area (DHRA), associated with unrecorded shallow depth working.

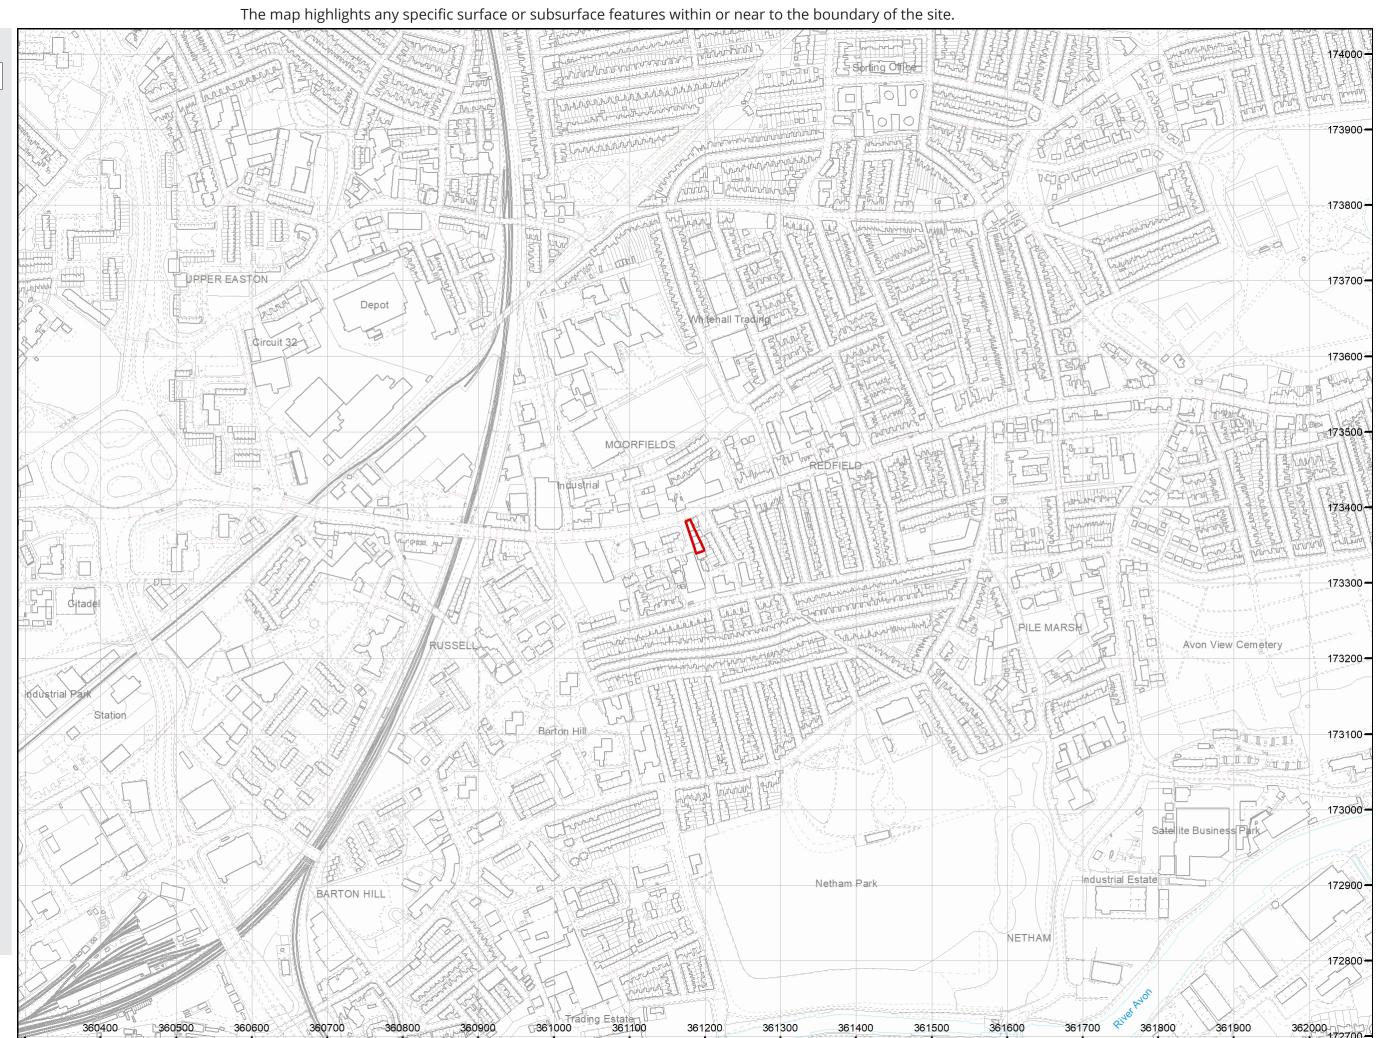
# Summary of findings

Approximate position of the enquiry boundary shown
