Construction noise and vibration Monthly Report – June 2025

London Borough of Hillingdon

This Noise and Vibration Monitoring Report fulfils HS2 Limited's commitment detailed in the Environmental Minimum Requirements (EMRs), Annex 1, Code of Construction Practice, to present the results of noise monitoring carried out within the London Borough of Hillingdon during the month of June 2025.

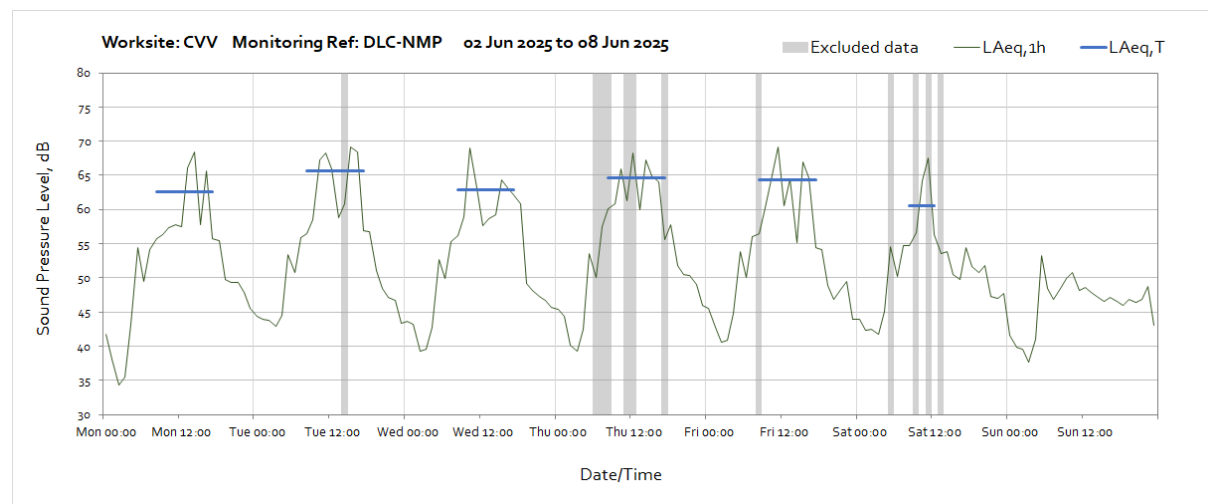
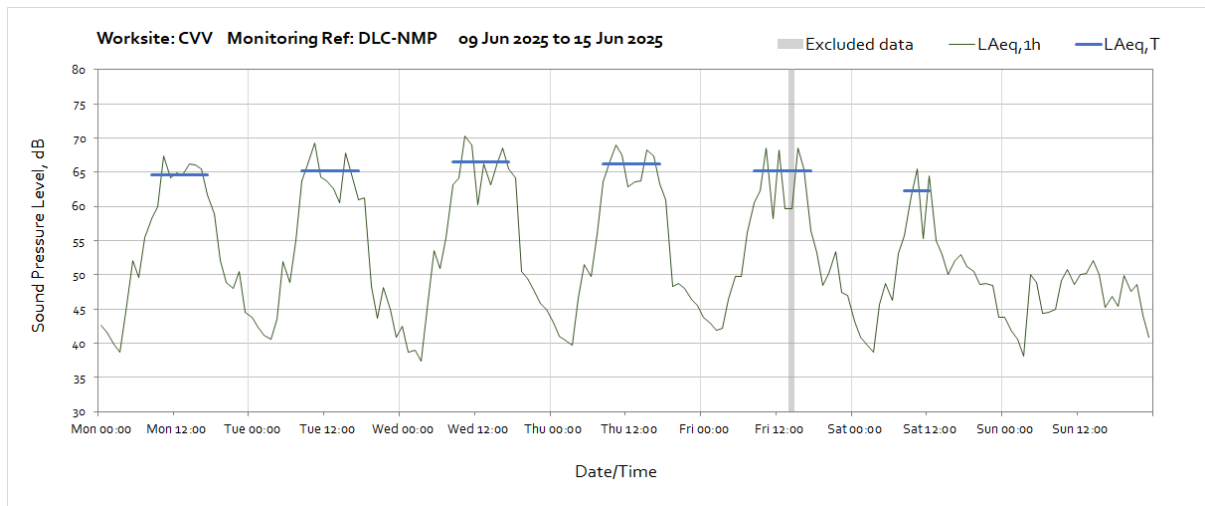
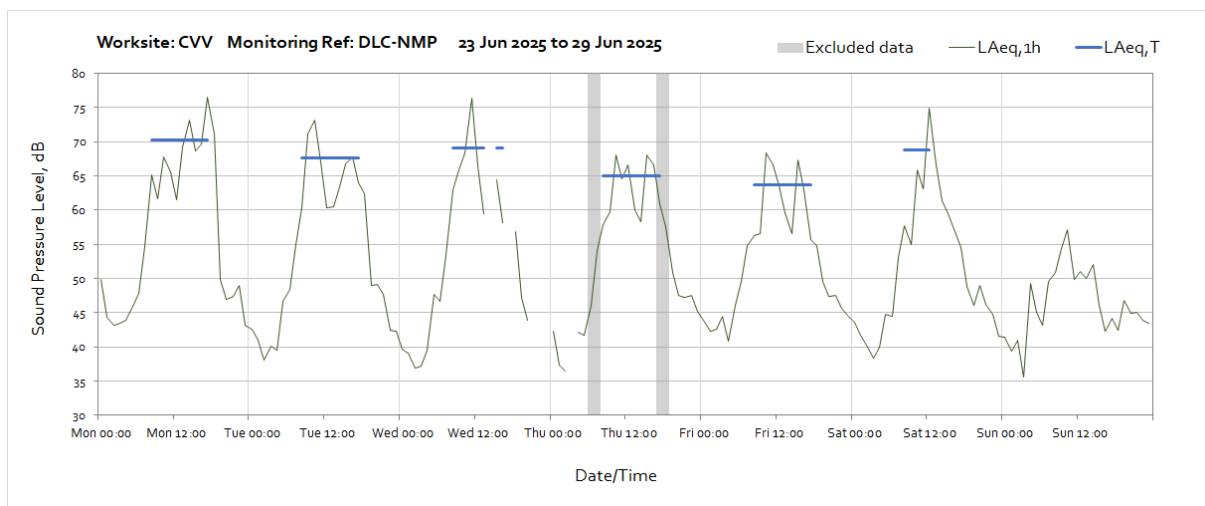
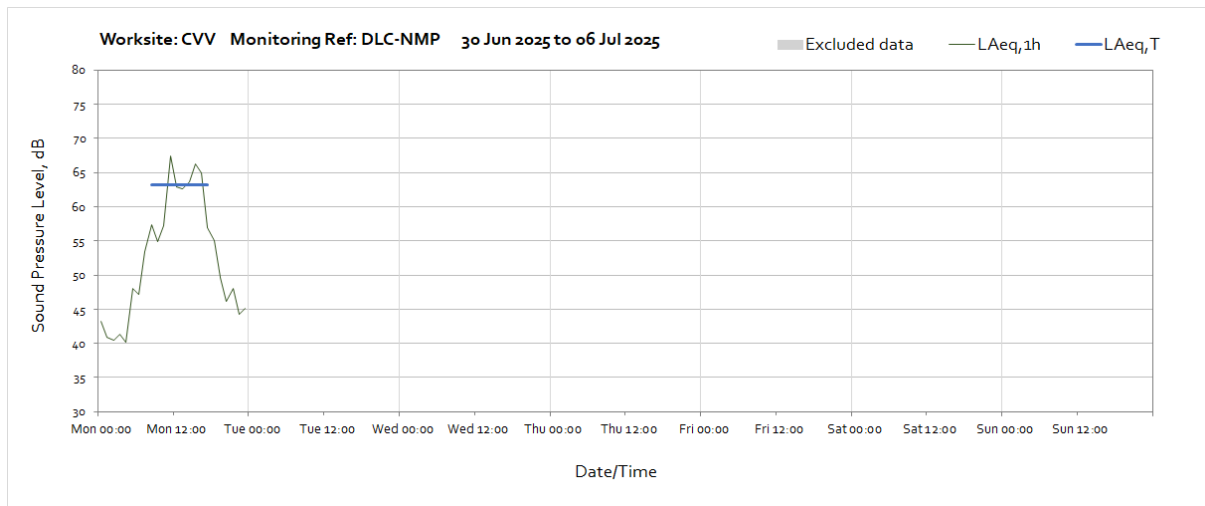
Worksite: CVV – Monitoring Ref: DLC-NMP

The following graphs show the hourly measured ambient noise level $L_{Aeq,1h}$ and, where relevant, the averaged noise level $L_{Aeq,T}$ values, where the time period T is as specified in Table 1 of HS2 Information Paper E23. Periods where noise levels are adversely affected by weather or only measured for part of the period, which are not representative of HS2 construction works, have been greyed out and excluded from the calculation of the $L_{Aeq,T}$ values in Table 3 of the main report.

Note: Missing data throughout Wednesday 25th June and Thursday 26th June was due to a communication error between the monitoring station and server.

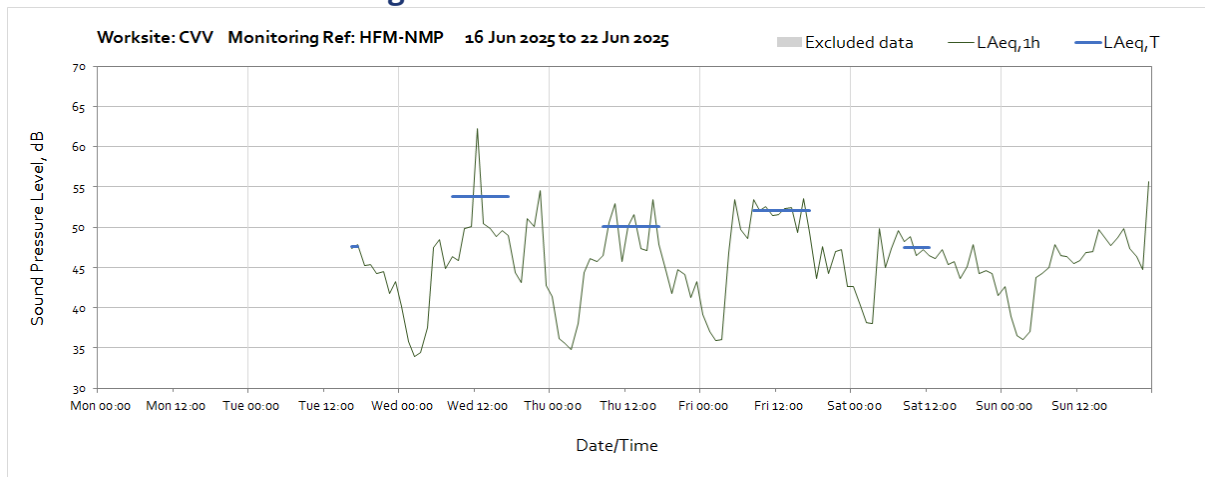
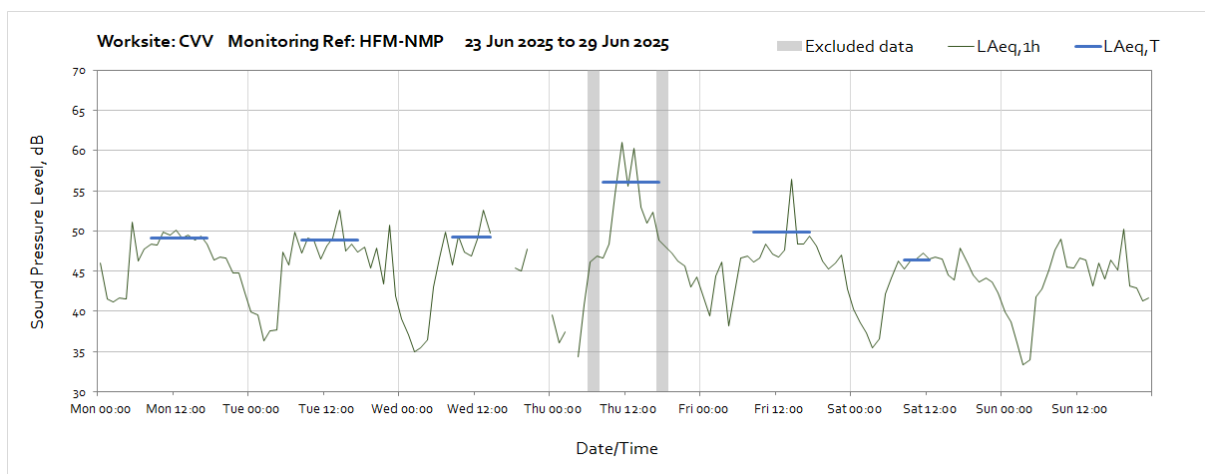
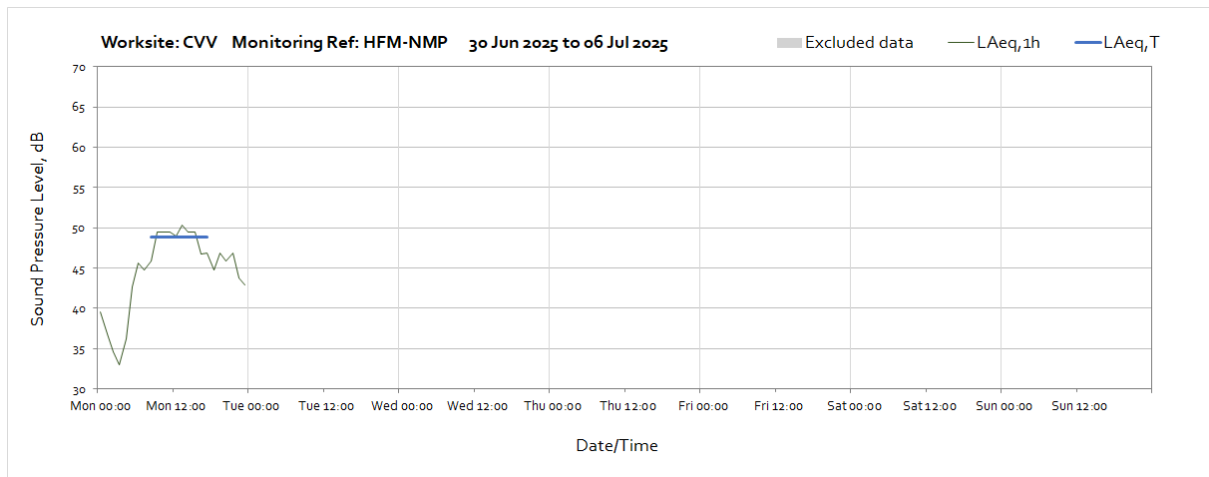
Worksite: CVV – Monitoring Ref: HFM-NMP

Note: Missing data between beginning of the month and 16:00 on Tuesday 17th June was due to loss of solar power.

Note: Missing data throughout Wednesday 25th June and Thursday 26th June was due to a communication error between the monitoring station and server.

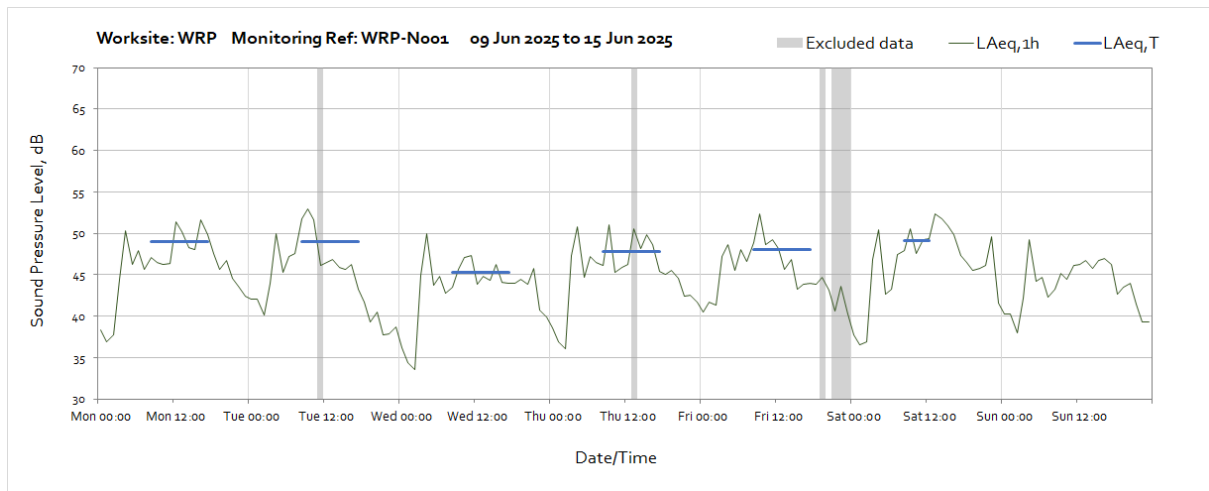
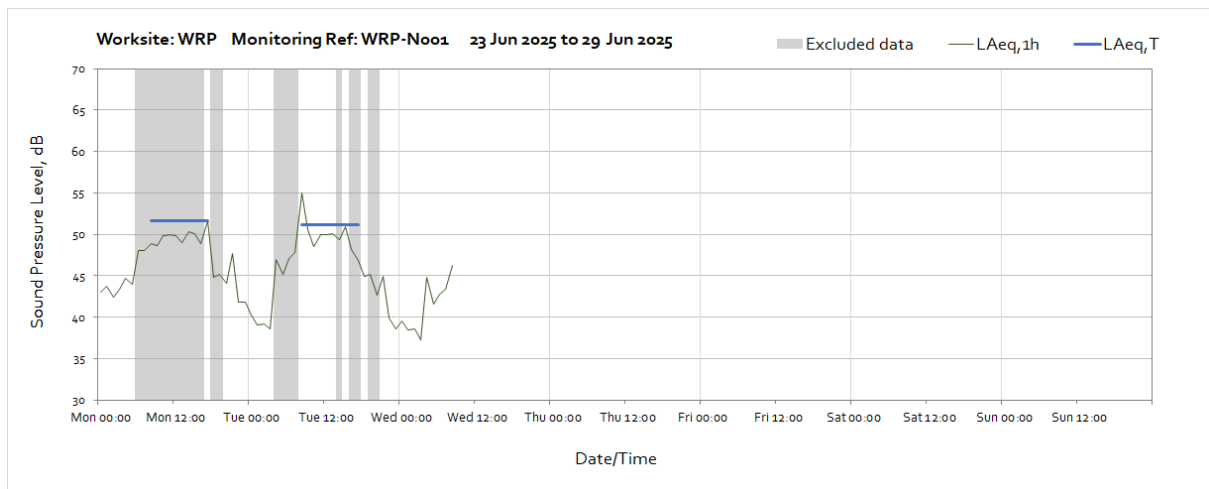
Worksite: WRP – Monitoring Ref: WRP-N001

Note: Missing data between 09:00 on Wednesday 25th June and the month end was due to an internal issue related to a SIM card fault.
