# **Construction Noise and Vibration Monthly Report – June 2025**

**Lichfield District Council**

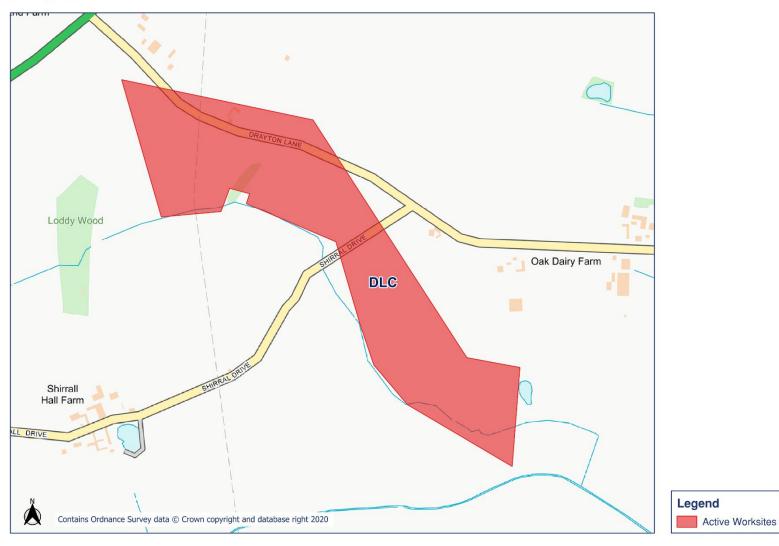
#### **Worksite Identification Plan - 6**

- Water diversion.
- Trunk's Road ref: N23 (see Works Identification Plan 6 in Appendix A), where work activities included:
  - o Piling.
  - o Demobilisation.

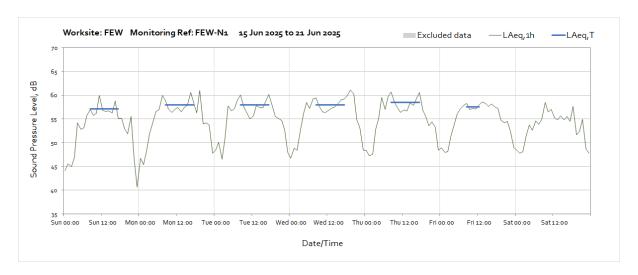
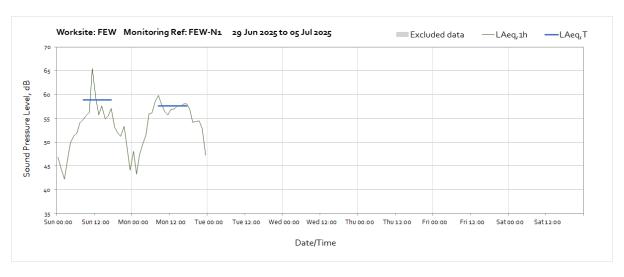
#### Worksite: FEW - Monitoring Ref: FEW-N1

The following graphs show the hourly measured ambient noise level  $L_{Aeq,1h}$  and, where relevant, the averaged noise level  $L_{Aeq,T}$  values, where the time period T is as specified in Table 1 of HS2 Information Paper E23. Periods where noise levels are adversely affected by weather or only measured for part of the period, which are not representative of HS2 construction works, have been greyed out and excluded from the calculation of the  $L_{Aeq,T}$  values in Table 3 of the main report.

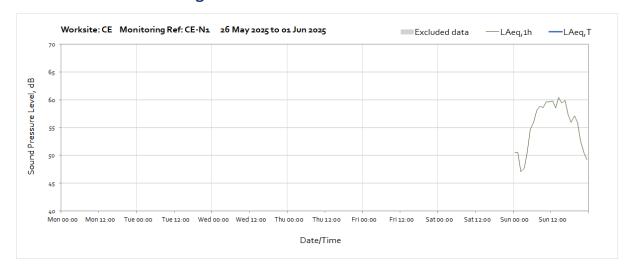
#### **Worksite: CE - Monitoring Ref: CE-N1**

Note: Monitor decommissioned at 10:00 on Wednesday 11th June.

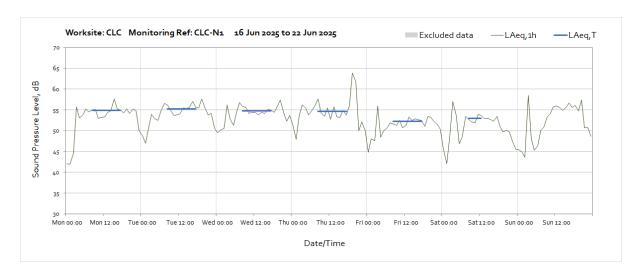
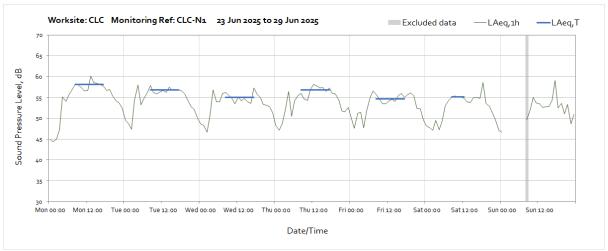
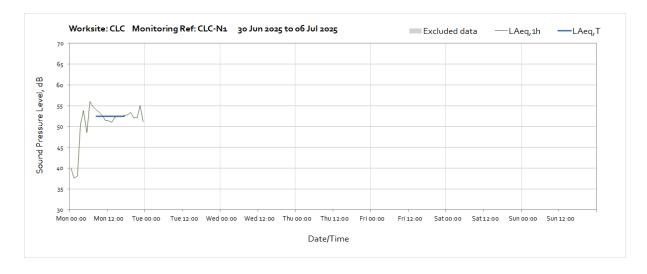
# **Worksite: CLC - Monitoring Ref: CLC-N1**

Note: Missing data between 01:00 and 07:00 on Sunday 29th June was due to a monitoring station fault.

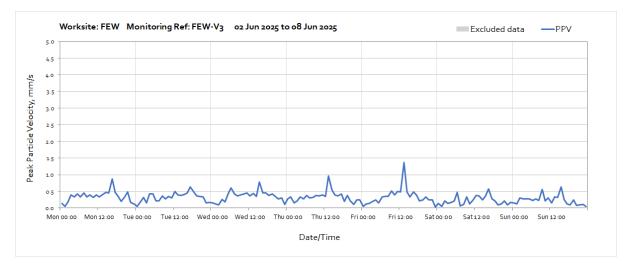
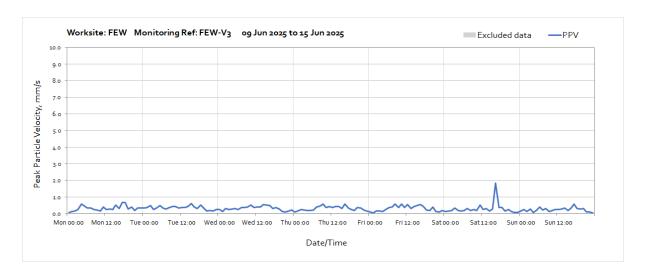
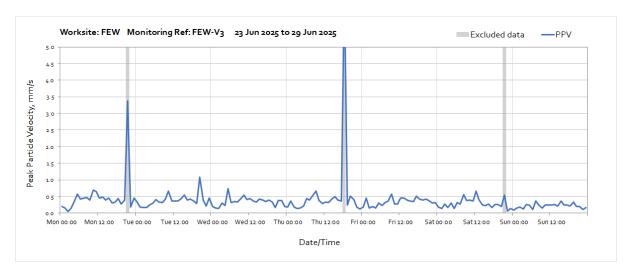
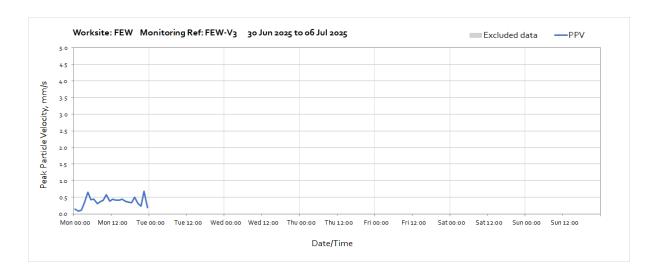
#### Worksite: FEW - Monitoring Ref: FEW-V3

The following graphs show the hourly measured peak particle velocity PPV recorded during the monitoring period. The graphs show the highest PPV of the three orthogonal axes x, y and z. Periods where PPV values have been affected by local interference with the vibration monitor or only measured for part of the period, which are not representative of HS2 construction works, have been greyed out and excluded when calculating values in Table 4 of the main report.

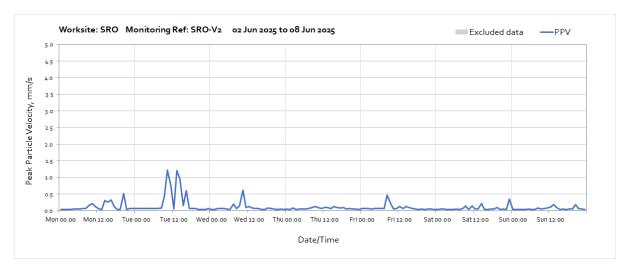
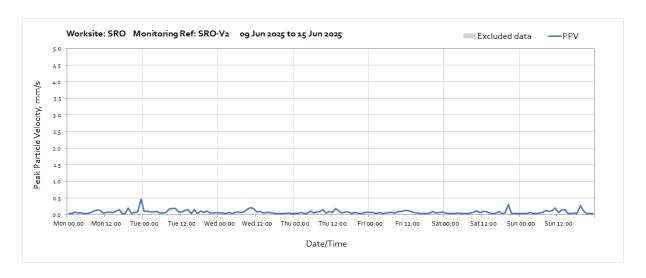
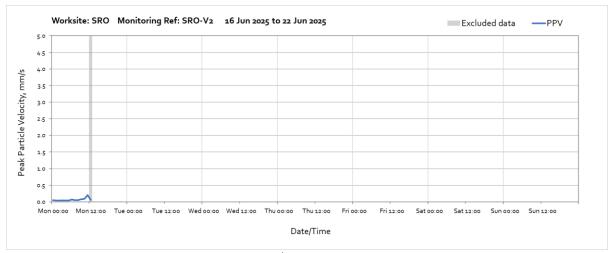
# **Worksite: SRO - Monitoring Ref: SRO-V2**

Note: Missing data between 13:00 on Monday 16<sup>th</sup> June and the end of the month was due to the monitoring station being replaced.
